**ASSESSMENT OF DRILLING & WORKOVER RIG STORM SEA  
FASTENINGS ON OFFSHORE FLOATING PLATFORMS DURING  
HURRICANE IVAN  
PHASE 1: Data Collection Report**

**E.G. Ward (OTRC) and J.M. Gebara (Technip)**

**Prepared for the Minerals Management Service**

**August 1, 2006**

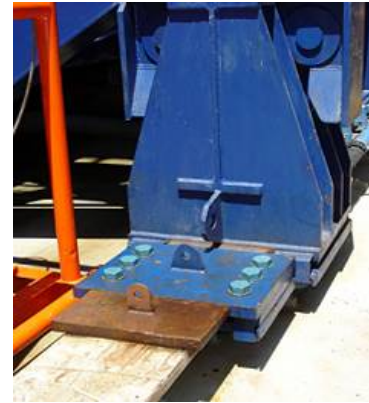
Skid Beam to Deck with Weldment Stop

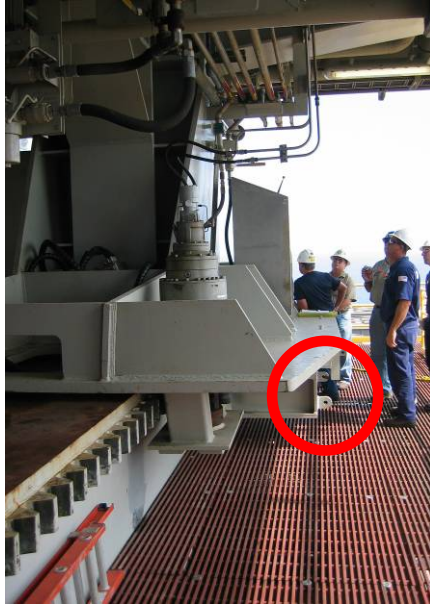
The rig skidding system on Holstein is a hydraulically driven rack and pinion system. The sea fastening system is a set of locking dogs that are forced into the cogs by locking screws. See Figures 4.

Rack & pinion system to move skid base across deck

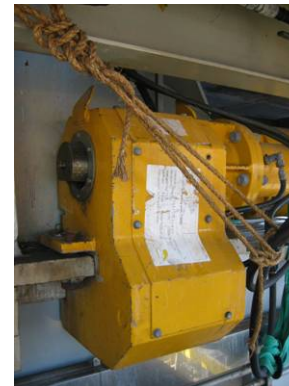
Hydraulic clamp with tapered pin

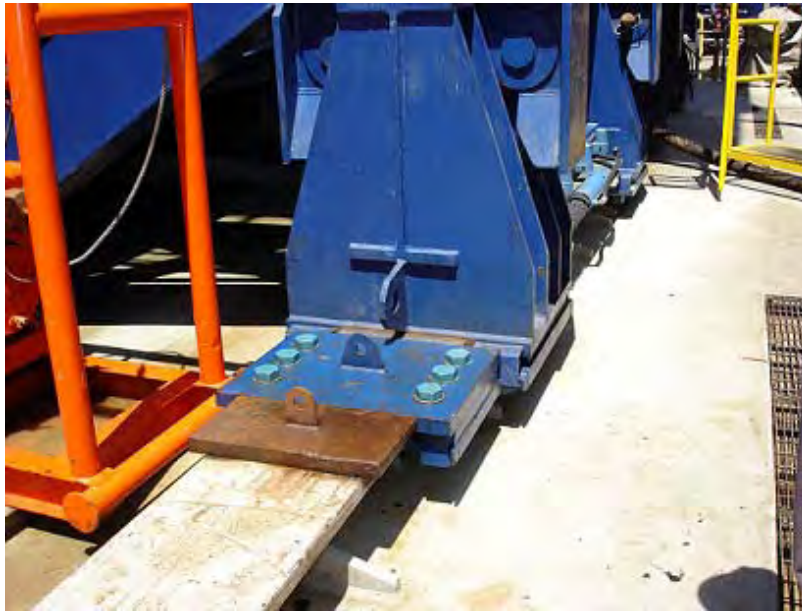
**Figure 5 - Rig Clamps on Front Runner**

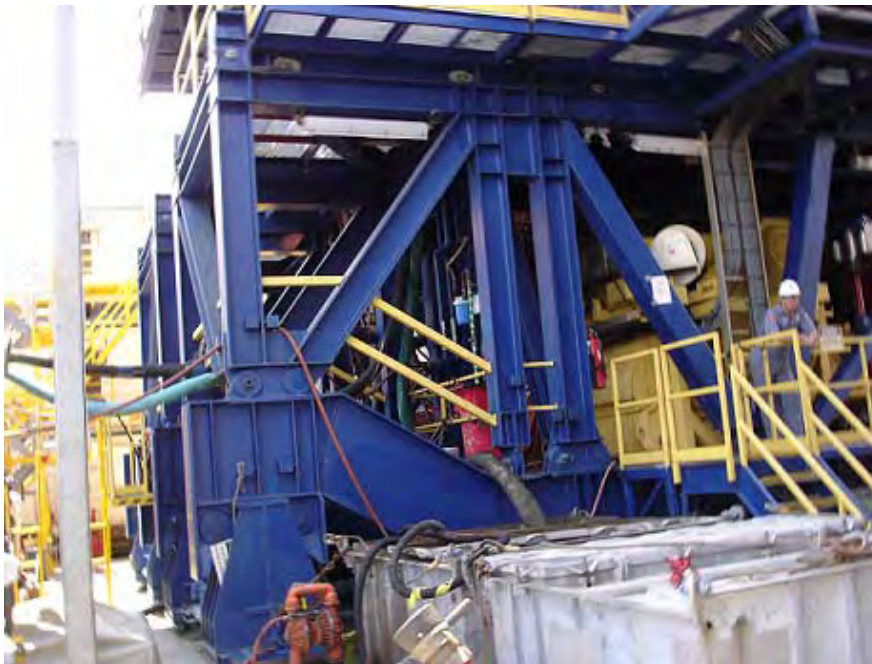
**Figure 8 - Substructure (Dynamic Base) on Front Runner**

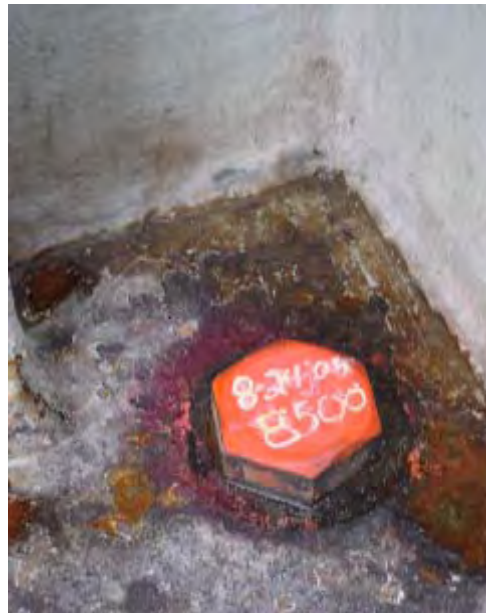
**Figure 3 – Bolt After Torque Is Complete**

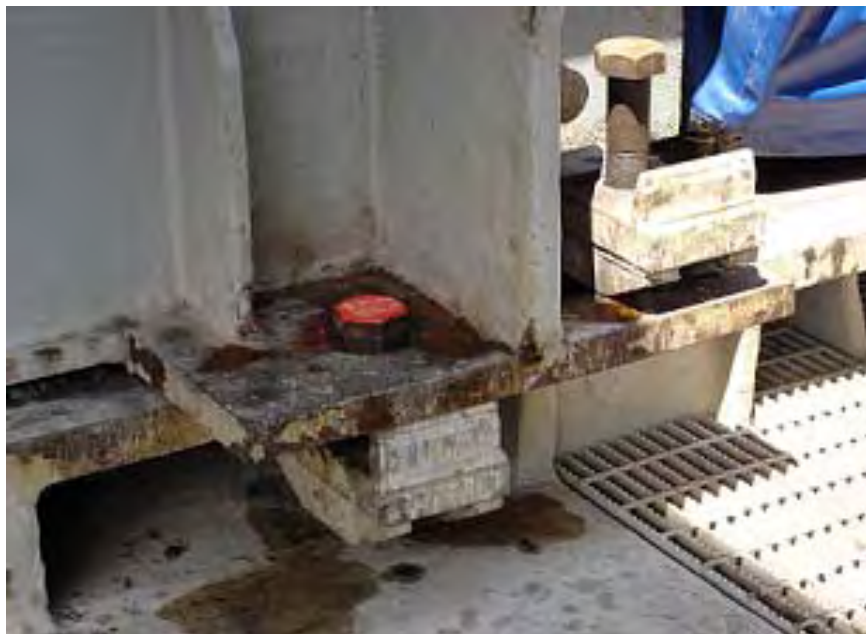
**Figure 4 – Tie-Down Bolt on Clamp**

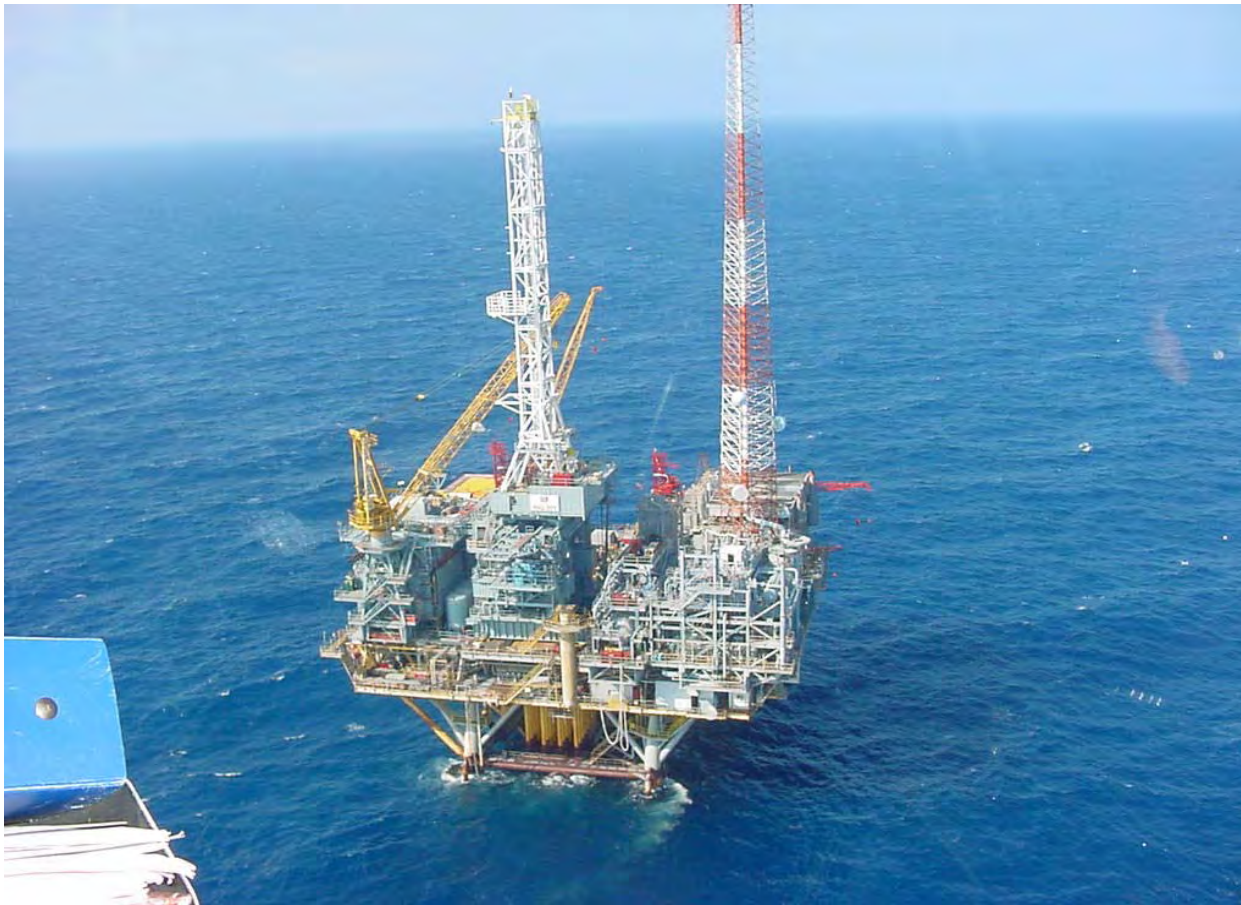
# Damage Assessments – MC 194

- Evidence of Green Water in the deck, 45 feet above the water line; platform 100 miles from the eye of the storm.
- Platform damage consisted of:
  - ❖ Missing Grating and Handrails
  - ❖ Minor Facilities equipment
  - ❖ Gaugers Shack

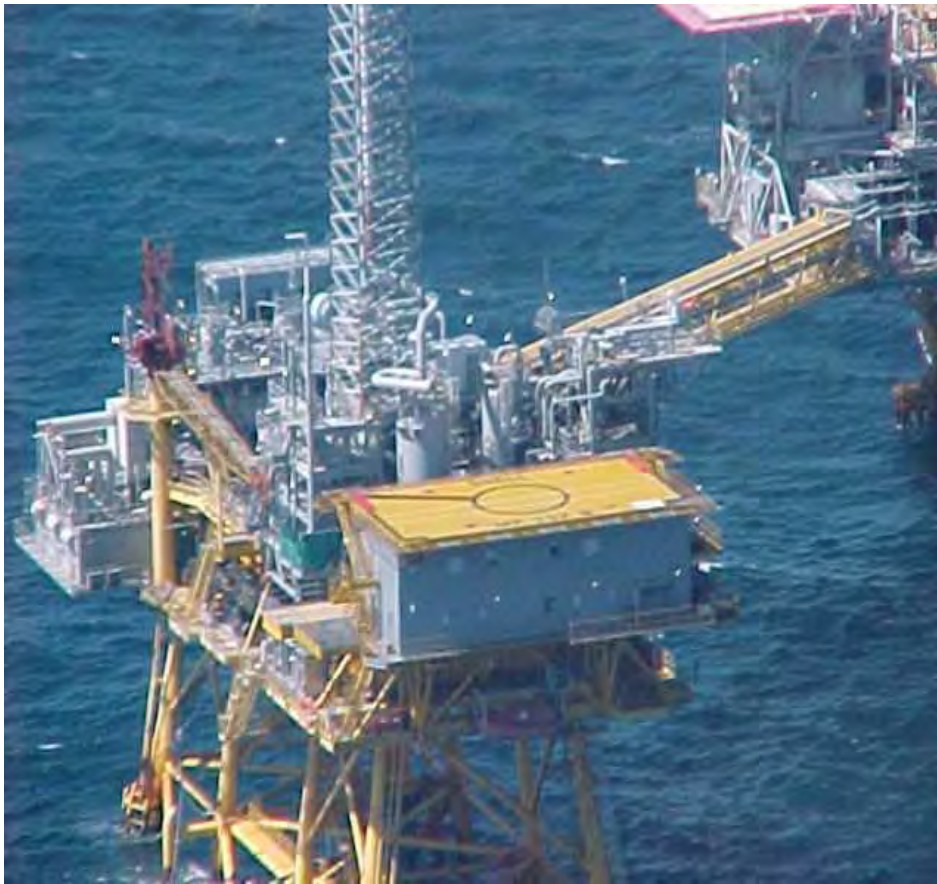
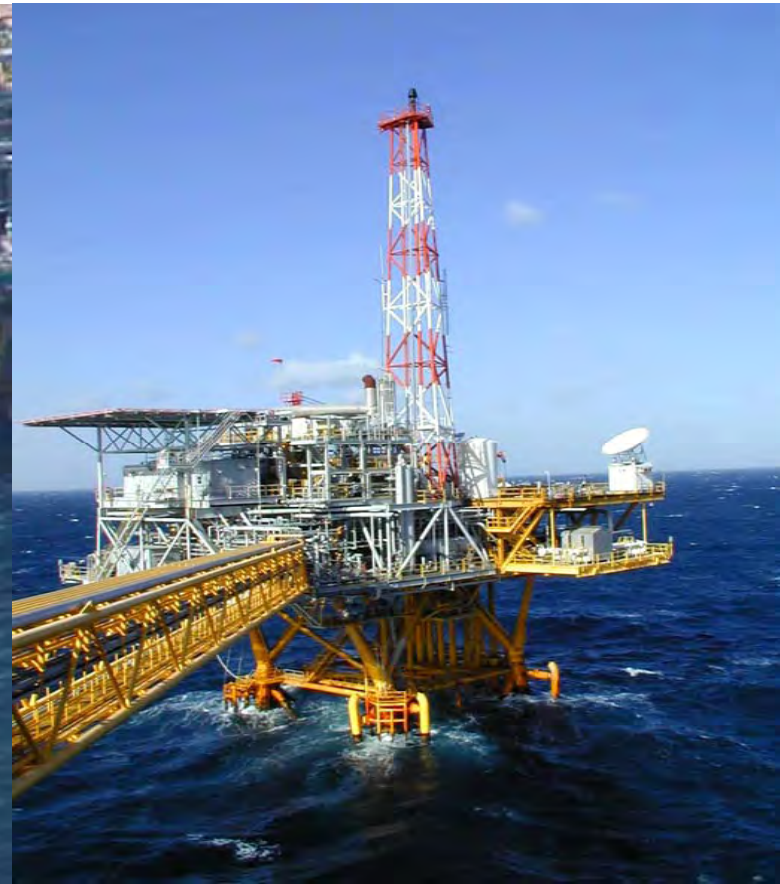
# Damage Assessments – MP 252

- Evidence of Green Water in the deck, 50 feet above the water line. Platform was near the eye of the storm.

- Platform damaged consisted of:
  - ❖ Missing Grating and Handrails (100 % at boatlanding to 20 % on lower deck)
  - ❖ Facilities equipment, cable tray and mostly support utilities

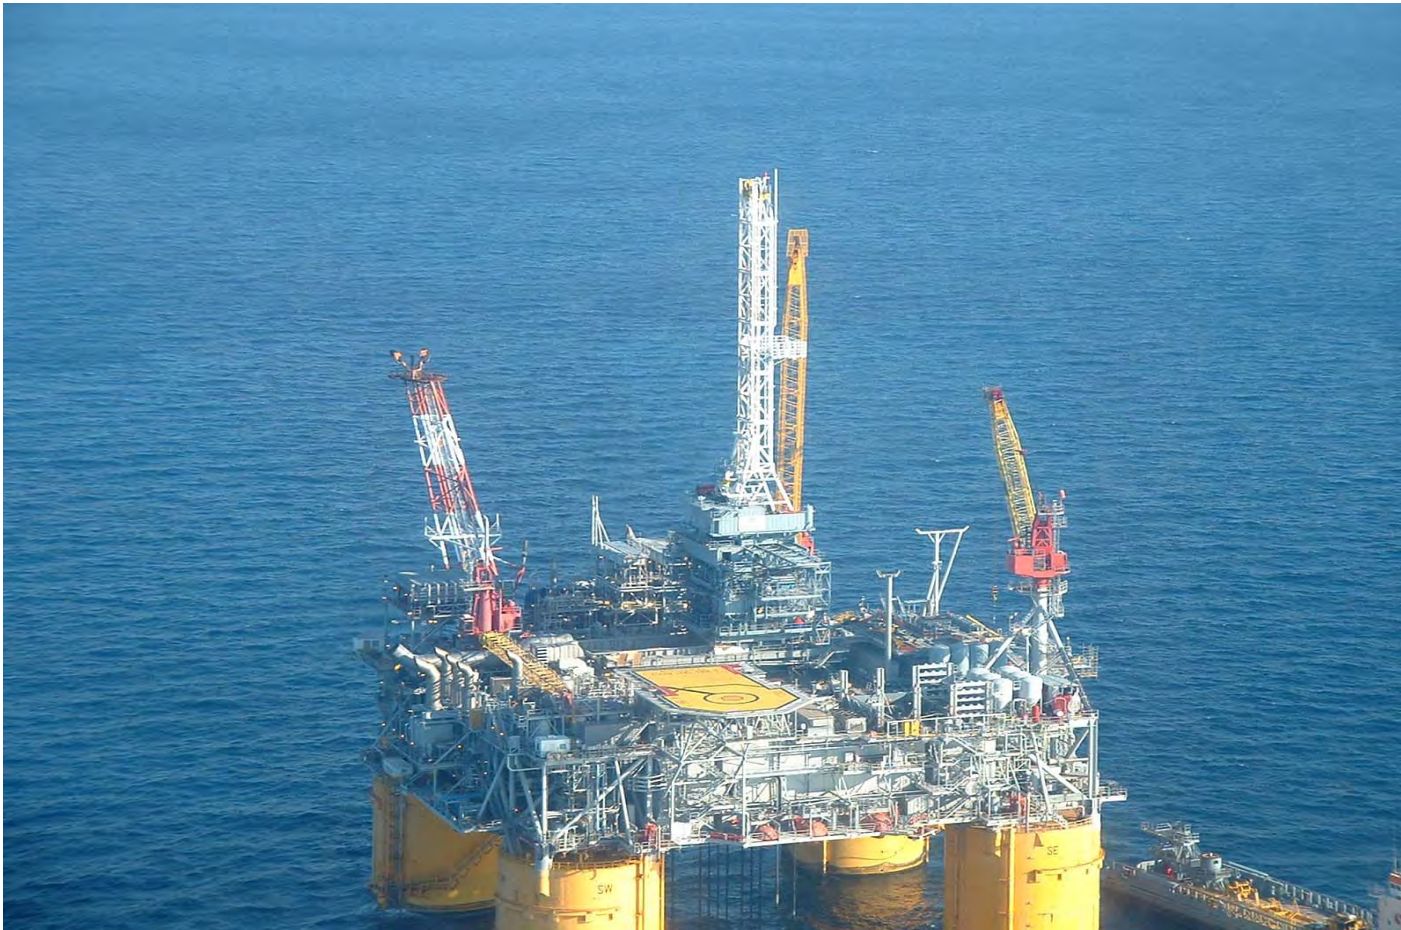
# Damage Assessments – VK 956

- Evidence of Green Water in the deck, 90 feet above the water line. Platform near the eye of the storm.
- Estimated wave height at this location is around 100 ft. Design wave was around 87 ft.
- Platform damaged consisted of:
  - ❖ Drilling rig moved off location
  - ❖ FGC 2 exhaust
  - ❖ Missing Grating and Handrails (100 % at boatlanding to 20 % on lower deck)
  - ❖ Facilities equipment, cable tray and mostly support utilities

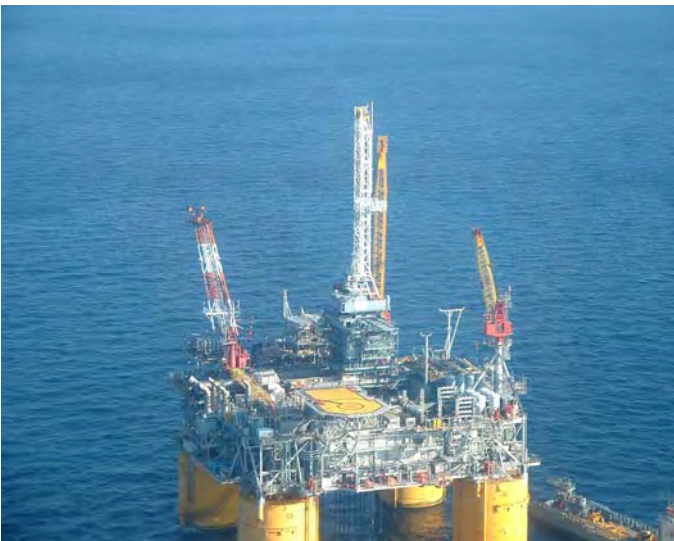
Figure 9 – Ram Powell post rig recovery

Figure 9 shows the rig in its post recovery operating position.

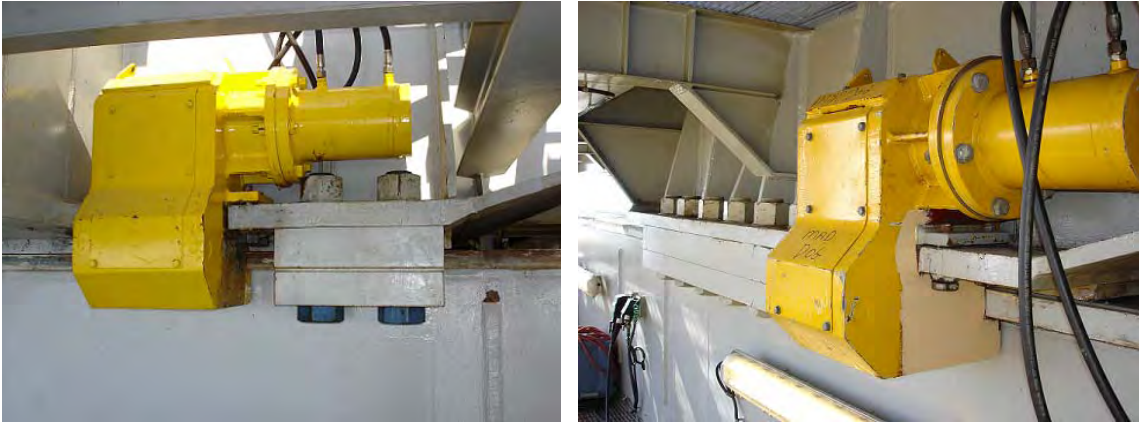
**Figure 11 - Hydraulic Brake System on Mad Dog**

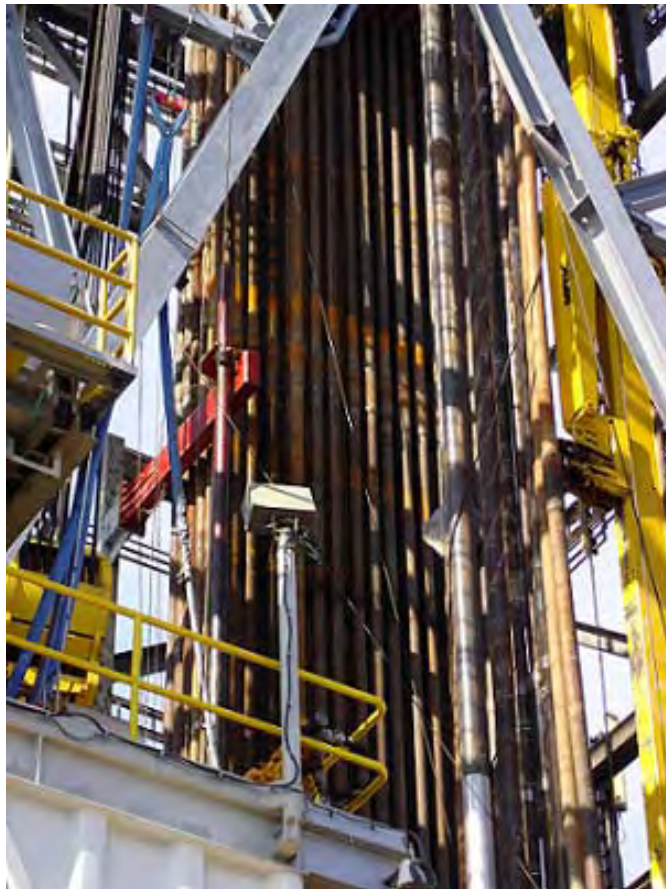
**Figure 12 - Winch Wire Wrapped Around Mad Dog Setback**
