U.S. Department
of Transportation
**Federal Railroad
Administration**

Documentation of Deformation from Passenger Rail Two-Car Impact Test

DOT/FRA/ORD-03/08

Final Report
November 2003

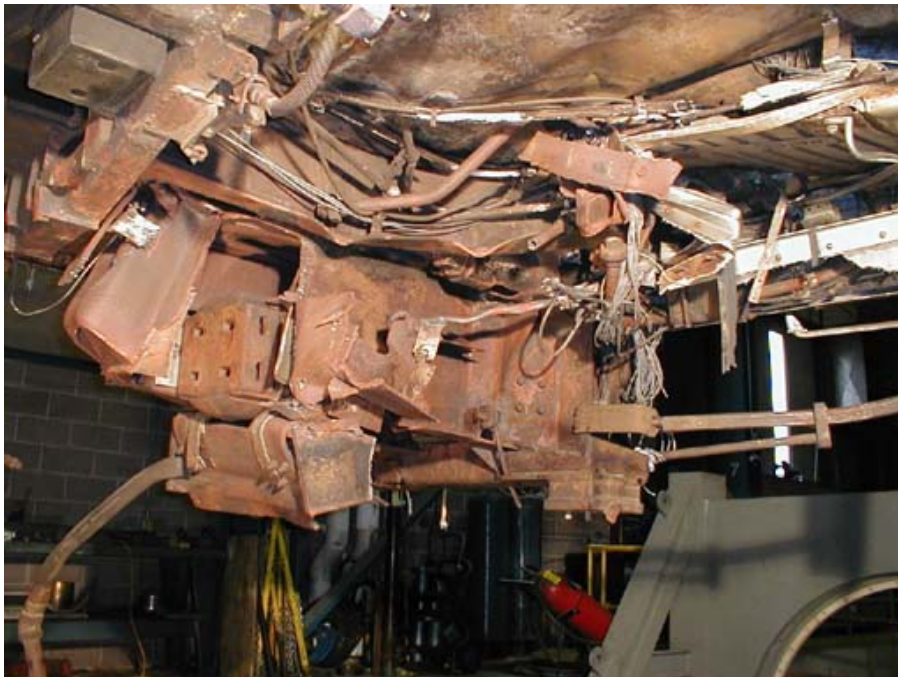
Figure B1-10. Draft Sill, from Right Looking Forward

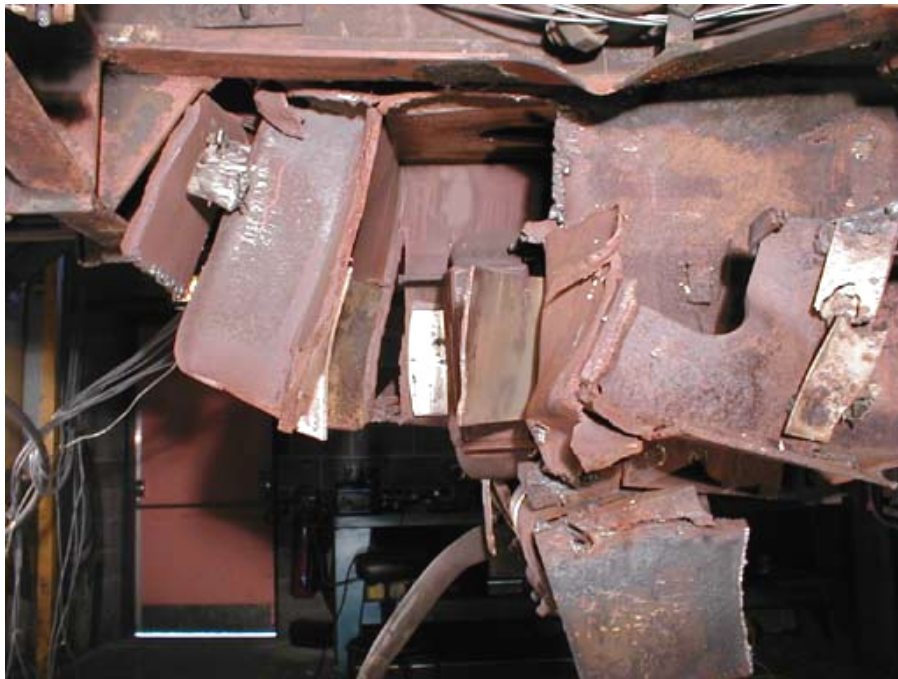
Figure B1-22. Draft Gear/Buff Stop Detail from Right Side

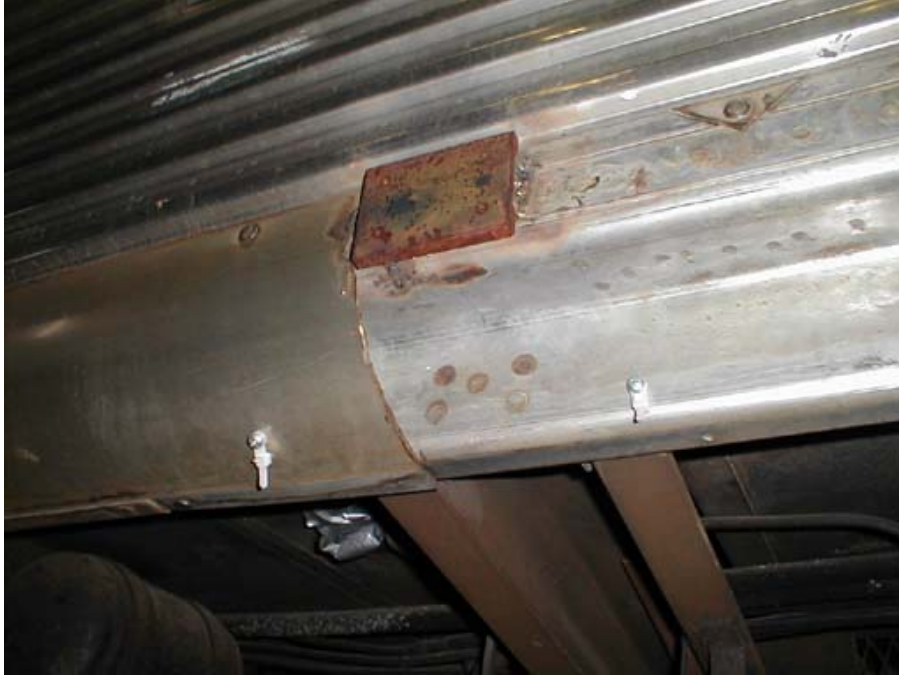
Figure B2-5. Detail - Side Sill Section and Accelerometer Mount

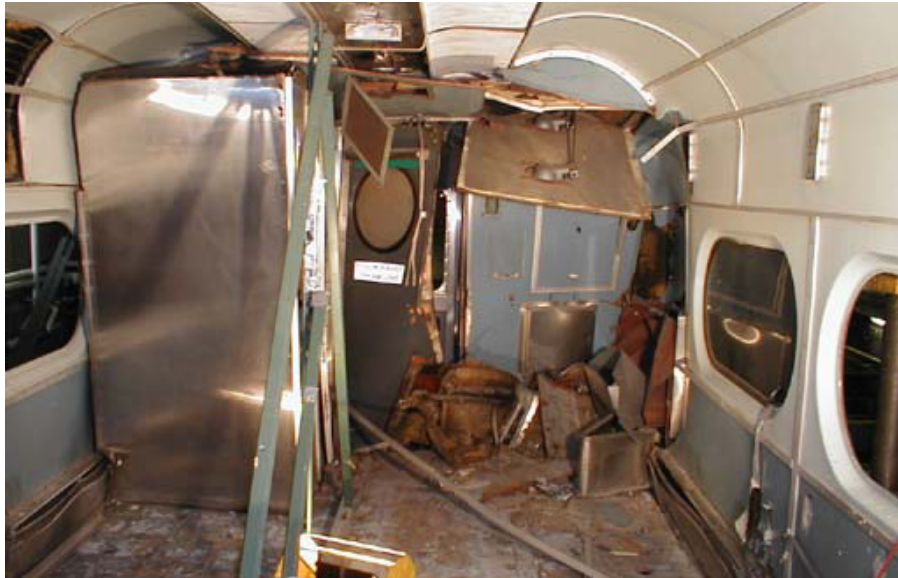
Figure B3-1. Internal View Looking Forward at Crush Zone

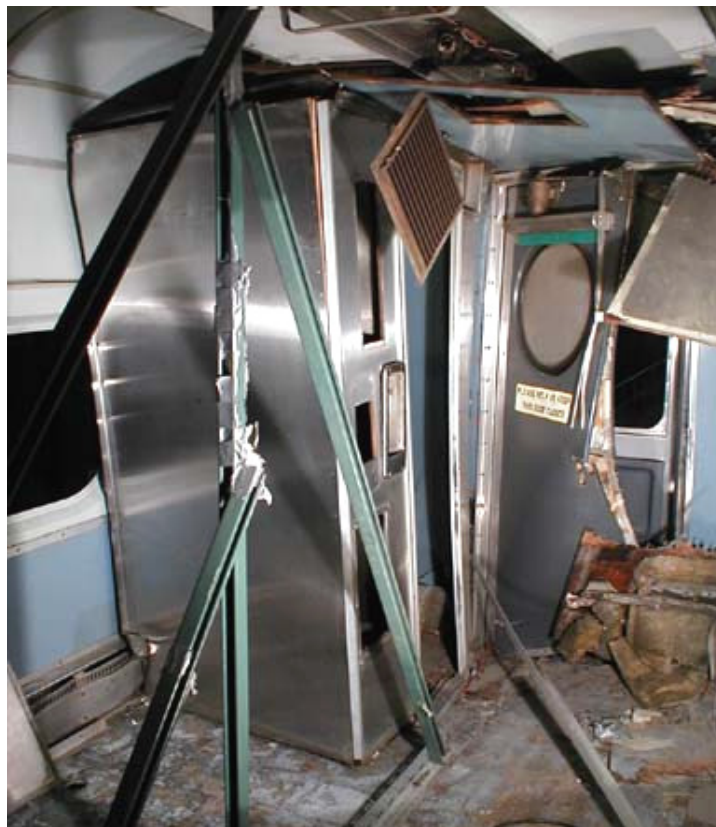
Figure B3-2. Inside View, Detail of Water Closet Pushed Back Past First Window

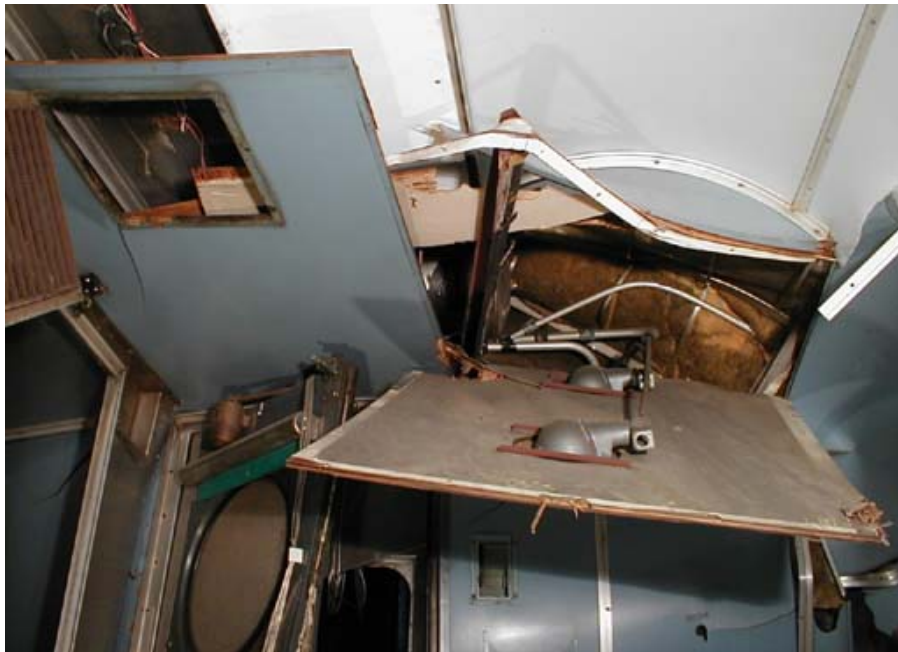
Figure B3-6. Detail of Roof Structure Aft of Bulkhead

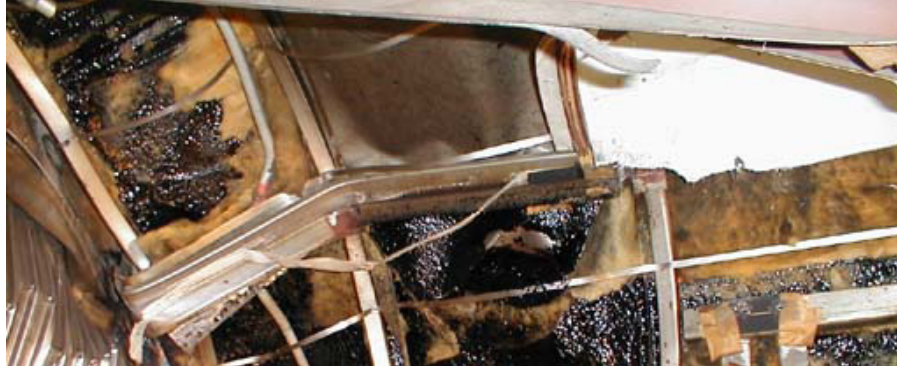
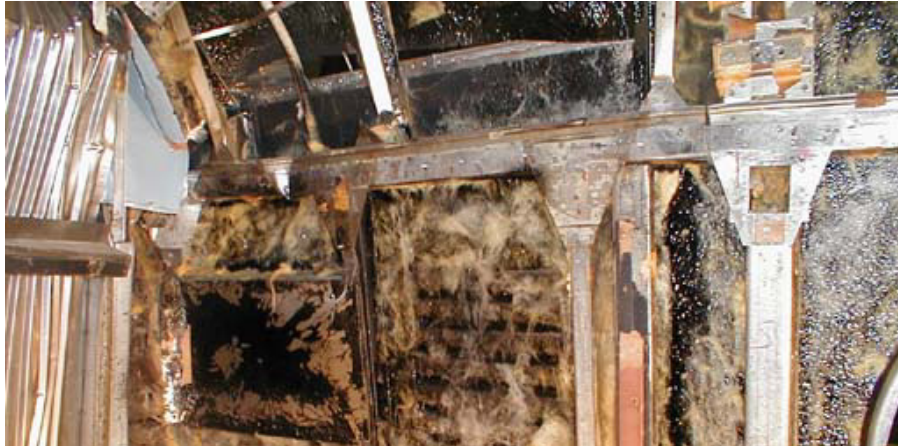
Figure B3-12. Composite Showing Forward Right-side Wall Between Bulkhead Wall and First Window Frame

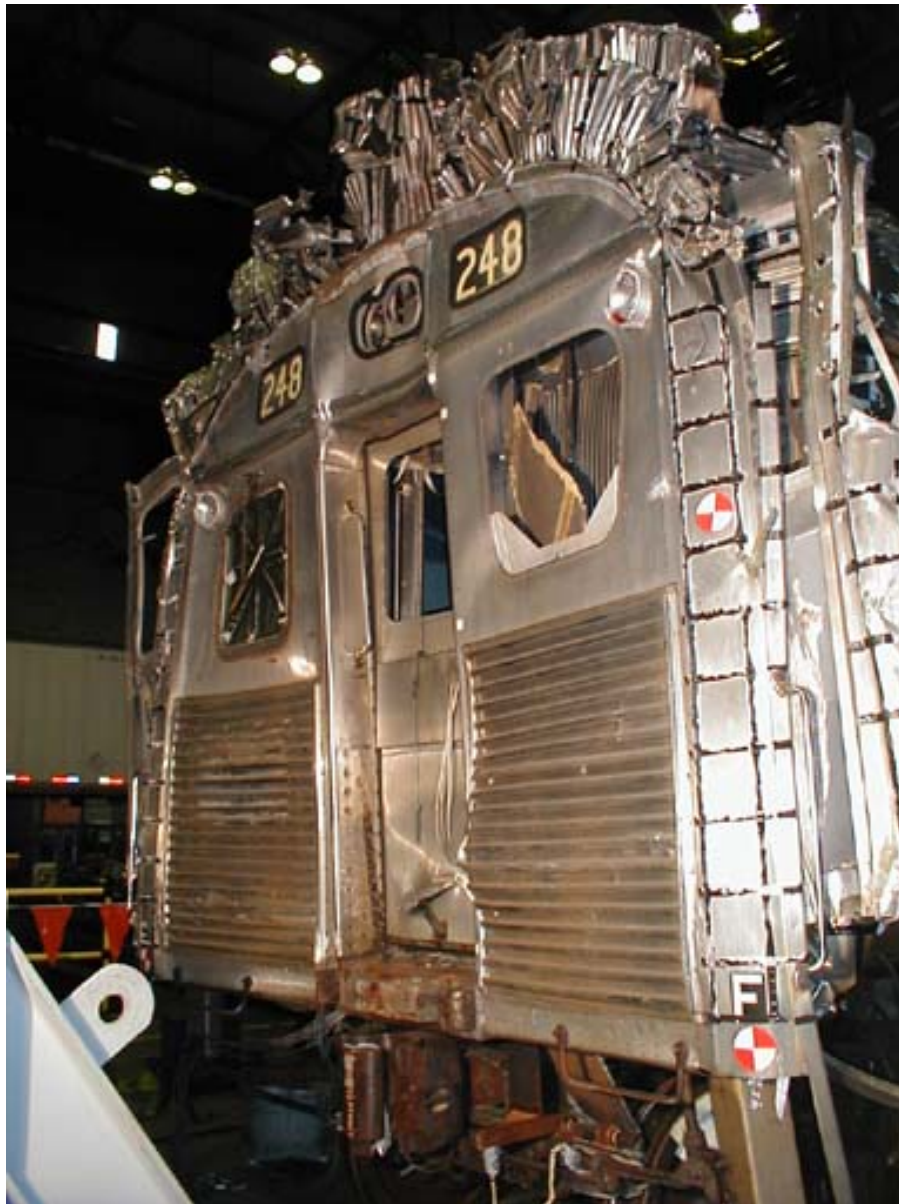
Figure B4-6. Front Face and Left Corner of Crush Zone

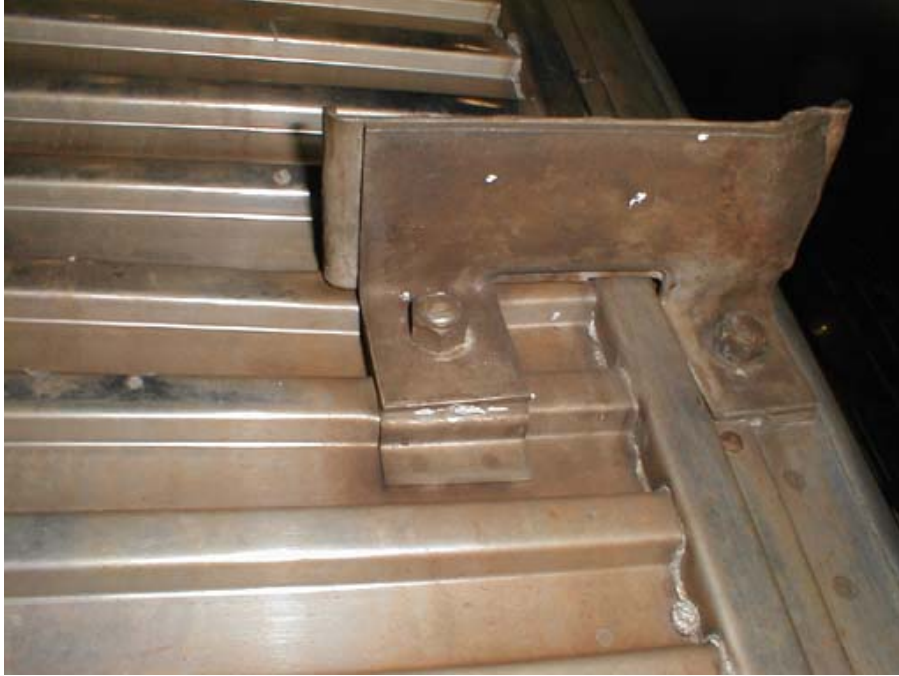
Figure B5-9. Step on B-End of Lead Car (From Below)

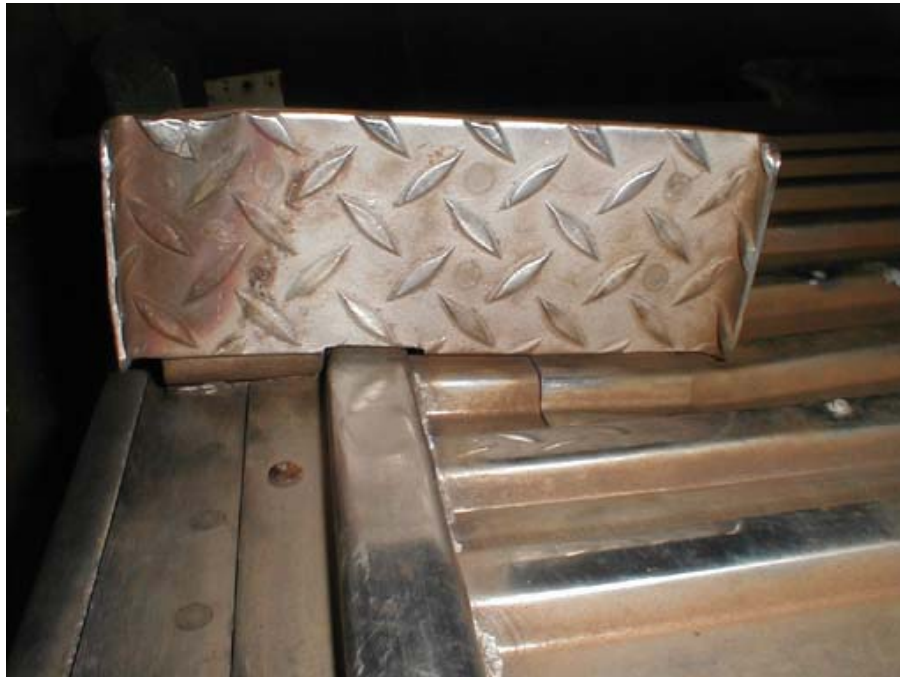
Figure B5-10. Detail – Step on B-End of Lead Car (From Above)

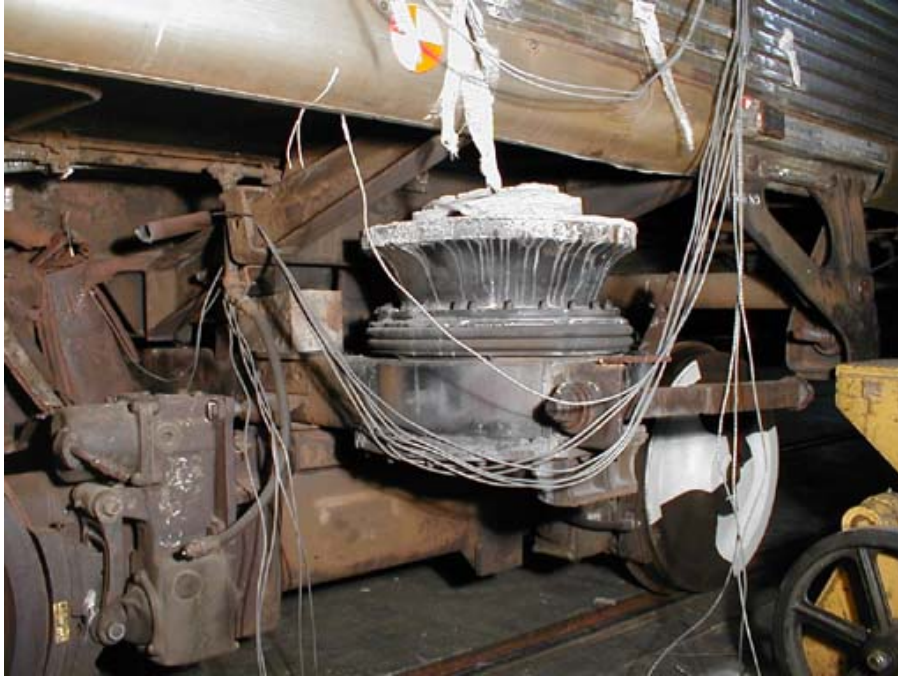
Figure B6-1. Forward Left-side Bladder Suspension Detail—Before Truck Removal

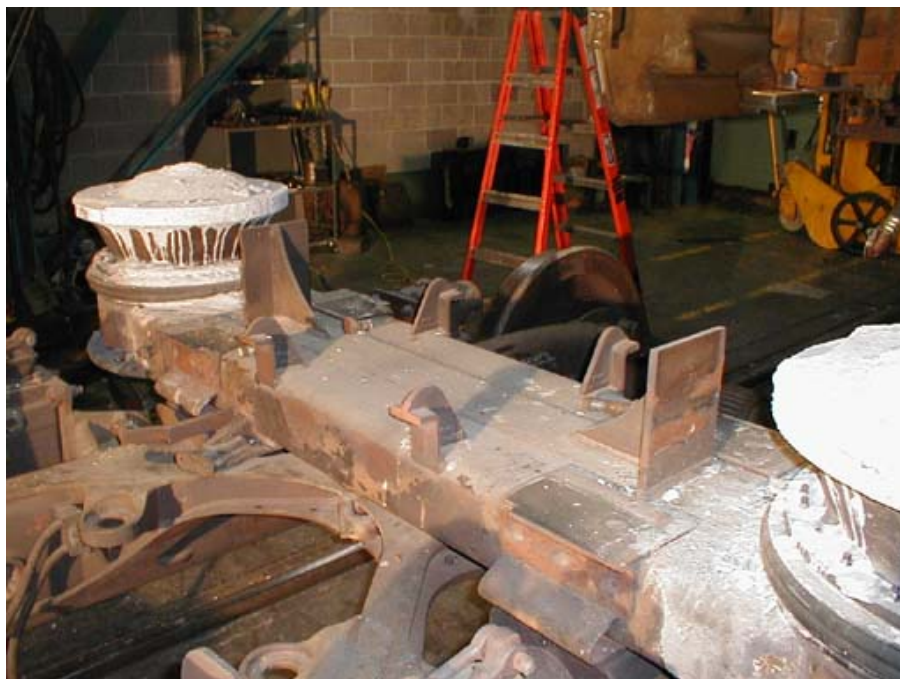
Figure B6-6. Rear Truck - Bolster Beam, Viewed from Rear Right Side
