MECHANICAL DAMAGE: HOW BIG IS THE PROBLEM ? A EUROPEAN PERSPECTIVE

Mechanical Damage Workshop: February 29th, March 1st, 2006

Dr. Murès ZAREA, Gas Facilities Development Manager

Gaz de France R&D Division

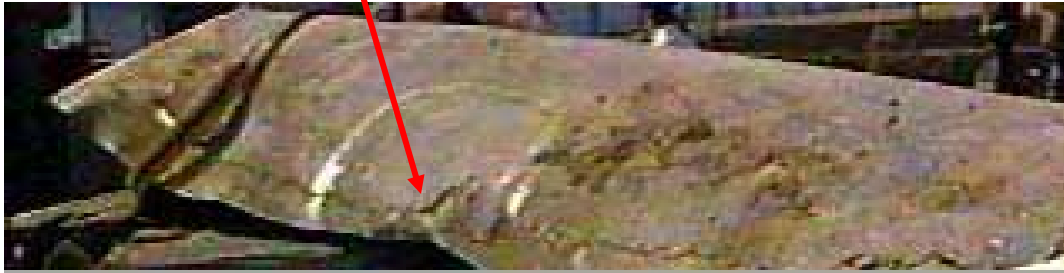
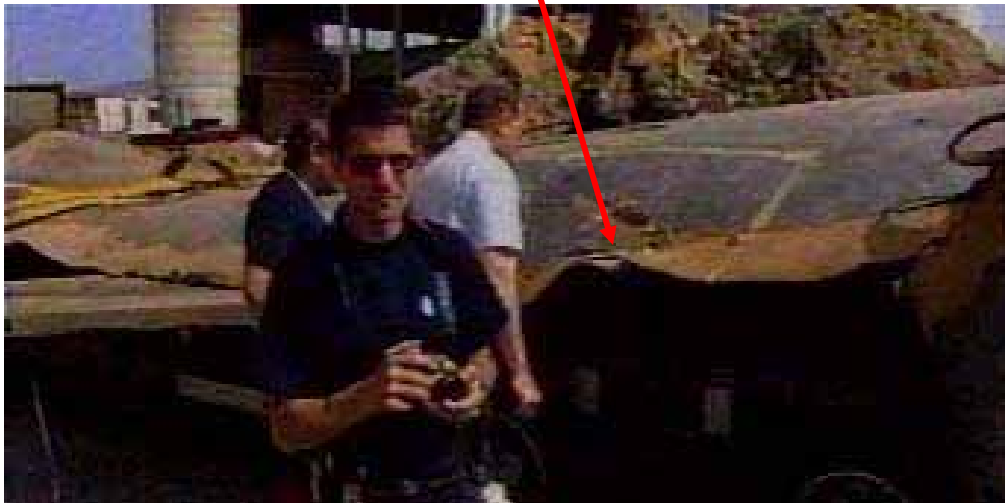
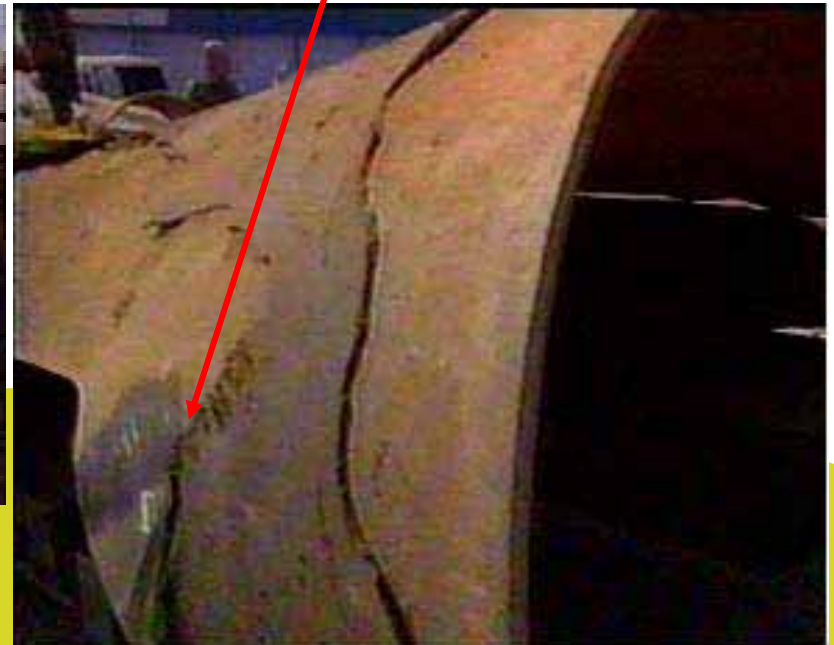
Defects on piece of broken pipe

- **Accident occurred during a planned pipeline maintenance shutdown, resulting in pressure increase above the value at which the damage was inflicted.**
- **Defect failure resulted in a leak, producing a gas cloud, that caught fire after transition to rupture**
- **Defects were introduced by a subcontracted soil stabilizing work needed to build an access road to a new parking lot, for the new Diamant Boart factory**
- **The operator had reviewed the yard with the contractor**
- **Depth of cover was reduced due to ground leveling**
- **Operation of a soil stabilizing equipment does not give any view of what happens beneath the soil surface**

Defect n°2

Defect n°1

Defect n°3

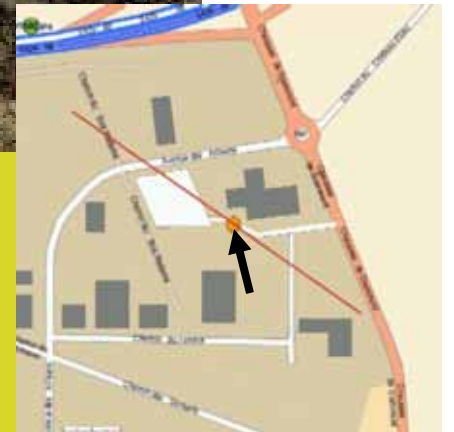
The crater

DN900

DN1000

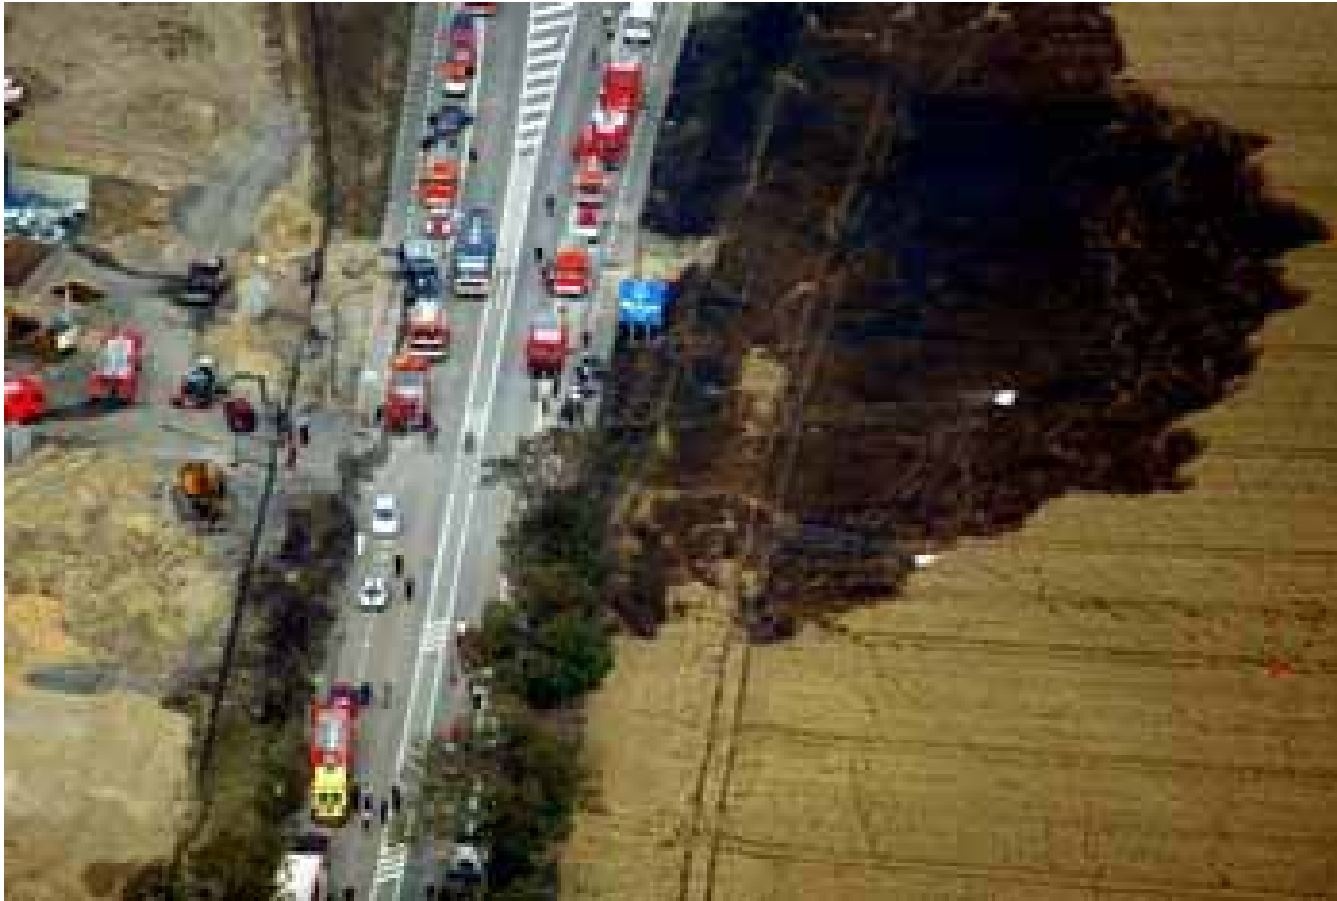
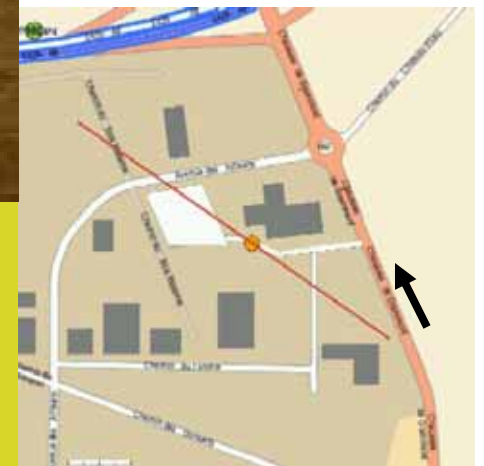
East entrance to Diamant Boart

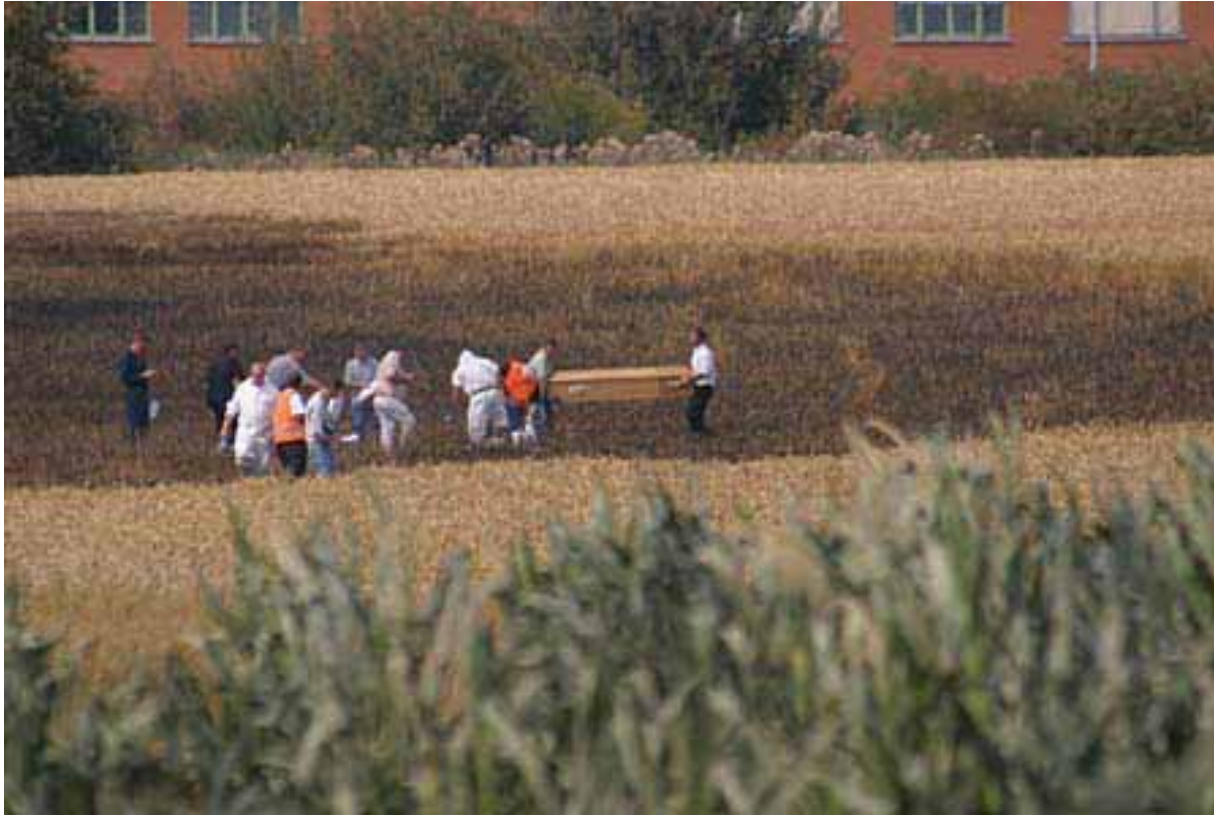
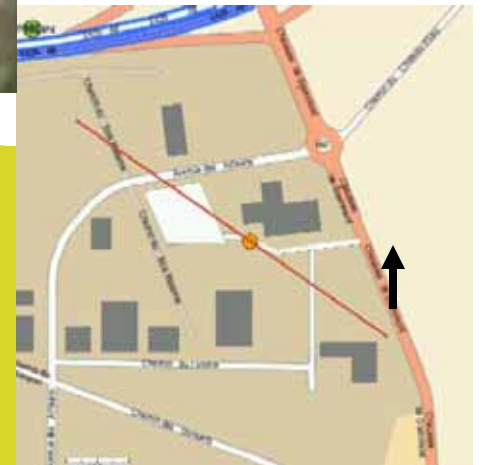
Wheat field to the east of Diamant Boart

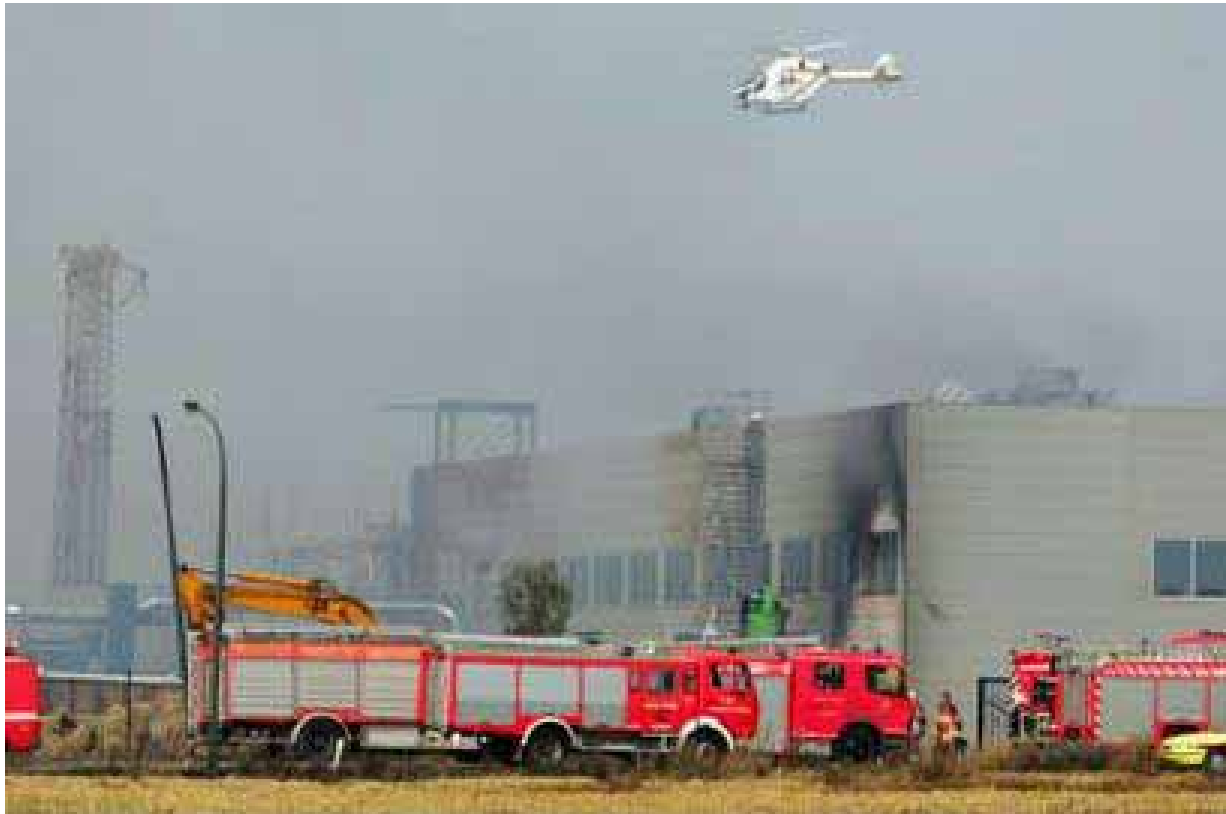
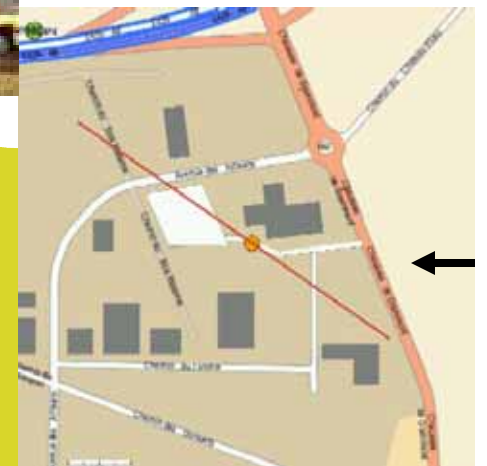
East entrance to Diamant Boart

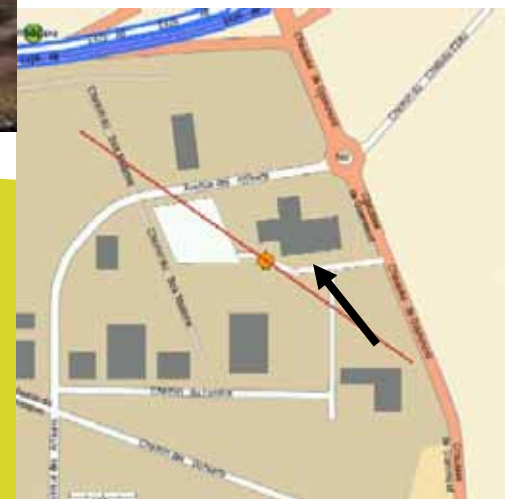
Aerial view of Diamant Boart from south east

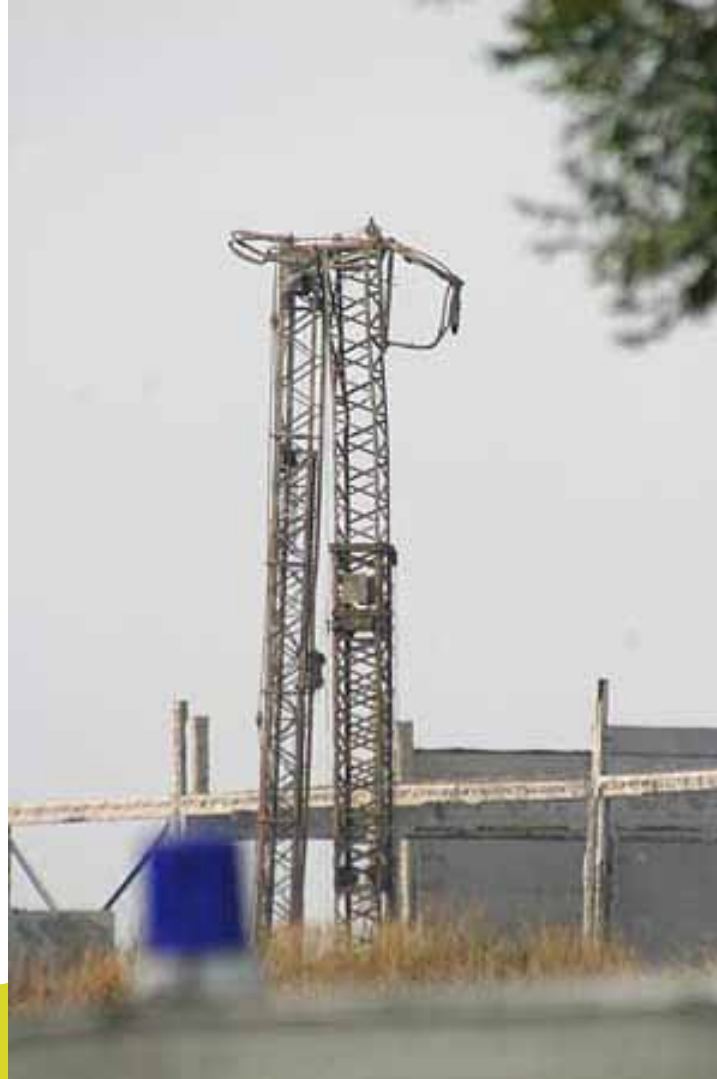
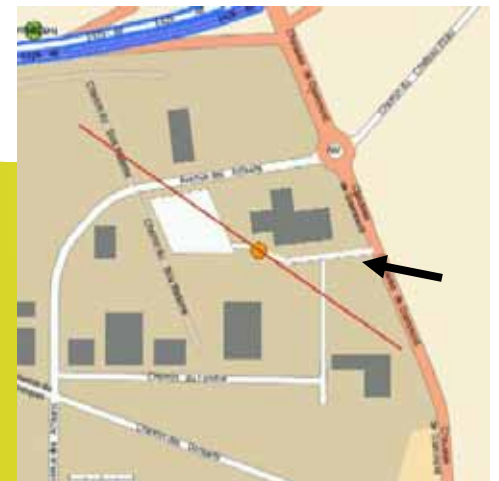
Construction crane

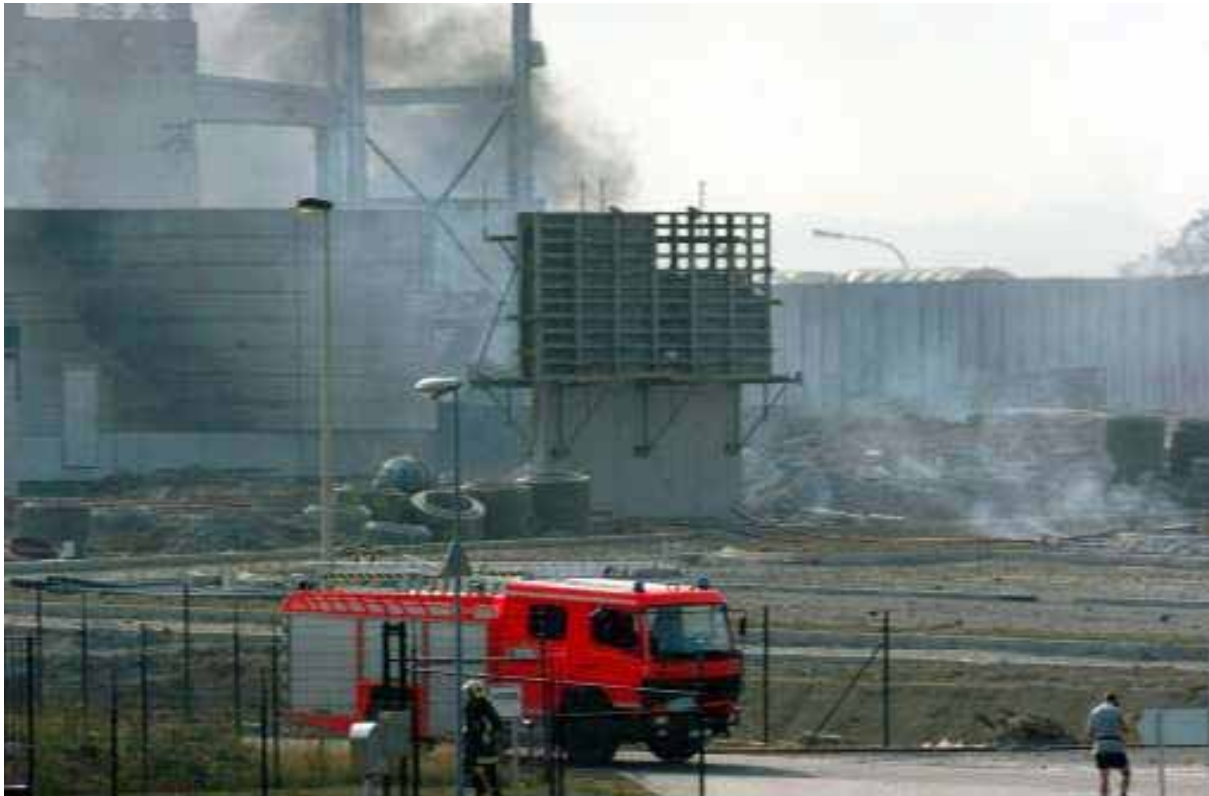
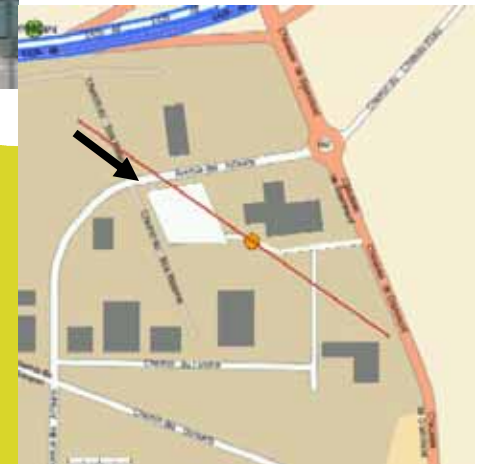
North west entrance to Diamant Boart parking

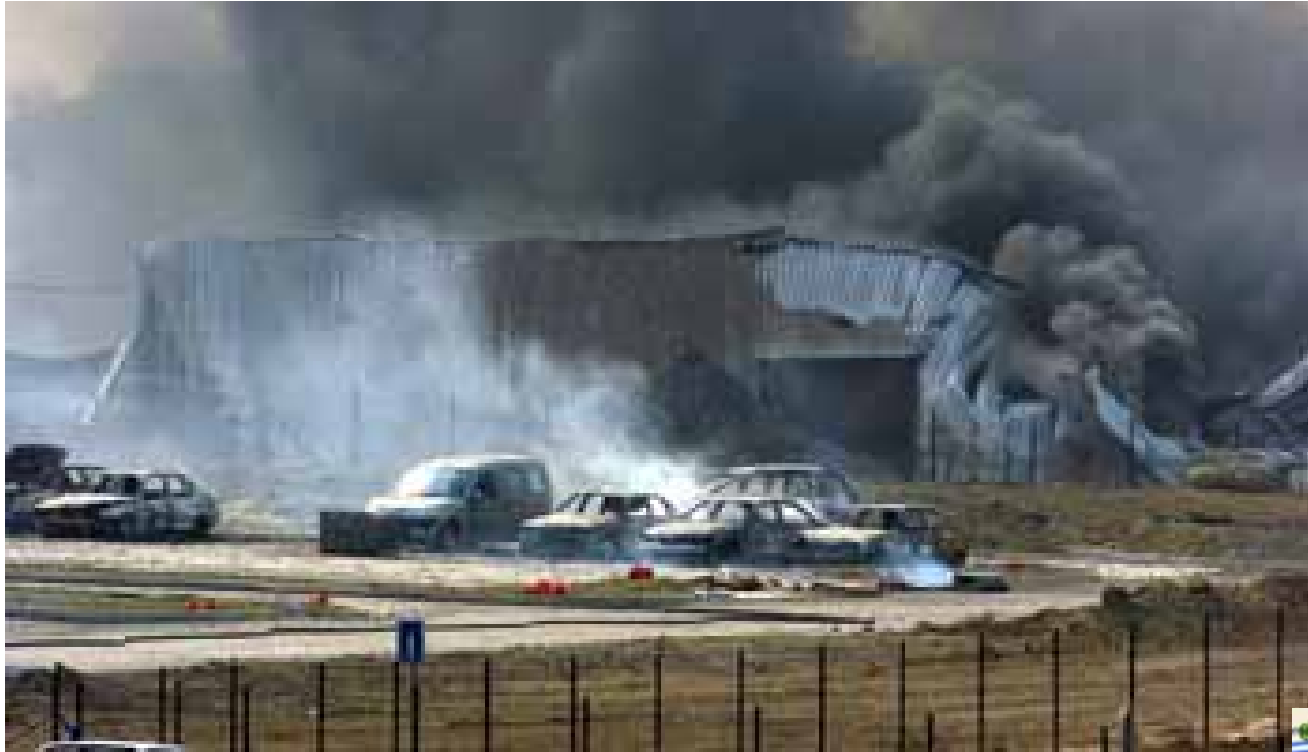
Diamant Boart parking seen from north west

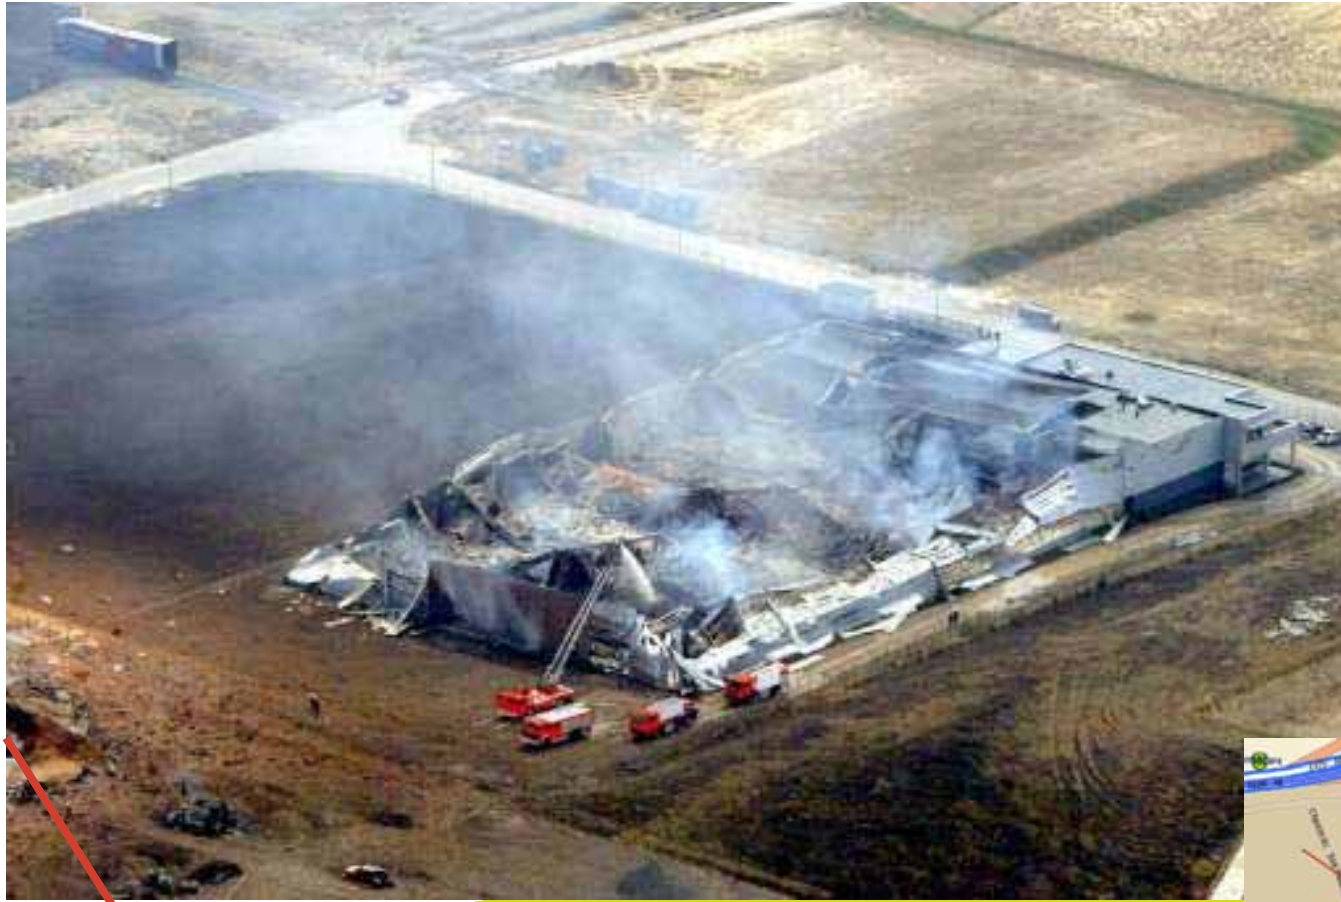
Aerial view of JS Packaging from north west

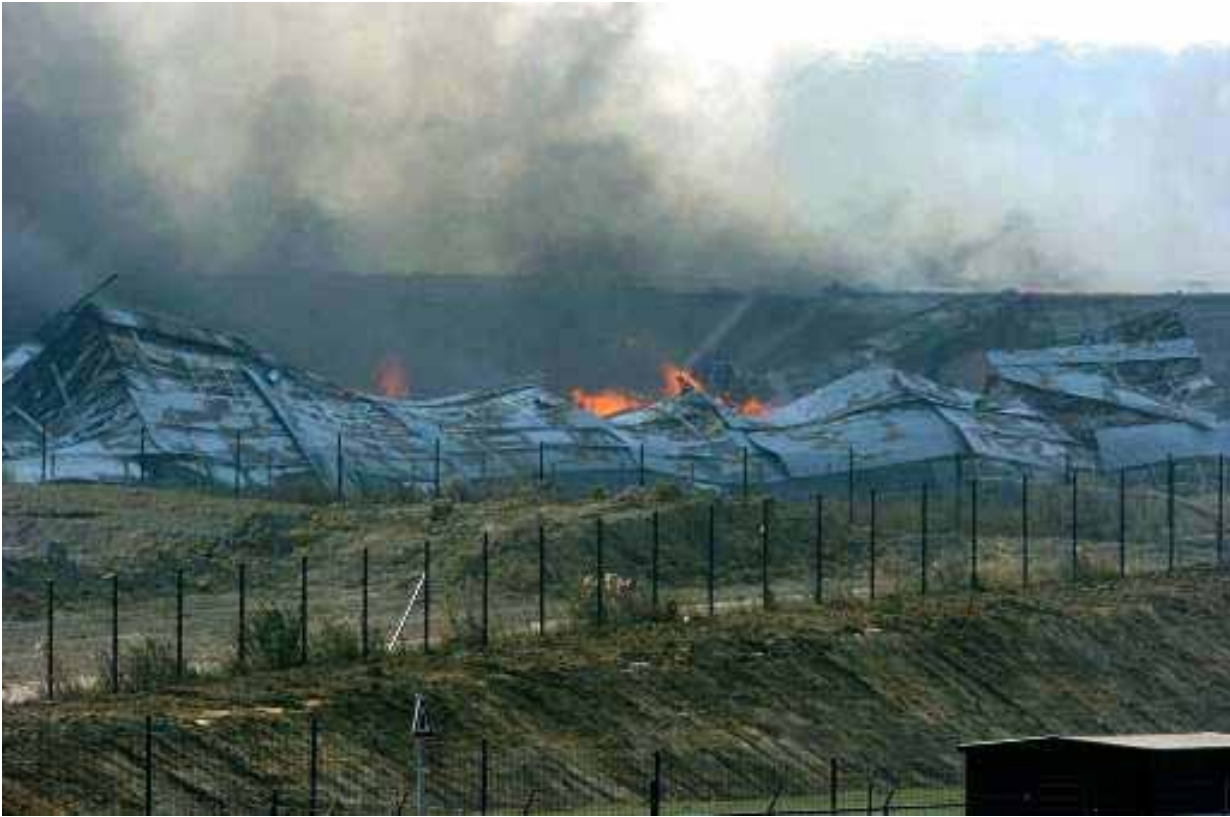
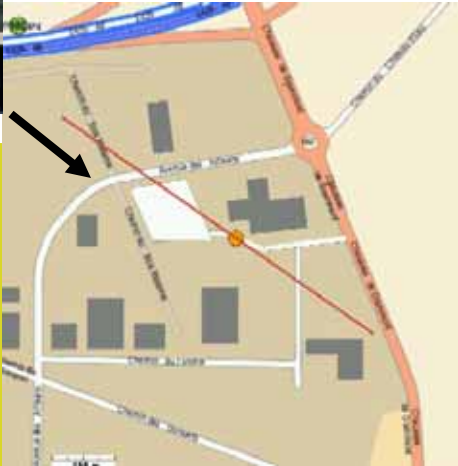
JS Packaging seen from north west

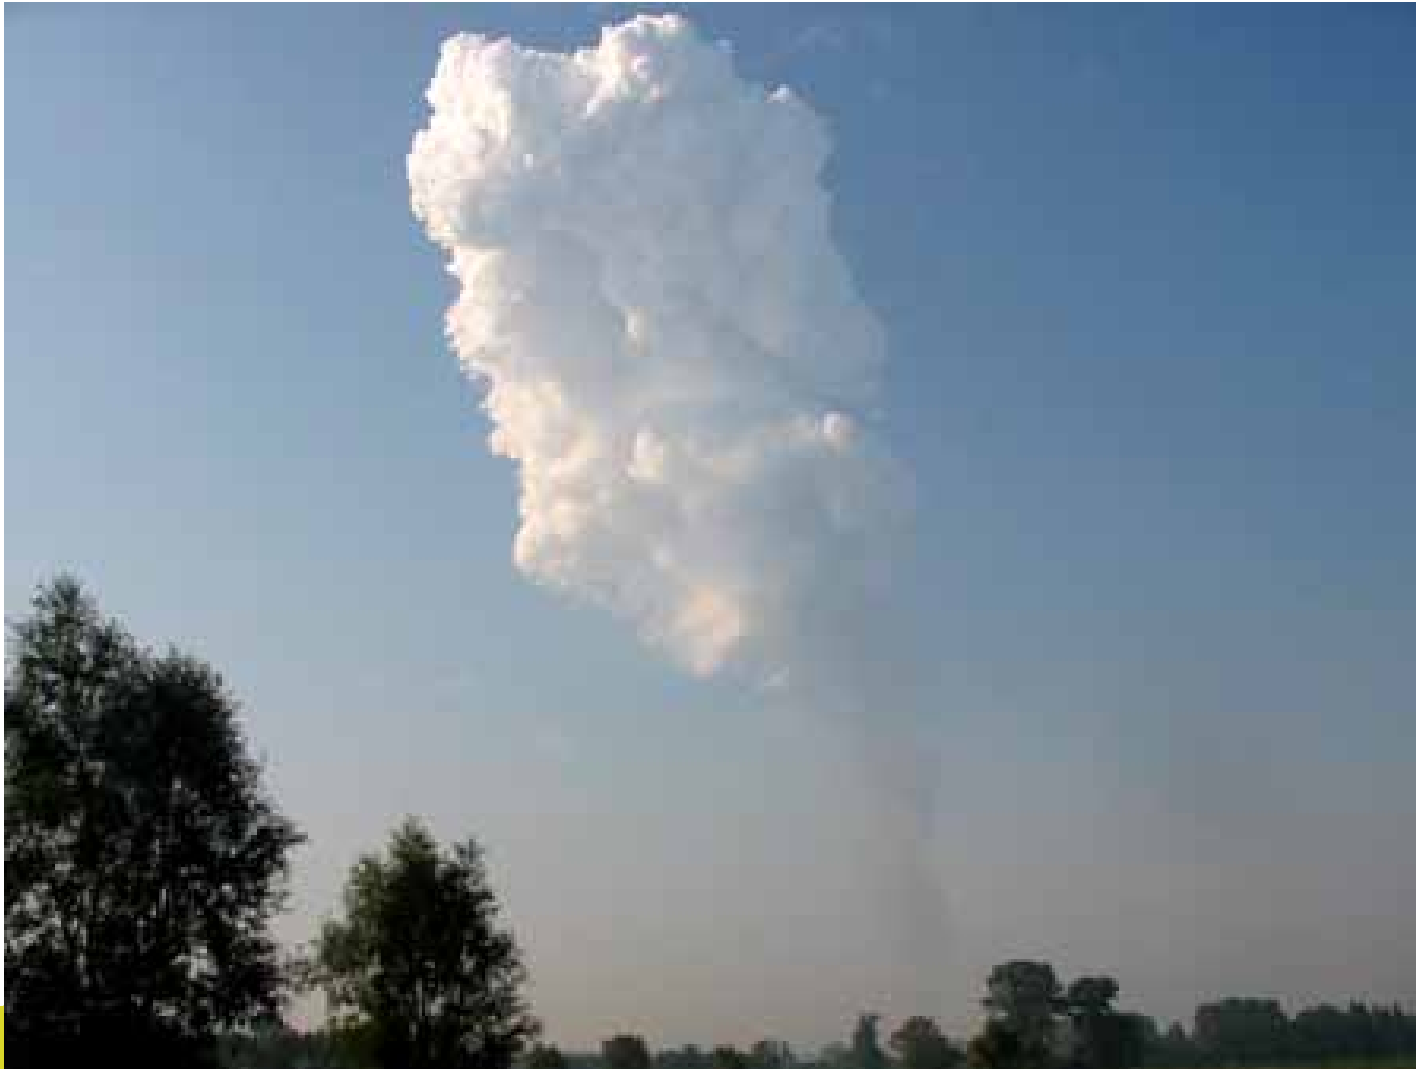
Gas plume seen from 10 km to the north (with condensation in the atmosphere)

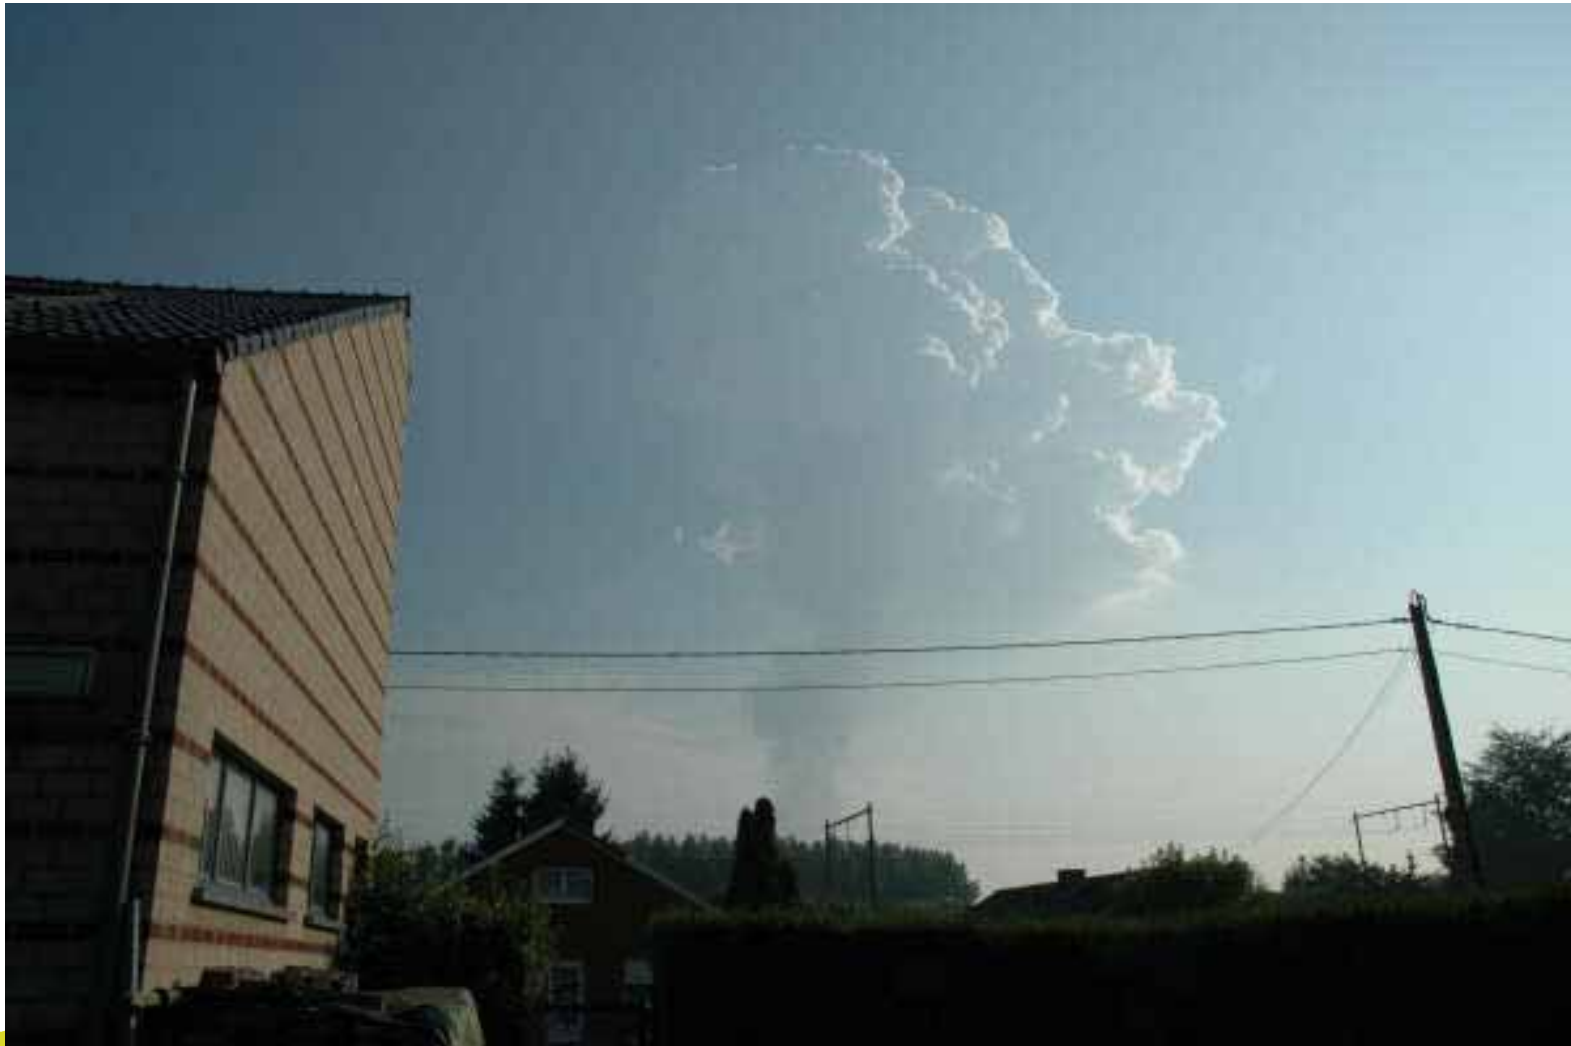
Gas plume seen from the south (with condensation in the atmosphere)

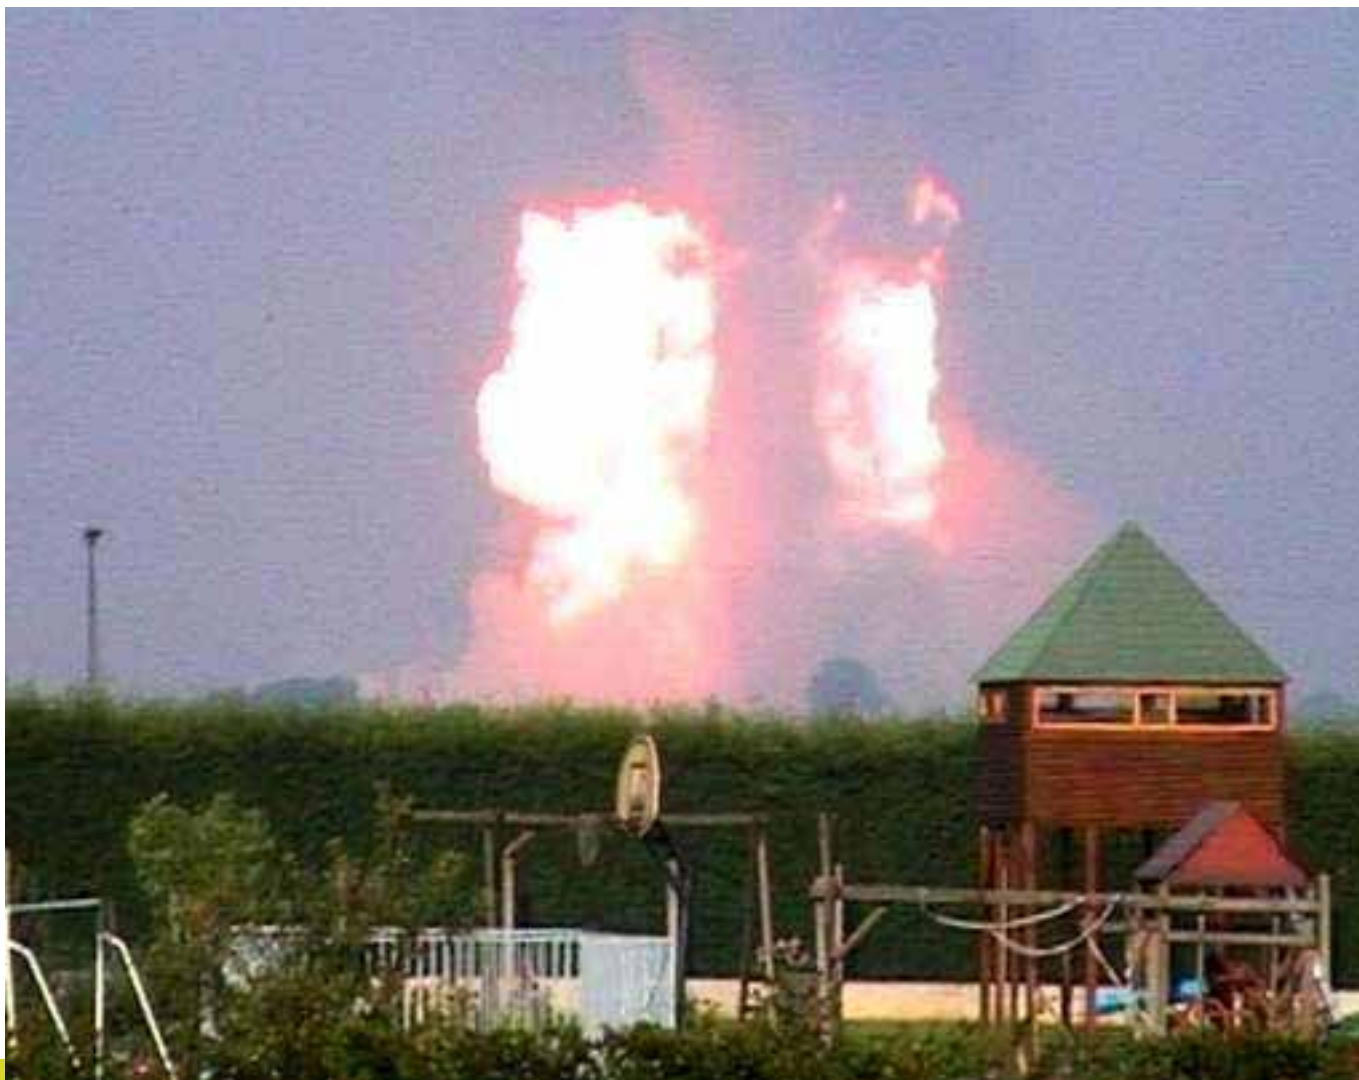
Flame

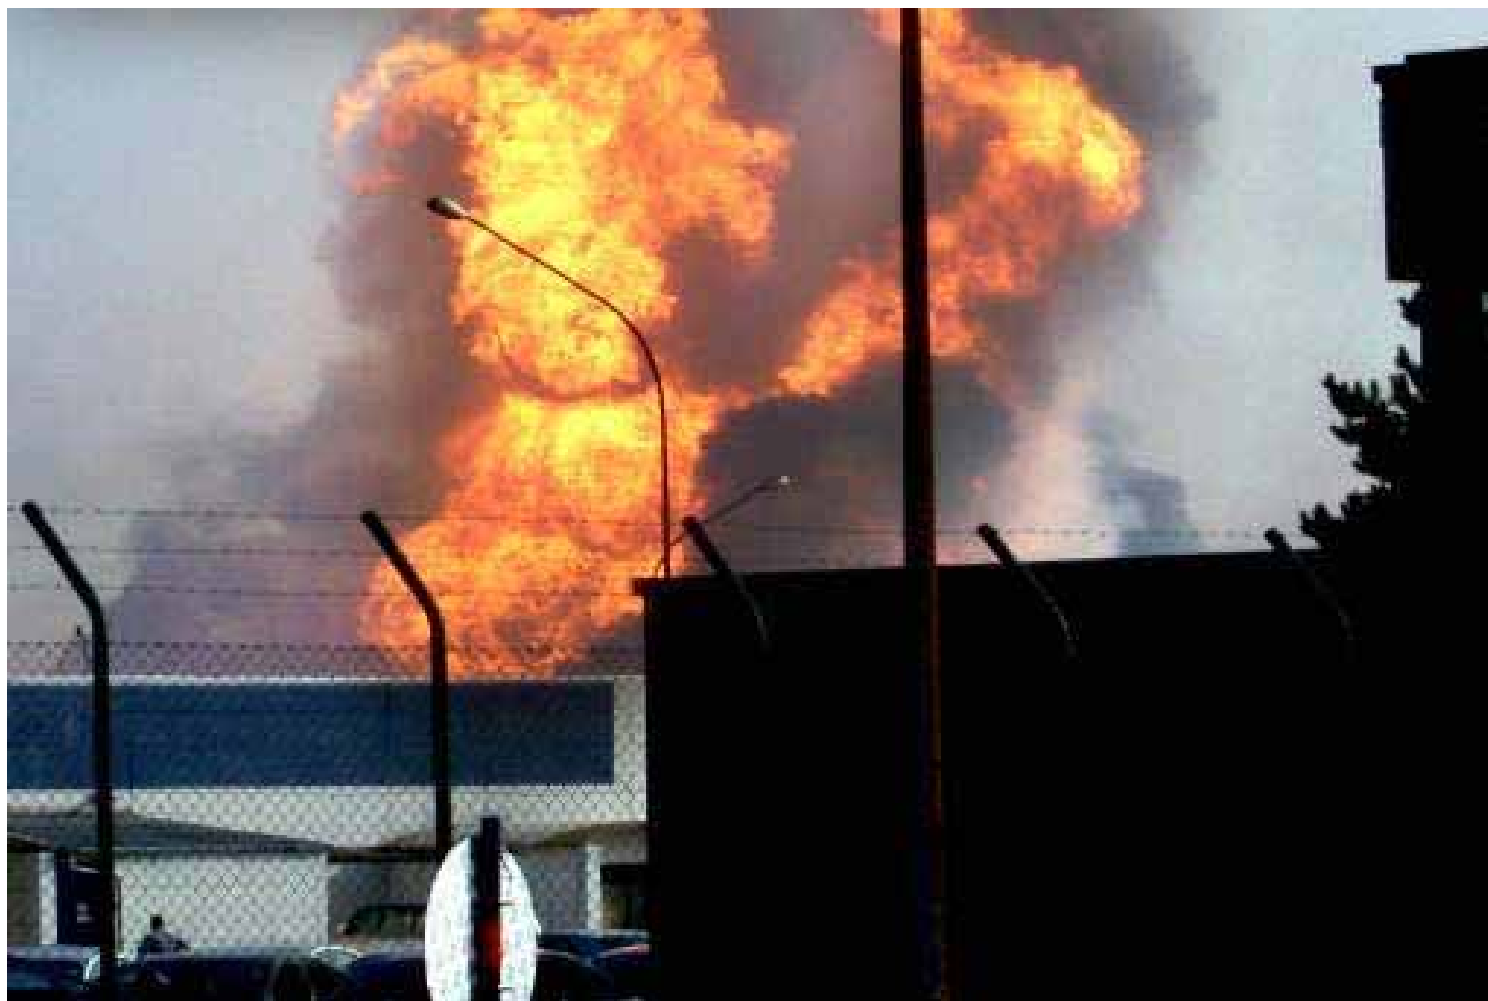
Flame seen from south

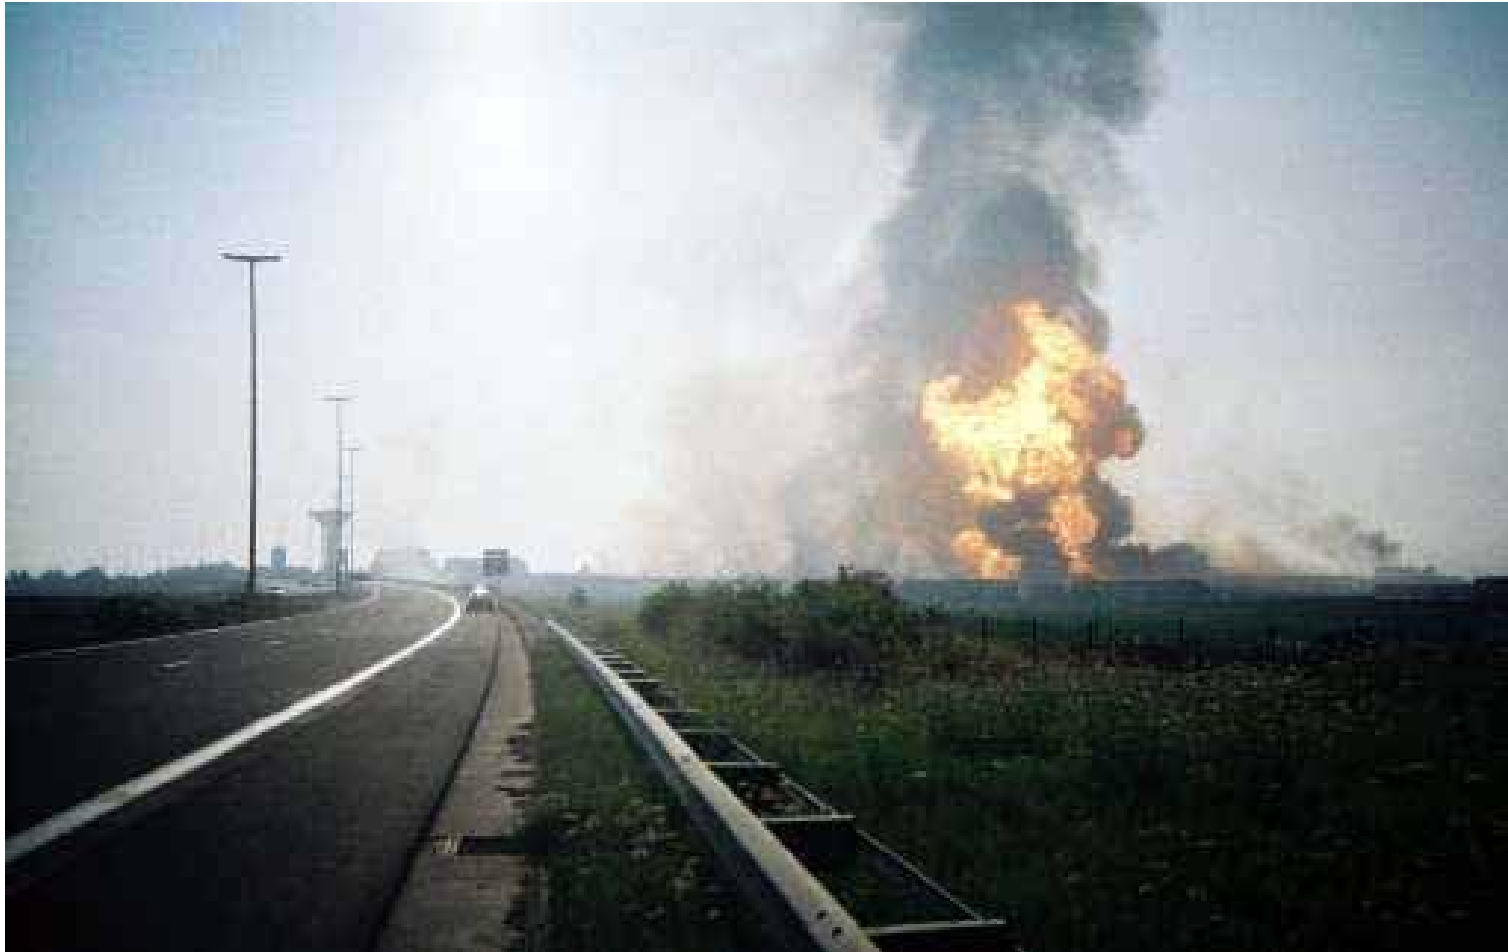
Flame seen from north west on highway

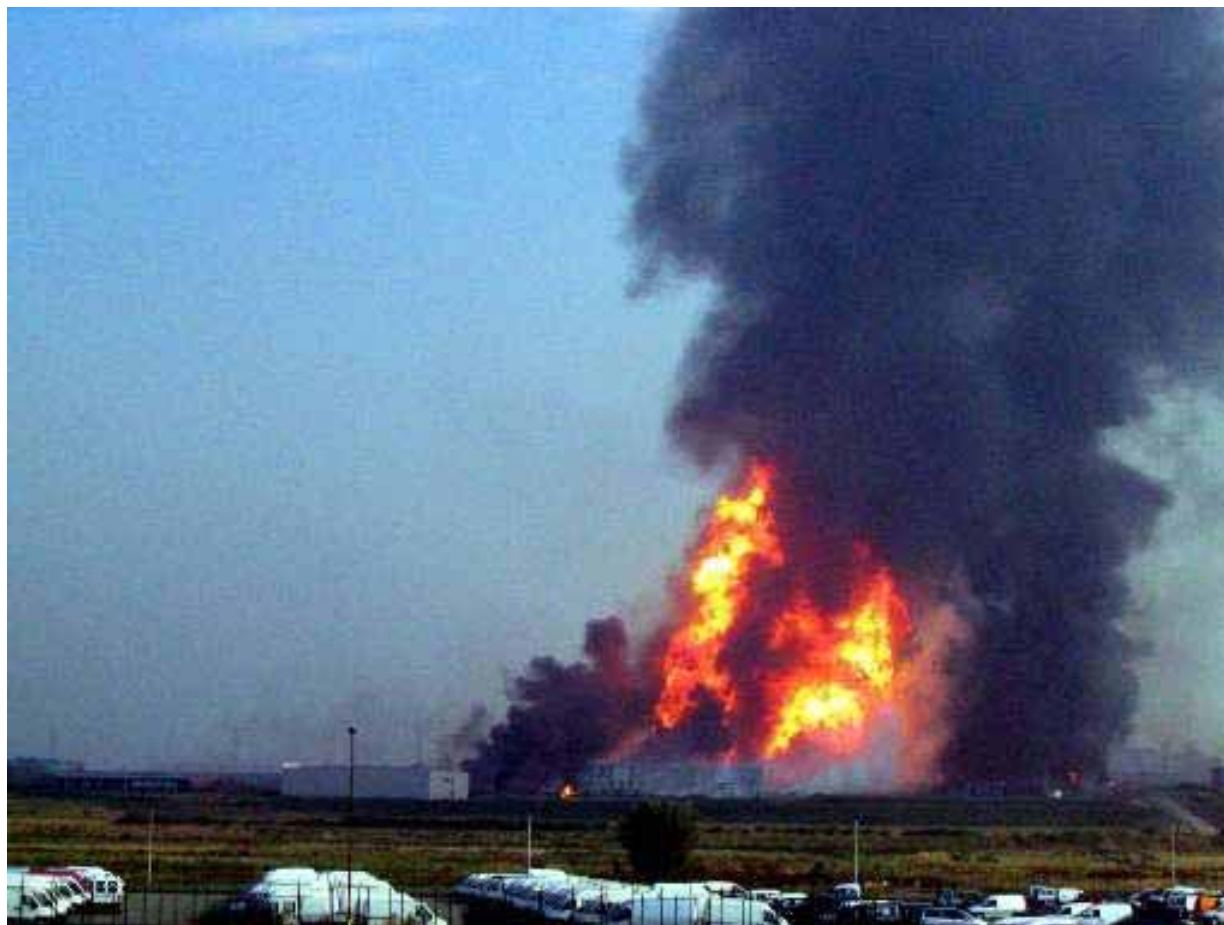
Flame seen from the south

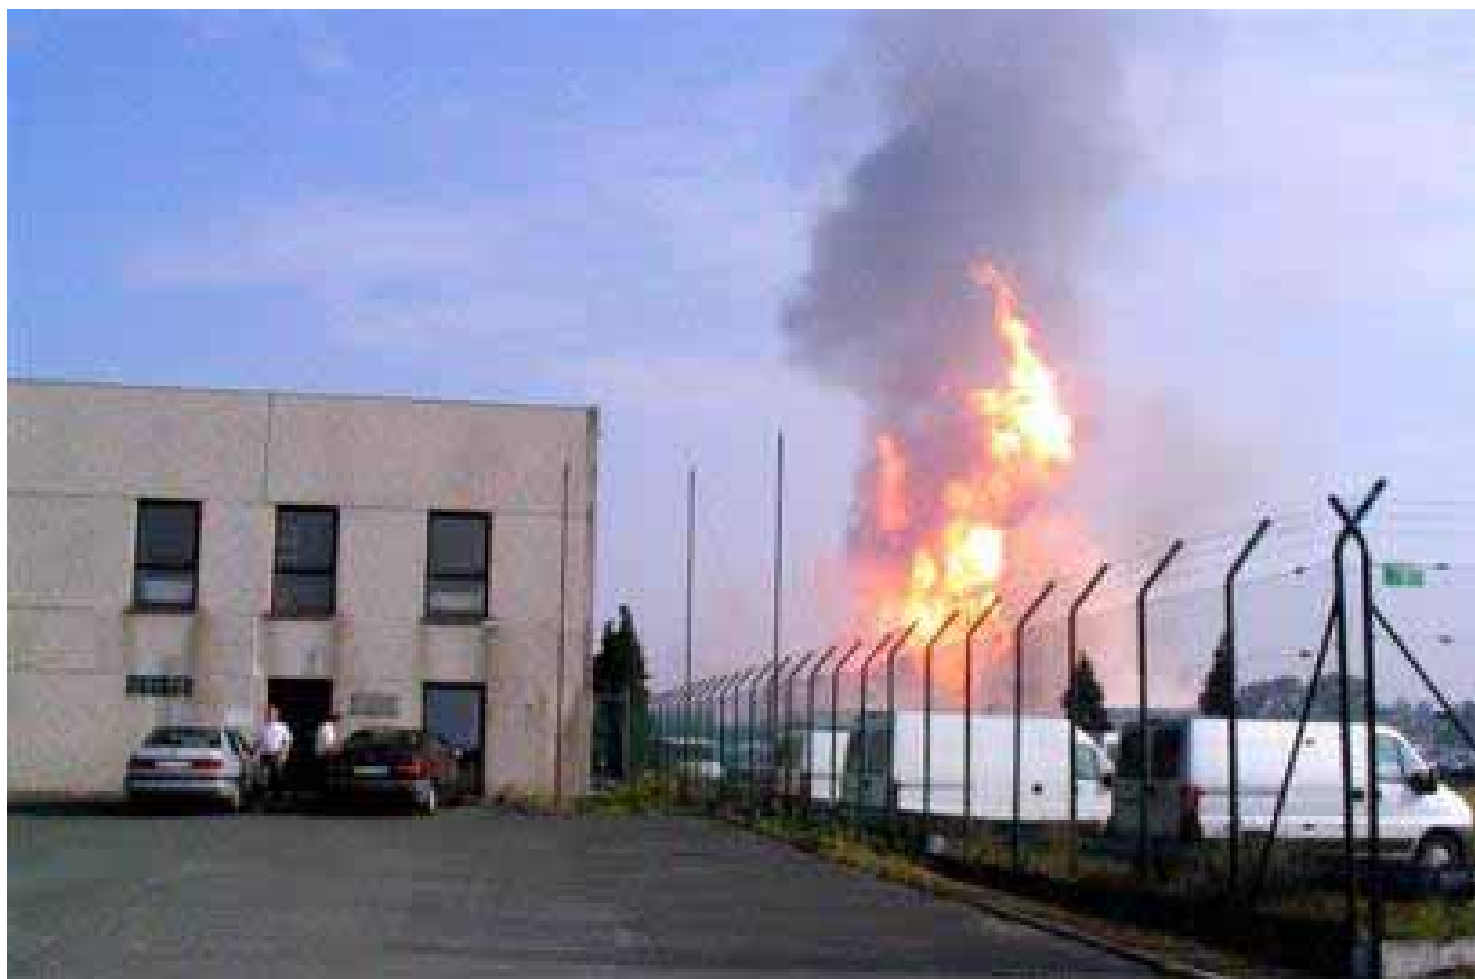
Flame seen from the south
