MECHANICAL DAMAGE: HOW BIG IS THE PROBLEM ? A EUROPEAN PERSPECTIVE

Mechanical Damage Workshop: February 29th, March 1st, 2006

Dr. Murès ZAREA, Gas Facilities Development Manager

Gaz de France R&D Division

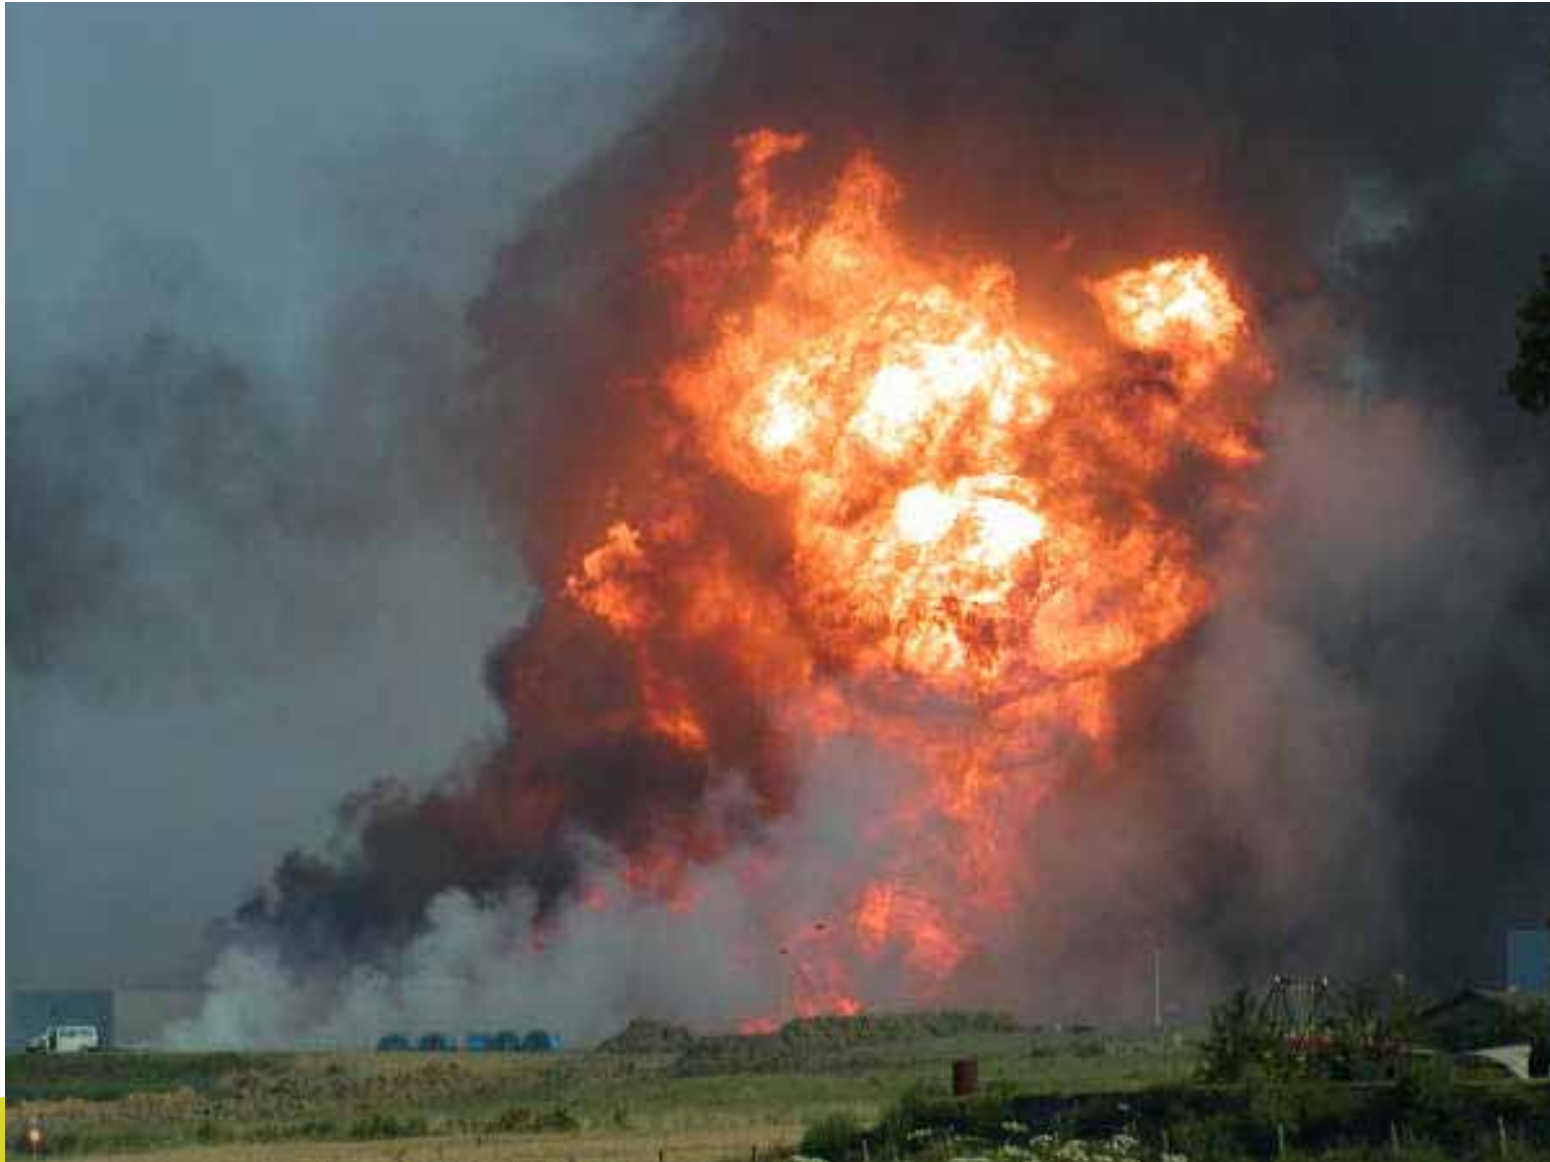
Flame seen from the south

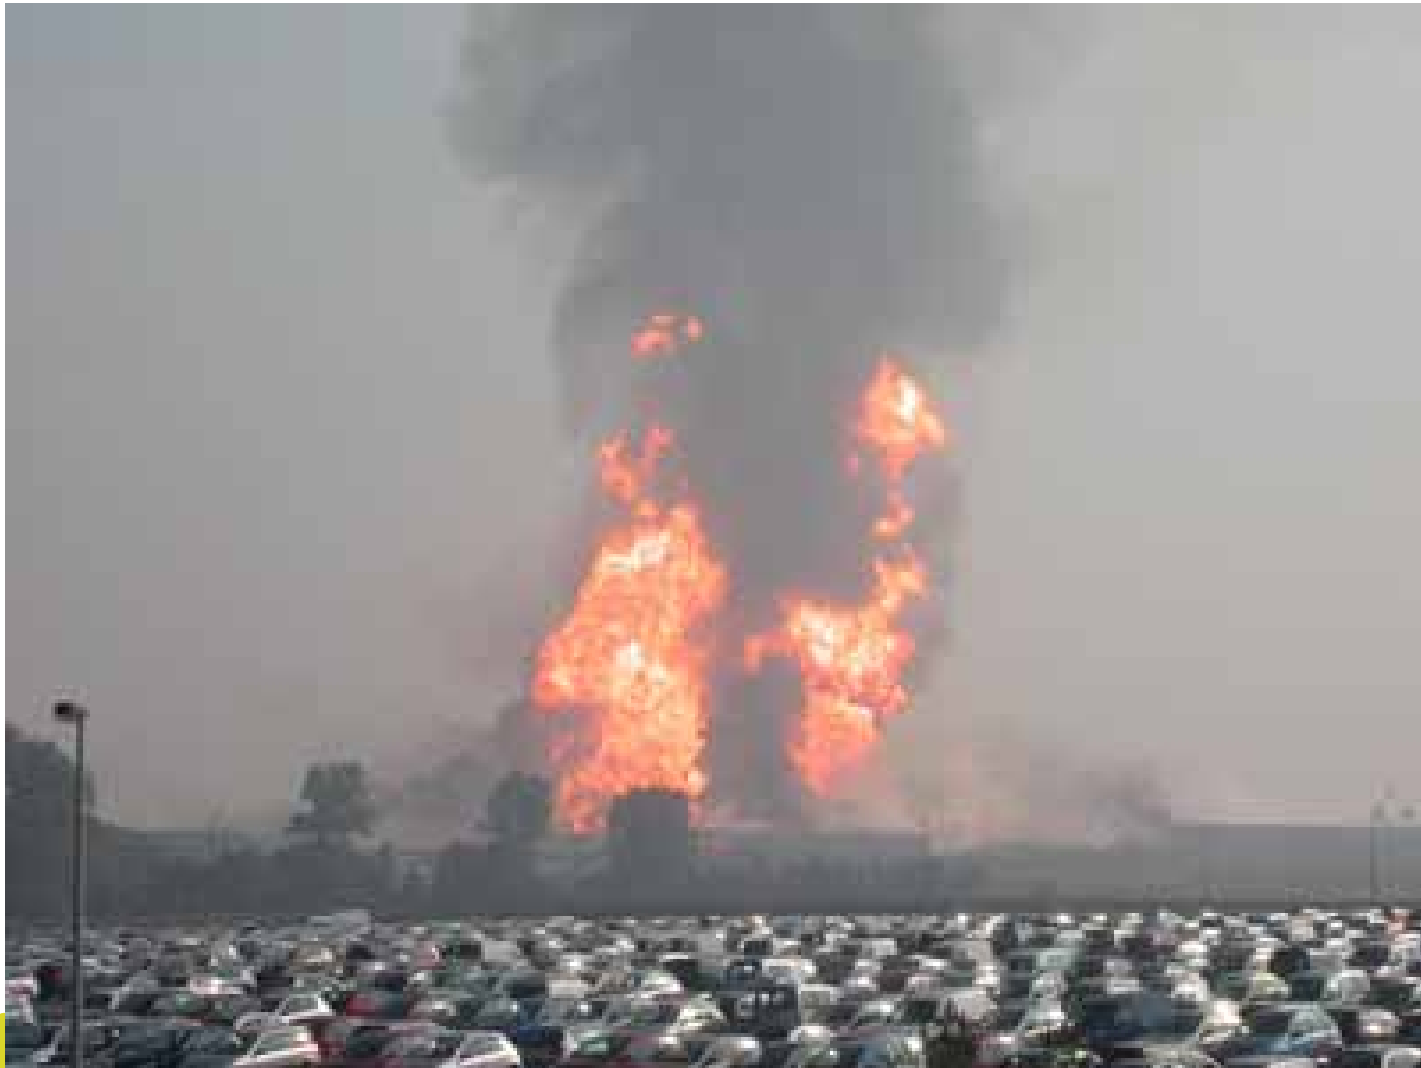
Flame seen from the south

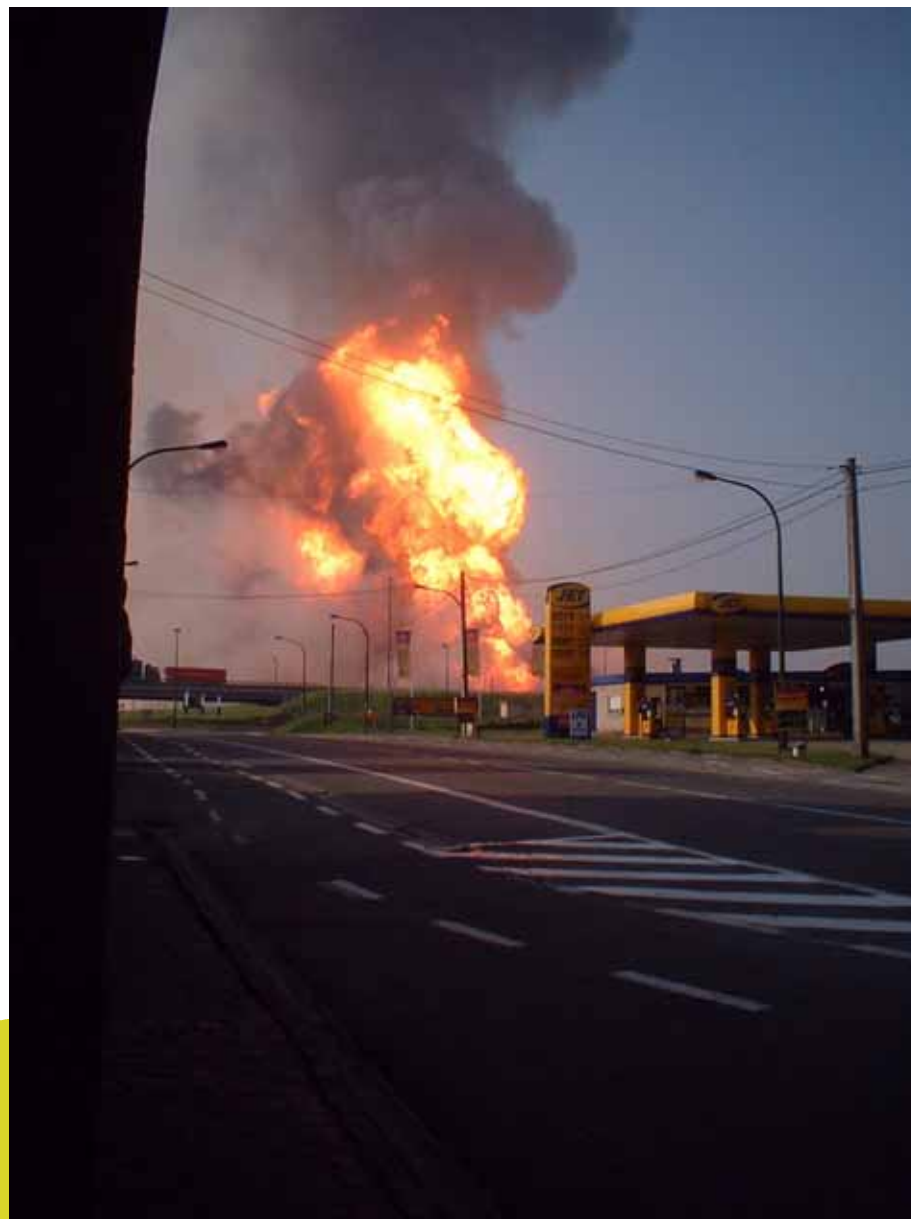
Flame seen from the north

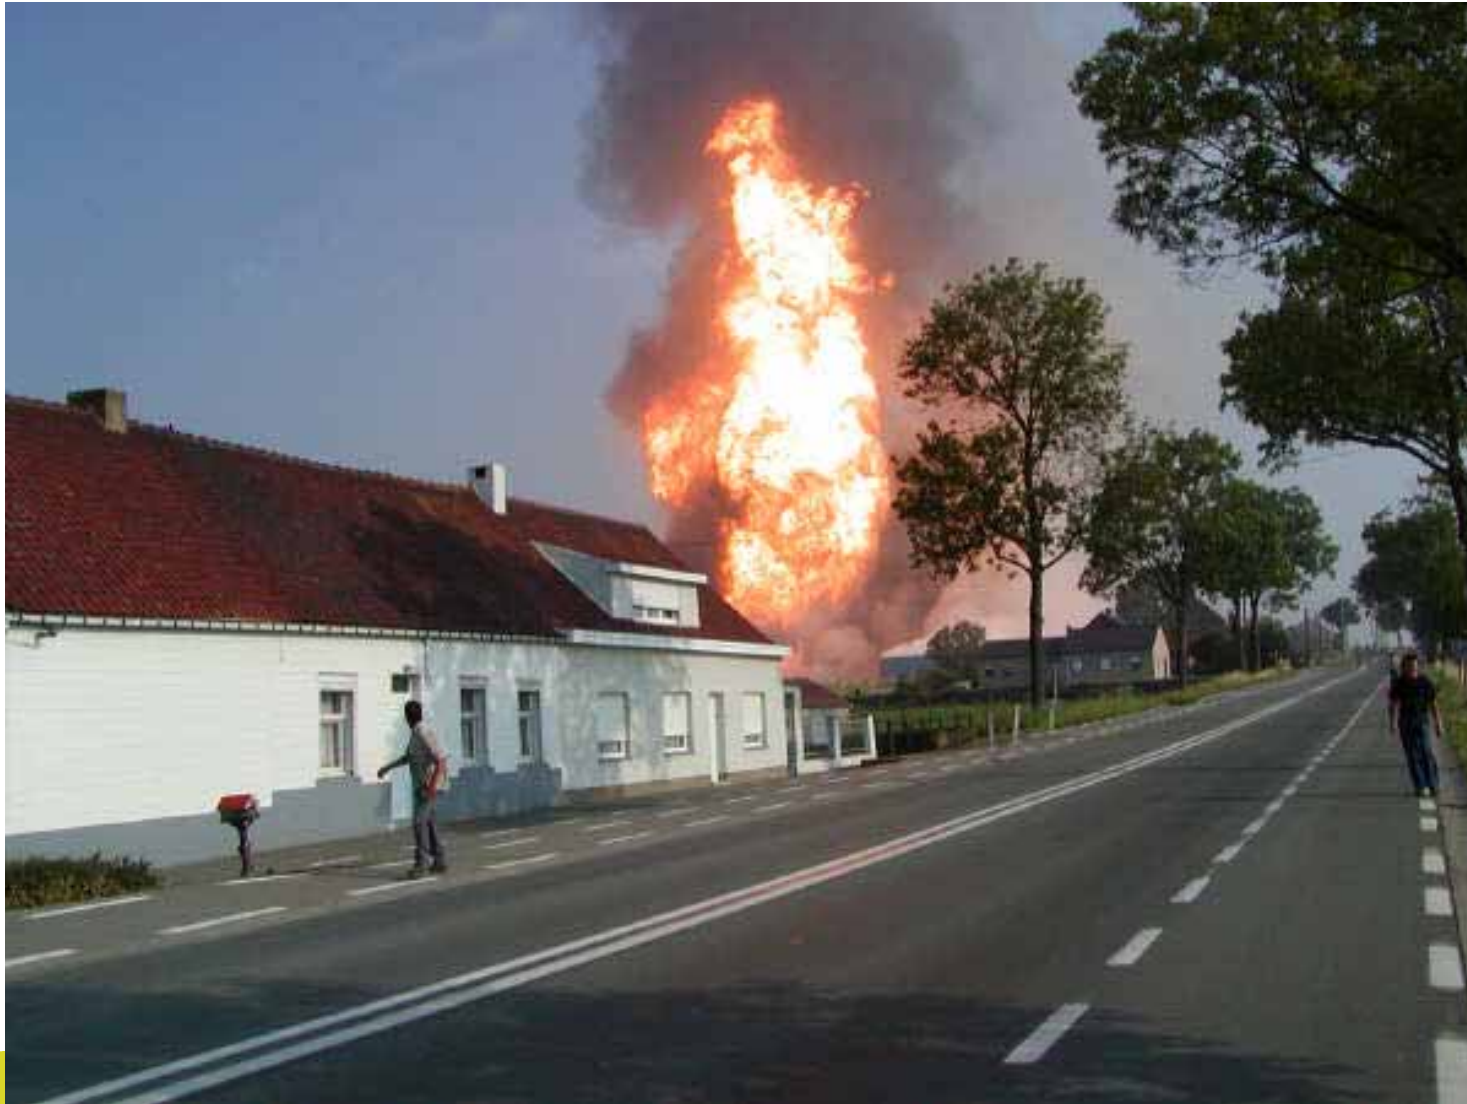
Flame seen from the south east

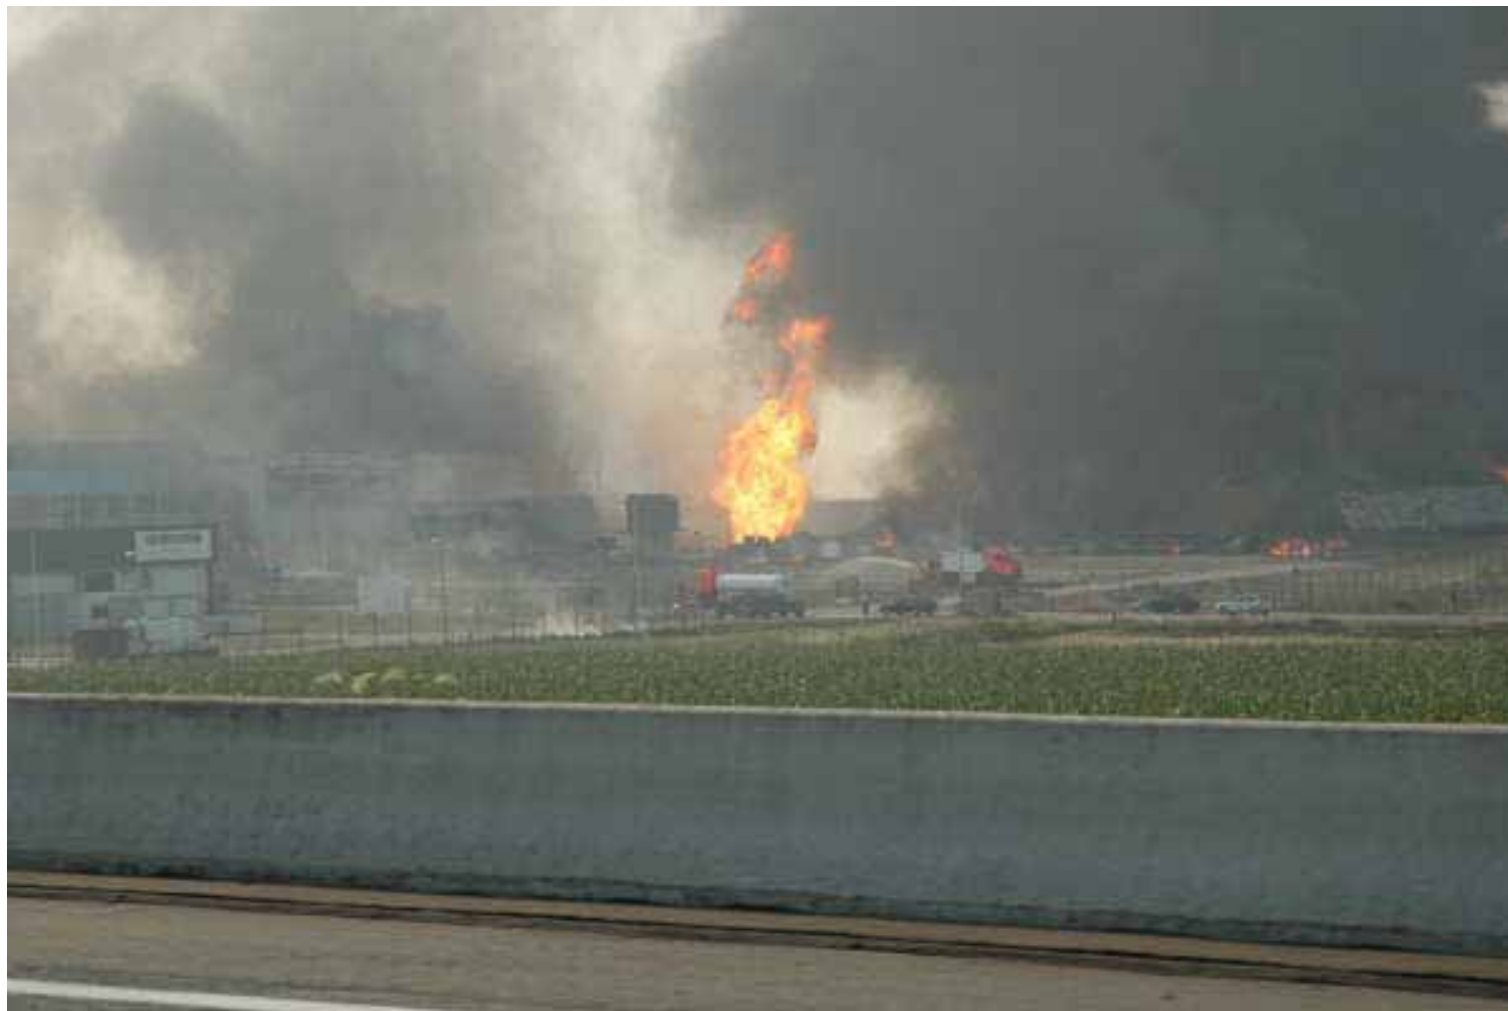
Reduced flame seen from highway

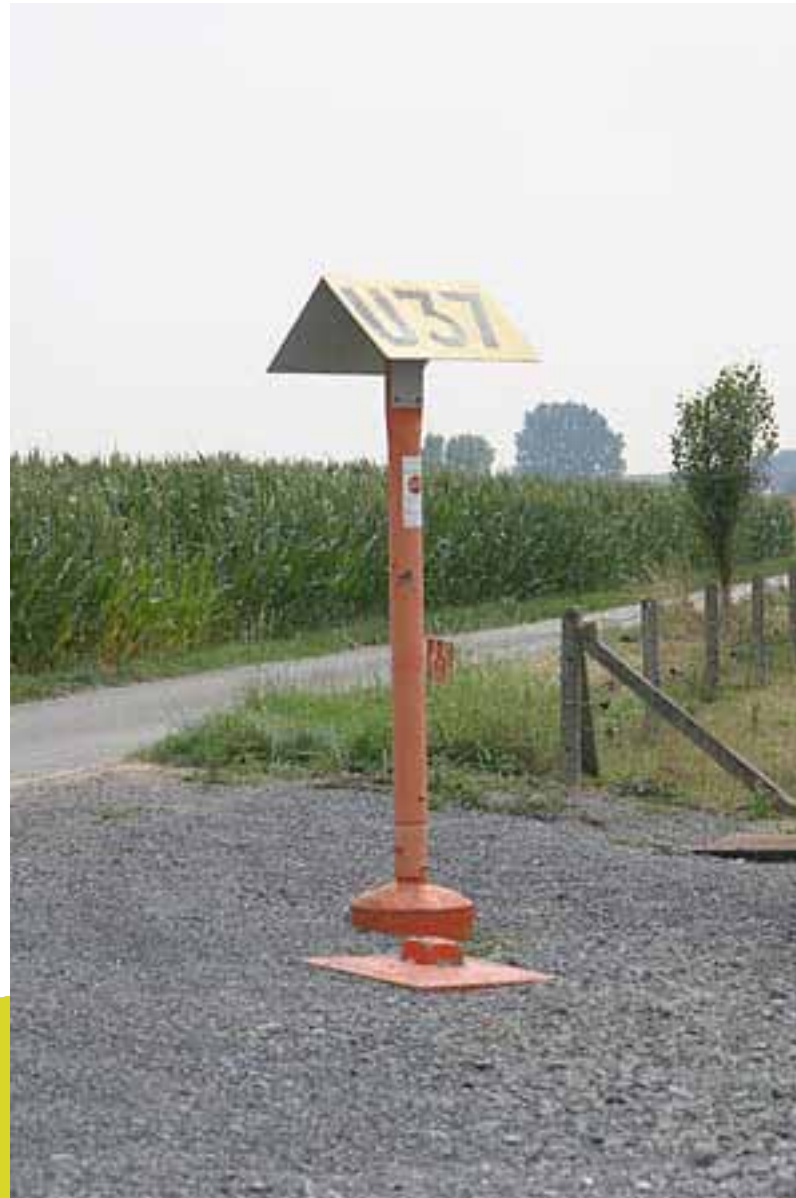
U37 marker post (south east of crater)

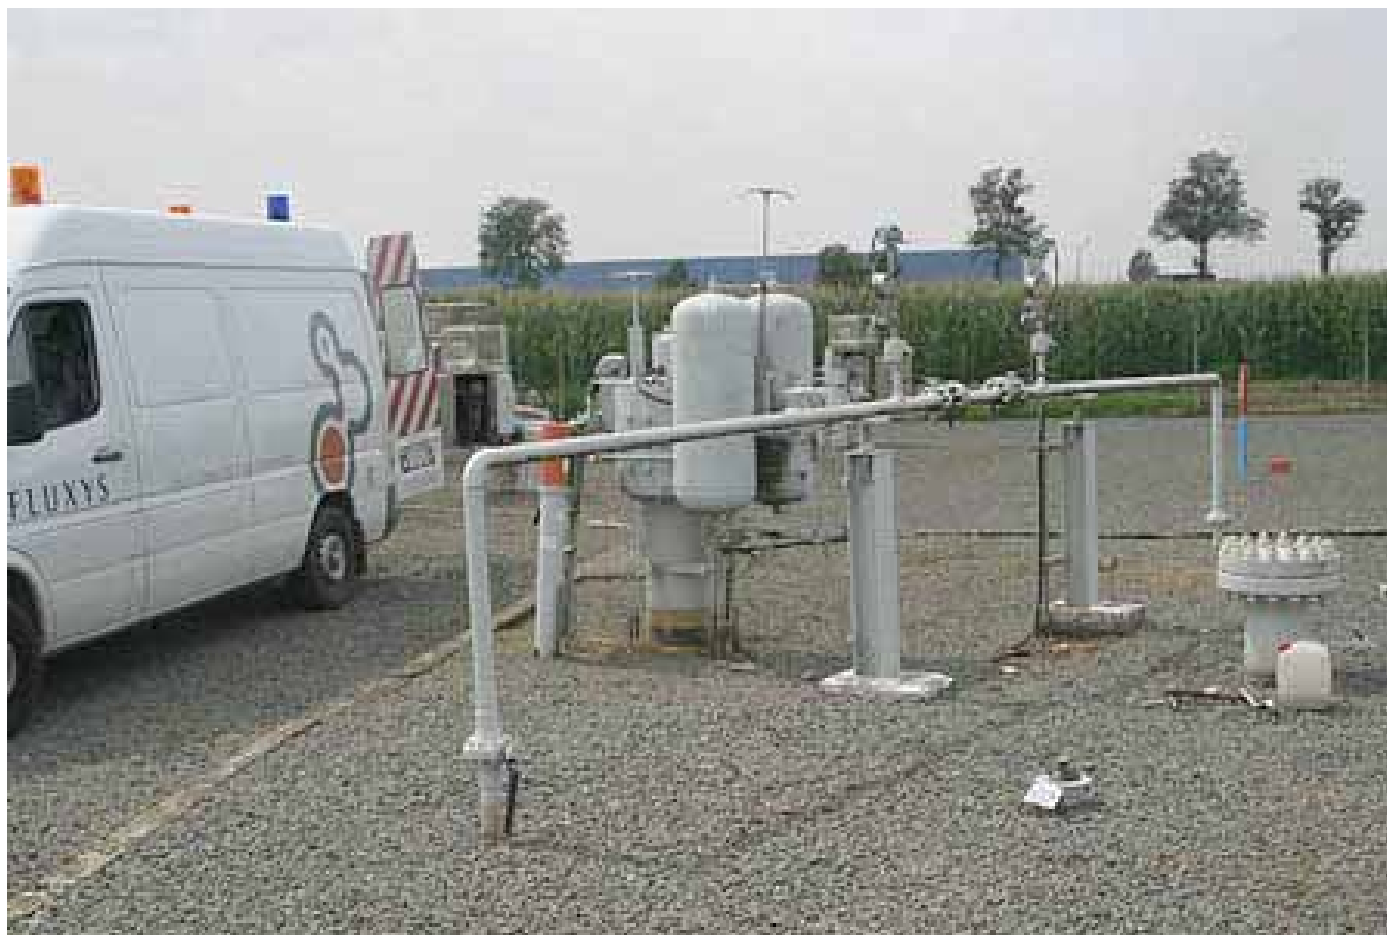
Valve station (not localized)

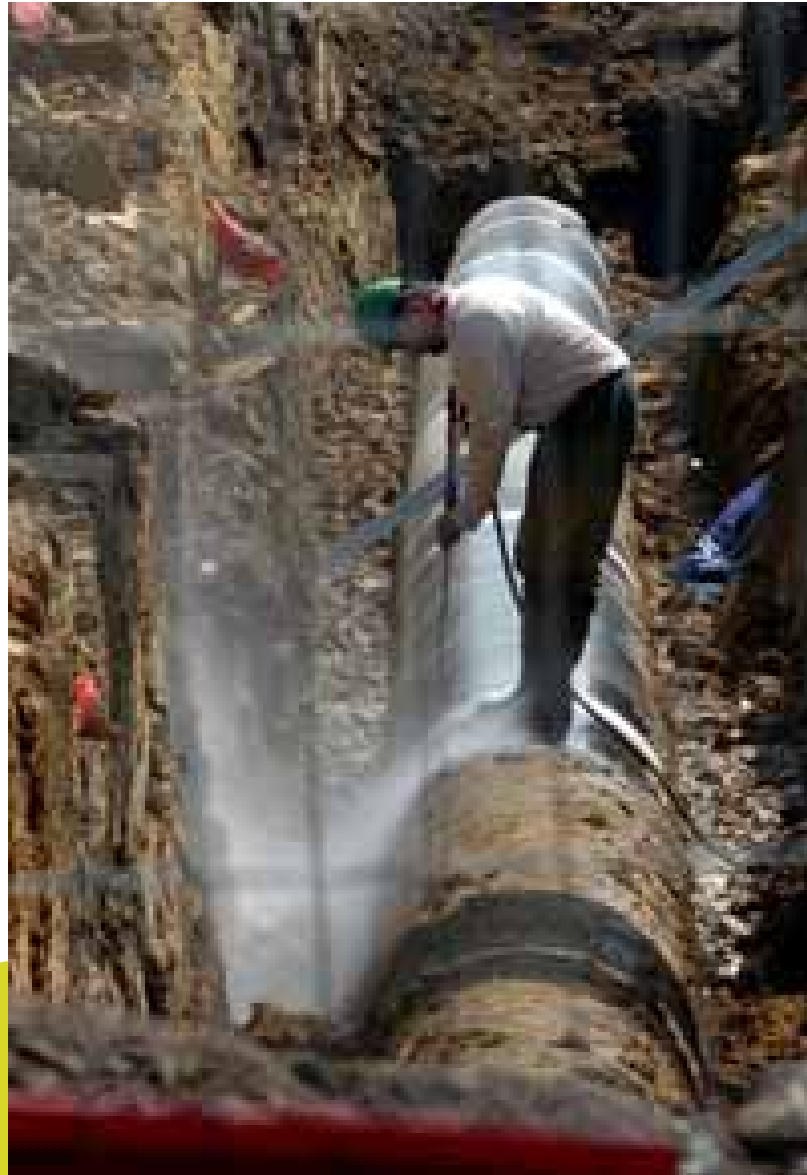
Inspection of pipeline (DN 900 – 36" or DN1000 - 40")
