1966 BEECH BARON

CASE 1-1

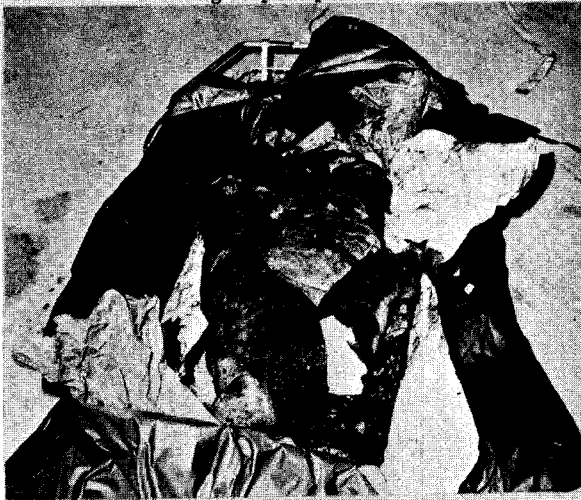
C. Remains of passenger in right front seat.

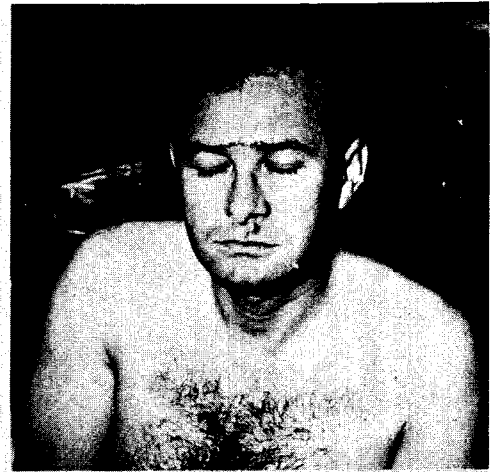
In Case Number 5 a Piper Comanche PA 24-250 (1962) skidded 305 feet on muddy ground before coming to rest. Assuming a flight velocity of 65 miles per hour just before initial contact with the ground, one can calculate an average de-

celeration of less than $\frac{1}{2}$ "g". However, since the pilot received a 5-inch laceration across the top of both eyebrows from striking the top edge of the instrument panel, we can safely state that at one point the deceleration slightly exceeded

D. Pilot with 5-inch laceration from contact with upper instrument panel.

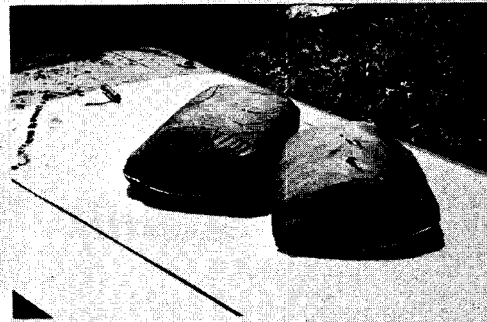
J. Seat cushions.

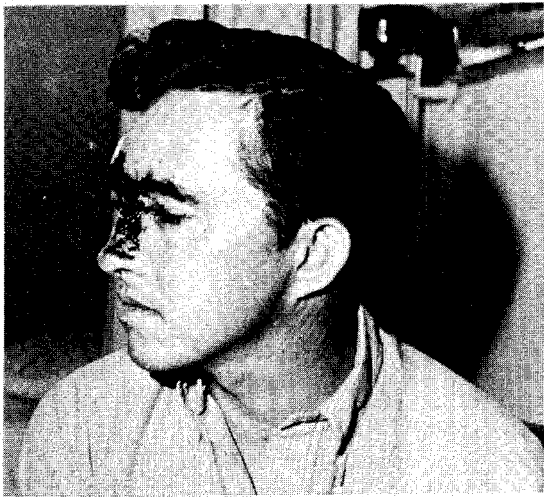
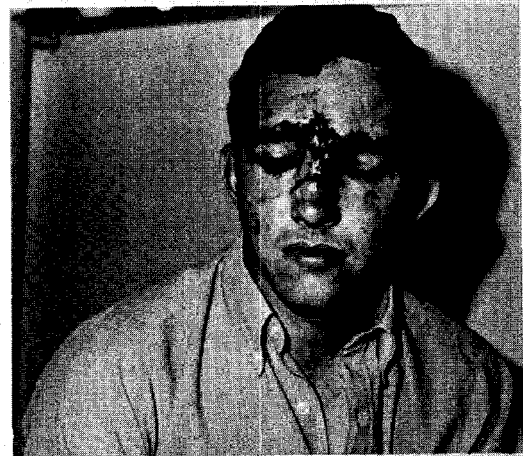
In Case Number 6, photographs are shown of the right front passenger with crushing fractures of the nose and right maxillary sinus along with severe lacerations of the nose and frontal sinus area (Case 6 K & L) received when he jack-knifed over his seat belt and impacted the top edge of the instrument panel at the point indicated by the head outline (Case 6F). Since this Ercoupe 415-C (1946) skidded 114 feet before coming to rest, an average deceleration of slightly over one "g" can be calculated, assuming an impact velocity of 95 ft./sec. However, as discussed earlier, one can brace against a one "g" impact and it must be assumed that since he hit the ground at about a 30° angle, the deceleration forces were somewhat higher than one "g" during a few milliseconds time span. Again, as in Case 5, the chest contacted the control wheel and evidently the occupant was able to hang onto the rim with sufficient strength to deform the wheel toward the instrument panel (Case 6 G), probably reducing the head impact velocity to a point that barely prevented the fatal head injuries. It is impossible to calculate the exact velocity of head impact, but based upon the author's studies of tolerances of the human face to crash impact (to be discussed later), the author estimates that the head impact velocity could not have been more than 15 ft./sec. in this case. Since the stopping distance of the head was about one inch ($\frac{1}{4}$ inch dent in panel + $\frac{3}{4}$ inch crushing of facial bones), the deceleration of the head may be calculated to be 42 "g". The human face cannot tolerate this magnitude of deceleration force on two square inches of area (see tolerances of face discussed later). We begin to appreciate the head injuries which may occur at cabin decelerations as low as three "g" when the impact force must be absorbed on small areas of the head.

K & L Side & frontal views of facial injuries suffered by copilot when his head hit the top corner of the instrument panel (Figure F).

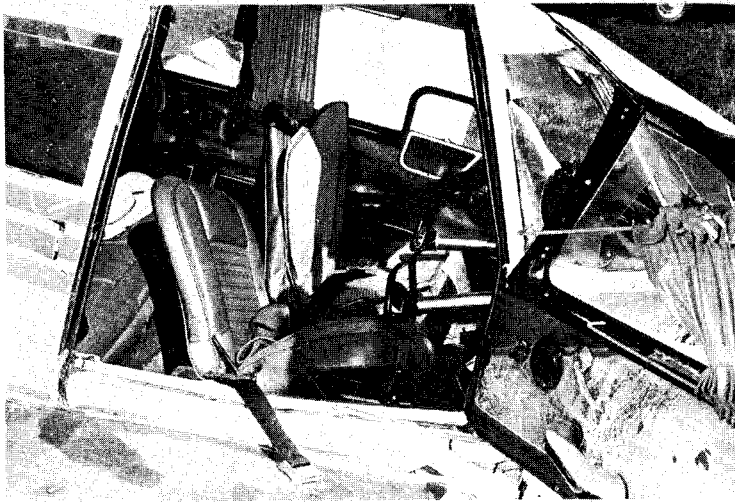
D. General appearance of cabin interior.
