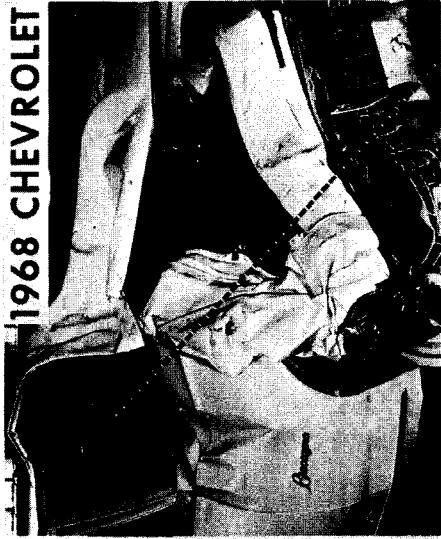
FIGURE 7. Automobile accident in which driver was subject to 7 "g" forward deceleration.

Note: Hood hinge penetrated windshield

① DRIVER

Cervical strain, pain in trapezius muscles, pain in left arm and upper chest

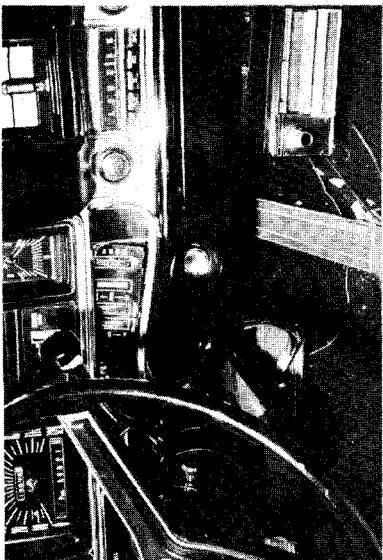
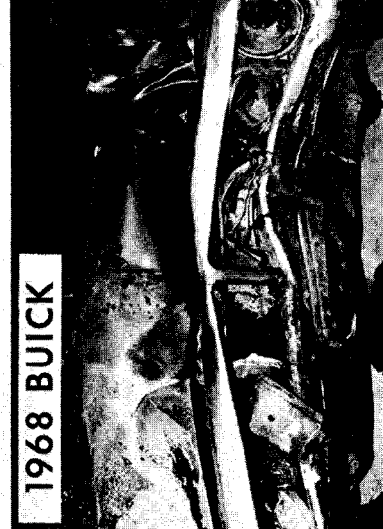
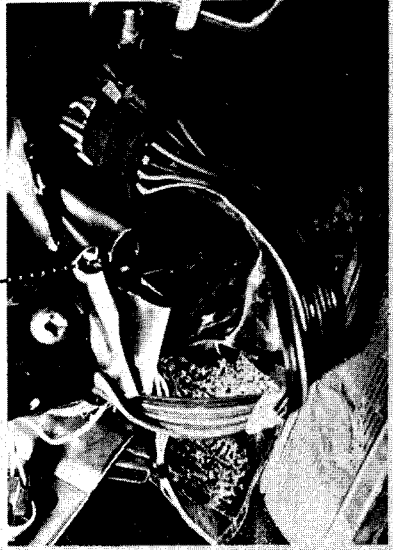
FIGURE 10. Driver impact against right door and dash in a 12 "g" intersection crash.

1968 BUICK

③ RIGHT FRONT

- (No knee bruises)
- 3 bottom front teeth knocked out
- Fracture floor (R) orbit
- Both maxillary sinuses cloudy
- Fracture both zygomas
- Subcutaneous emphysema both sides of face
- LeFort 1, 2, & 3 fracture mandibular alveolar ridge
- Floating maxilla
- Nasal fracture

① DRIVER

Unknown (believed to be minor)

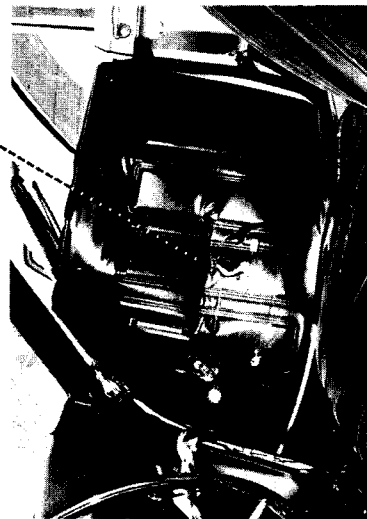
FIGURE 11. Automobile collision of 12 "g" magnitude in forward direction.

① DRIVER  
No injuries

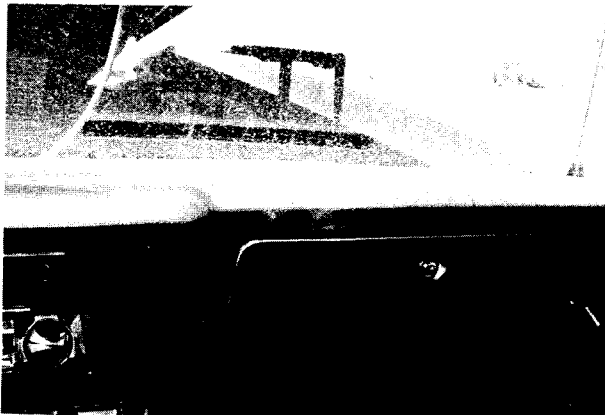
FIGURE 14. An example of a padded dash panel in a late-model automobile.

A separate study by the author<sup>58</sup> shows that this can be accomplished utilizing a fairly firm, slow-return padding material to distribute impact forces evenly over the contour of body structures being impacted along with a ductile backing structure that will yield and extend the deceleration time. In addition, there is evidence in the literature<sup>59,60</sup> that brain injury and even concussion may be prevented with head impacts up to 300 "g", *provided* skull deformation is prevented through the use of force distribution. The principle itself is not new as even the Knights of King Arthur's Round Table wore suits of armour to distribute the blow of their opponents' sword edge and prevent body penetration by distributing the load. For the same reason we have invented bullet-proof vests, football helmets, and even shoes. Since this simple principle has been known for such a long time, it is difficult for one to understand why manufacturers of people-shiping containers have neglected the use of it. Lack of protective design has been the direct cause of over 300,000 deaths and better than 20,000,000 serious head injuries in transportation vehicles over the past ten years. The automotive manufacturers in the past two or three years have begun using a dash panel of ribbon steel covered with slow-return padding (Figures 14 and 15) that is proving effective in preventing head injuries.

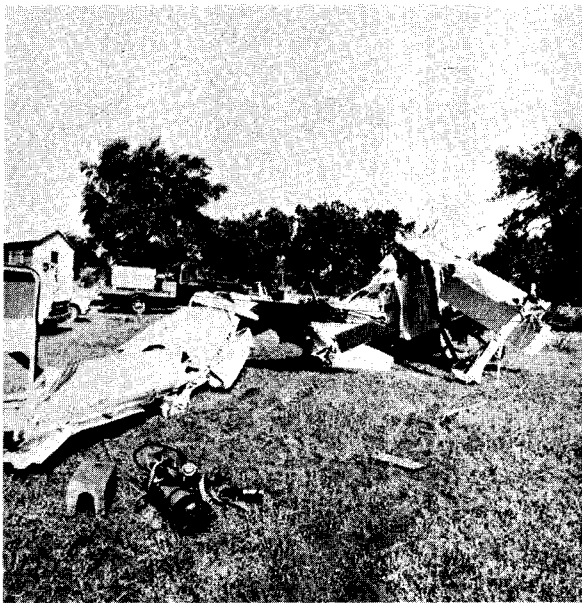
CESSNA 182 B, a 1959 model aircraft with pilot and one passenger (R. F. ), was flying over a lake (approximately 18 feet from the water), flew under a telephone wire and hooked the vertical stabilizer on it, nosing over into the water. Both occupants were wearing seat belts and both belts held. No shoulder harnesses were in the aircraft. Pilot and passenger were thrown straight forward. Impact forces are not known but must, of necessity, have been very low, impacting water from only 18 feet.

A. Side shot of wreckage retrieved from the lake.

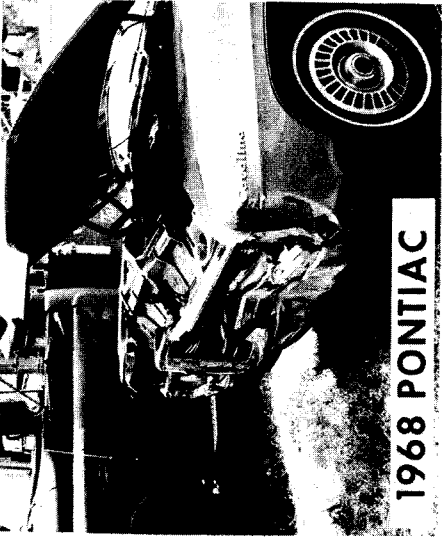
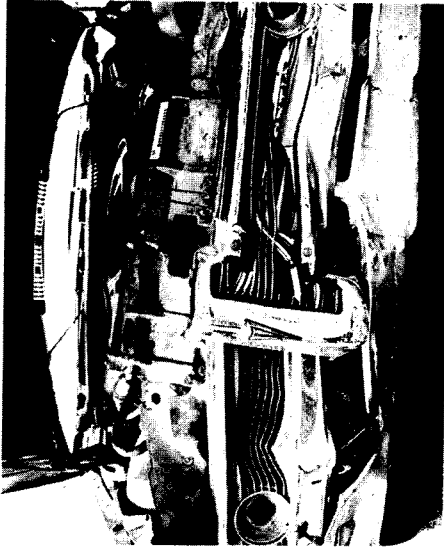
FIGURE 16. Automobile accident—calculated 19 "g".

① DRIVER  
 Contusions and superficial abrasions both knees  
 Complains of soreness in (L) shoulder

③ RIGHT FRONT (5)  
 Contusion of upper lip

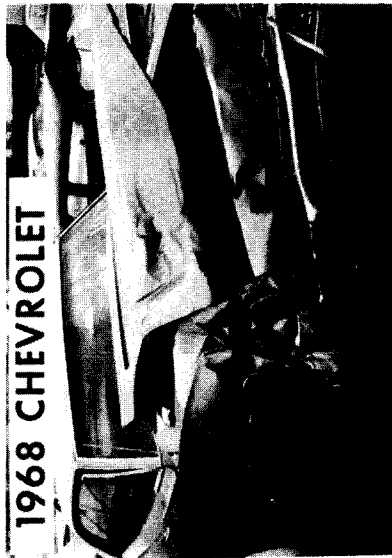
FIGURE 17. 19 "g" impact.

① DRIVER

Fracture (L) ankle

Swollen (L) knee

2 1/2 cm laceration forehead

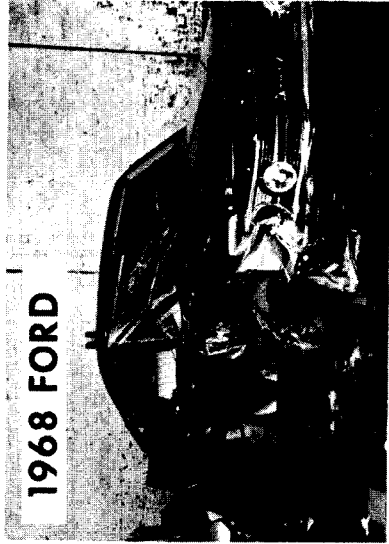
① DRIVER  
No injuries

② CENTER FRONT  
No injuries

No injury from door  
or window crank

③ RIGHT FRONT  
Minor head lacerations

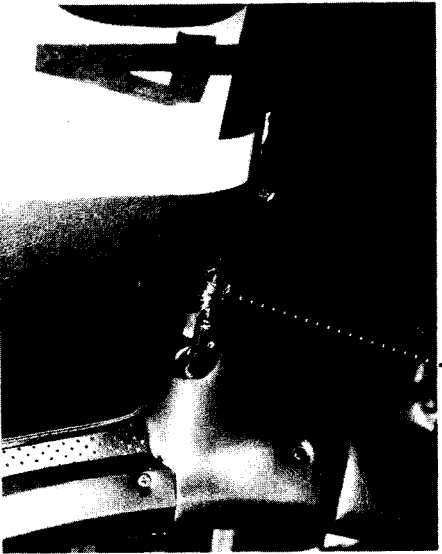
① DRIVER  
Contusion - center top of forehead

③ RIGHT FRONT  
No injuries

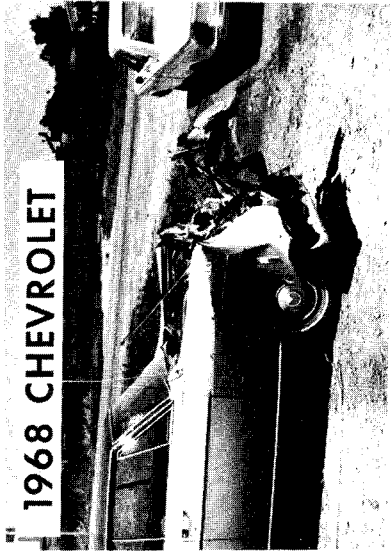
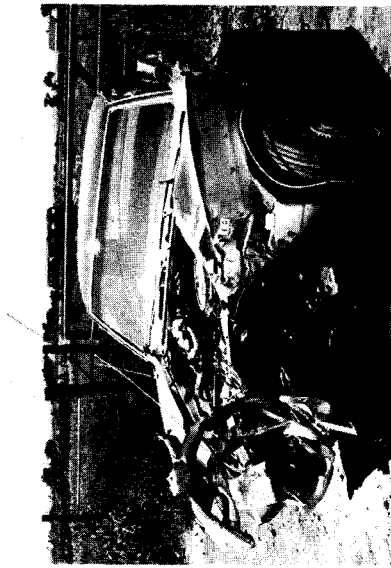
① DRIVER

Laceration (R) leg below knee

Fracture (R) clavicle

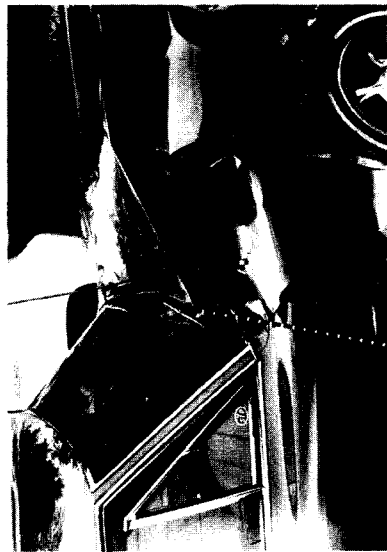
① DRIVER Uninjured

*Note: penetration of windshield*

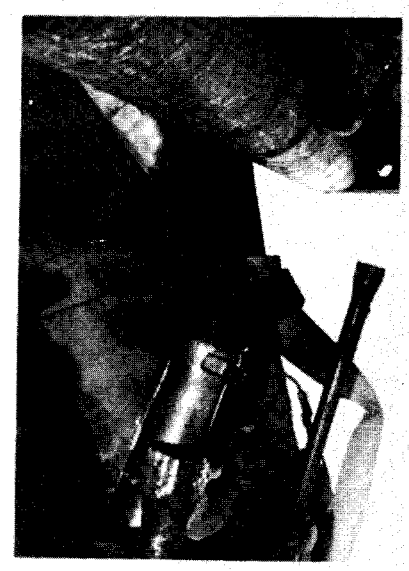
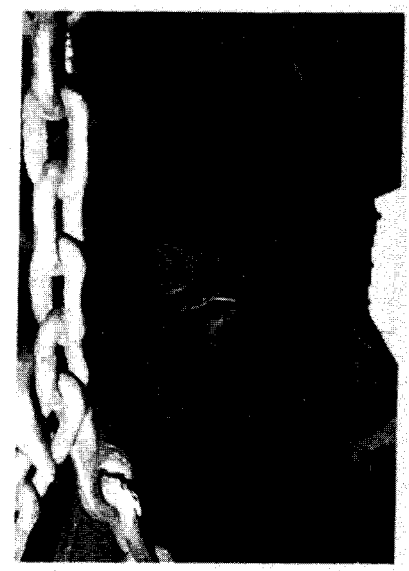
FIGURE 25. Deceleration = 38 "g".

- Fracture nose, cerebral concussion
- Fracture (R) fibula
- Fracture humerus (R)
- Laceration (R) knee

No chest injury

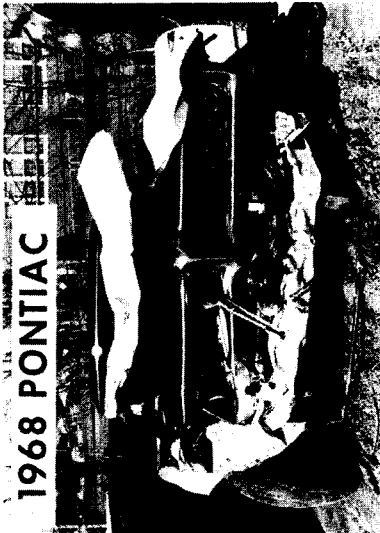
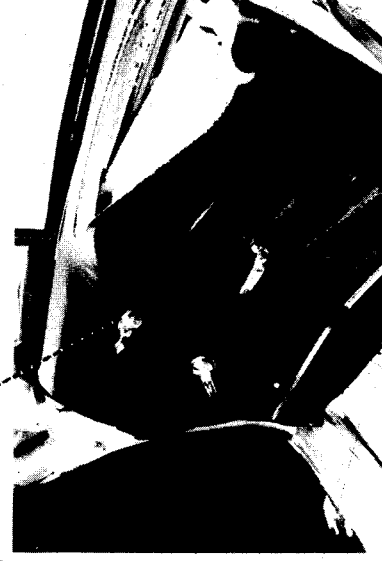
FIGURE 26. Deceleration = 42 "g".

① DRIVER  
Minor injuries

③ RIGHT FRONT  
Minor injuries

④ LEFT REAR  
Severe depressed skull fracture - (R) temporal loss of  
brain tissue (40 cc) through opening  
Severe (L) chest laceration

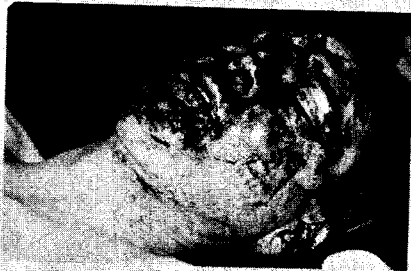
D. Photograph & artist sketches of head injuries of front seat passenger.

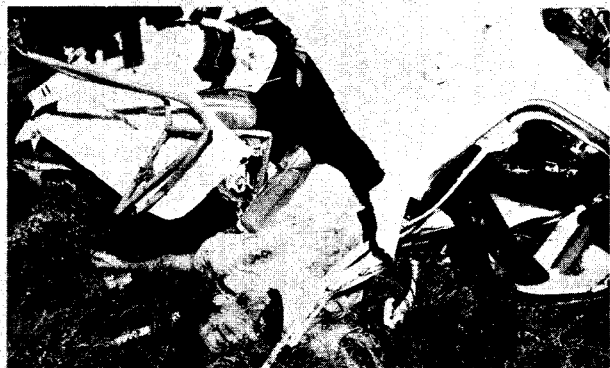
D. Copilot's body partly ejected through opening.

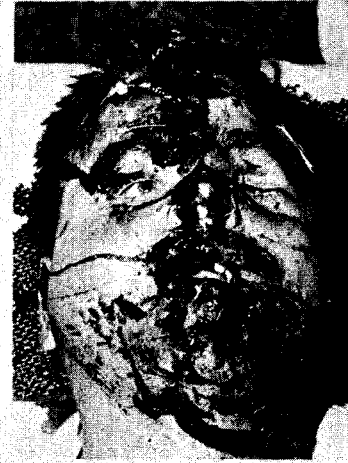
I. Crushing injuries of pilot's head.

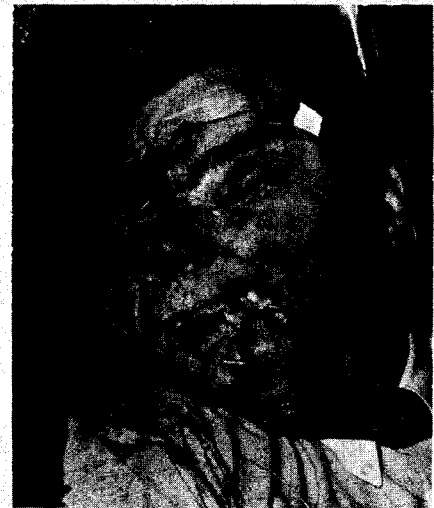
J. Copilot head injuries.

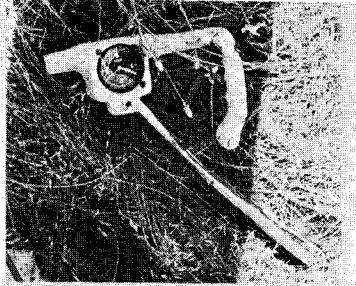
would have exceeded a velocity of 100 ft./sec. (70 mi./hr.). Since the depth of the head imprints measured less than 6 inches, the average deceleration of these two heads was in the order of 10,000 ft./sec.<sup>2</sup>, or over 300 “g” which approaches the tolerance limits of the human face and head with the load distributed evenly over the facial contours. In this case, the impact loads were concentrated by irregular structures and the crushing injuries inflicted would be expected. Also note that both seat belts and seat attachments did not fail. The author concludes that the crash forces in this case were less than 15 “g” and, since the rear cabin structure is intact, it is likely these two men could have survived this crash had they been wearing shoulder harnesses. Special attention should be called to the head impact areas outlined in Case 16 H. Note that these two depressions are down on the face of the instrument panel, the right one being lower than the left, and not on top as would have been expected, indicating that the instrument panel was moving or had moved away from the front seat occupants before they made their head strikes. In other words, the cabin structure had failed and most of the failure occurred on the right side of the cabin, allowing the right end structure of the instrument panel to fail (Case 16 B). The left side of the cabin of this aircraft does not have a door (Case 16 A) and for that reason has more structural strength. This weakness of cabin structure around the door area has been observed throughout this crash investigation study with the exception of aircraft manufactured by Beech Aircraft Corporation who, through the use of light channel, greatly increased the strength of the Beech aircraft cabins in the early 1950’s. Attention was called to the poor design of the control wheel of this aircraft in Case 11. Here we see it again—the protruding clock in the center of the wheel has left its mark and the horns have broken off (Case 16 K and L).

K. Broken control wheel with center-mounted altimeter & reset knob.

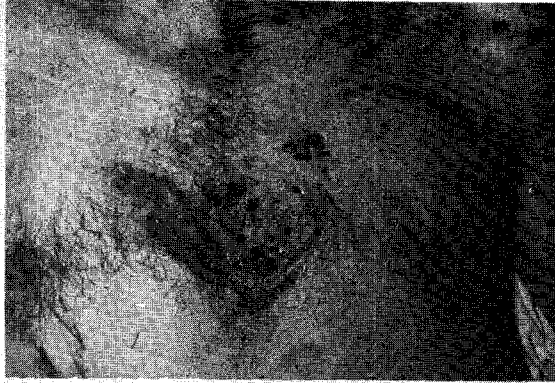
L. Chest injury inflicted by altimeter & reset knob shown in K.

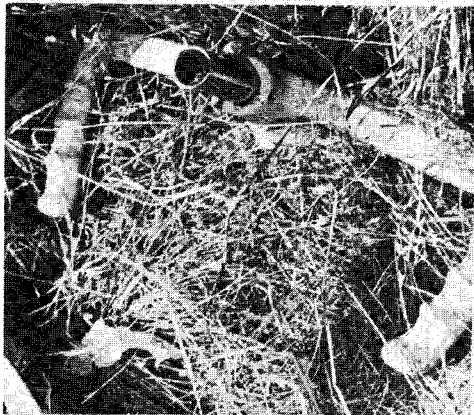
M. Tubular control column broken off.

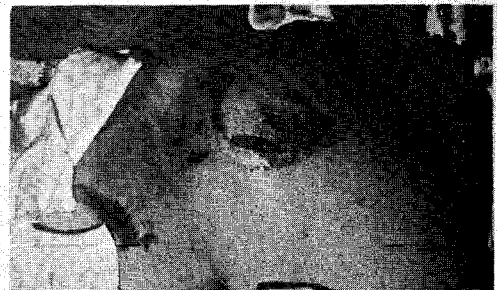
P, Q & R Severe lacerations & fractures inflicted when arms & legs flailed into broken structures.

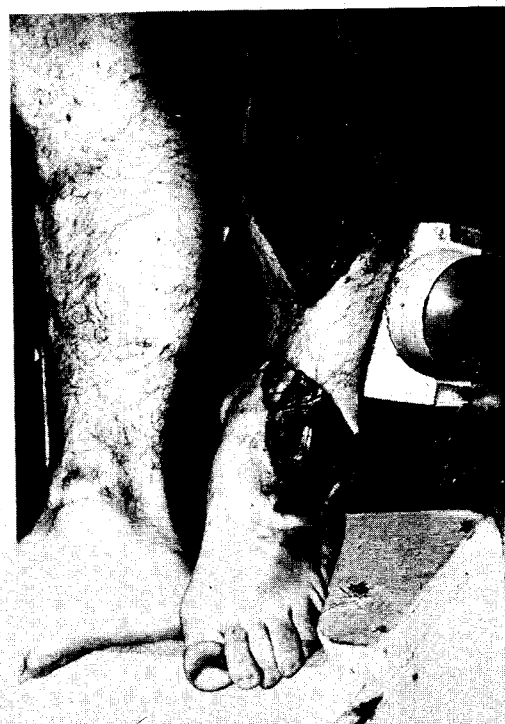
J. Lower leg injuries.

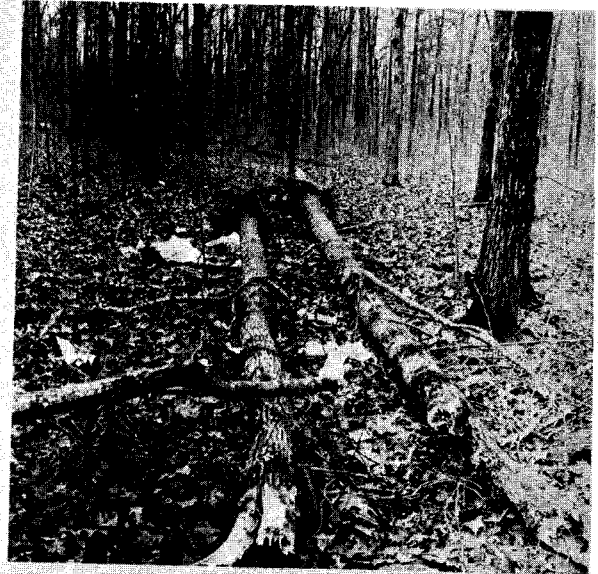
B. Two large trees uprooted by aircraft impact.
