1968 CESSNA 150

ACCIDENT INVESTIGATED BY:
GALE BRADEN AND DON ROWLAN
CAMI

CASE 20-1

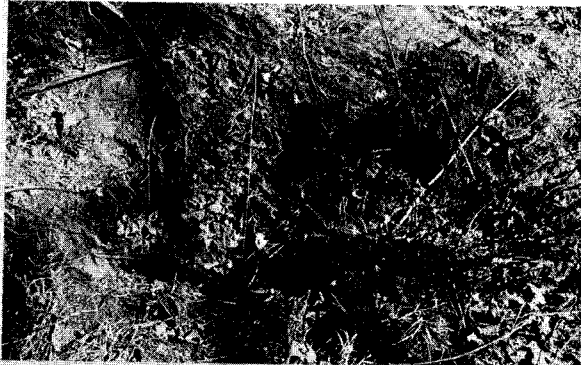
A. Small earthen depression from Pawnee impact.

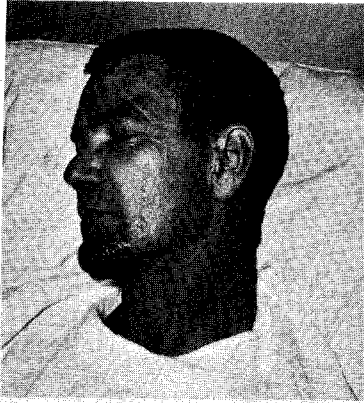
H. Slight chin laceration was only head injury.

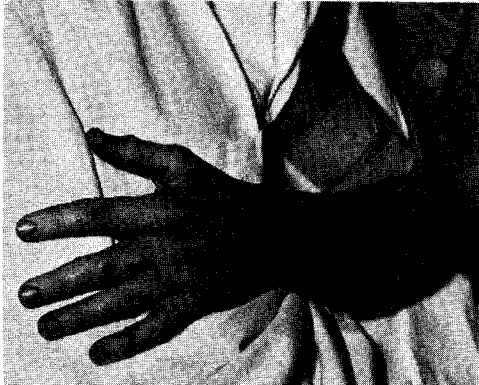
J. Minor laceration of left hand.
