THE ADMINISTRATION BUILDING (THE RYAN CENTER)

Gateway National Recreation Area
Floyd Bennett Field Unit
Brooklyn, New York

Historic Structure Report

By
Judith A. Quinn

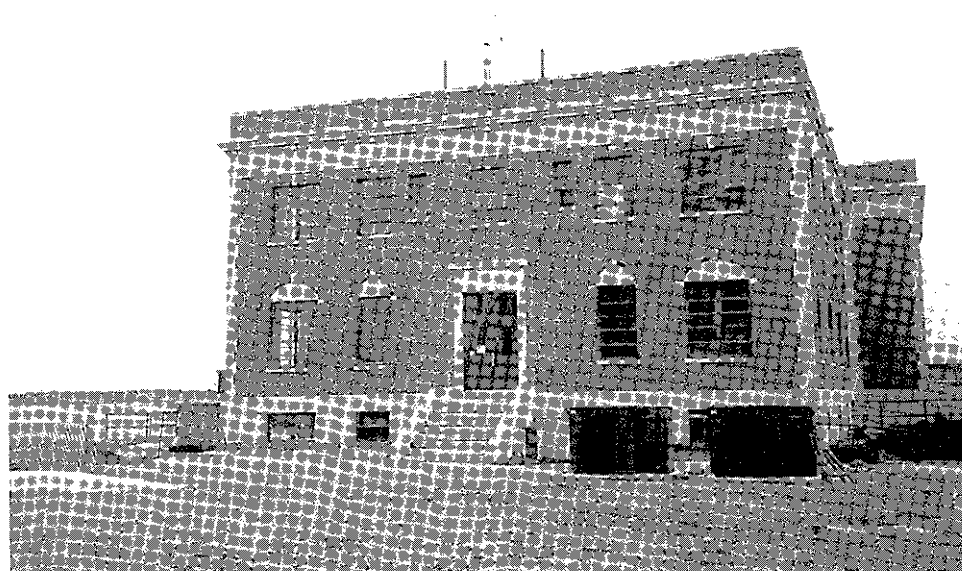
Figure 12. North end of building. Note ghost of former extension in brickwork around doorway.

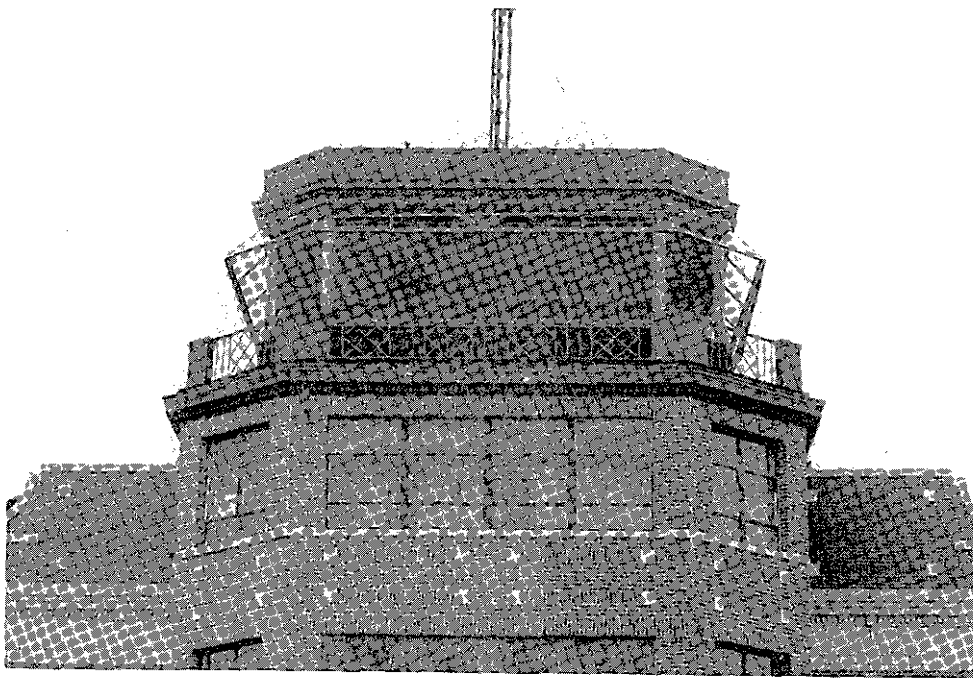
Figure 17. East side of building, detail of control tower. Note 1930 perimeter walkway and cornice, and 1943 glass enclosure.

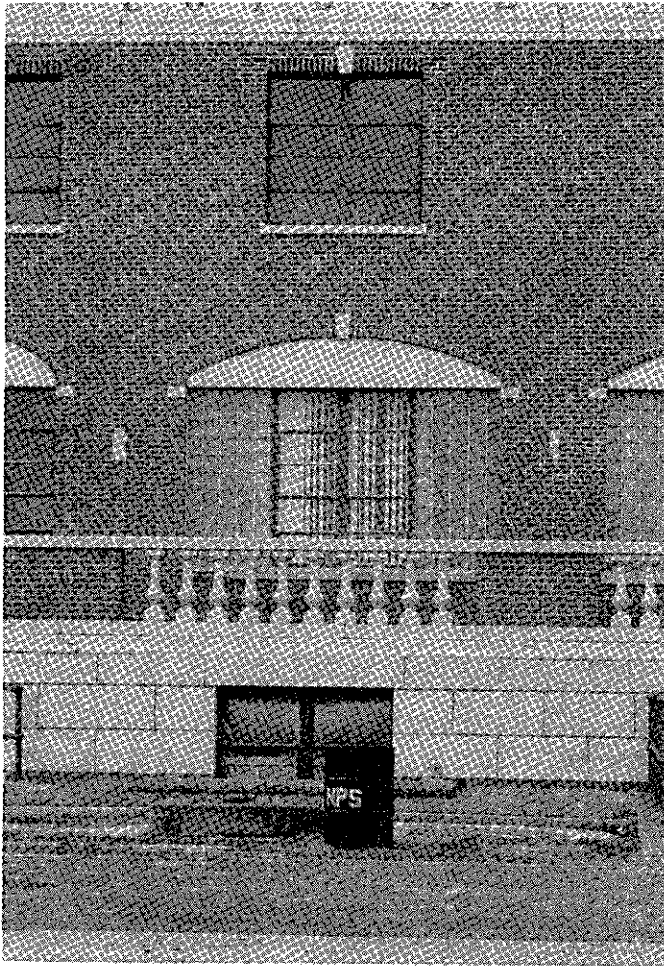
Figure 18. East side of building, north terrace, window 1-22, originally a doorway. Note scars on wall from former light fixtures.

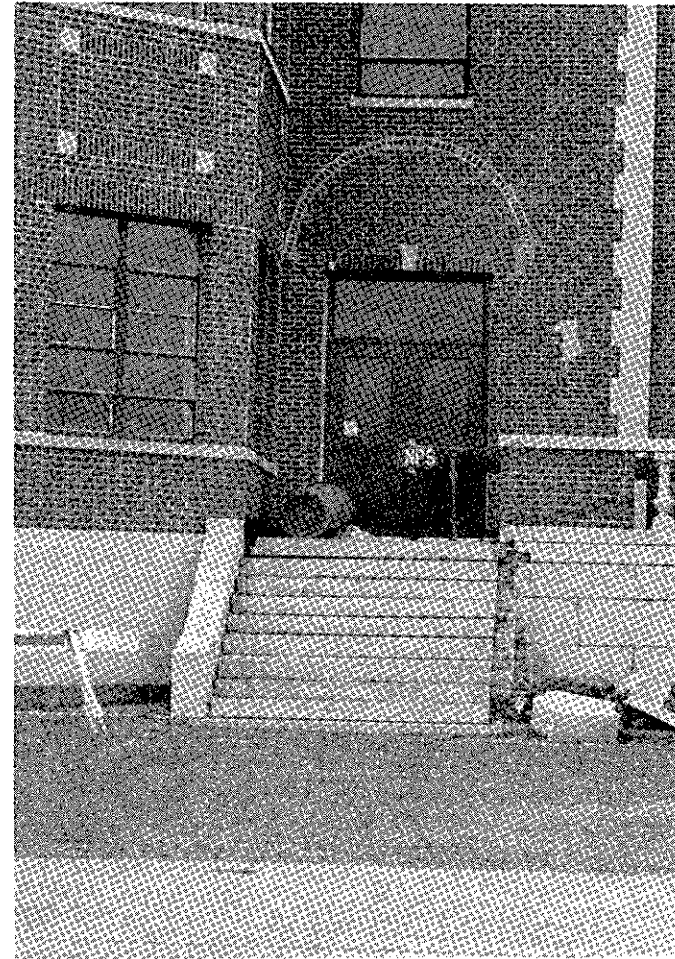
Figure 19. East side of building, north terrace, doorway D 1-24, tower to left. Note ghost of former doorway canopy.

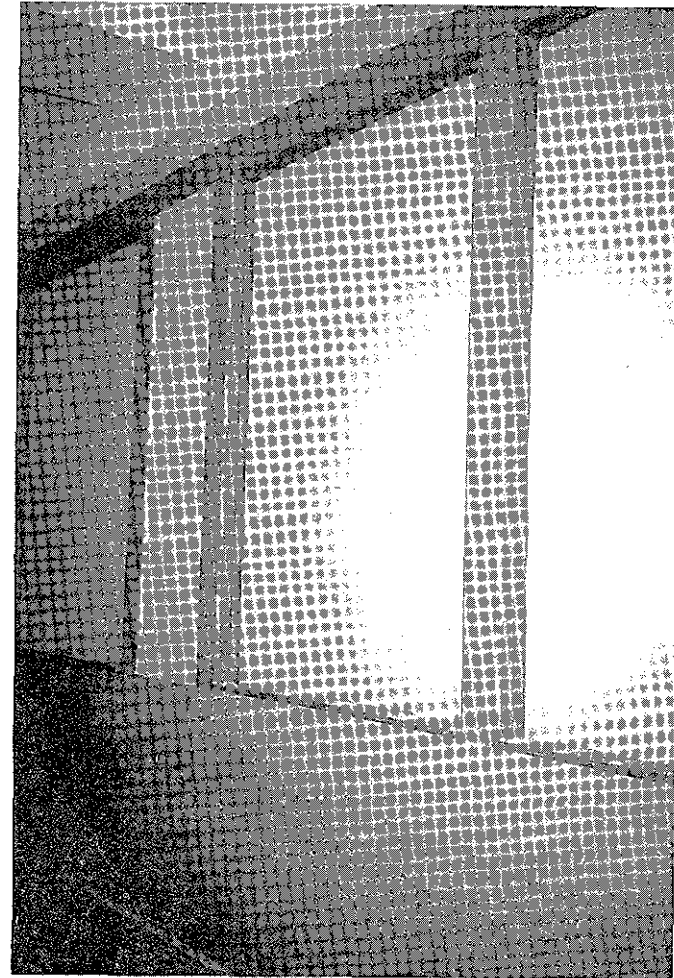
Figure 29. North corridor, east wall: former window wall looking into Room 110, plate glass now replaced with plywood.
