**WILLIAM JOHNSON HOUSE
NATCHEZ NATIONAL HISTORICAL PARK
NATCHEZ, MISSISSIPPI**

HISTORIC STRUCTURE REPORT

ANN BEHA ASSOCIATES

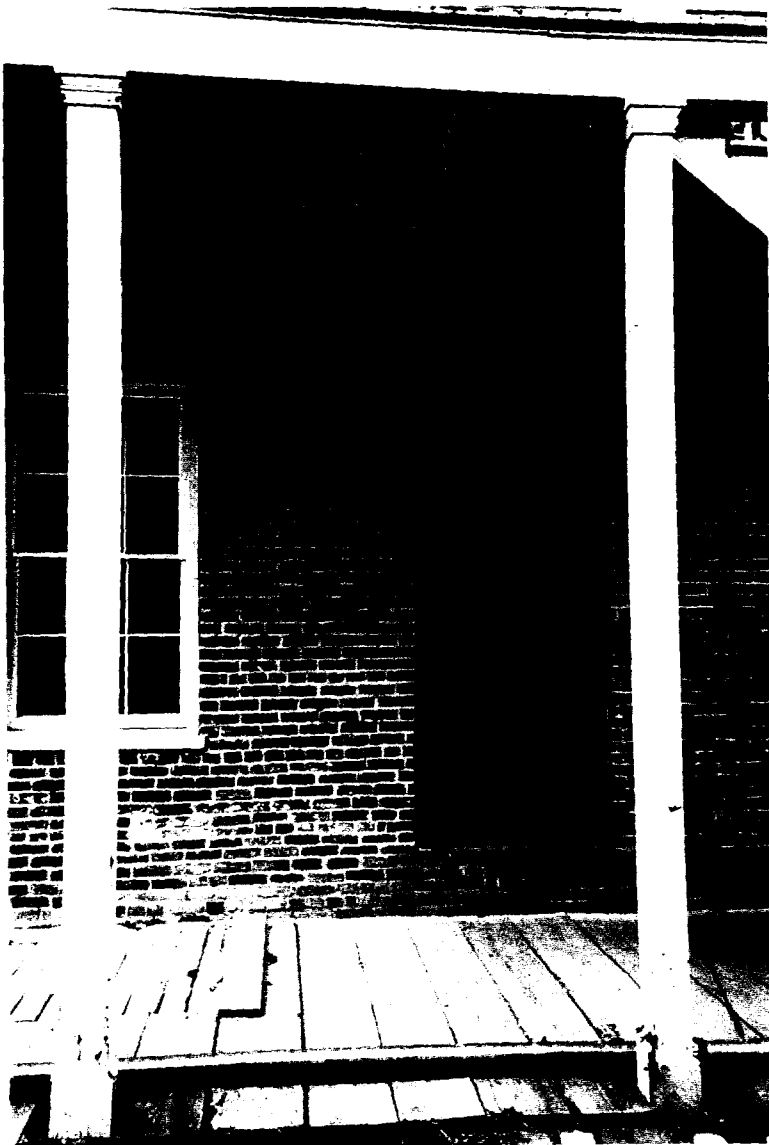
The south porch is currently in poor condition. The floorboards on the first floor were replaced. They are unpainted, gaps have opened up (1/4"-1/2") between some of the boards, and a few of the boards have split and checked (24-A). There is a hatch to the cellar that opens up, and a board has been nailed to the decking next to this hatch. This board can easily be tripped over. The bases of the columns supporting the second floor have opened up at their joints (25-A). The southeast corner column has come completely detached from the second-floor joists (26-A). Eighty to ninety percent of the board-and-batten ceiling for the first floor shows signs of mildew, as does the second-floor ceiling (25-A).

25-A Main House - Gaps between porch floorboards, opened joints at column bases, and mildewed ceiling.

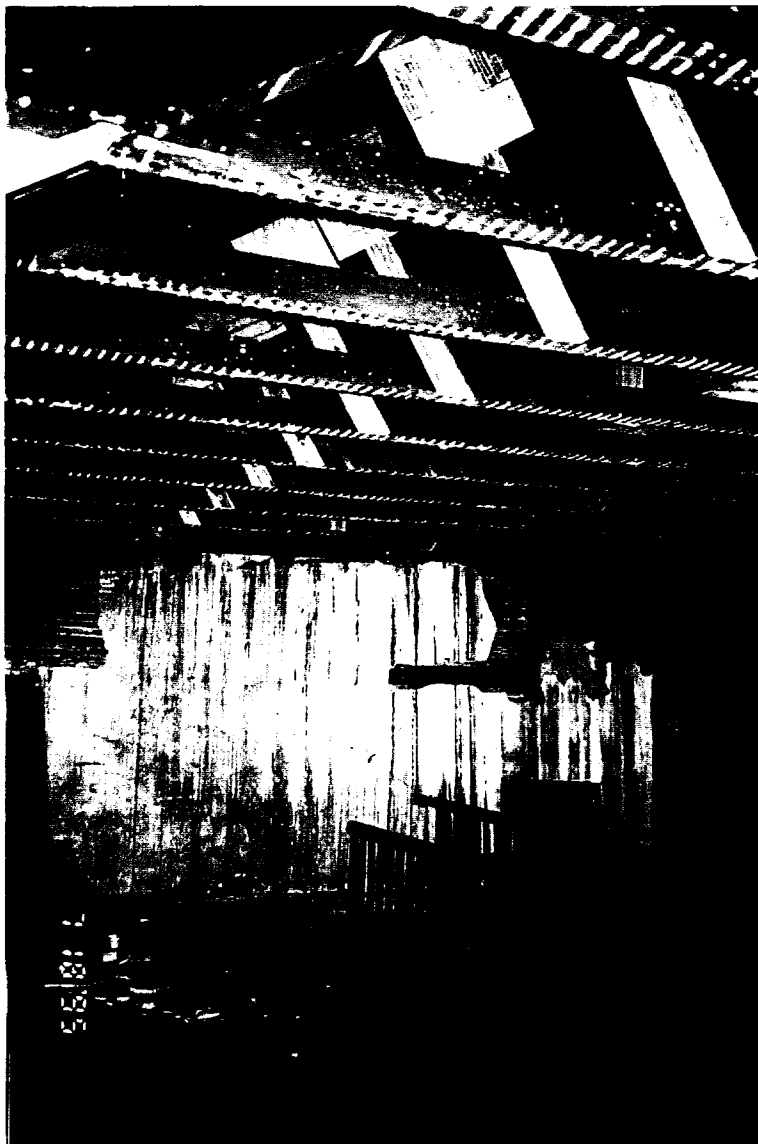
portions of the ceiling. The original baseboard remains in good condition, but it is pulling away from both the east and west walls. The original finish has worn off. There are no window casings. There is a wood balustrade around the top of the stairs which has pulled out of the east wall. The balusters are let into the floor and are loose (41-A).

41-A Main House - Third floor balustrade.

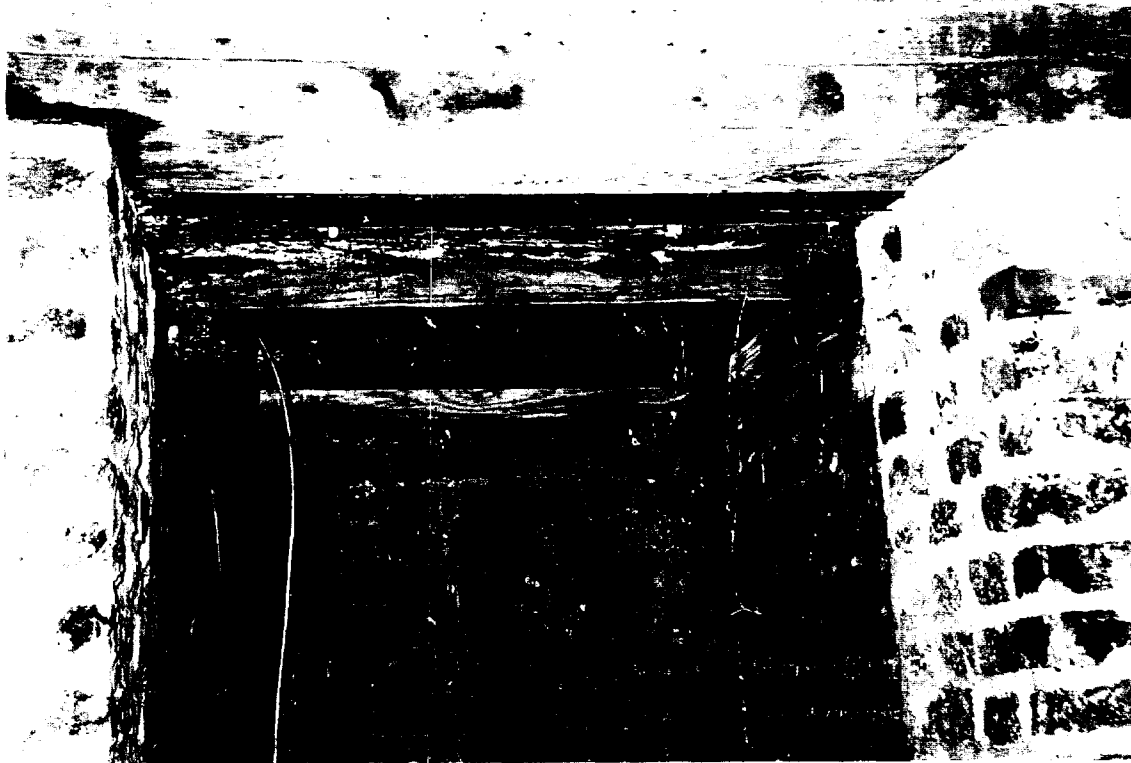
42-S Main House - View of rotted wood below south porch ground floor.

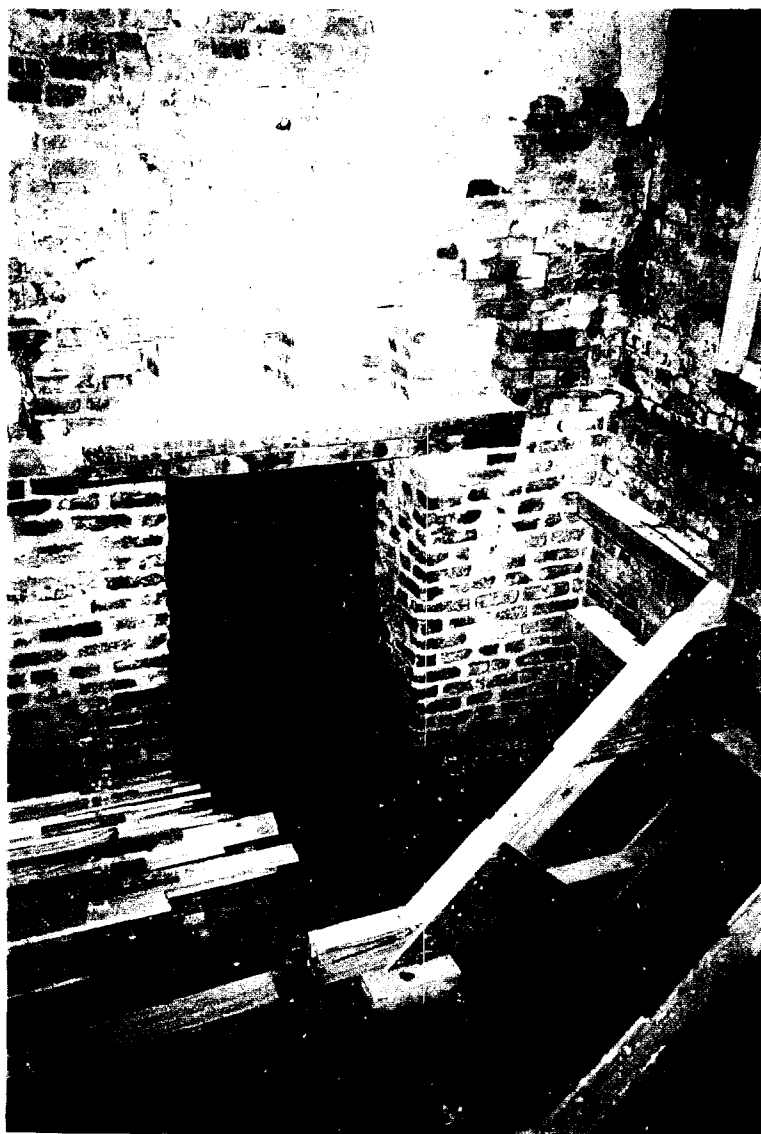
43-S Main House - View of northwest corner of basement.

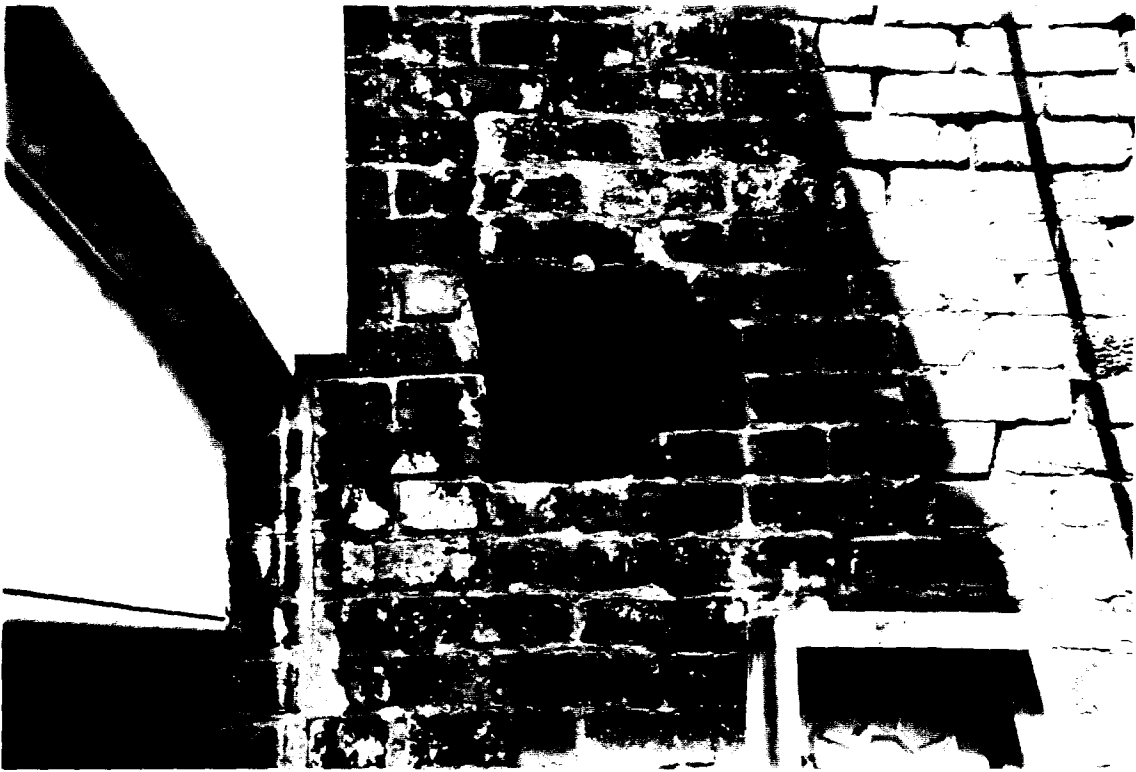
60-S Area of probe made into the south elevation of the McCallum House and William Johnson House.

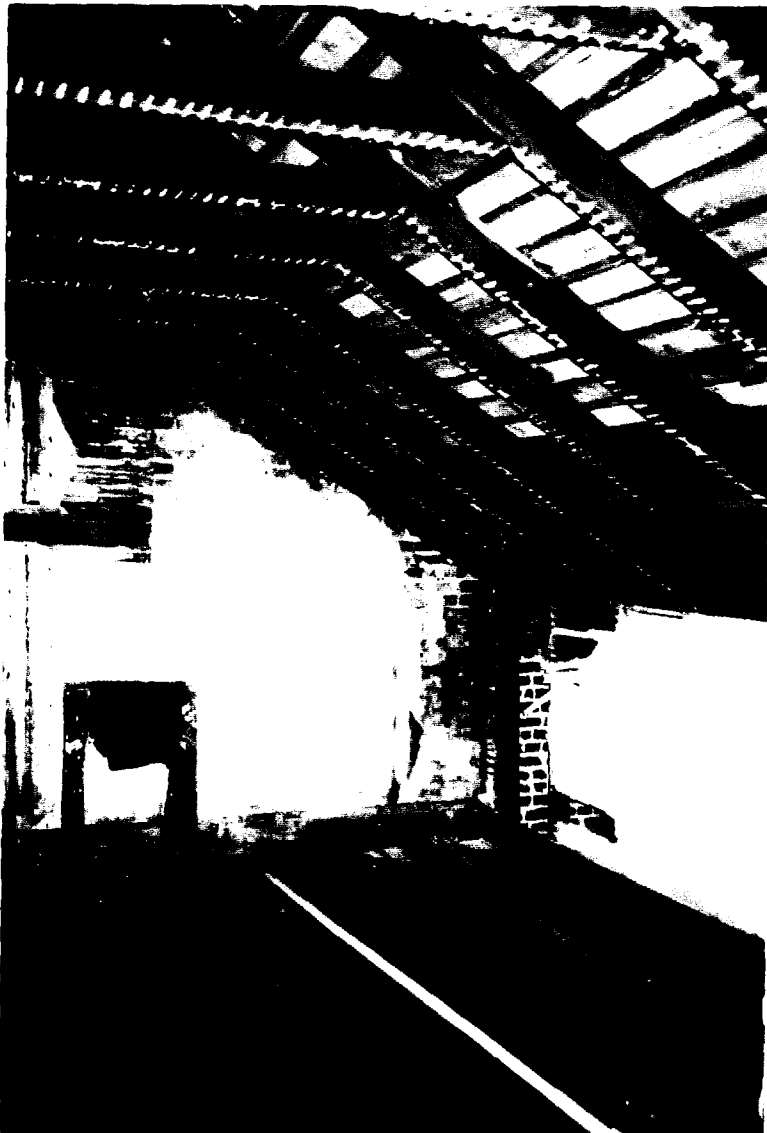
The interior plaster walls are also cracked throughout the interior of the building. The most obvious cracks are those associated with the separation between the exterior bricks on the north and south elevations and the adjacent bricks of the McCallum House. There are also numerous other cracks in the plaster walls of the building. These cracks appear to have been caused by several things, including water damage from the elements, gradual deterioration of the plaster and its keying into the lath, and vandalism or improper interventions over the years. (See Photograph 61-S for an illustration of typical damage in the attic.)

61-S Main House - View of attic looking toward the "party" wall.

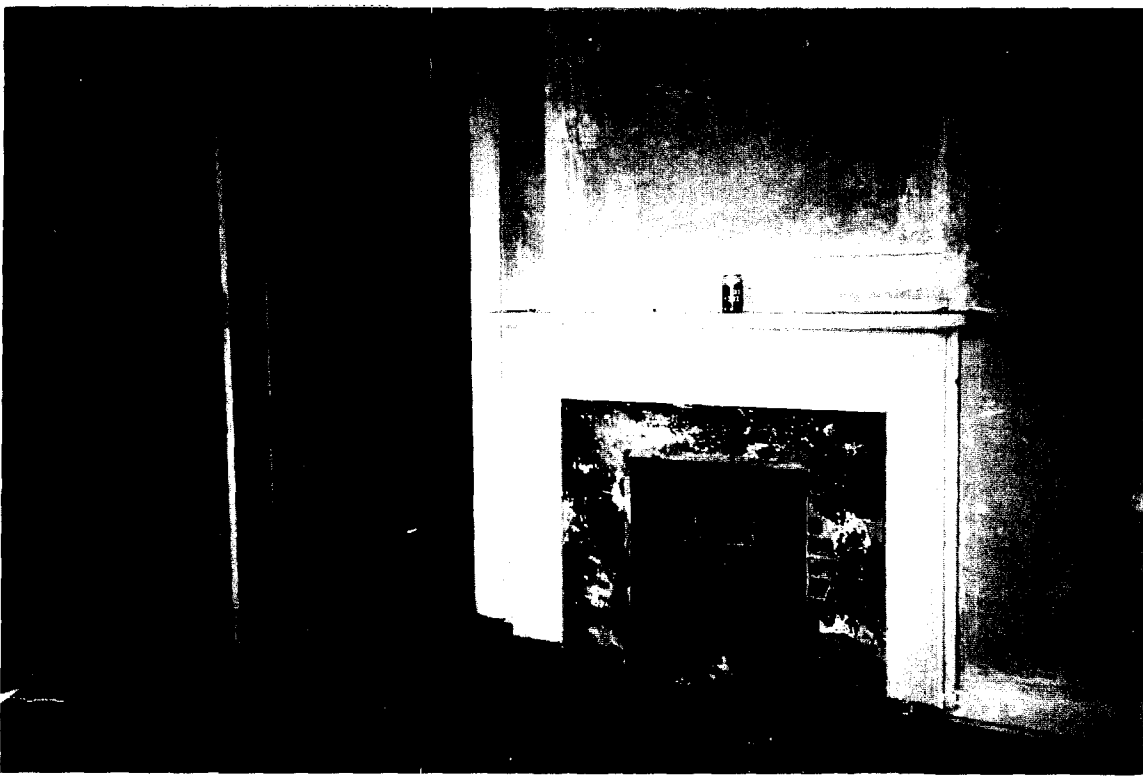
68-A Dependency - Second-floor walls replastered, unpainted.

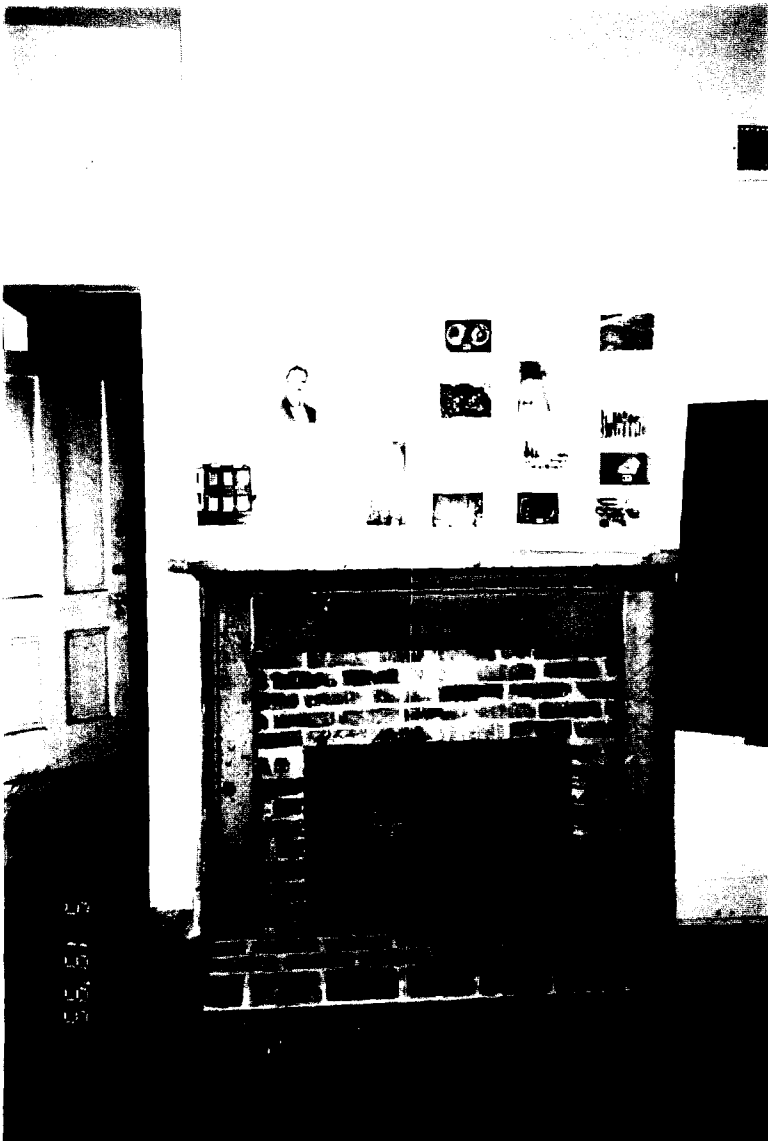
69-A Dependency - Original mantel repaired in west room of first floor.
