# THE DALLES HYDROELECTRIC PROJECT

## NORTH AND EAST FISH LADDER RELIABILITY ASSESSMENT REPORT

**The Dalles Dam North Fish Ladder  
Inspection Report**

**The Dalles Dam East Fish Ladder  
Inspection Report**

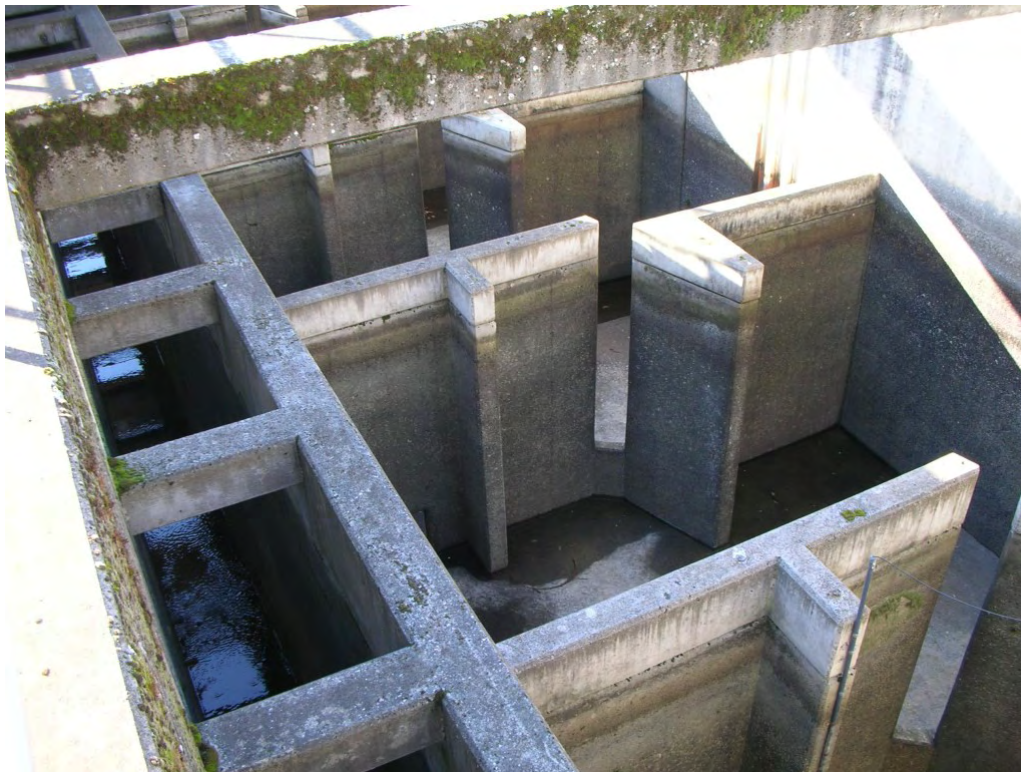
CS-3 Weir Extensions

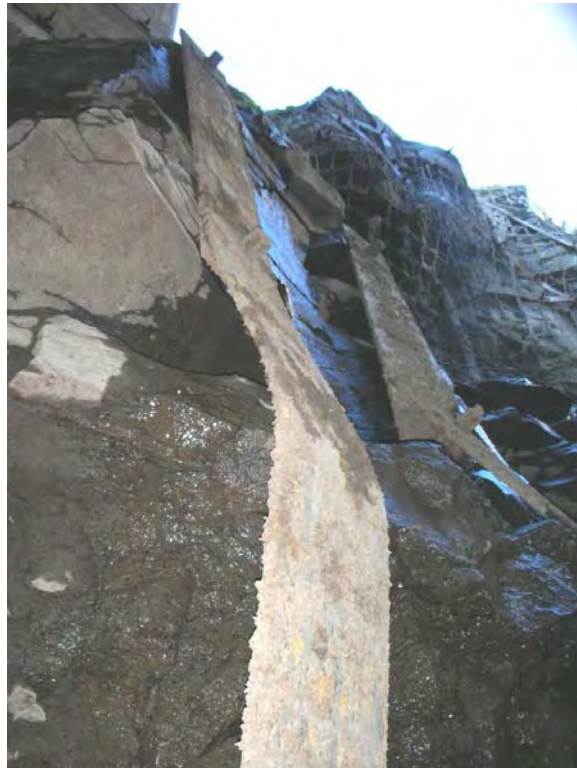
G-1 Plunge Pool Tiebacks

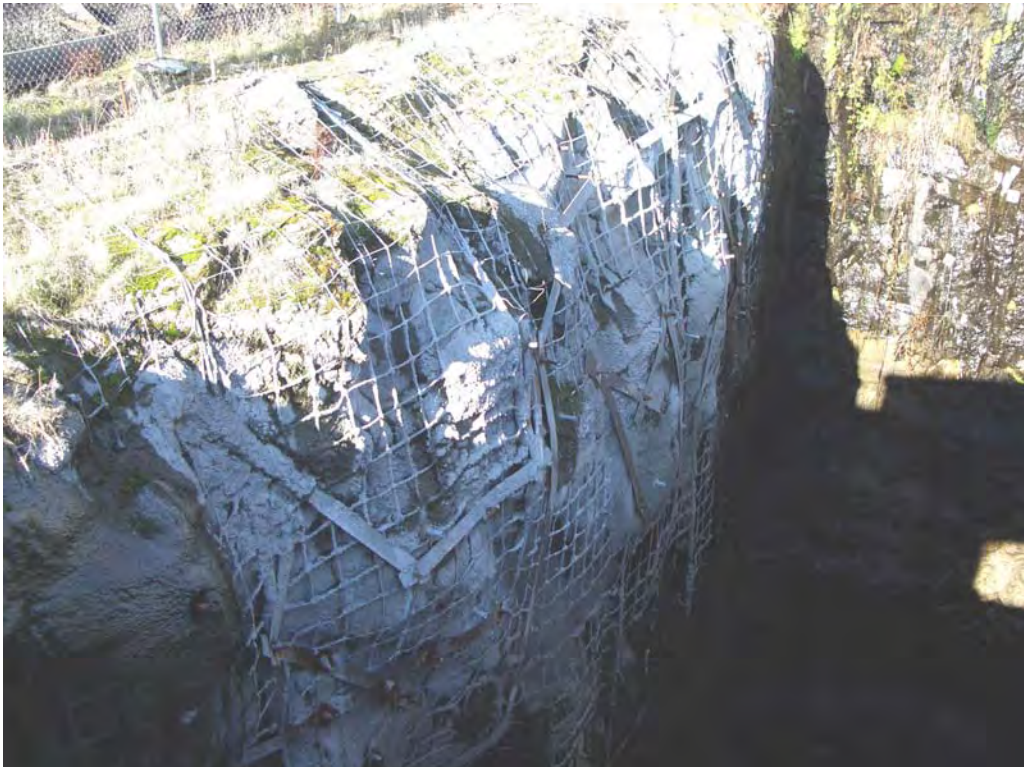
H-2 Original AWS Plunge Pool

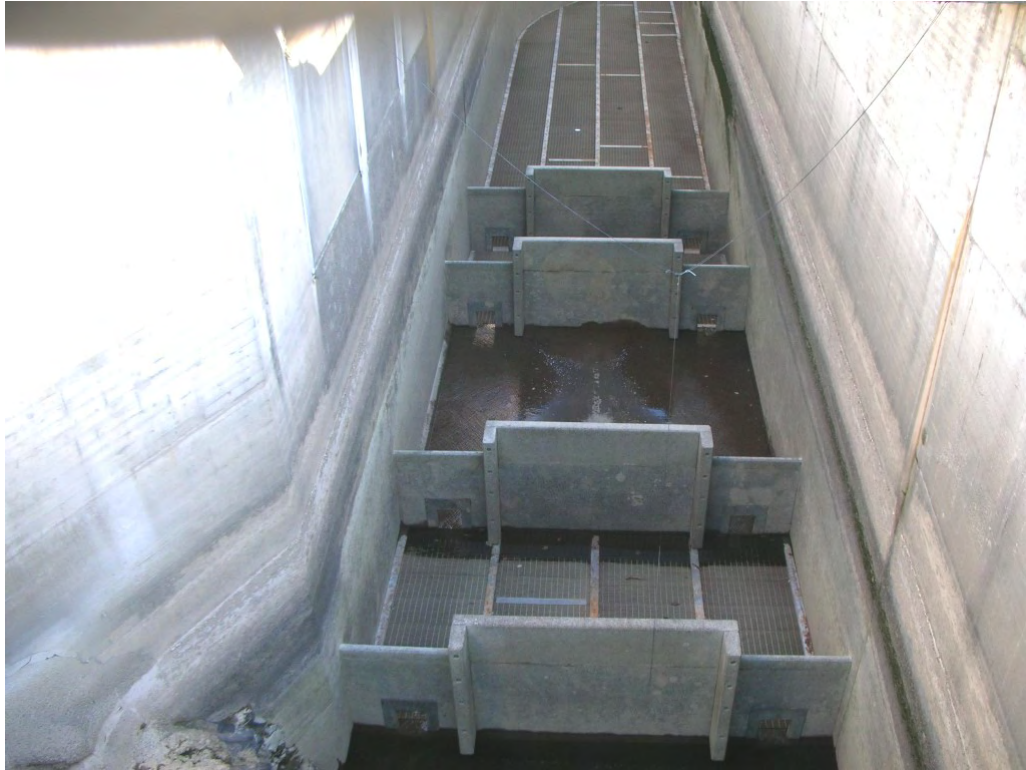
H-7 Floor Diffusers and Weirs

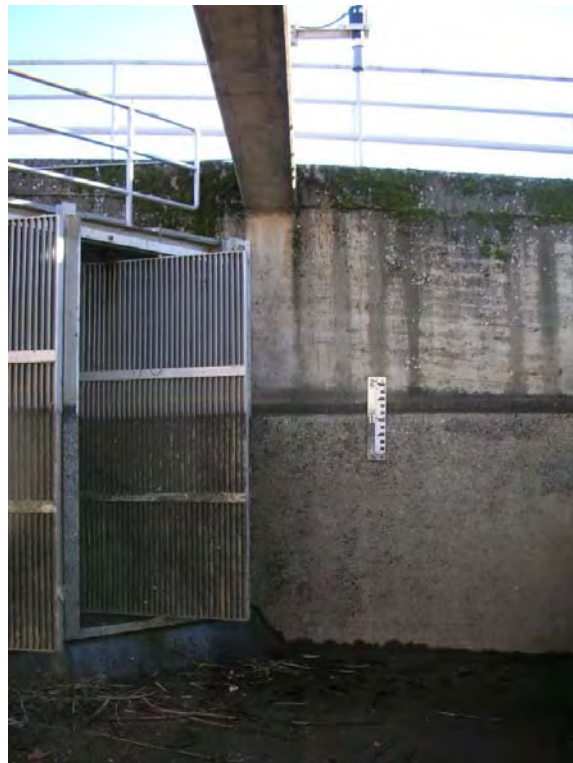
H-8 Picket Leads at Counting Station

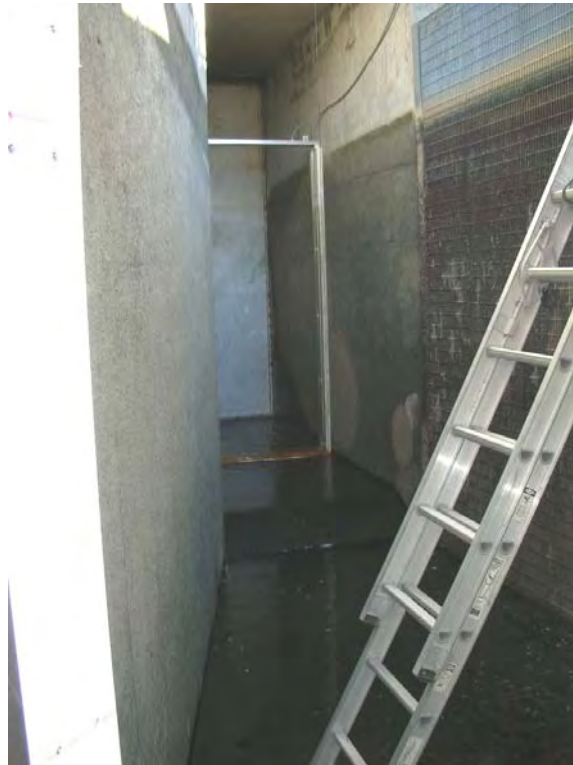
H-11 Fish Channel Exit

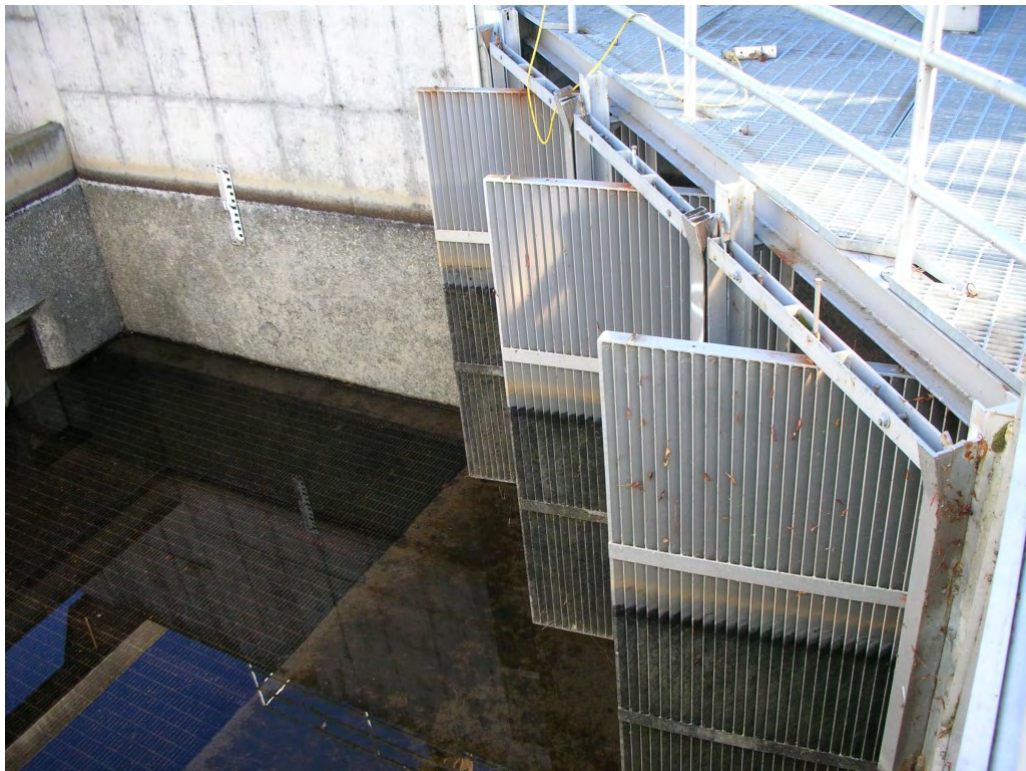
H-12 Counting Station Floor Diffuser Grate and Picket Leads

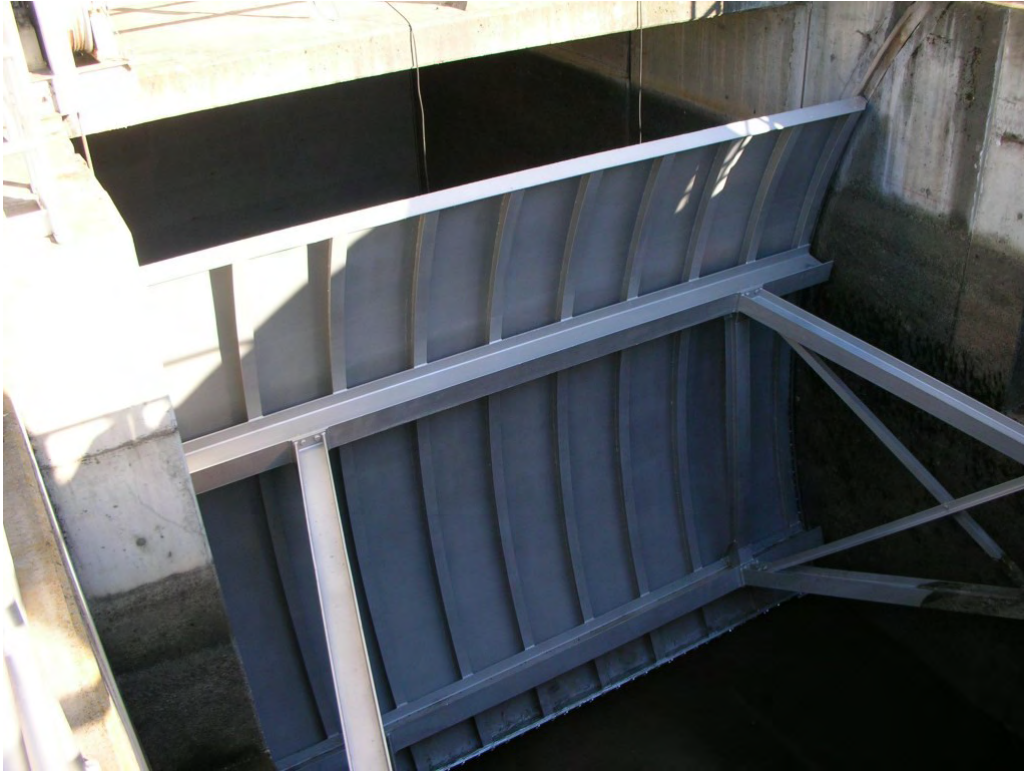
H-13 Tainter Gate

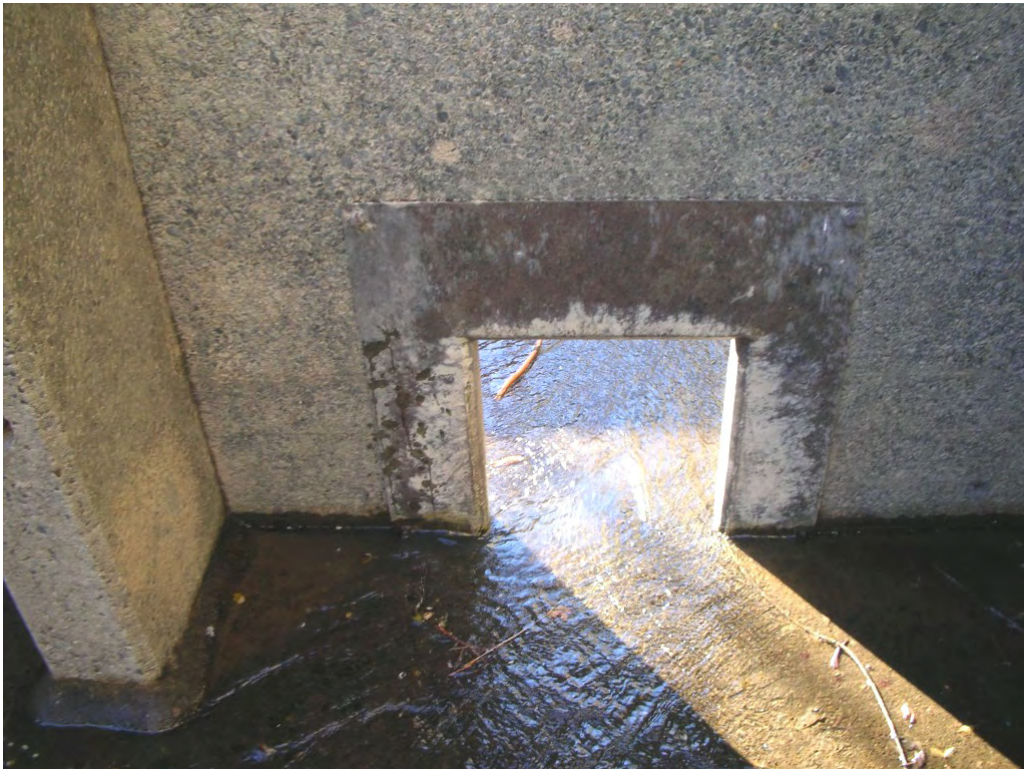
H-14 Modified Orifice

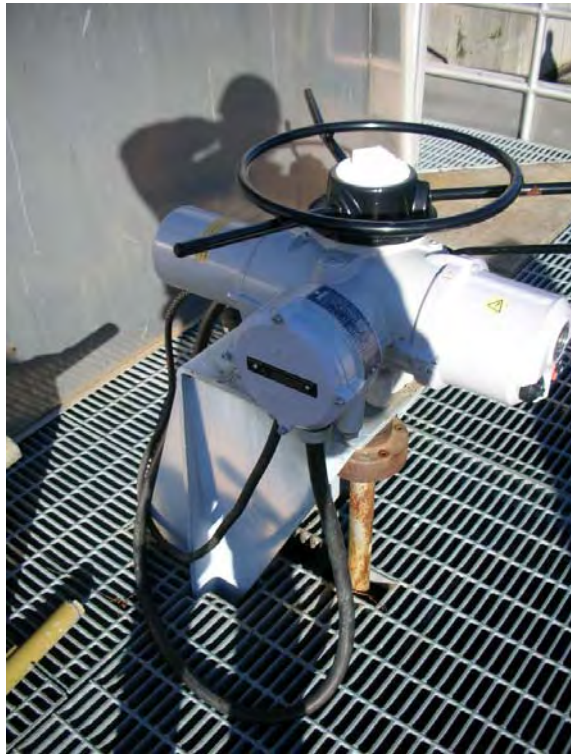
M-8 Counting Window Crowder Actuator

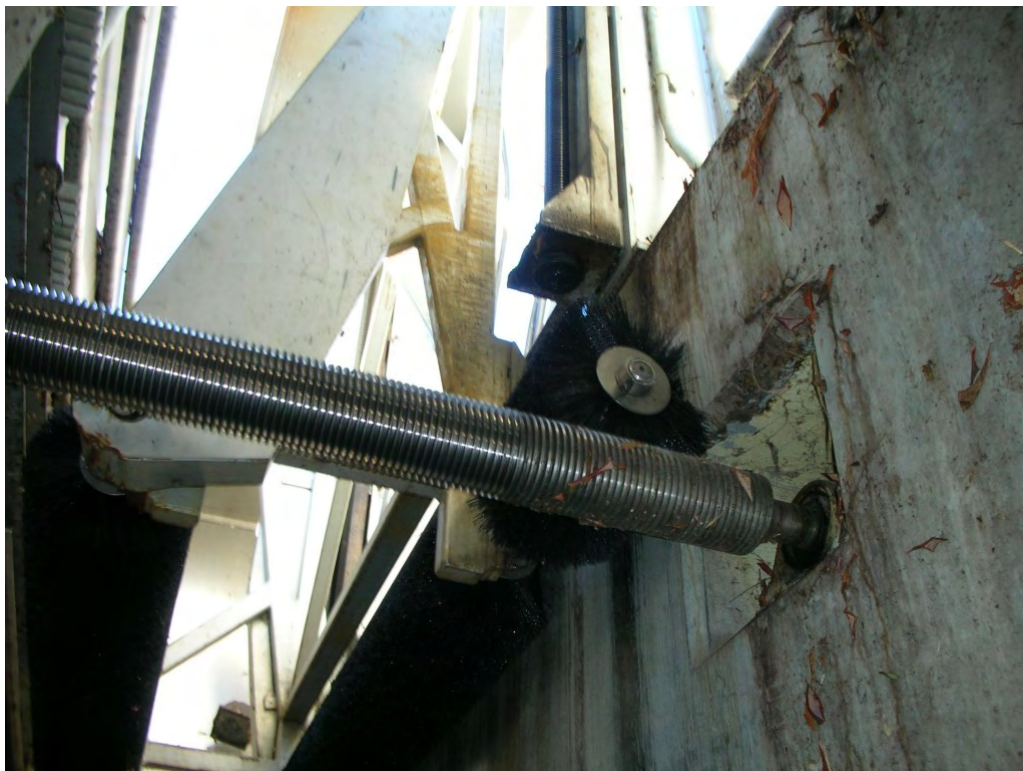
M-9 Counting Window Crowder Drive Screw

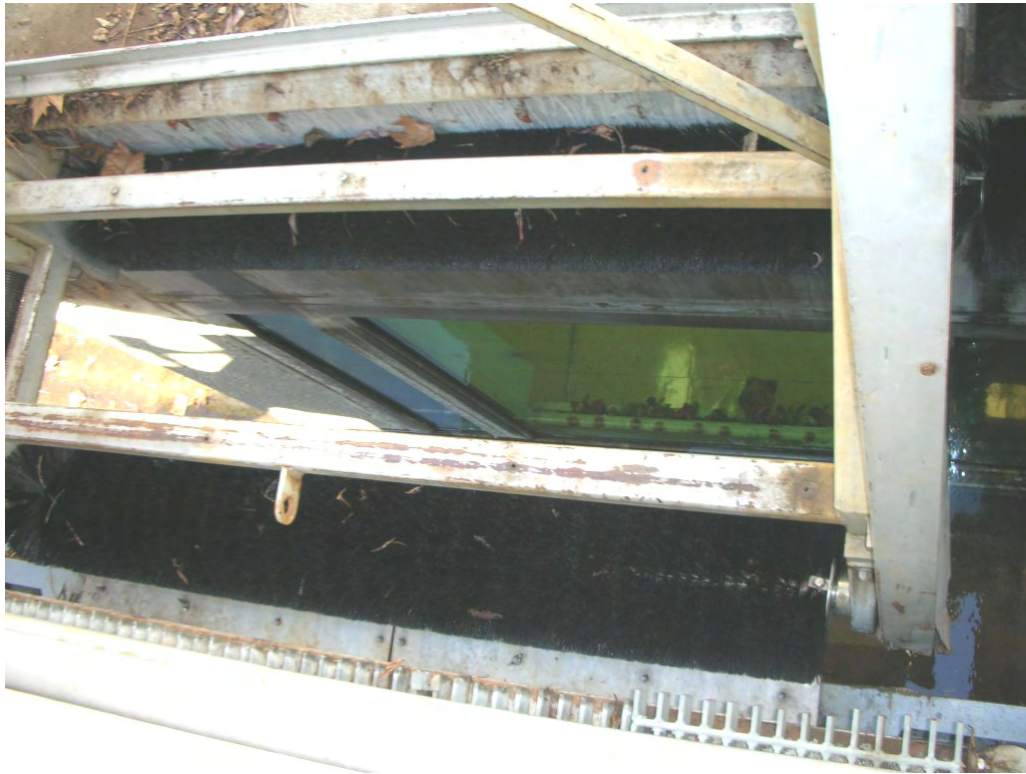
M-10 Counting Window (View from above)

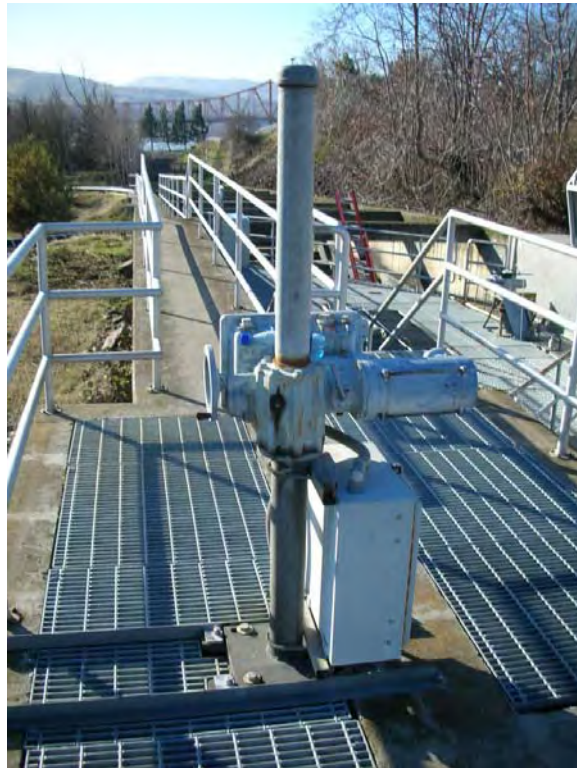
M-12 Juvenile Fish Bypass Gate Actuator

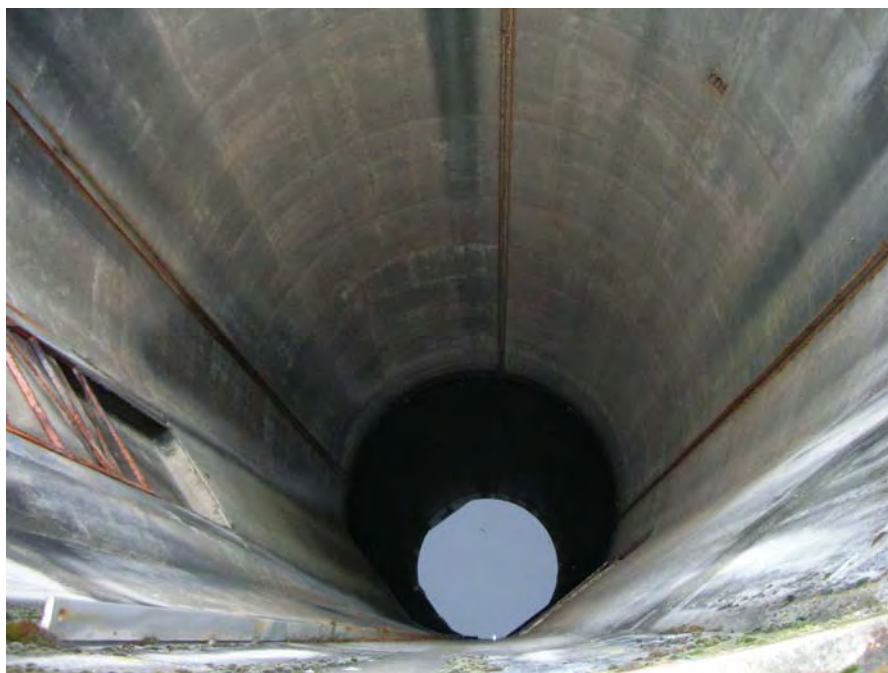
Photo ME-14 Fish Lock – View from top

The original east fish ladder construction included a fish lock designed to lift fish from the junction pool to the ladder exit. (Photo ME-14) The fish lock had not been used in several years; District staff reported that 1) fish were not inclined to enter it, and 2) fish that did enter it experienced descaling during the lifting operation. A valve room used to supply forebay water to the fish lock and other areas was entered and observed. (Photo ME-15) The valves, actuators, and controls appeared to be in good condition. District staff shared that operation of the valves had been considered to supply additional attraction flow to the east fish ladder via the fish lock.

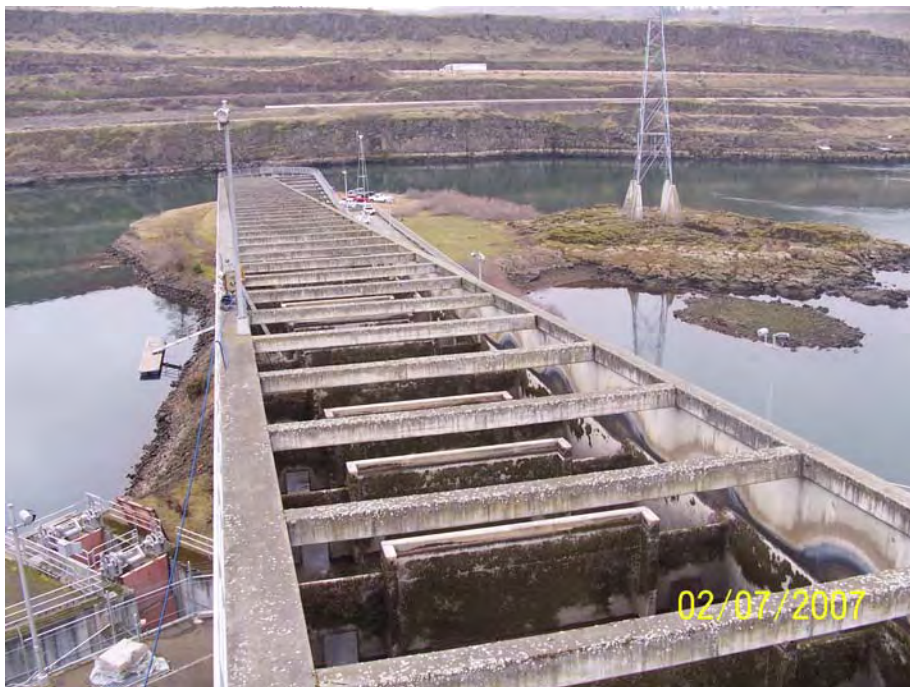
Photo H-12 Upper EFL

The upper section of ladder weirs upstream of the 180° bend was observed to have significantly greater algal growth as shown in Photo H-12.
