**EPA REGION 6 ANNOUNCES THE COMPLETION OF THE DRAFT FINAL
REMEDY SYSTEM EVALUATION (RSE) REPORT**

**HOMESTAKE MINING COMPANY SUPERFUND SITE
CIBOLA COUNTY, NEW MEXICO**

REMEDIATION SYSTEM EVALUATION (RSE)

**Homestake Superfund Site
Milan, New Mexico**

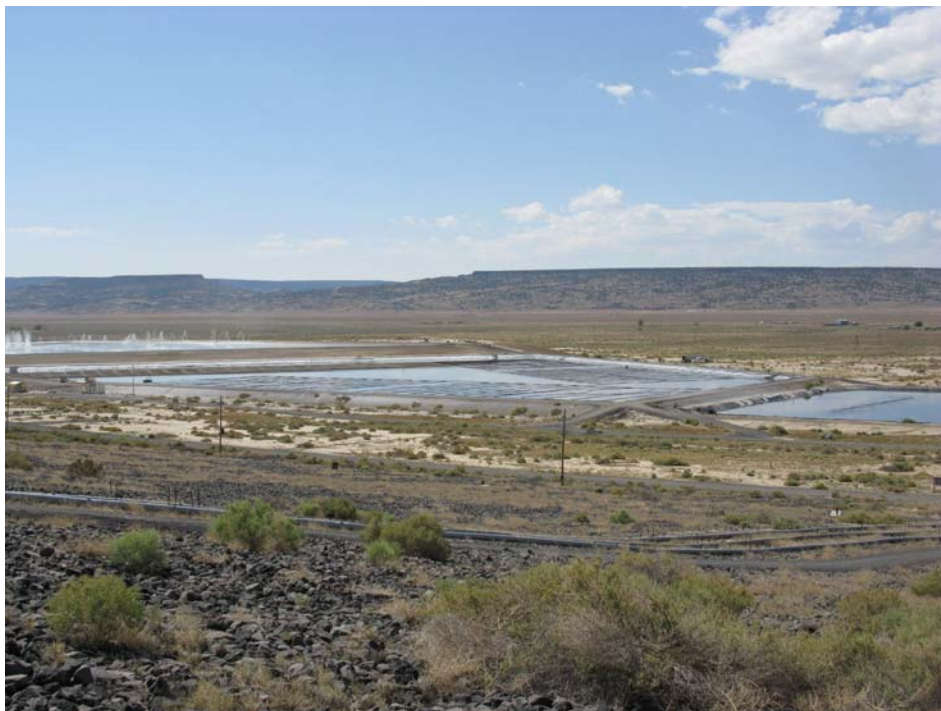
Evaporation Pond #2 from the Large Tailings Pile (looking southeast)

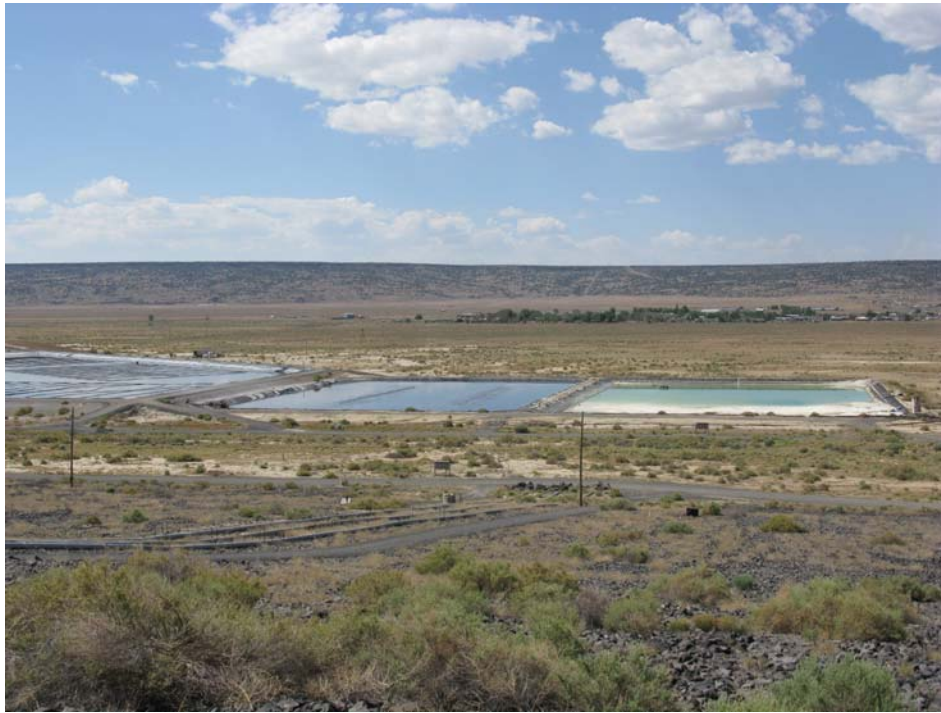
Collection ponds #1 and #2 from Large Tailings Pile (looking south)

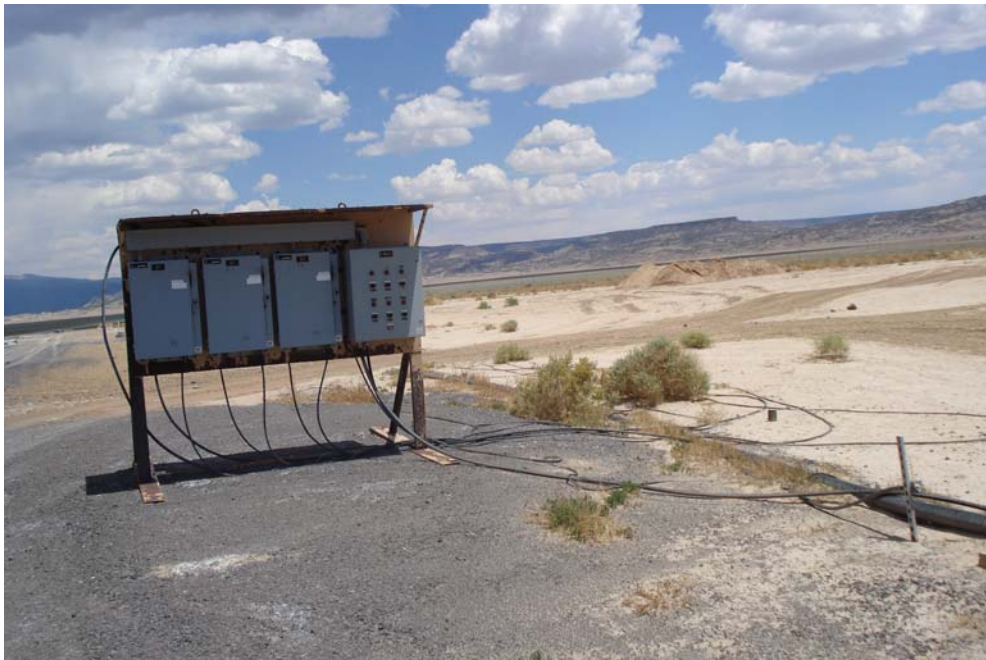
Control panel

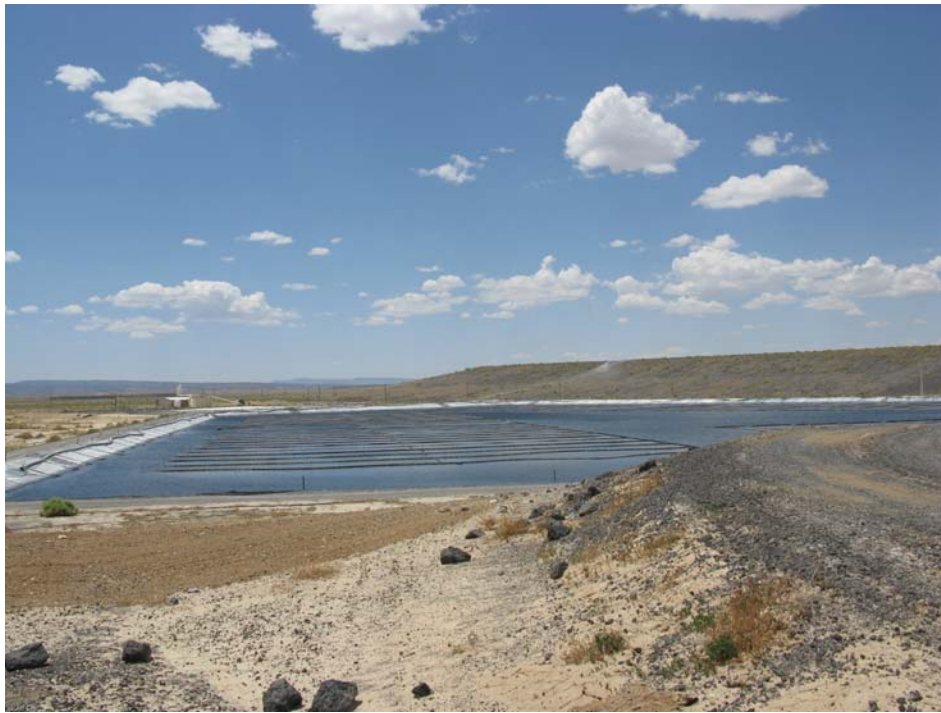
Evaporation Pond #2 (looking west from Pond #1)

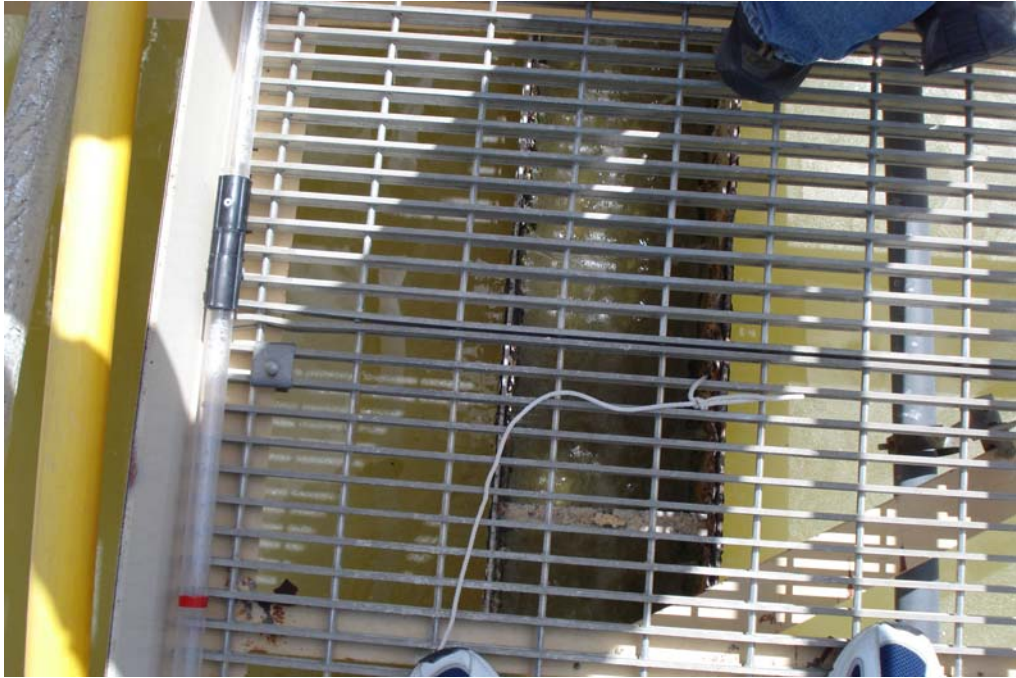
Clarifier Overflow (from top)

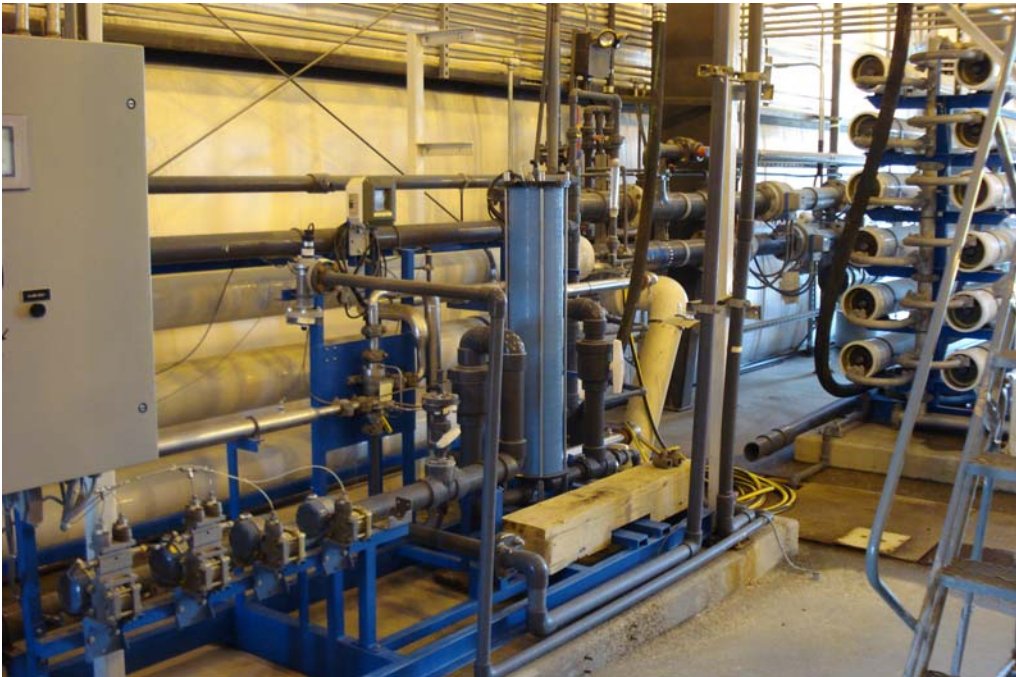
RO Unit Pumps with RO Membrane Filters to the Right

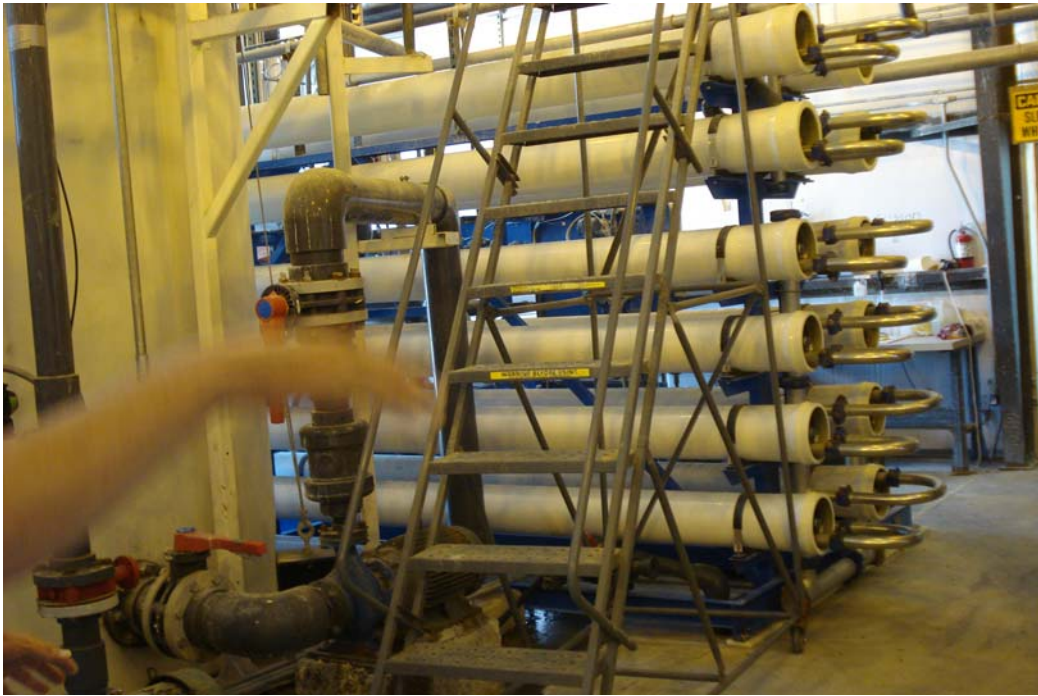
RO Membrane Filters (from side)

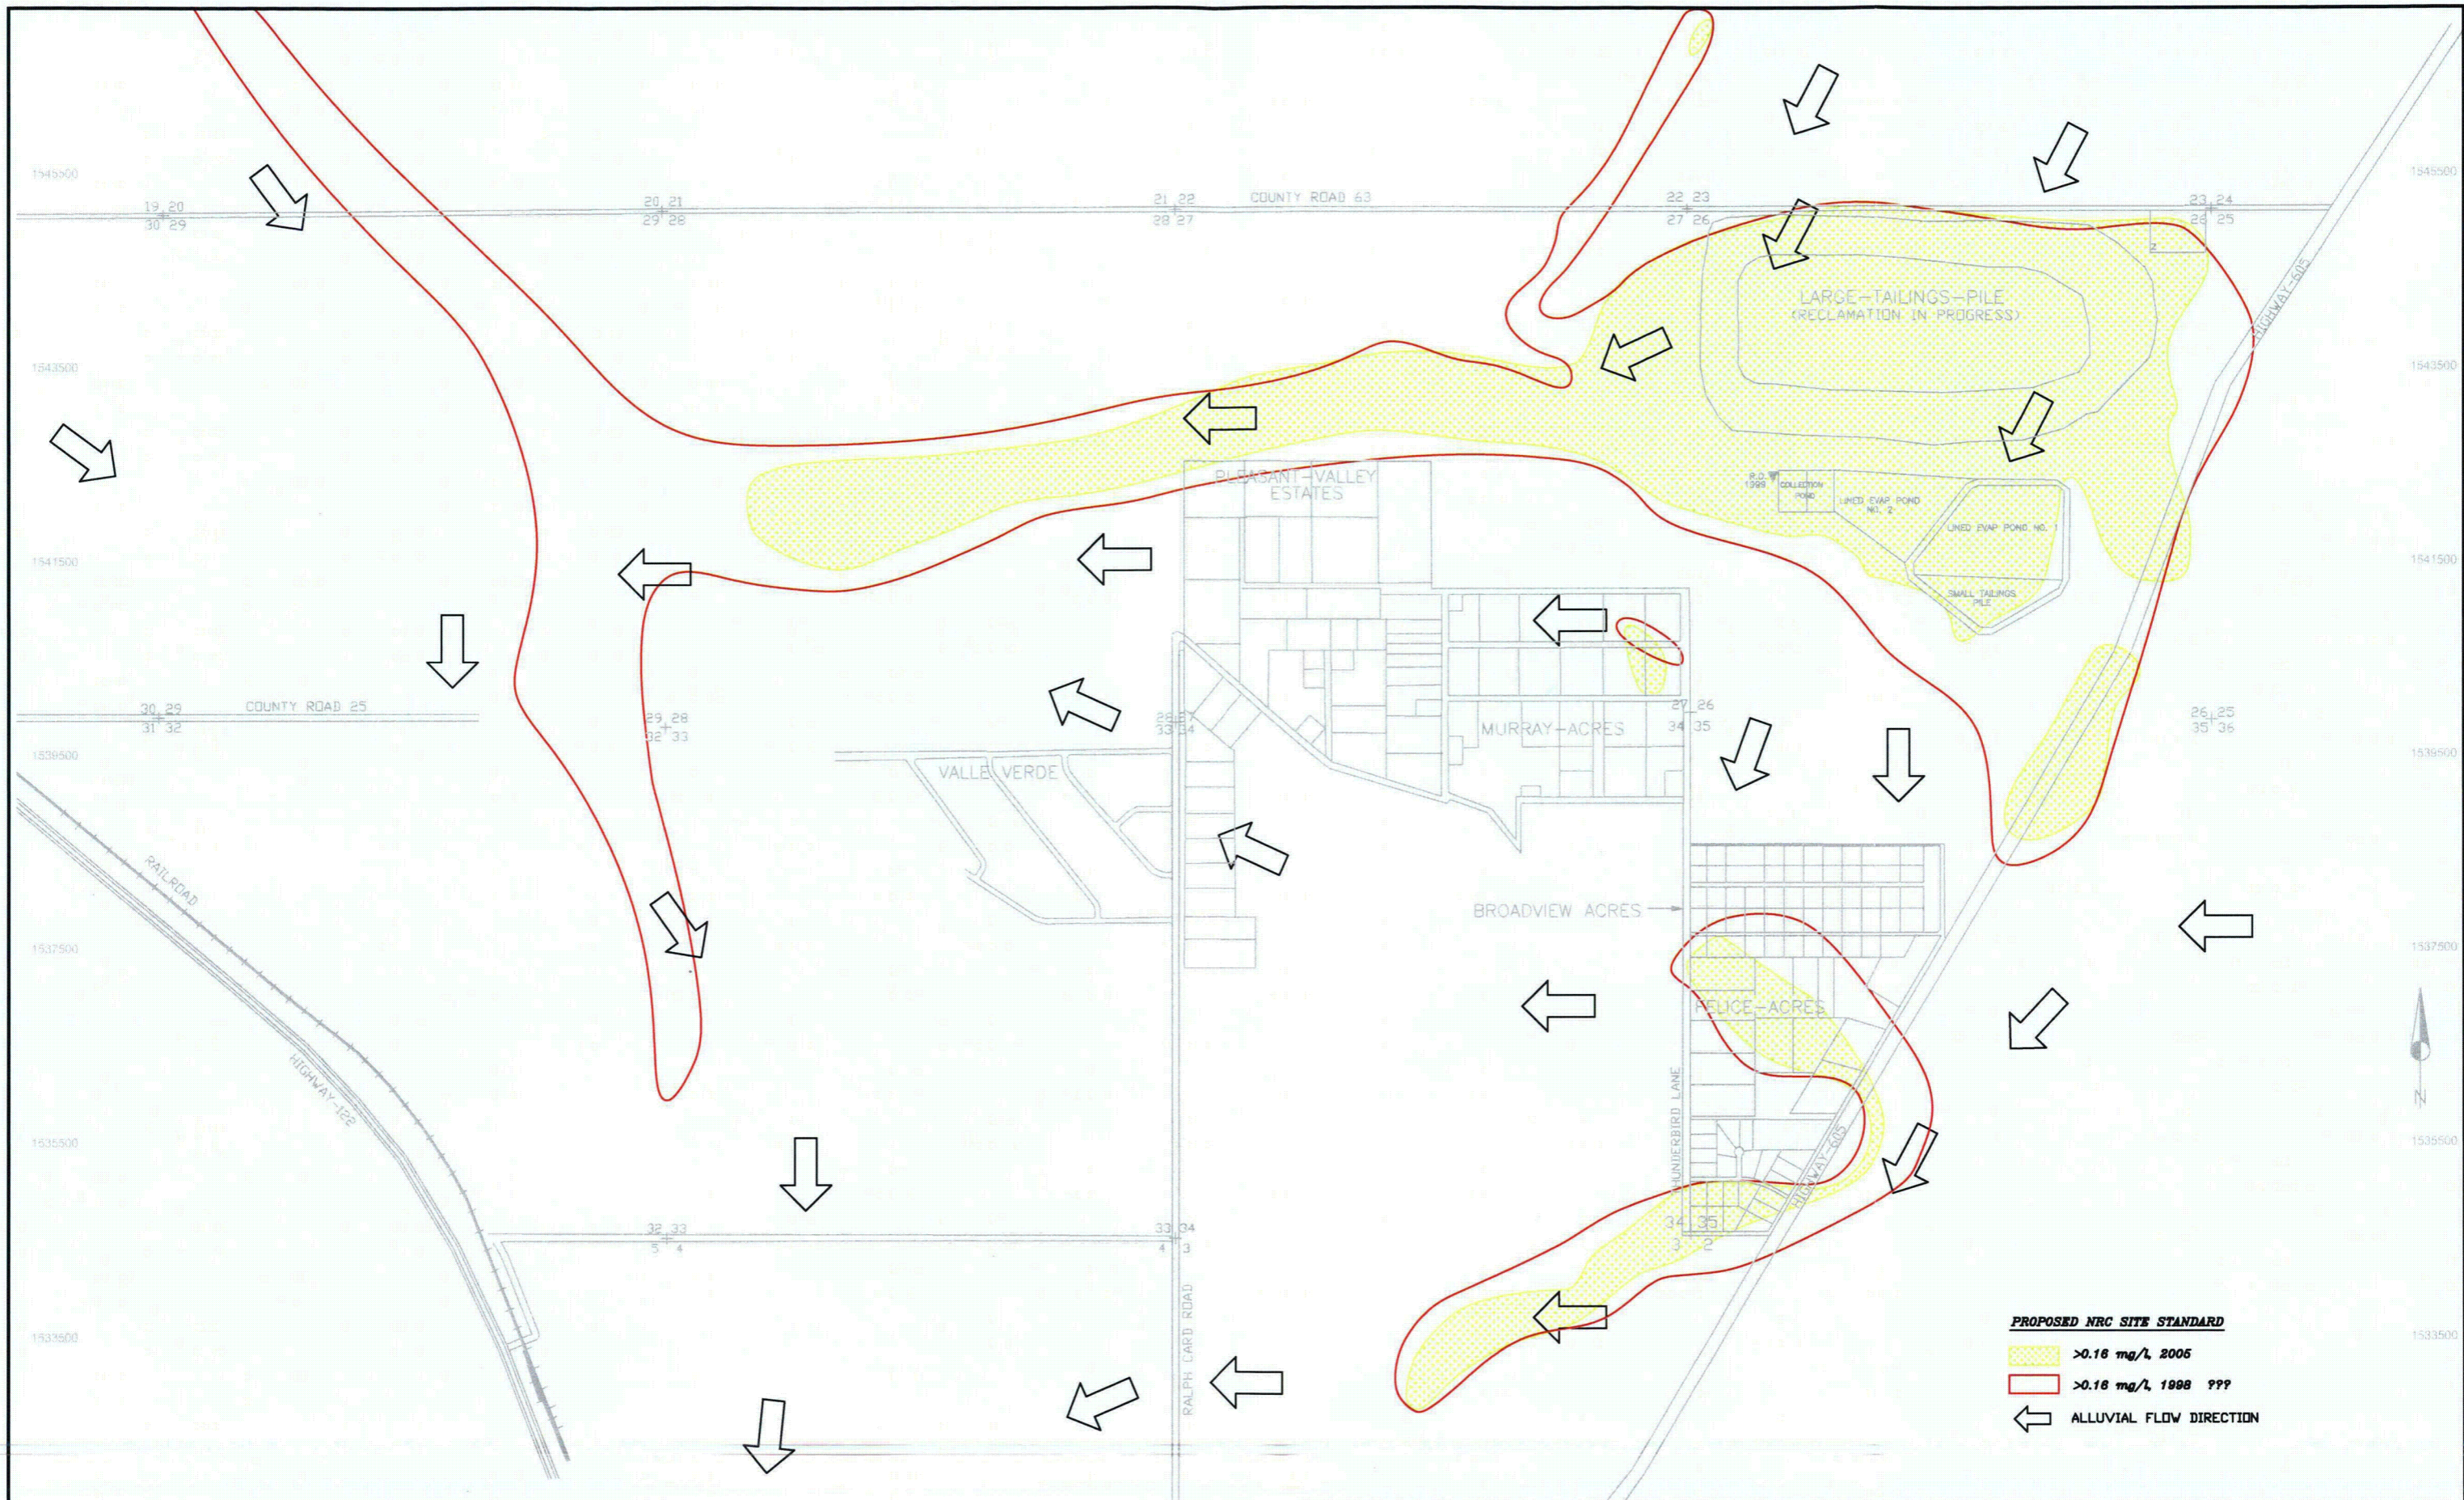
FIGURE 36
URANIUM CONCENTRATIONS FOR THE
ALLUVIAL AQUIFER, FOR 1998 & 2005, MG/L

To judge the effectiveness of the groundwater remediation program, it is necessary to compare past groundwater quality conditions with more current conditions. Figure 36 and 37 (Section 1.5.3) show the uranium and selenium plumes in the Alluvial Aquifers in 1998 and 2005. In both cases the plumes have become smaller over time indicating that the systems are resulting in improved conditions. (Similar historic trends are also evident for other COCs.) The plumes in the Alluvial and Chinle Aquifers are still areally extensive. Thus, the groundwater remedial system will have to operate for several more years before the NRC action levels are achieved in all aquifers.
