historic structures report
architectural data section
volume two
may 1981

HISTORIC STRUCTURES REPORT
ARCHITECTURAL DATA SECTION
FLOYD BENNETT FIELD
GATEWAY NATIONAL RECREATION AREA
VOLUME II

By
Susan Simpson

UNITED STATES DEPARTMENT OF THE INTERIOR
NATIONAL PARK SERVICE
DENVER SERVICE CENTER
MID-ATLANTIC/NORTH ATLANTIC TEAM
BRANCH OF HISTORIC PRESERVATION
DENVER, COLORADO

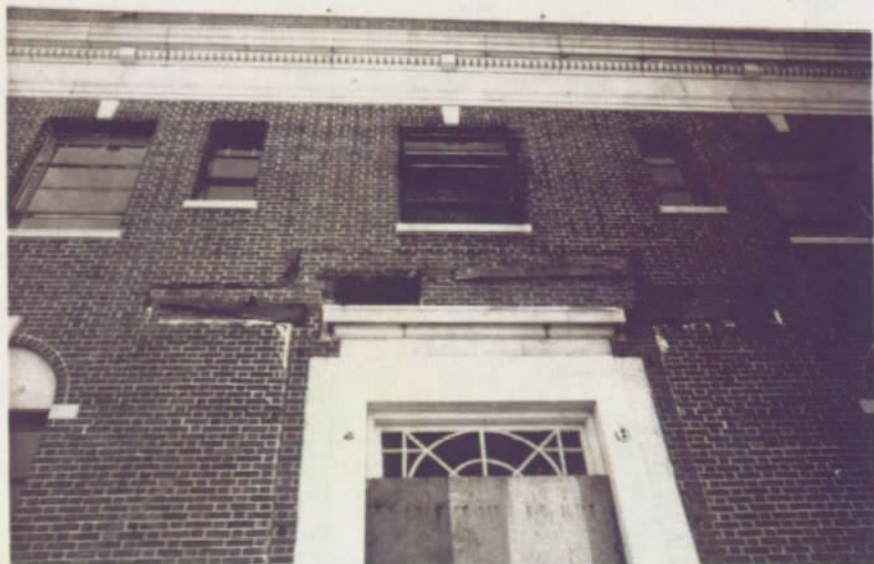
North Wall - Note ghost of recently removed wood-frame addition and pneumatic tubes above left side of door. January 1979.

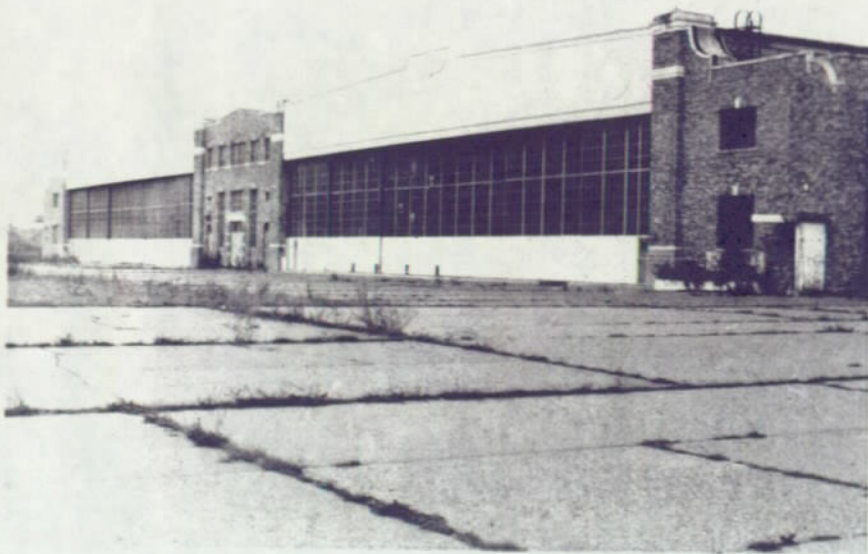
Hangar Complex 3 - South elevation
October 1978.

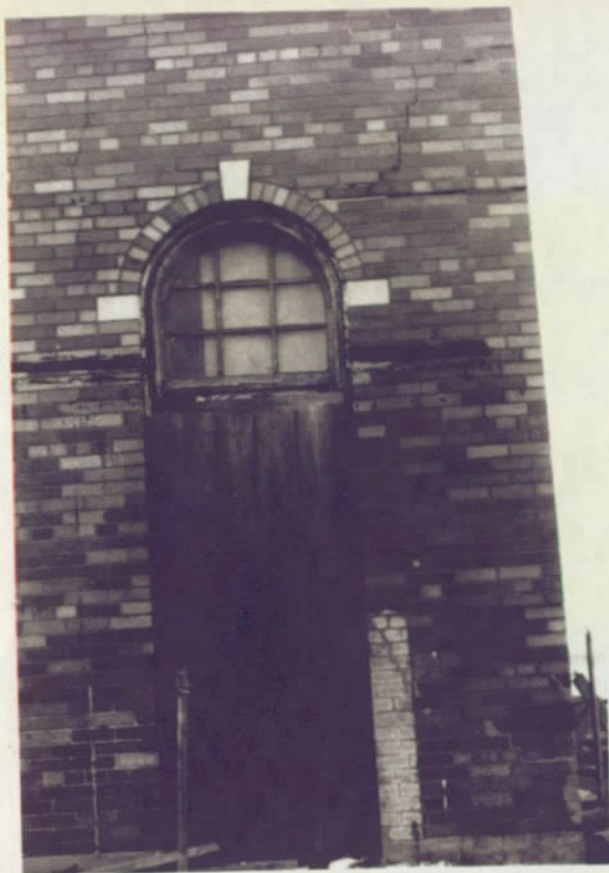
East Hangar Leanto - south
door original arched light
above door
April 1979

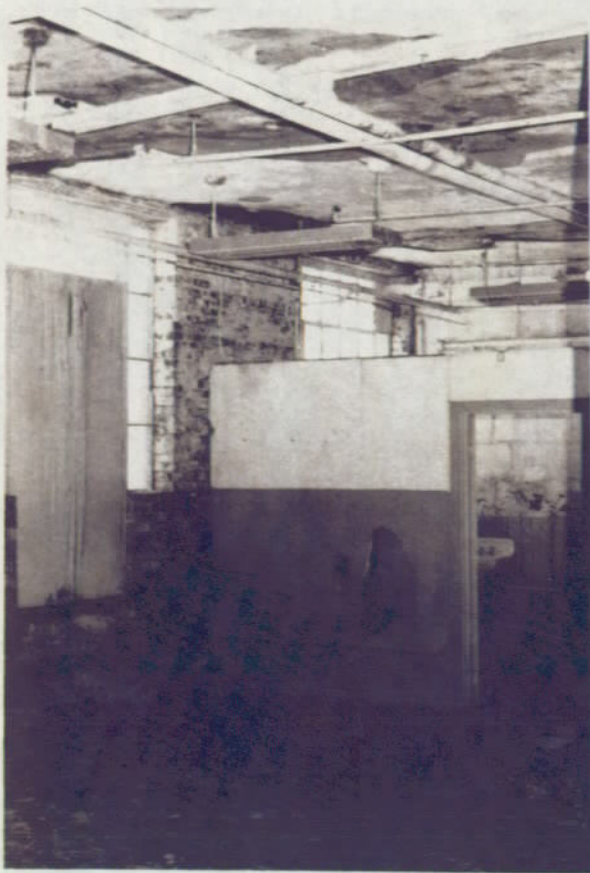
East Lean-to
Hangar Complex 5
June 1979

This space is extremely deteriorated. Plaster on ceilings and walls is falling, paint is flaking, and flooring is rotted.

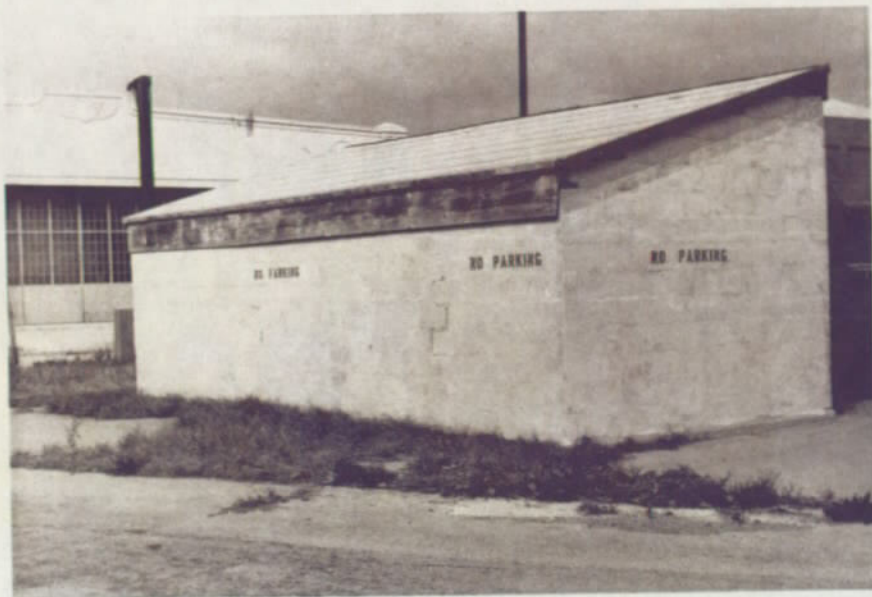
The concrete block walls of the addition are only in fair condition. There is vertical cracking near the main structure at the north elevation.

The wood-frame roof on the addition is deteriorating. Fascia boards are unpainted and warped and the southern board has fallen off.

West Elevation - Concrete block addition. October 1978

Repair roof deck and fascia of addition and paint fascia boards.

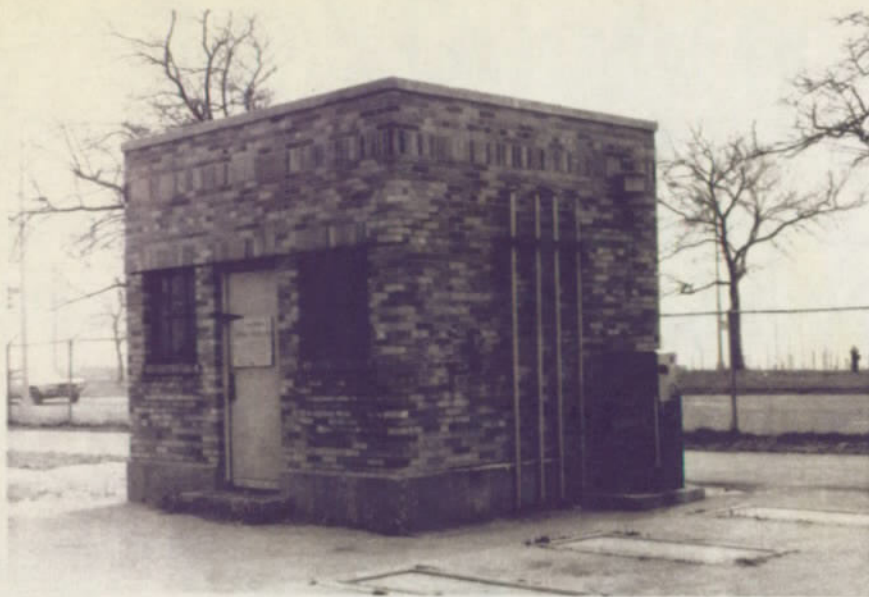
Northeast Elevation - Gas tank vents at north wall. October 1978
