SAGAMORE HILL HOME OF THEODORE ROOSEVELT

HISTORIC STRUCTURE REPORT

**Sagamore Hill National Historic Site
Oyster Bay, New York**

Written 1988

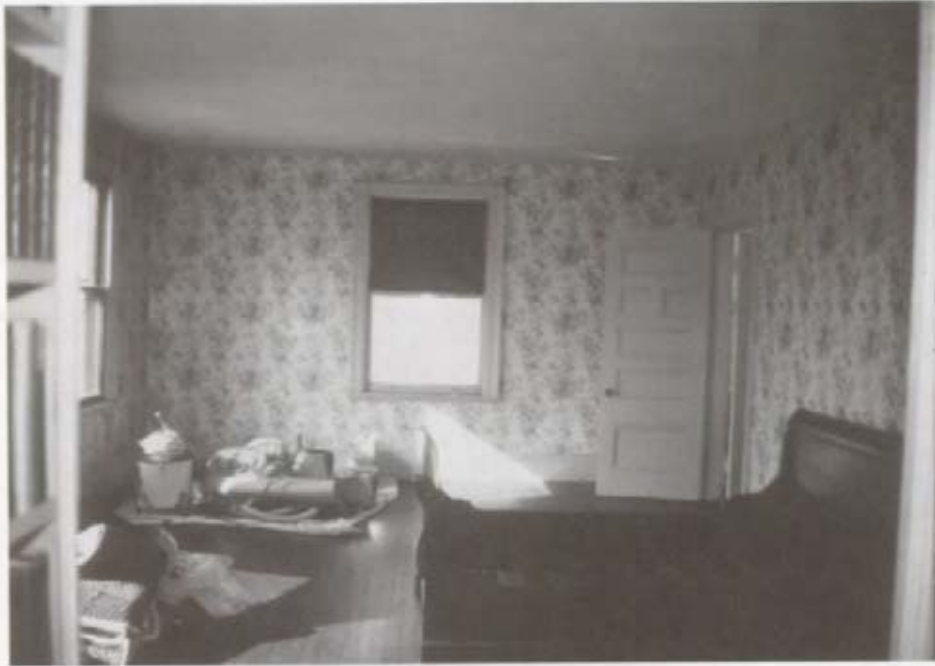
Gate Room: Before Restoration

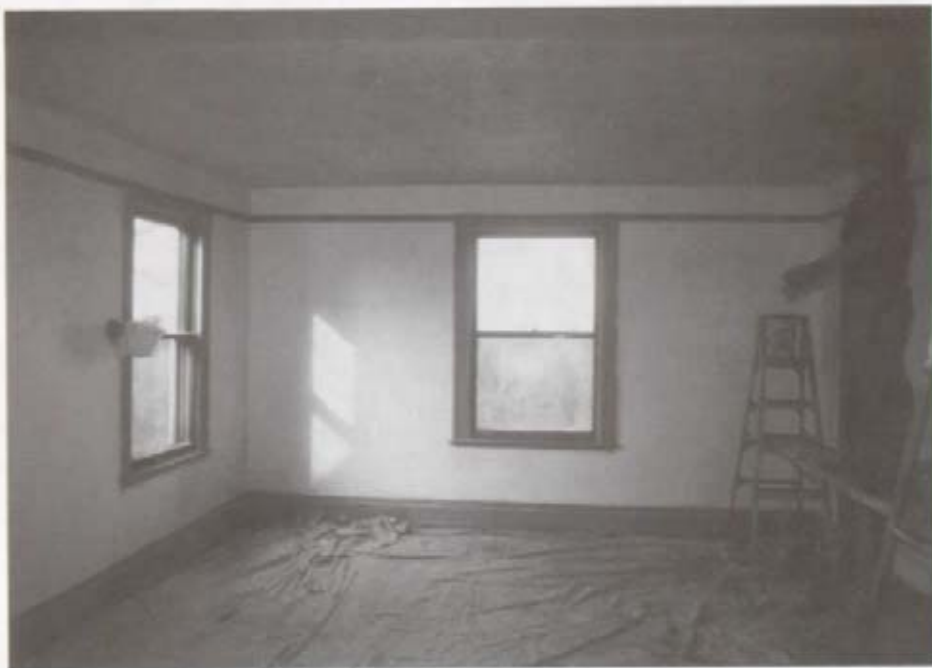
Gate Room: During Restoration (picture molding lowered, wallpaper removed).

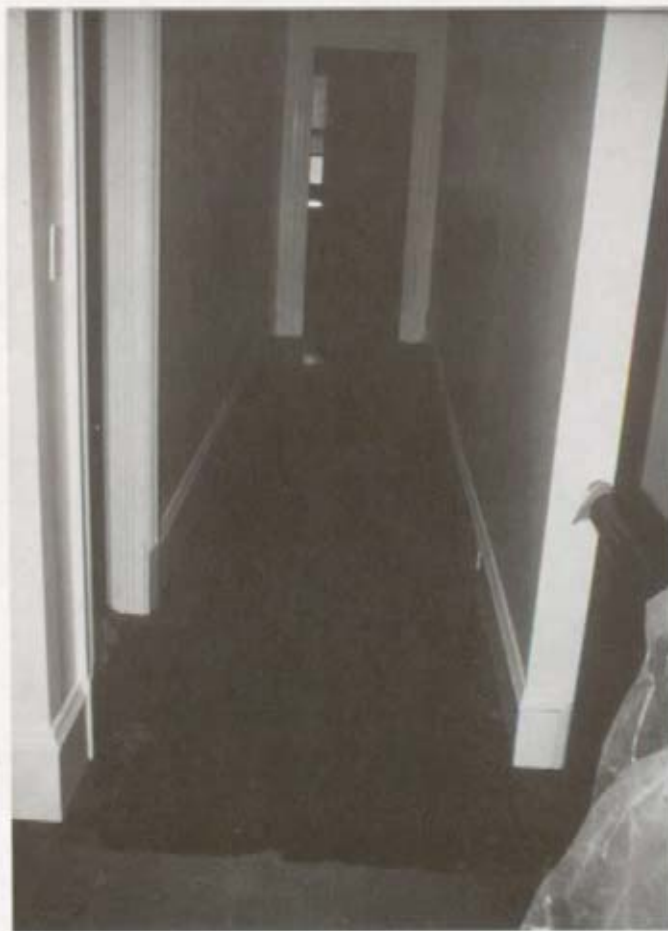
Third Floor Hall: After Repainting

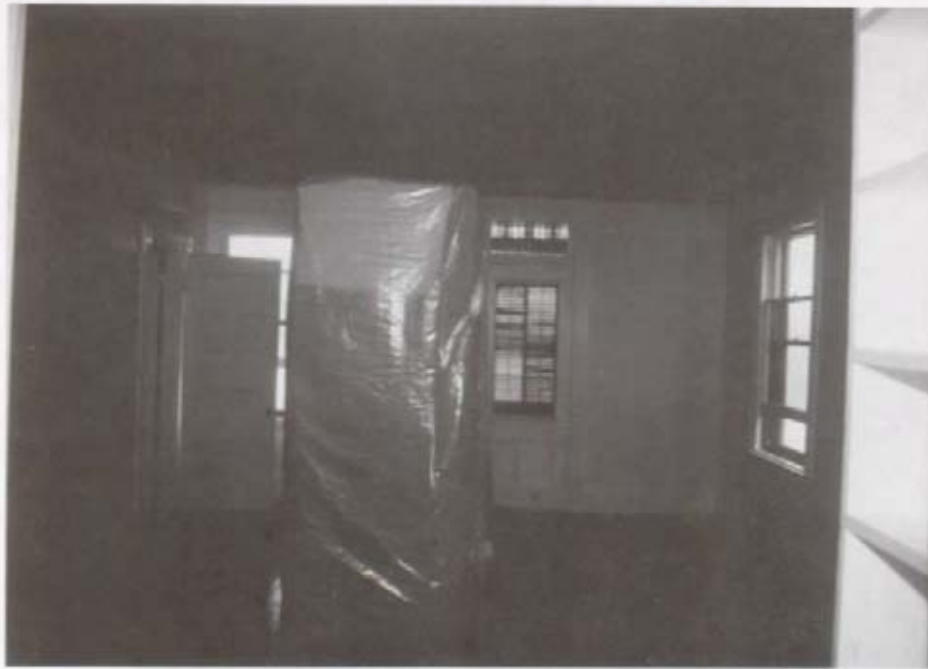
Mother's Room: After Restoration

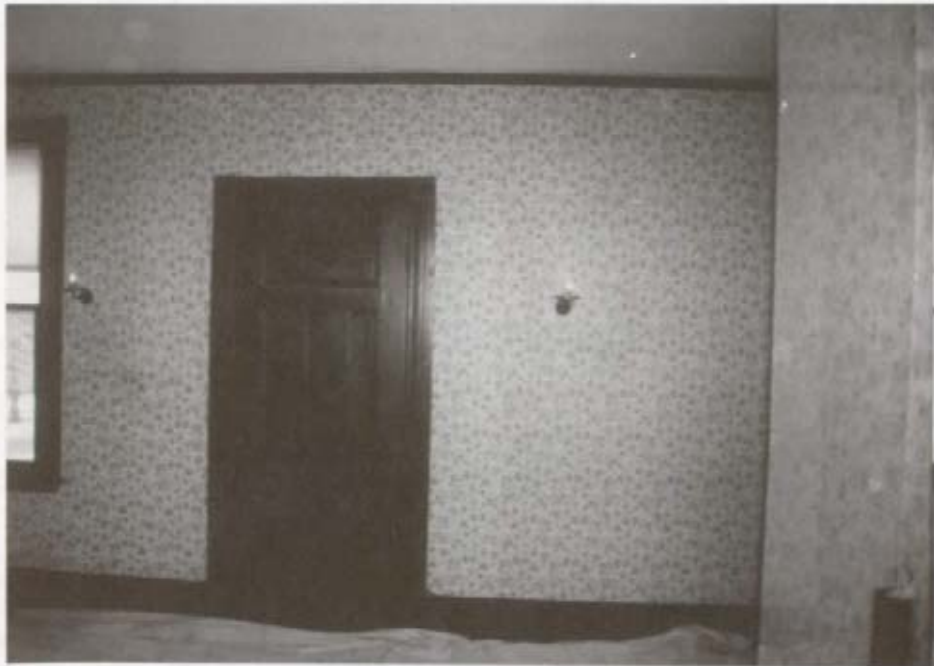
Nursery: Before Restoration

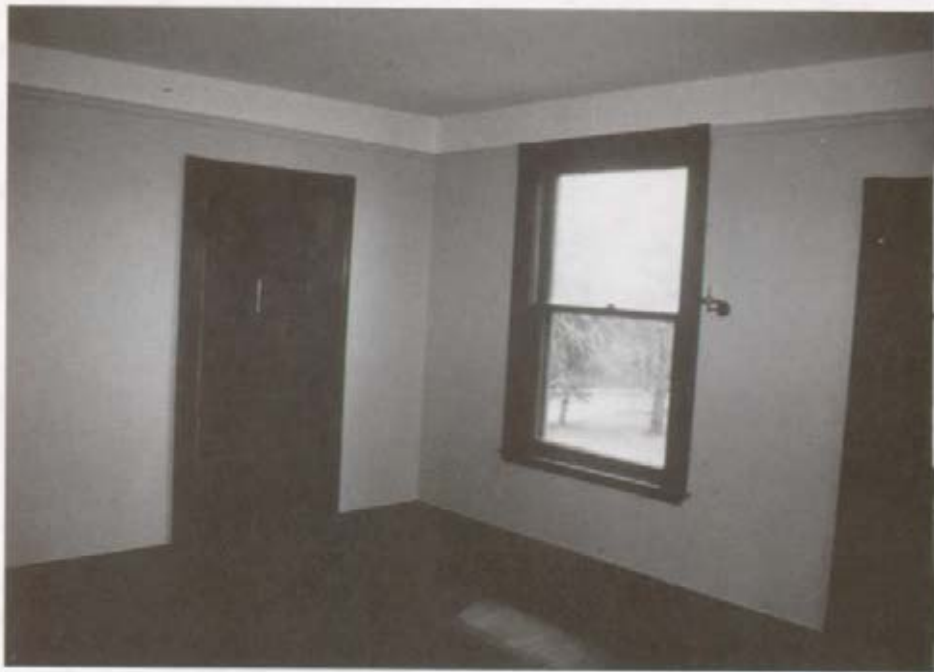
Nursery: After Restoration
