FIRE ISLAND LIGHTHOUSE AND KEEPER'S DWELLING

Fire Island National Seashore
Patchogue, New York

Historic Structure Report
Volume 2

**THE KEEPER'S DWELLING:
CURRENT APPEARANCE AND CONDITION**

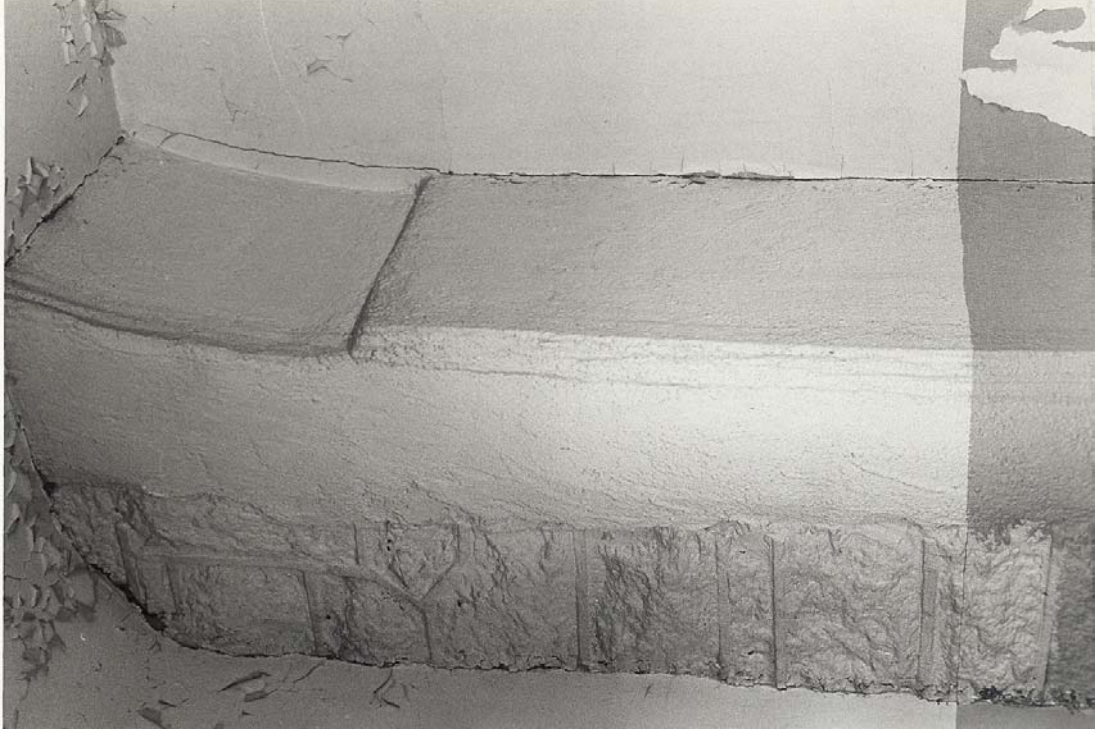
Figure 216. Dwelling interior: evidence for former covered passageway.

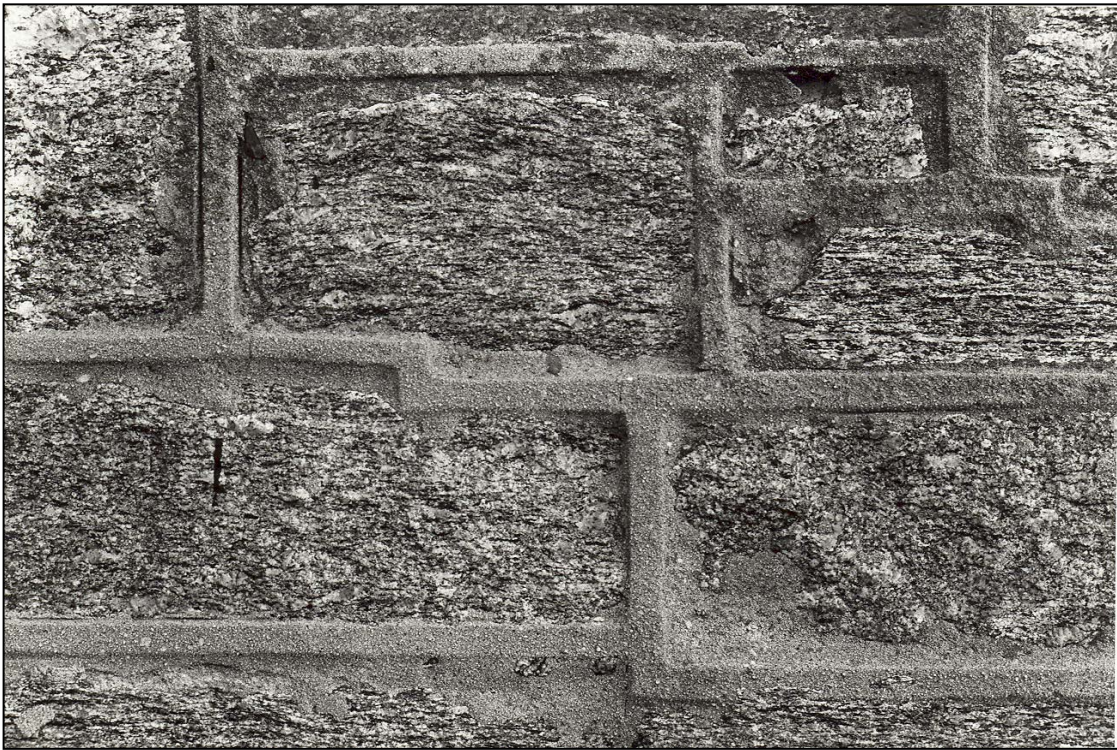
Figure 228. Dwelling exterior: detail of stone masonry (1983).
