**Maritime Museum Building**  
**Limited Scope Historic Structure Report**

San Francisco Maritime National Historical Park  
San Francisco, California

National Park Service Contract Number 1443-CX-2000-98-016

Drawing Number 641-41133

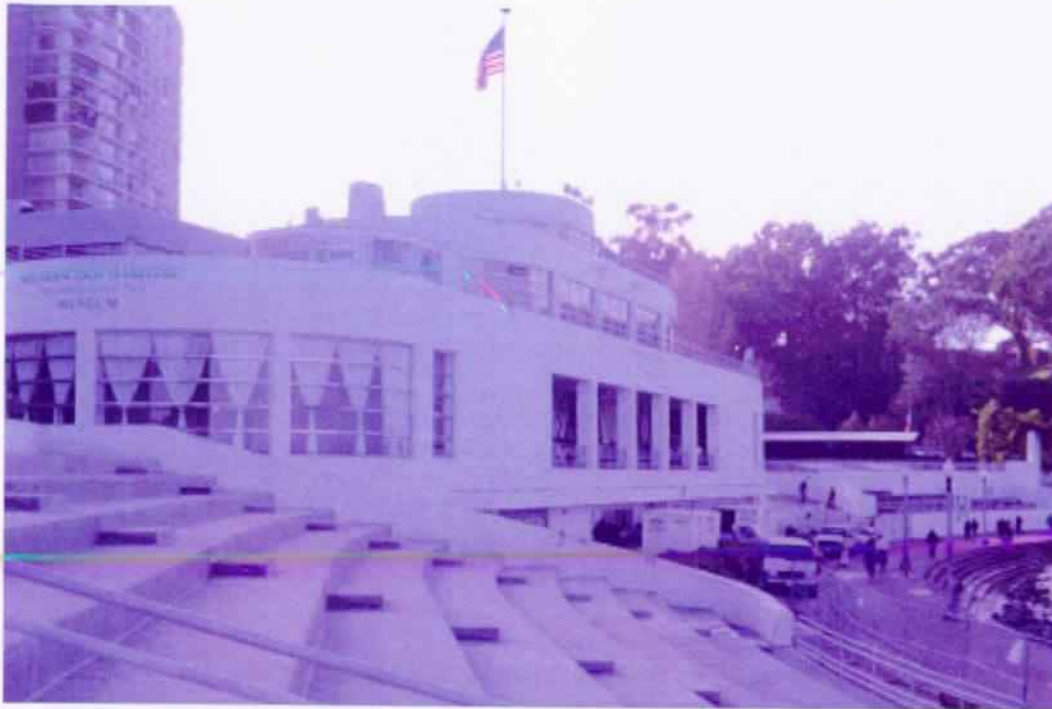
*Figure 1. View of the north and east elevations of the Maritime Museum Building.*

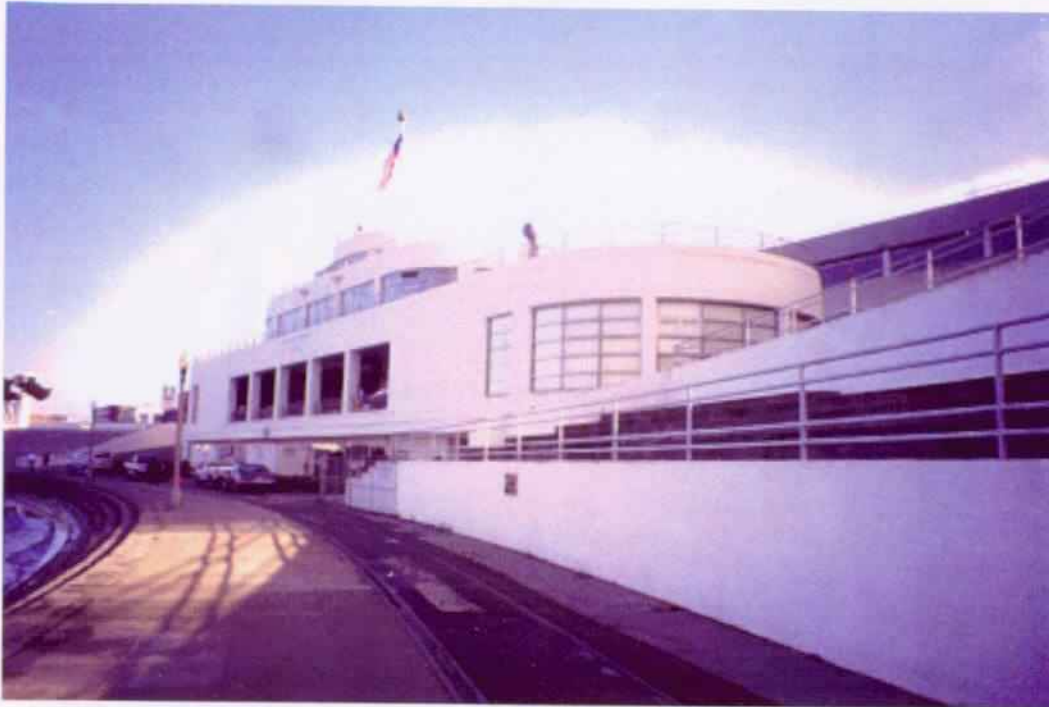
*Figure 2. View of the north and west elevations of the Maritime Museum Building.*

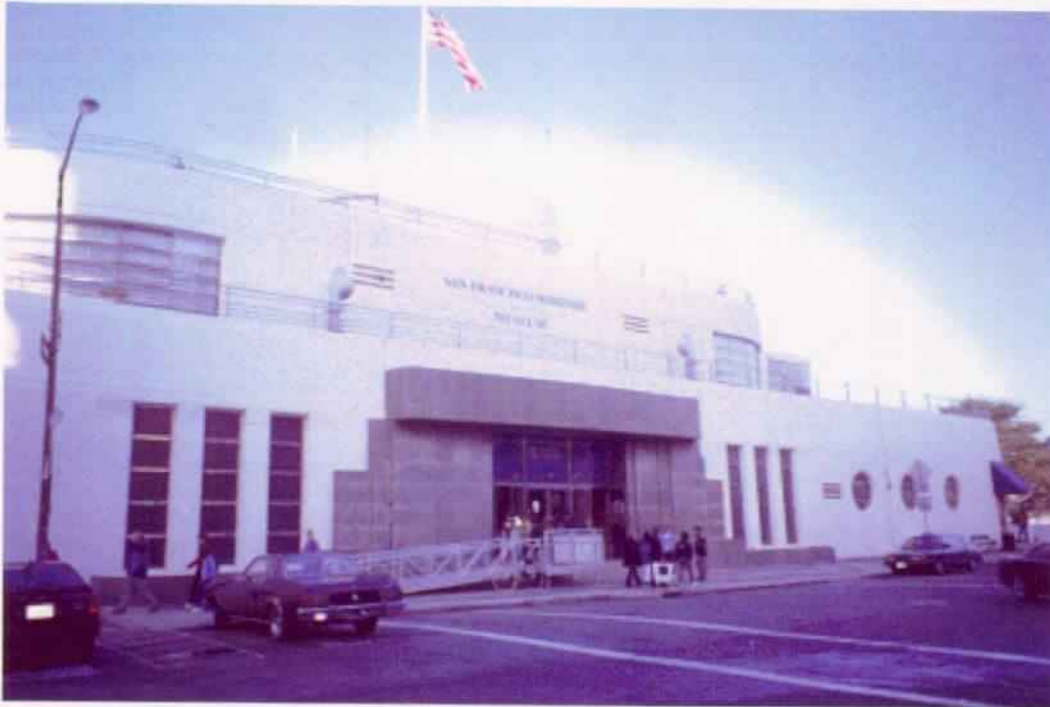
*Figure 3. South elevation showing carved slate sculpture at the main entrance, funnel-shaped ventilators, and various window configurations.*

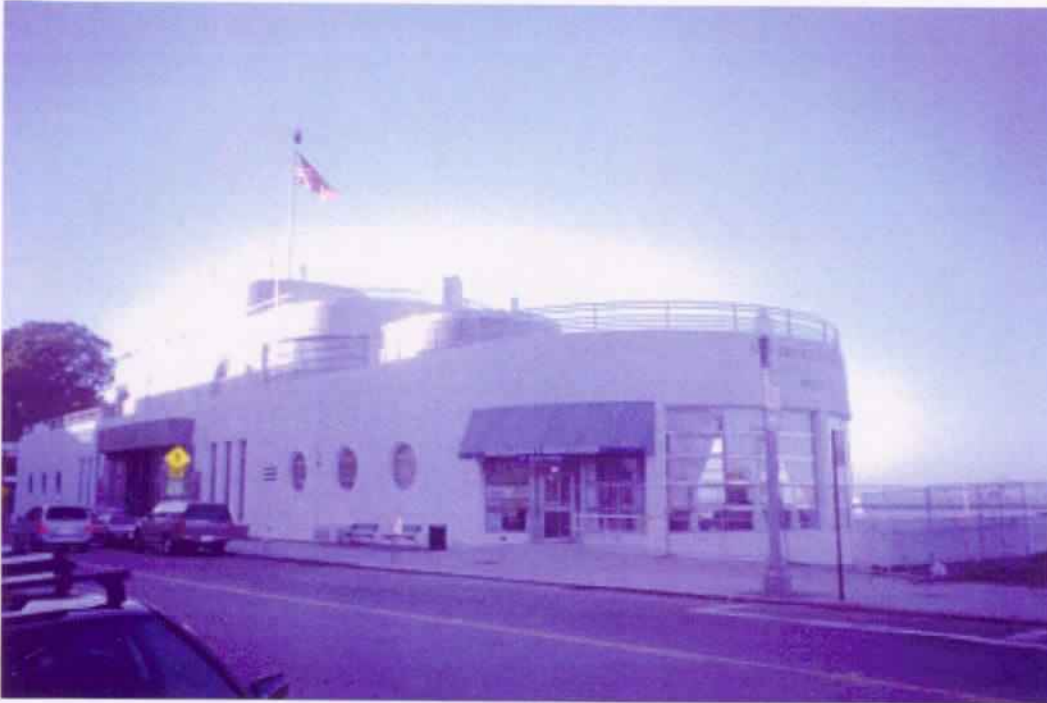
*Figure 4. View of the south and east elevations showing large window openings at the apse-shaped ends of the building. The top of the glass block pantry is visible on the large observation deck.*

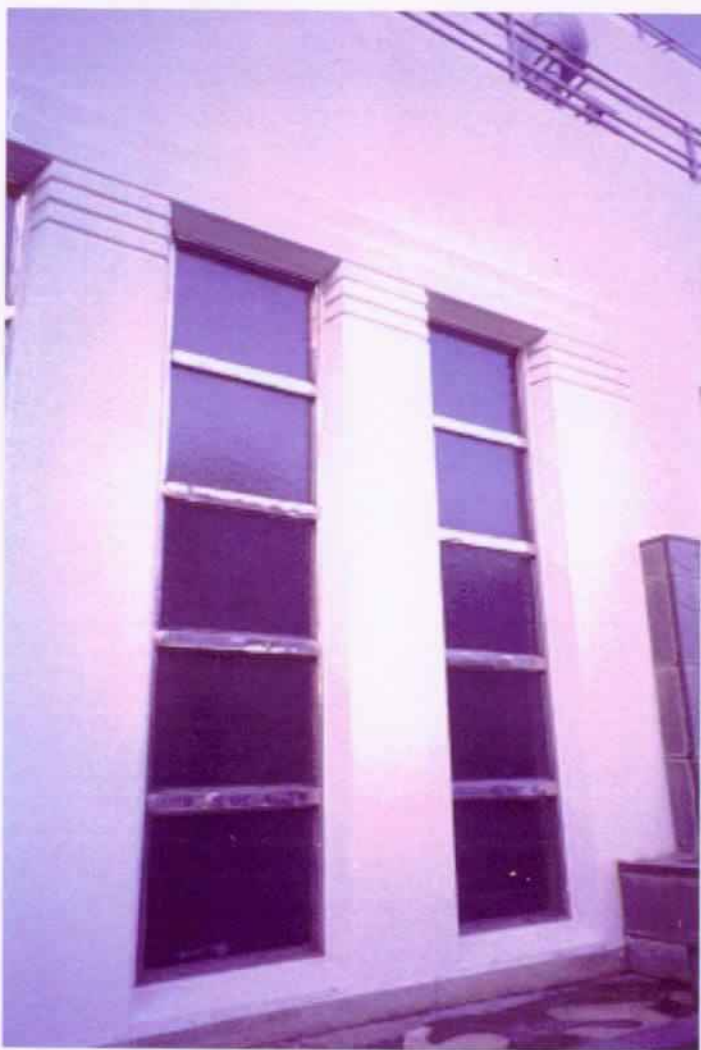
*Figure 7. Vertical band of stainless steel-clad windows on the south elevation adjacent to the main entrance. These windows all have obscure glass.*

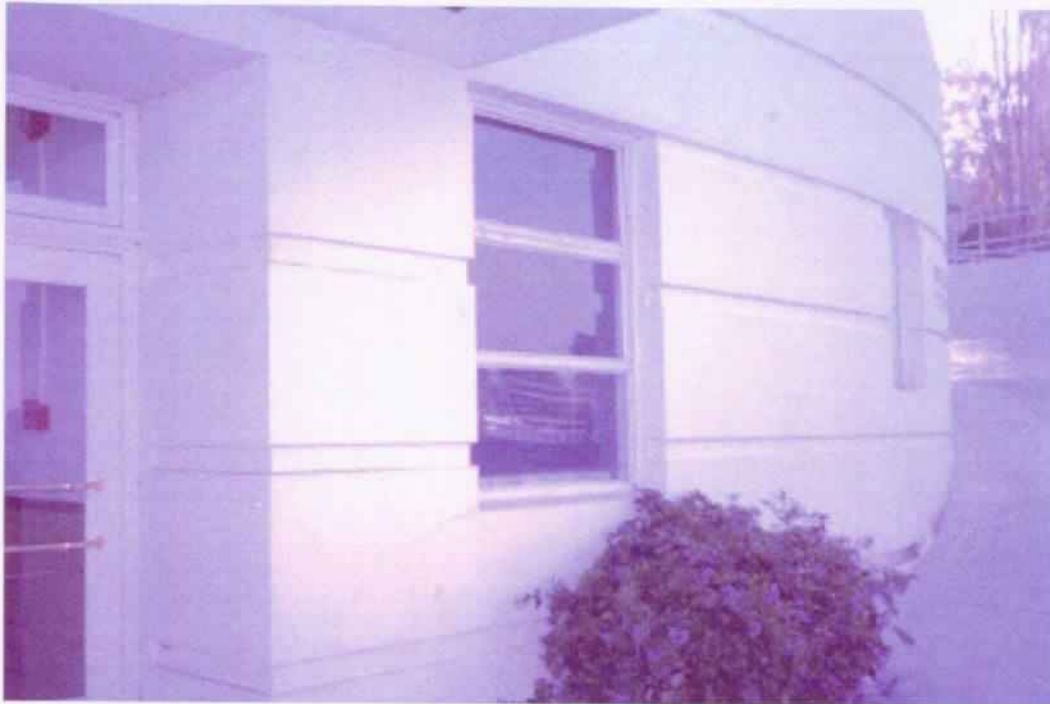
*Figure 8. Painted galvanized steel window on the north elevation at the first floor.*

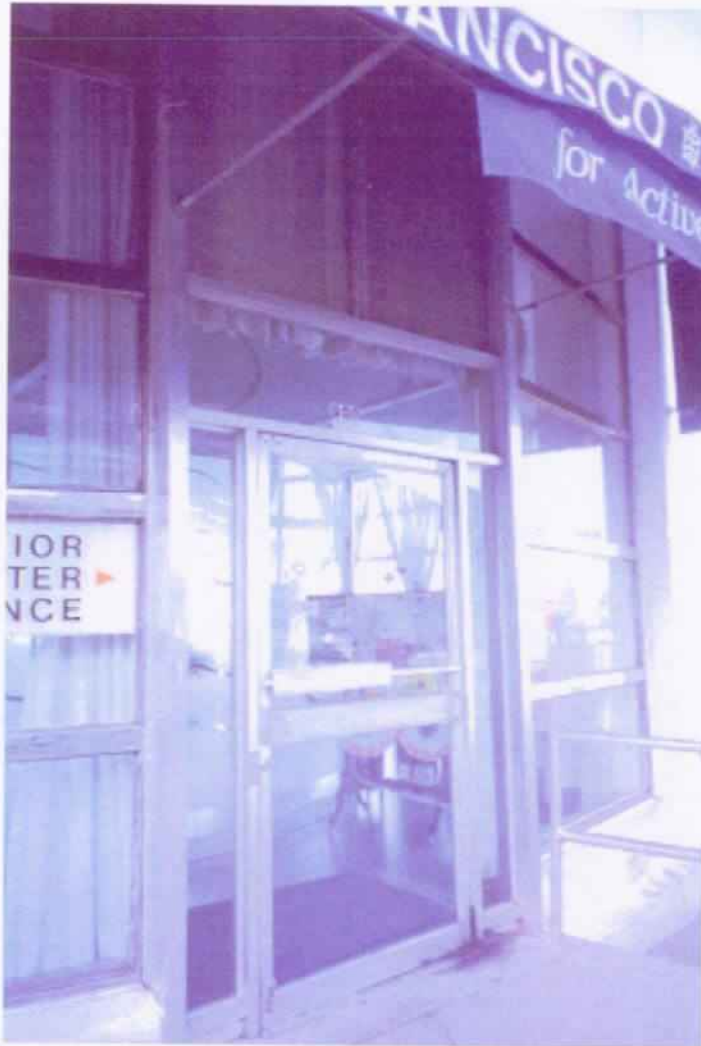
All of the exterior doors of the Maritime Museum Building are original with the exception of the second floor door at the southeast corner of the building. The original door at this location was removed and the current door installed to provide handicapped access to the San Francisco Senior Center.<sup>10</sup> All of the original doors on the second, third, and fourth floors have stainless steel frames with glass panels. (See **Appendix B, Figures 13 and 14**). Similar to the clad windows, the jambs, heads, and astragals of the original doors are constructed of steel channels and angles with stainless steel cladding. The door pushes are shaped like partial ship's wheels and are brass plated. The replacement door at the southeast corner of the building is a stainless steel door designed to blend in with the original doors. (See **Appendix B, Figure 15**). The doors on the first floor at the north elevation entrances are mostly paired sets of wood doors with glass panels. (See **Appendix B, Figure 16**). There is also one painted metal door at the first floor, north elevation. (See **Appendix E, Door Schedule**)

*Figure 15. Replacement door at the southeast corner of the building. This door was added in the late 1950s at an existing window wall system.*

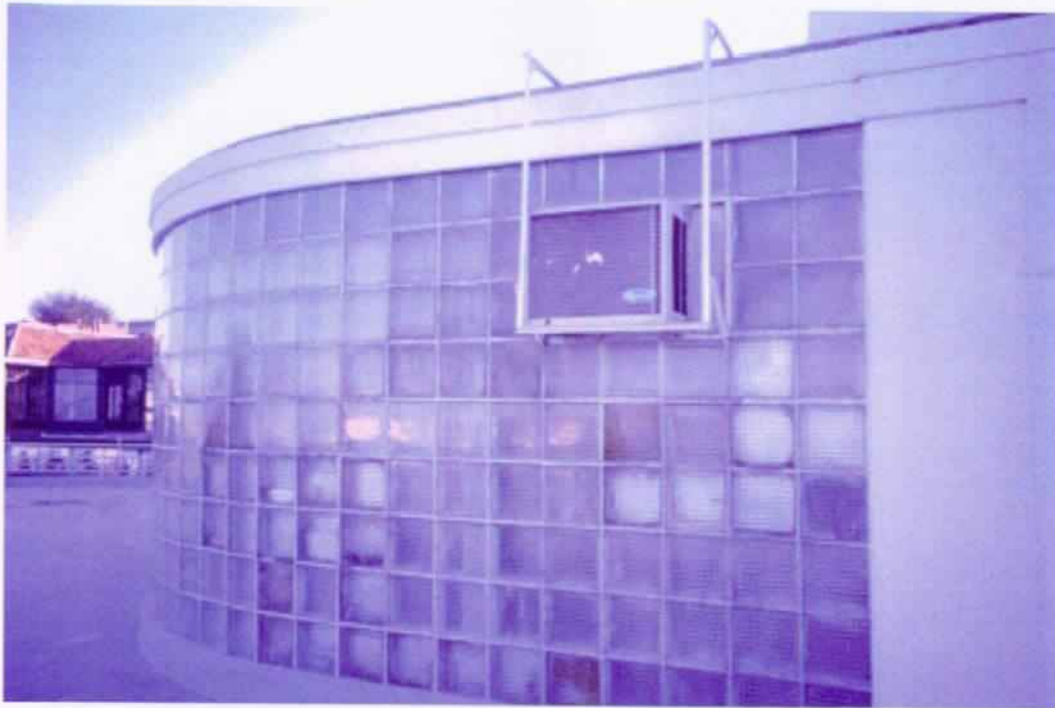
*Figure 20. The north side of the glass block pantry at the east end of the third floor.*

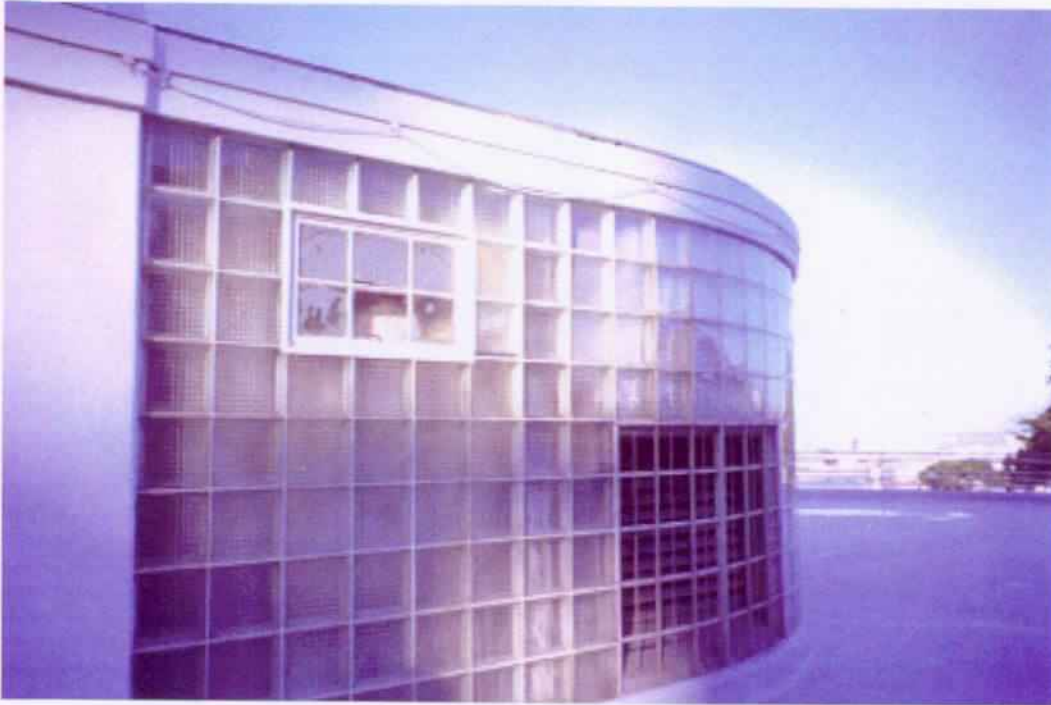
*Figure 22. The south wall of the third floor glass block pantry.*
