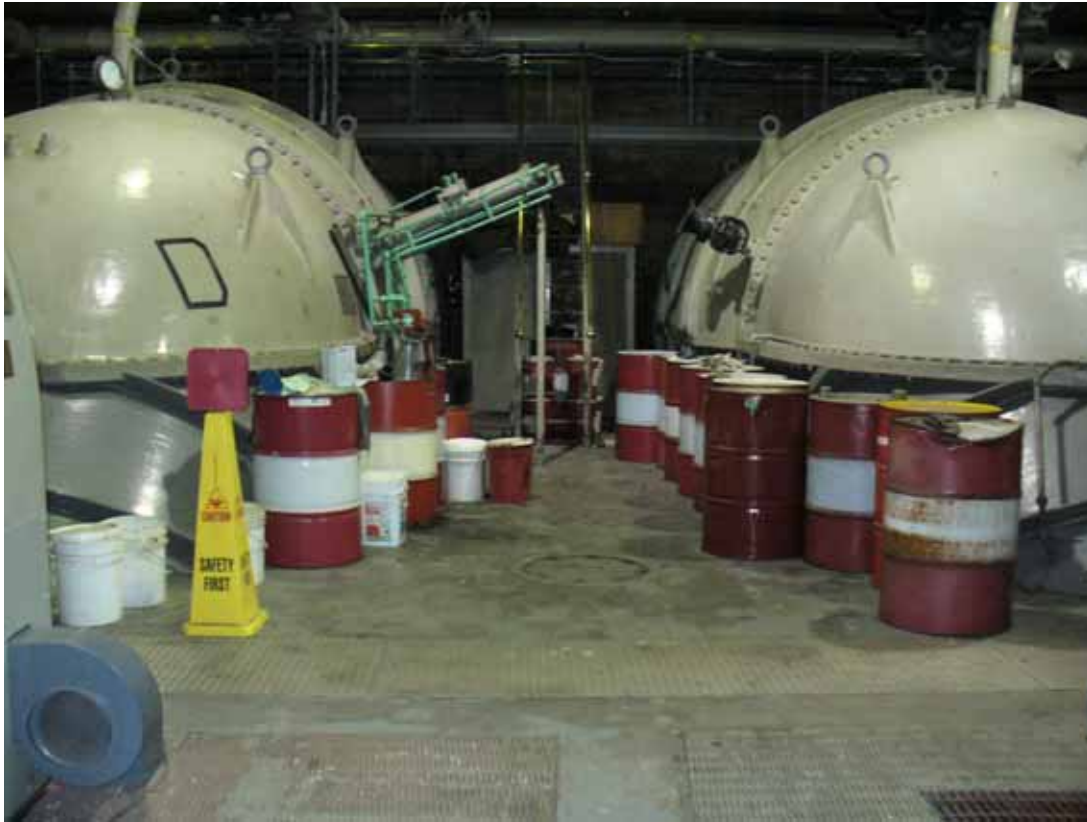
15. View of fifty gallon drums stored alongside pumps inside pump house.

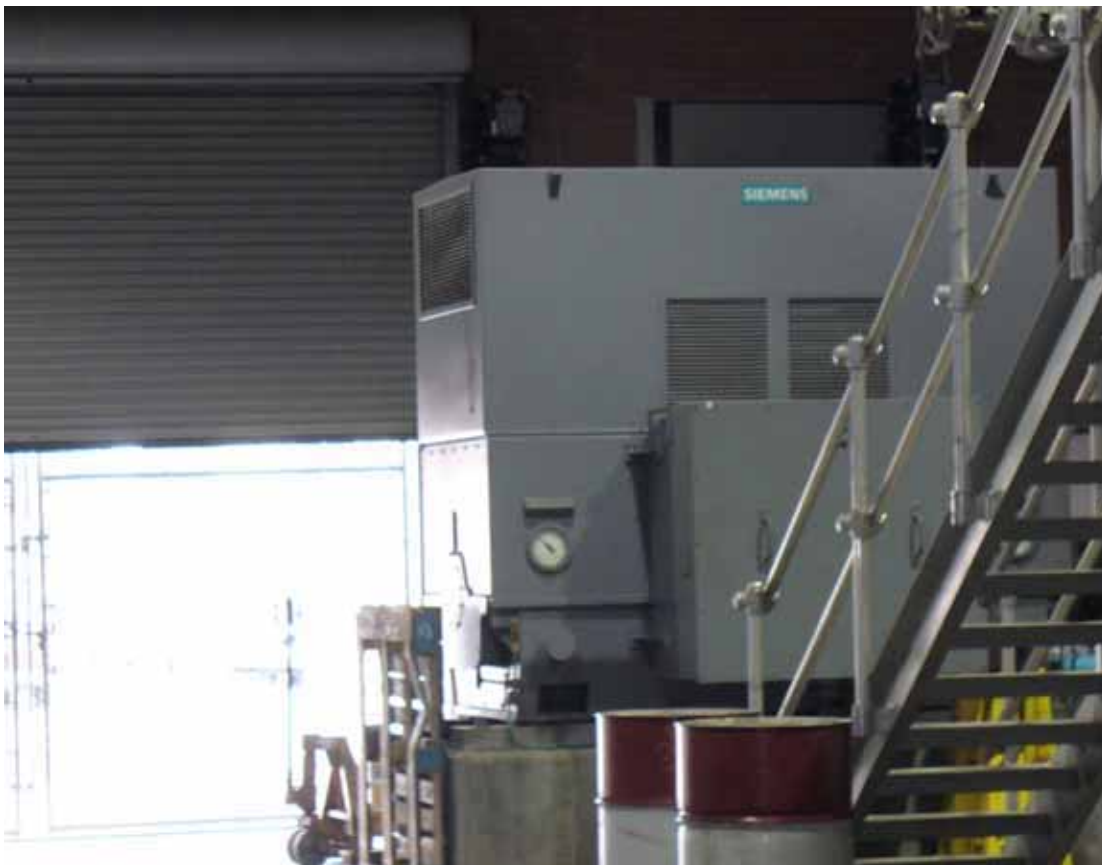
16. View of power transformer inside pump house.

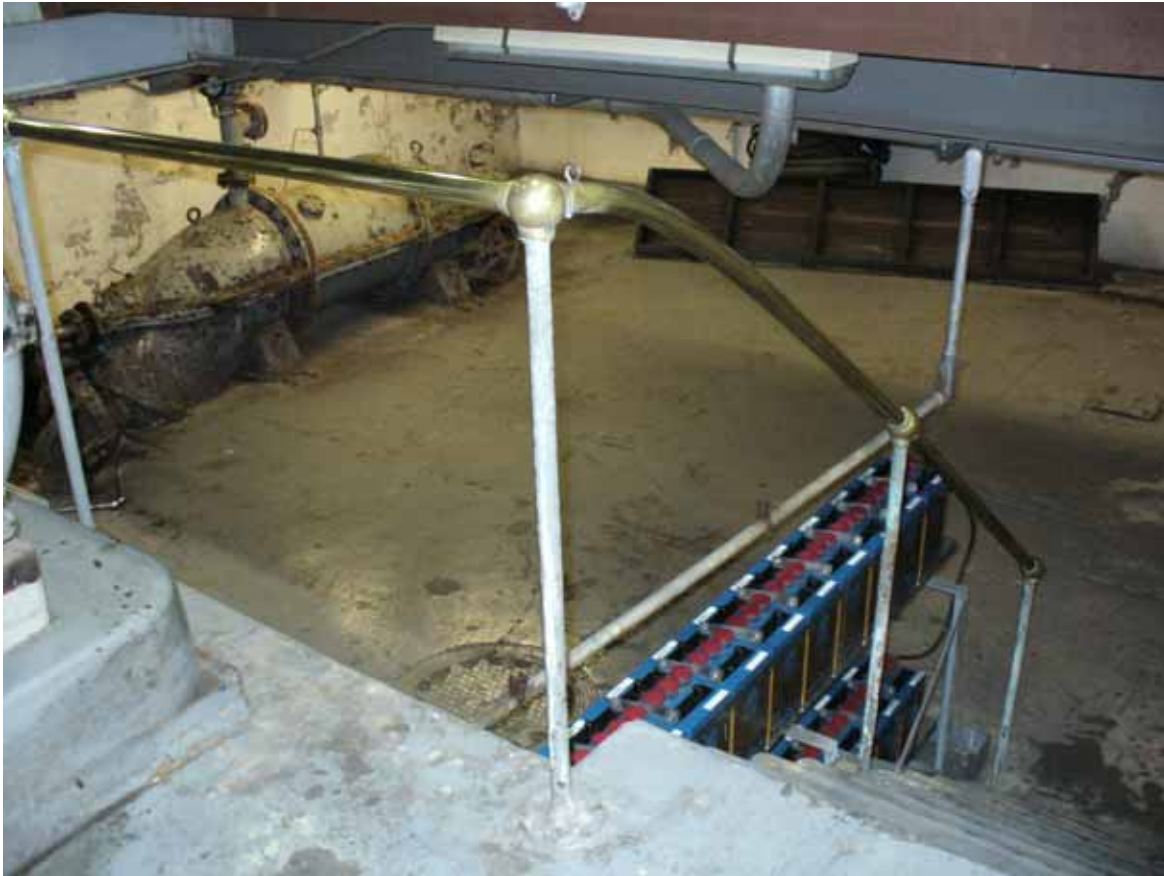
17. Battery banks inside pump house

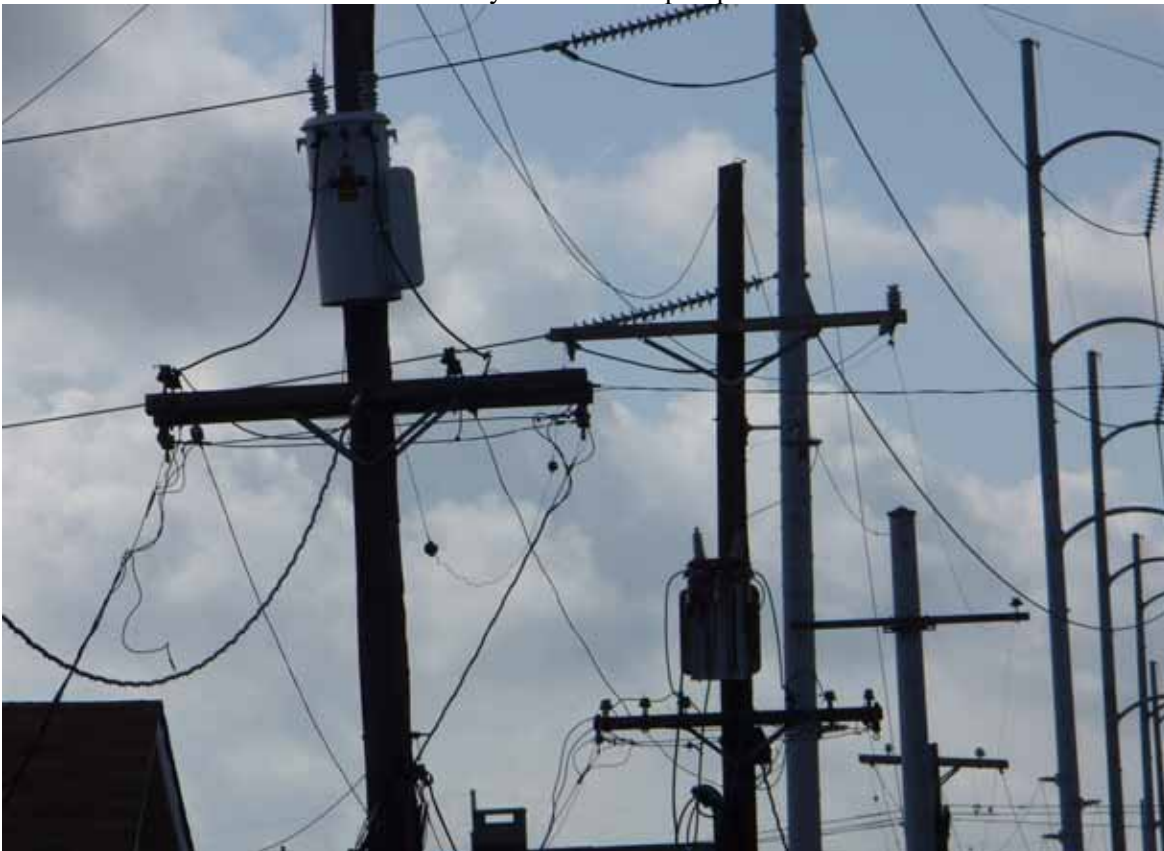
18. Transformers on street - south side of building

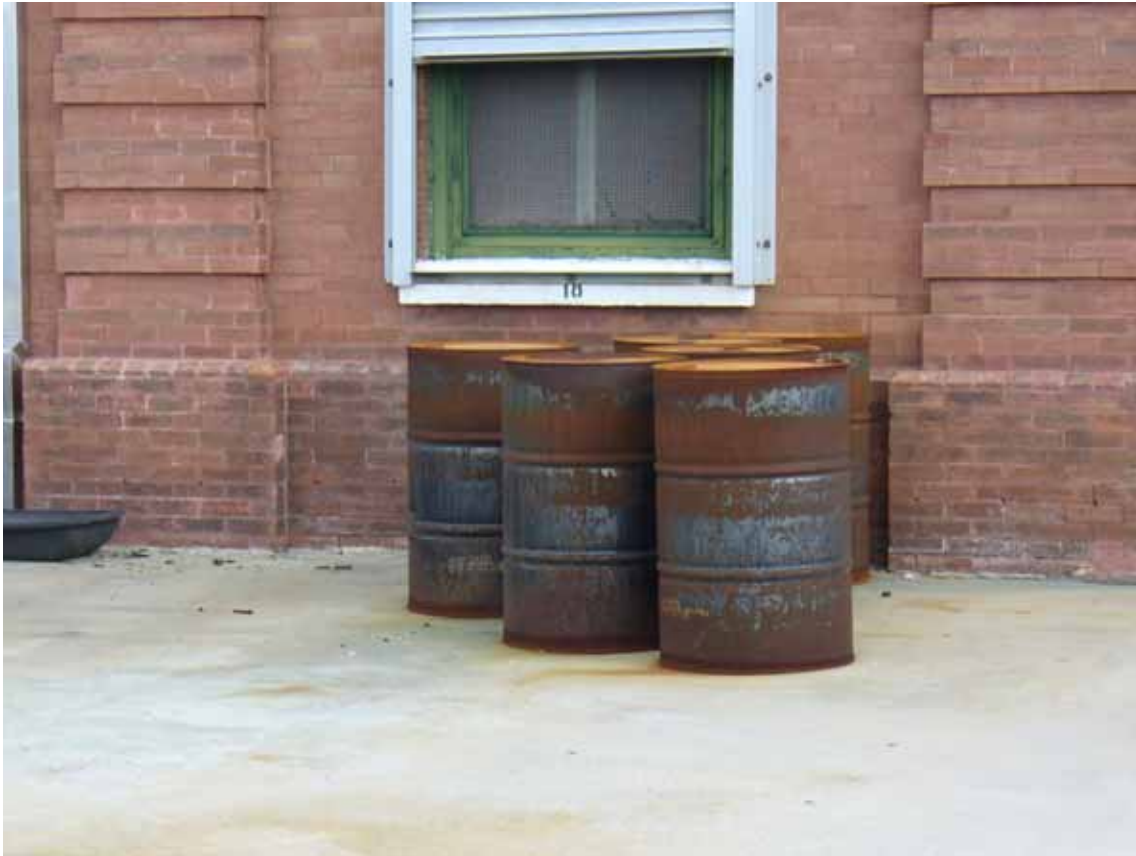
19. Miscellaneous drums out side pump house on property.

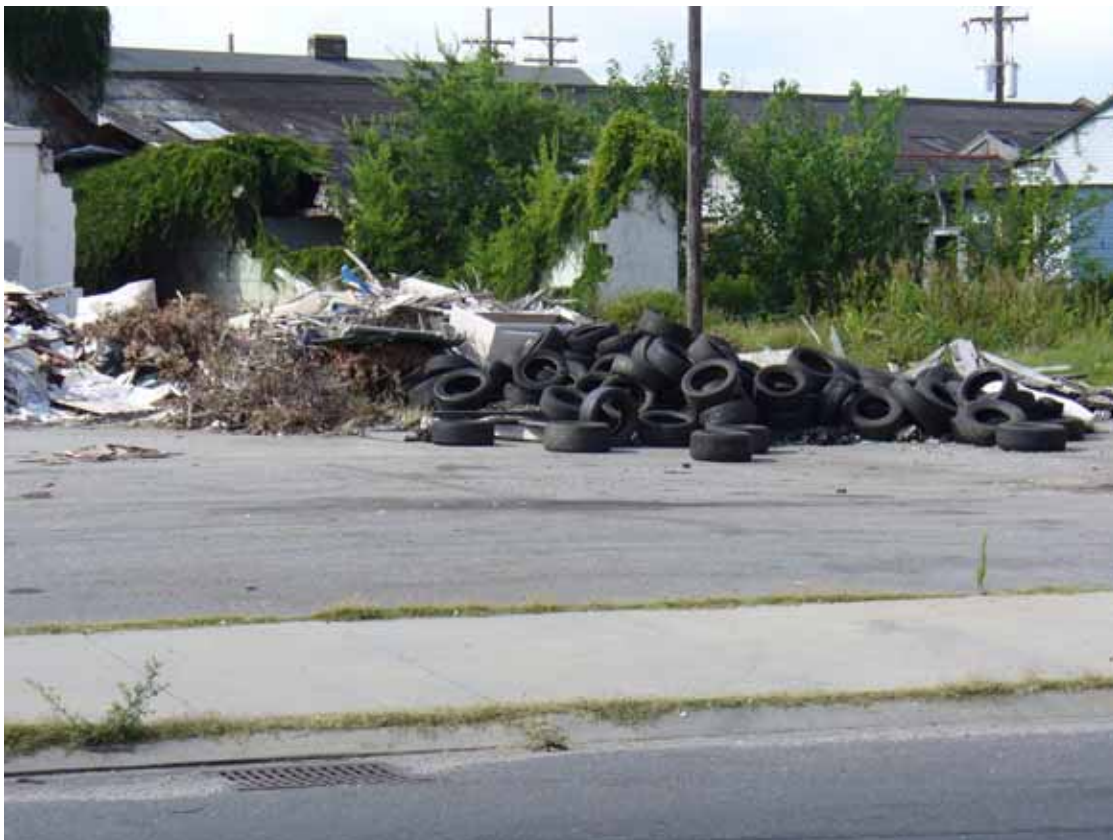
20. Refuse piles on an adjacent parcel.

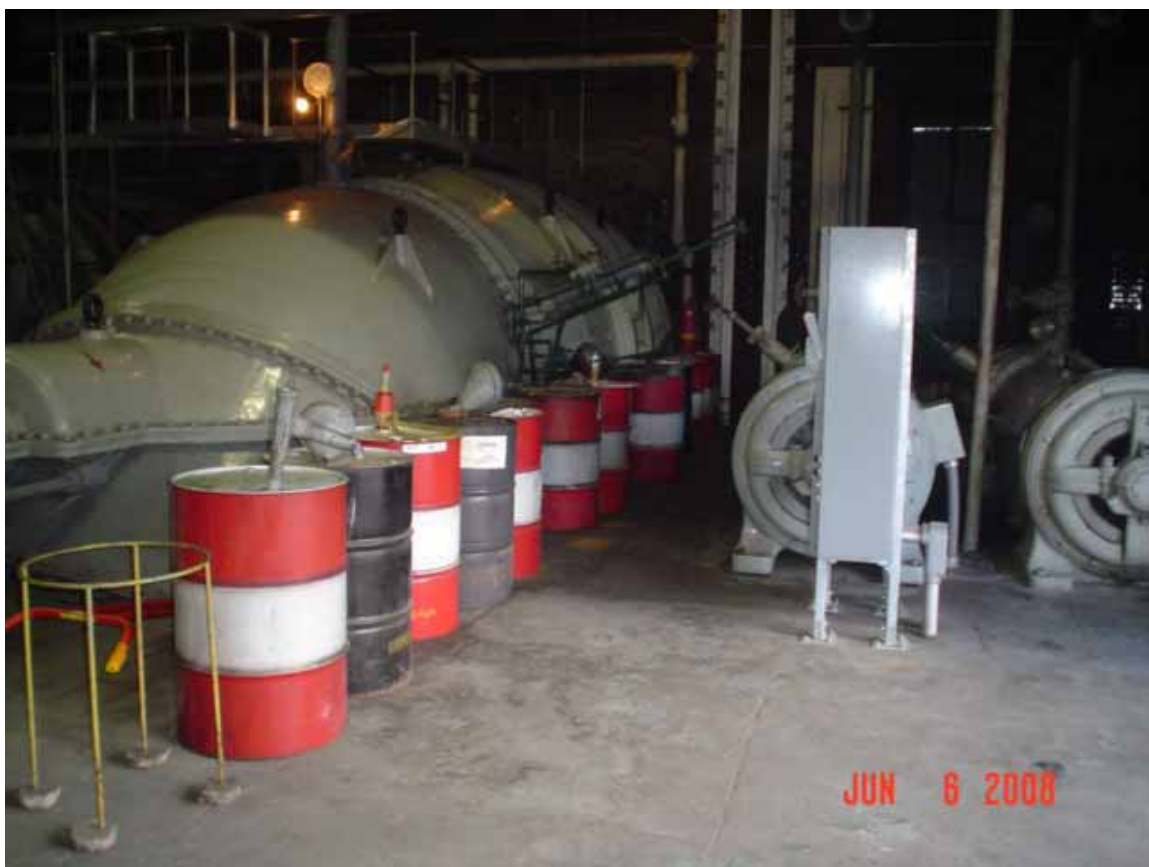
16. View of miscellaneous 55 gallon drums alongside pump inside station building.

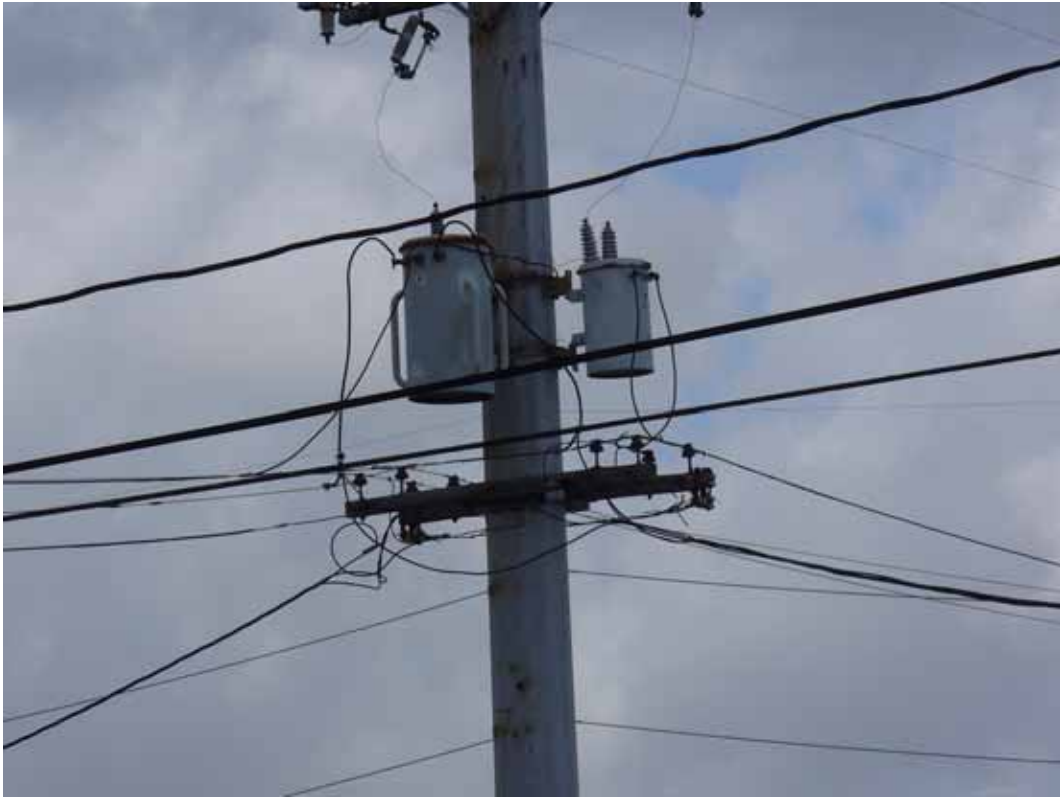
17. View of transformers located outside on west side of property. Several others were observed in the area.

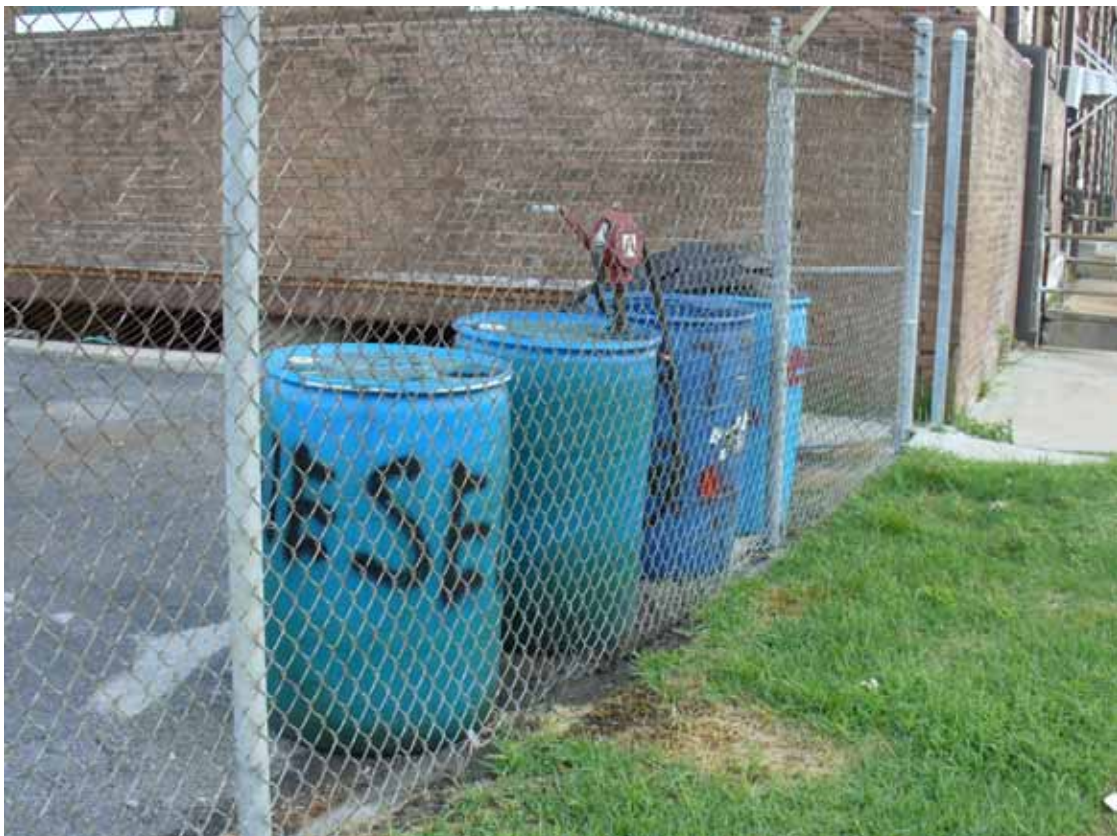
18. View of 55 gallon drums stored outside the building, on the property.

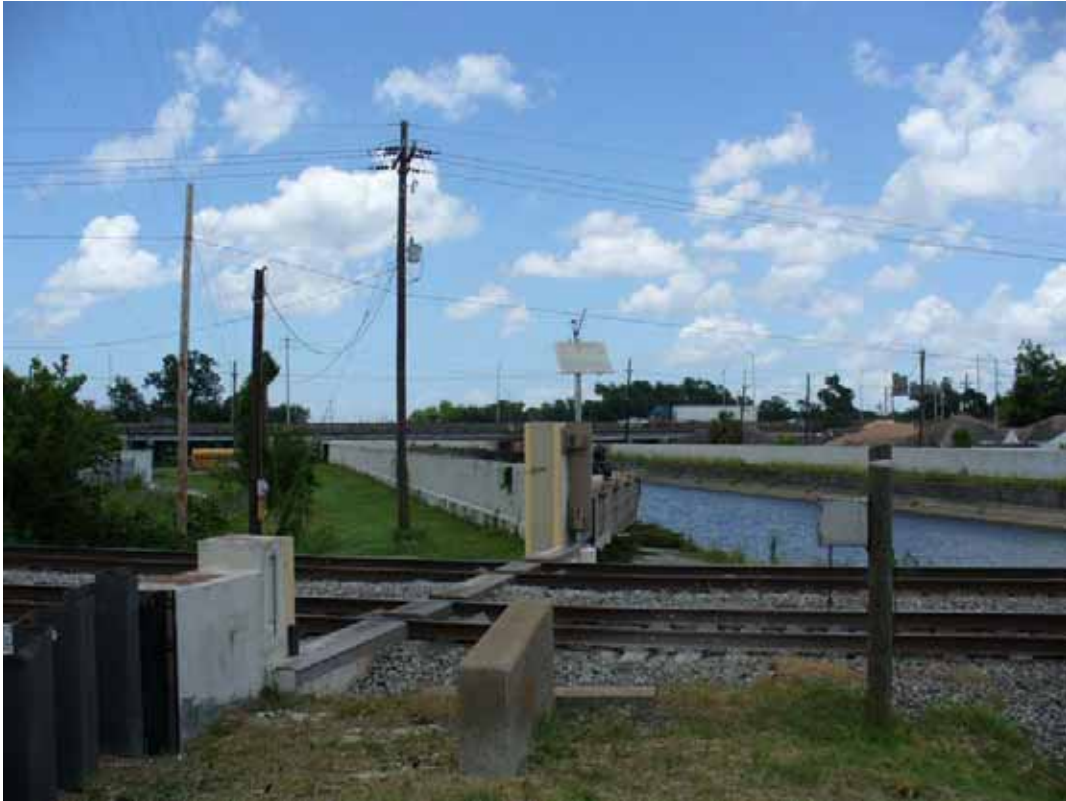
3. View of north area adjacent to the site, canal and railroad tracks.

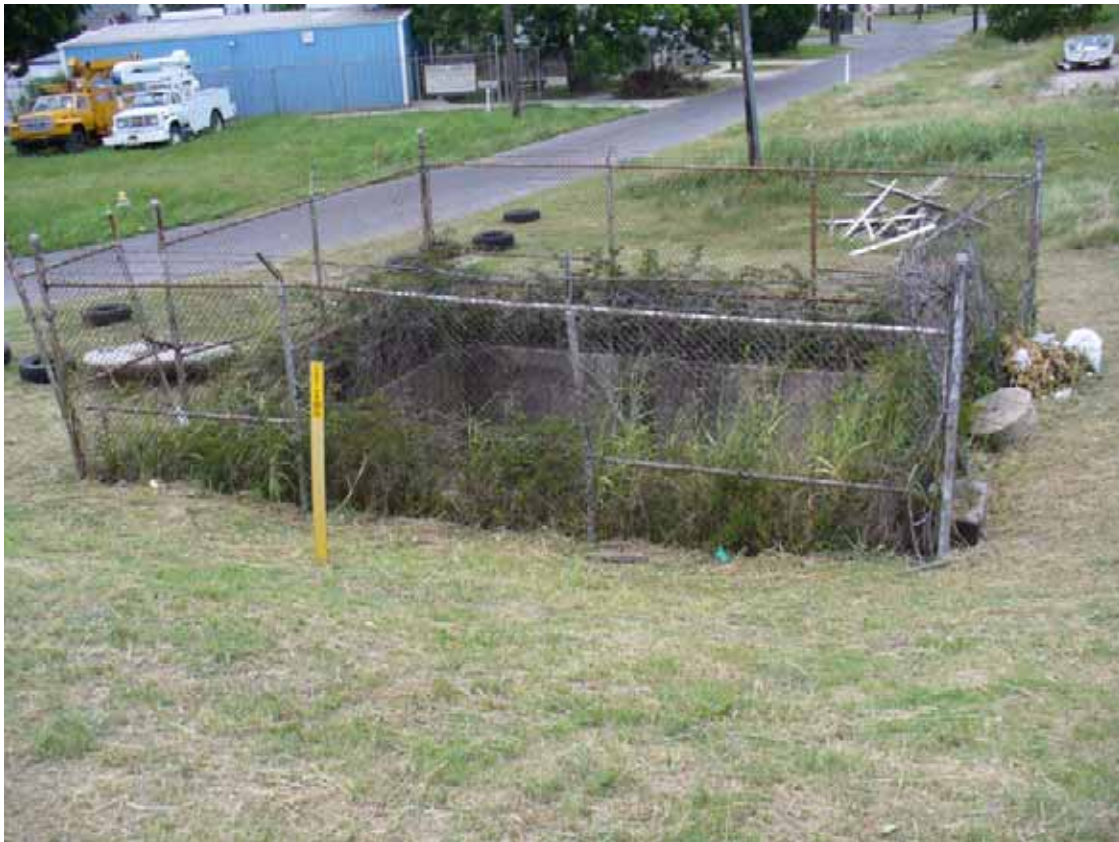
4. View of fenced-in pit open to drainage canal and Real Wood Company, located in northwest area.

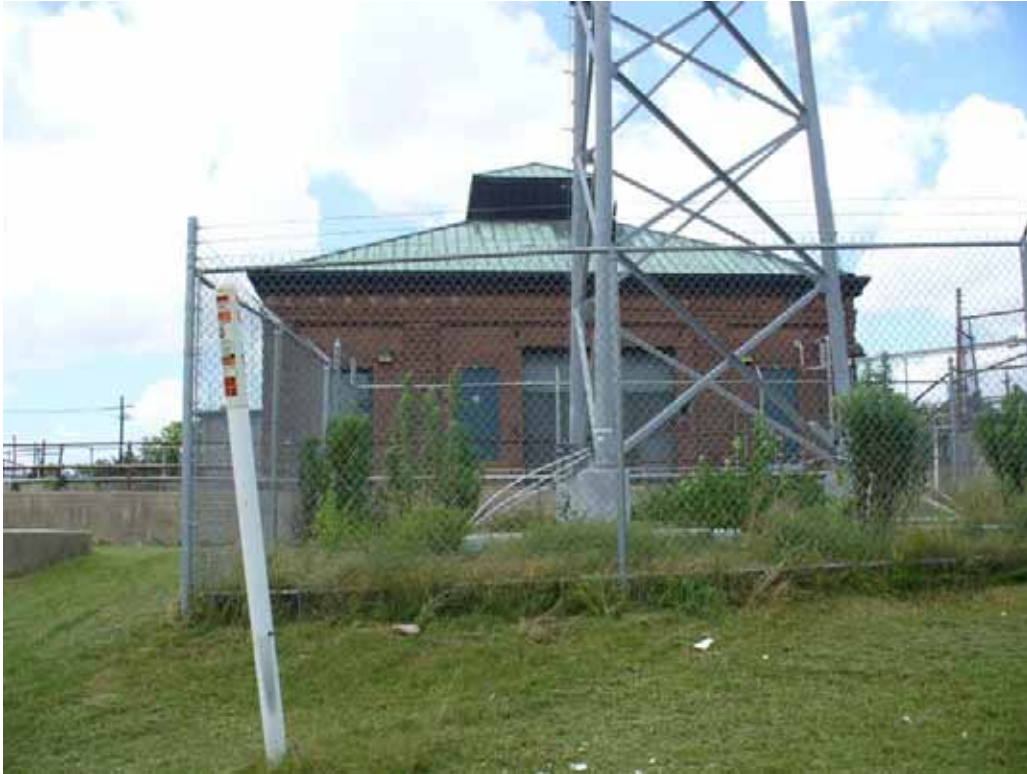
5. View of site as seen from the east direction, including buried fiber optic cable post.

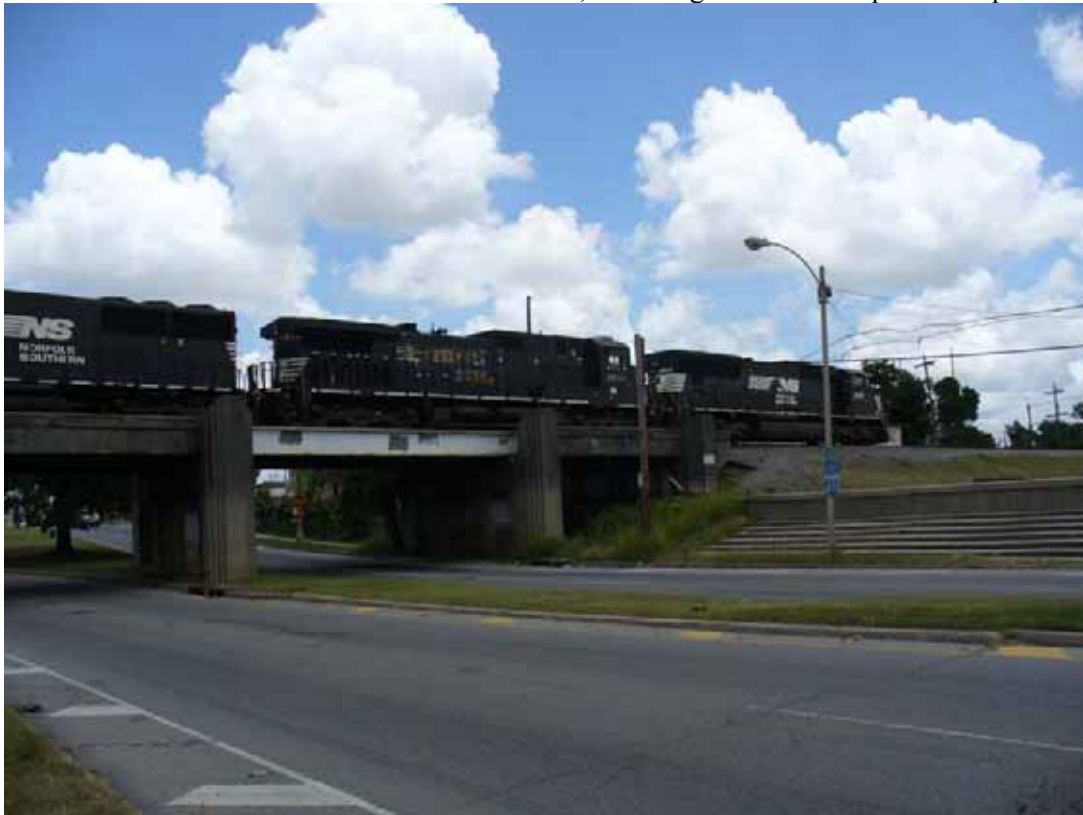
6. View of east area adjacent to the site, observe railroad over pass.

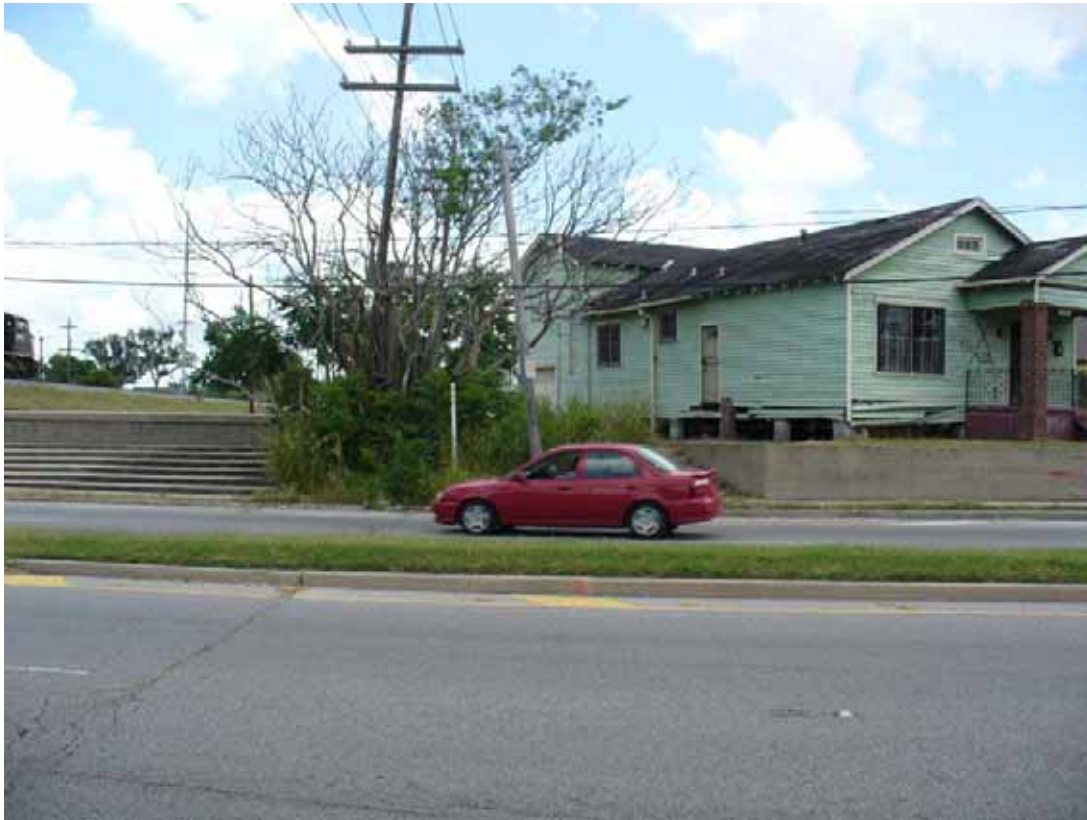
7. View of east area adjacent to the site, across North Broad.

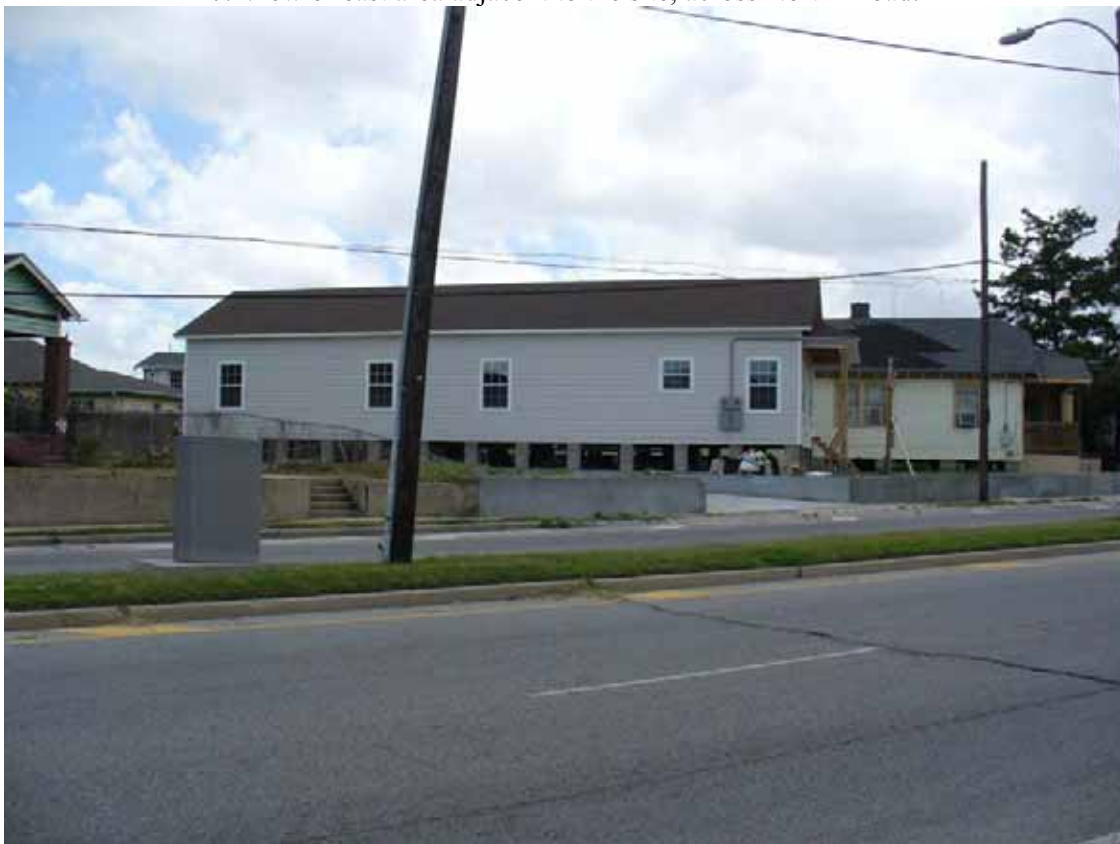
8. View of east area adjacent to the site, across North Broad, in southeast area.

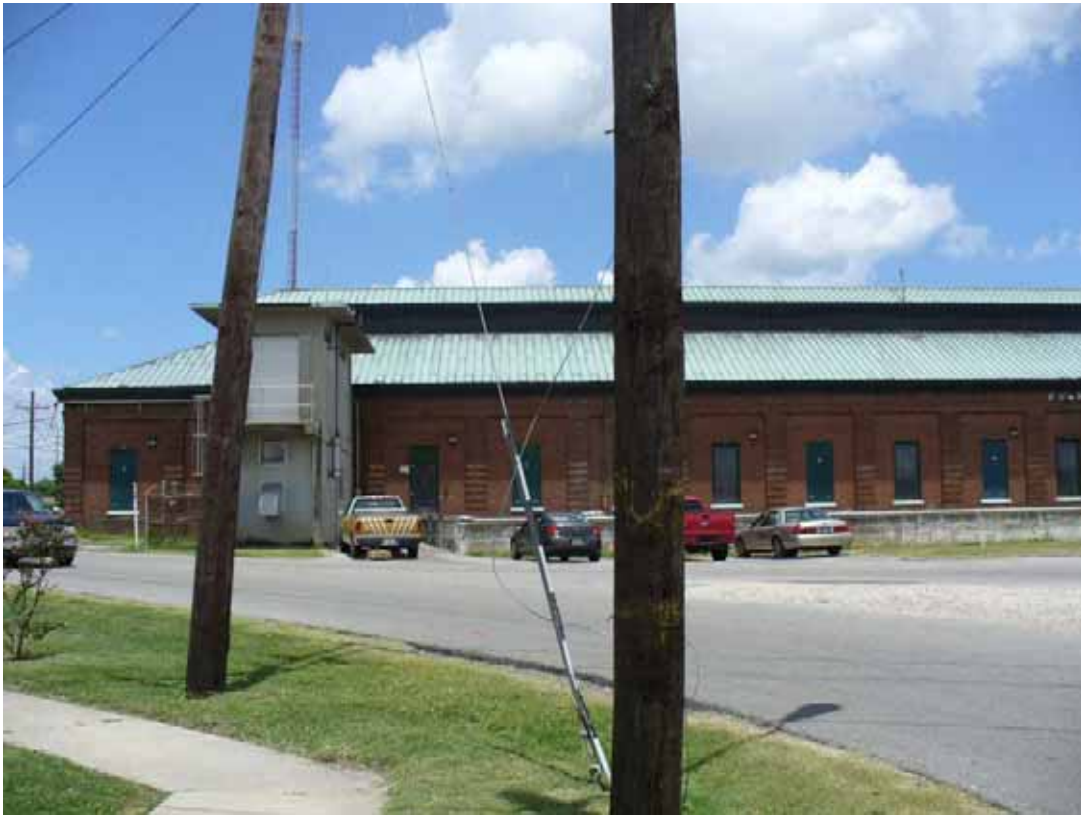
9. View of site as seen from the south direction, in southwest area. Generator Building is located on left side.

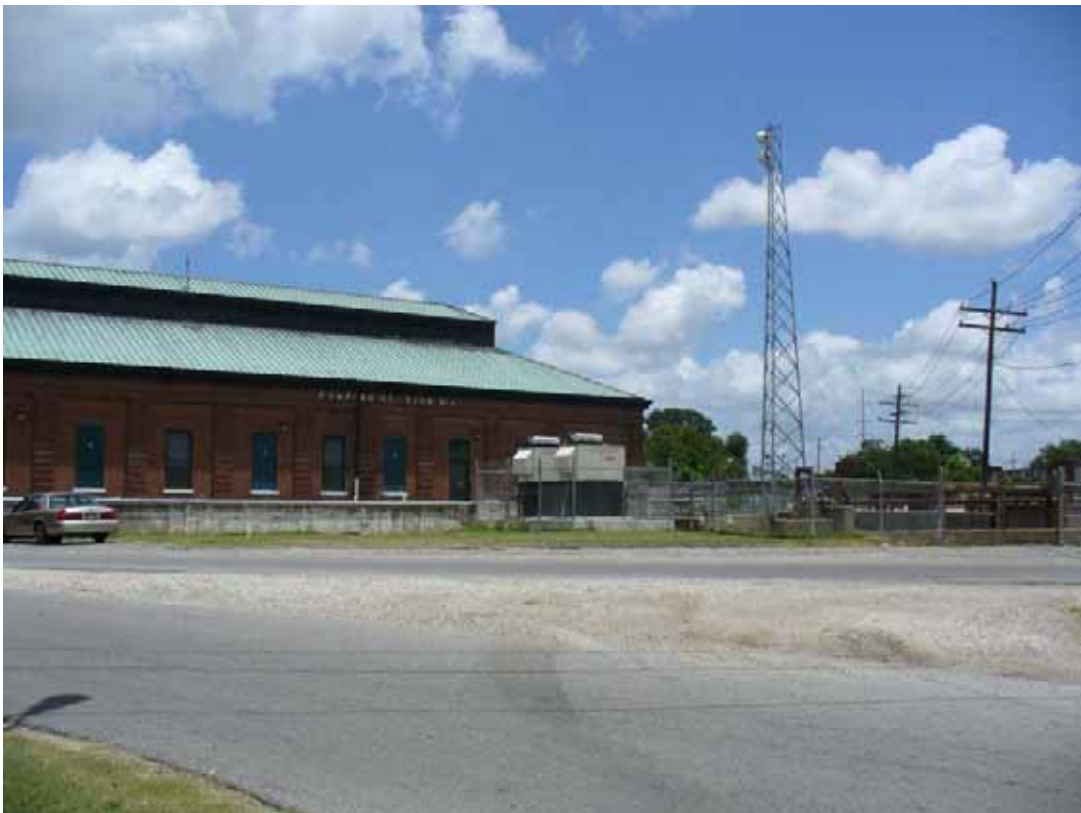
10. View of site as seen from the south direction, in southeast area.

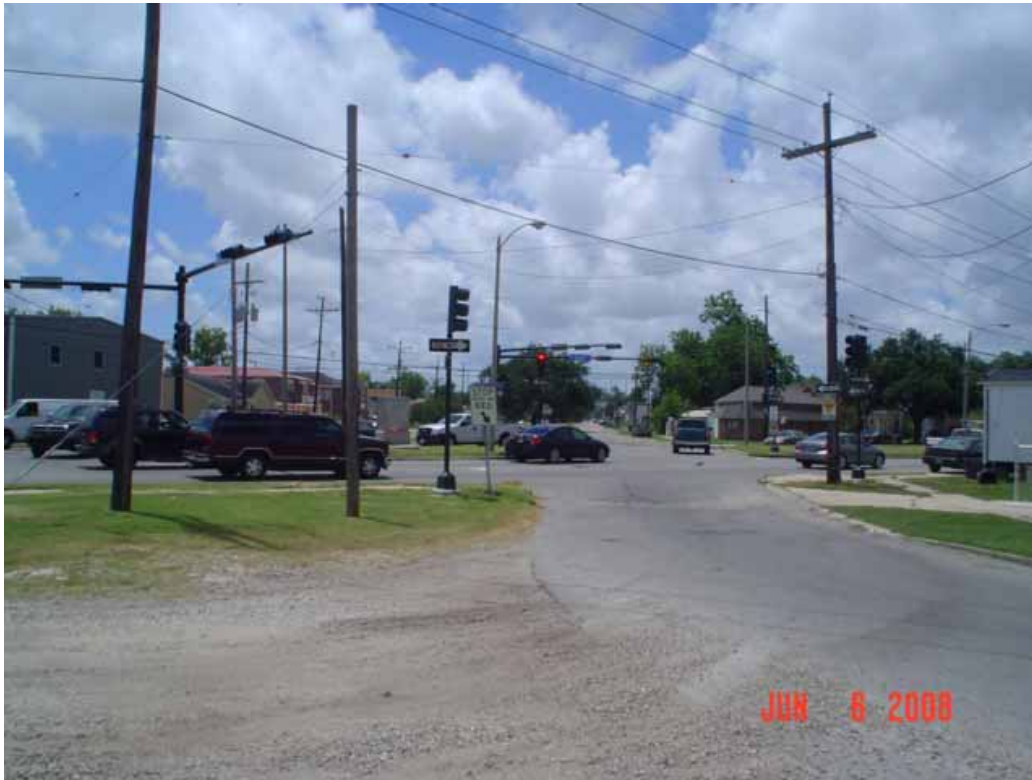
11. View of south area adjacent to the site, AP Tureau Street, in east area.

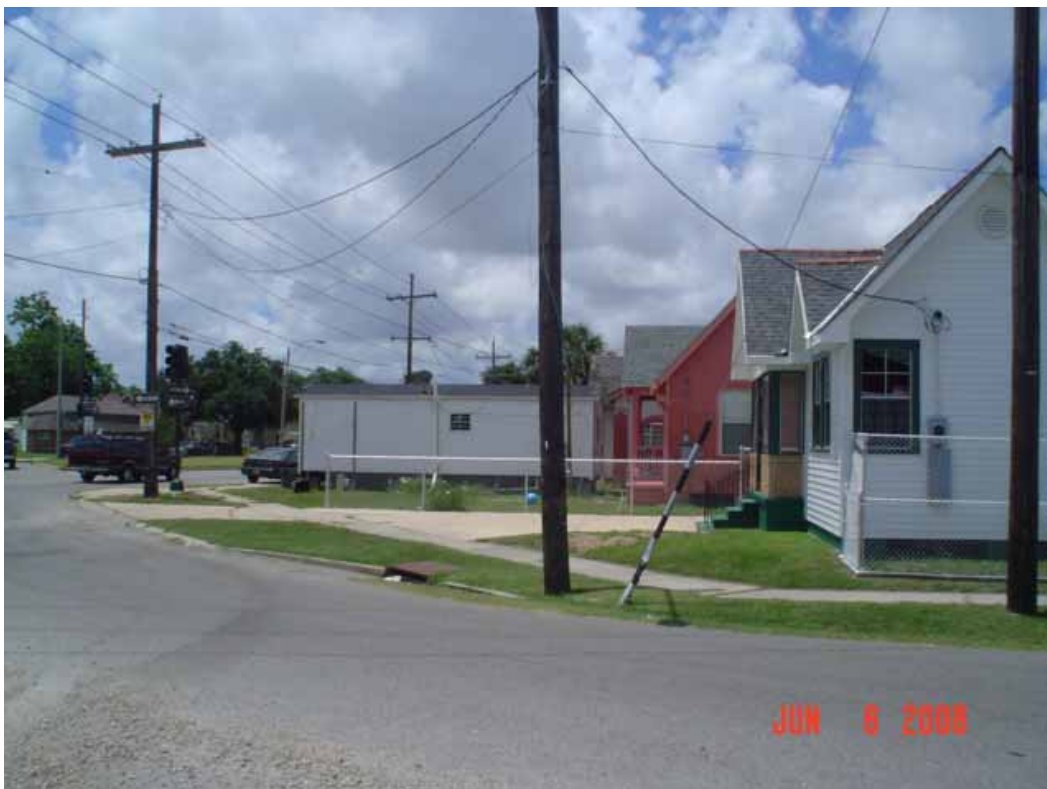
12. View of south area adjacent to the site, AP Tureau Street, in west area.

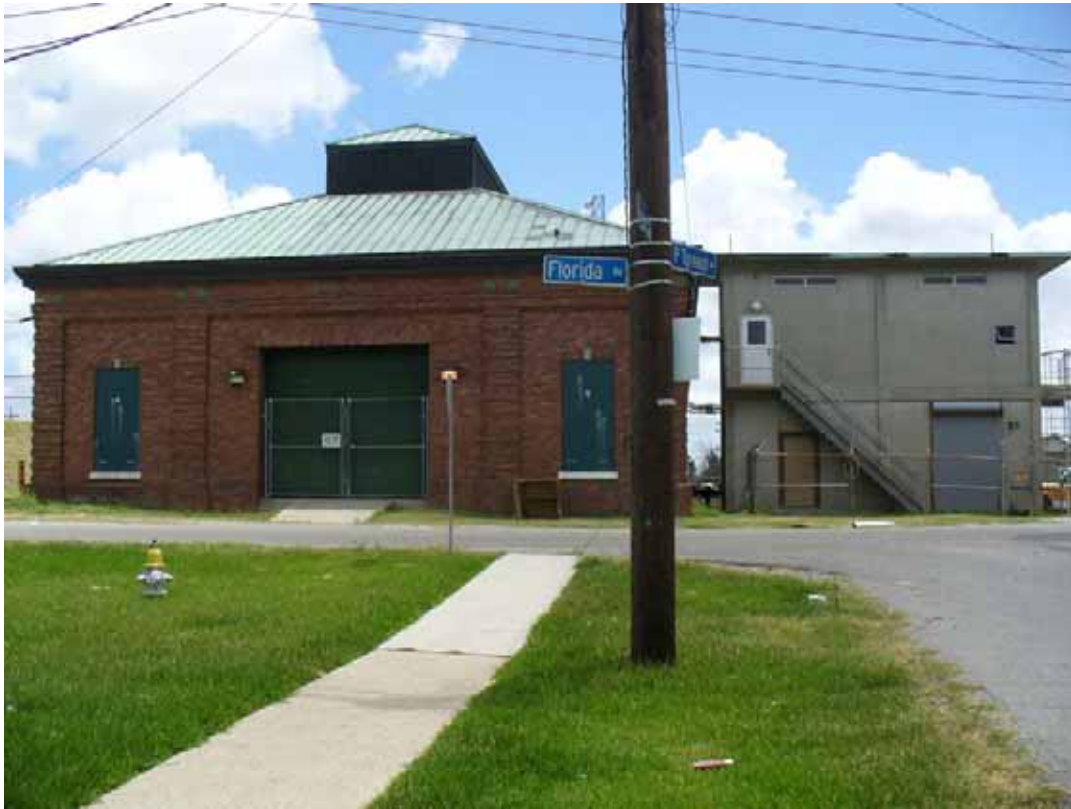
13. View of site as seen from the west direction, observe Generator Building to the right.

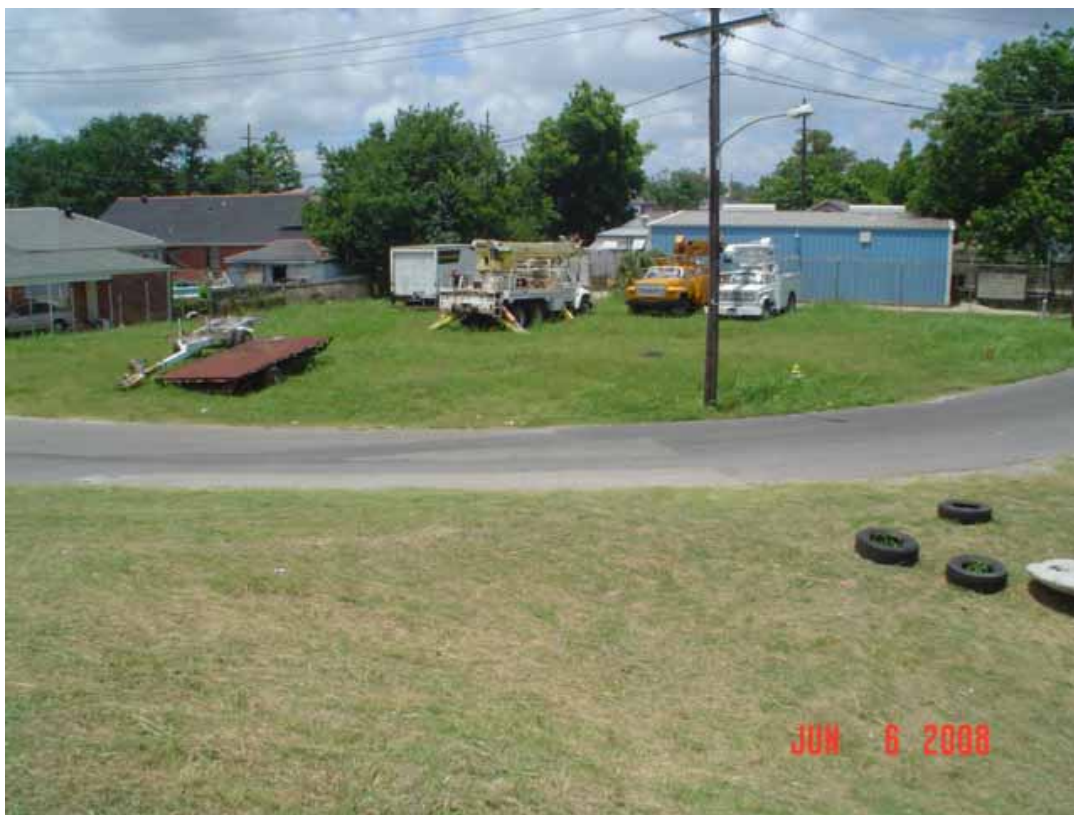
14. View of west area adjacent to the site, showing Real Wood Company and empty lot locations. Observe abandoned tires in north area.

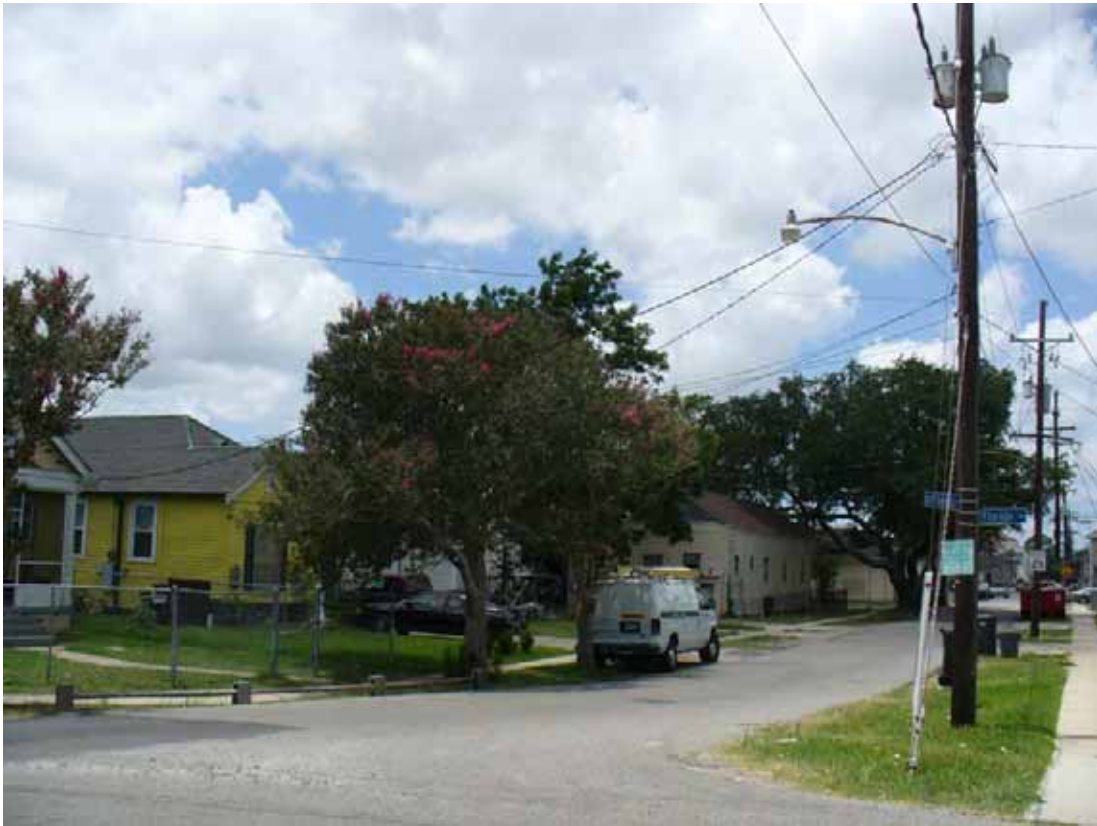
15. View of west area adjacent to the site, showing the residential area across from Florida Avenue and AP Tureau Street, observe the transformers located at corner.

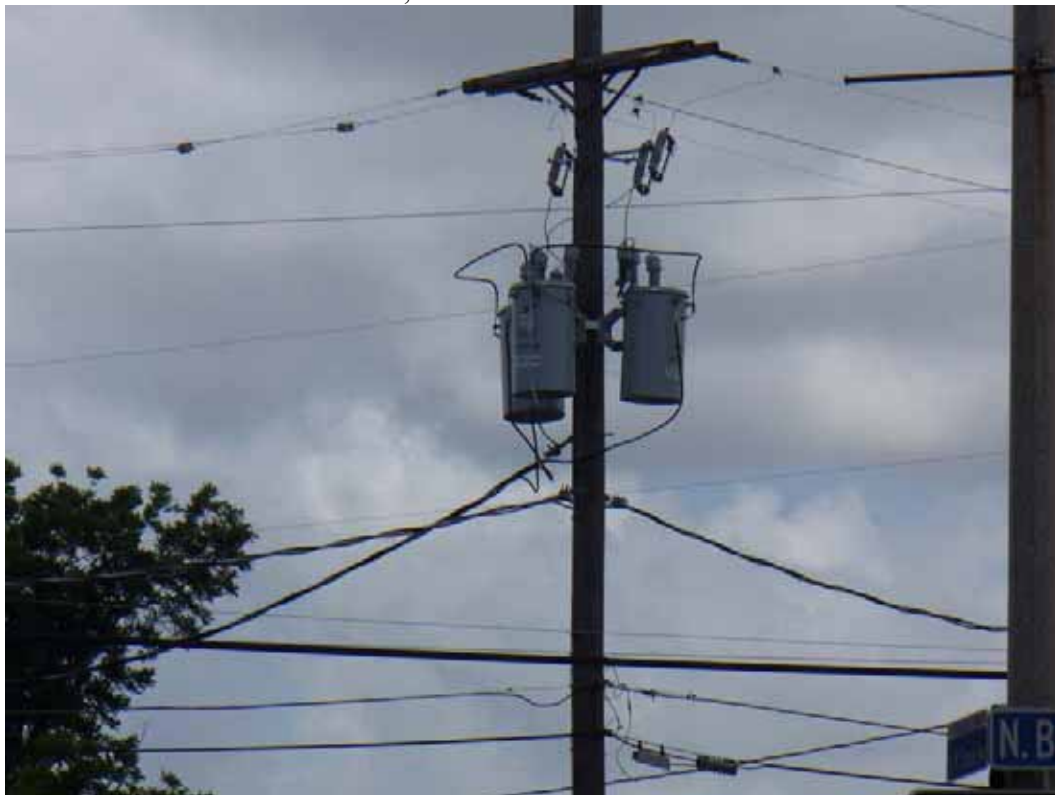
16. View of transformers located in southeast direction from building, across AP Tureau Street.

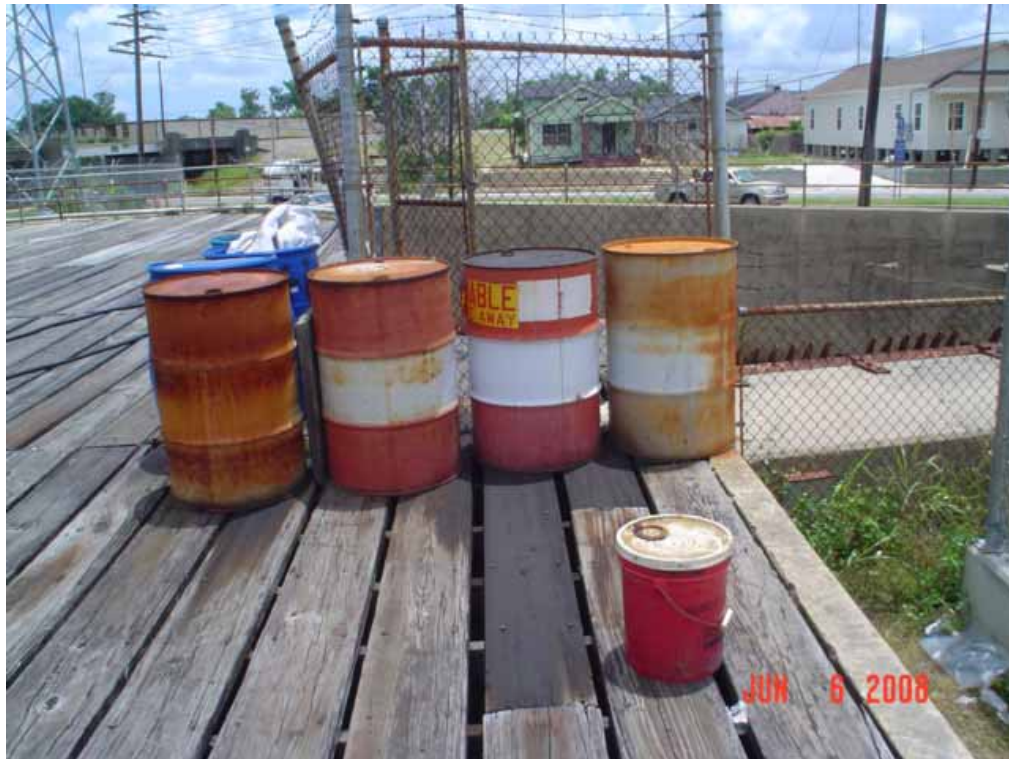
17. 55 gallon drums outside pump building on deck in southeast area.

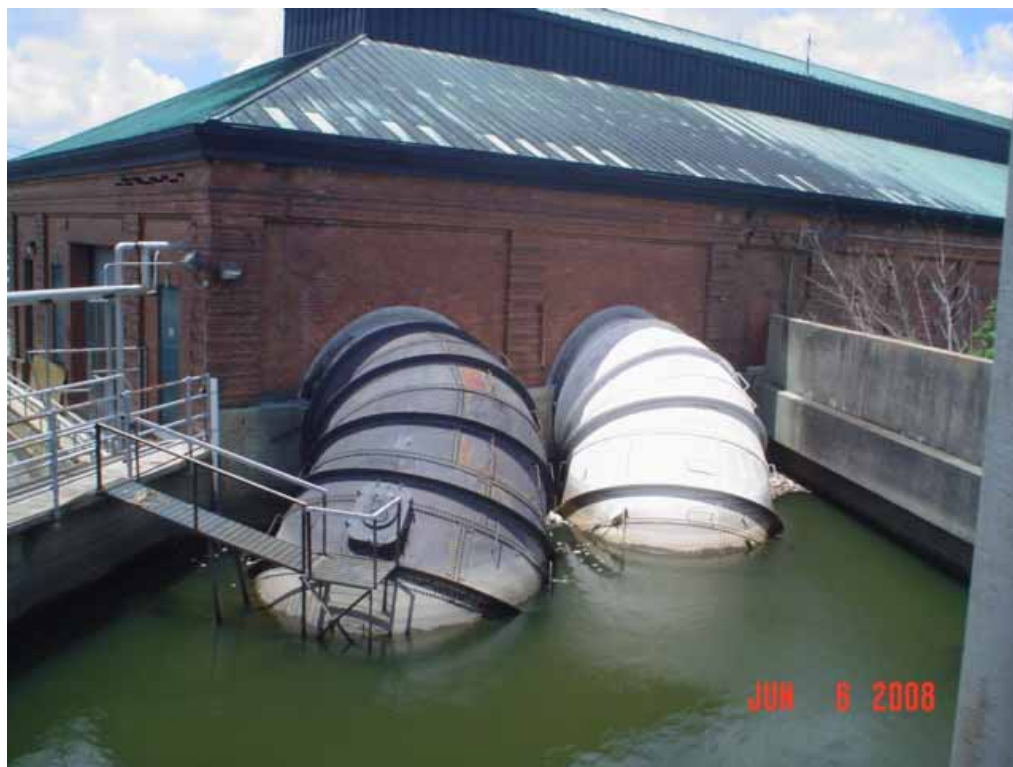
18. View of pump lines in northeast corner.
