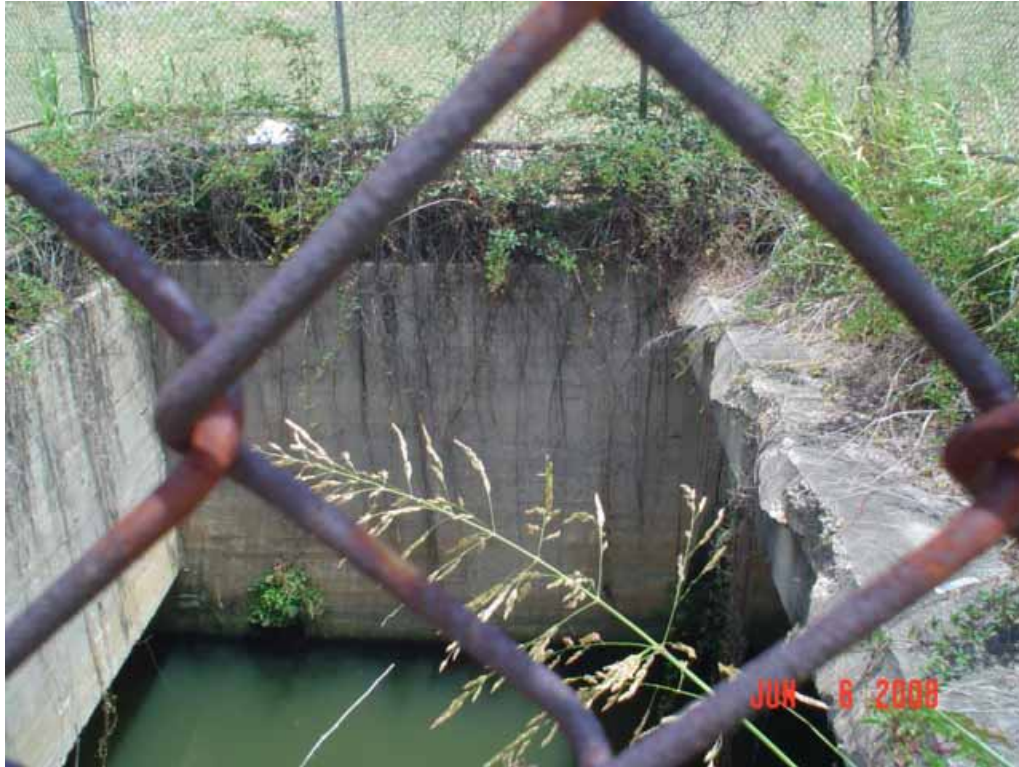
19. Another view of fenced-in pit adjacent to railroad tracks in northwest area.

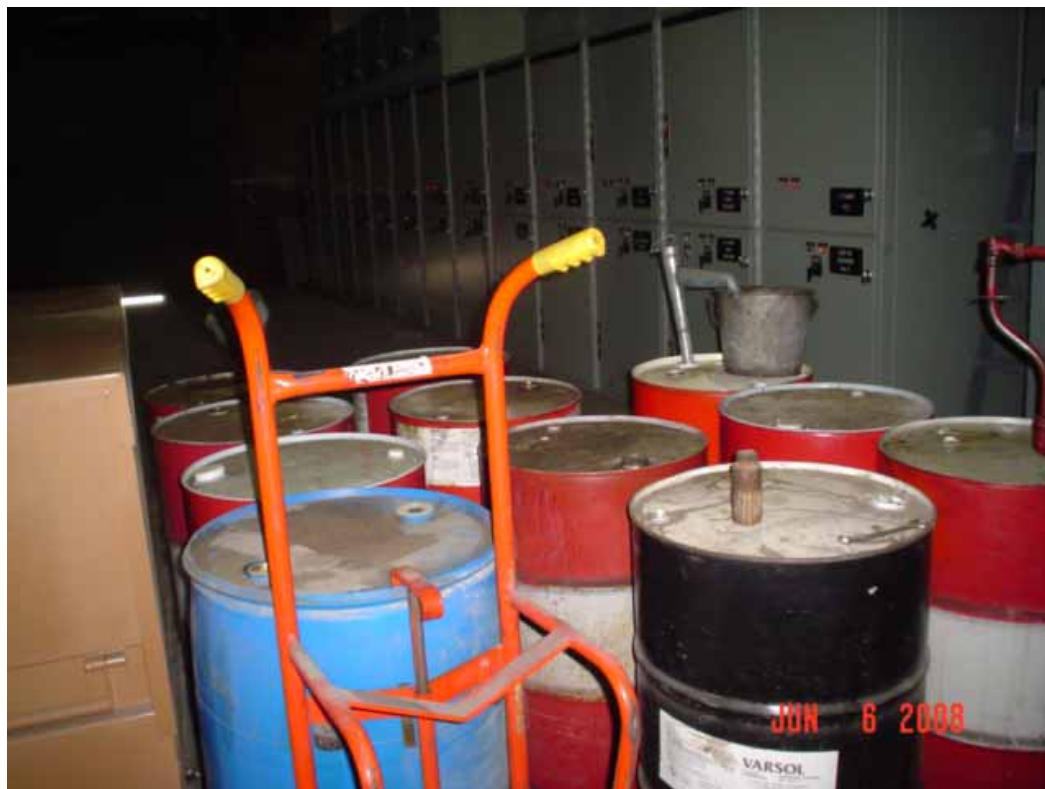
20. View of 55 gallon drums located inside pump building.

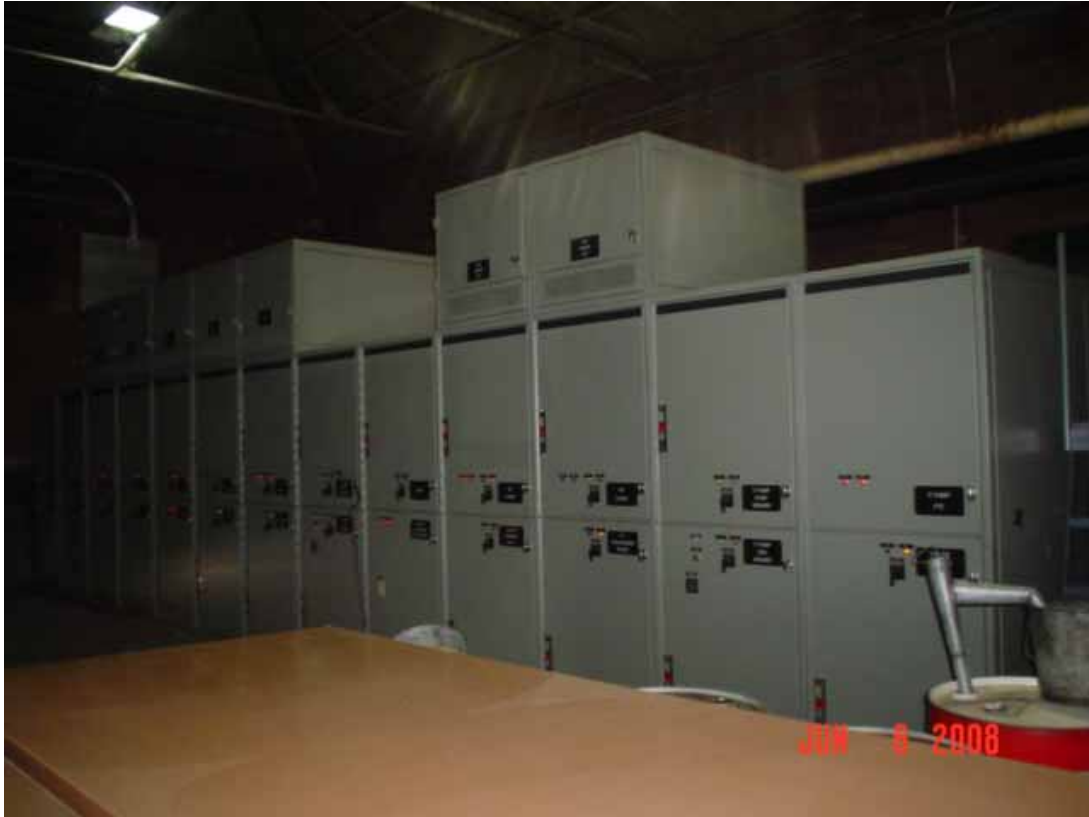
21. View of switches inside building.

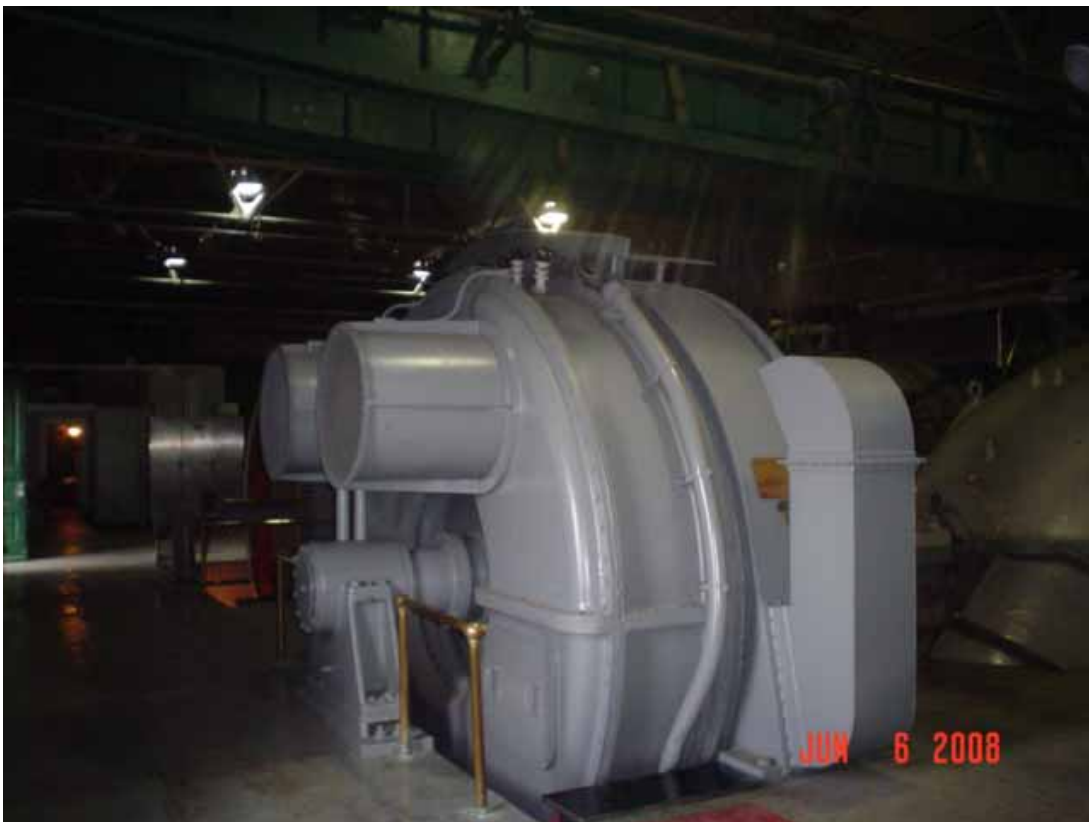
22. View of fully enclosed pump.

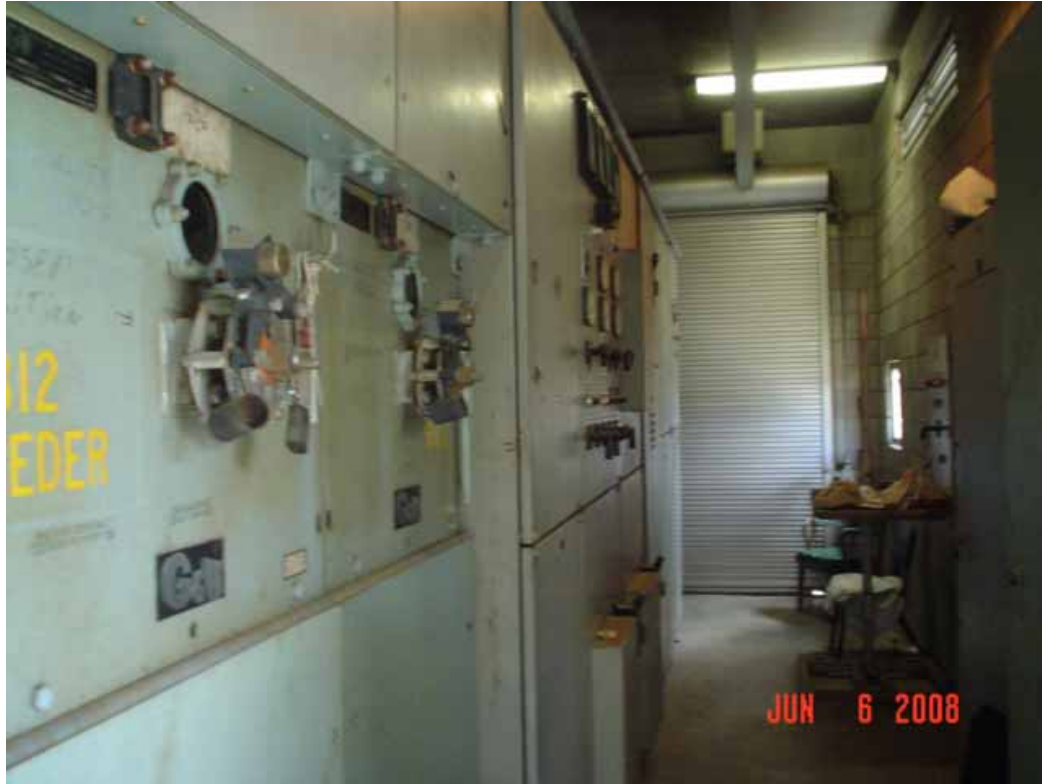
23. View of breakers.

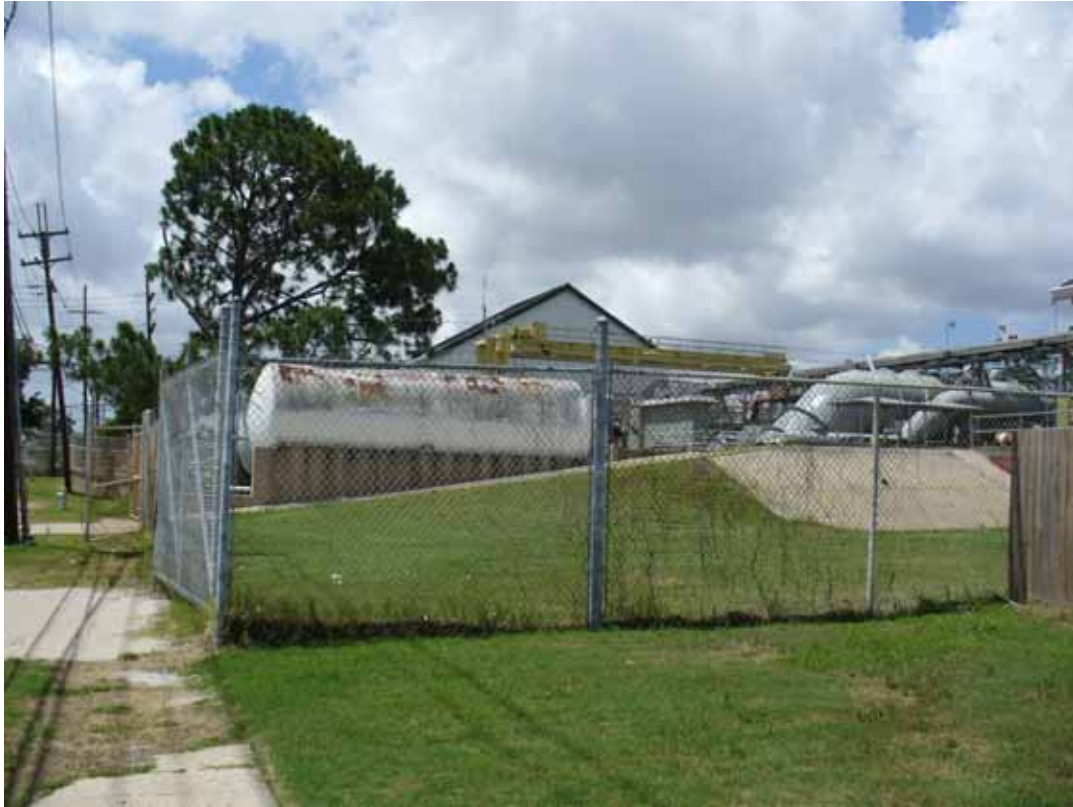
1. View of site as seen from the north direction. Observe abandoned chlorine AST's in foreground.

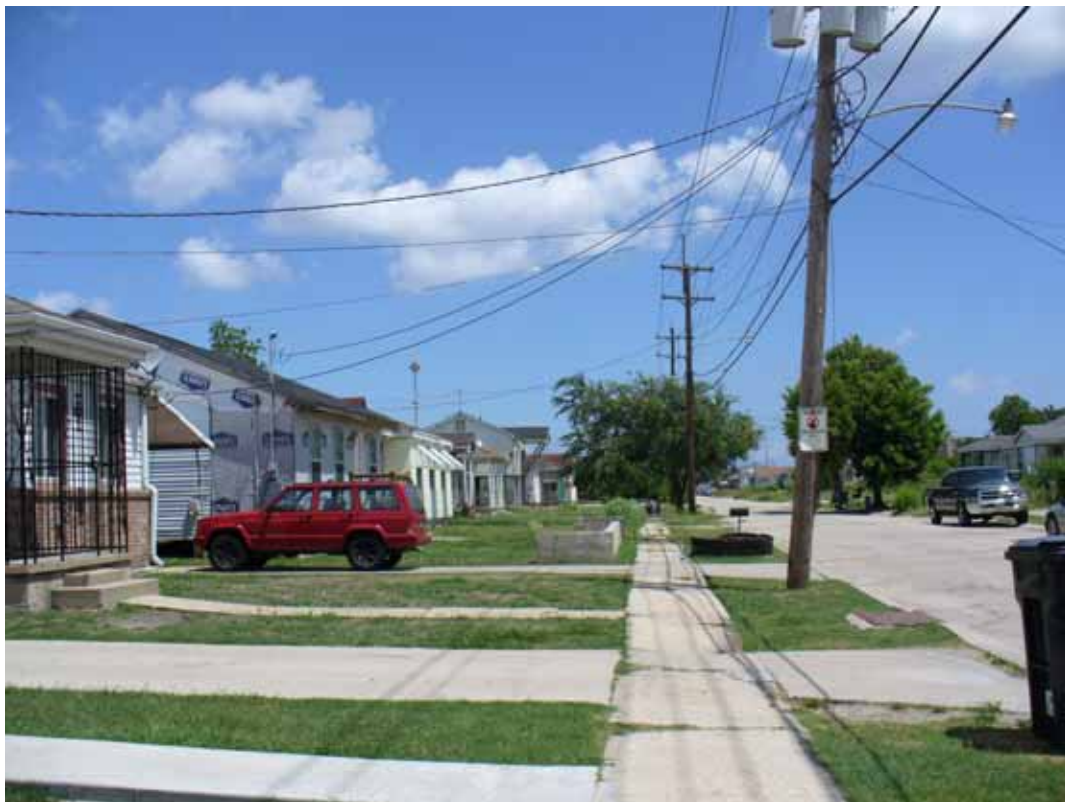
2. View of north area adjacent to the site, Warrington Drive, west side.

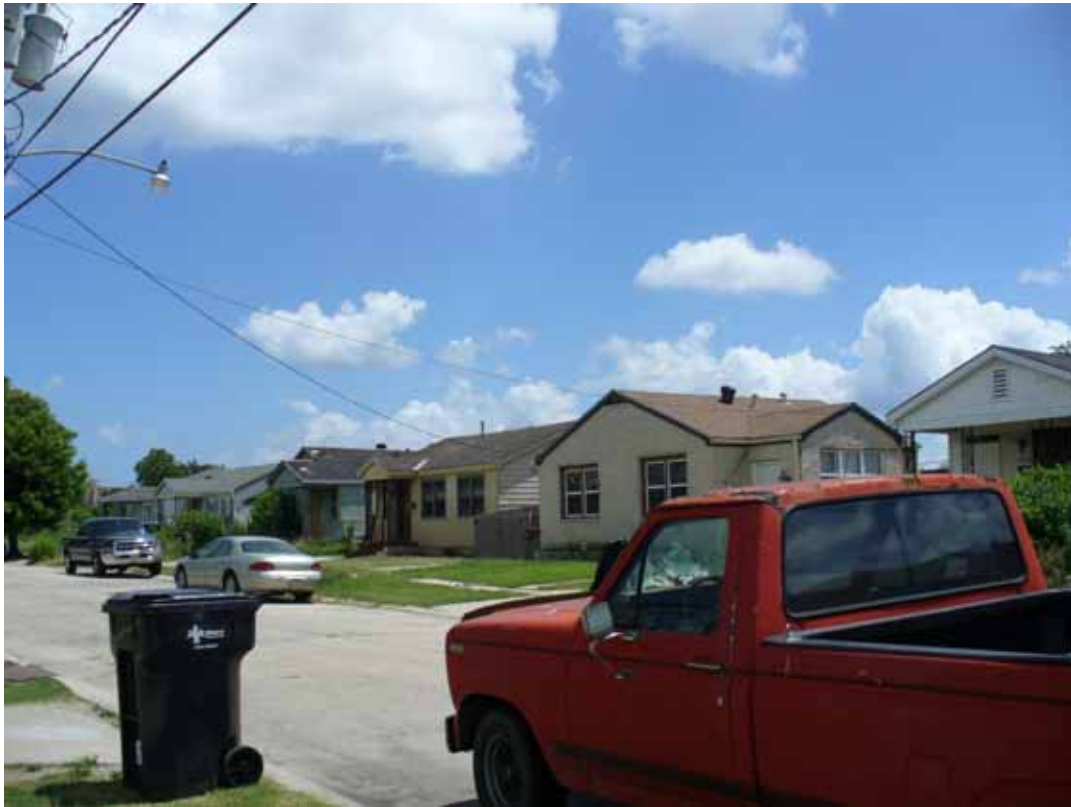
3. View of north area adjacent to the site, Warrington Drive, east side.

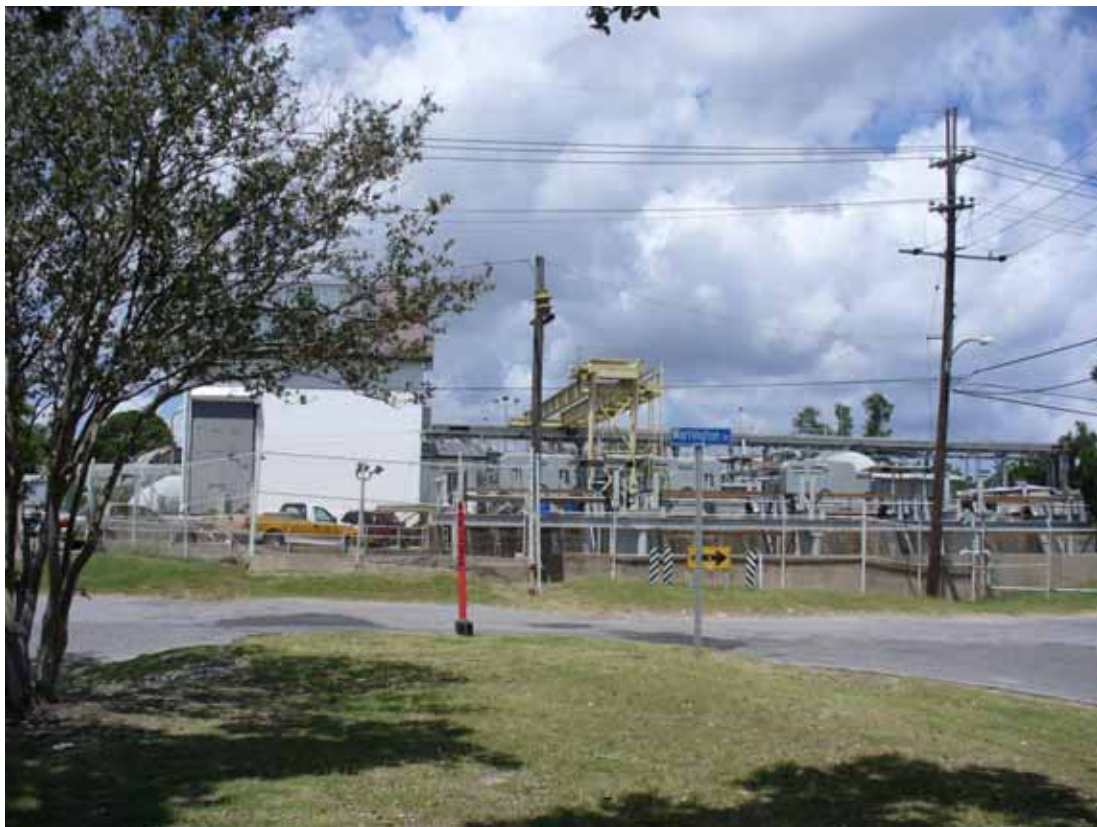
4. View of site as seen from the east direction.

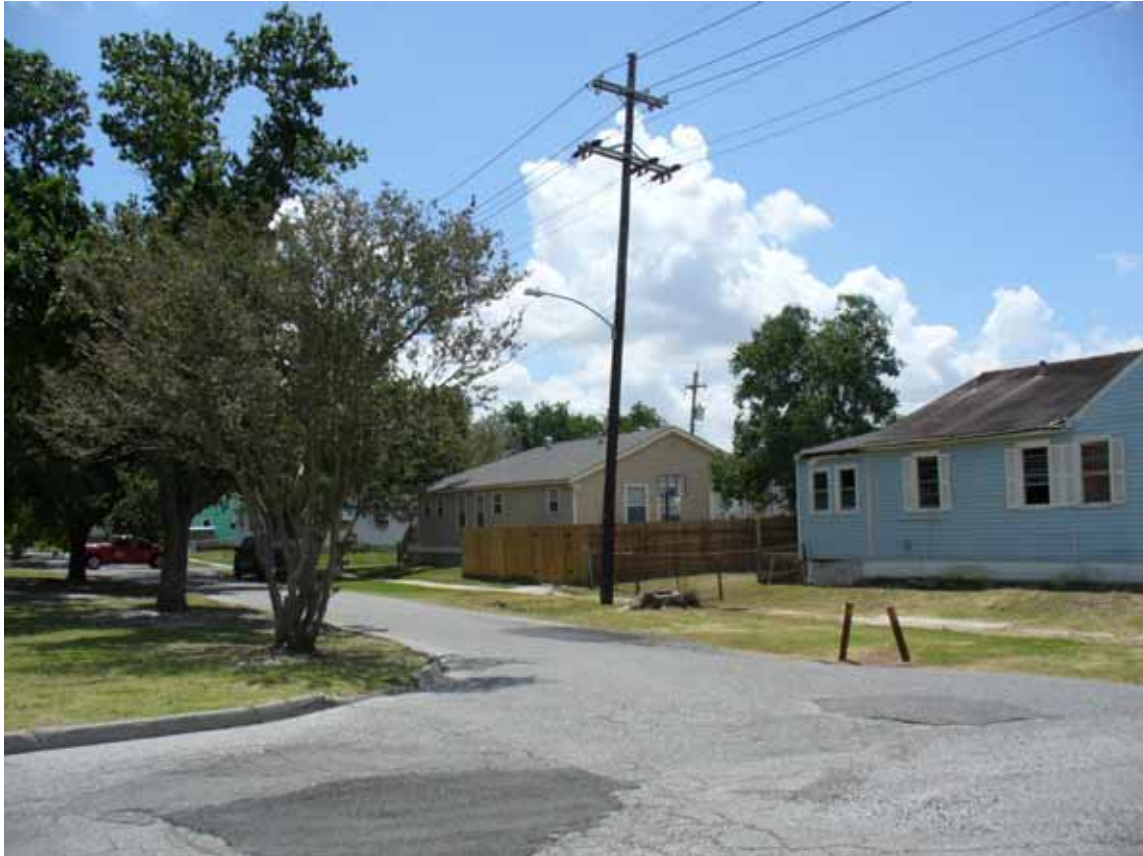
5. View of east area adjacent to the site, Warrington Drive.

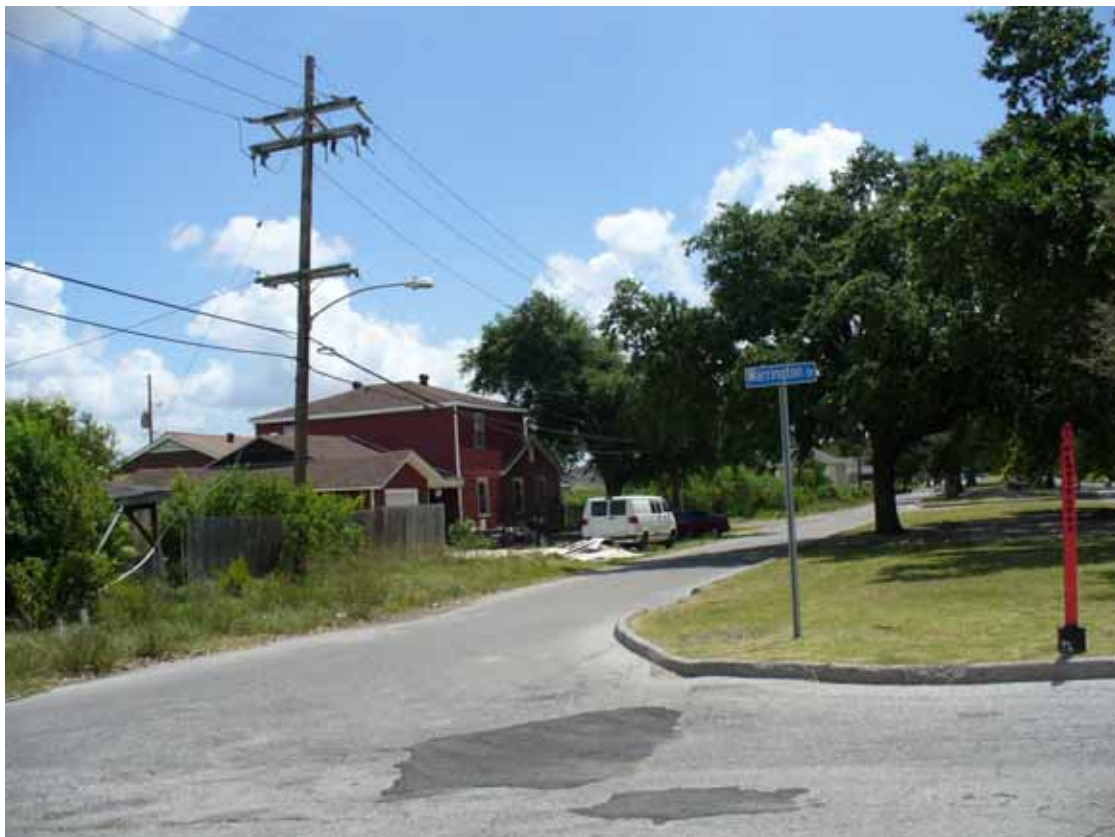
6. View of east area adjacent to the site, Prentiss Avenue.

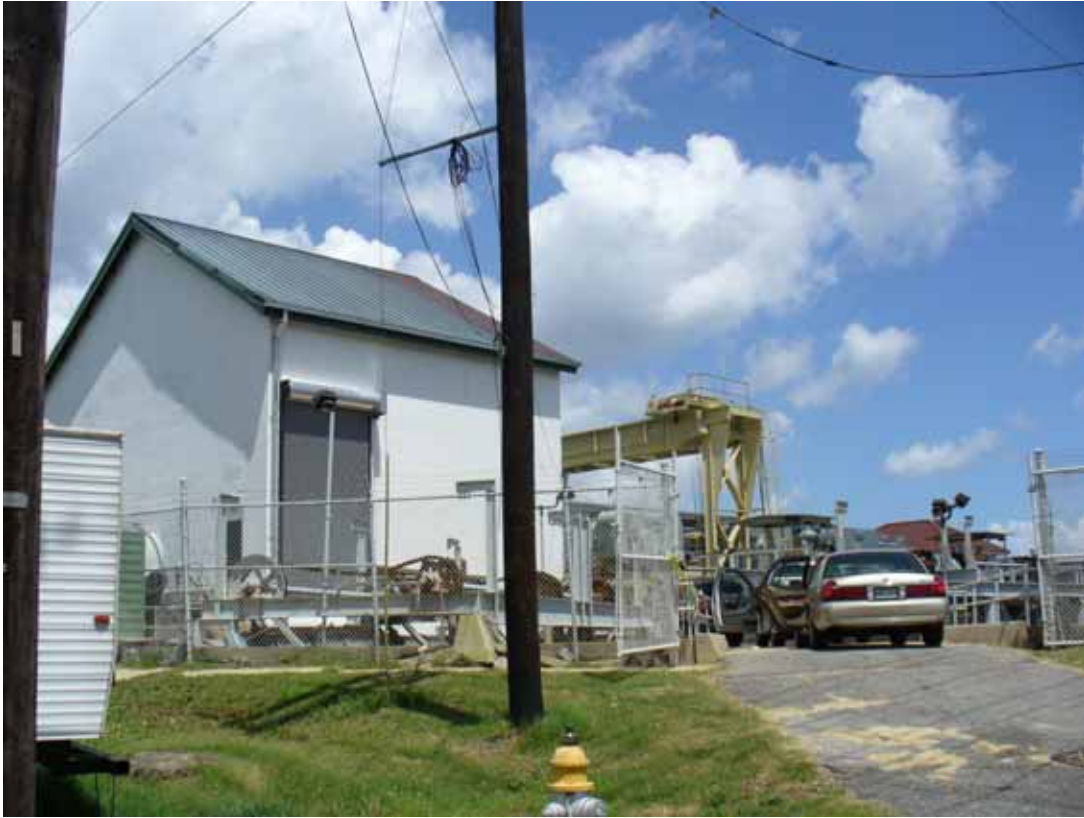
7. View of site as seen from the south direction.

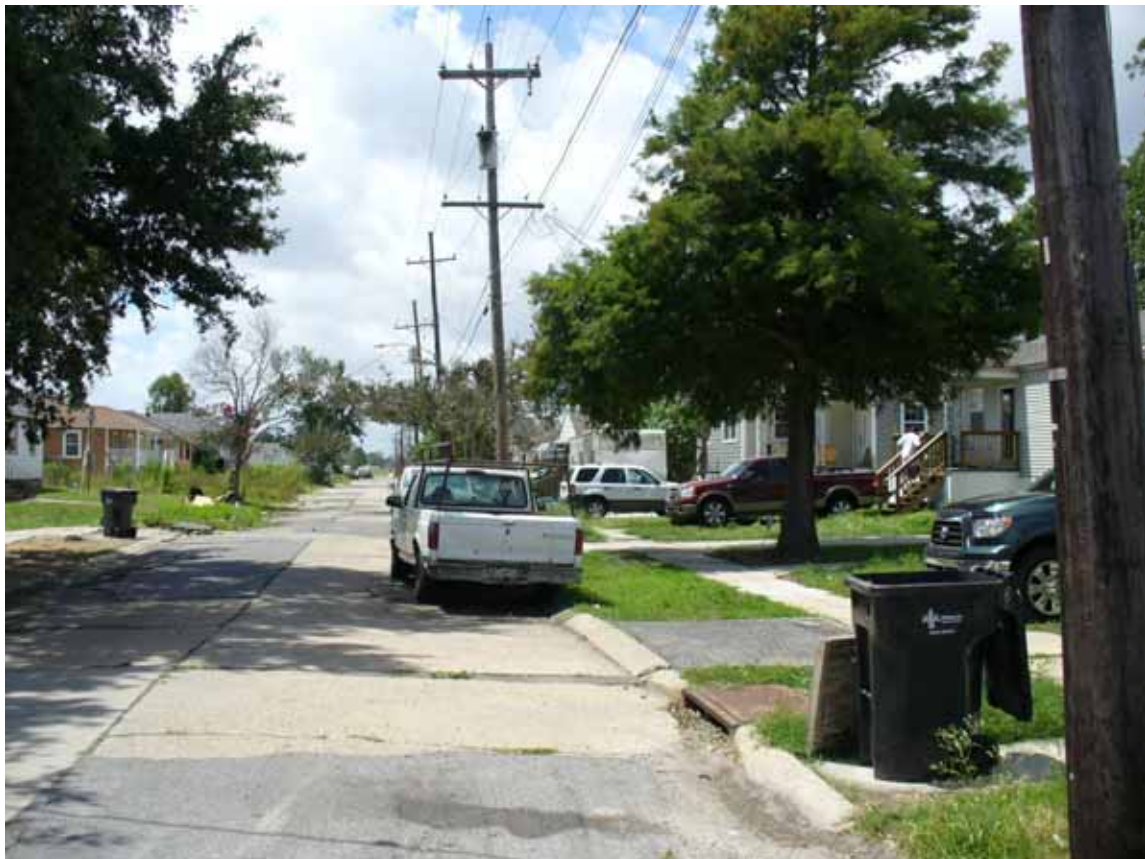
8. View of south area adjacent to the site, Warrington Drive, west side.

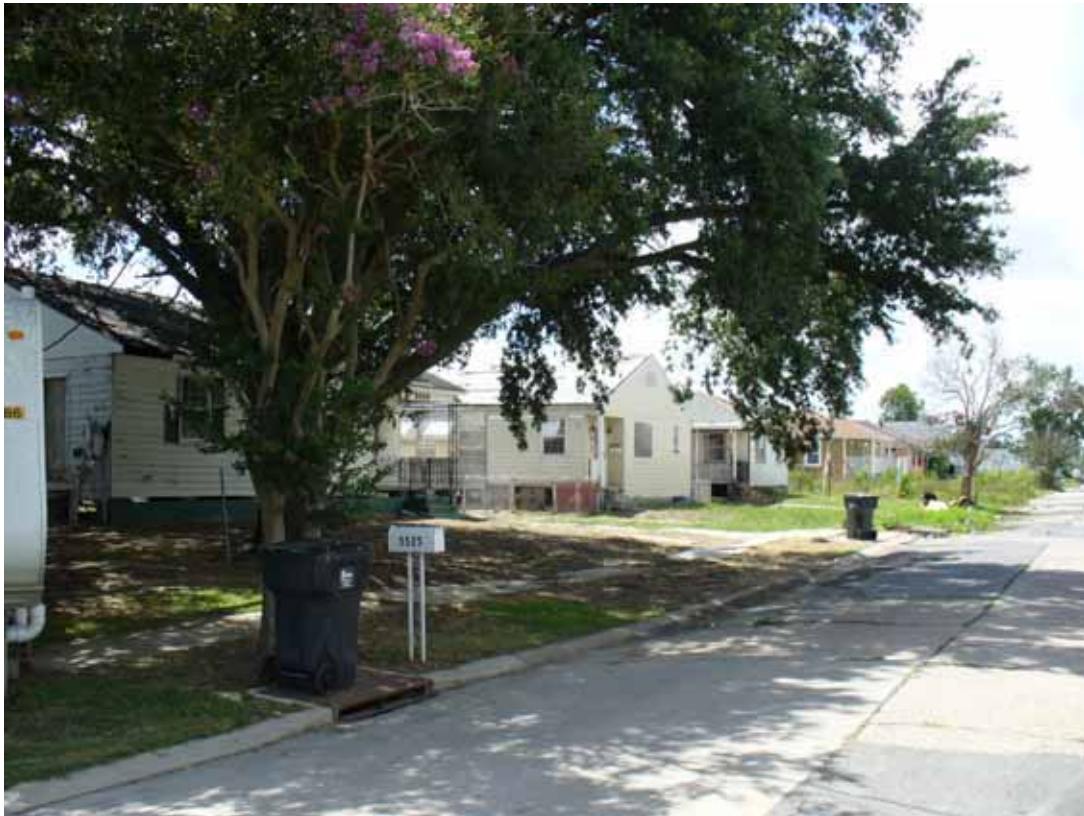
9. View of south area adjacent to the site, Warrington Drive, east side.

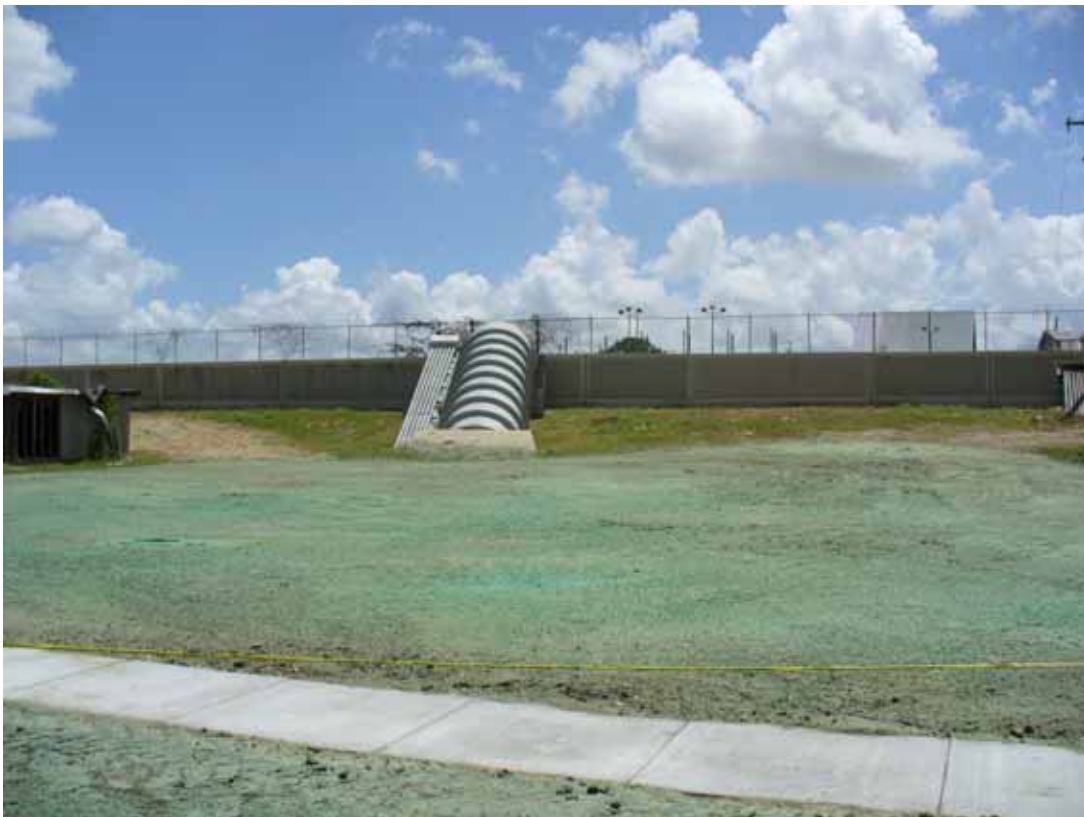
10. View of site as seen from the west direction, across canal.

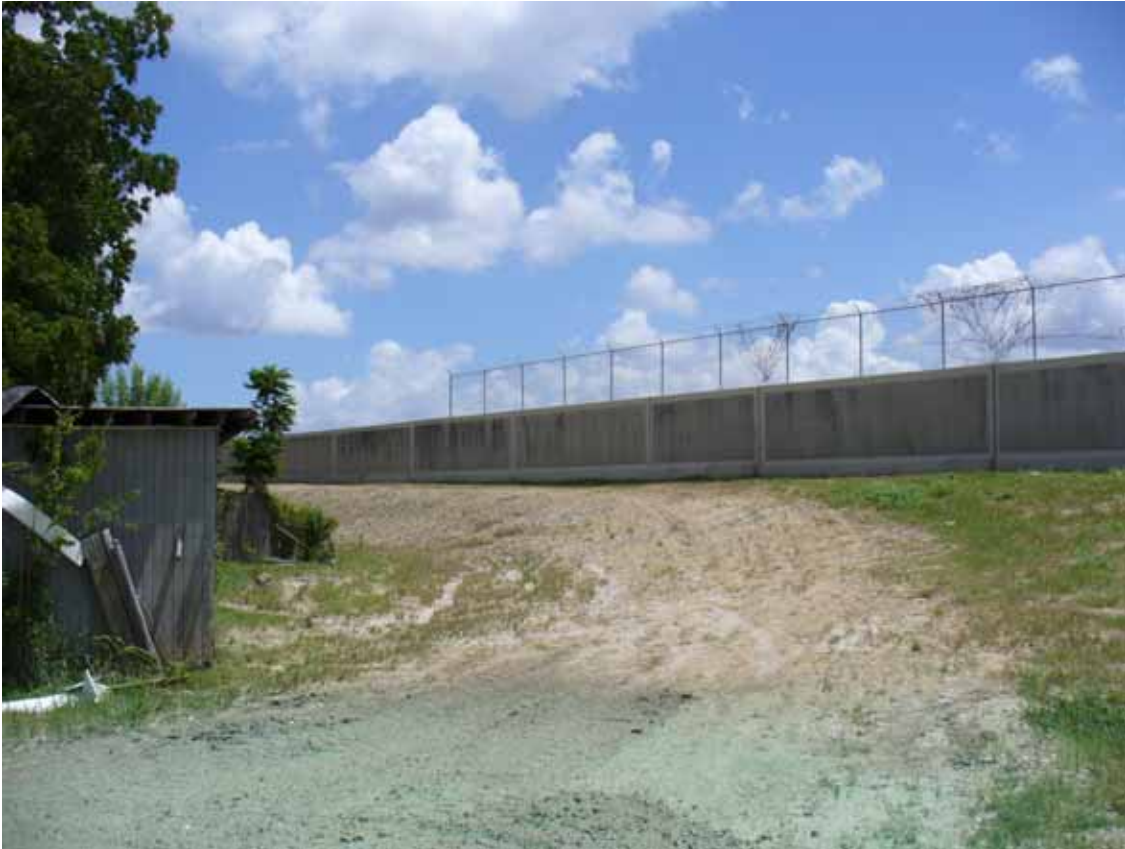
11. View of west area adjacent to the site.

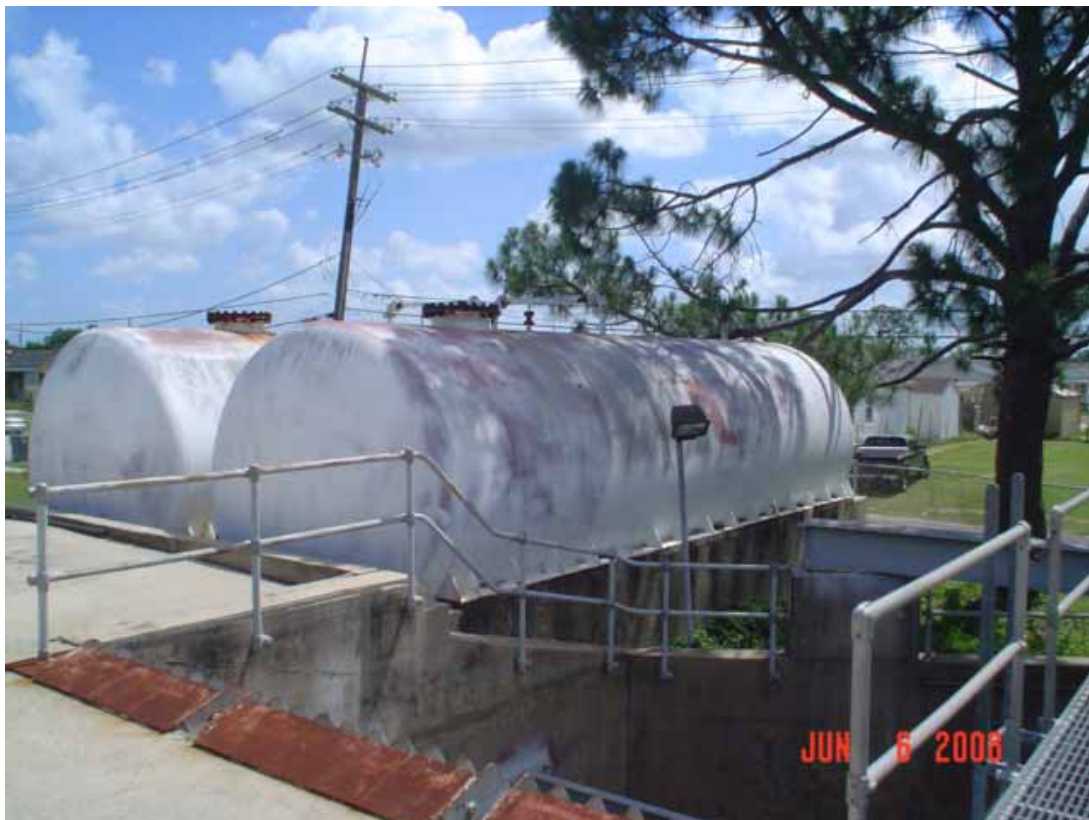
12. Abandoned chlorine storage tanks in northeast area.

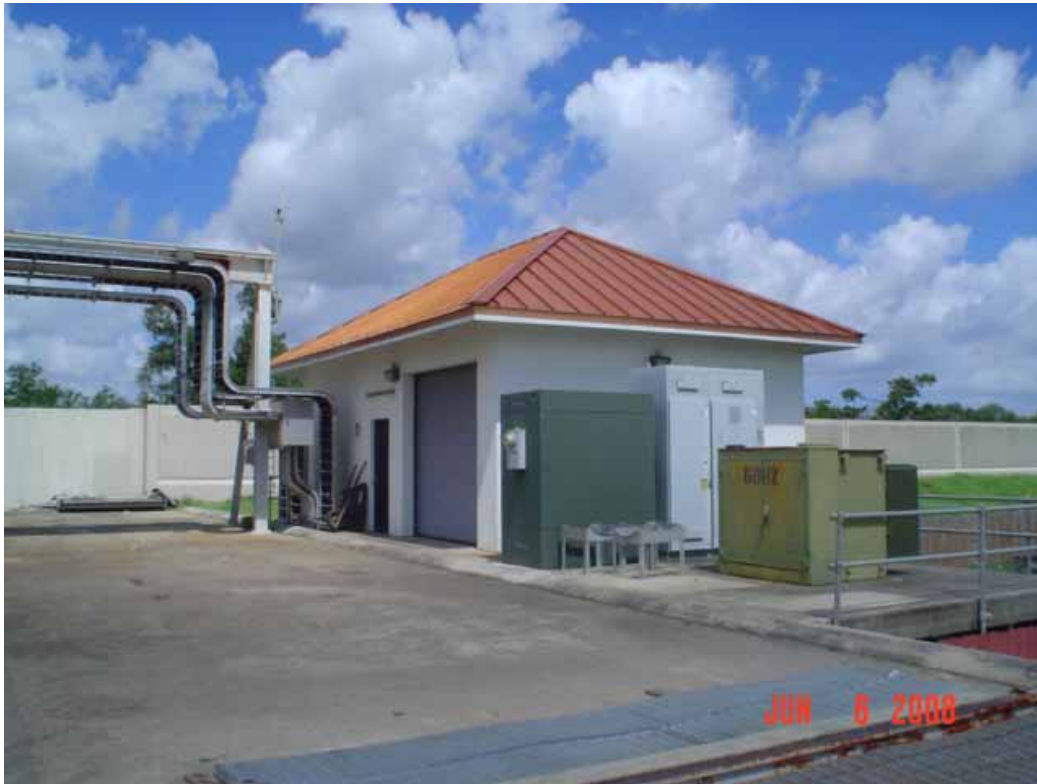
13. Transformers and small building on property.

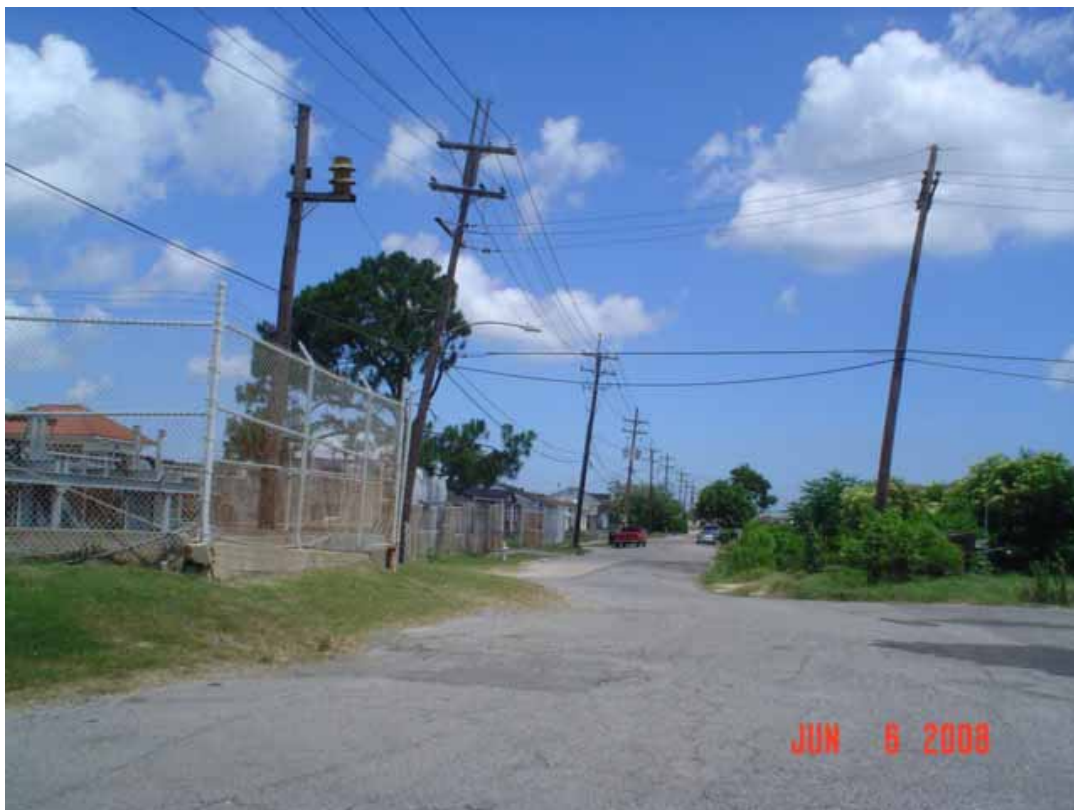
14. Transformers on Warrington Drive, north.

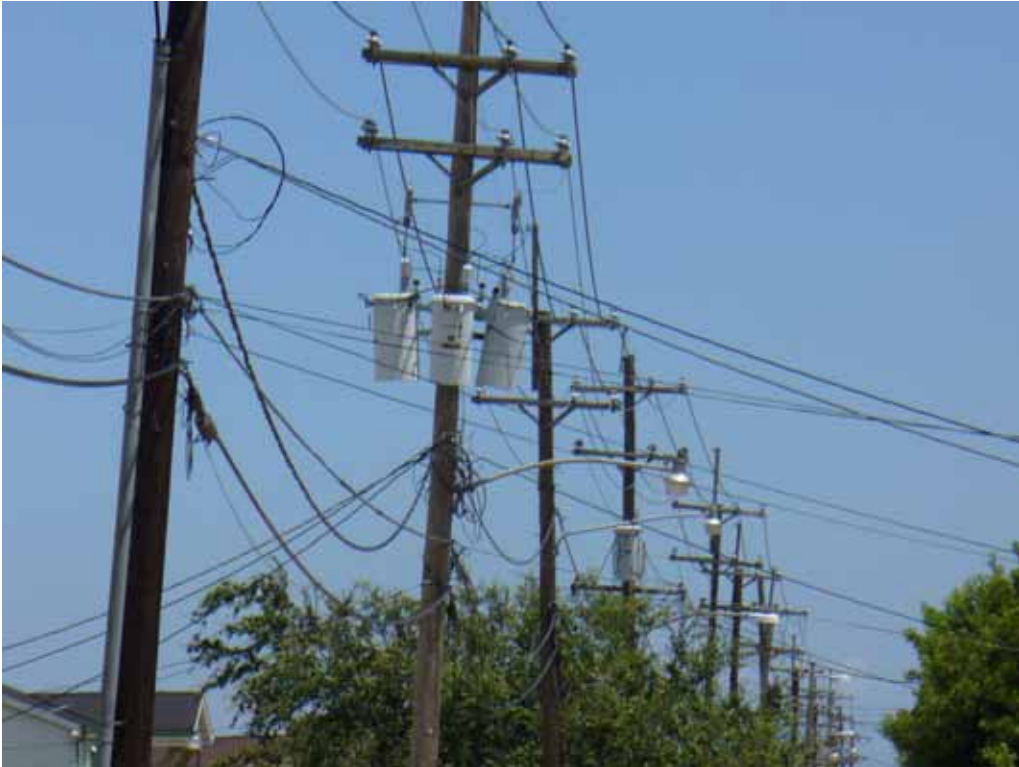
15. Transformers on Warrington Drive, south.

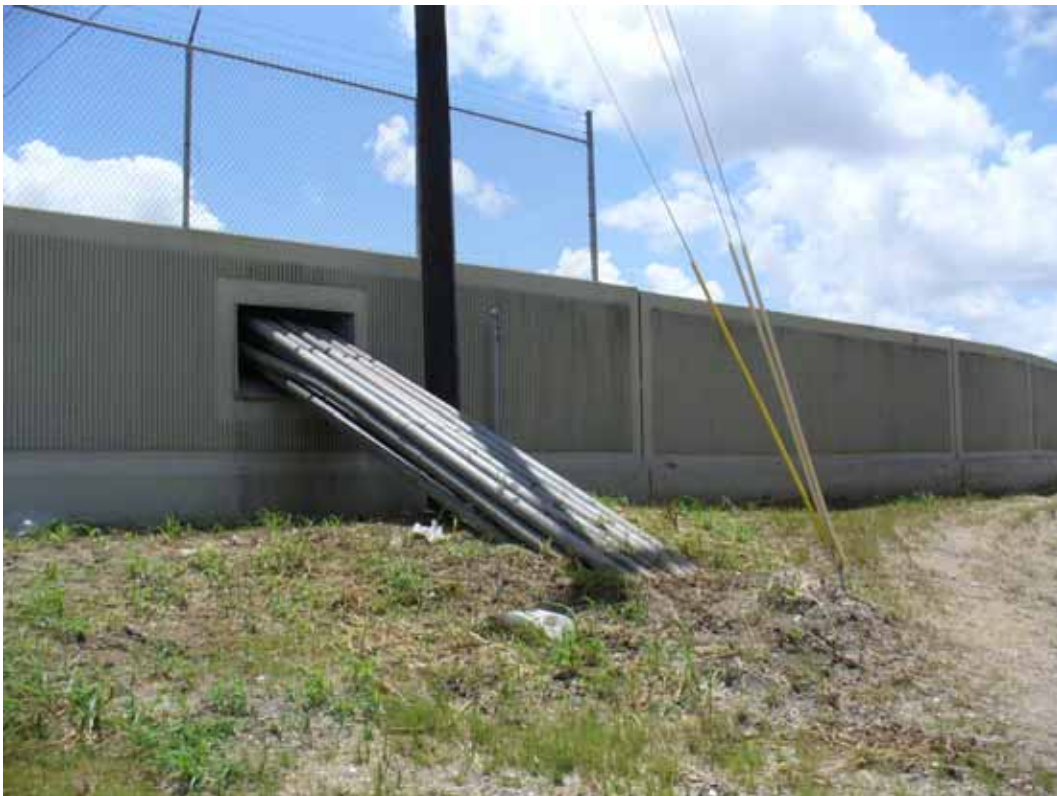
16. Electrical connections across canal, adjacent to Pratt Park.

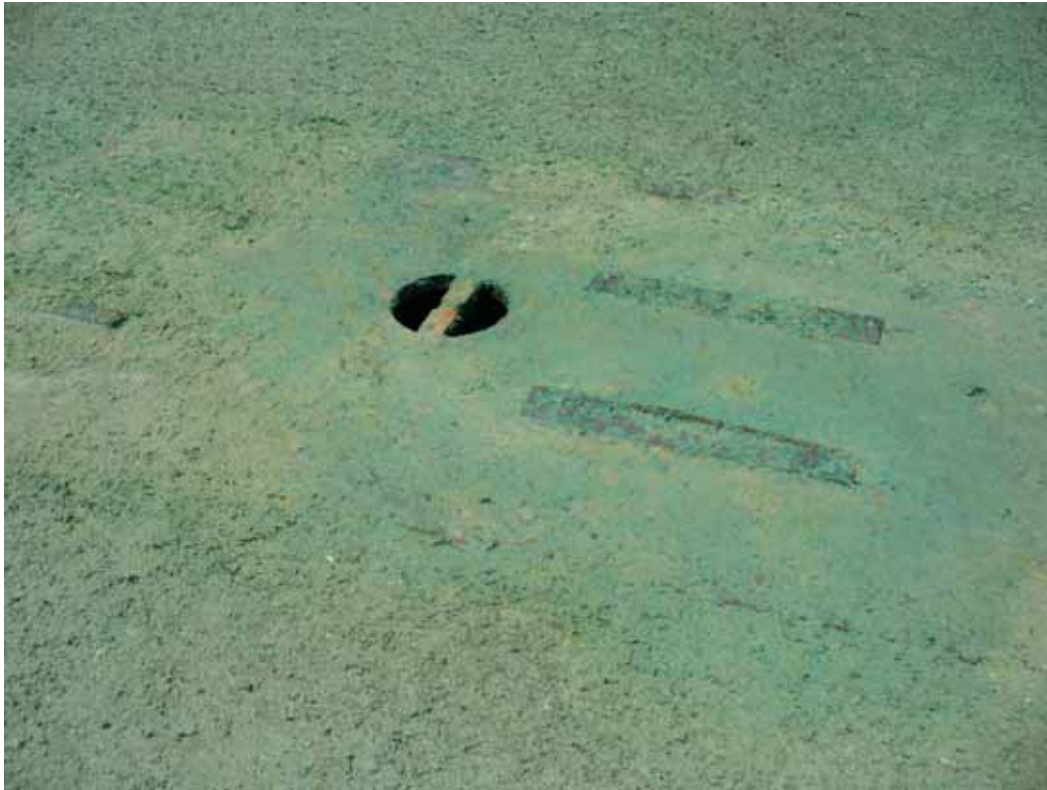
17. Large man-hole, pump drain access, across canal.

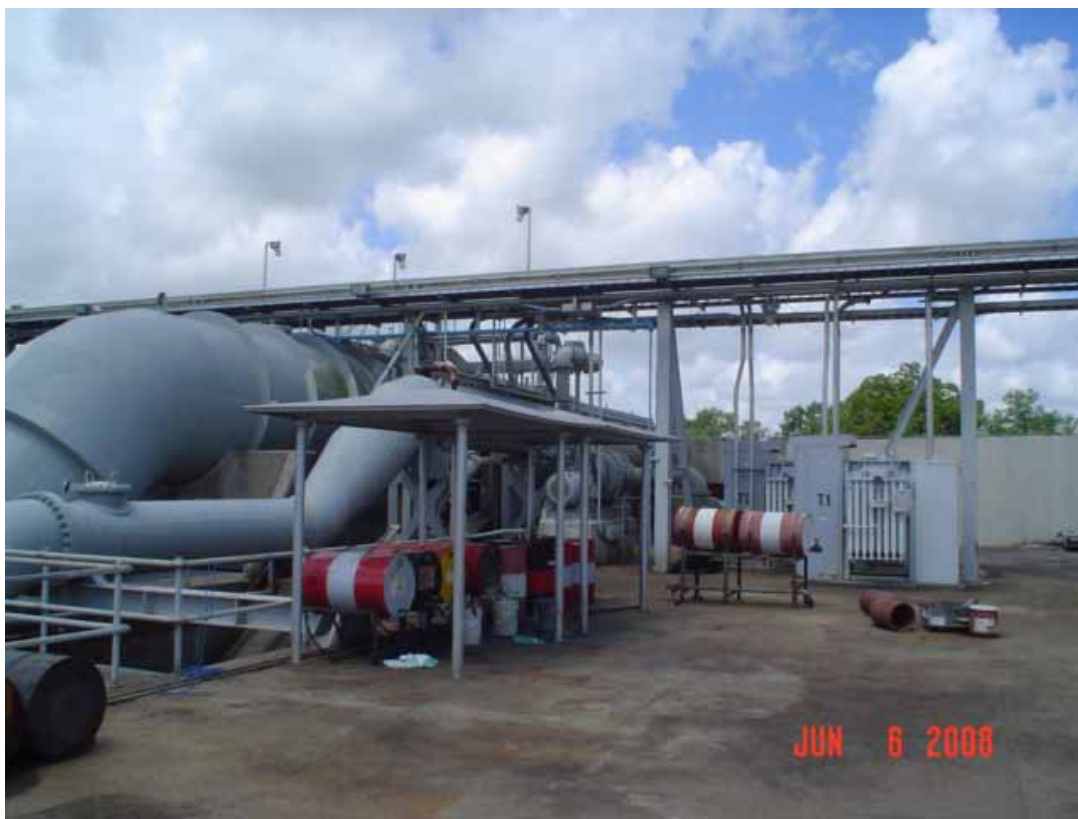
18. 55 gallon drums and pipeline on property, transformers in rear.

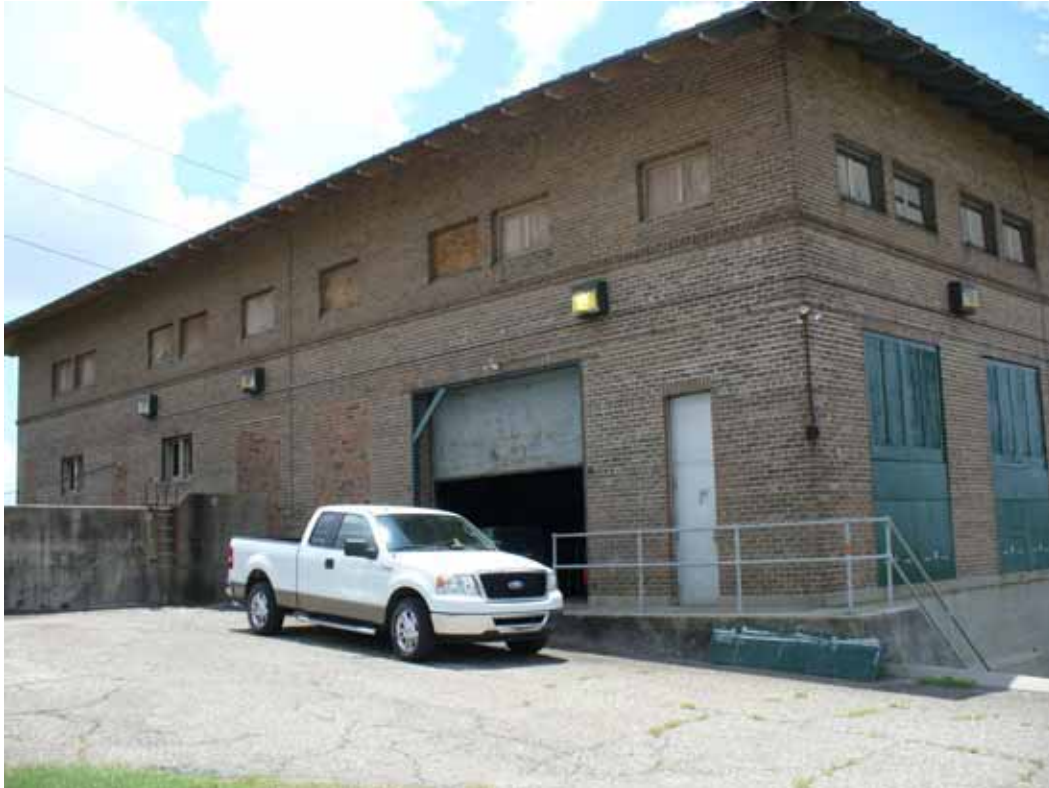
1. View of site as seen from the north direction.

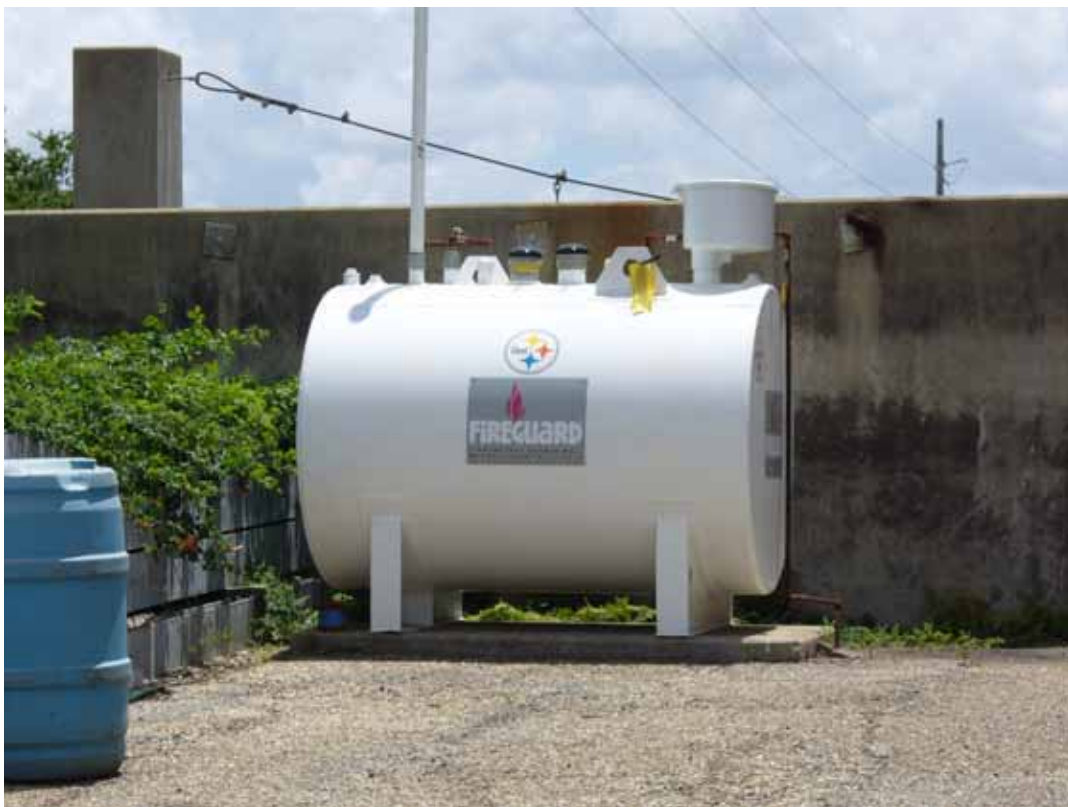
2. View of north area adjacent to the site, fuel tank, northeast corner on property.

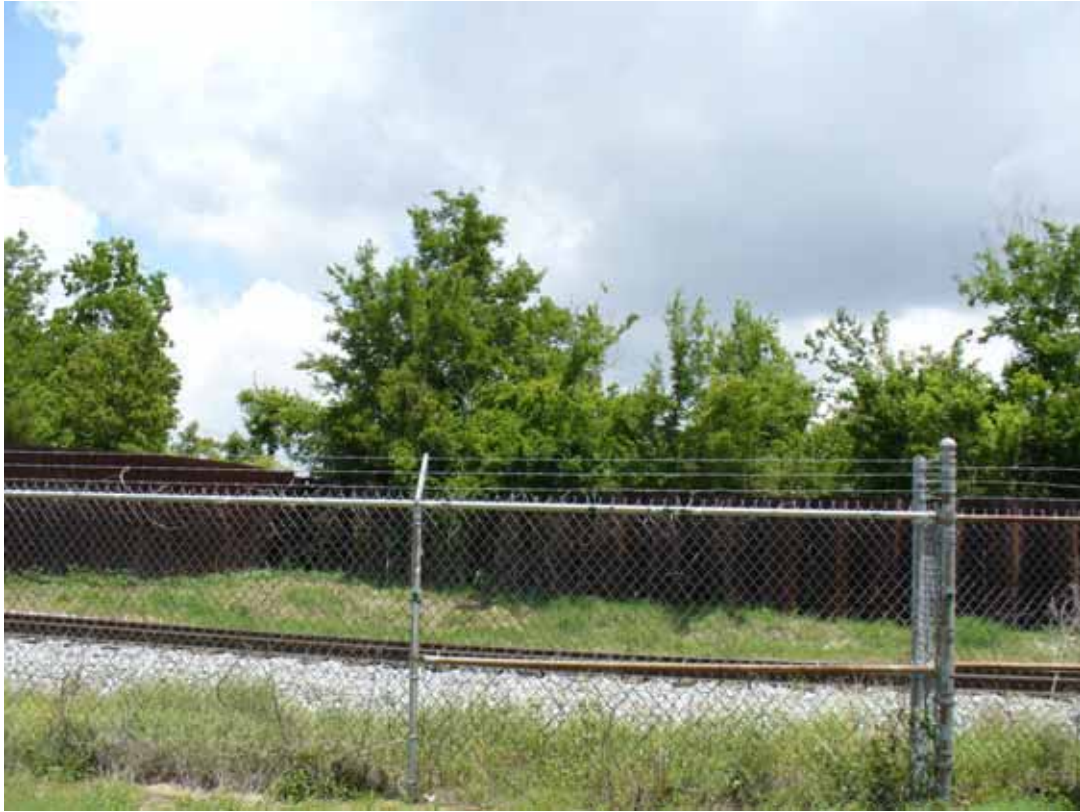
3. View of north area adjacent to the site, railroad tracks
