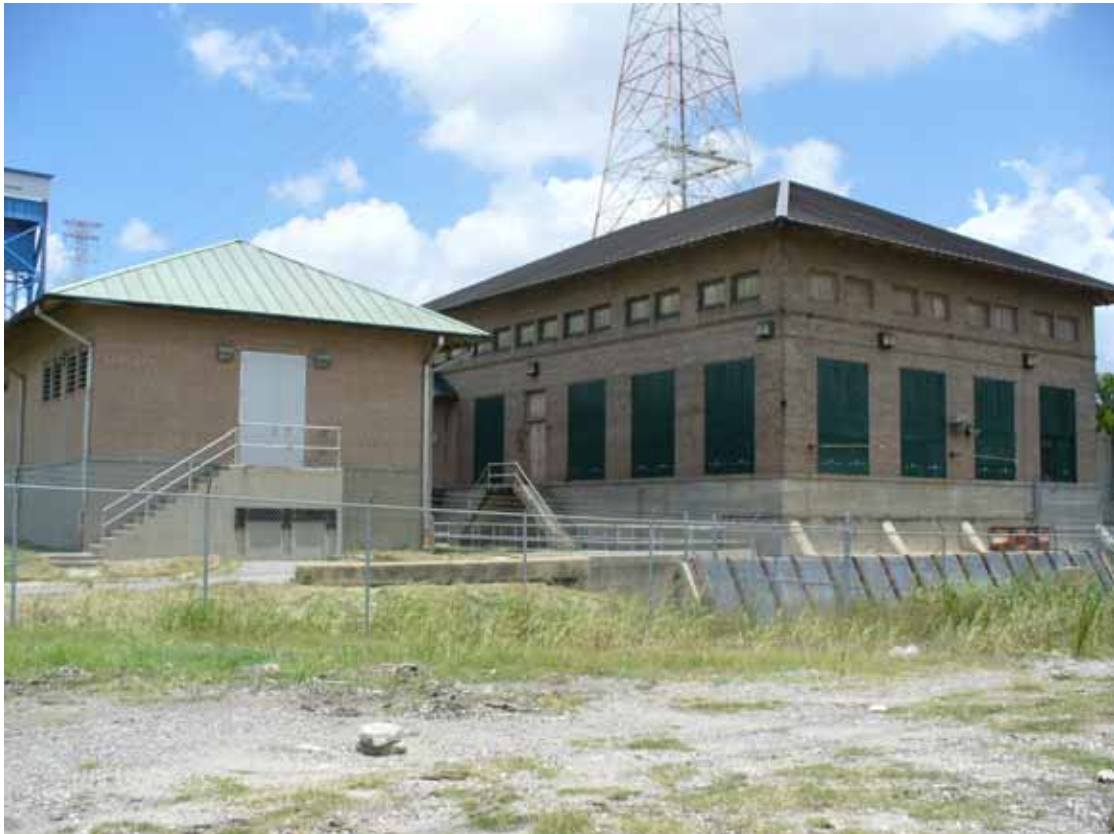
4. View of site as seen from the east direction.

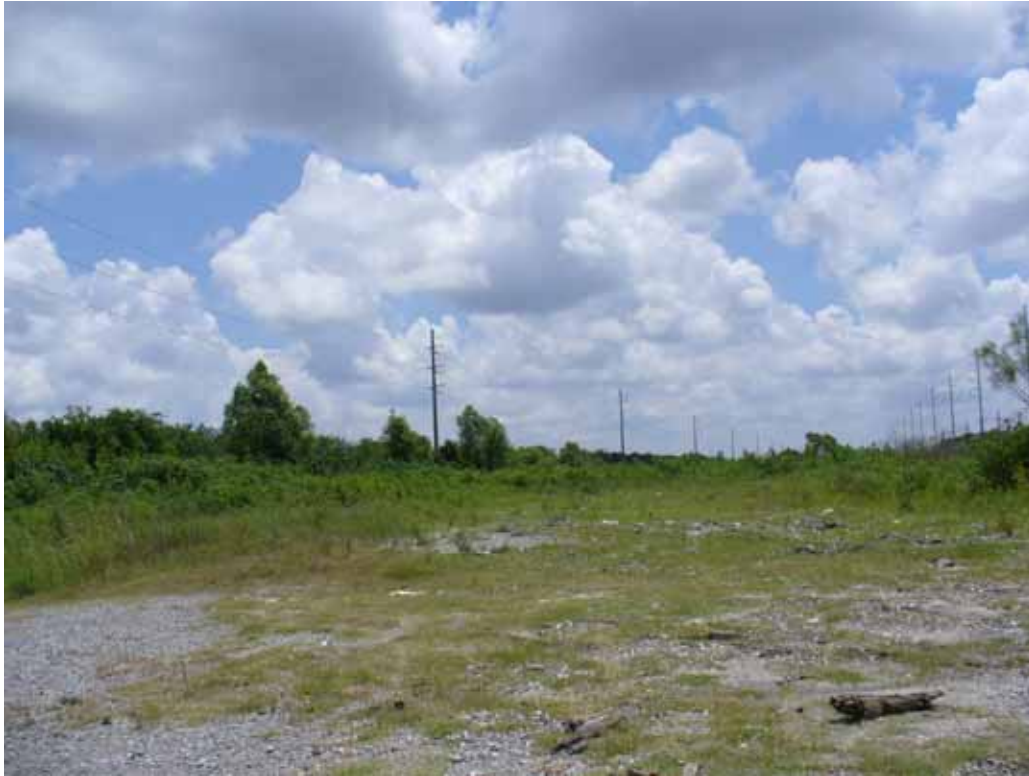
5. View of east area adjacent to the site, railroad tracks follow power poles on left of picture.

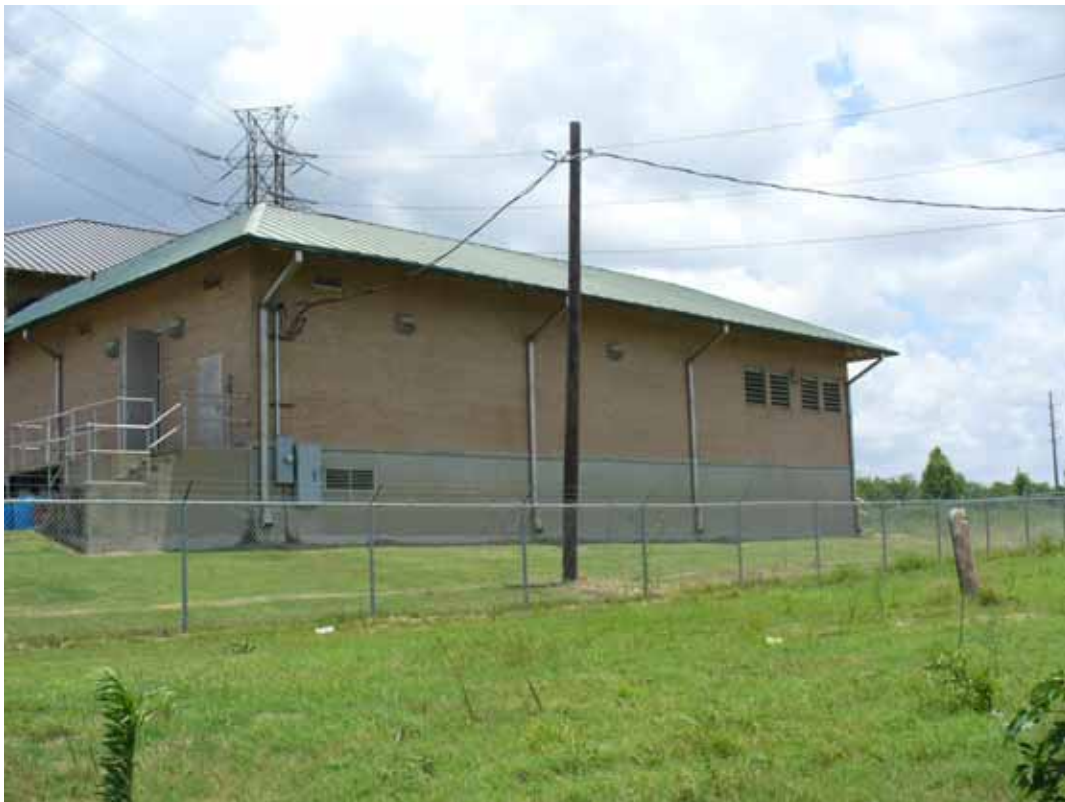
6. View of site as seen from the south direction.

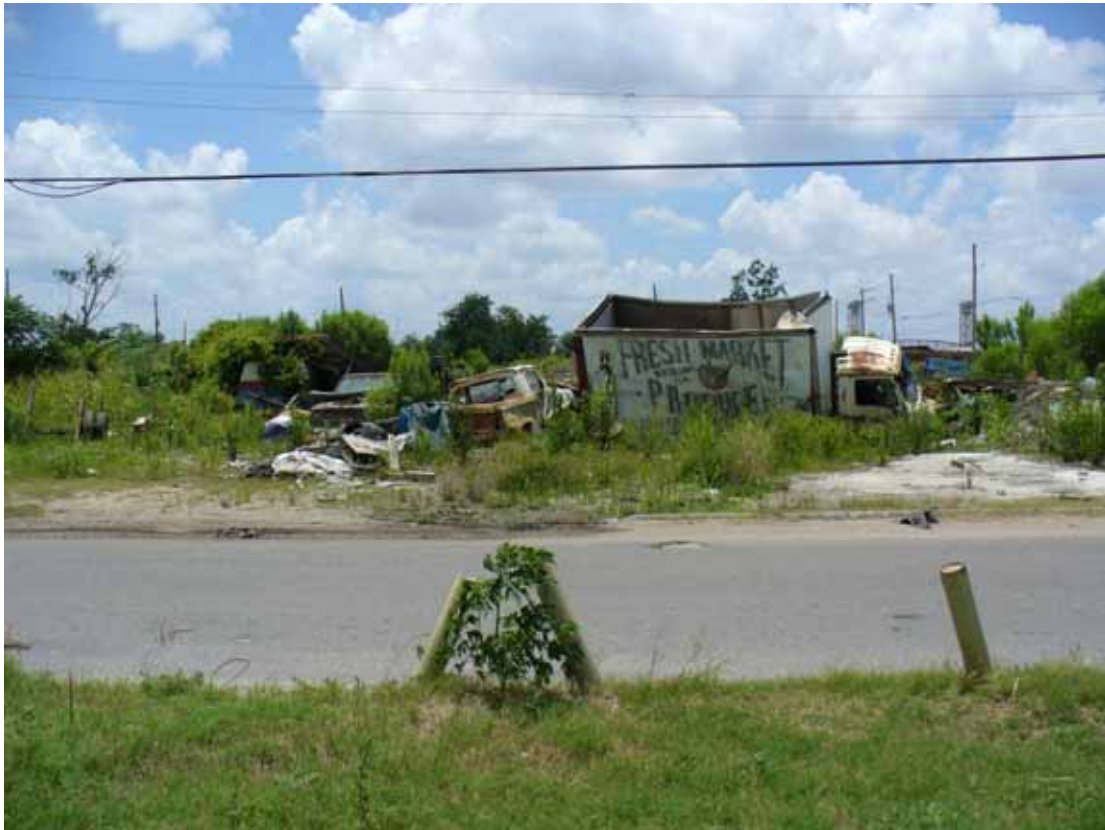
7. View of south area adjacent to the site.

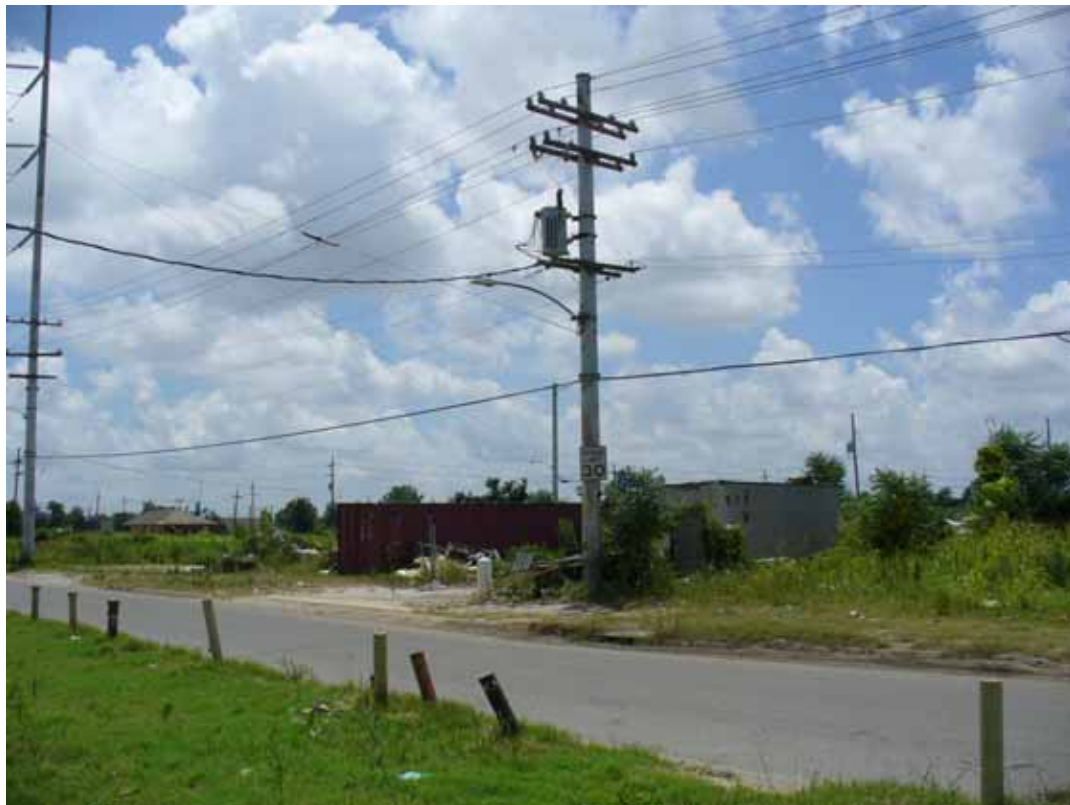
8. View of south area adjacent to the site including transformer, southeast corner.

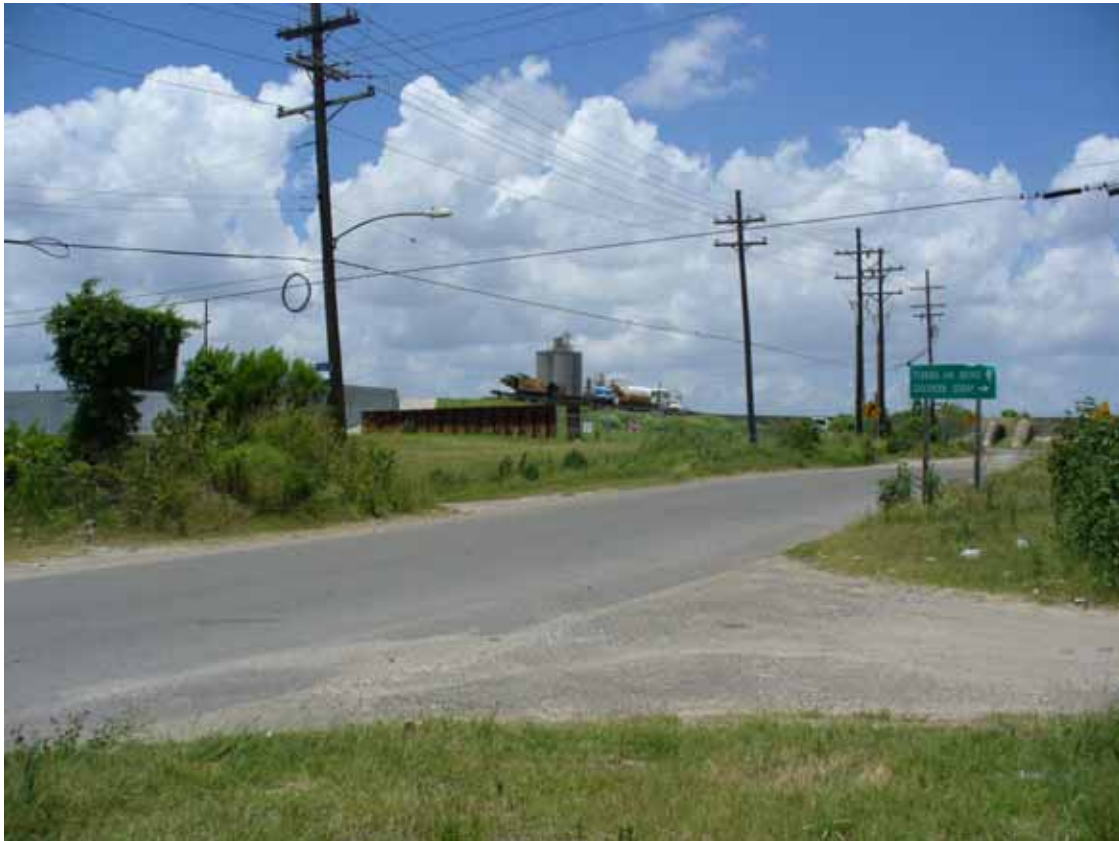
9. View of south area adjacent to the site including Southern Scrap, southwest corner.

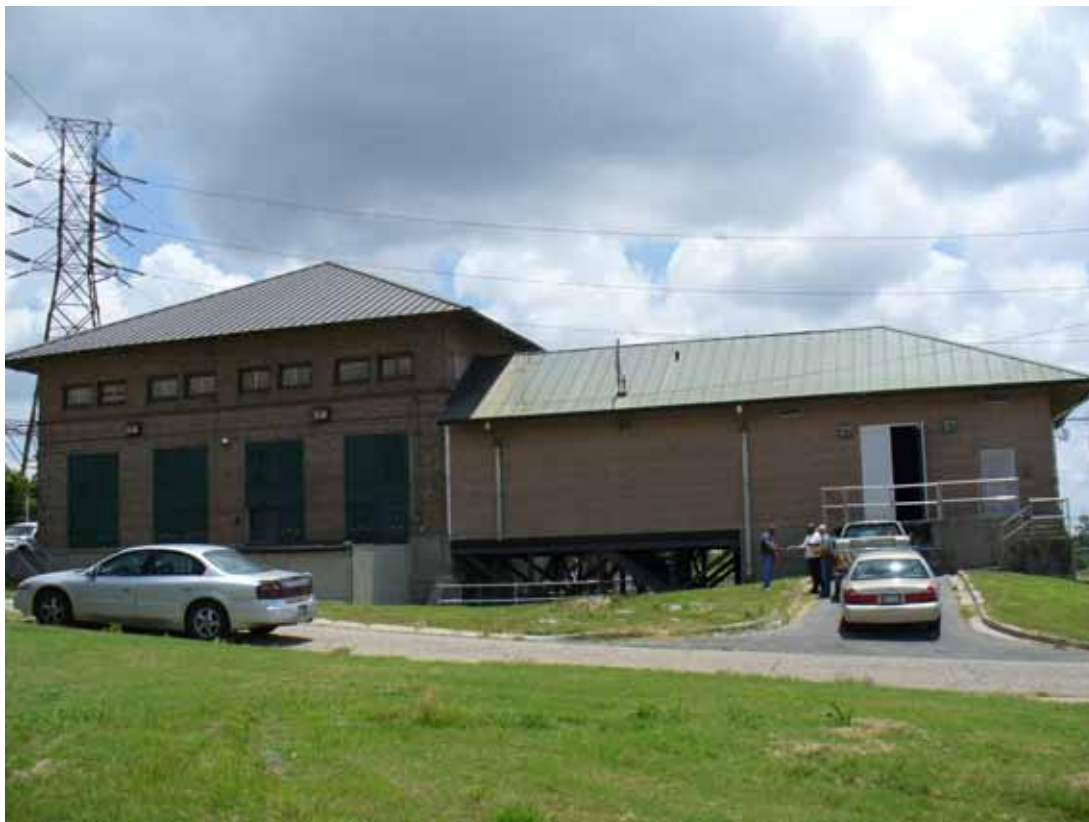
10. View of site as seen from the west direction.

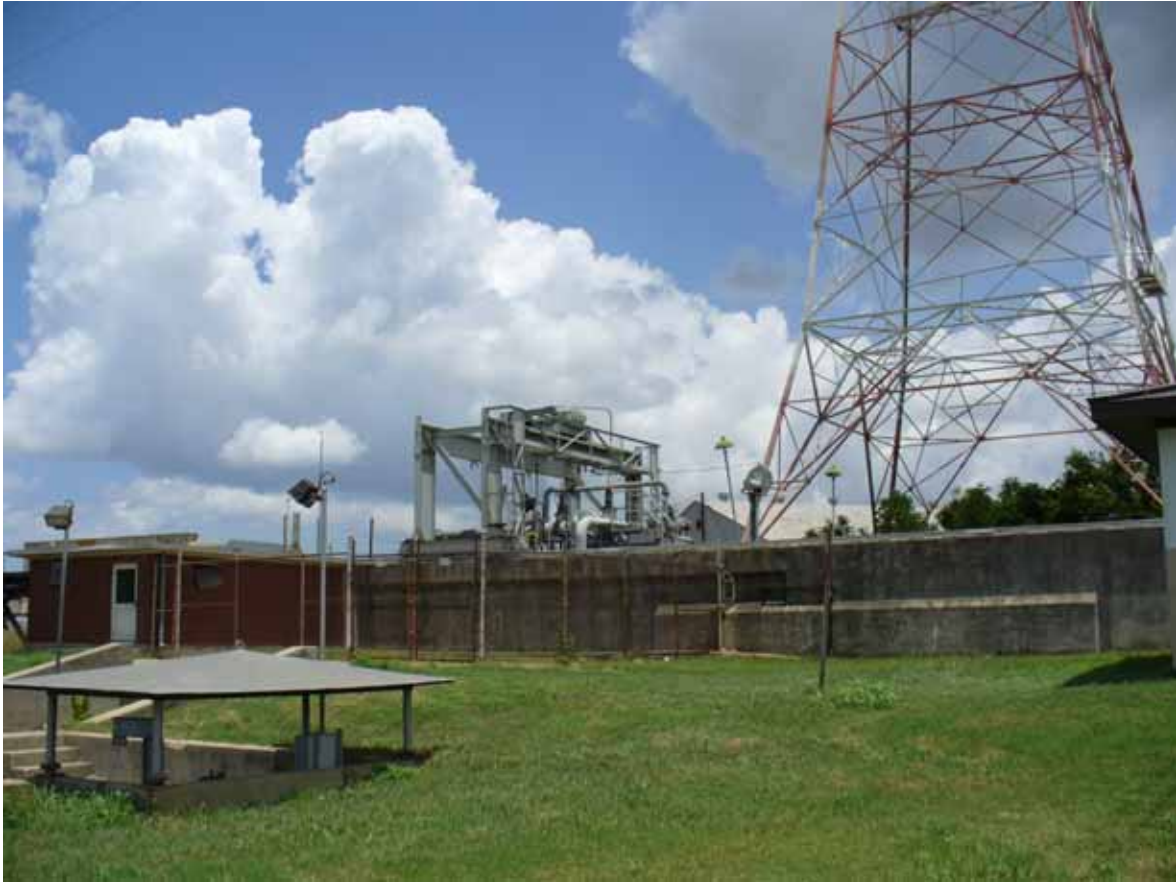
11. View of west area adjacent to the site, additional building and tower, northwest corner.

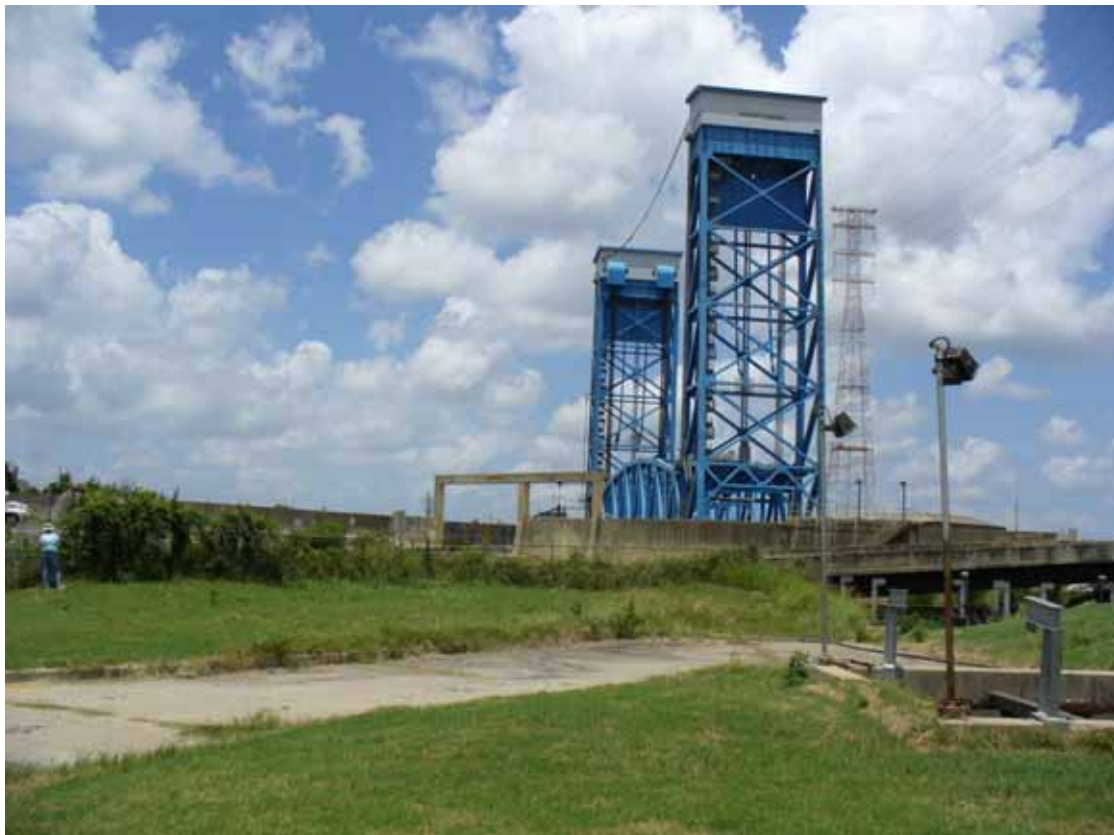
12. View of west area adjacent to the site, Florida Avenue Bridge, southwest corner.

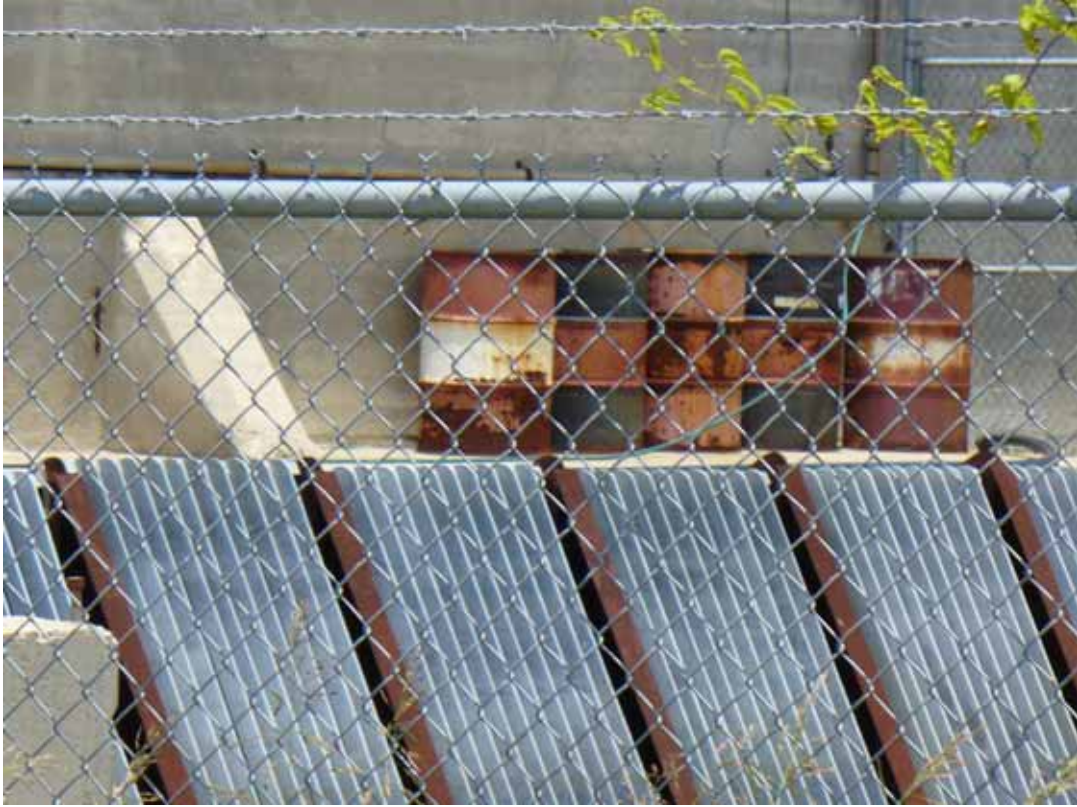
13. 55 gallon drums next to screens, east side of building.

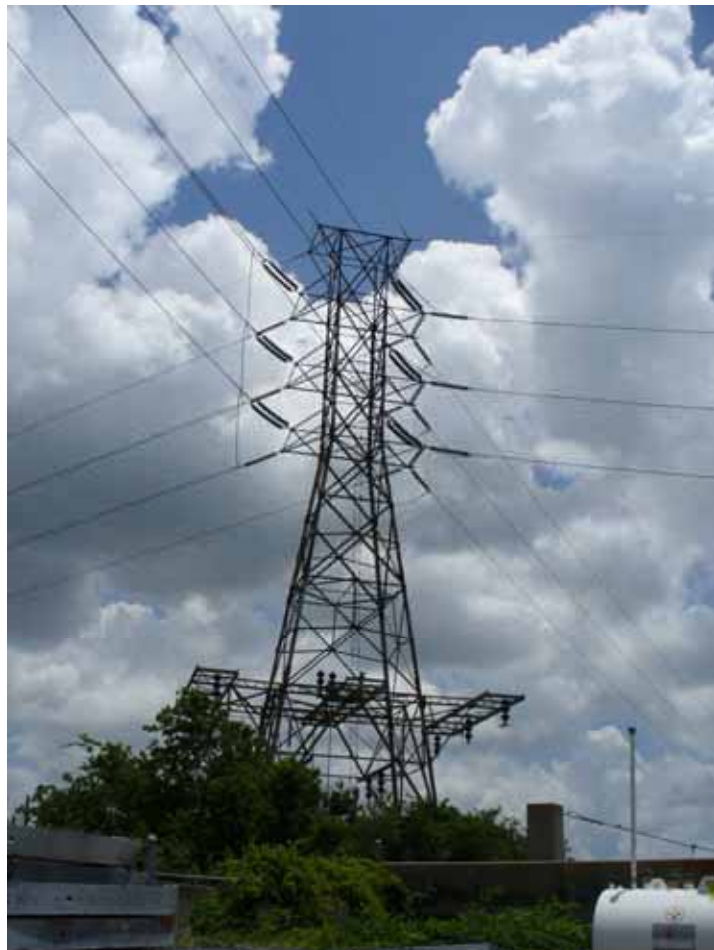
14. Tower, northwest corner.

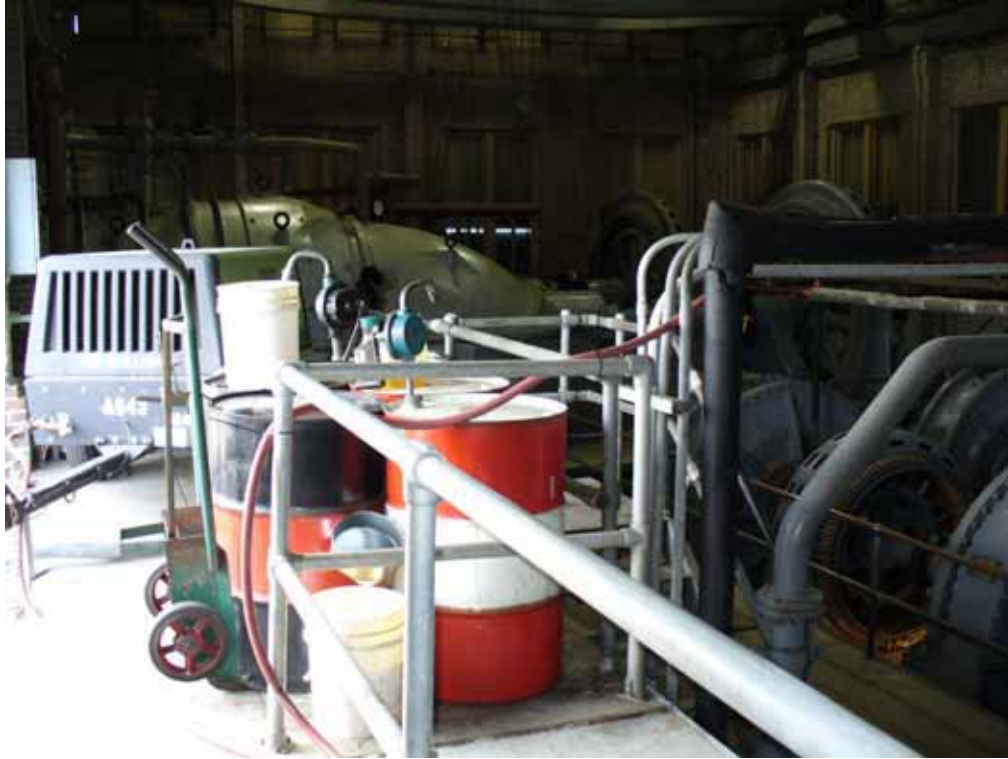
15. Drums and pumps inside building.

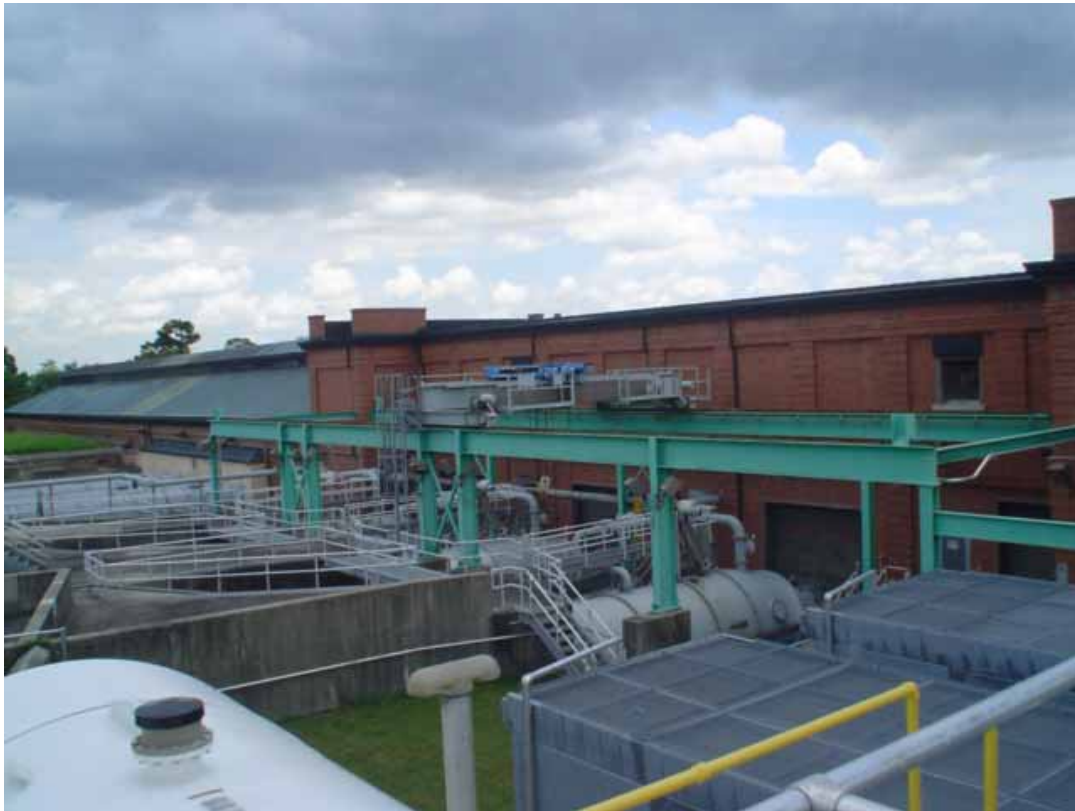
1. View of site as seen from the north direction.

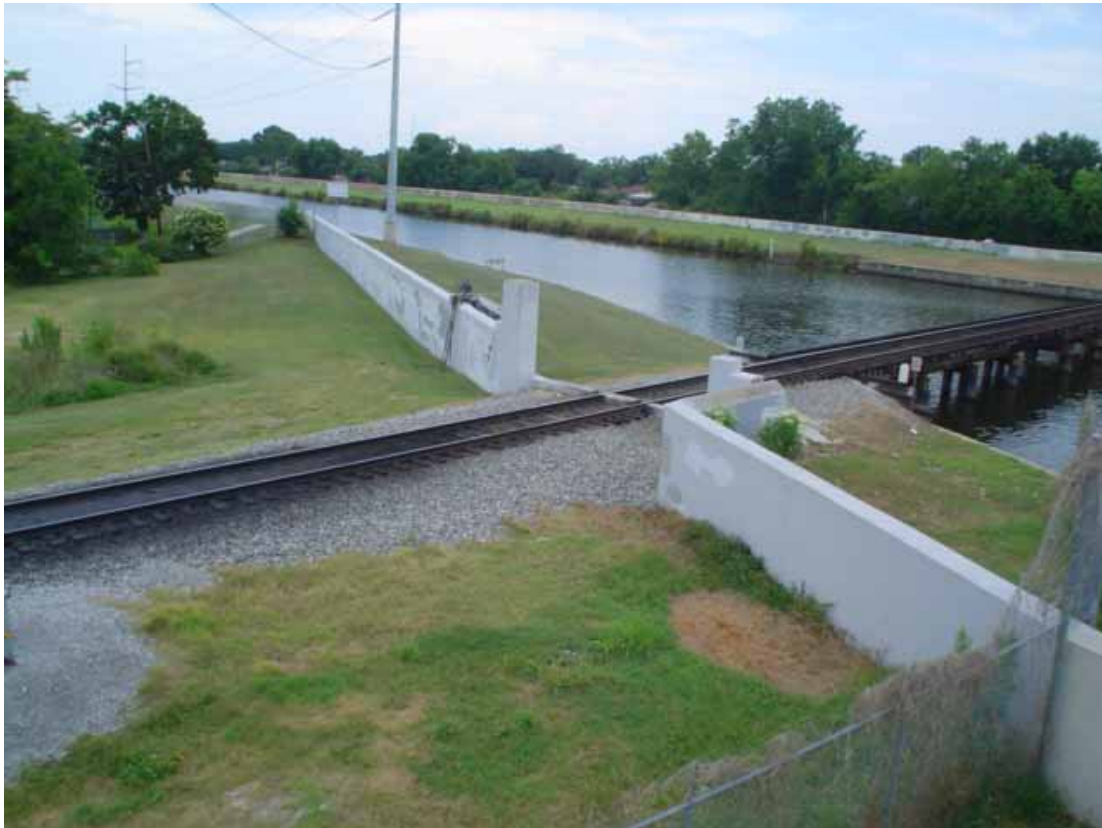
2. View of north area adjacent to the site, 17th Street canal.

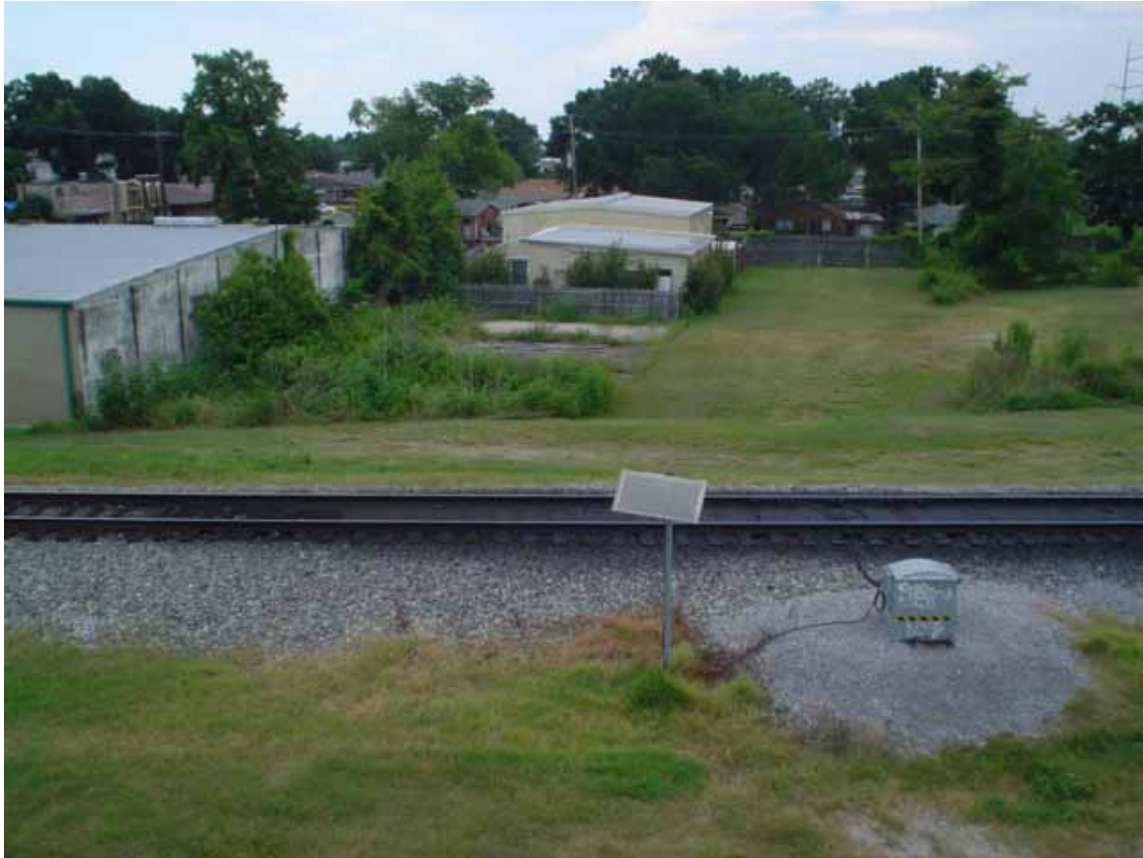
3. View of north area adjacent to the site, west side of canal.

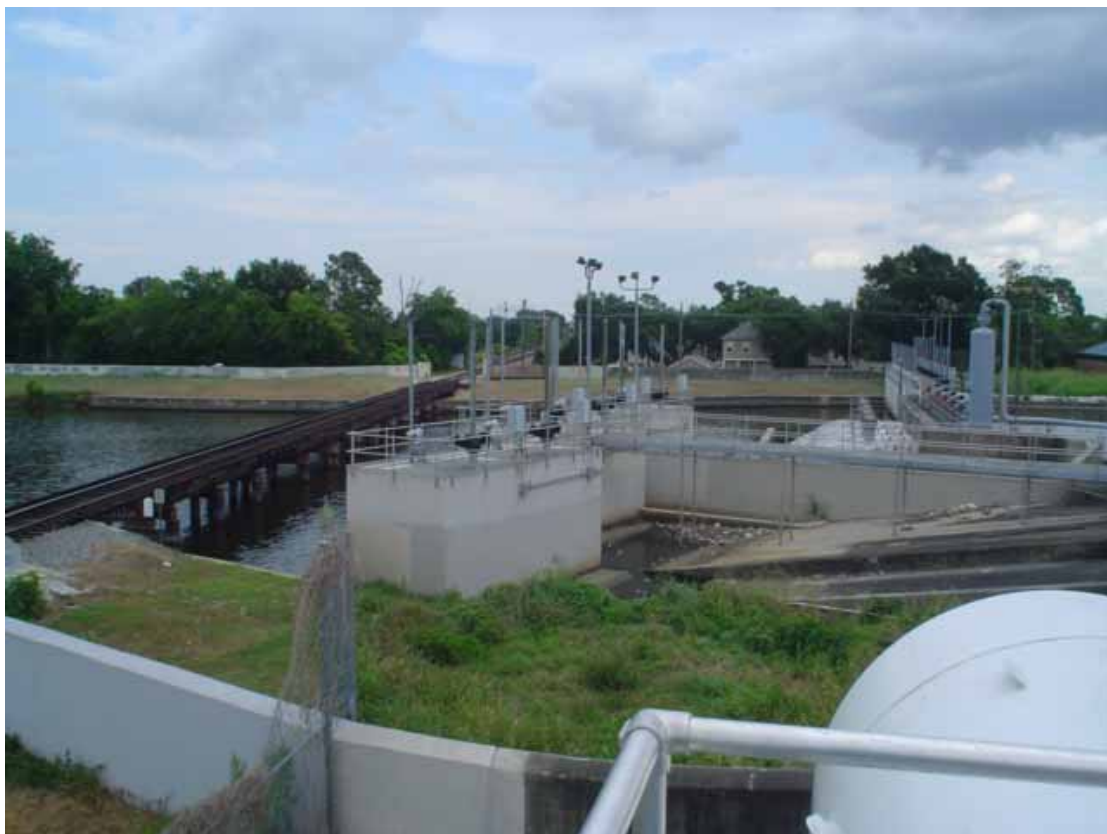
4. View of north area adjacent to the site, east side of canal.

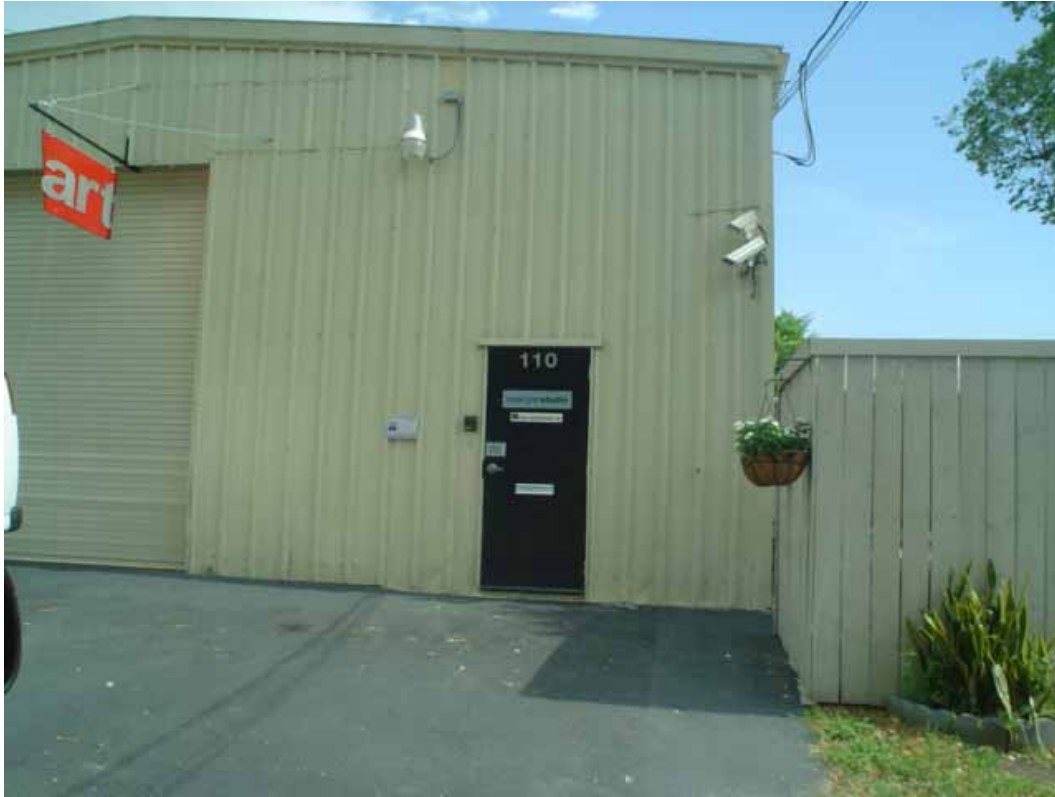
5. Art studio across levee, northwest corner.

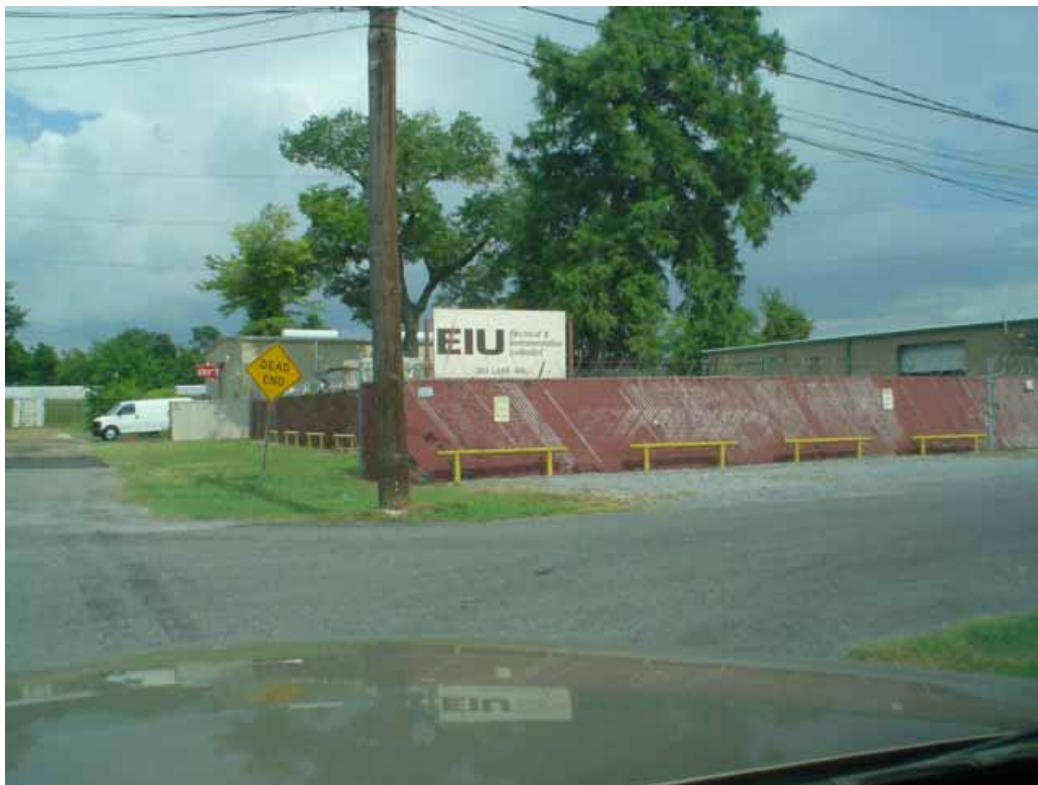
6. Electrical business, across levee, northwest corner.

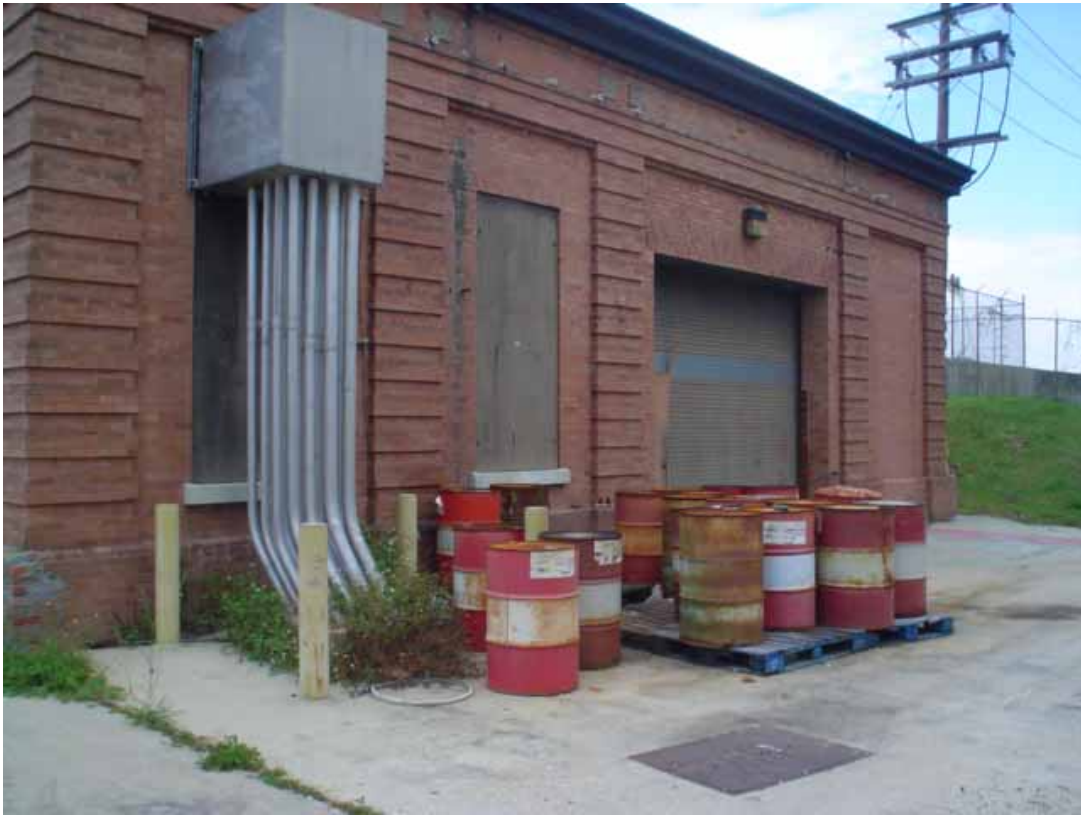
7. View of site as seen from the east direction. Observe 55 gallon drums stored outside.

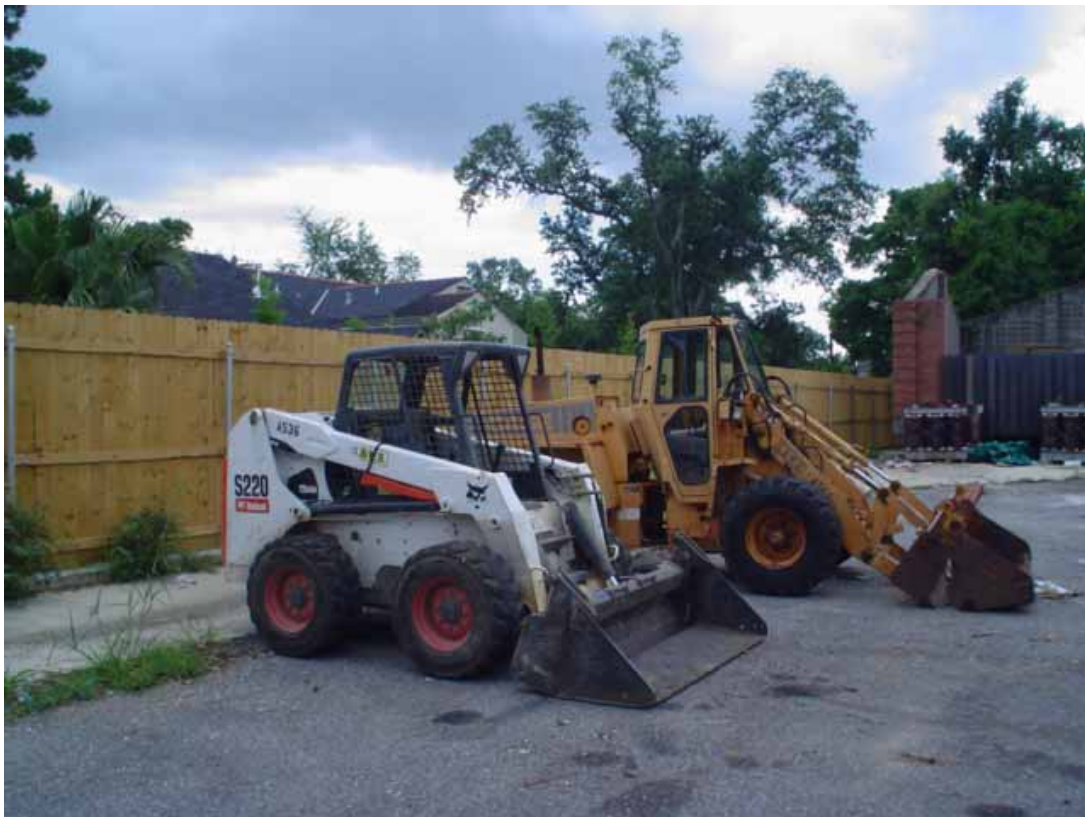
8. View of east area adjacent to the site, residential area over fence, southeast corner.

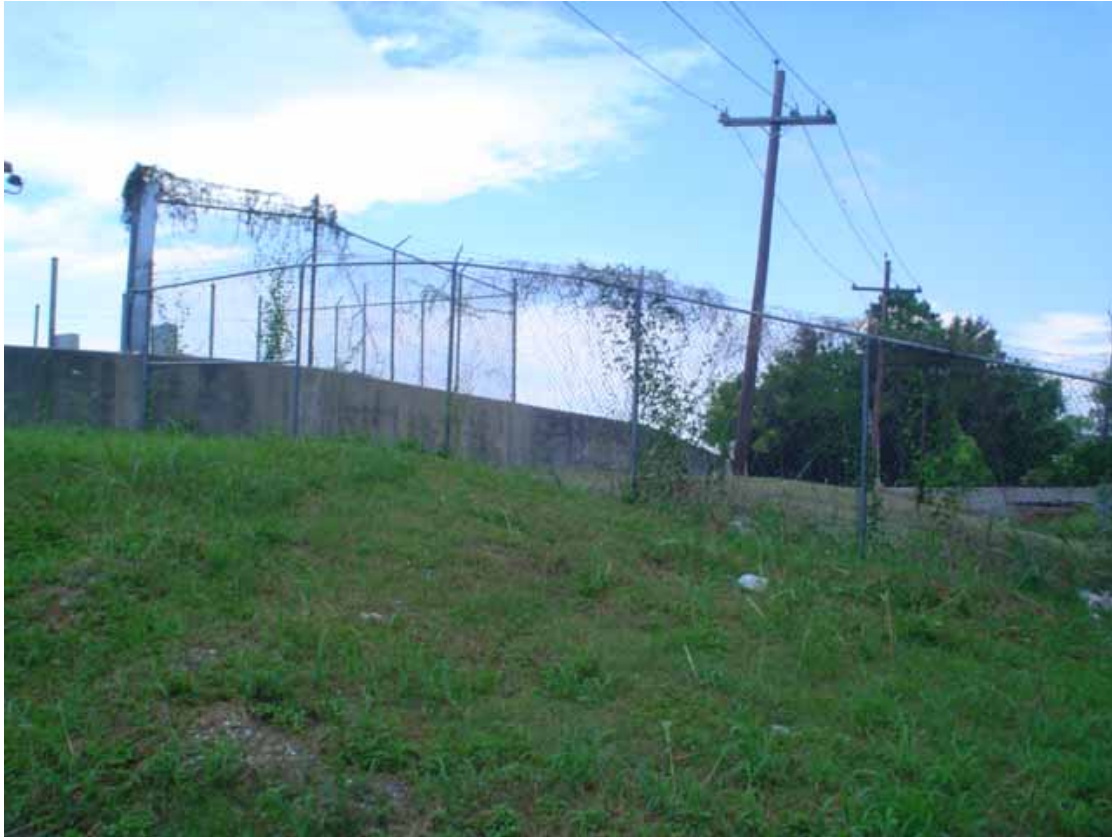
9. View of east area adjacent to the site, levee and flood wall, northeast corner.

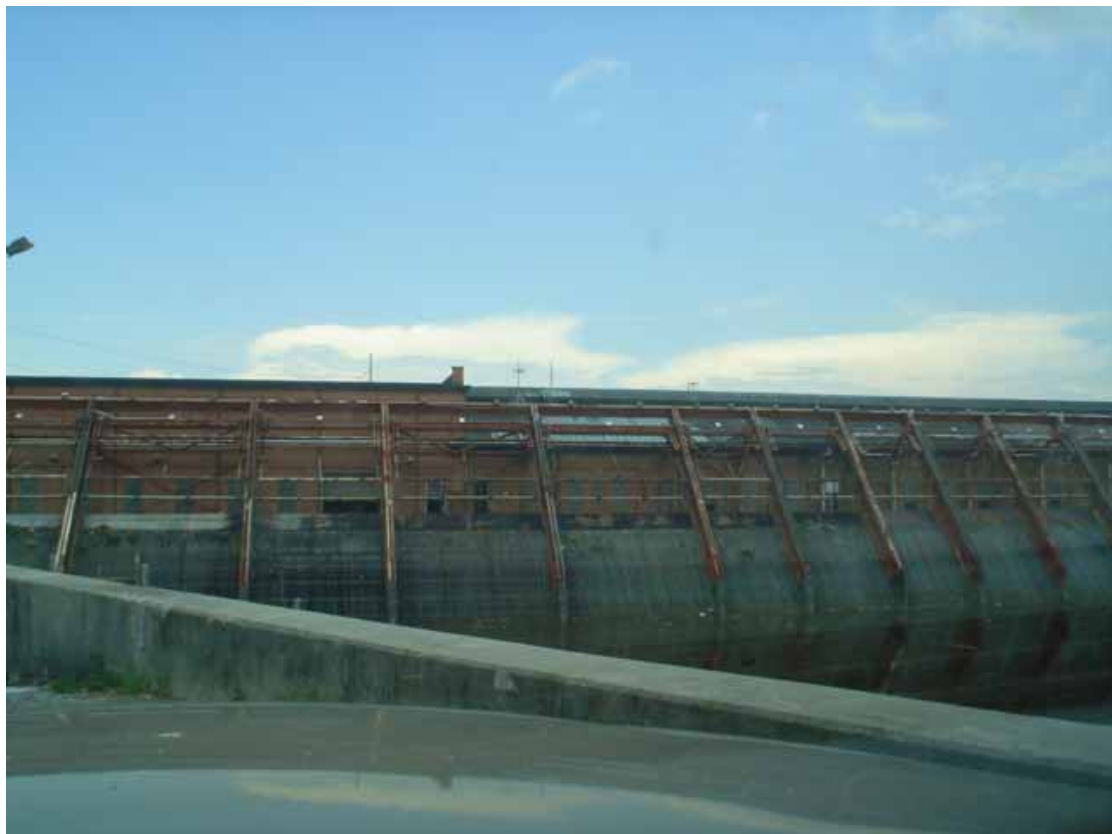
10. View of site as seen from the south direction.

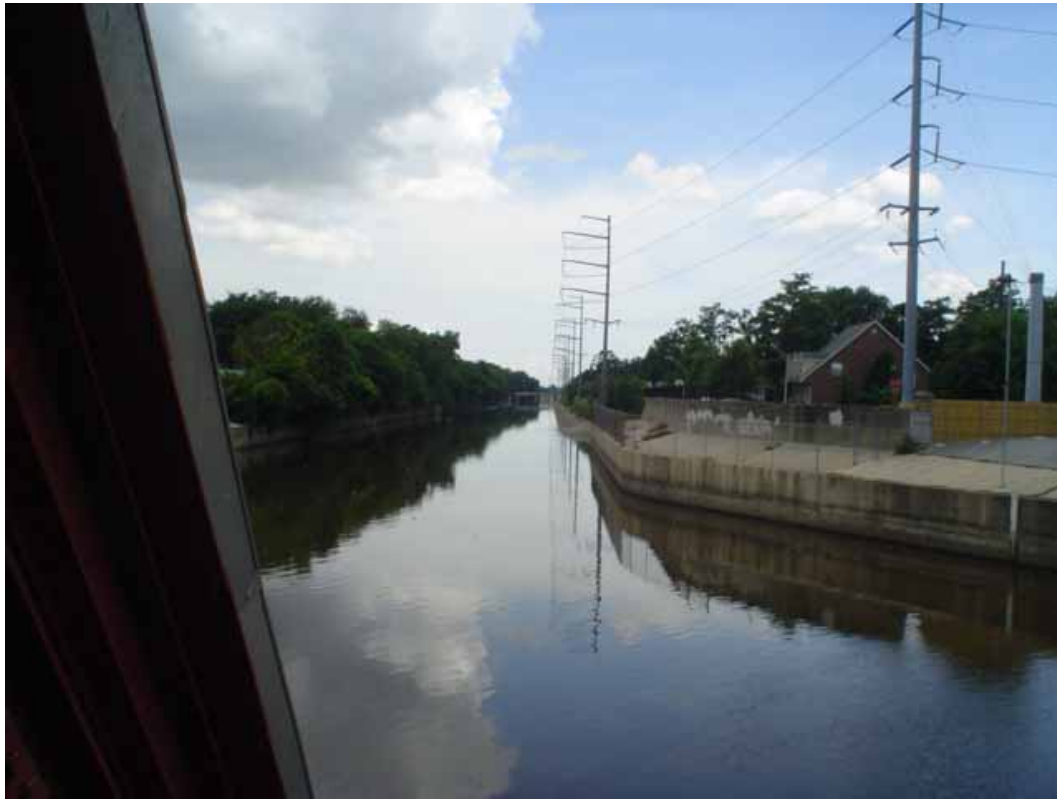
11. View of south area adjacent to the site, 17th Street canal.

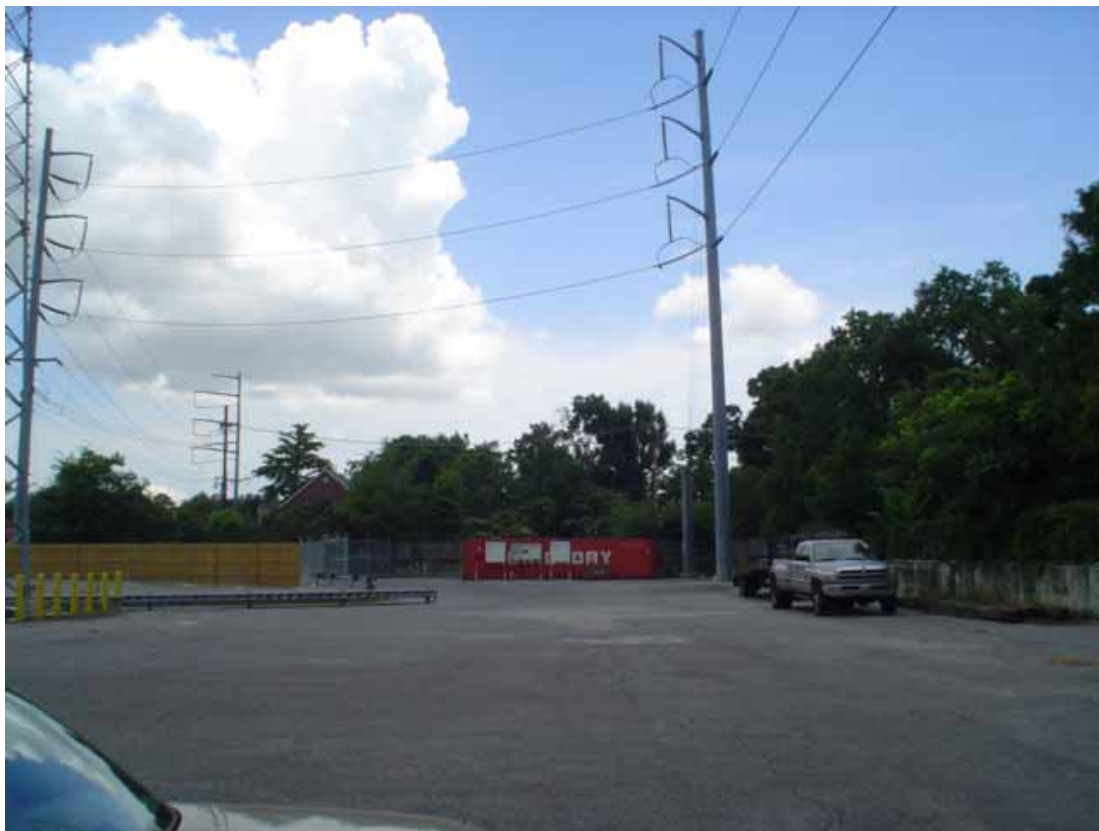
12. View of south area adjacent to the site, parking lot and residential area behind fence, southwest corner.

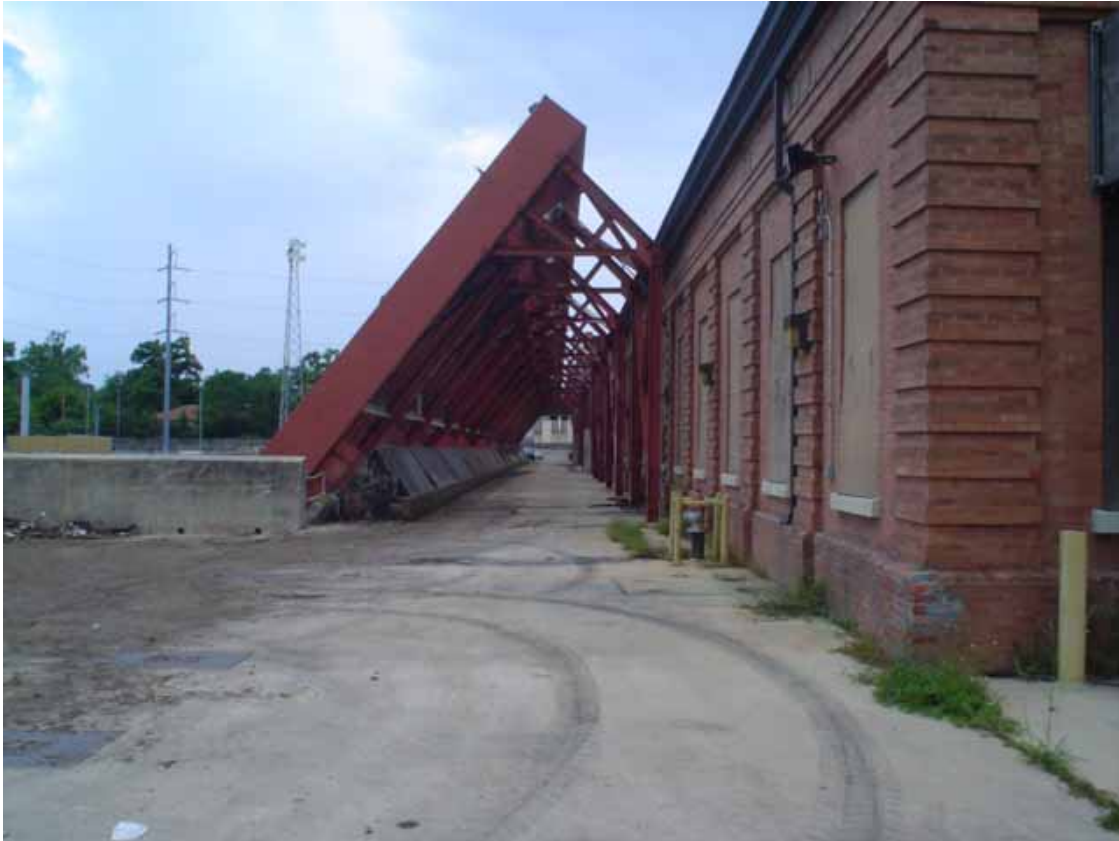
13. View of south area adjacent to the site, canal screens.
