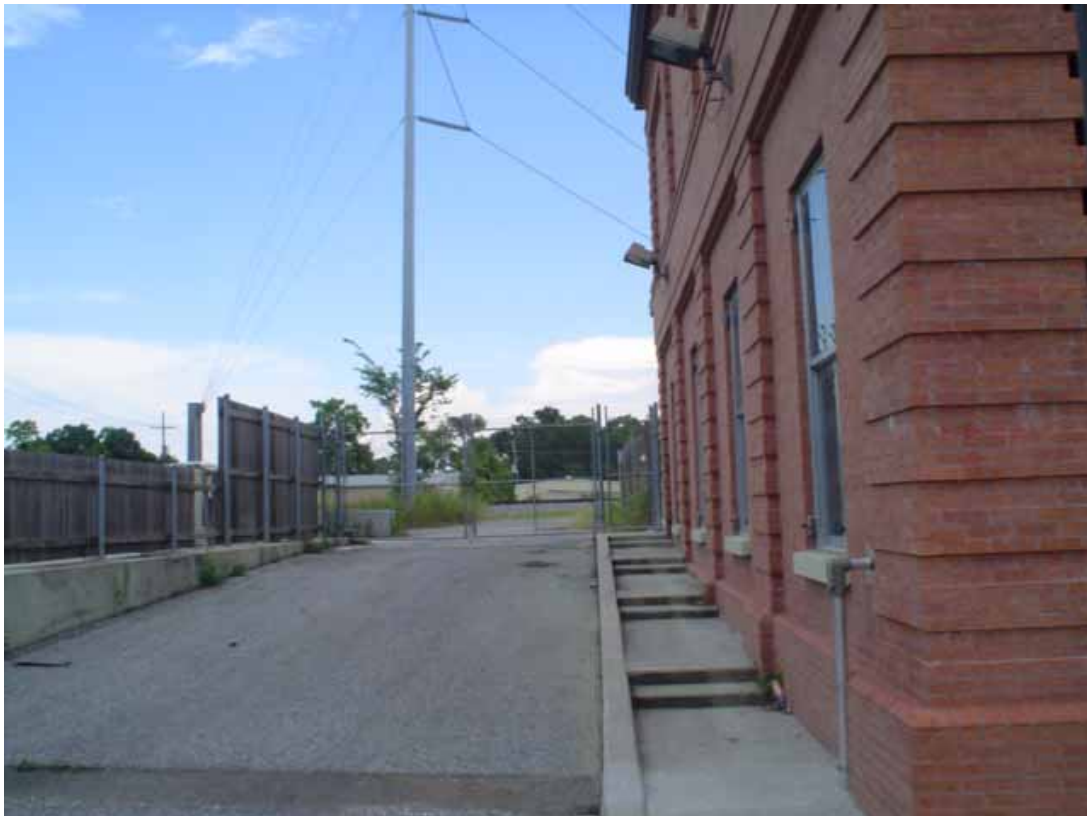
14. View of site as seen from the west direction.

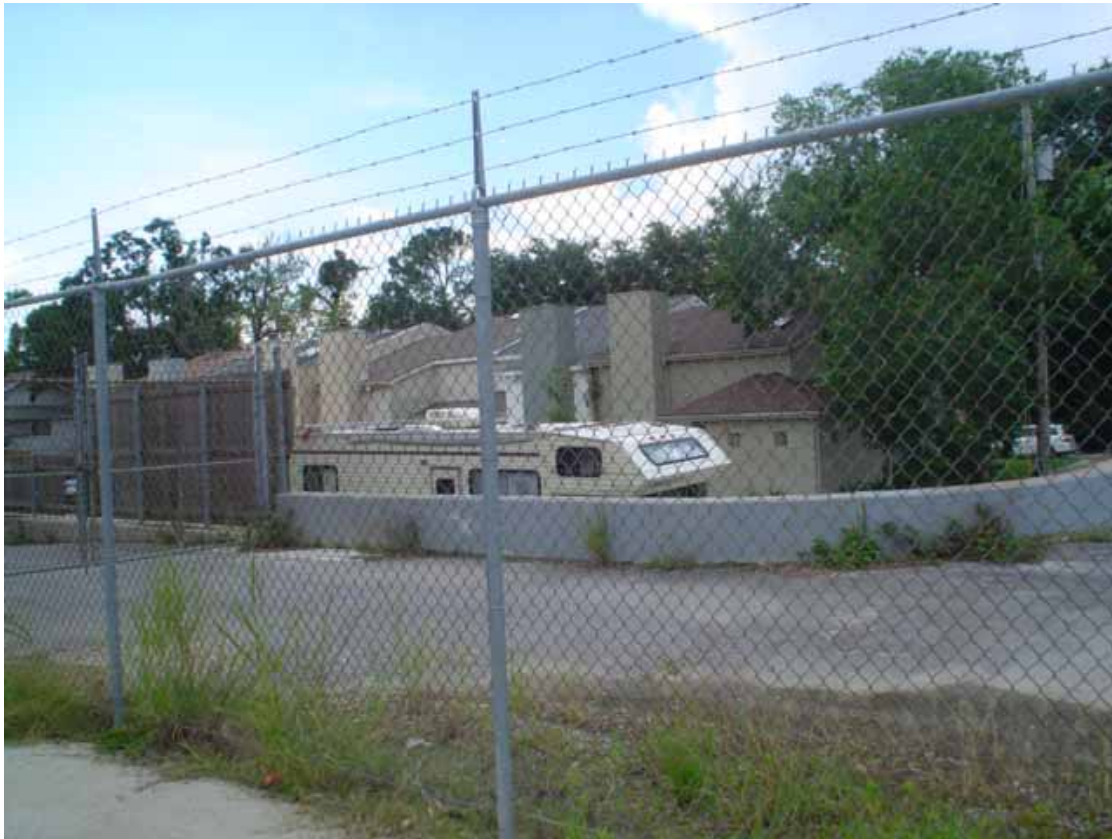
15. View of west area adjacent to the site, residential area, southwest corner.

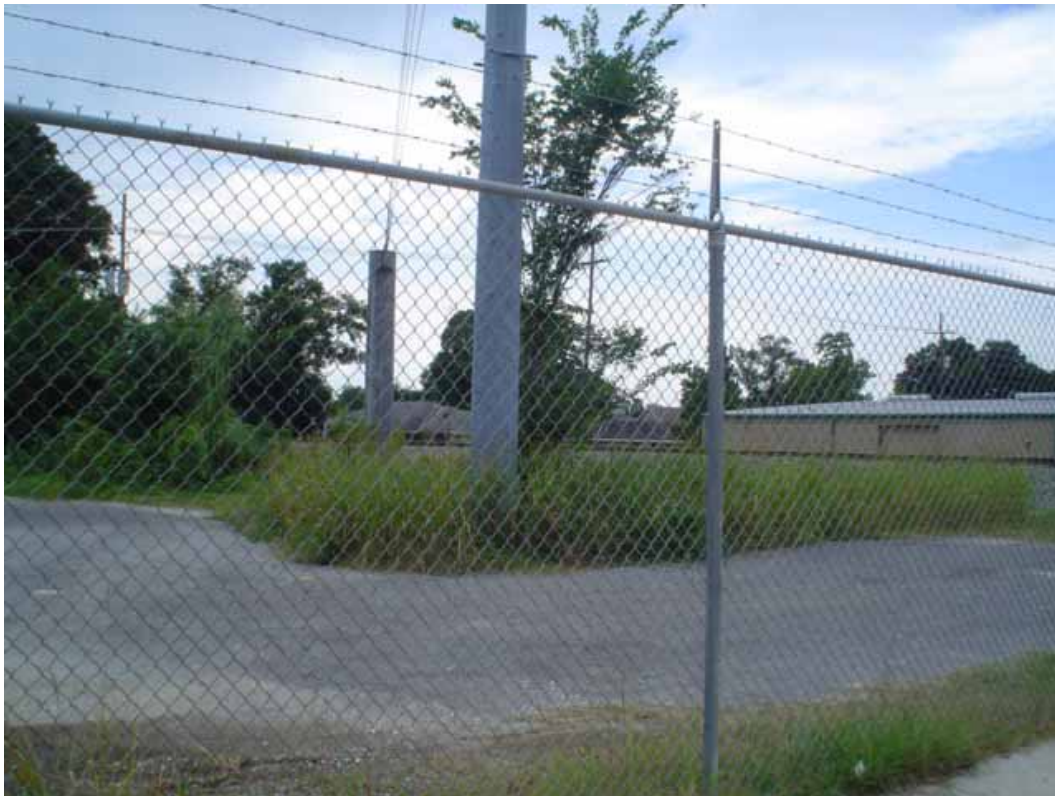
16. View of west area adjacent to the site, railroad tracks, and residential area, northwest corner.

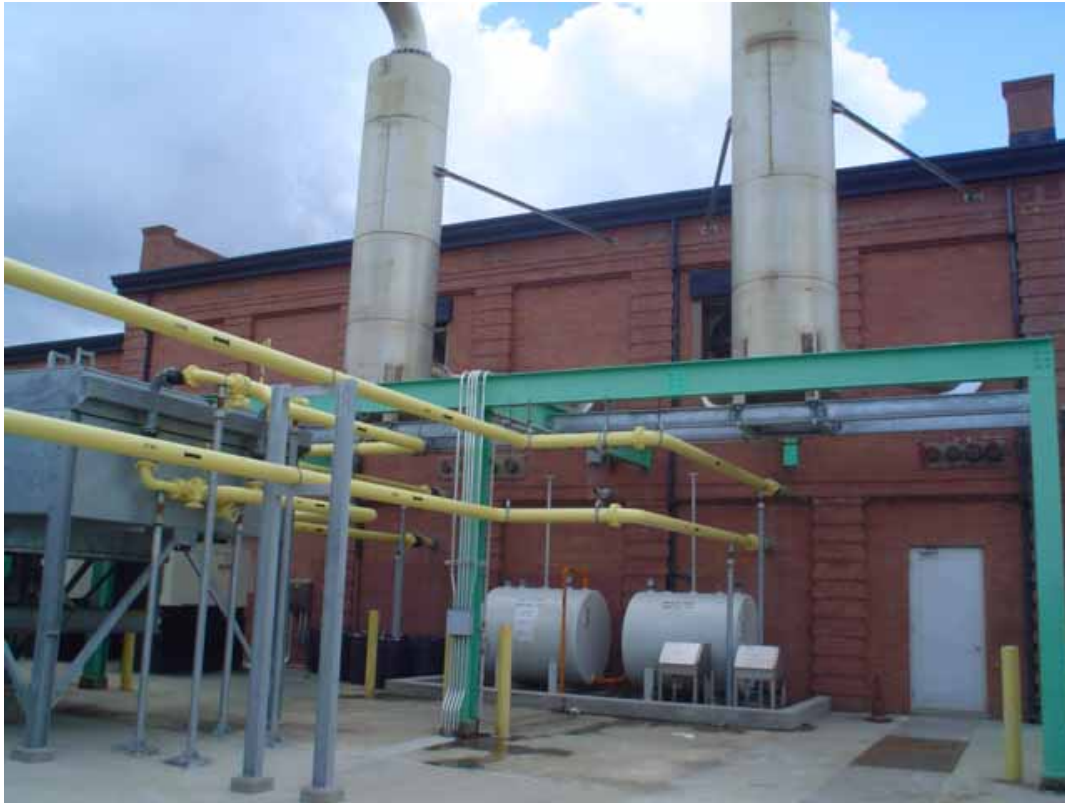
17. Oil and lubricant tanks, northwest corner of building.

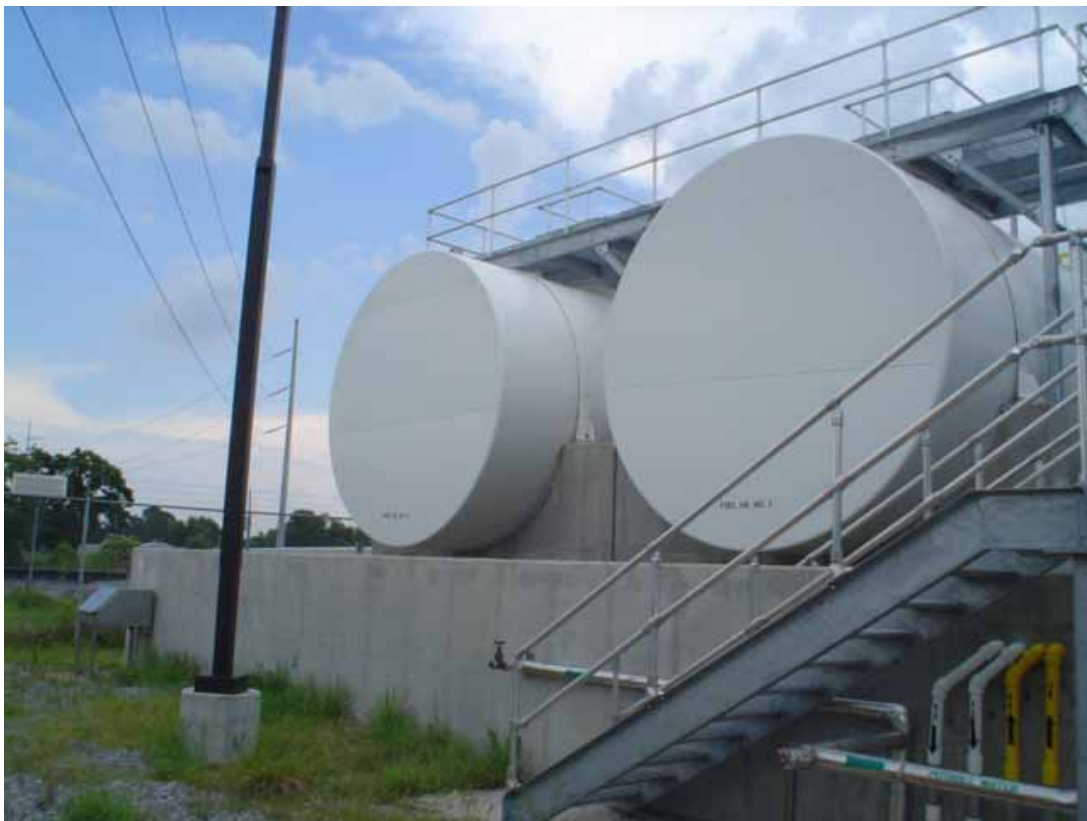
18. Diesel tanks, northwest corner of property.

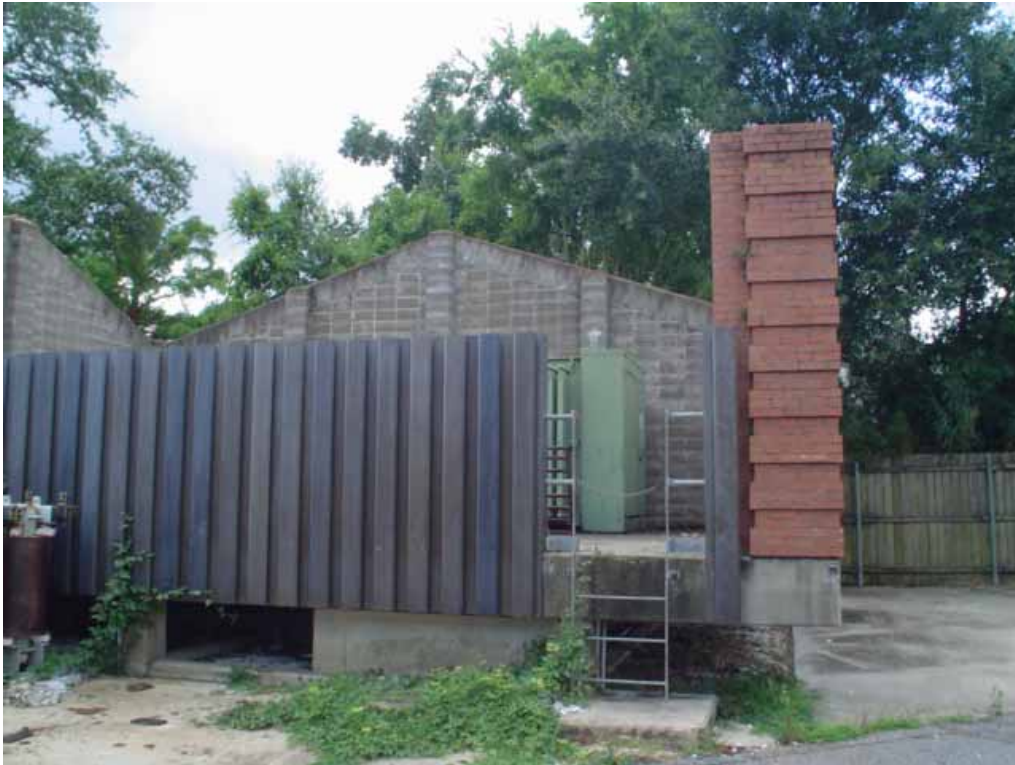
19. Transformer 'building', raised approximately two feet.

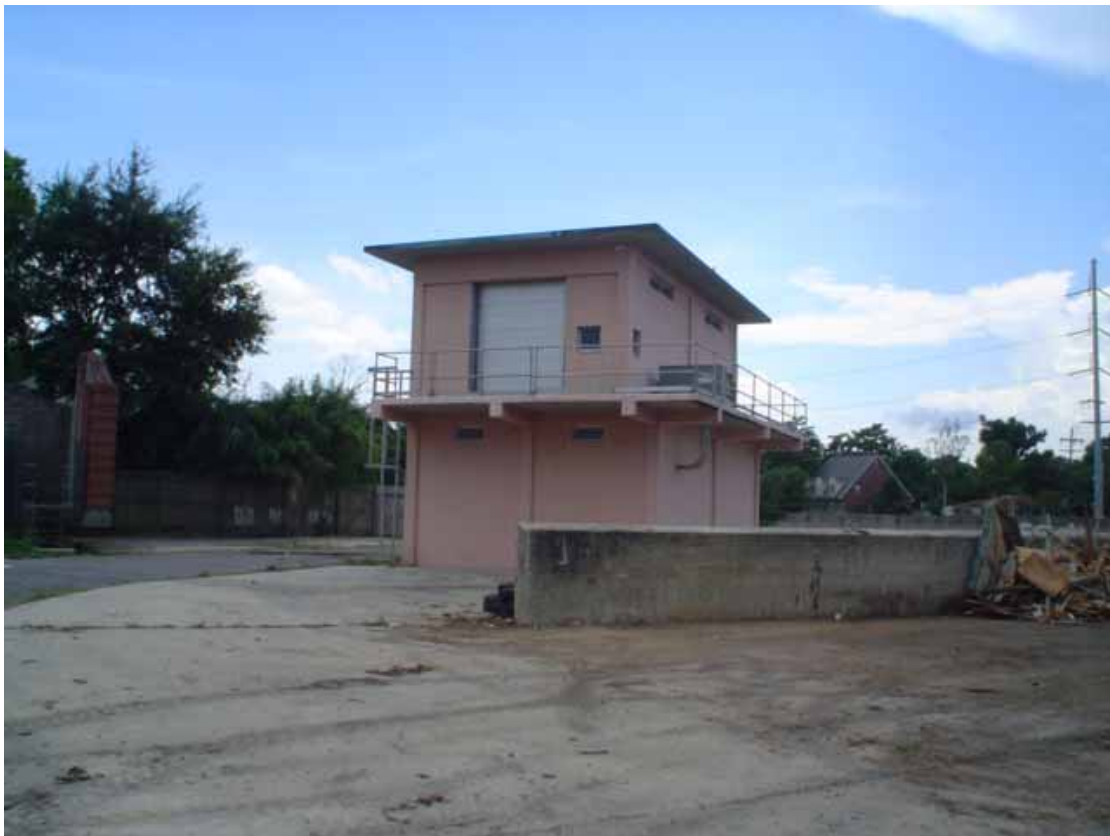
20. Transfer tower, electrical materials, southeast corner of property.

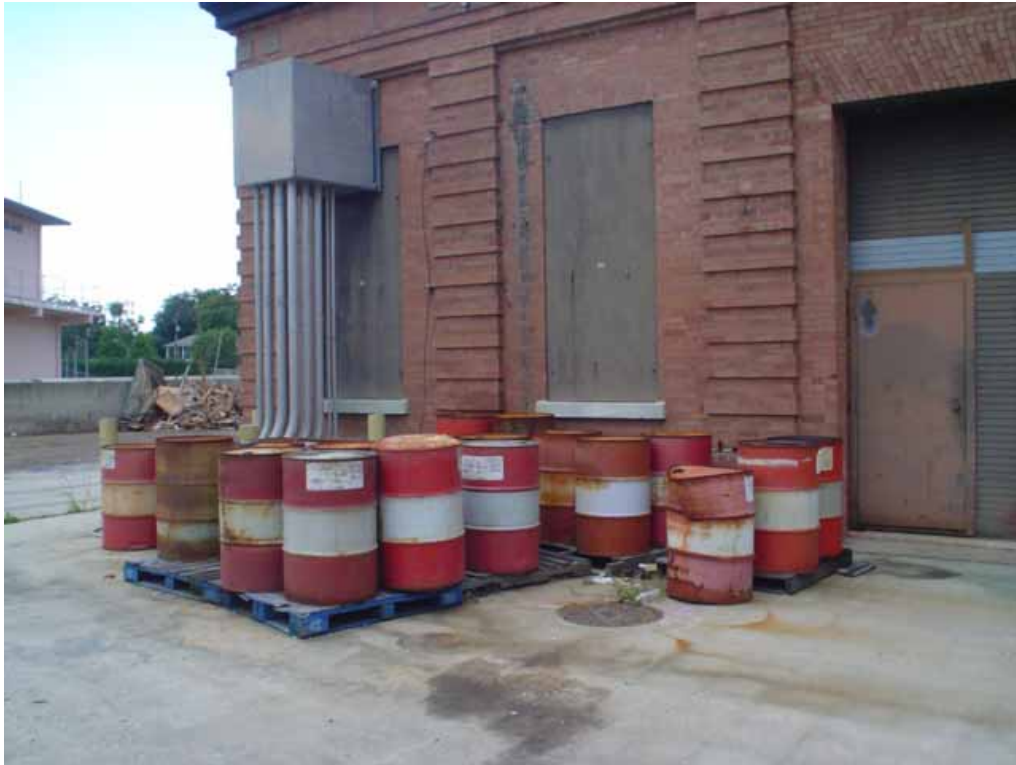
21. Example of 55 gallon drums outside building.

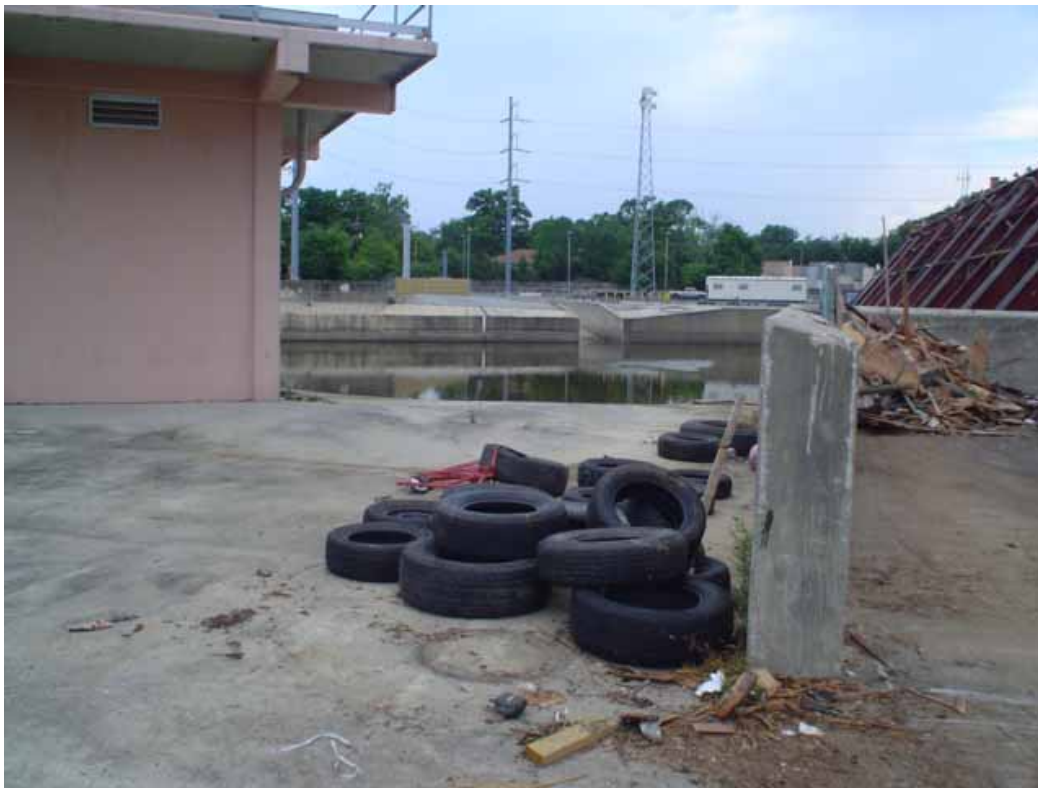
22. Refuse from the canal.

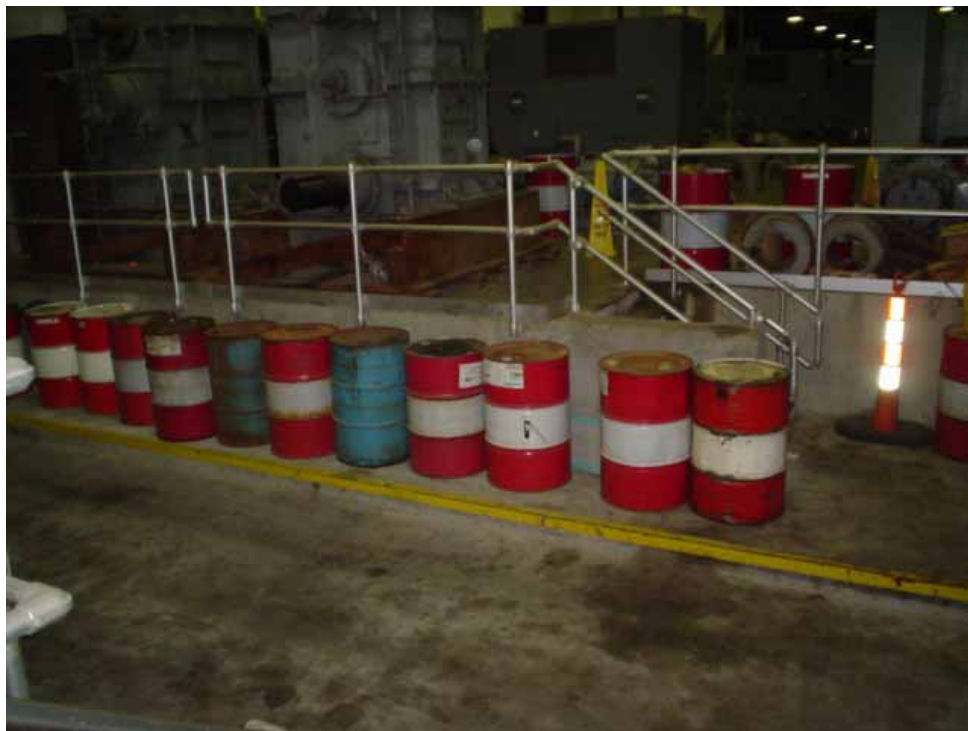
24. Example of 55 gallon drums inside building. Observe discoloration to concrete floor, some from transfer spillage.

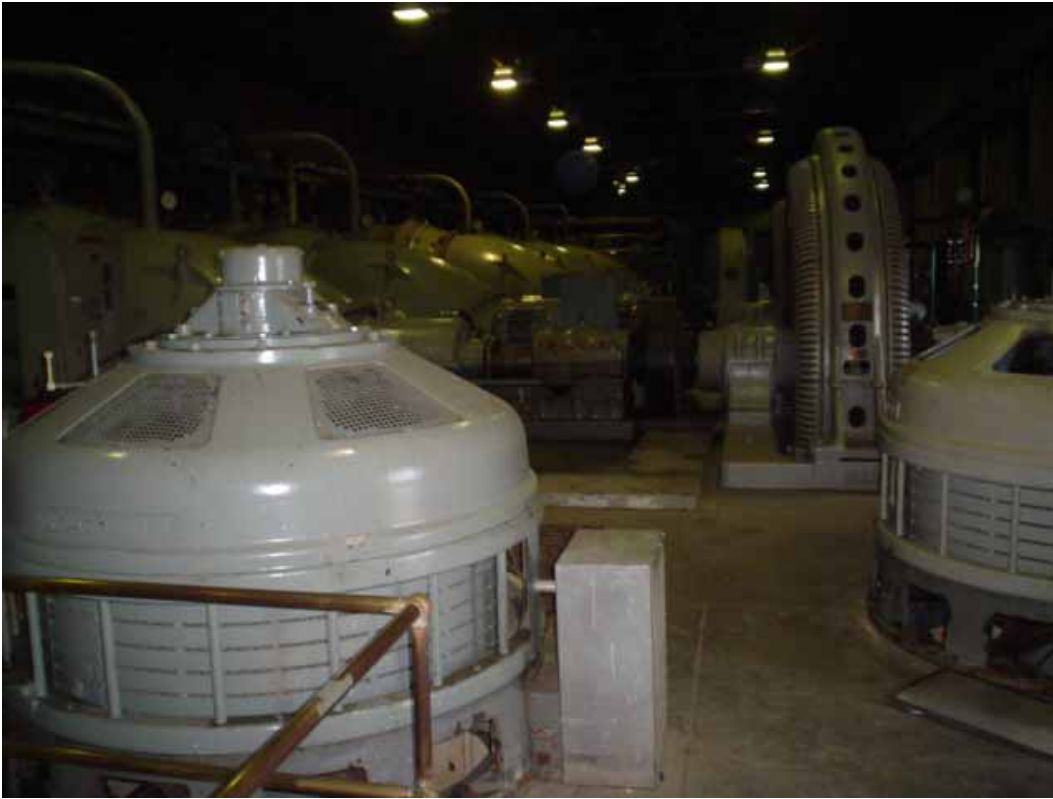
25. Pumps inside building.

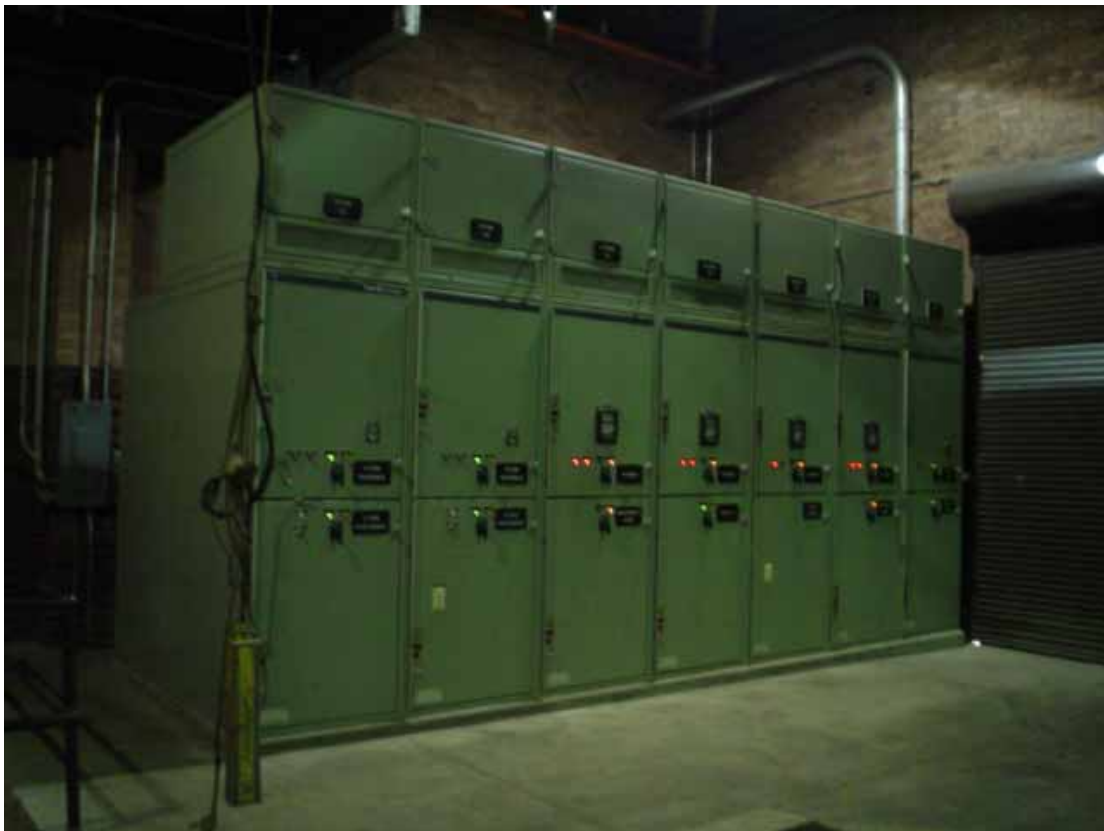
26. Switches inside building.

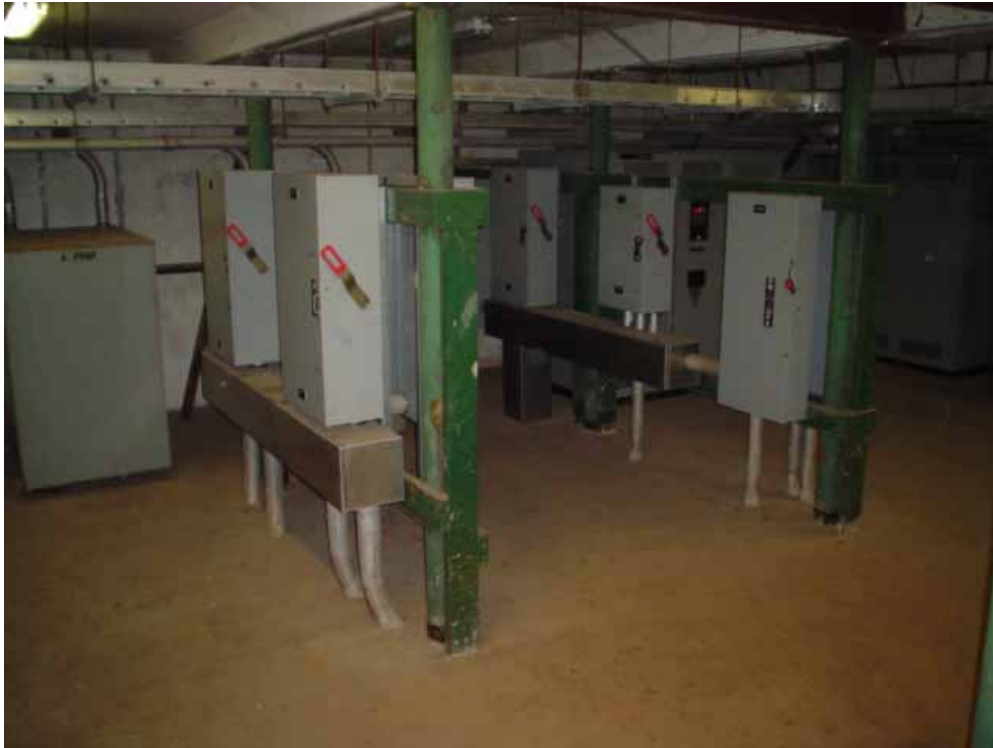
27. Electrical panels in the basement.

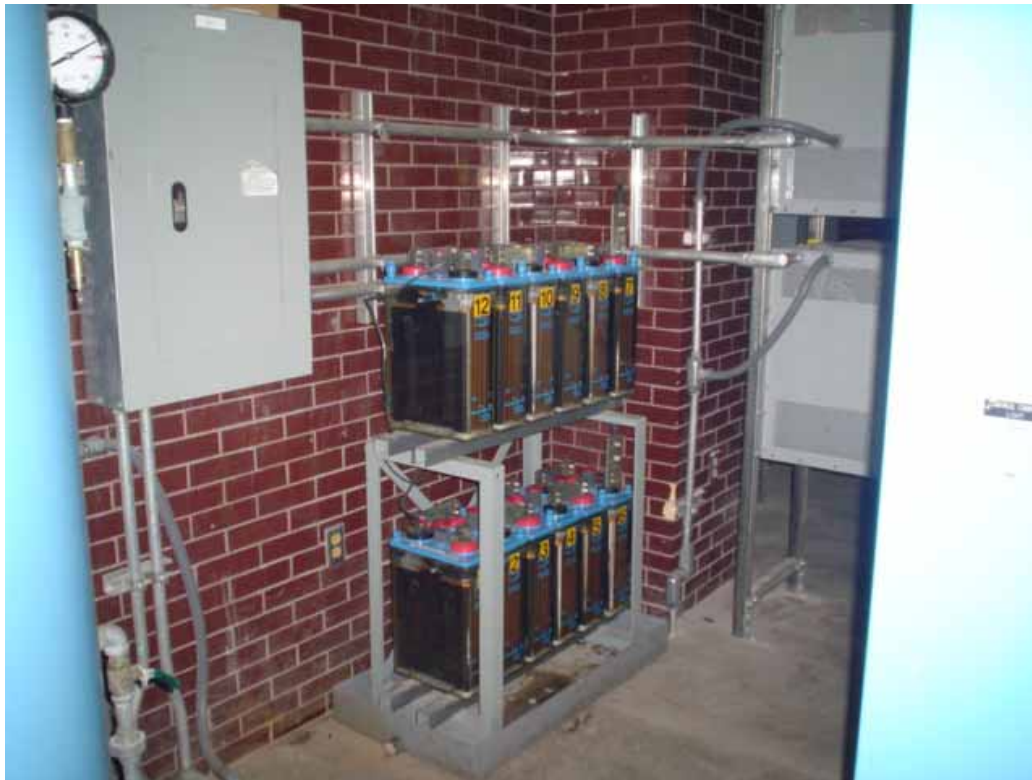
28. Battery banks near control center.

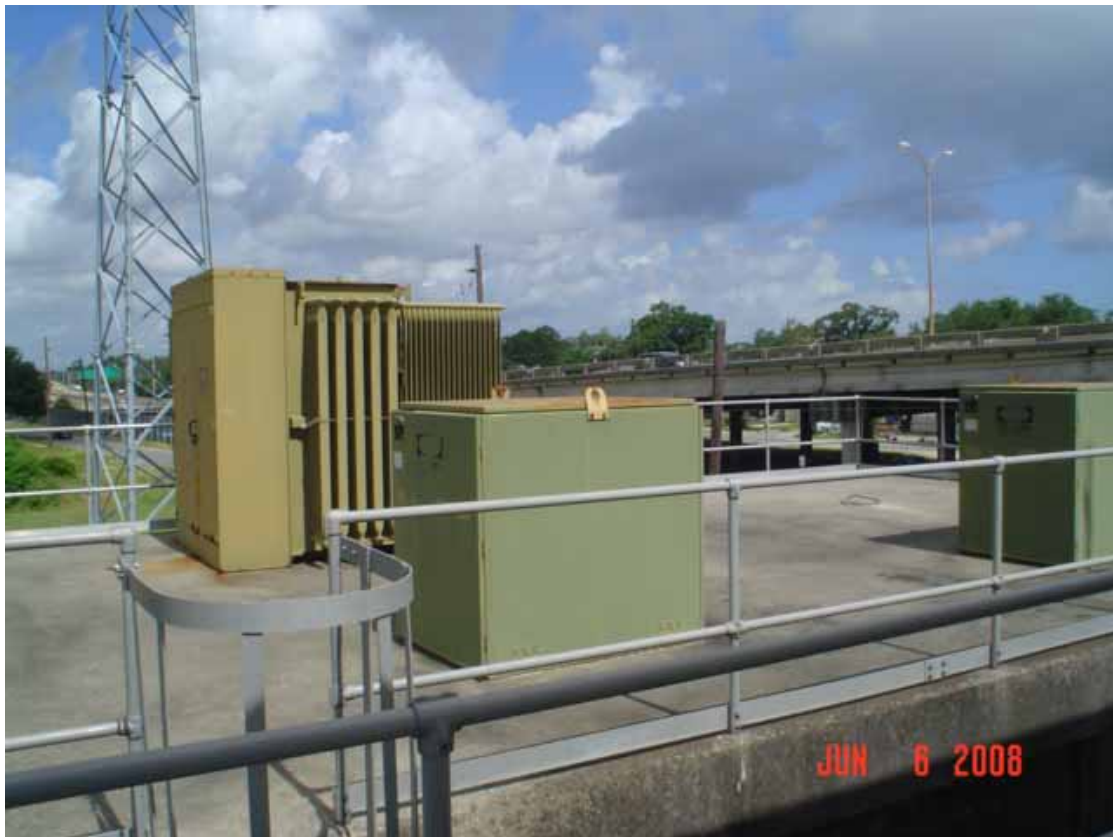
18. Transformers on property.

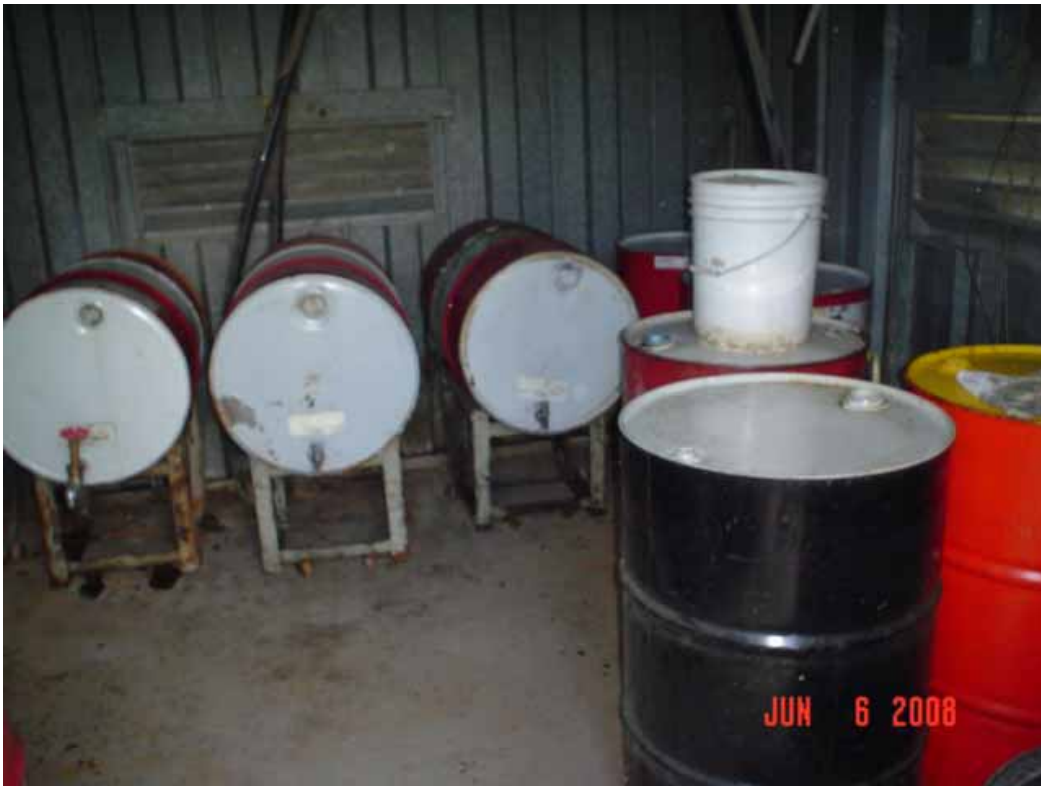
20. 55 gallon drums inside building.

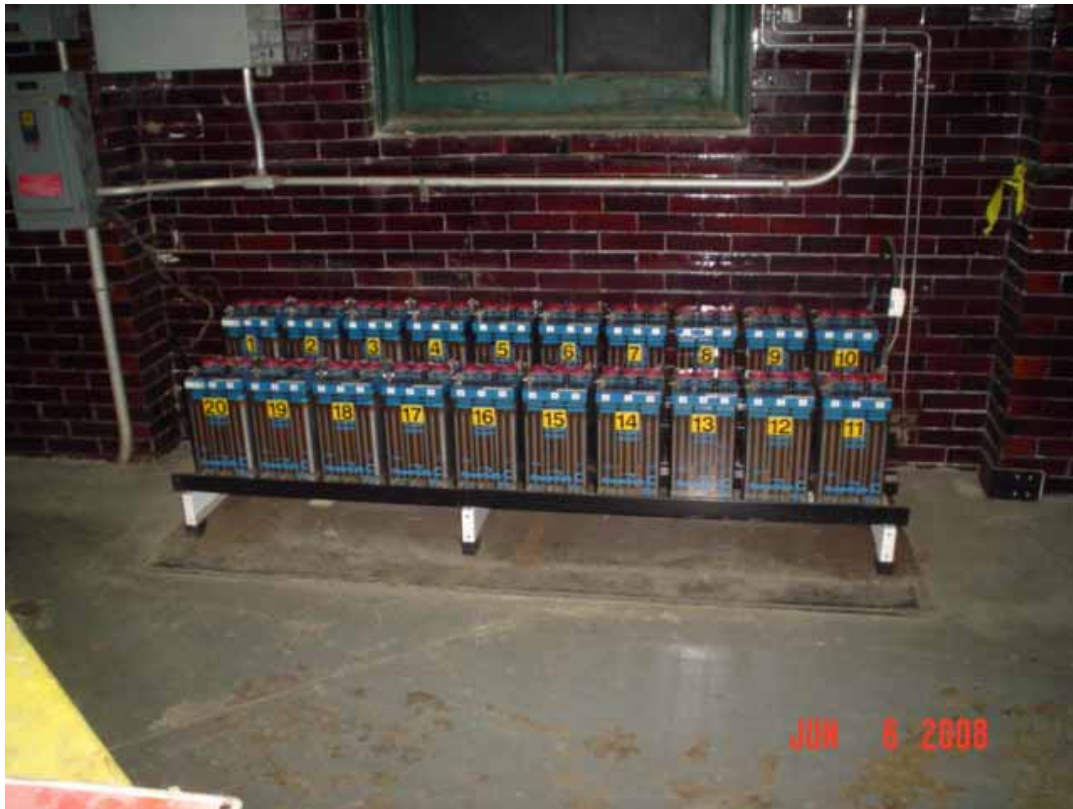
21. Battery bank inside building.

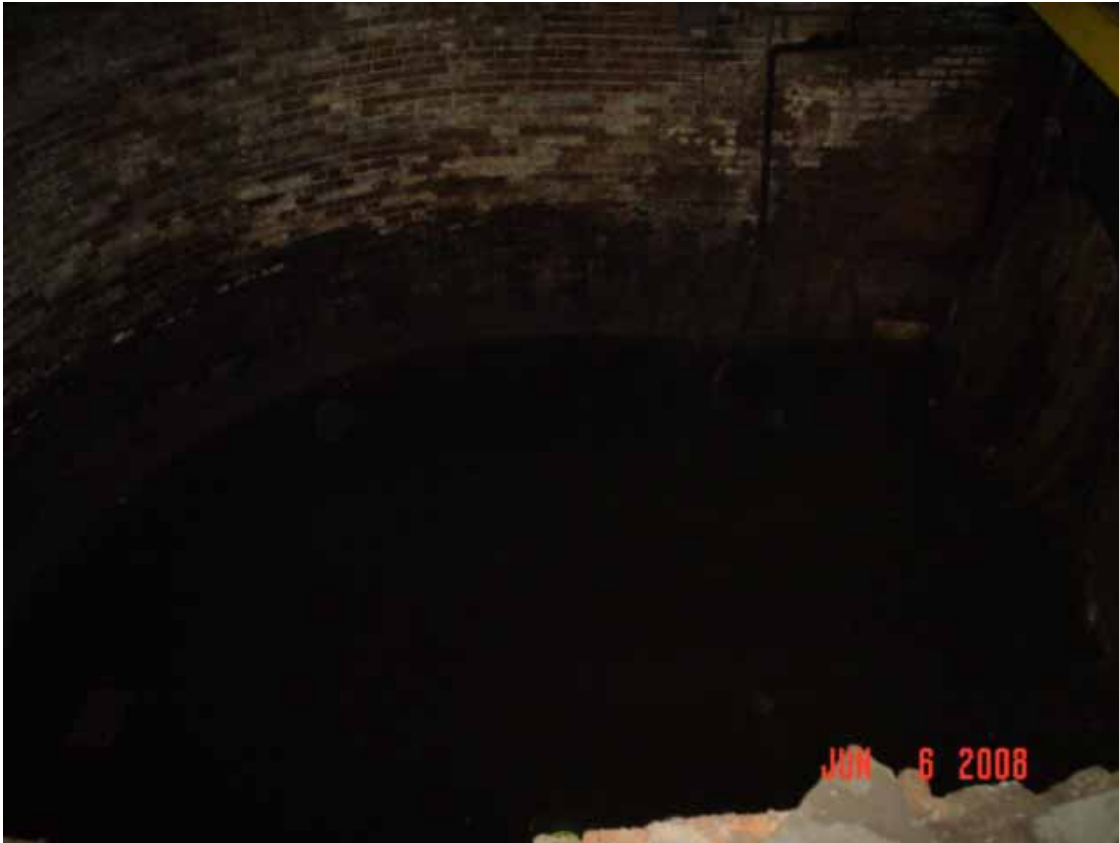
23. Bottom of hole.

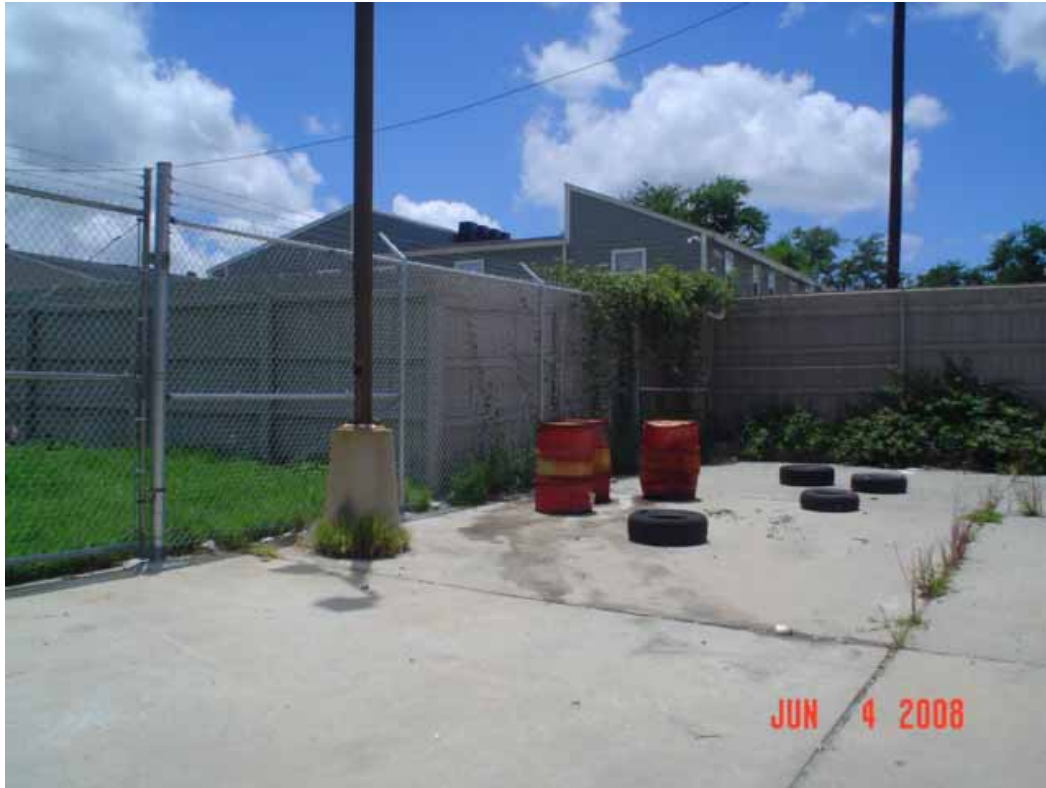
11. 55 gallon drums outside building, southeast corner.

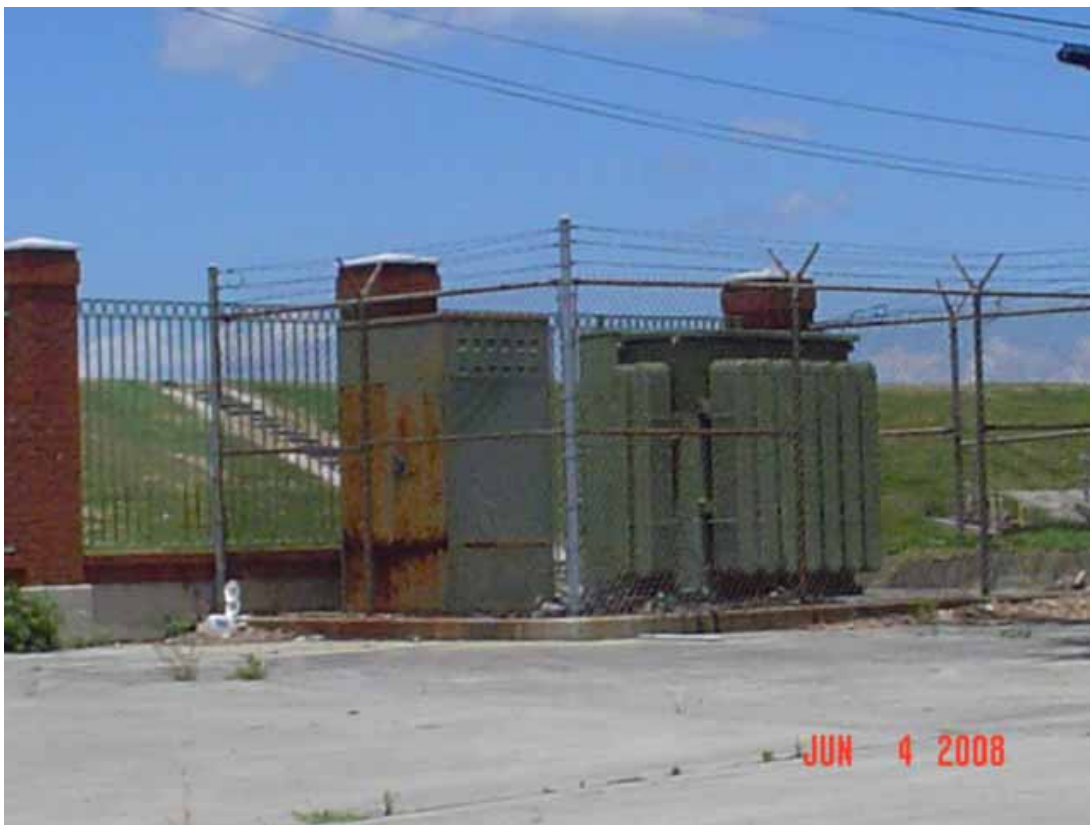
12. Entergy transformer, northeast corner.

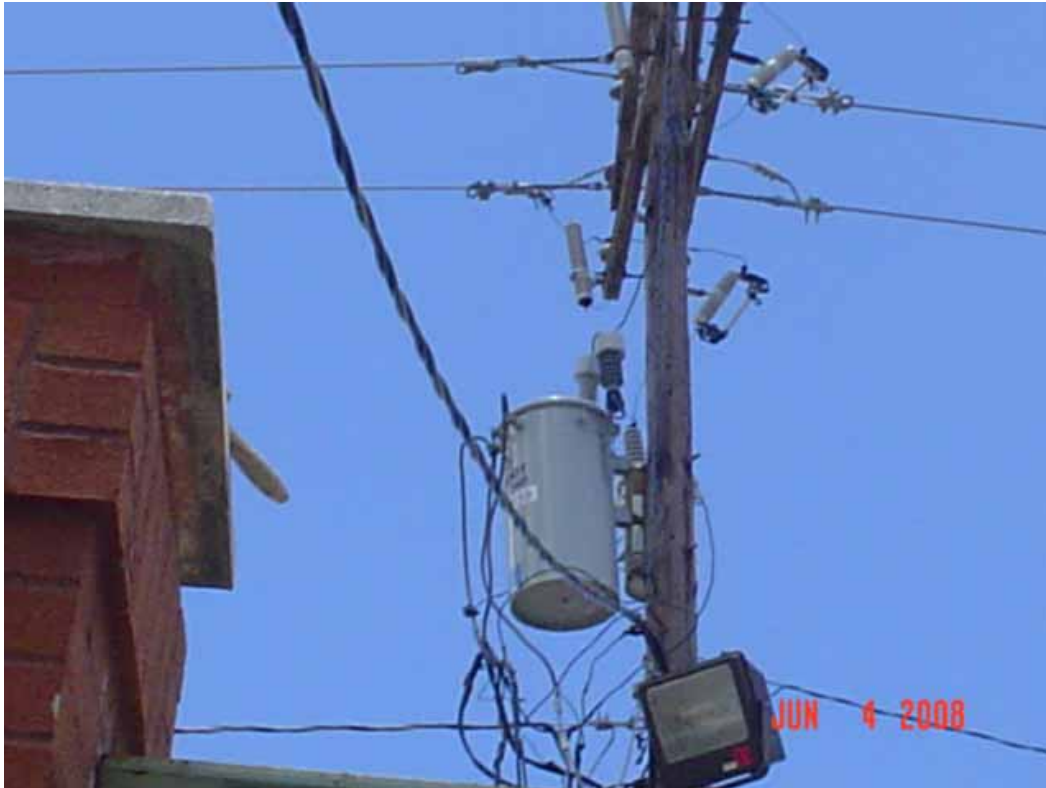
13. Transformer west of building.

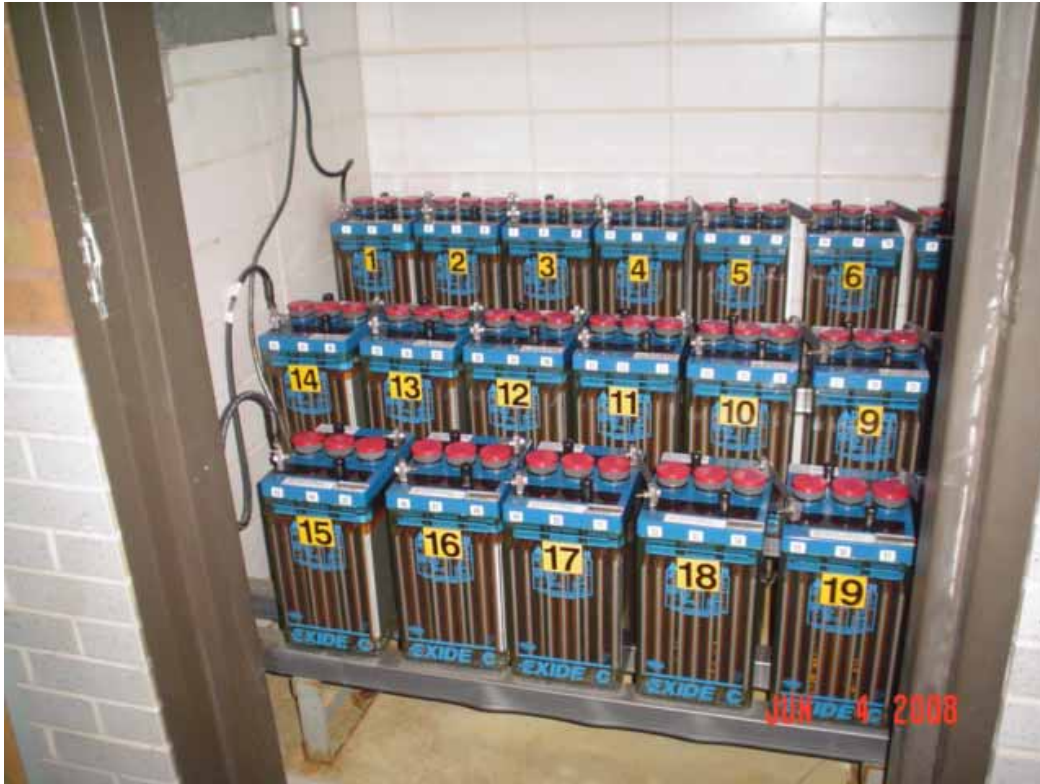
15. Battery bank.

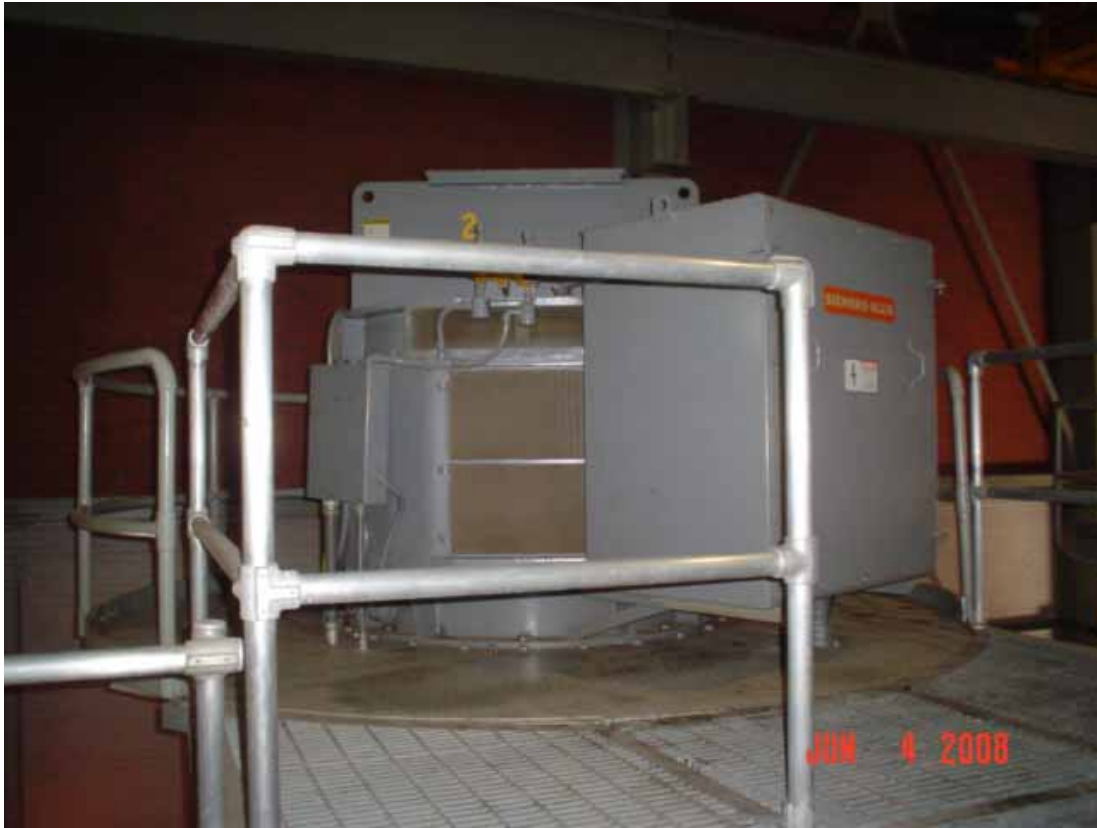
17. Pump motor.

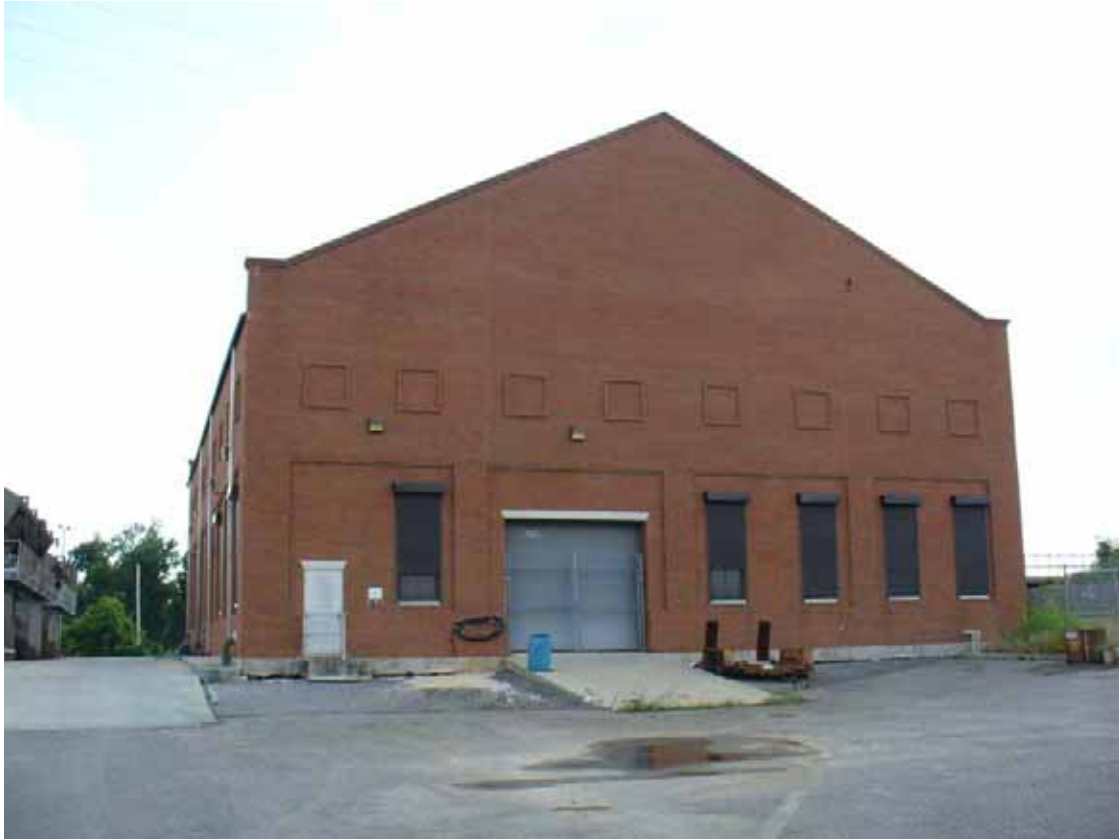
3. View of site as seen from the east direction. Observe leaking drums to right of picture.

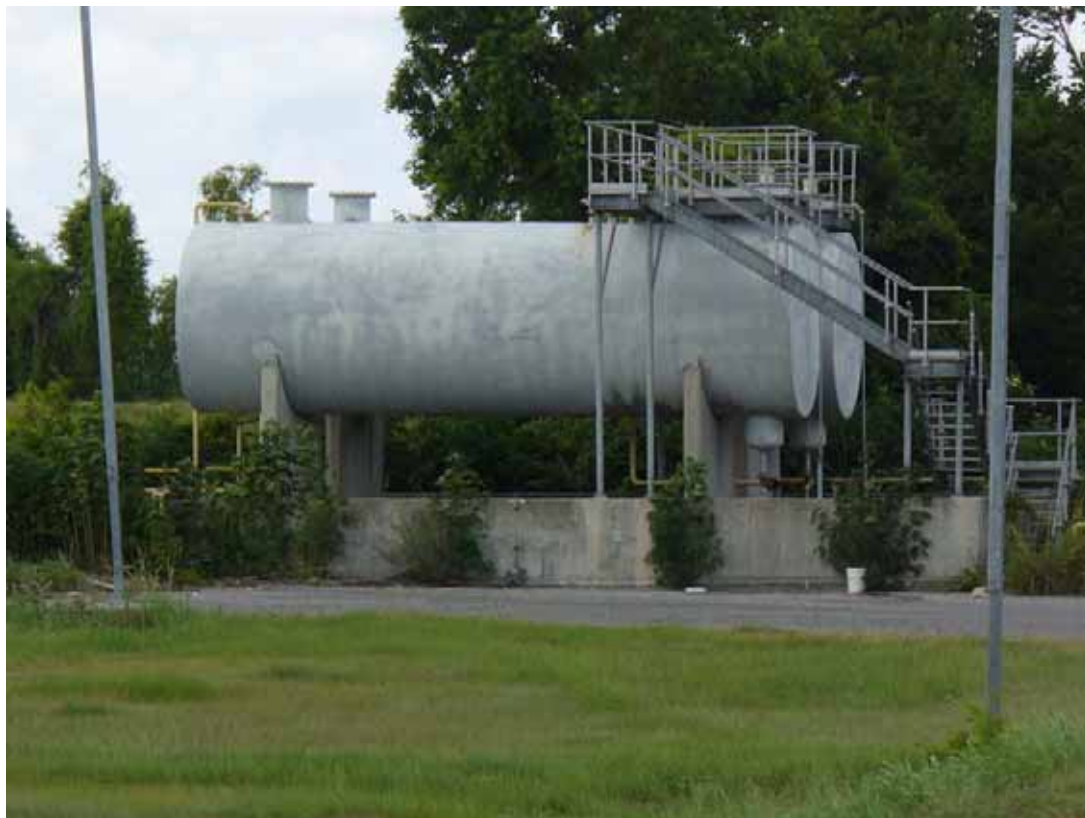
4. View of east area adjacent to the site, where 2 - 30,000 diesel AST's are located.

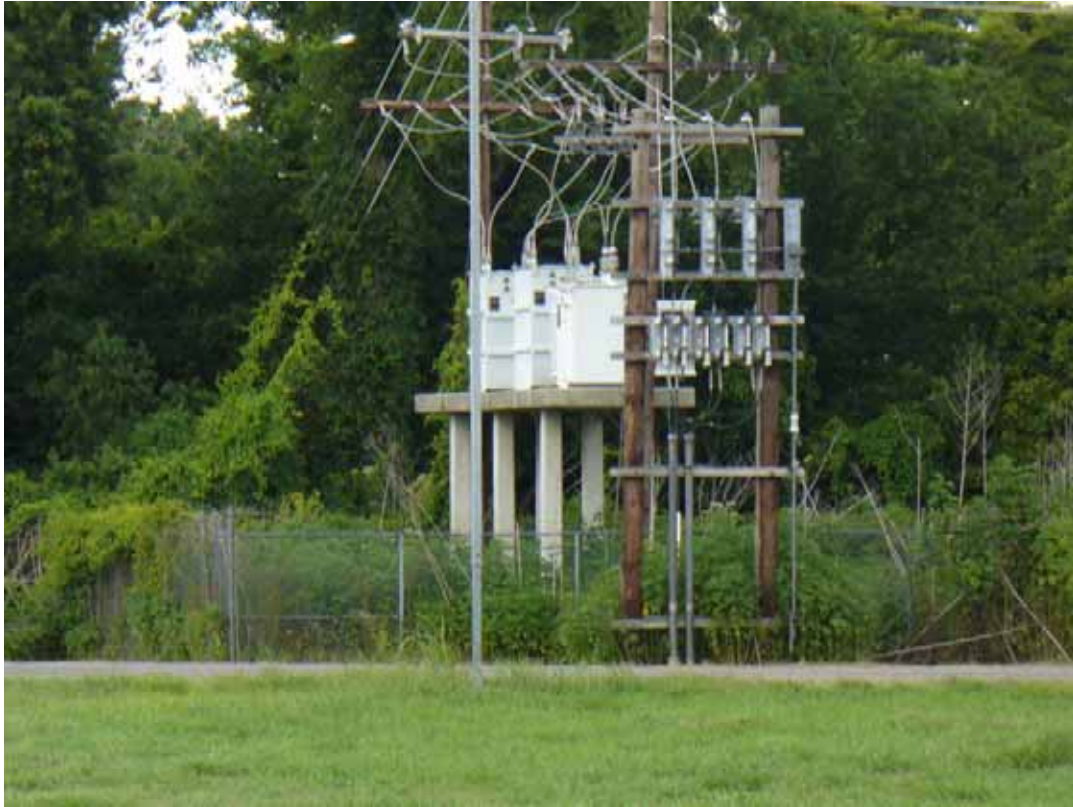
5. View of east area adjacent to the site. Observe transformers in southeast corner past property fence lines.
