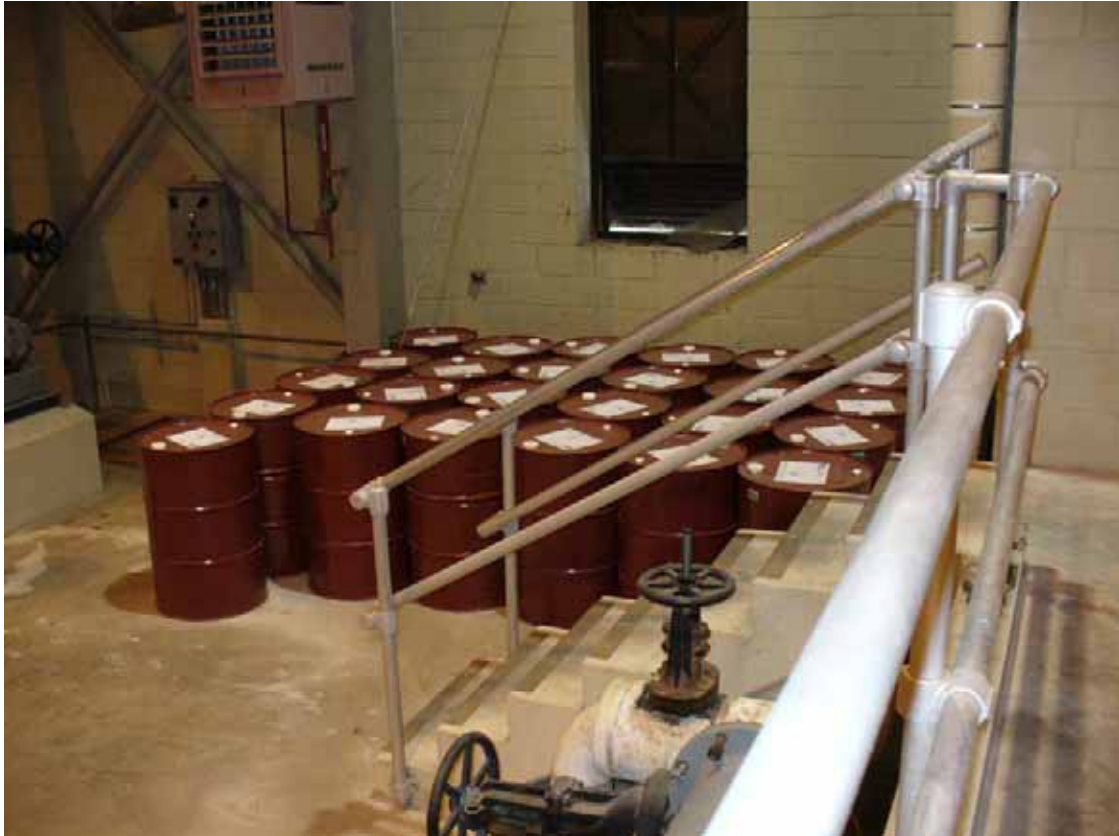
12. View of 55 gallon drums of petroleum product stored inside building.

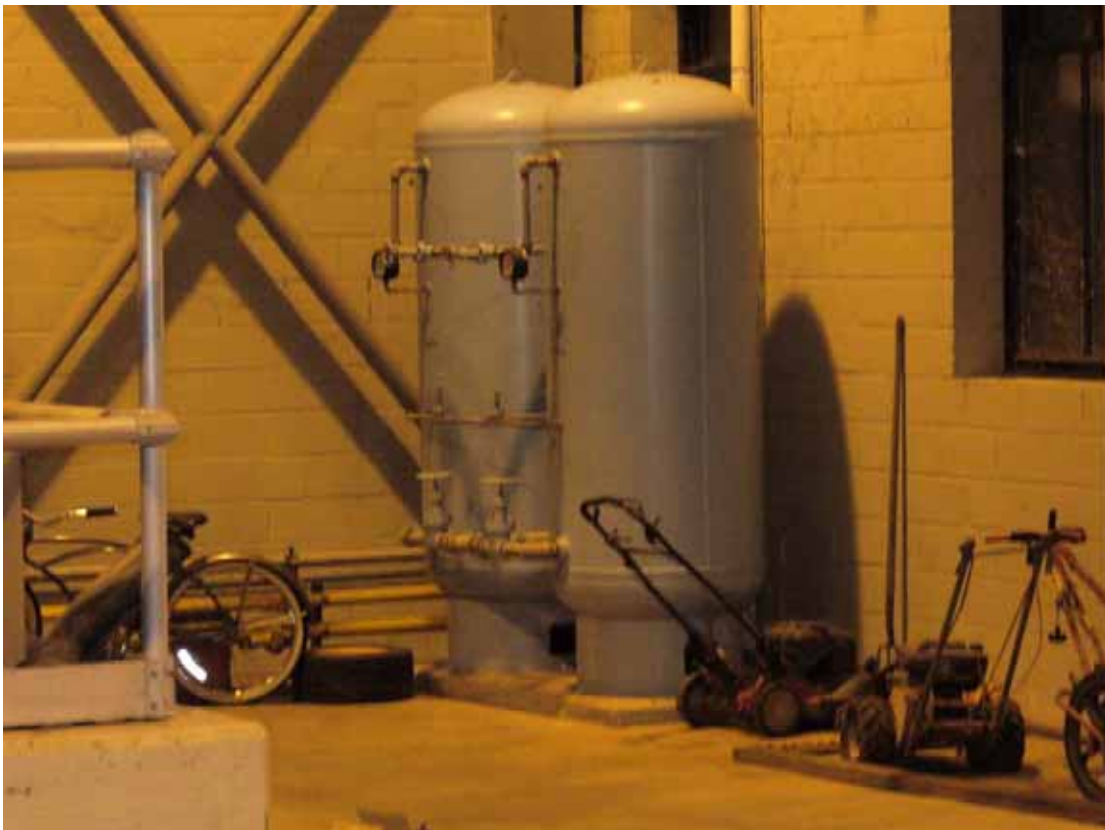
14. Air compressor tanks and mowers located inside building in southeast area.

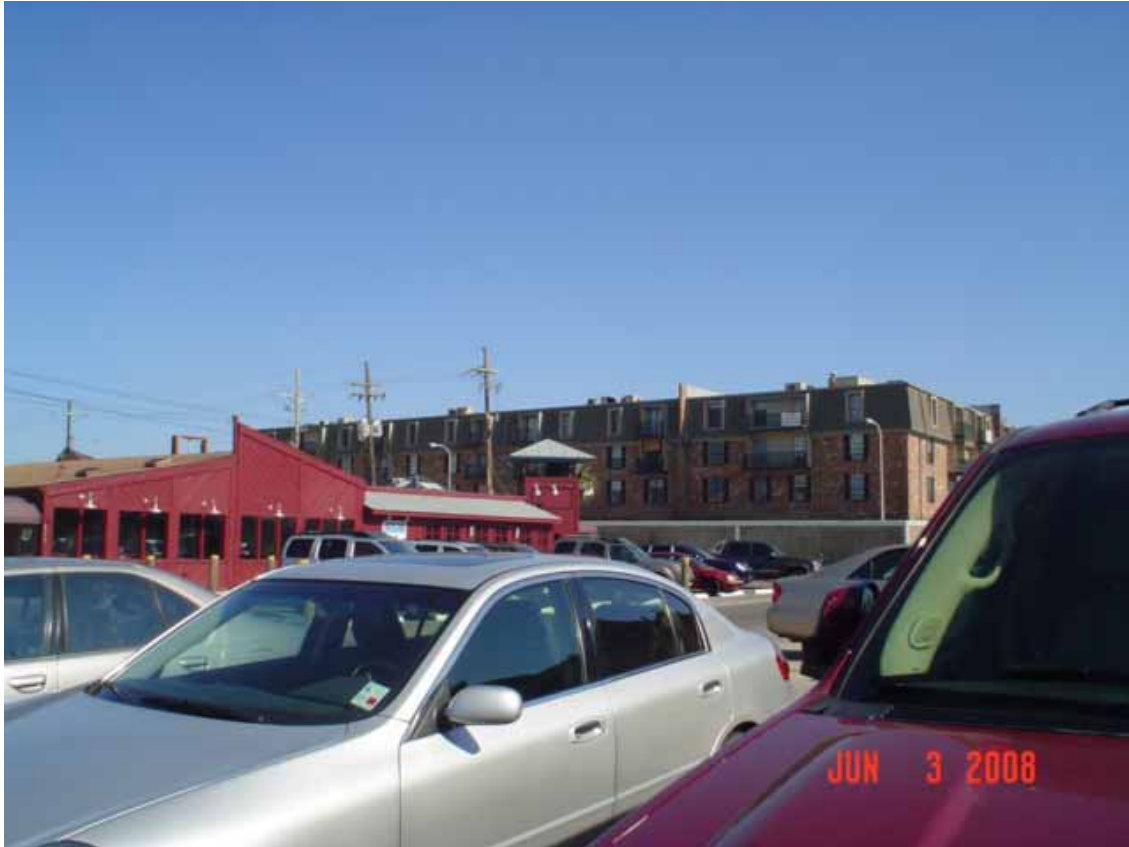
3. View of northwest area adjacent to the site, with apartments and restaurant. Observe transformers on poles in background across street.

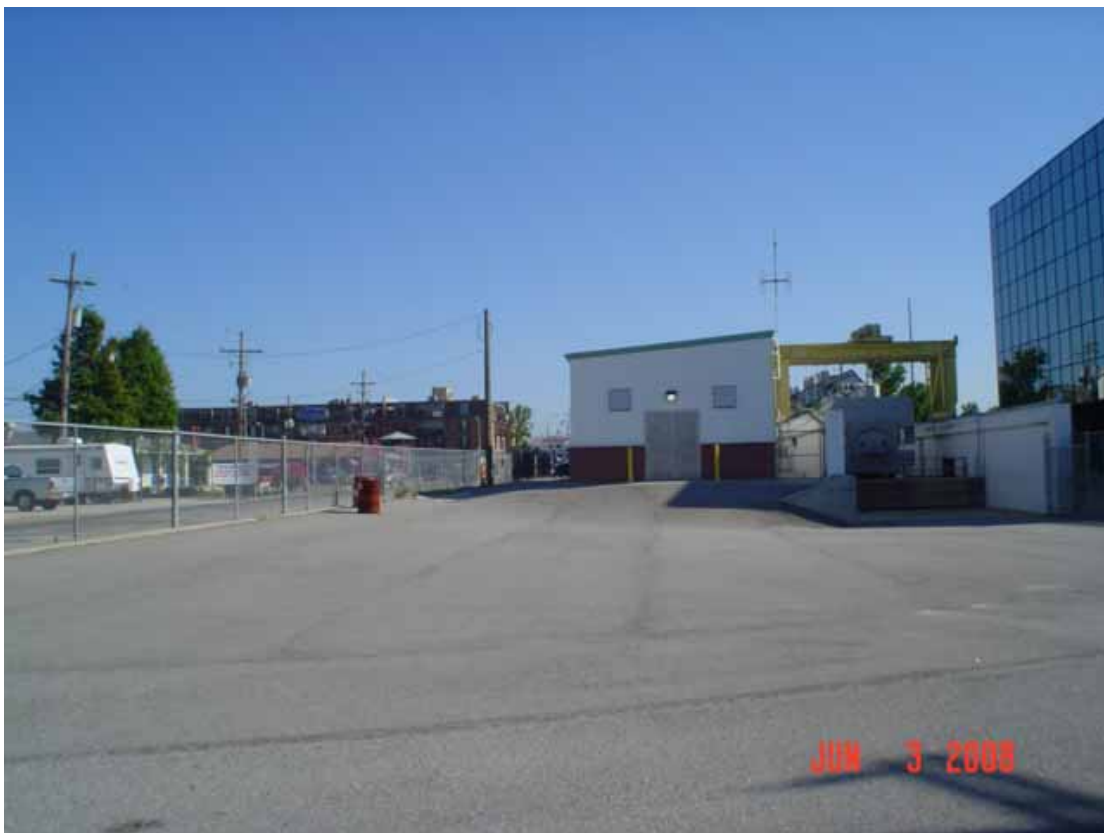
6. View of site as seen from the south direction. Observe transformers on poles located west of the site.

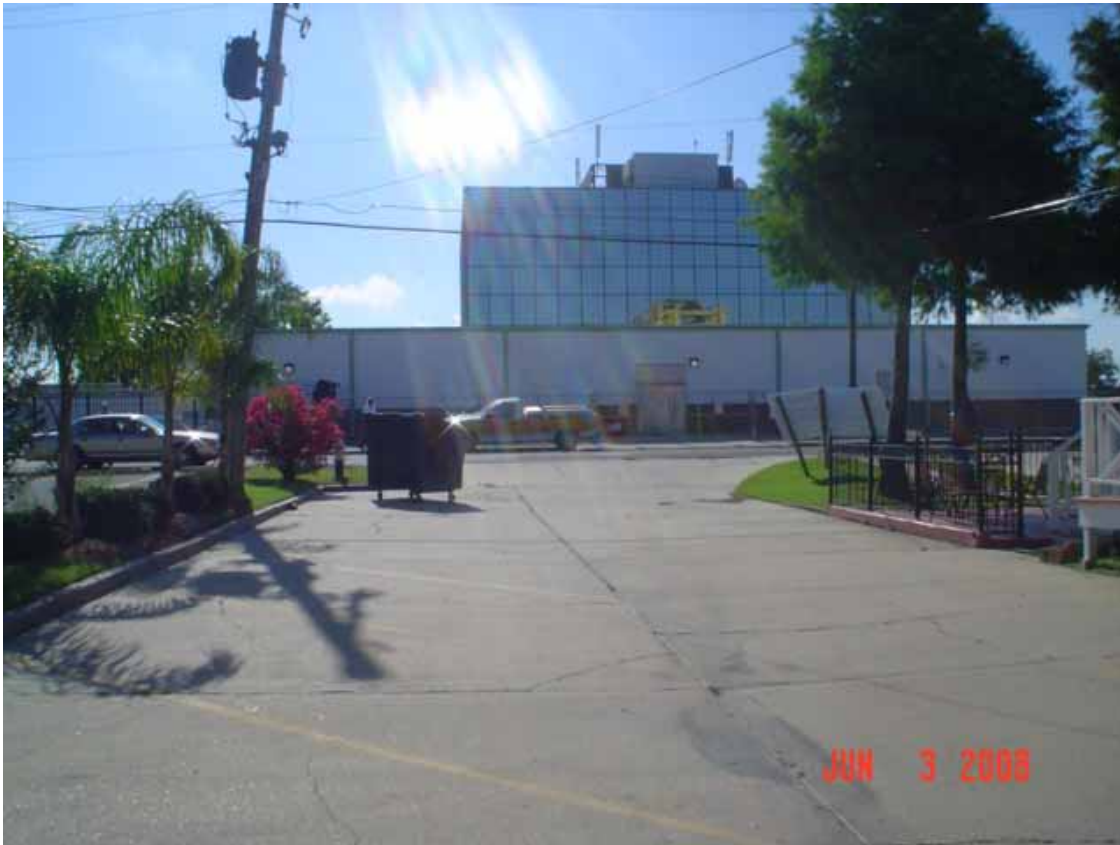
9. View of site as seen from the west direction. Observe transformer on pole west of Pontchartrain Boulevard.

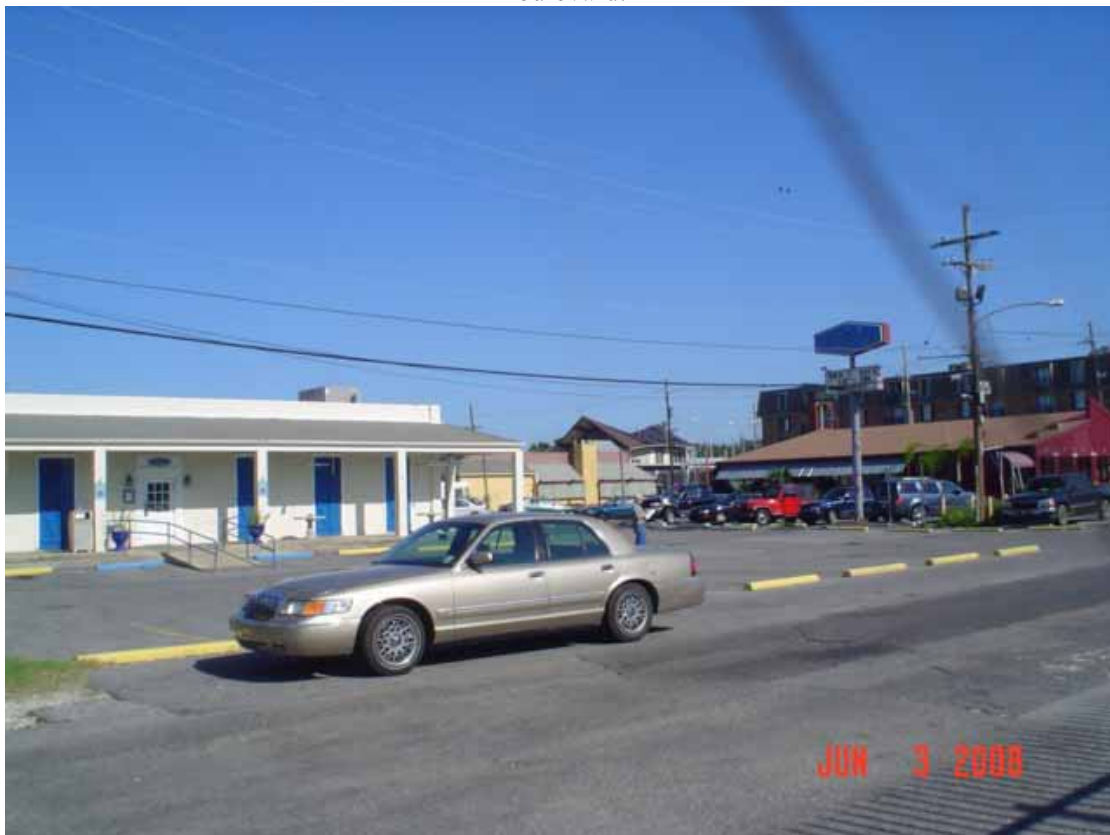
10. View of west area adjacent to the site. Observe transformers on poles in northwest area.

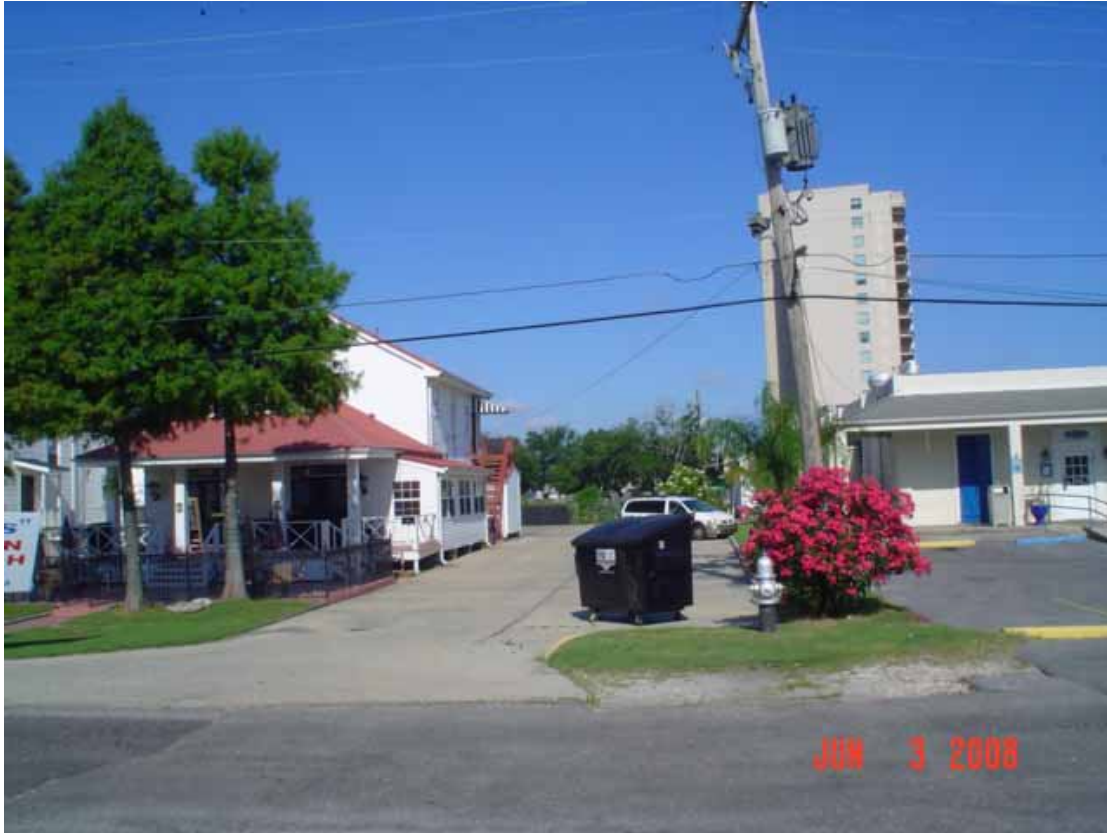
11. View of west area adjacent to the site, two restaurants. Observe transformers on pole west of Pontchartrain Boulevard.

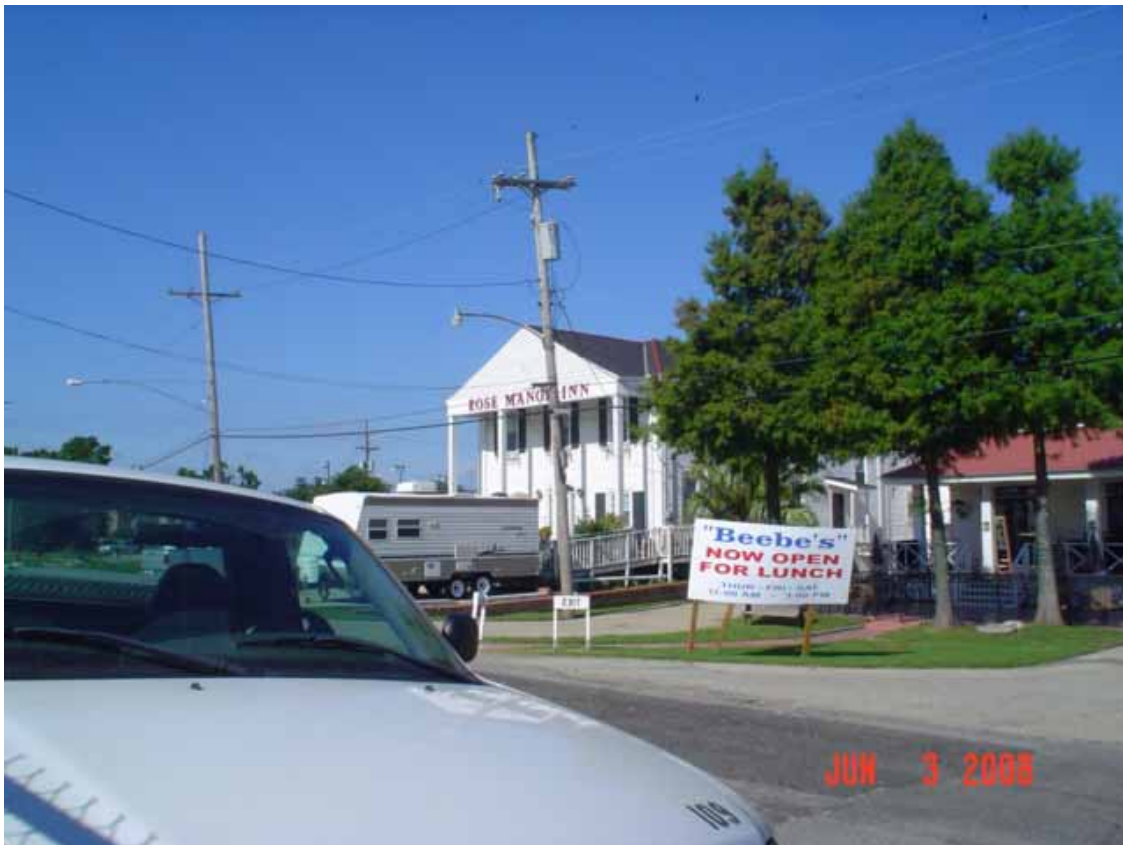
12. View of west area adjacent to the site, bed and breakfast. Observe pole transformer located southwest of site across Pontchartrain Boulevard.

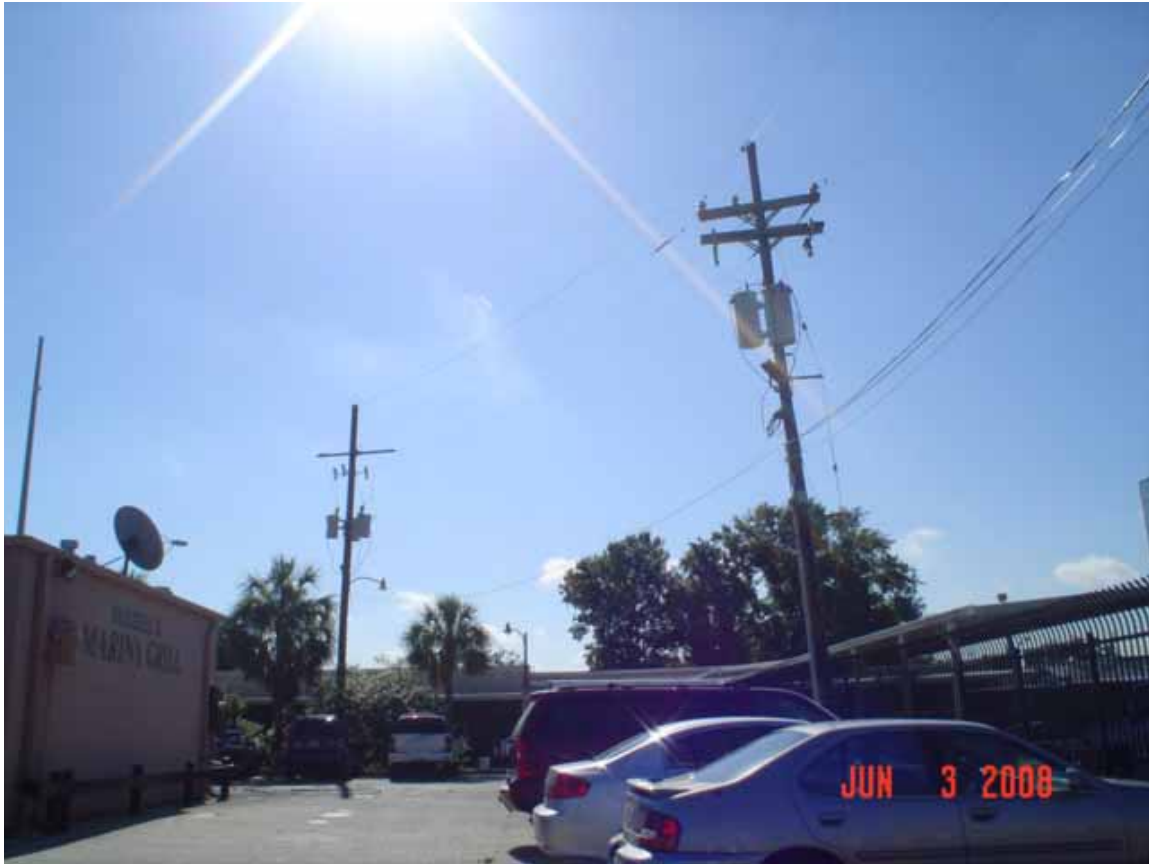
13. Observe transformers northwest of site.

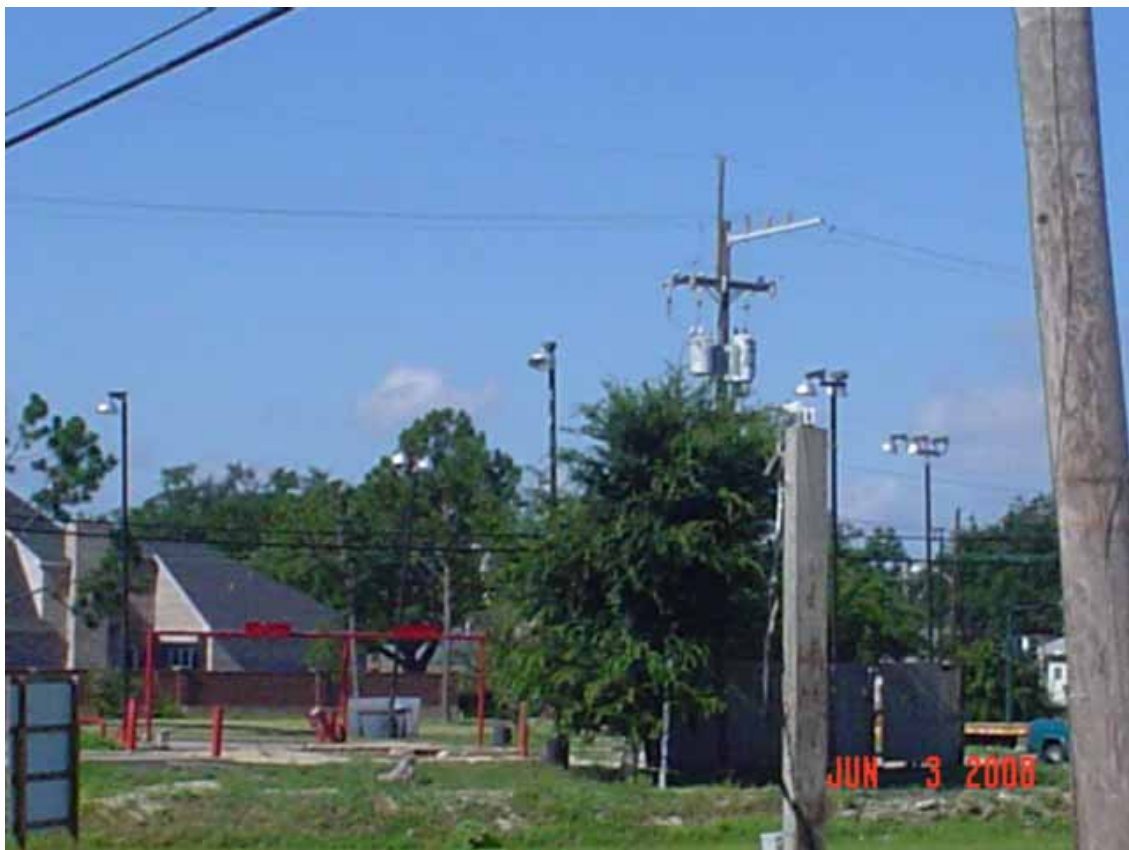
14. Partially demolished Rally's, in southwest area from site. Observe pole transformers in background.

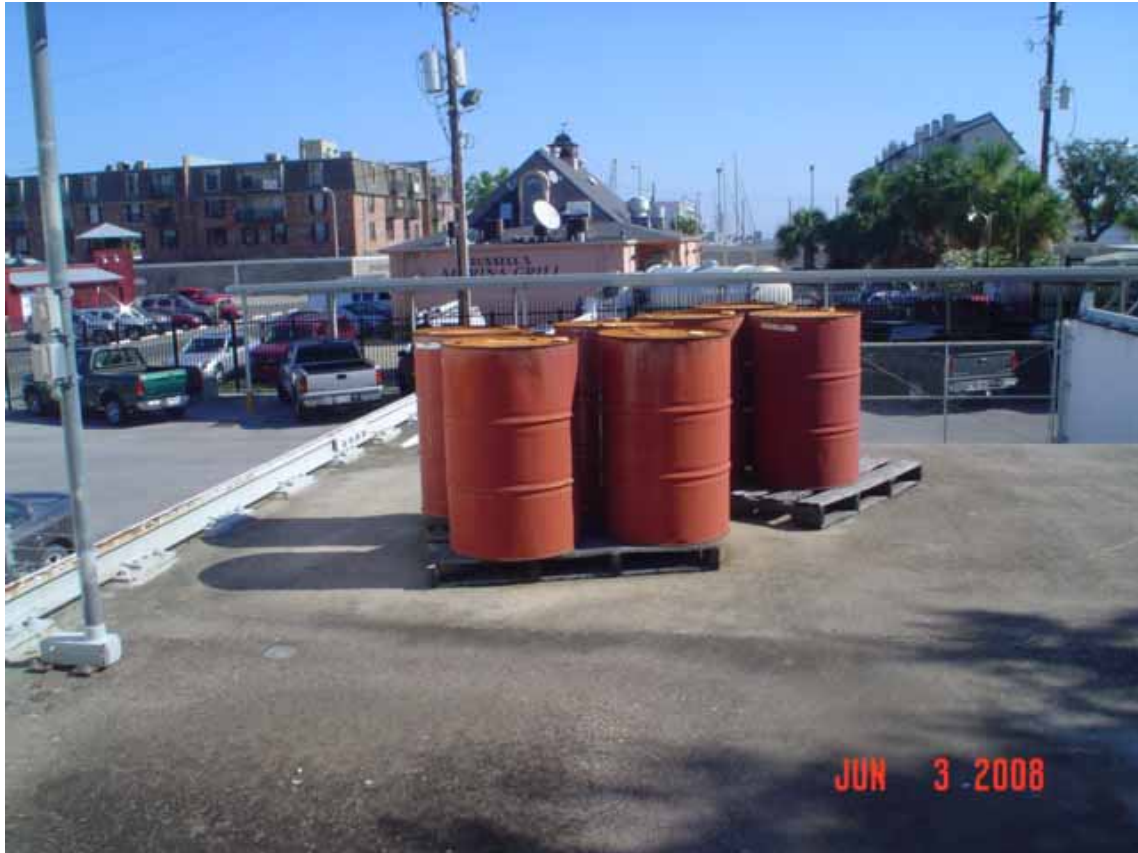
15. View of rusting 55 gallon drums located on roof in northeast area.

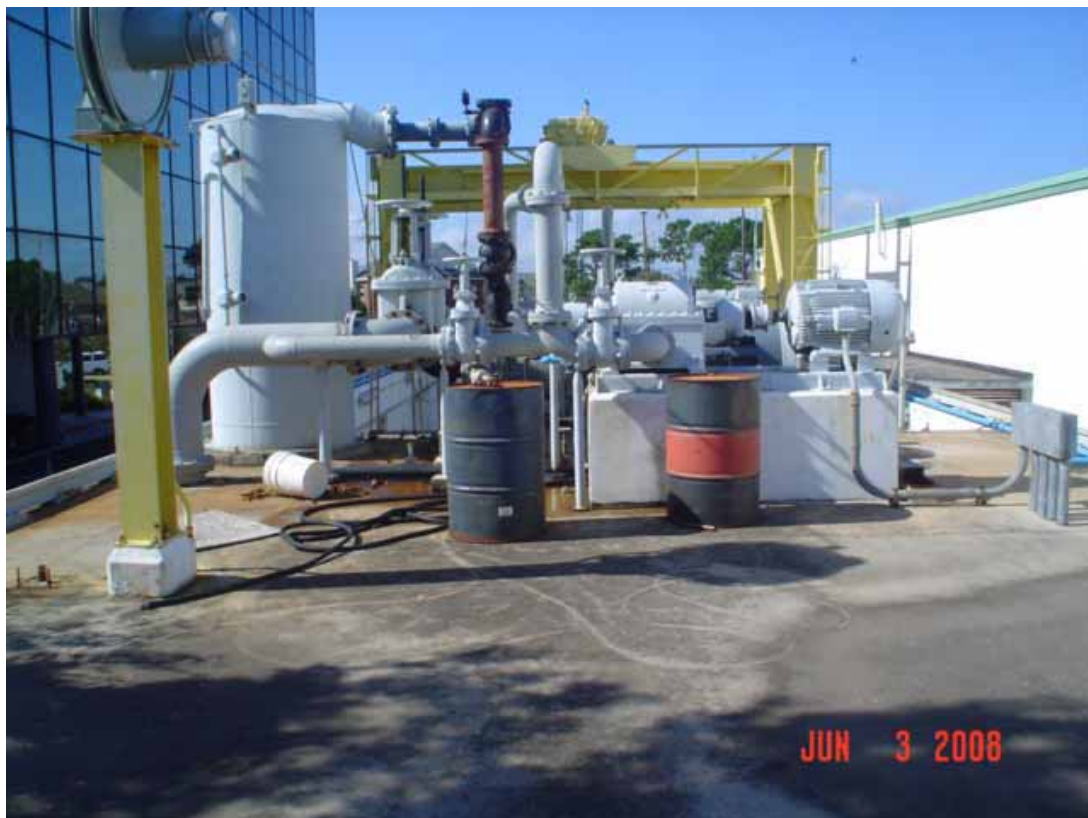
16. Observe pumps and rusting 55 gallon drums located on roof in northeast area.

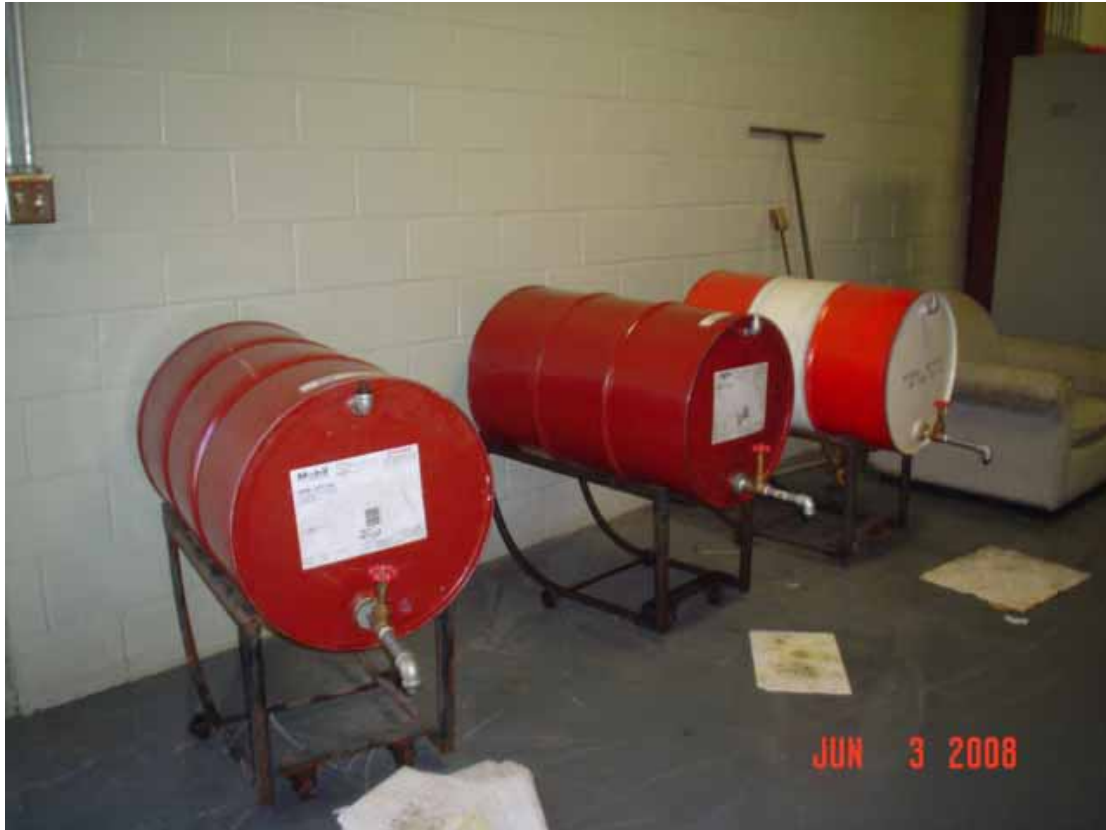
17. View of drums observed inside of building against west wall.

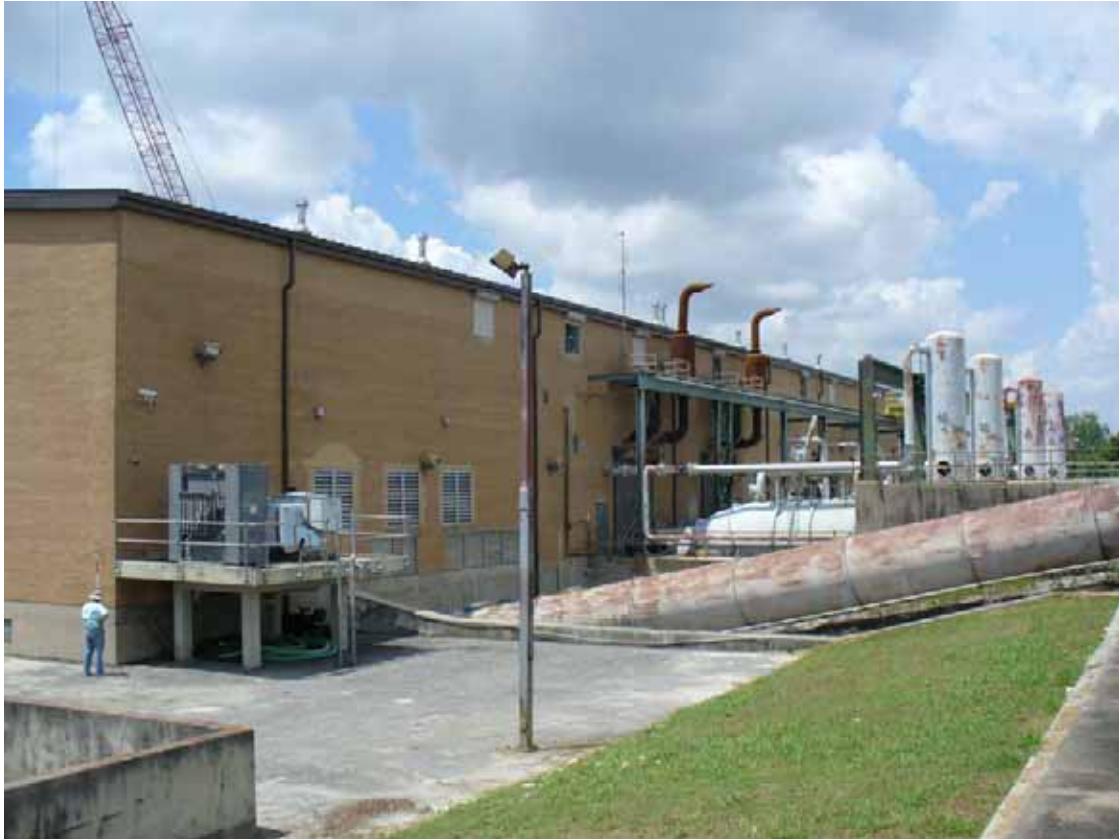
1. View of site as seen from the east direction. Observe two transformers at southeast corner of building.

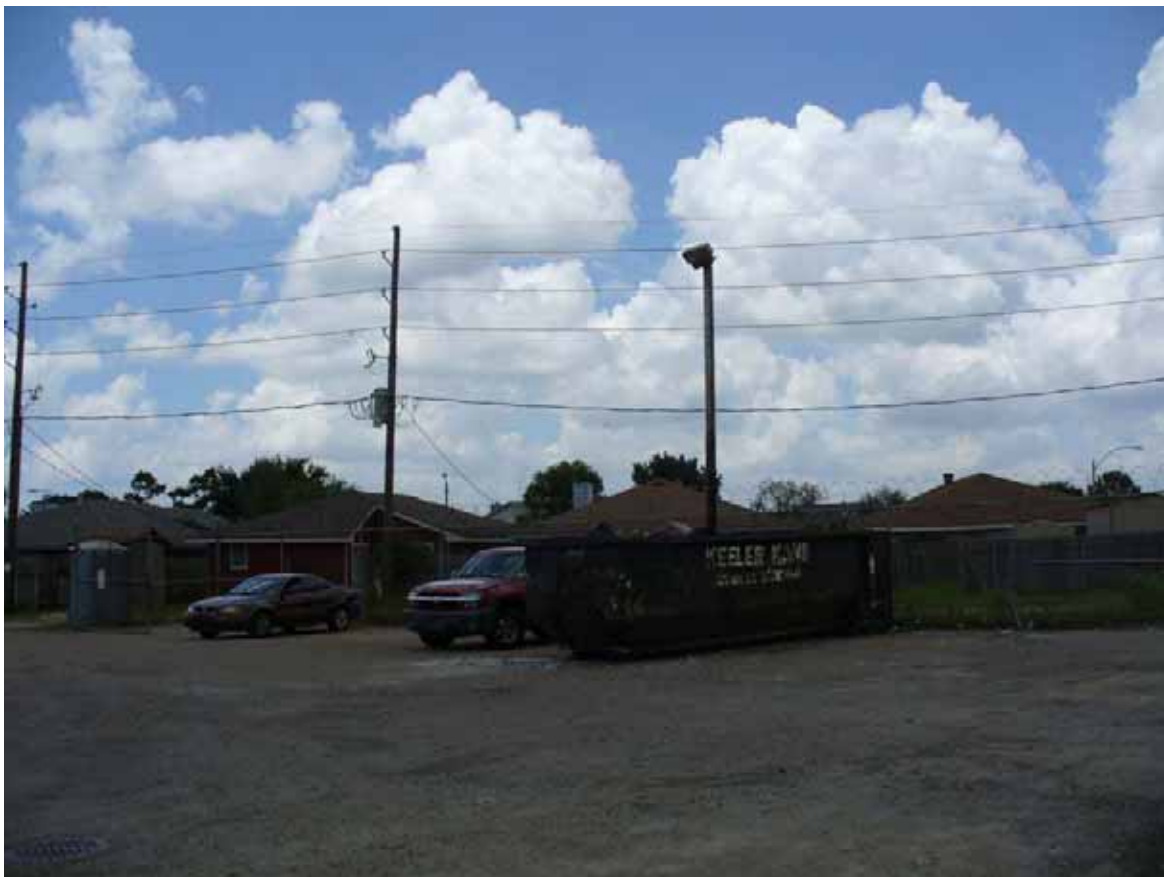
6. View of northwest area adjacent to the site. Reportedly, a septic tank is located near gate entrance.

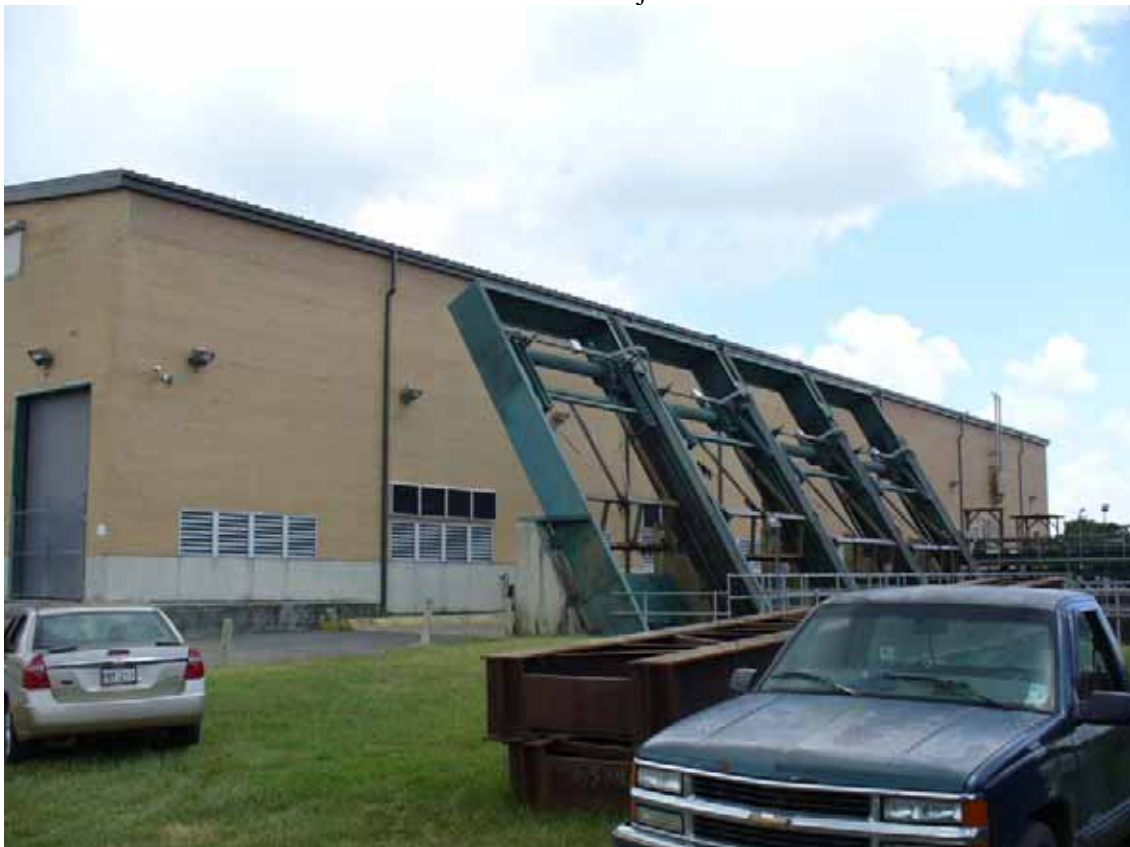
8. View of site as seen from the west direction.

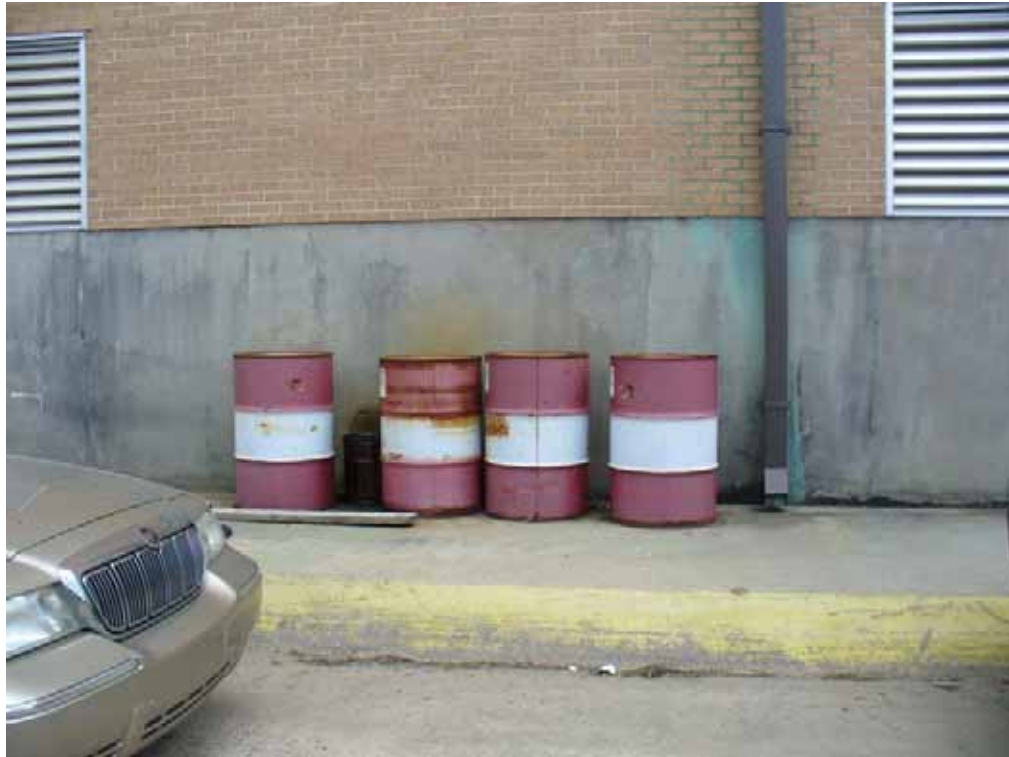
13. View of 55 gallon drums stored outside of east side of building.

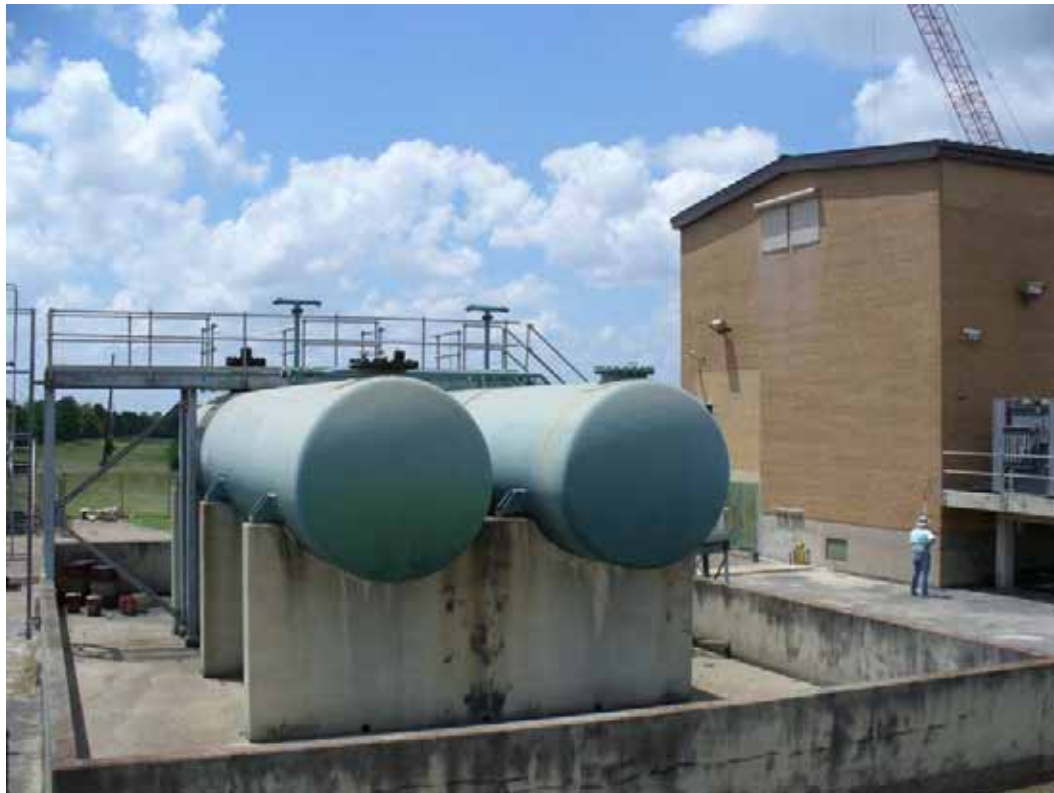
14. View of fuel tanks stored in southwest corner.

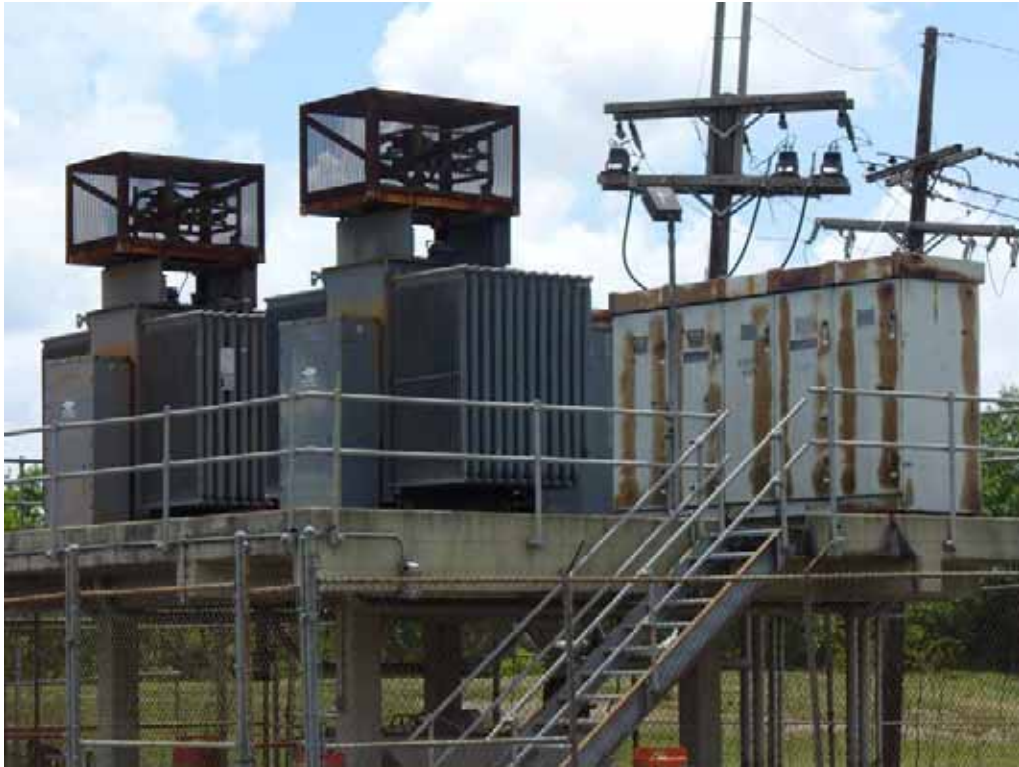
15. View of transformers and switchgear located southwest of site.

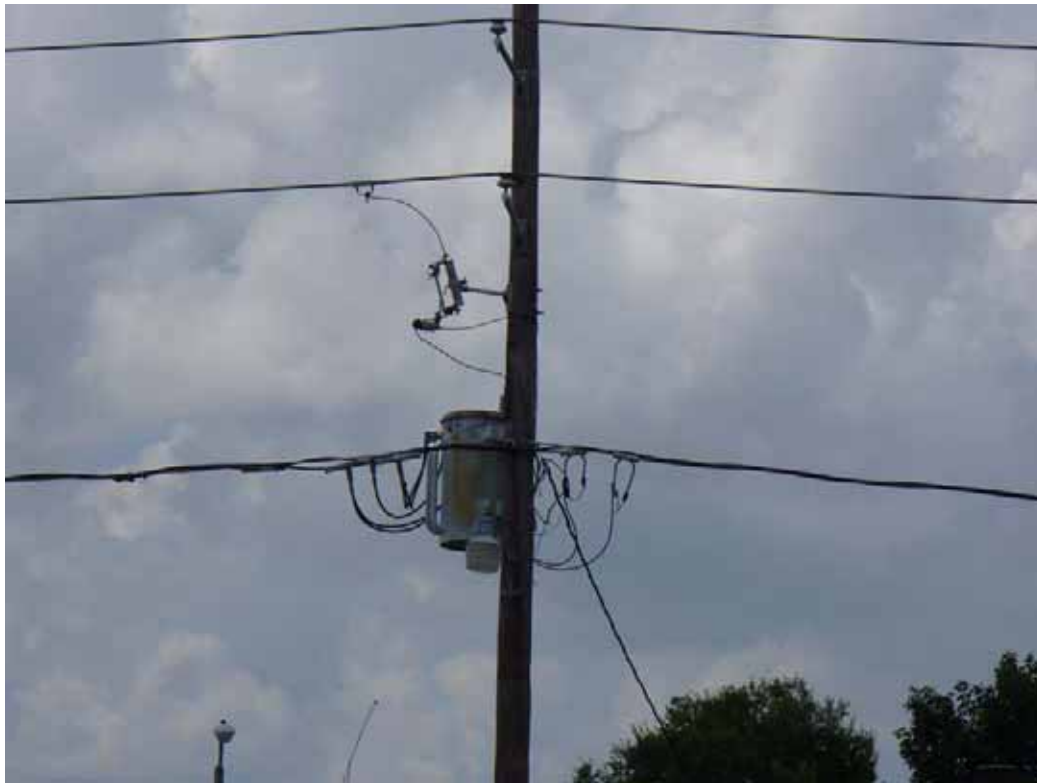
16. View of transformer north of property.

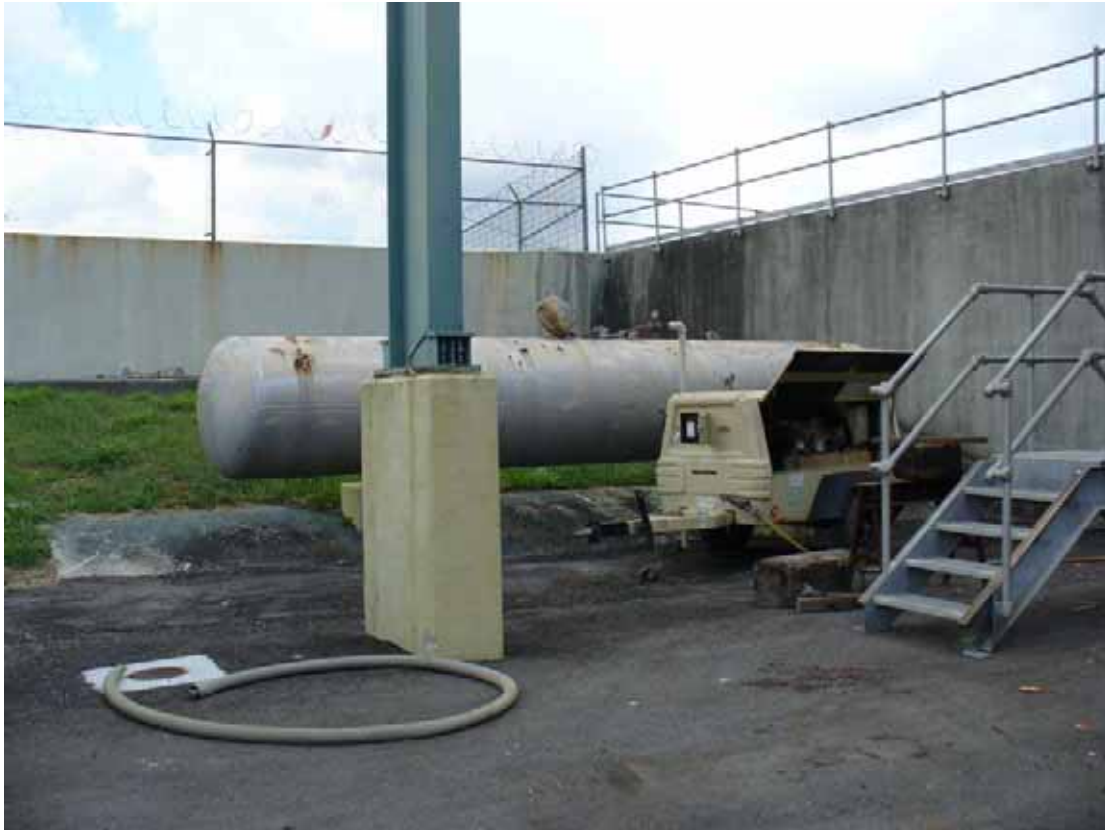
17. Empty propane storage tank observed in northeast area.

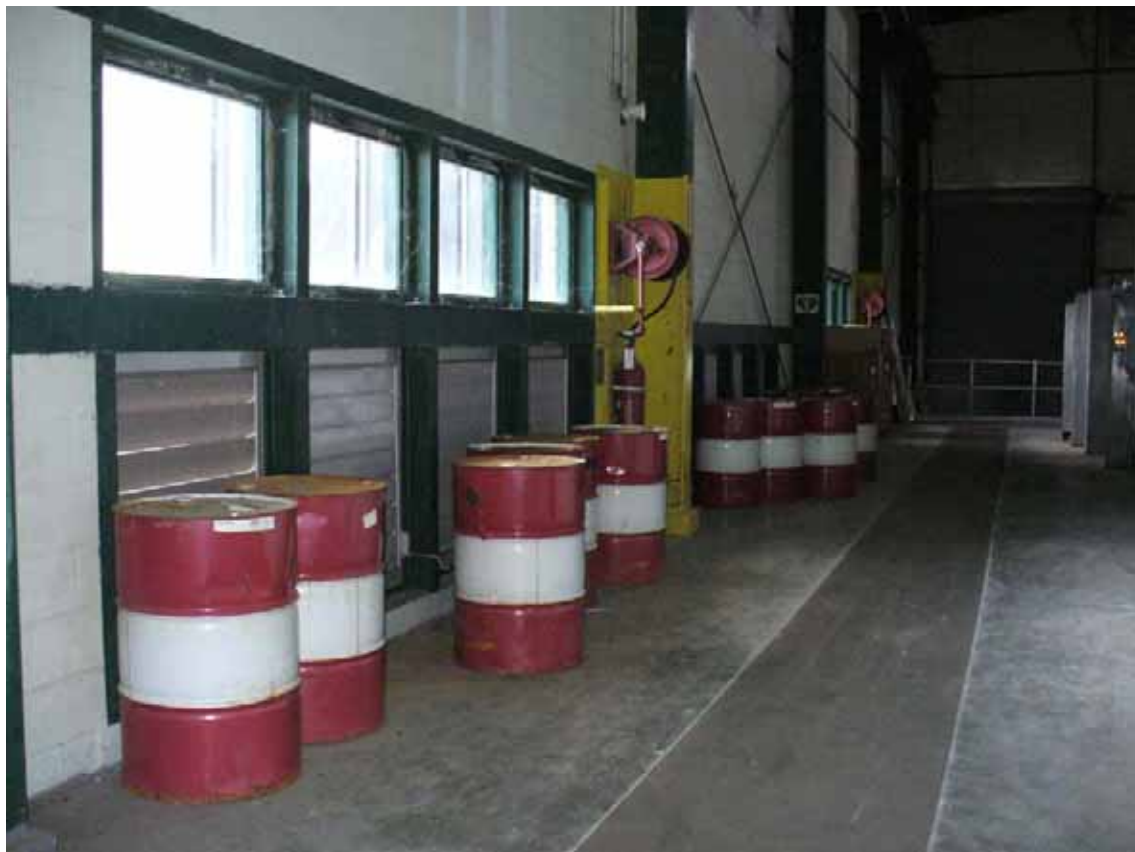
18. View of drums stored inside building.

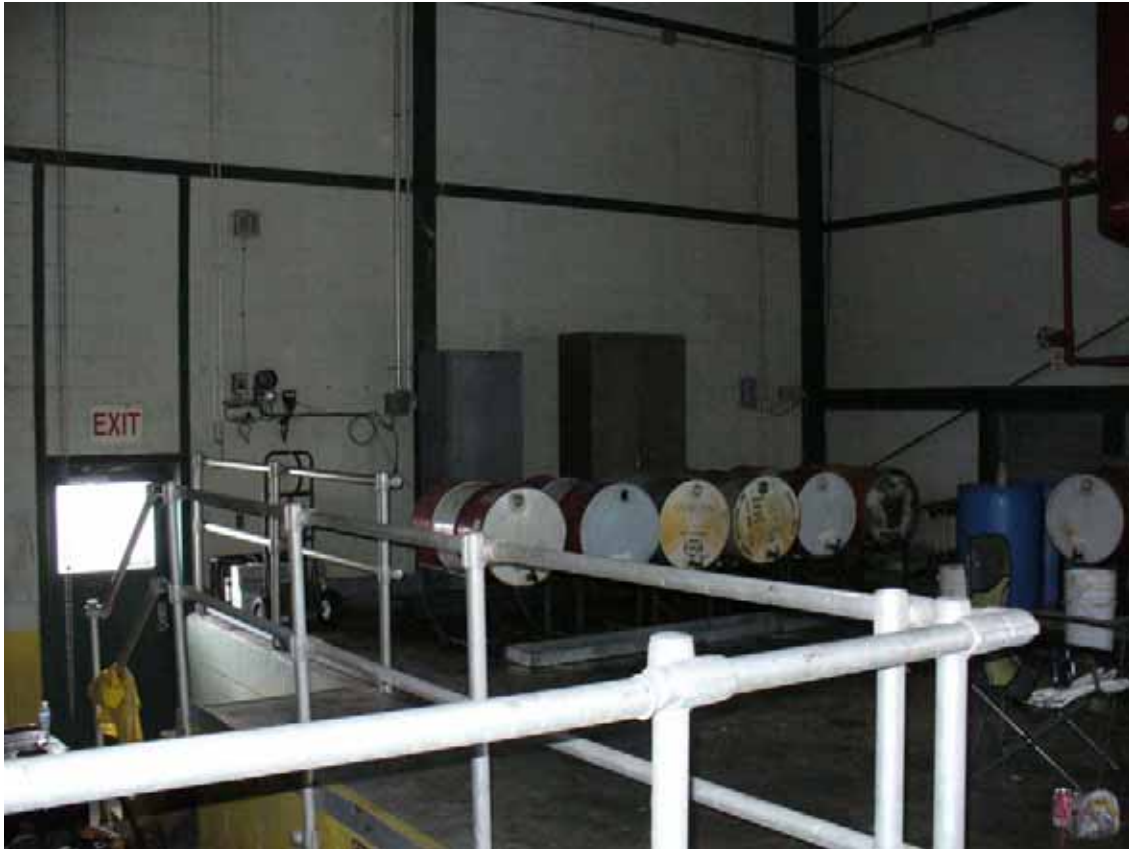
19. Drums in use inside building.

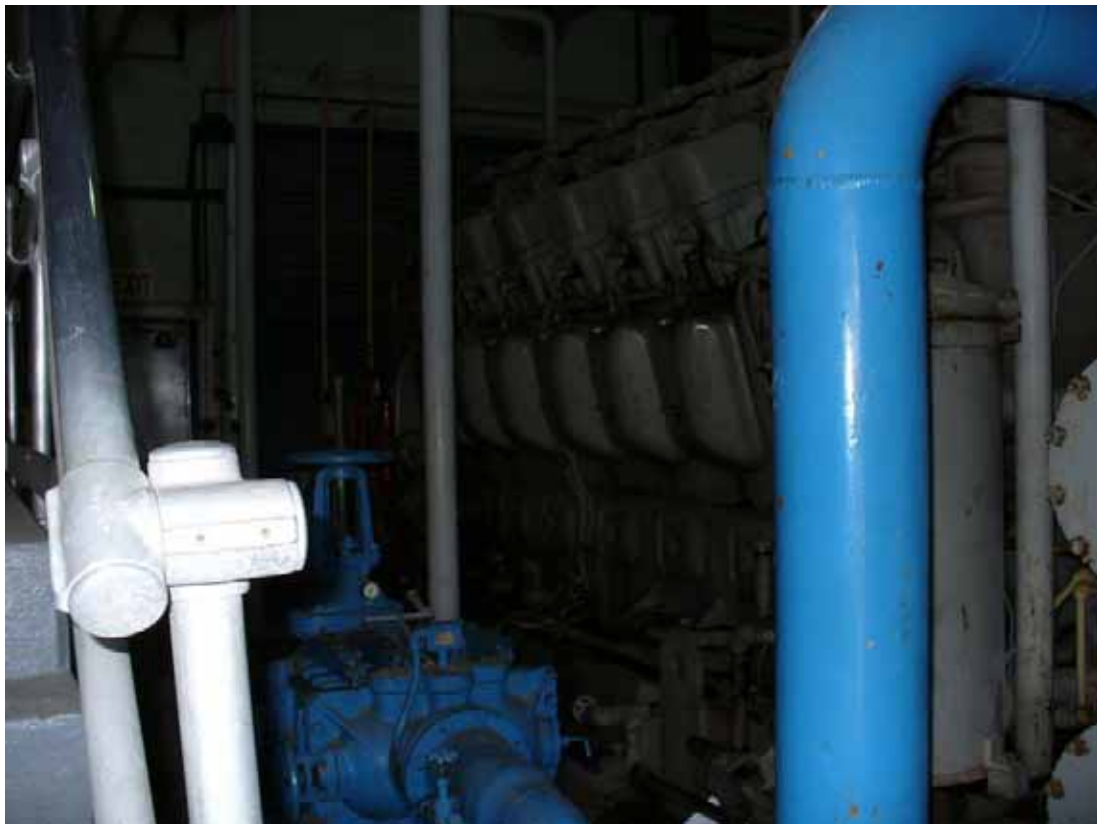
20. Diesel engine.
