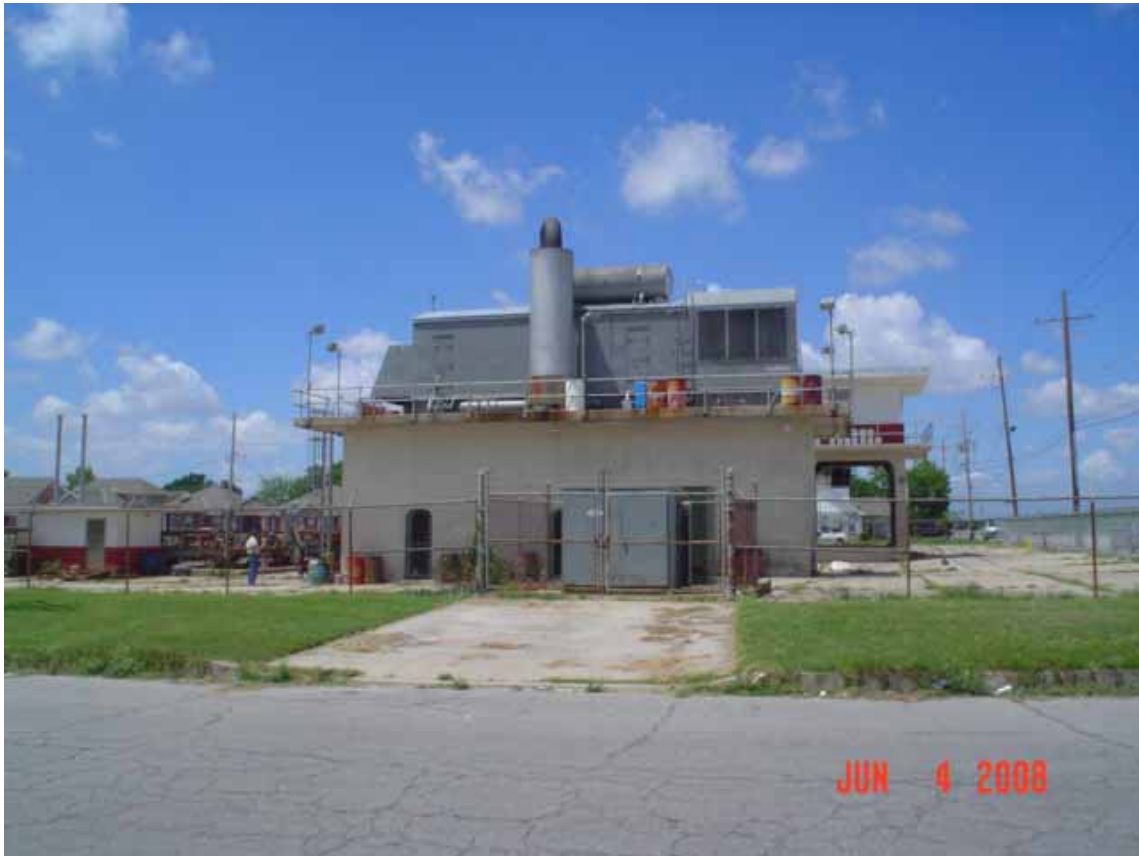
3. View of site as seen from the east direction. Observe 55 gallon drums in southeast area and on roof.

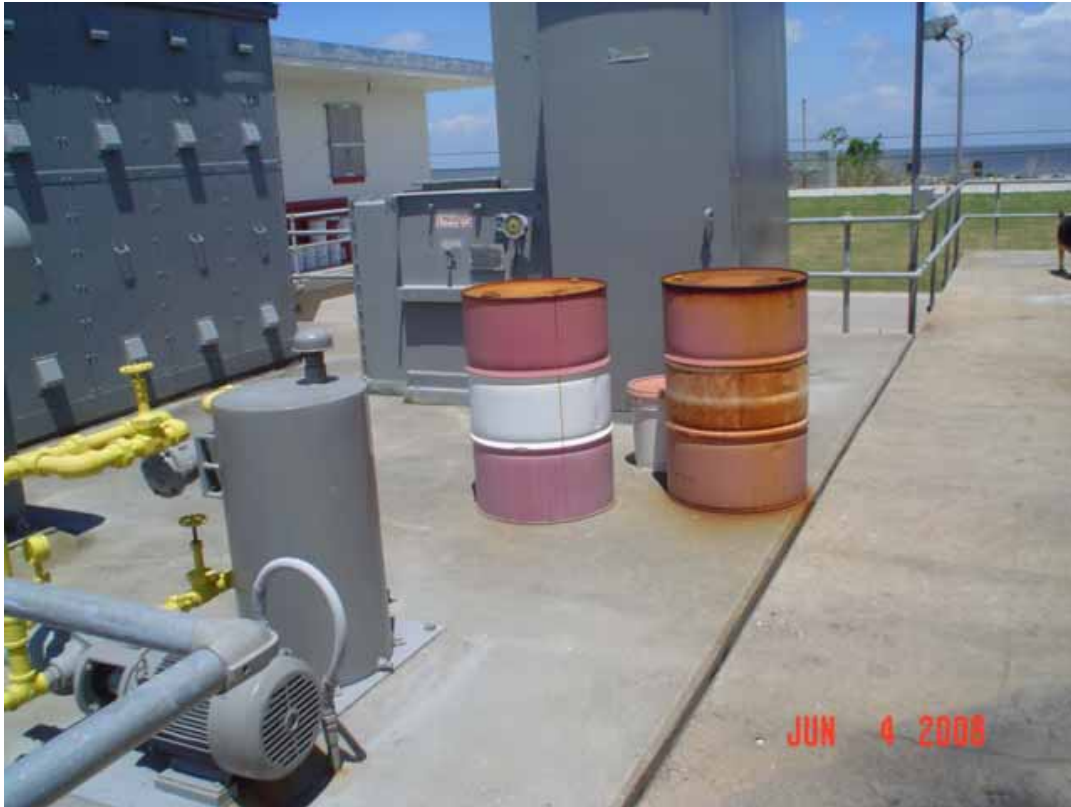
11. 55 gallon drums stored on top of the station building.

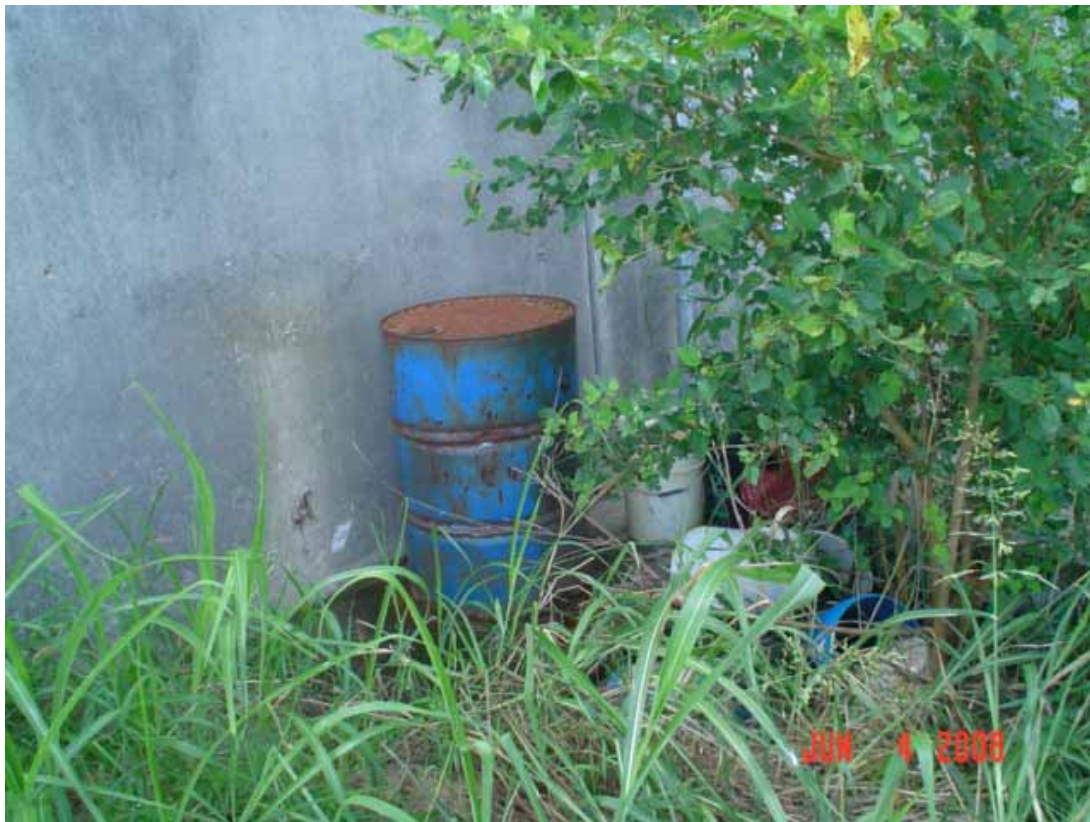
13. View of empty, abandoned 55 gallon drum located north of site.

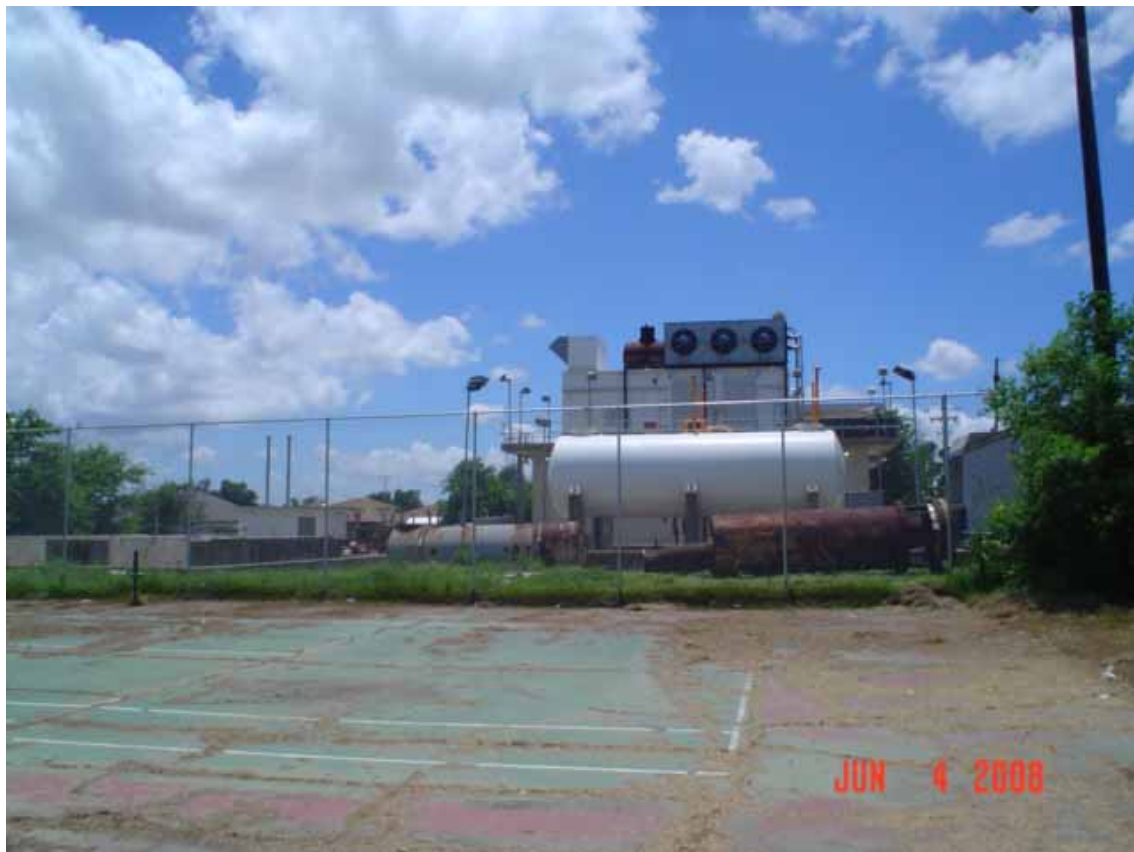
4. View of site as seen from the east direction.

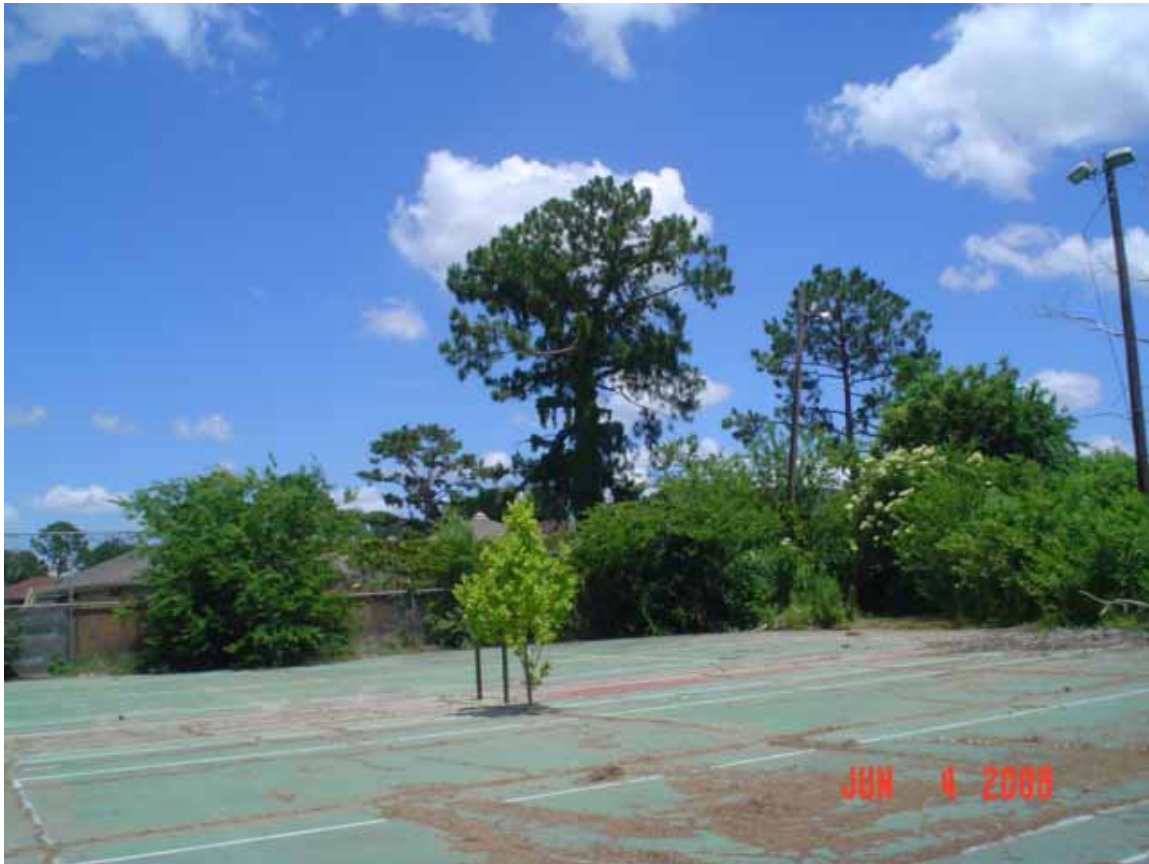
5. View of east area adjacent to the site.

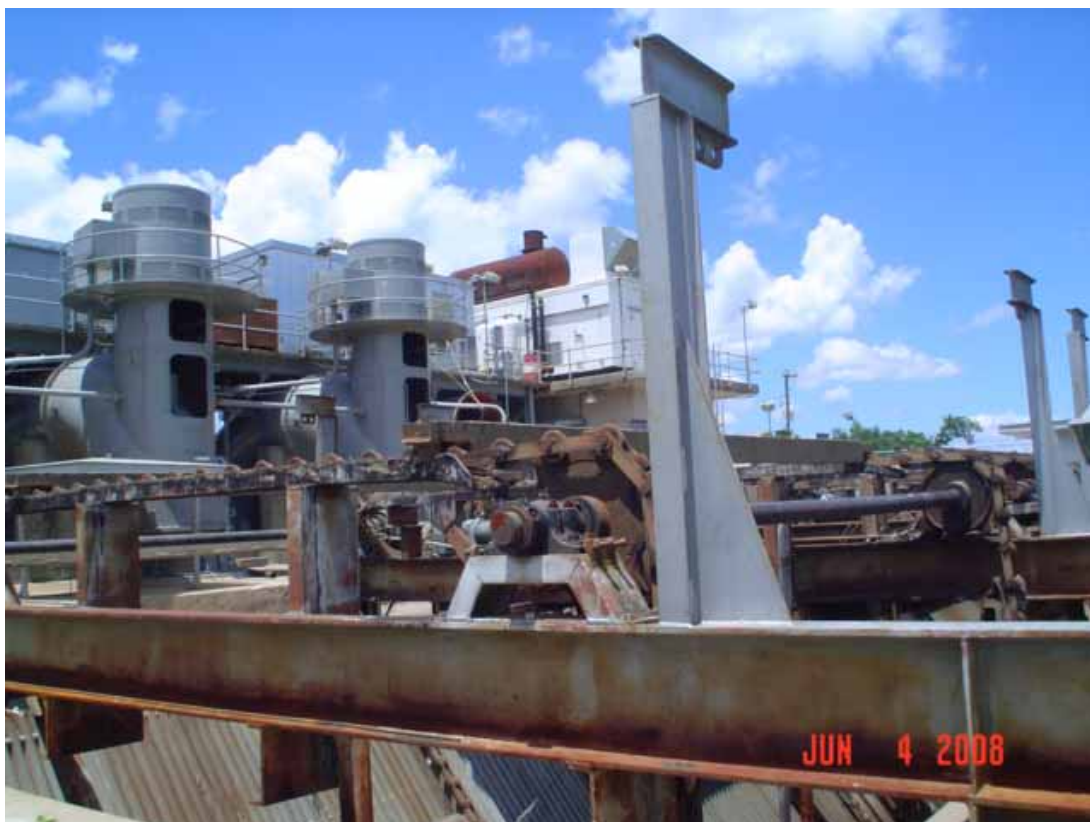
6. View of site as seen from the south direction.

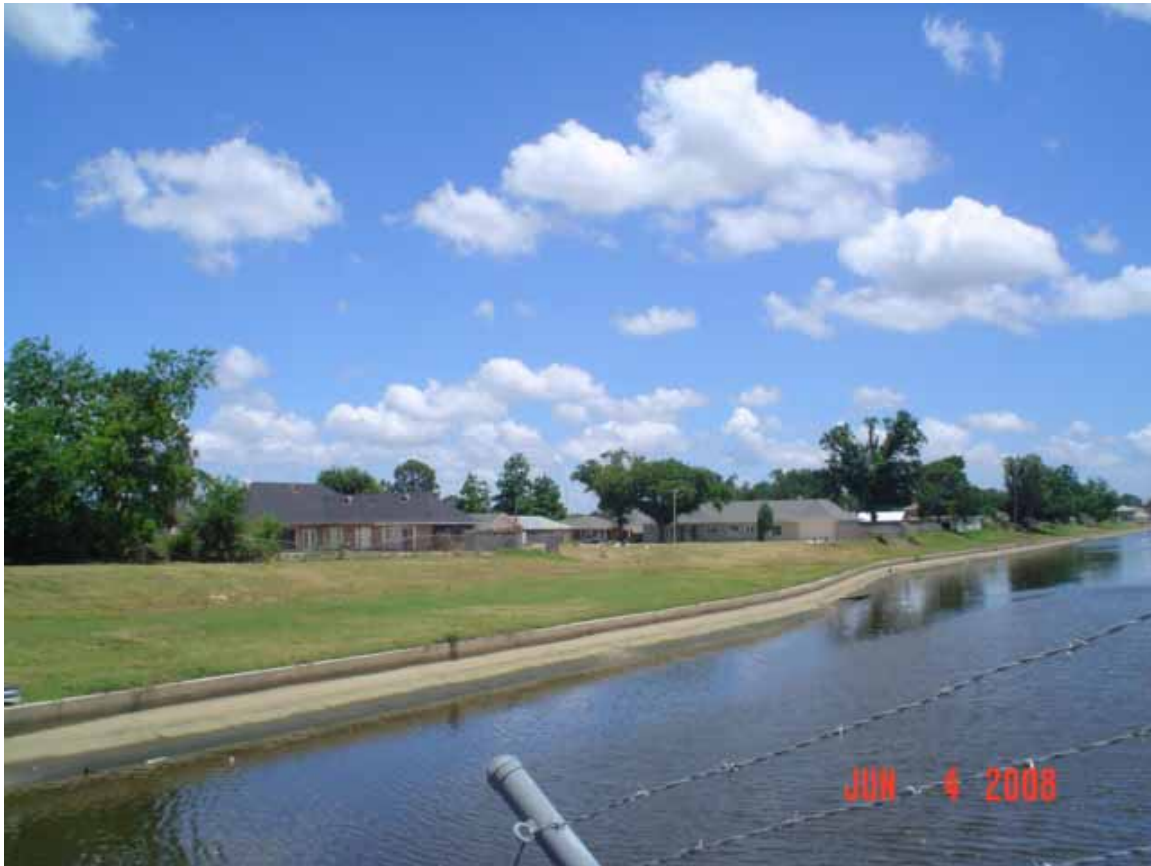
7. View of south area adjacent to the site, canal in southeast direction.

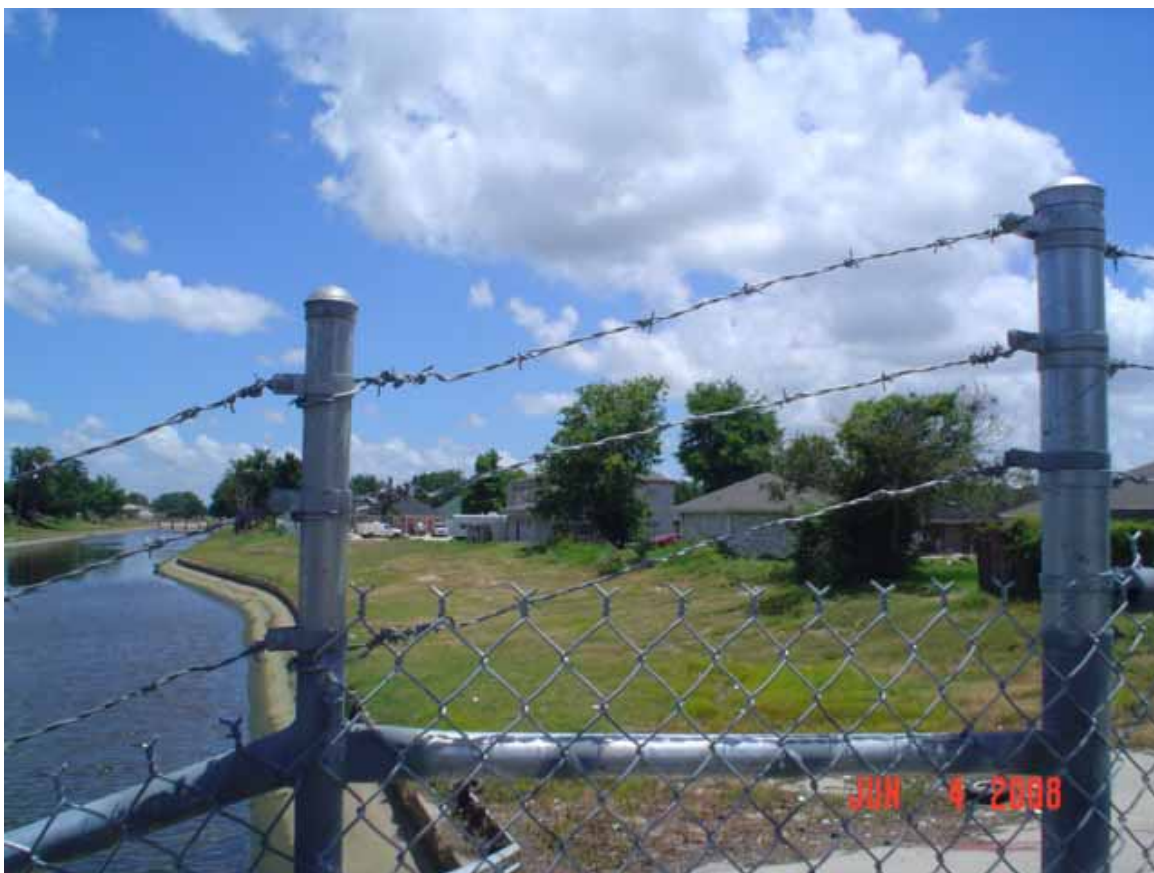
8. View of south area adjacent to the site, canal in southwest direction.

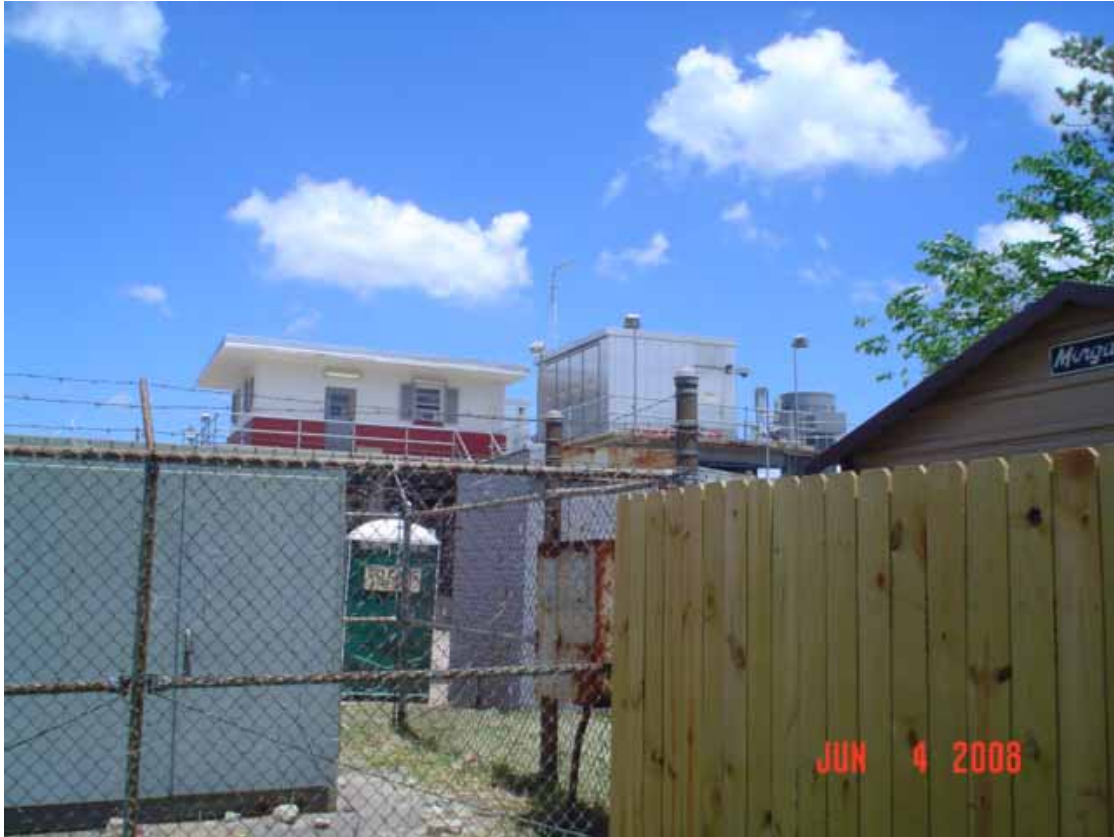
9. View of site as seen from the west direction.

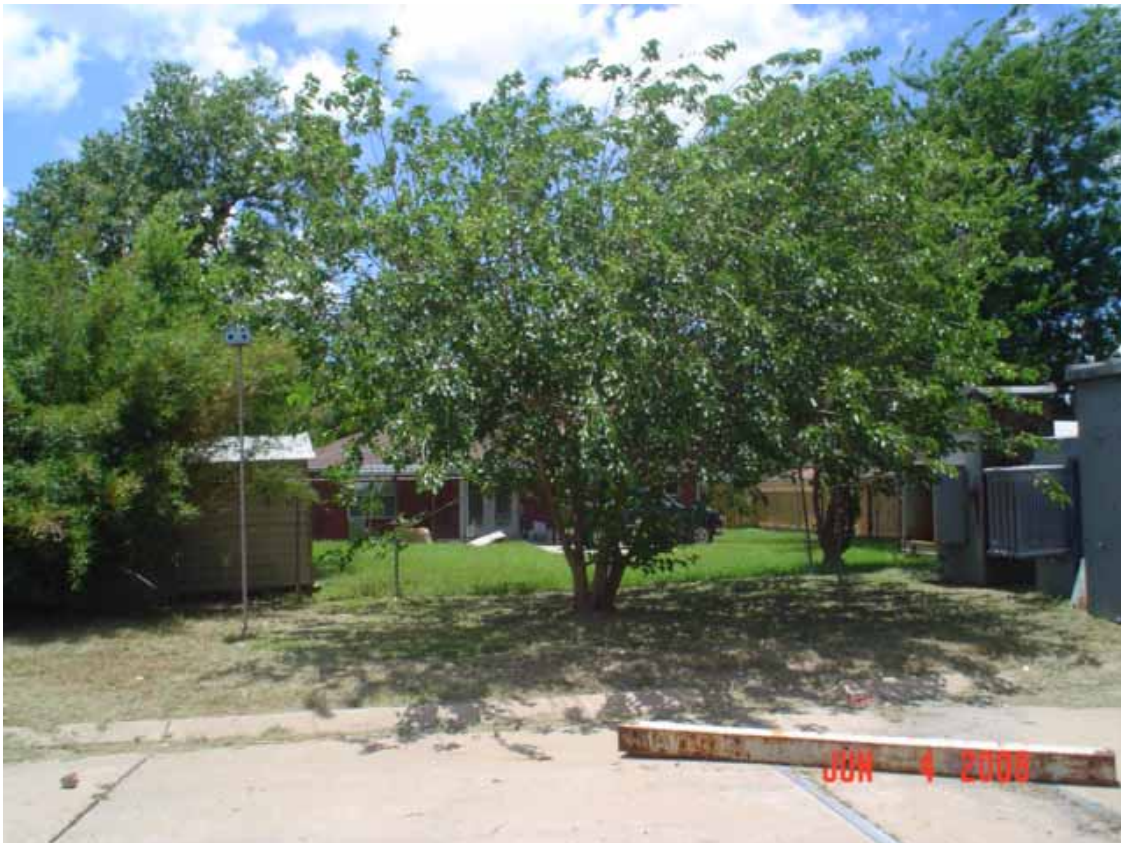
10. View of west area adjacent to the site, showing transformers on property in northwest direction.

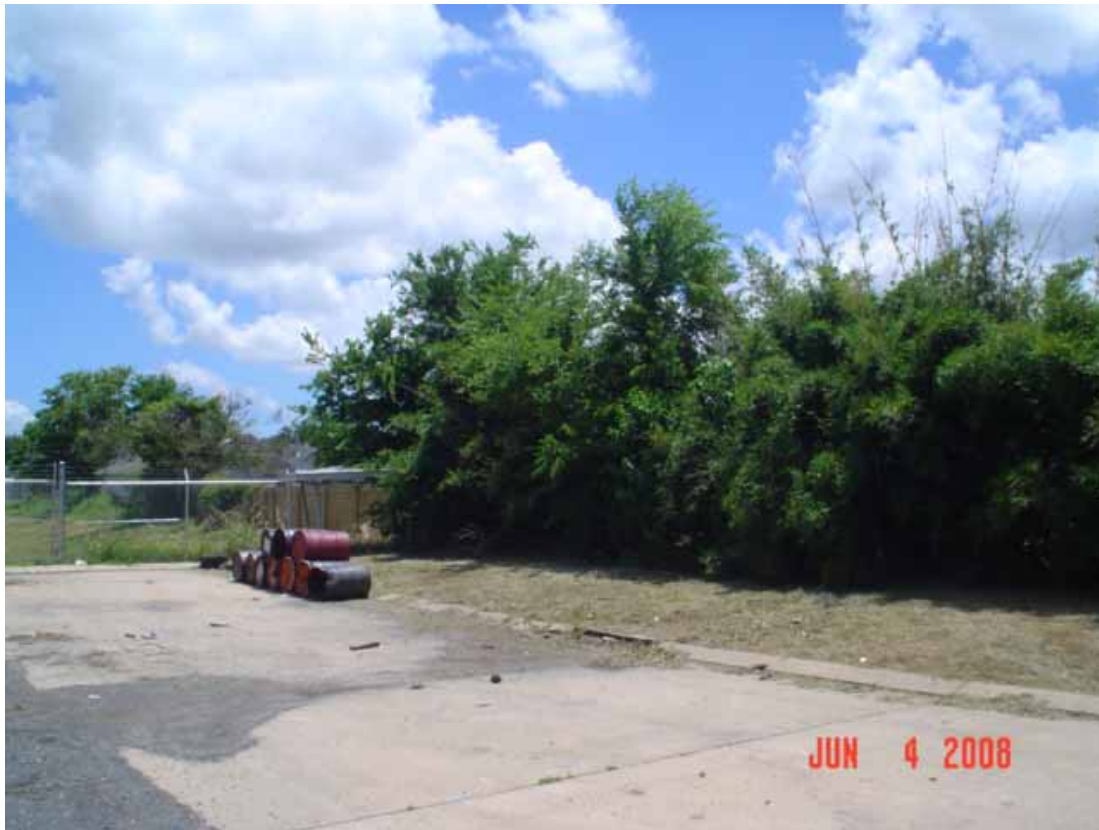
11. View of west area adjacent to the site, showing empty 55 gallon drums in southwest corner.

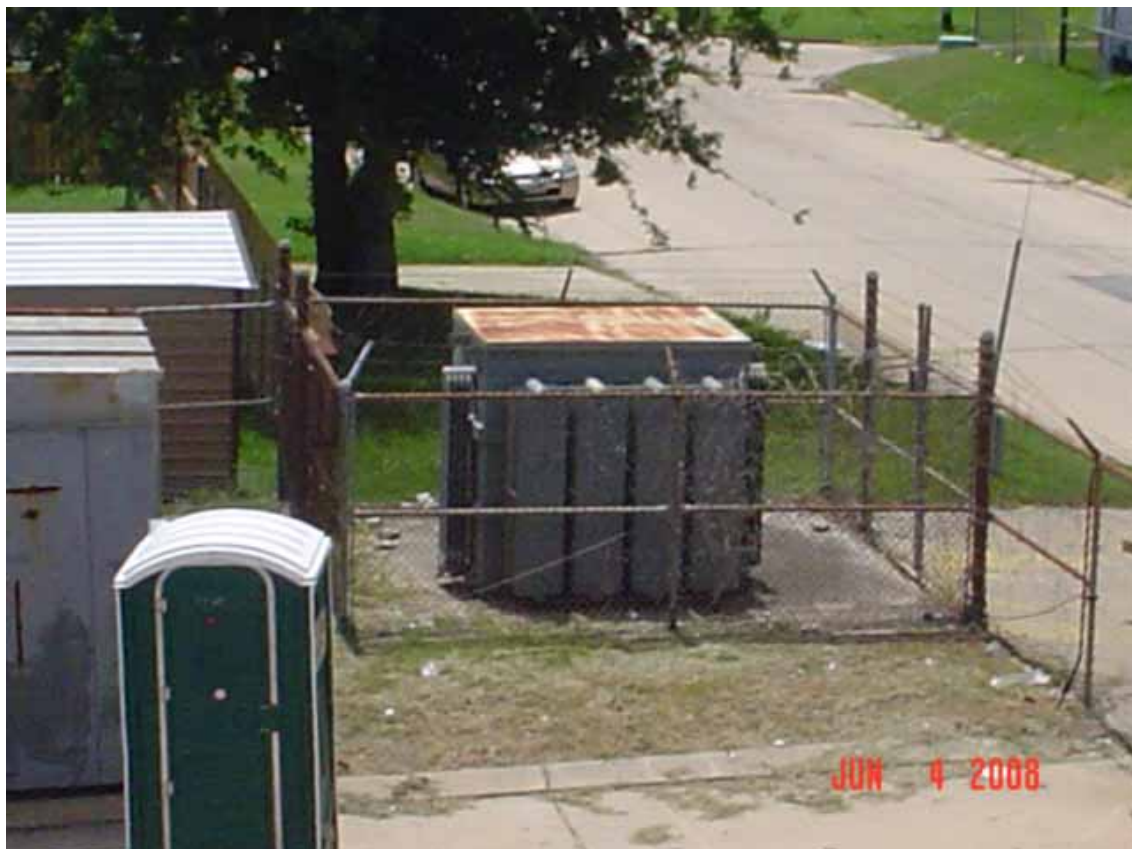
12. Additional transformer in northwest corner, owned by Entergy.

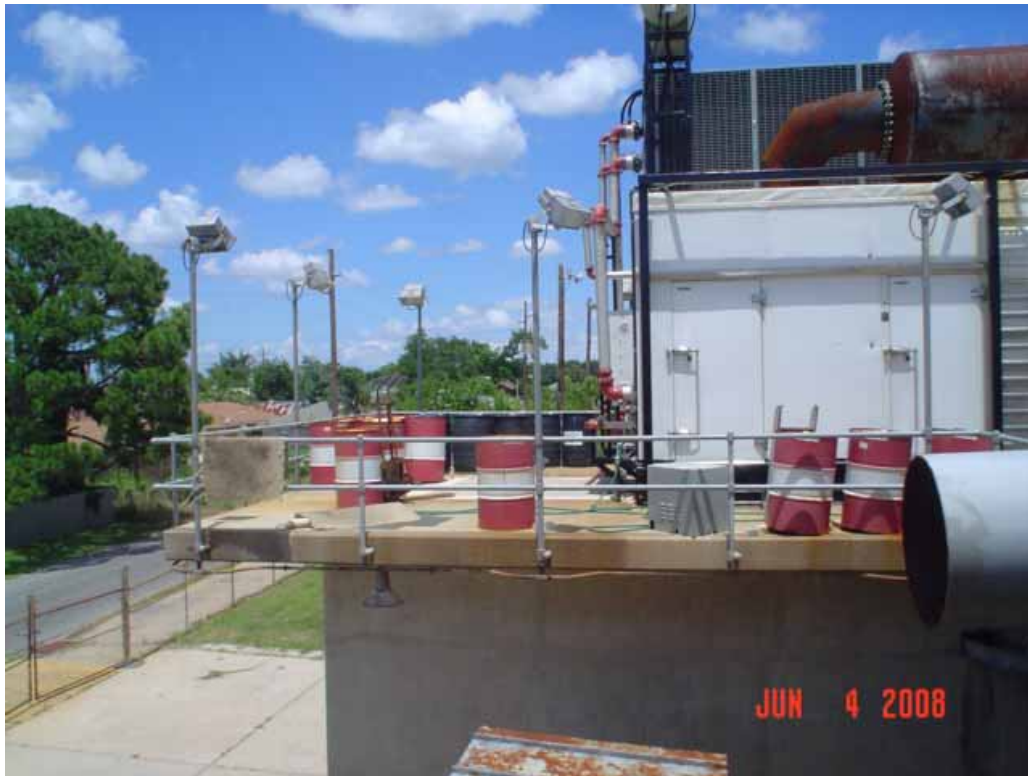
13. Observe drums of stored petroleum on second floor.

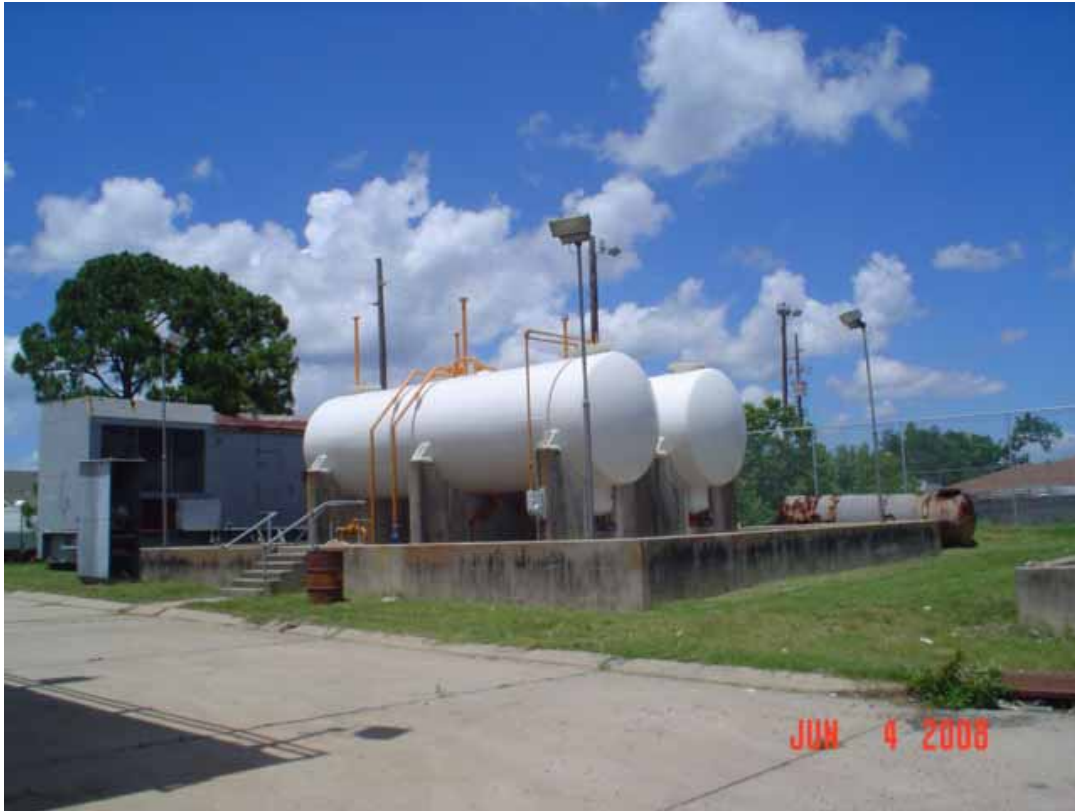
15. View of diesel fuel tanks in northwest area.

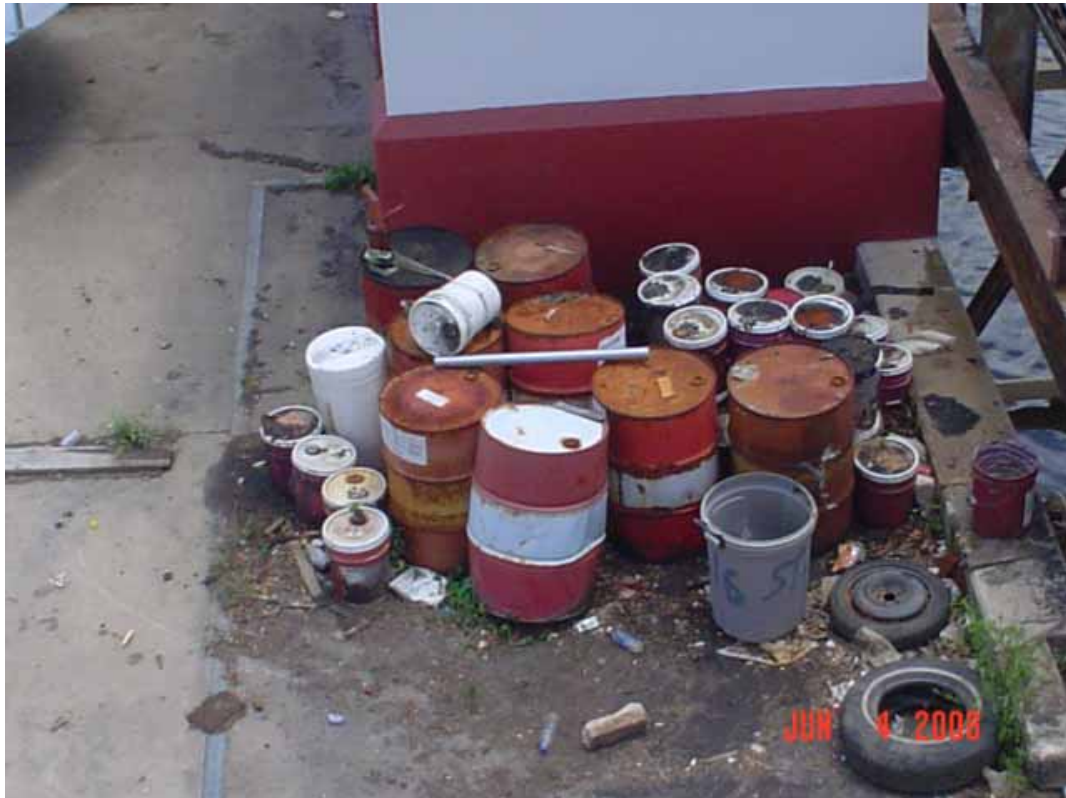
16. View of oil and lubricant containers stored near canal. Tires are part of debris removed from canal.

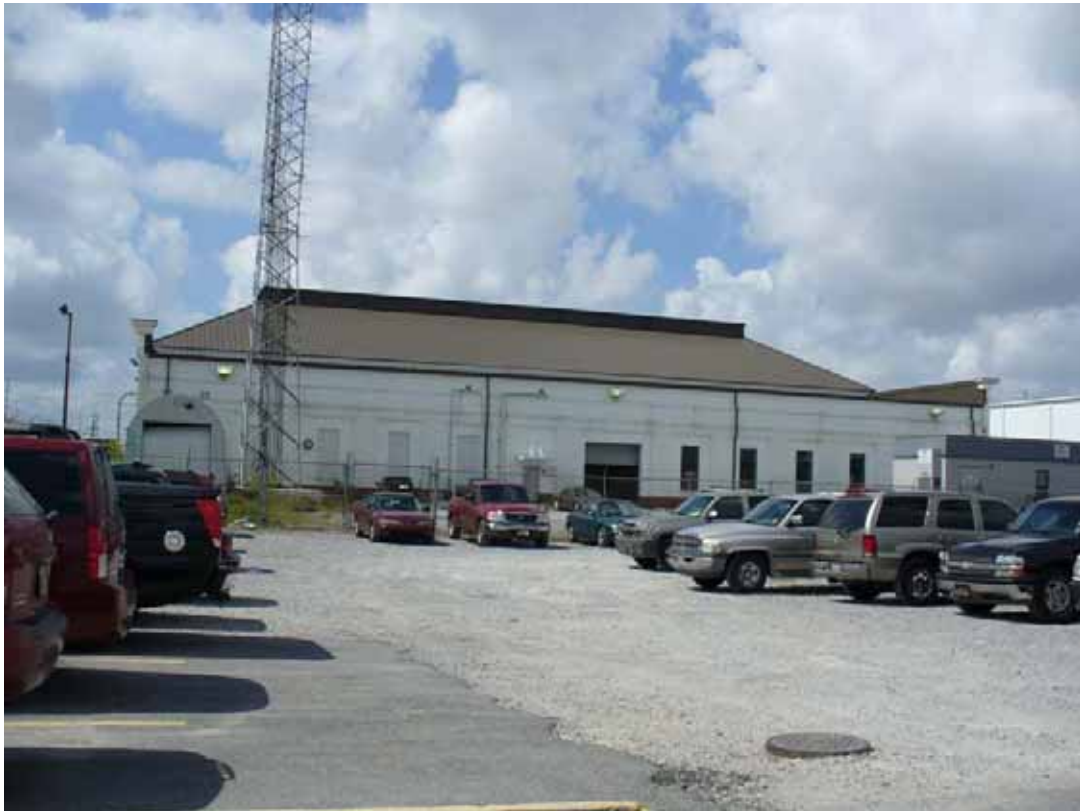
1. View of site as seen from the north direction.

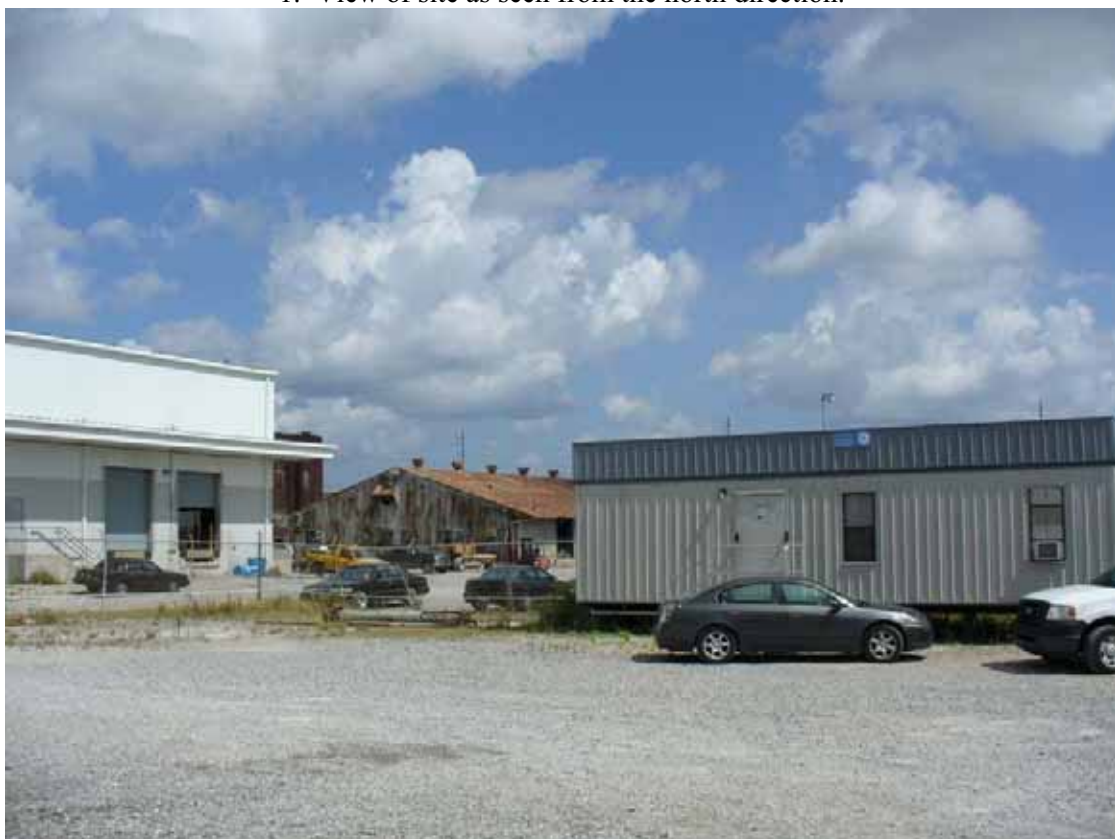
2. View of north area adjacent to the site, from adjacent parking lot.

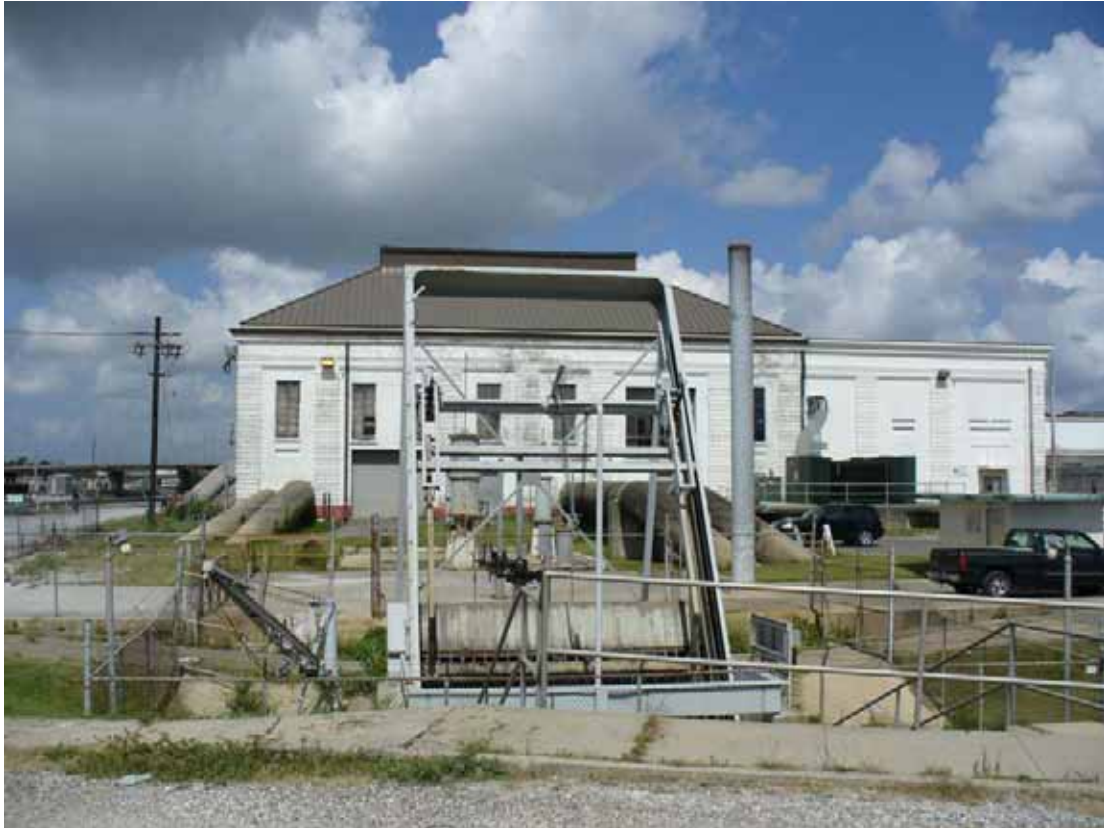
3. View of site as seen from the east direction.

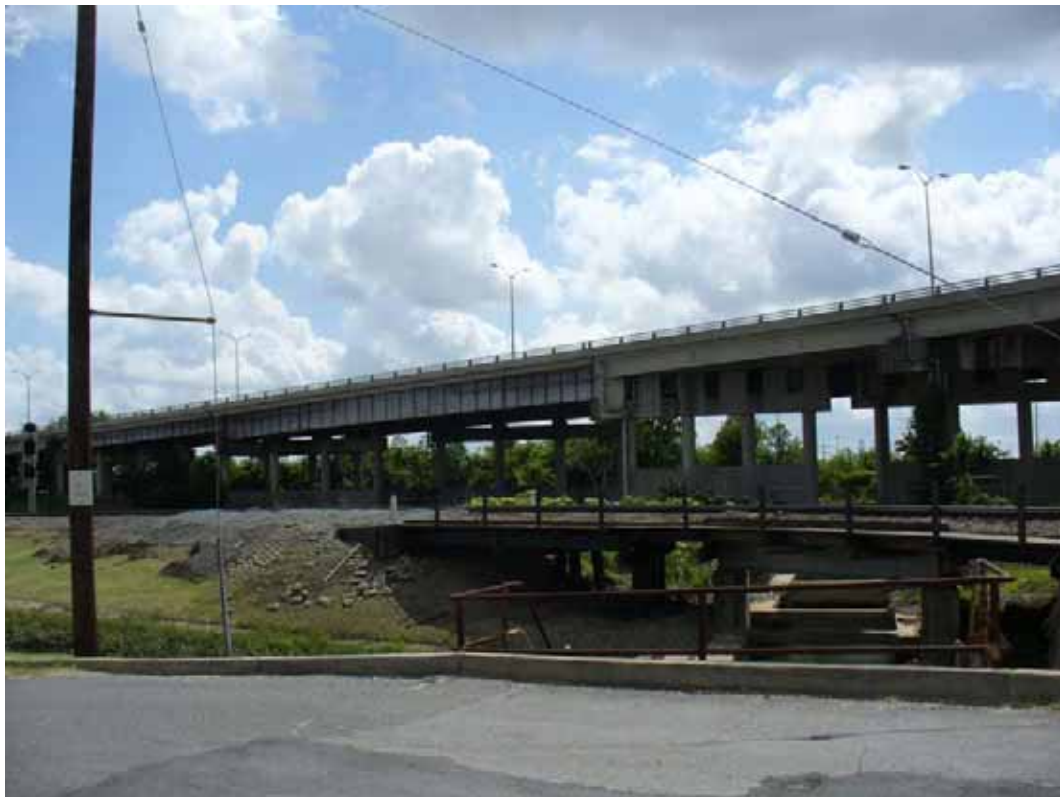
4. View of east area adjacent to the site, northeast area.

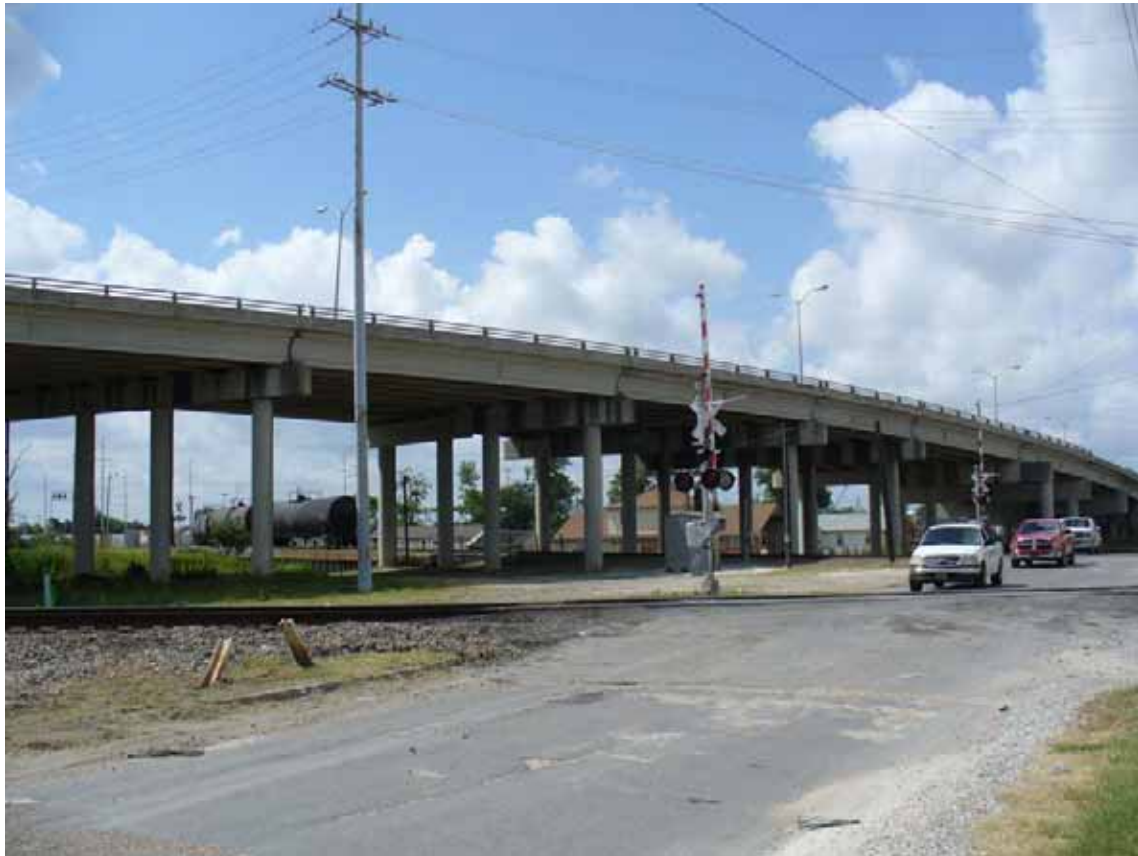
5. View of east area adjacent to the site, southeast area.

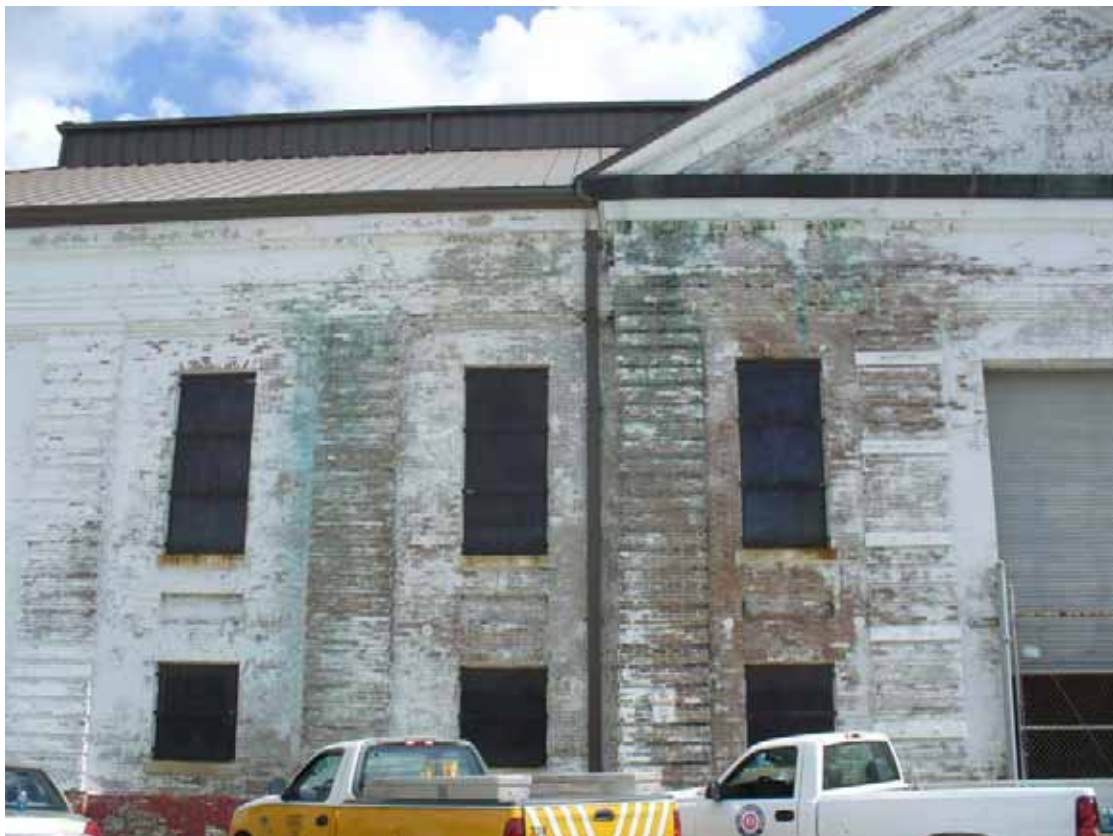
6. View of site as seen from the south direction, southwest area.

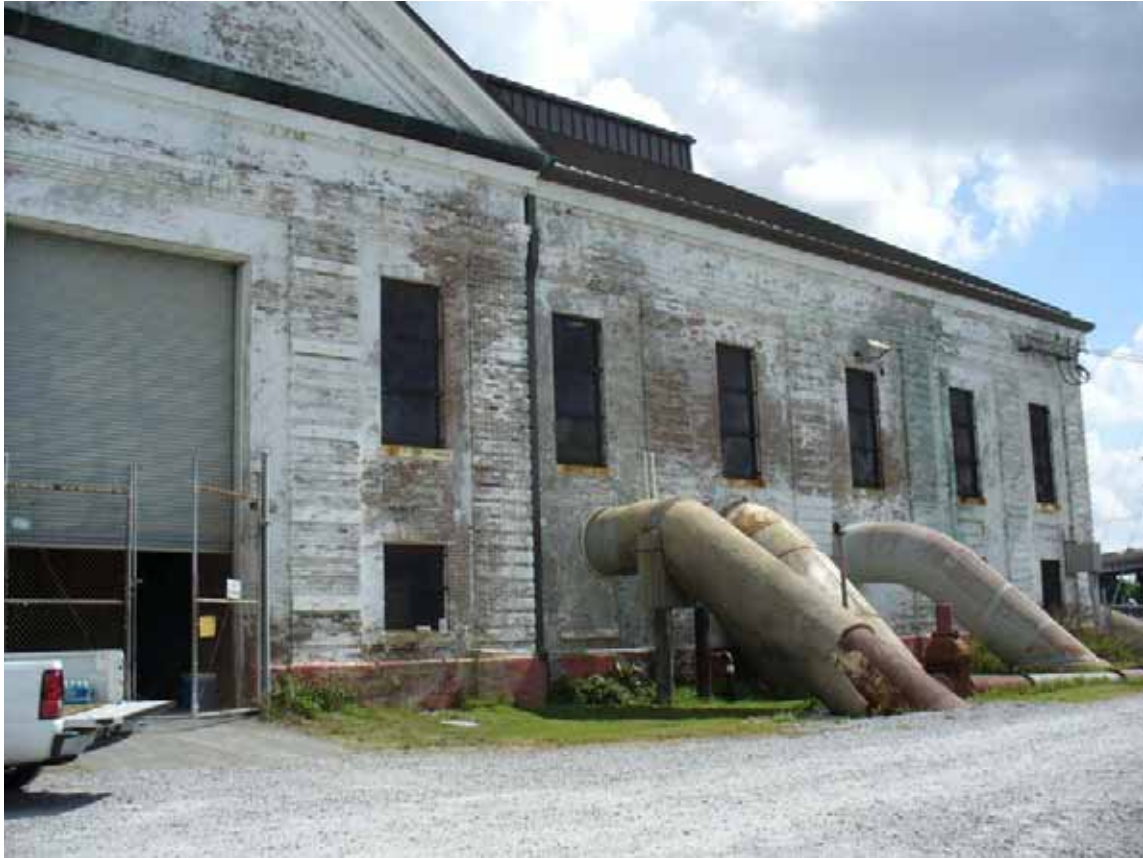
7. View of site as seen from the south direction, southeast area.

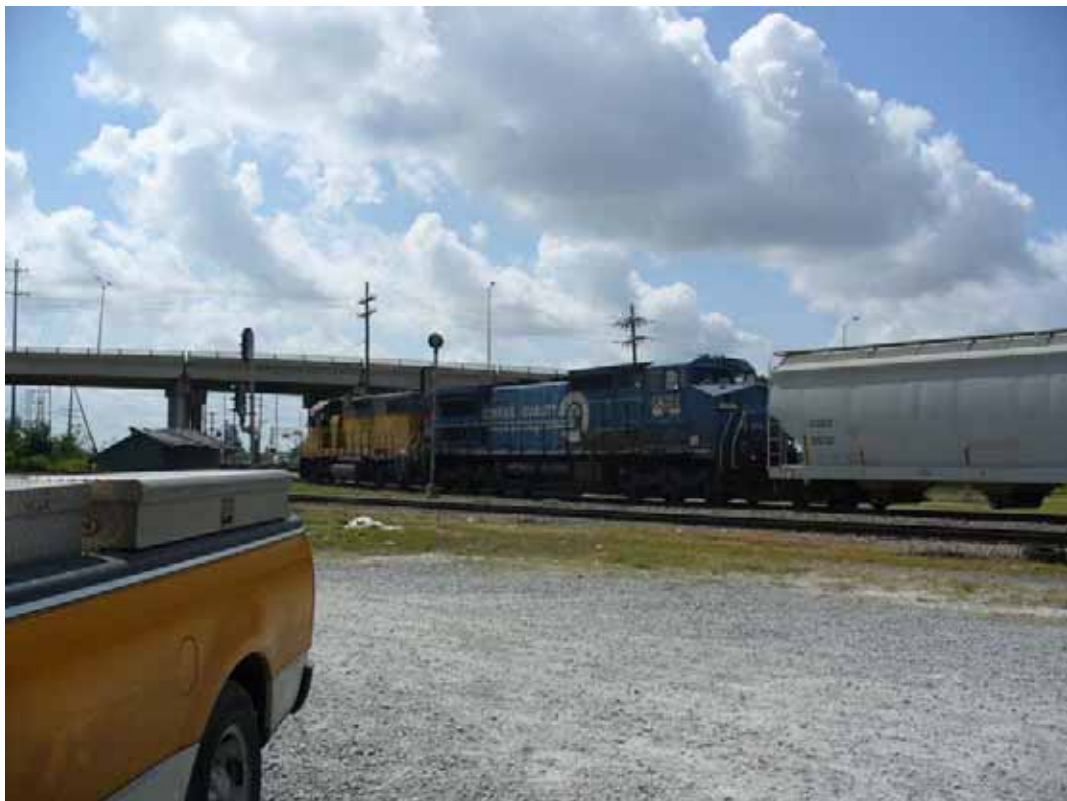
8. View of south area adjacent to the site, showing rail traffic.

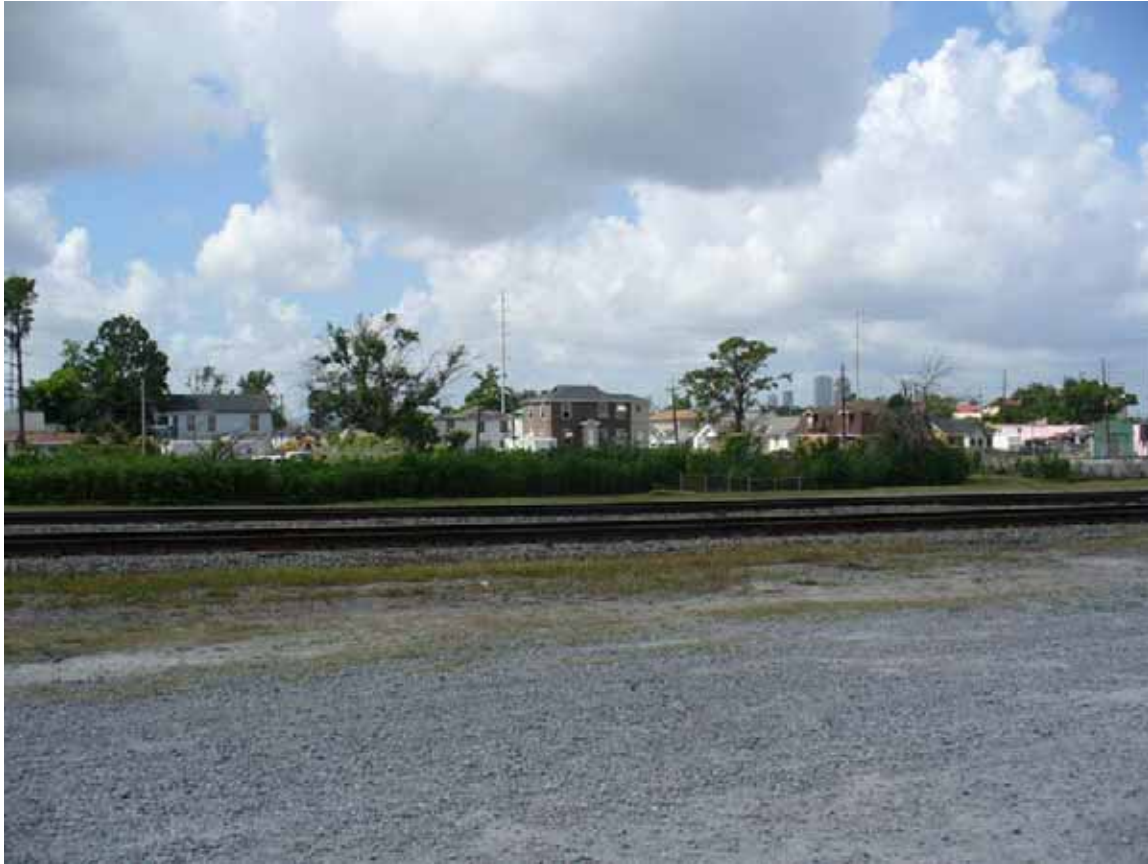
9. View of south area adjacent to the site, showing residential area.
