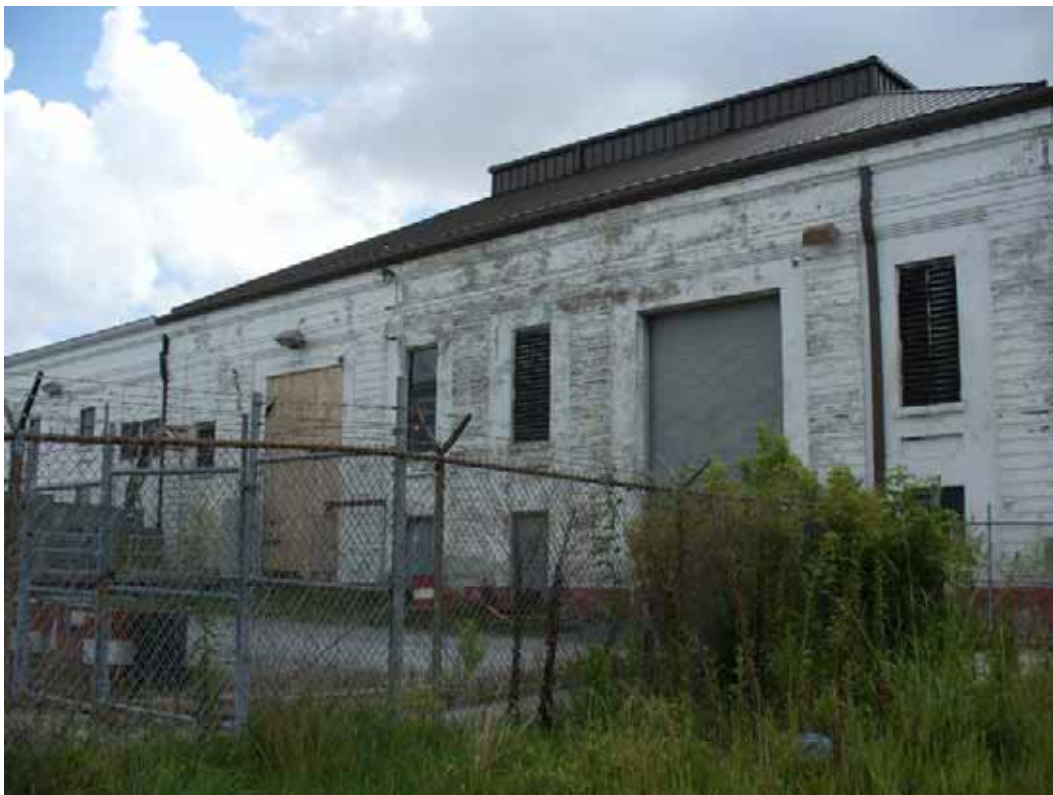
10. View of site as seen from the west direction.

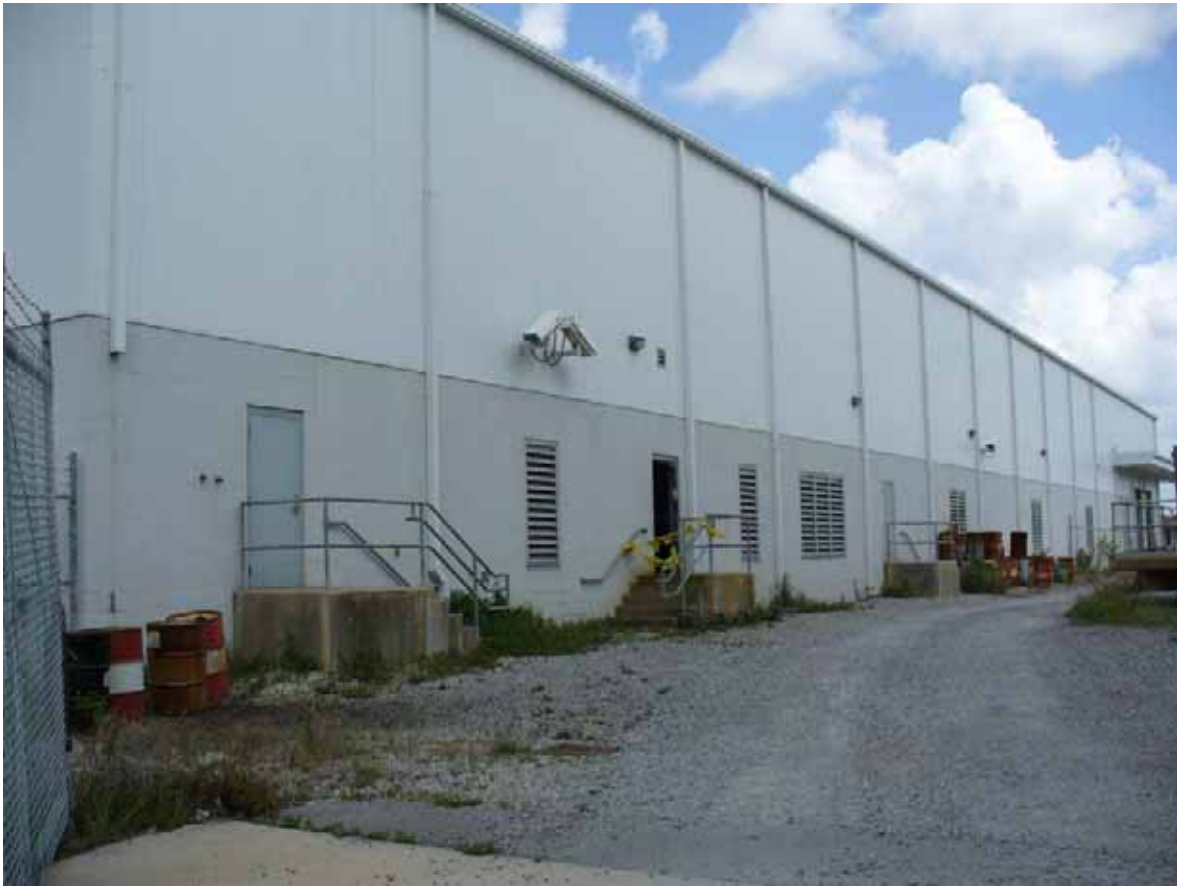
11. View of storage building, located in the west area adjacent to the site.

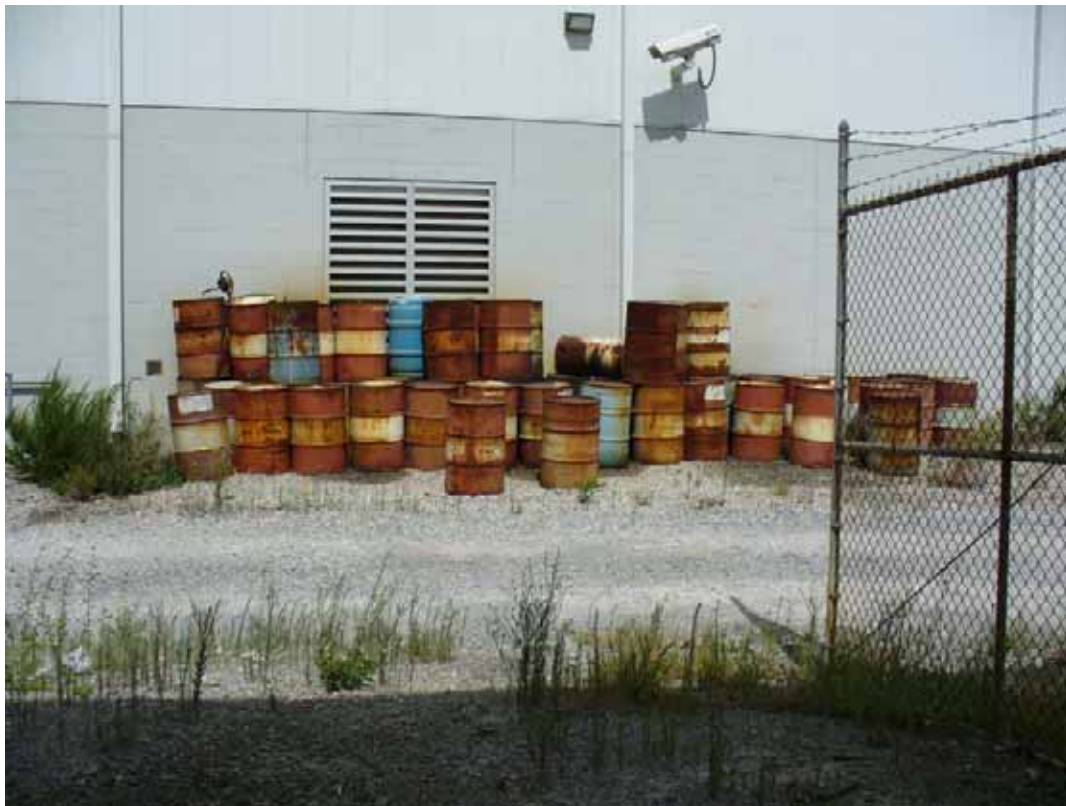
12. View of 55 gallon drums stored outside storage building.

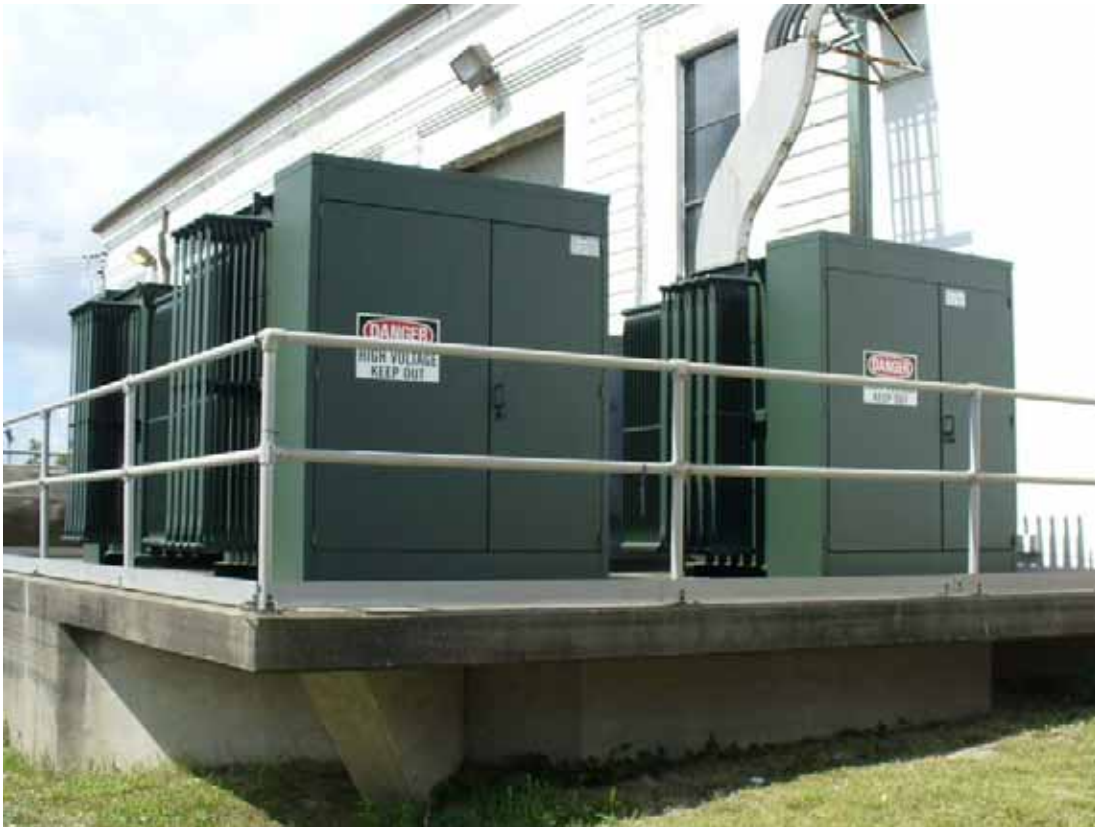
13. View of transformers in east area.

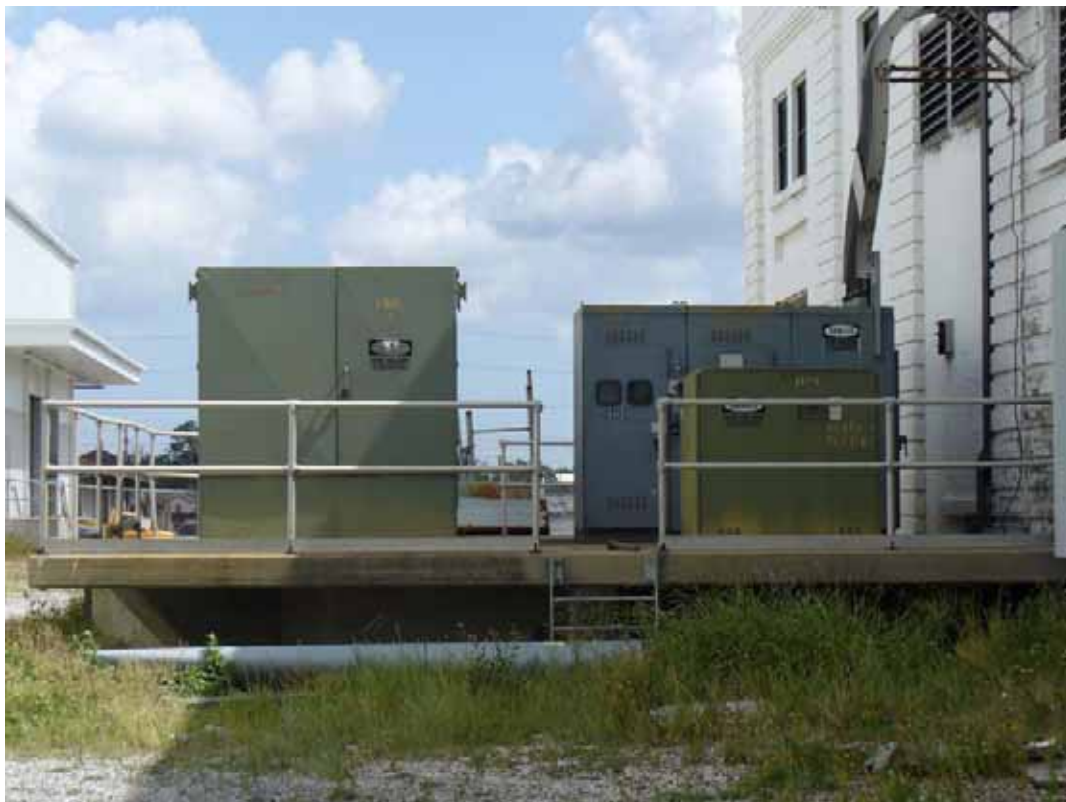
14. View of transformers in west area.

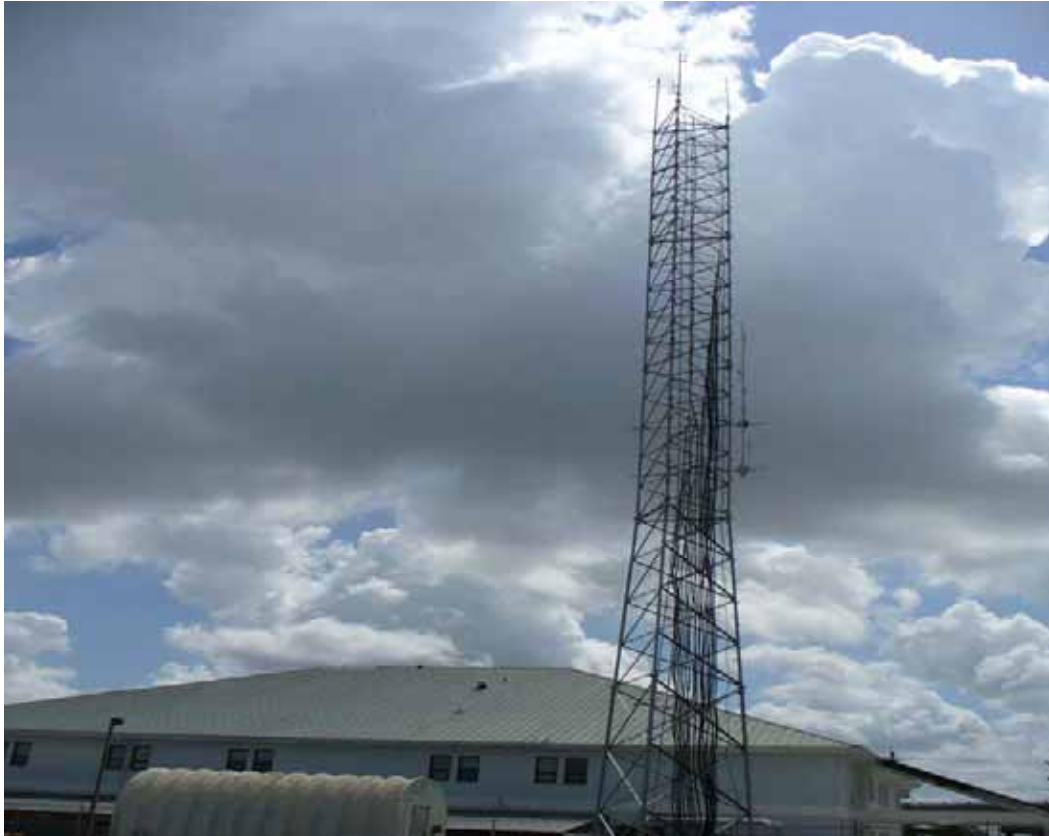
15. Radio tower located on north side.

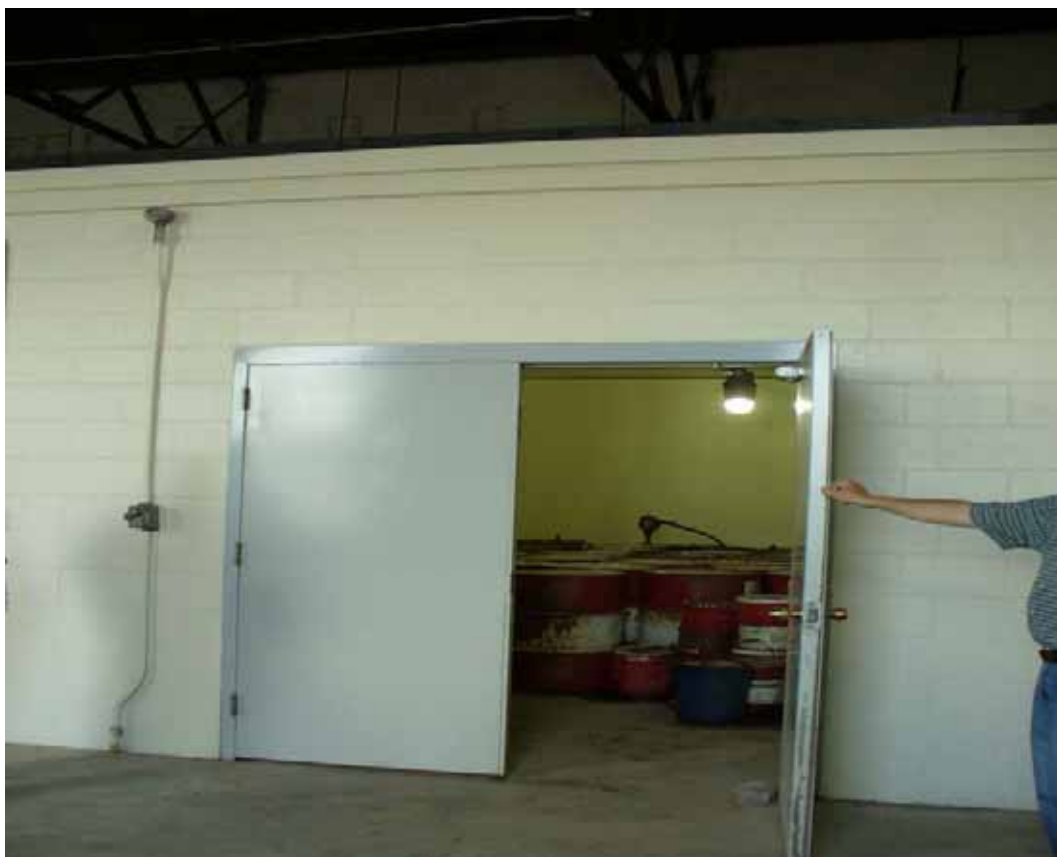
16. Fire proof storage room located in northwest area.

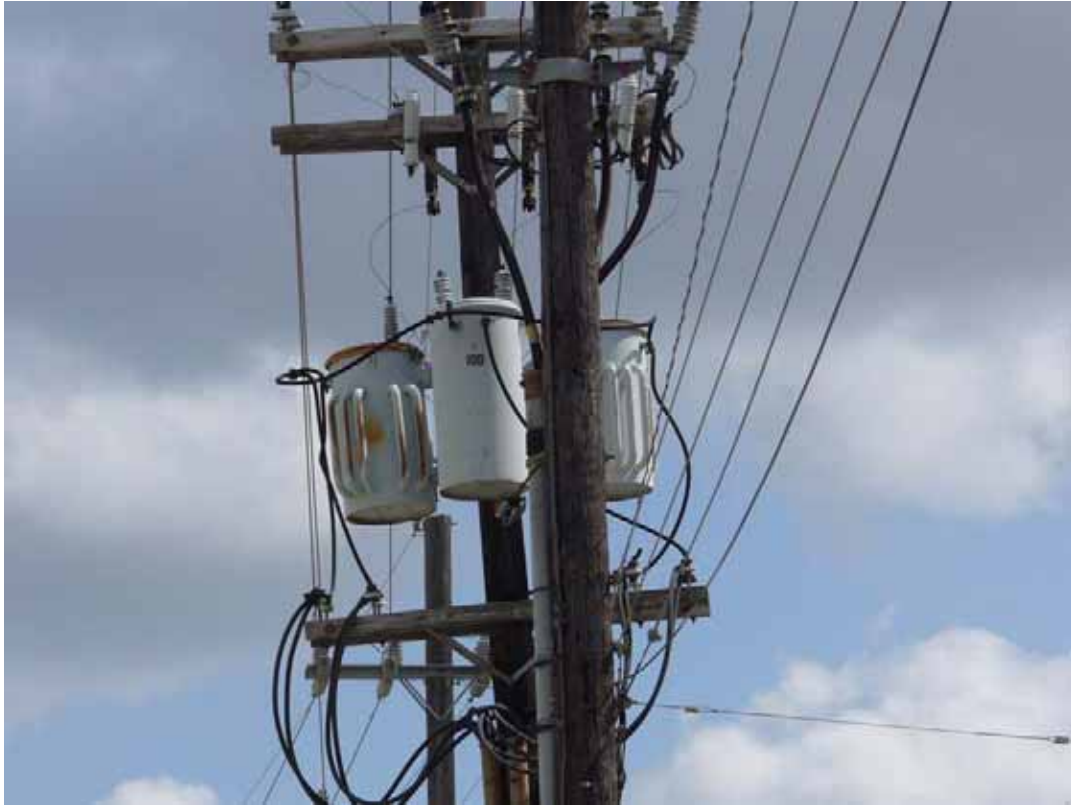
17. View of transformers located east of property.

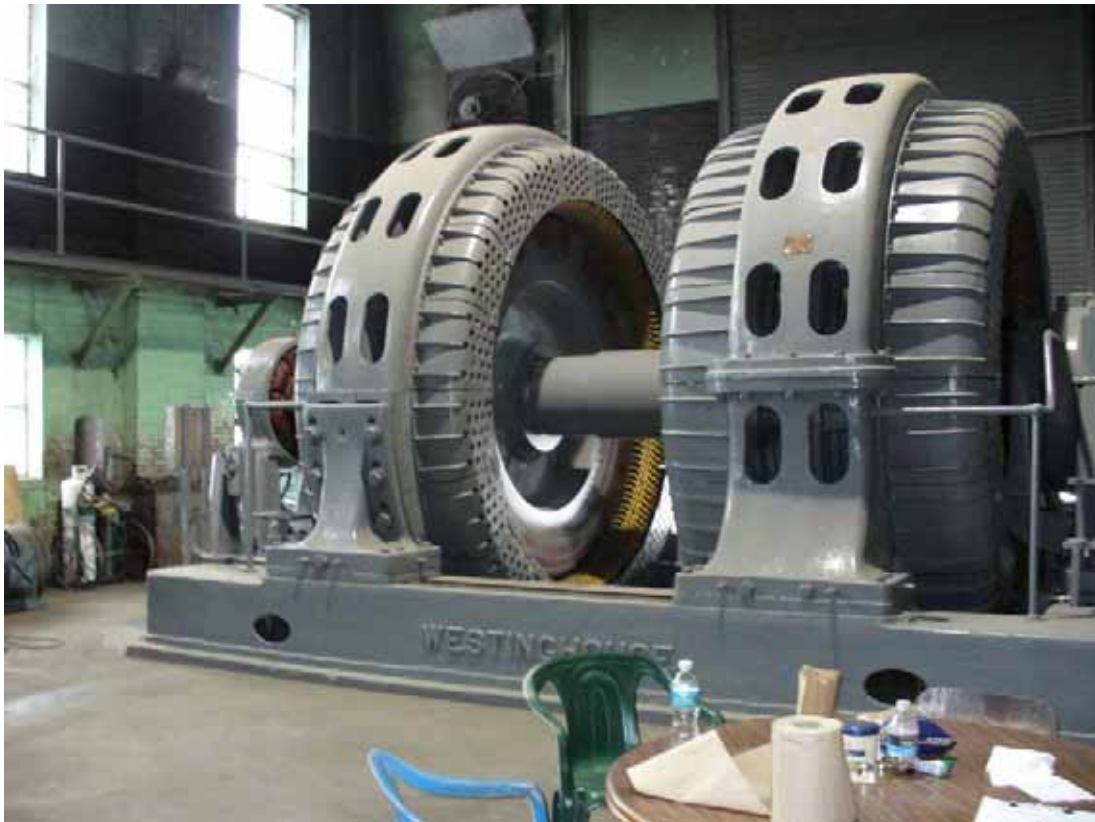
18.

View of pump located inside building.

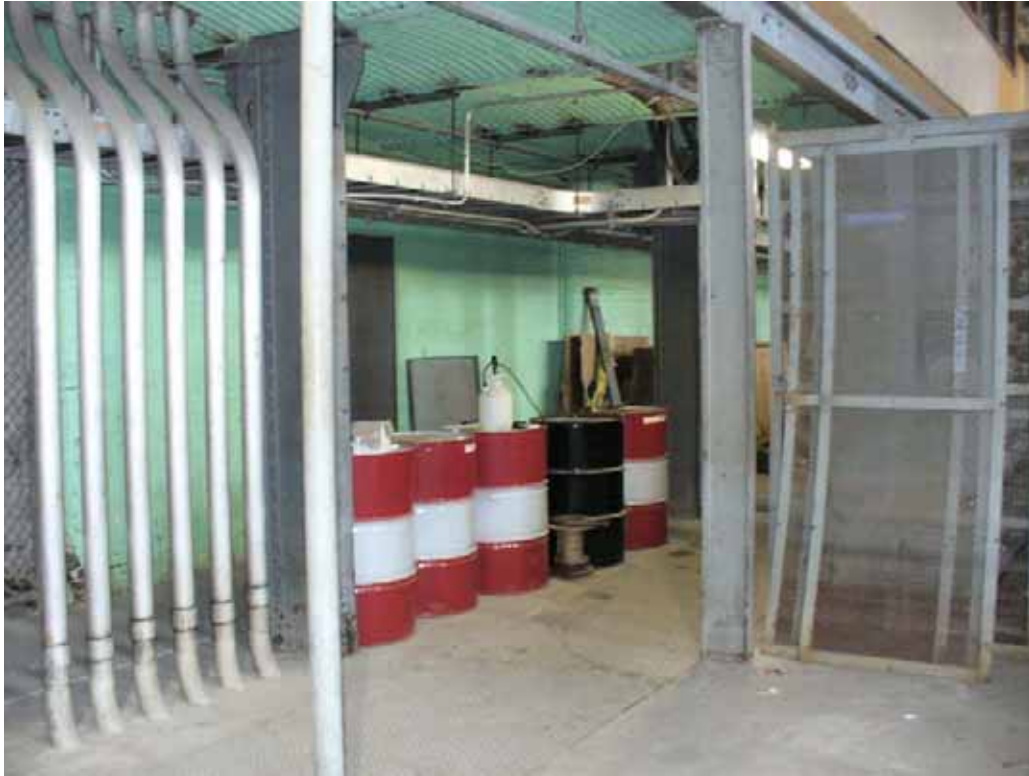
19. Drums and resistors located inside building.

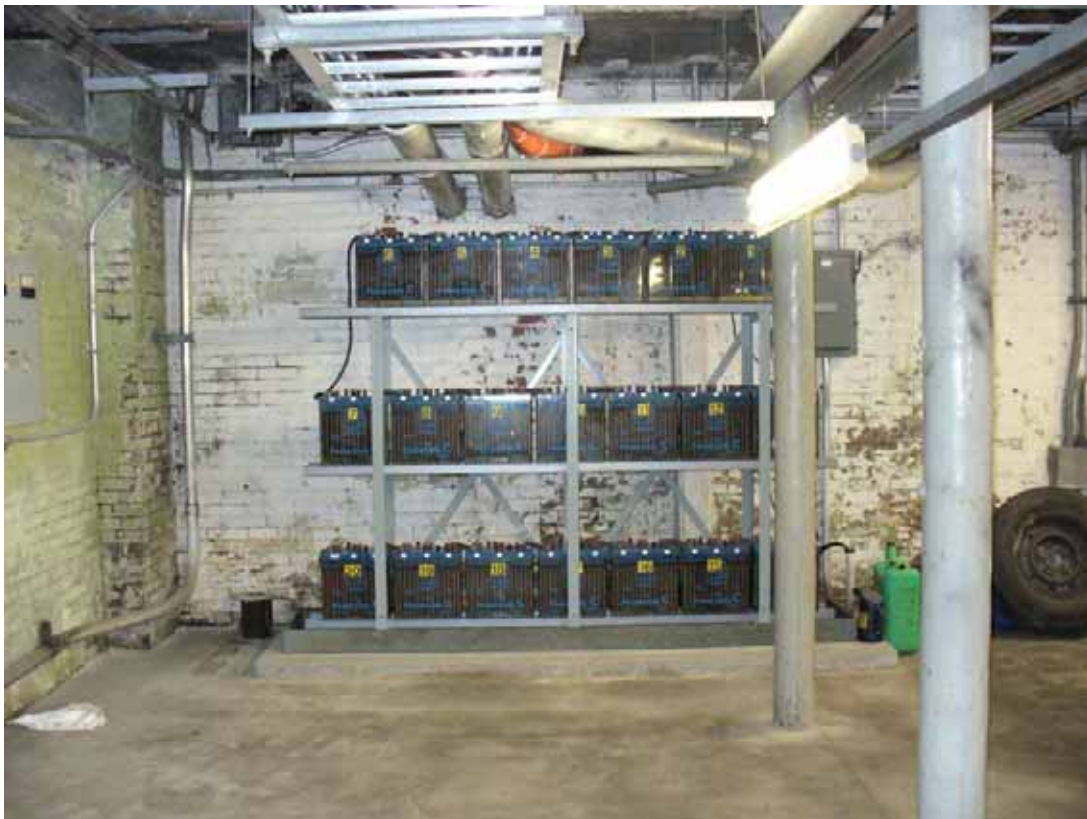
20. Battery bank located against north wall.

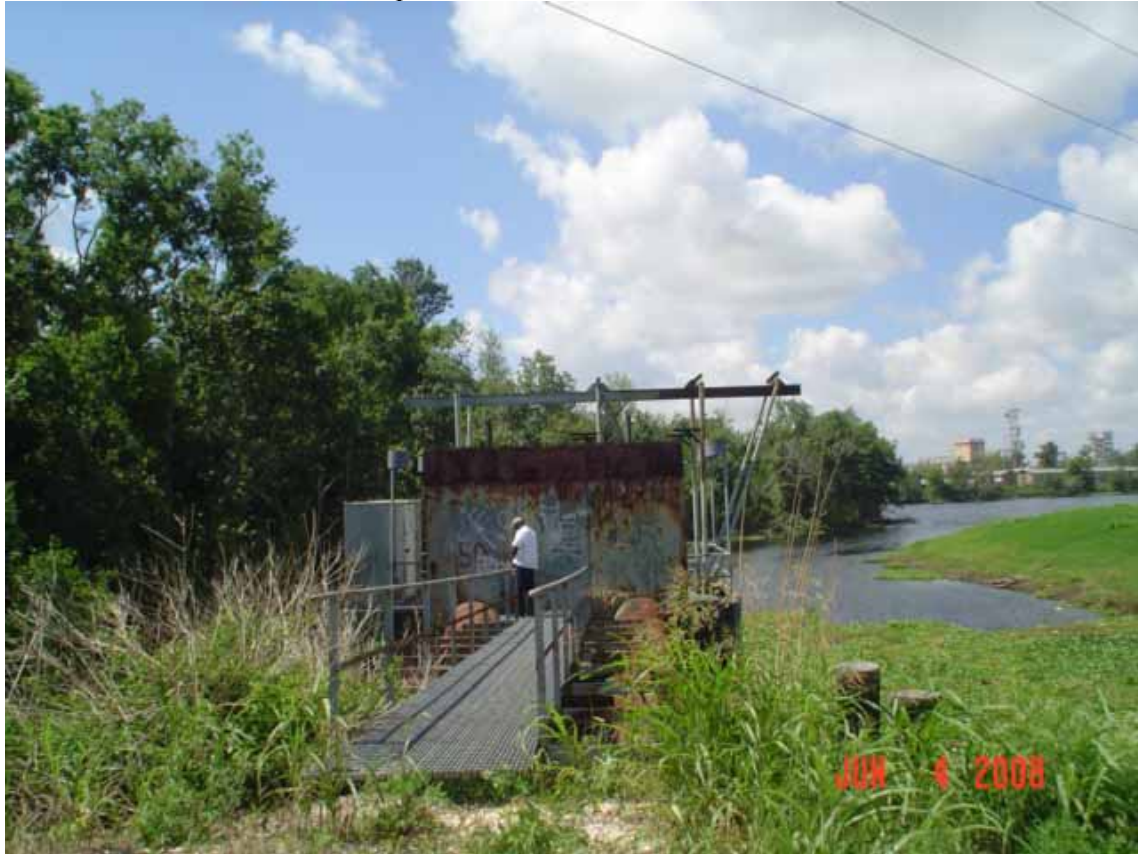
1. View of site as seen from the north direction.

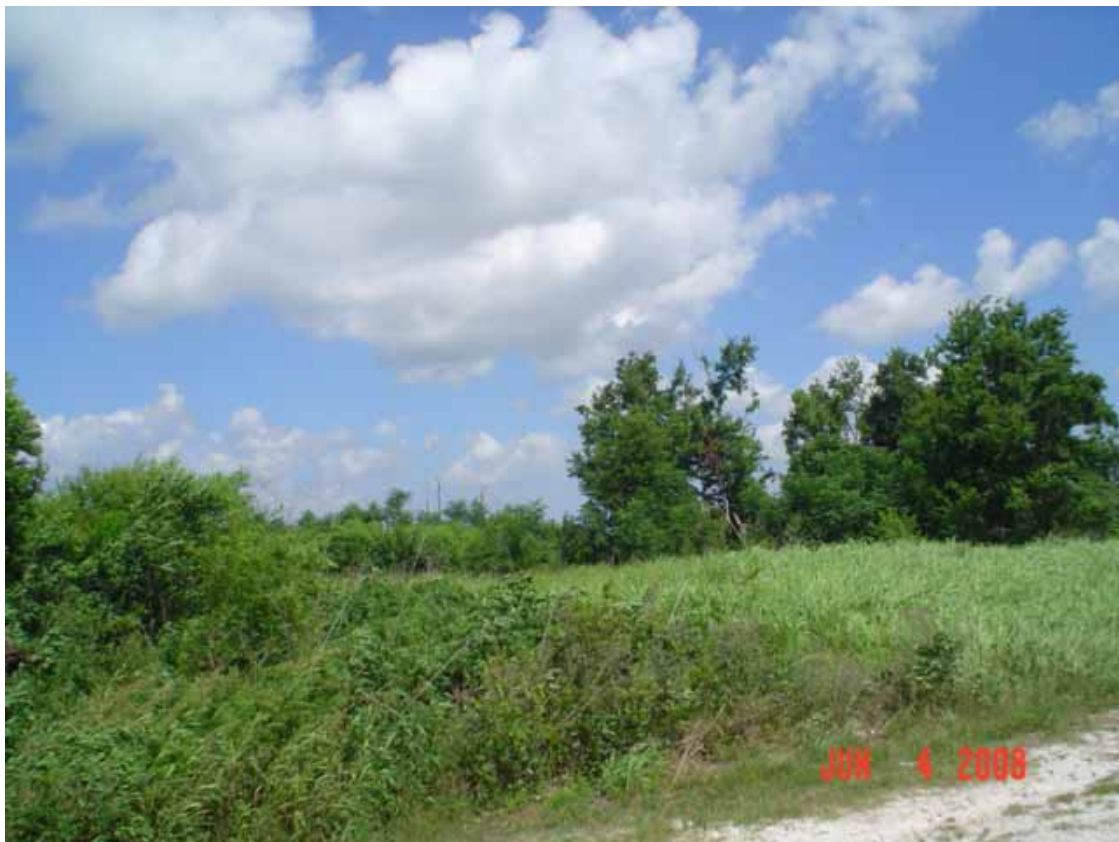
2. View of north area adjacent to the site, northwest corner.

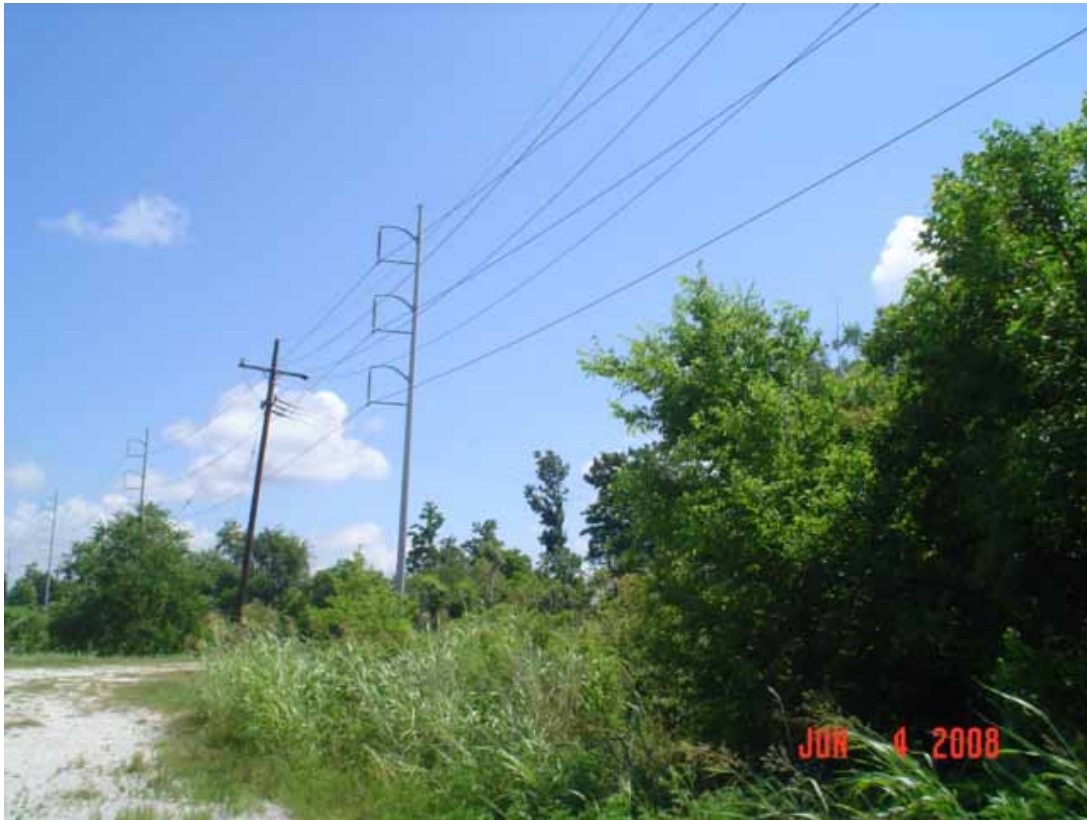
3. View of north area adjacent to the site, northeast corner, including levee.

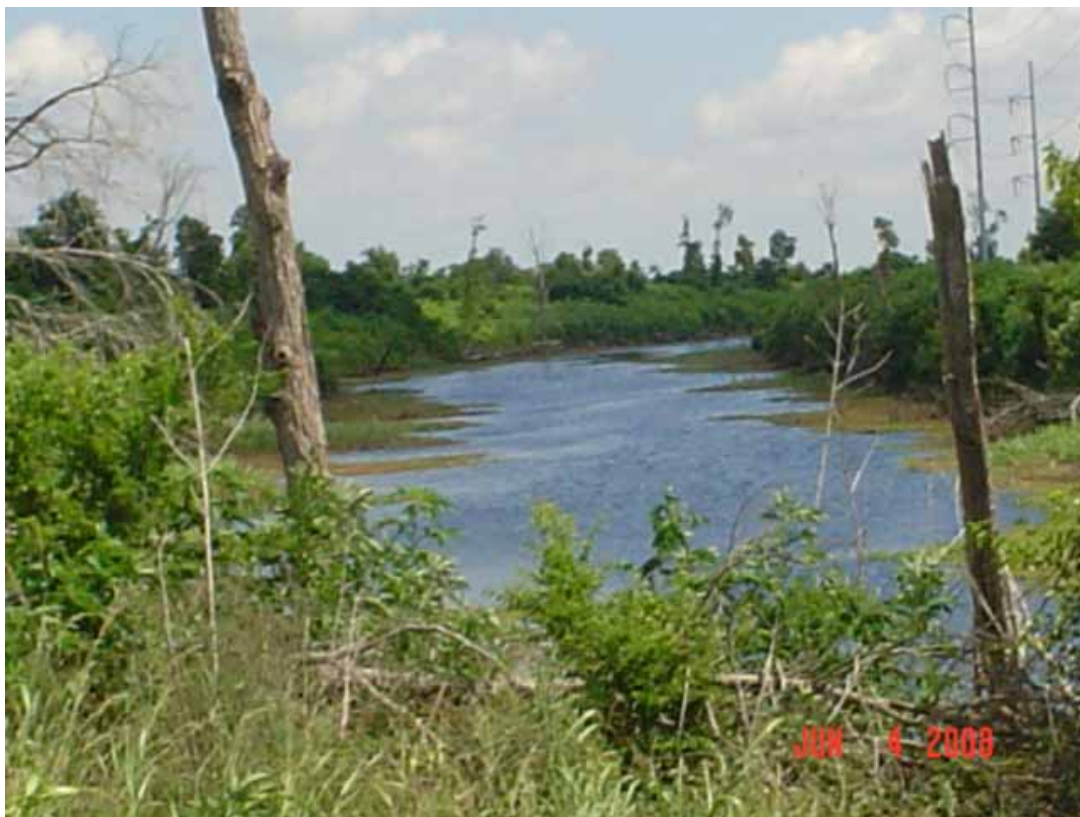
4. View of north area adjacent to the site, canal on other side of levee.

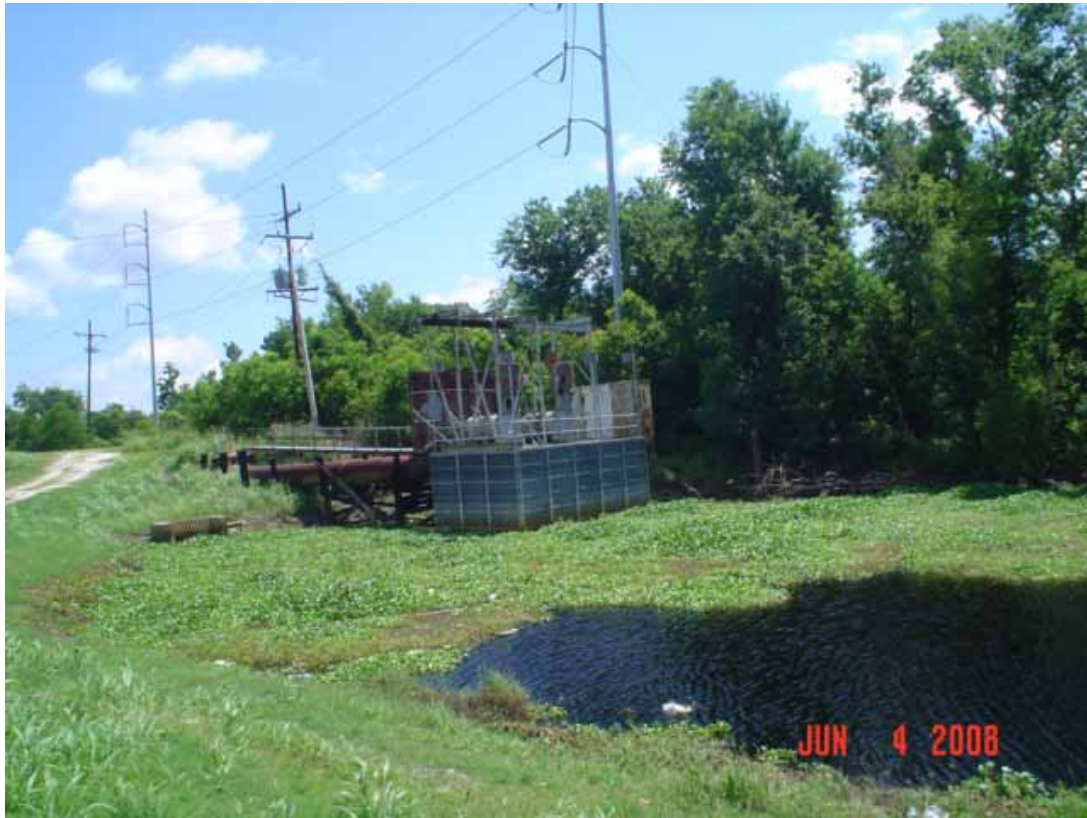
5. View of site as seen from the south direction.

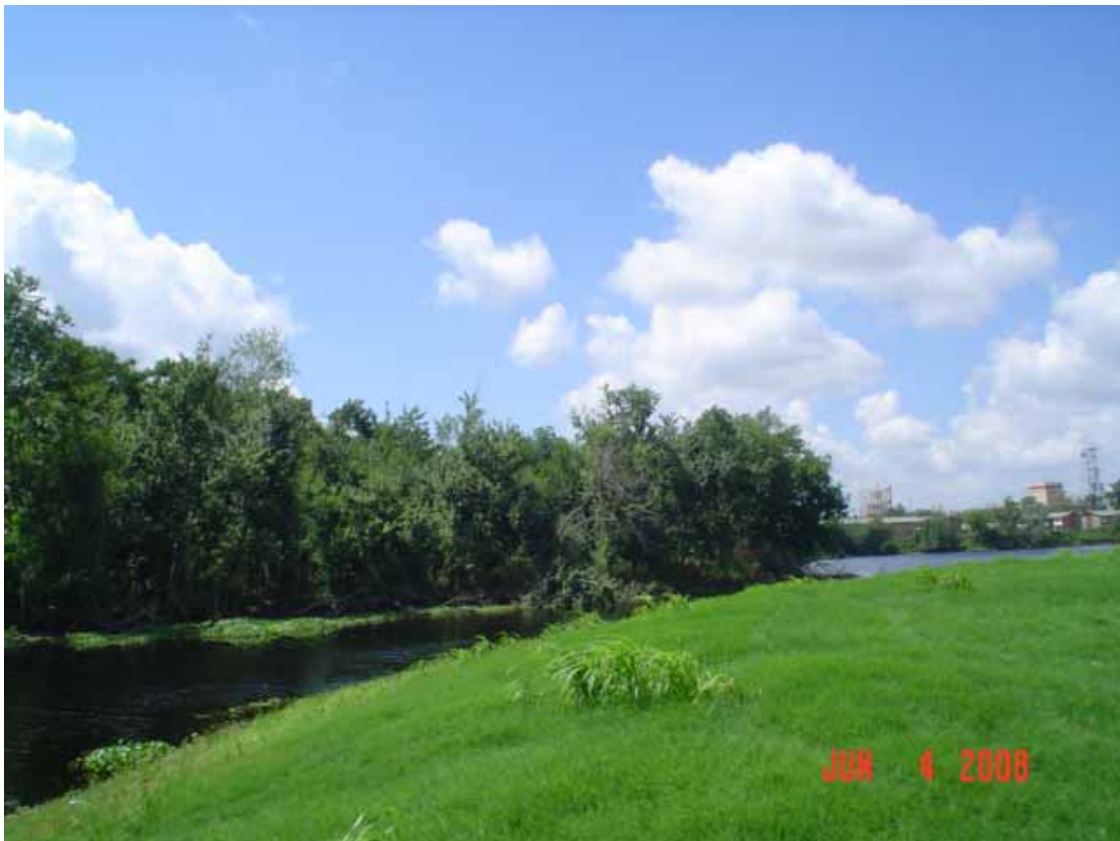
6. View of south area adjacent to the site, canal.

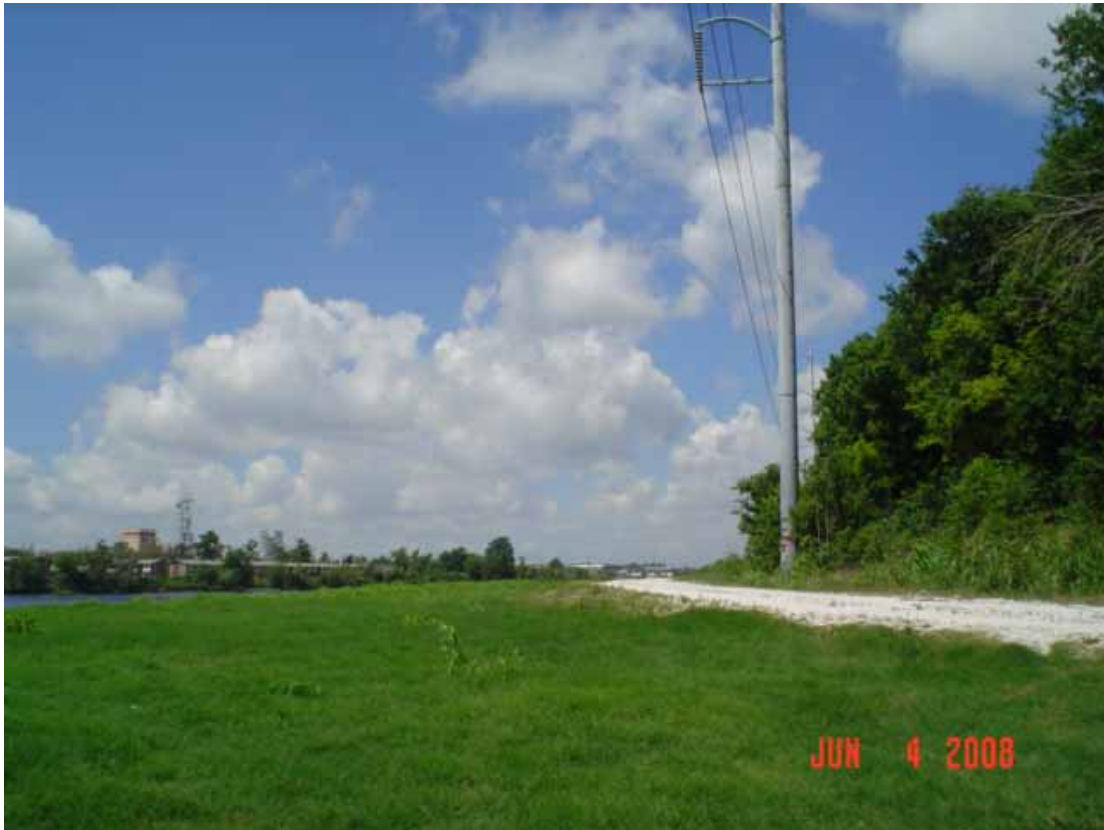
7. View of south area adjacent to the site, west.

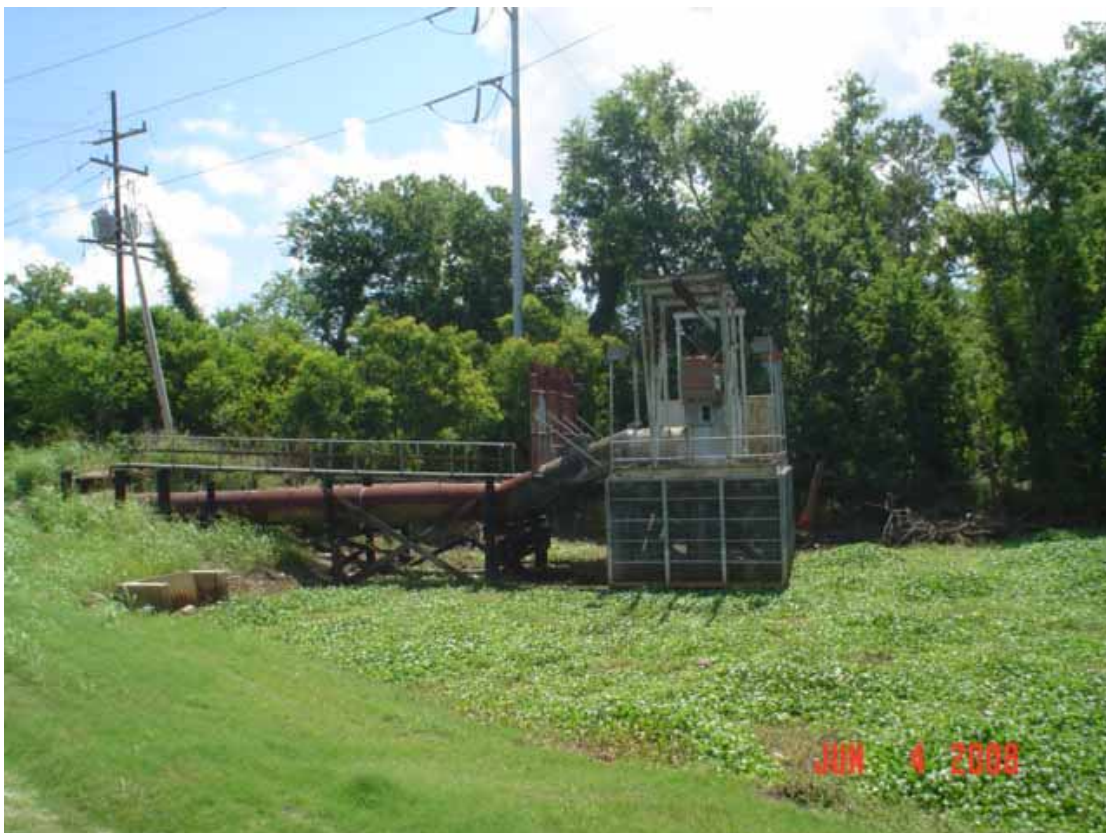
8. View of site as seen from the west direction, including transformers on the northeast corner.

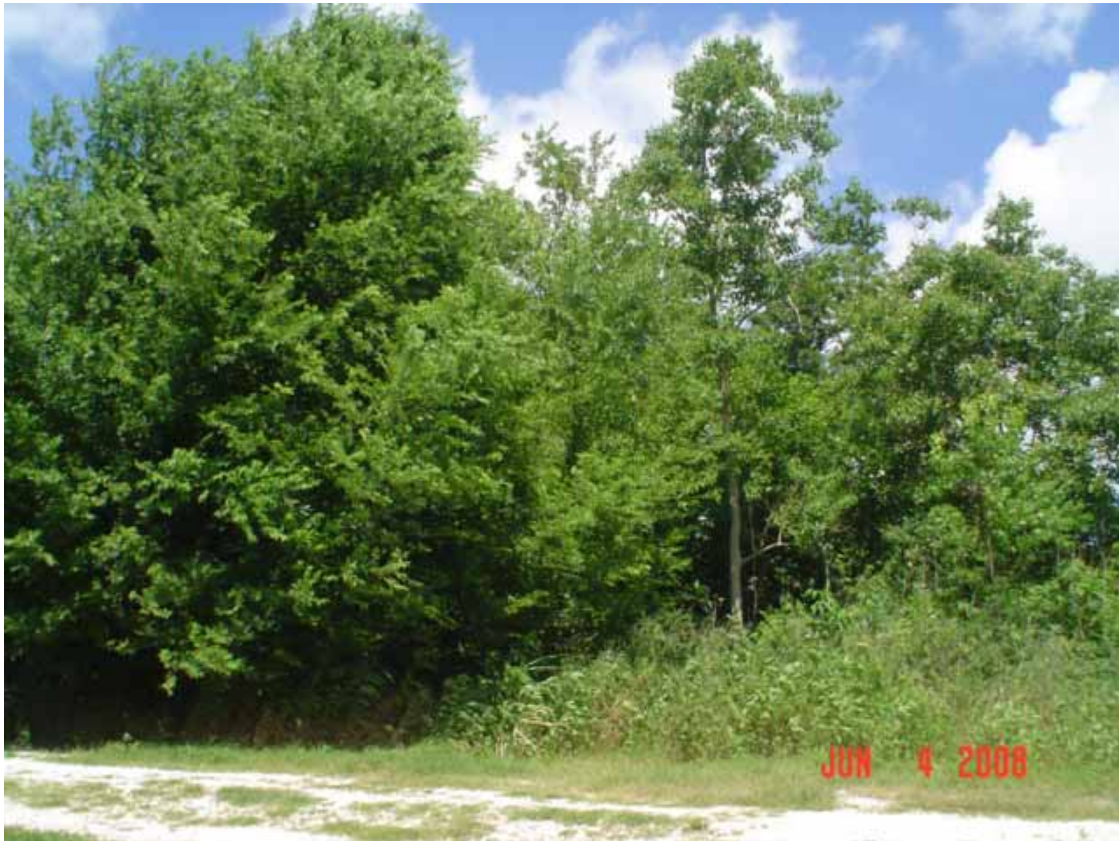
9. View of west area adjacent to the site, southwest corner.

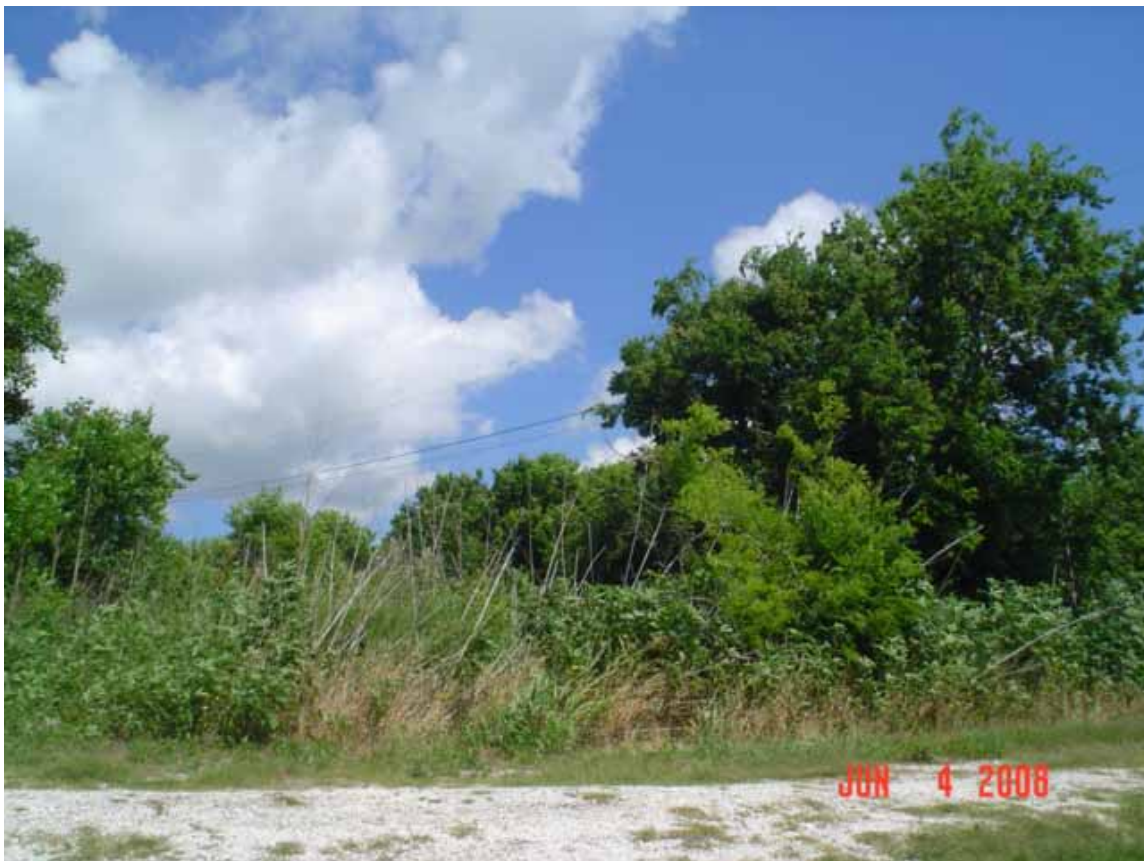
10. View of west area adjacent to the site.

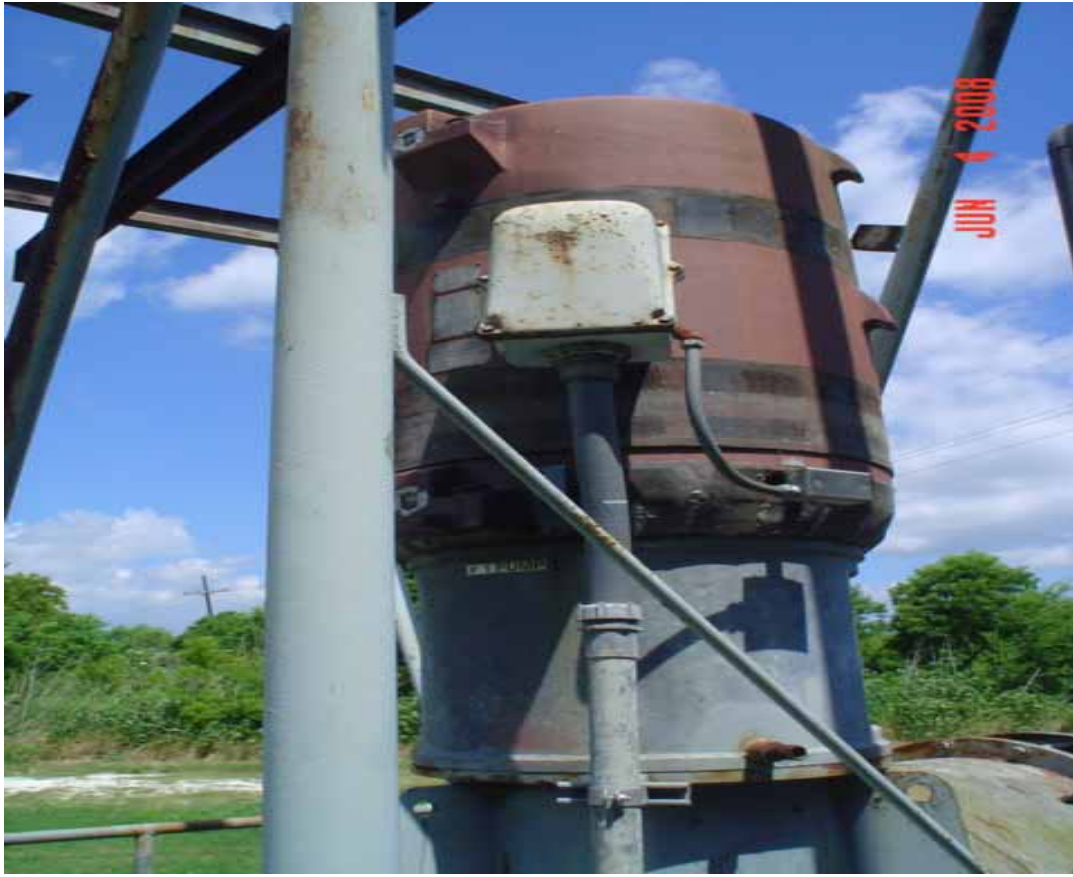
11. Vertical pump motor

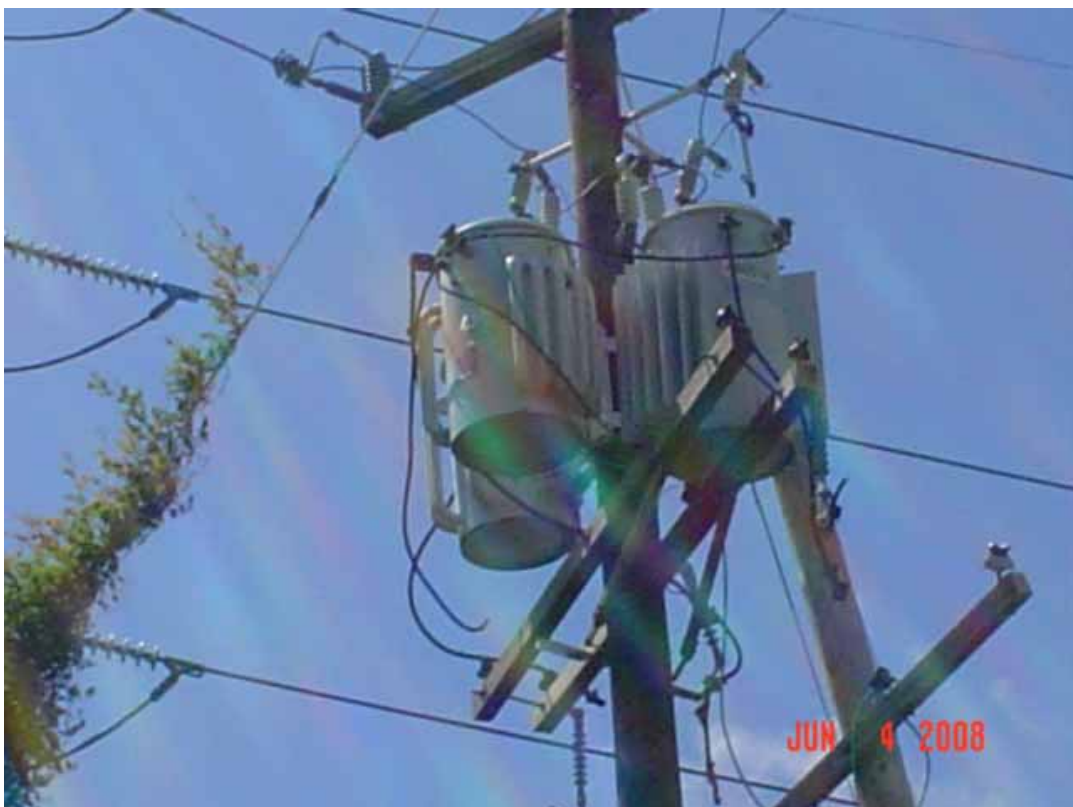
12. Transformers on the northeast corner.

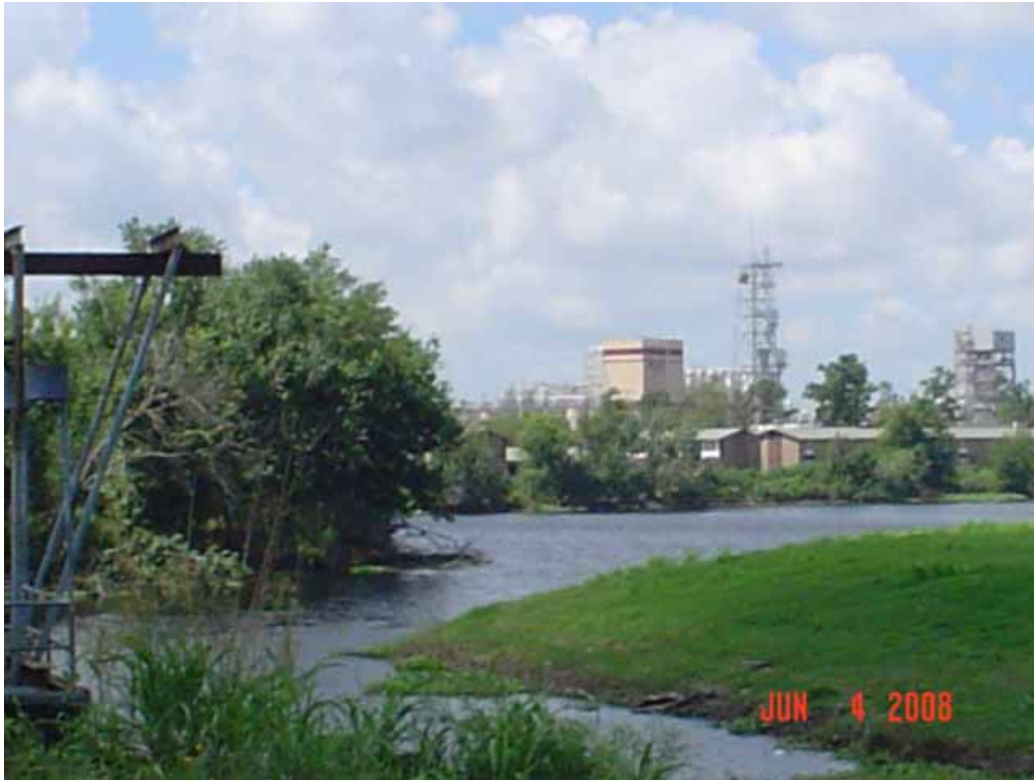
13. Industrial area southeaset of station and canal.

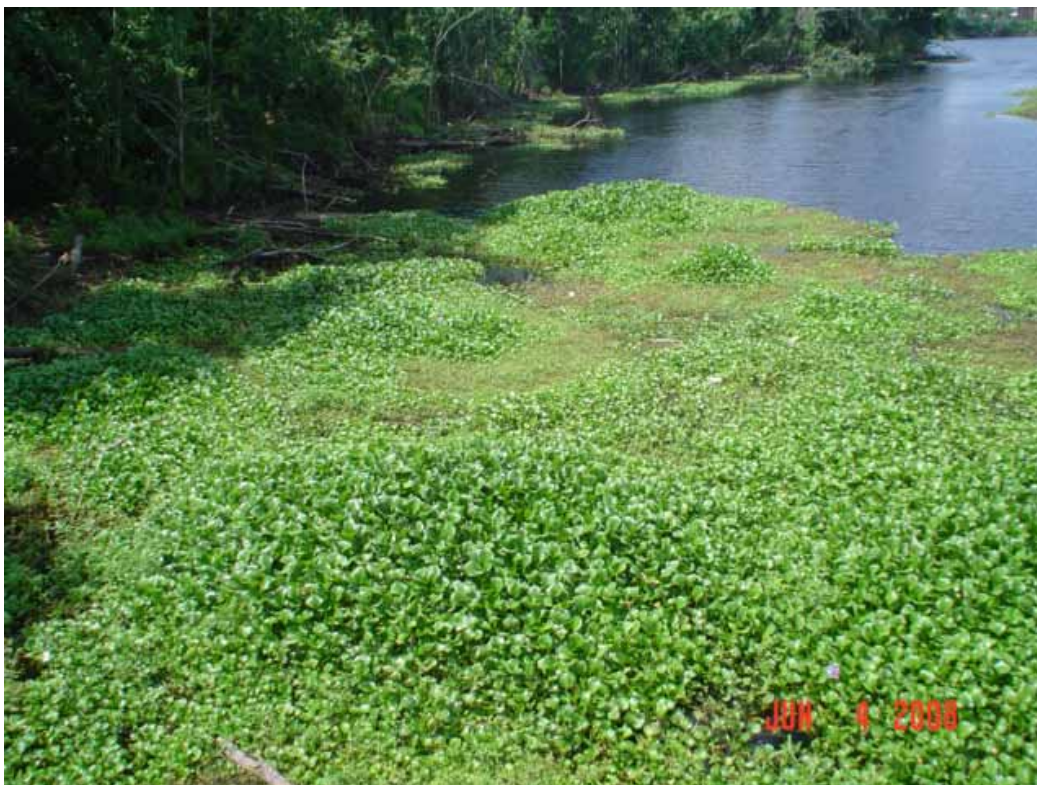
14. Aquatic plants growing next to station.
