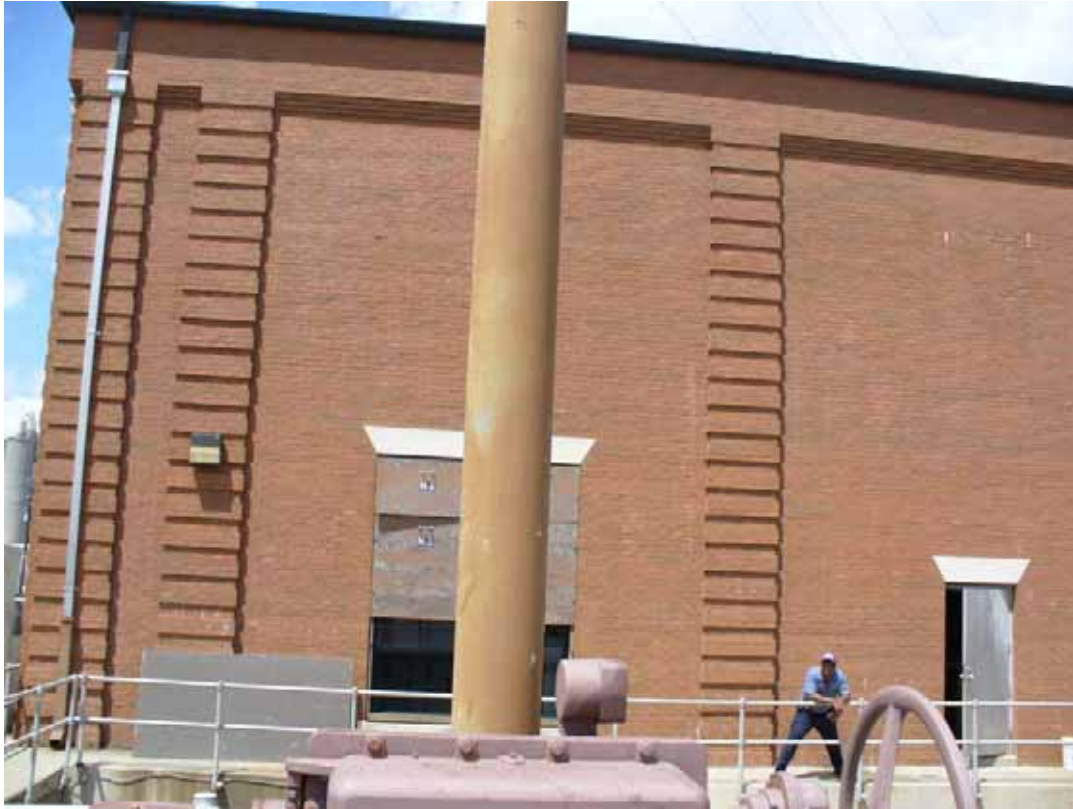
1. View of site as seen from the north direction, left side.

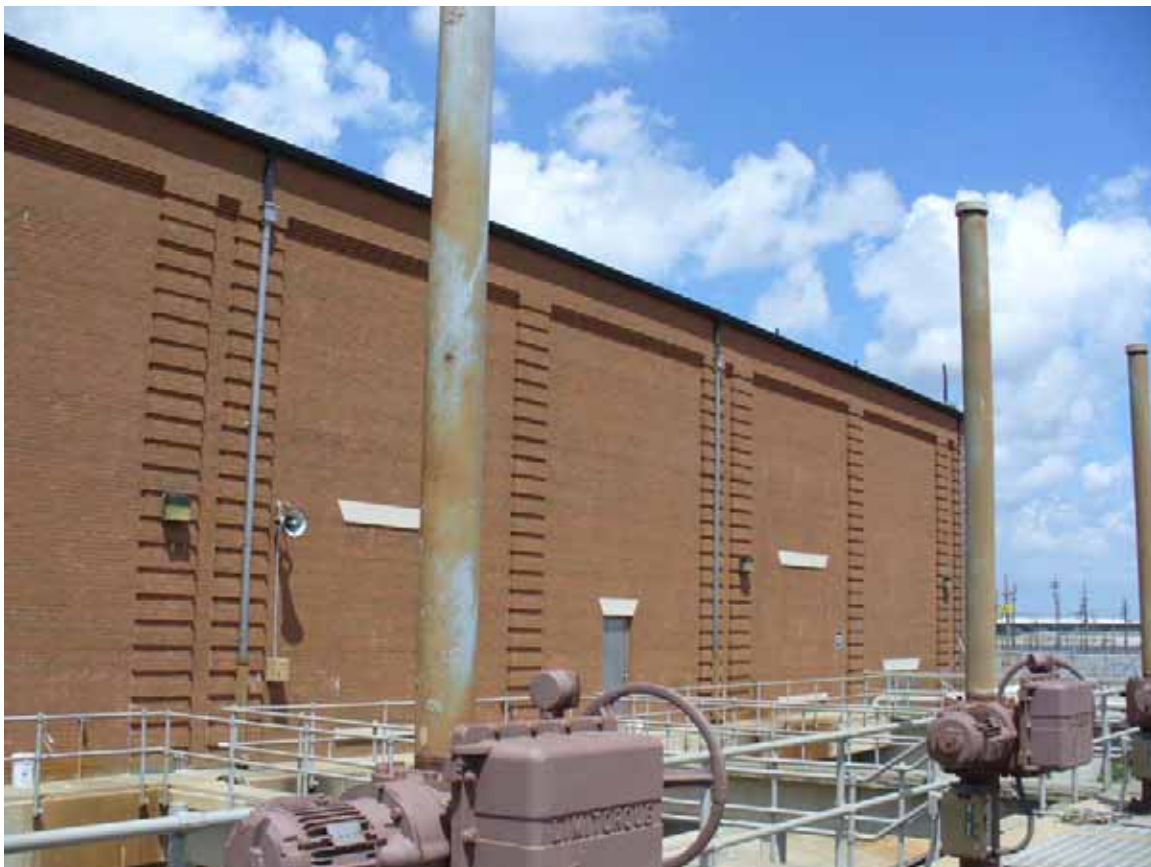
2. View of site as seen from the north direction, right side.

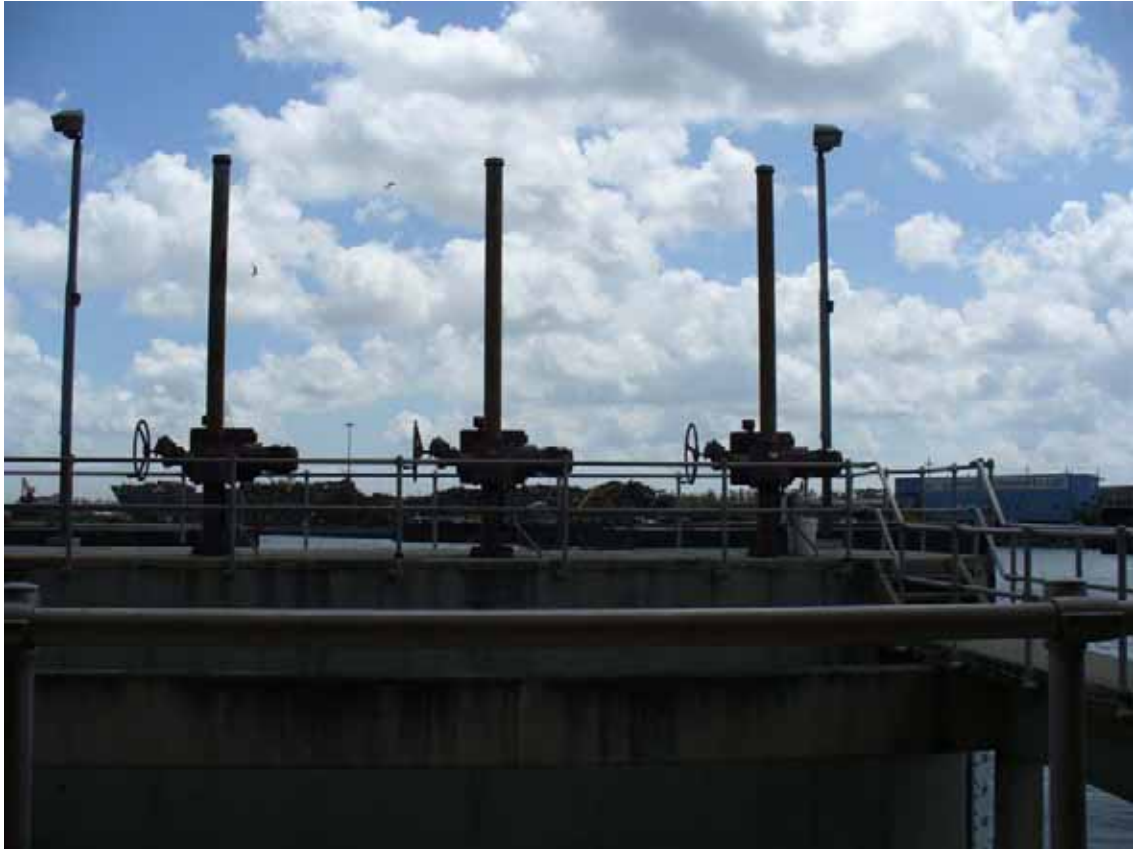
3. View of site as seen from the north direction, building is located to left of picture.

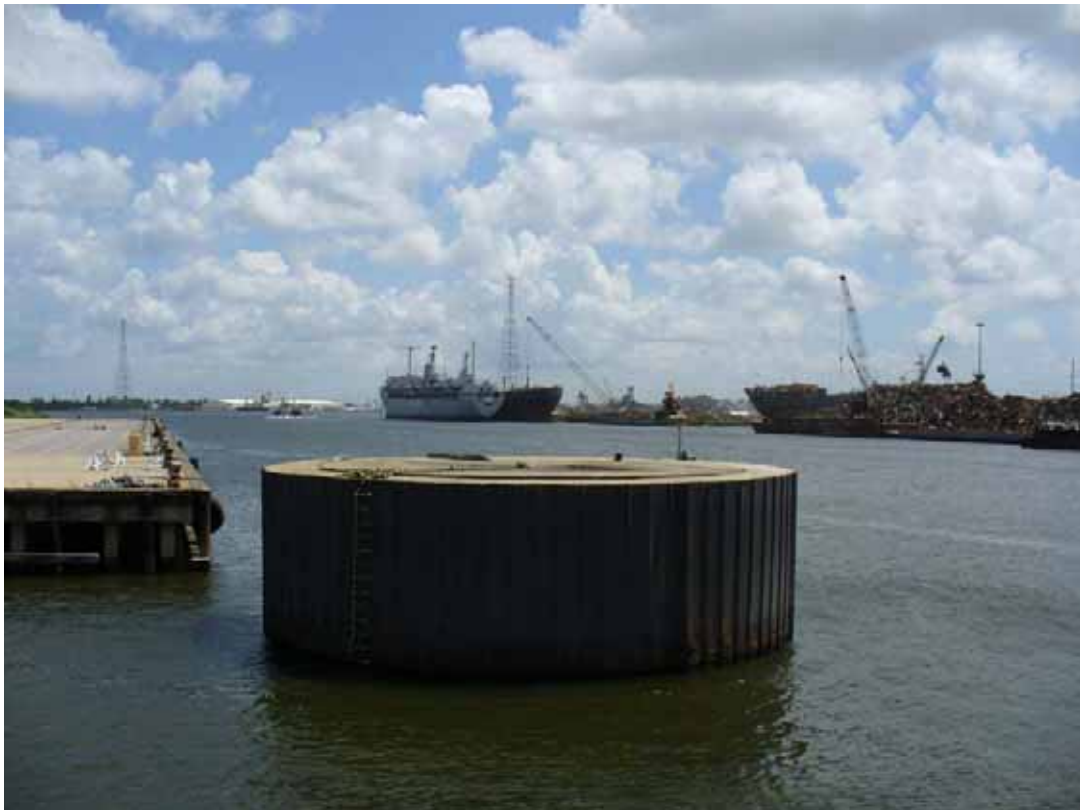
4. View of Dolphin located in north area adjacent to the site.

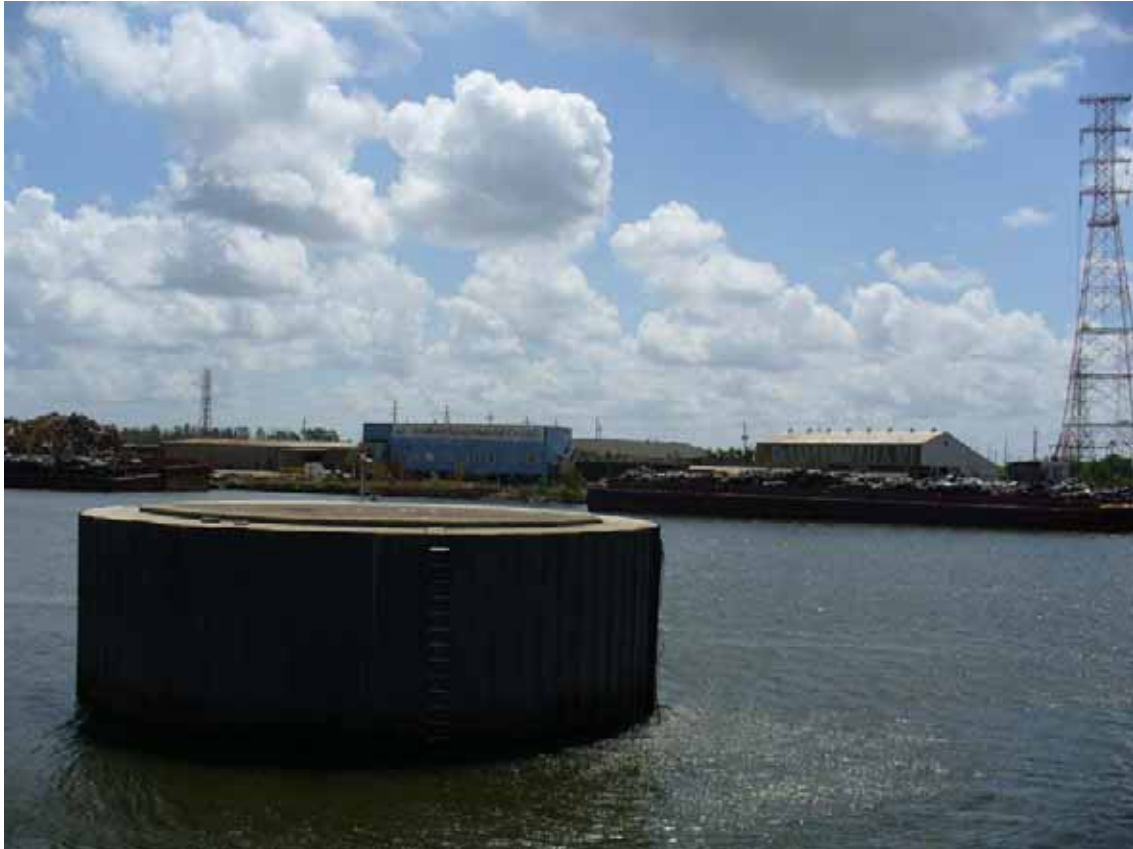
5. View of north area adjacent to the site in southeast area.

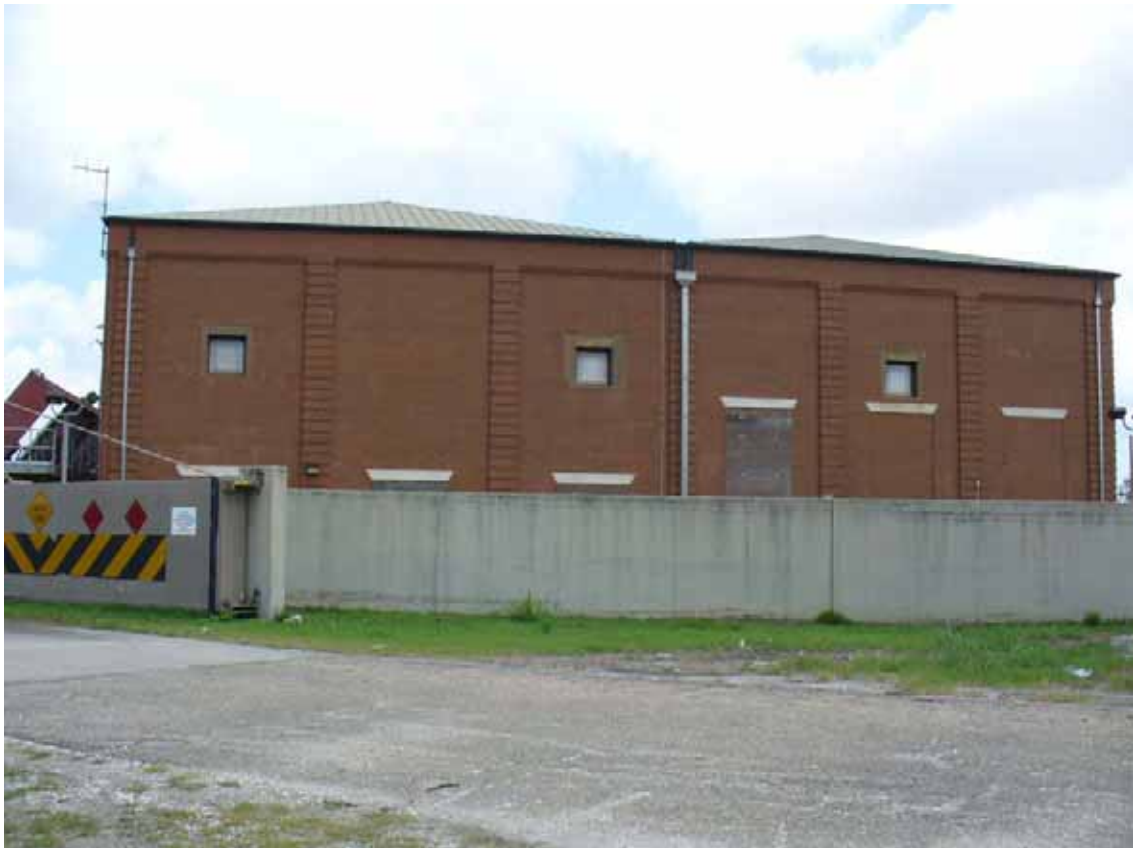
6. View of site as seen from the east direction.

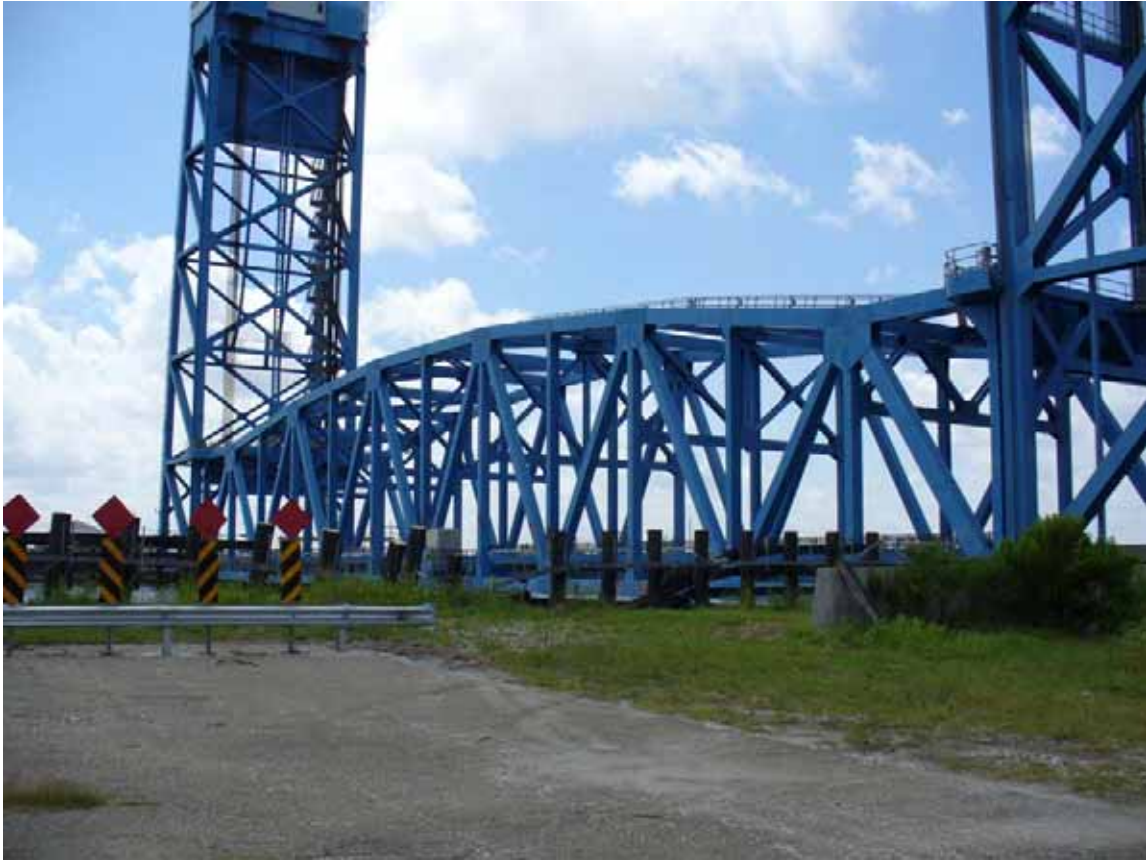
7. View of east area adjacent to the site, with Florida Avenue Bridge further east.

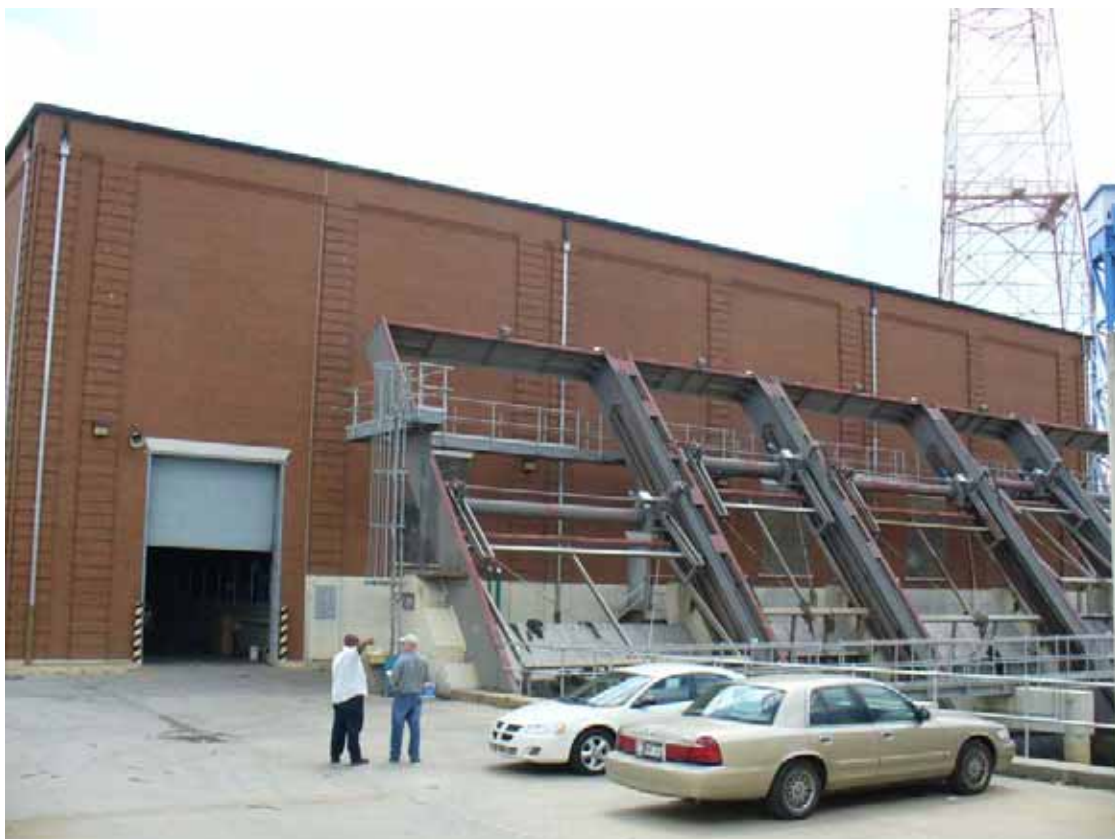
8. View of site as seen from the south direction.

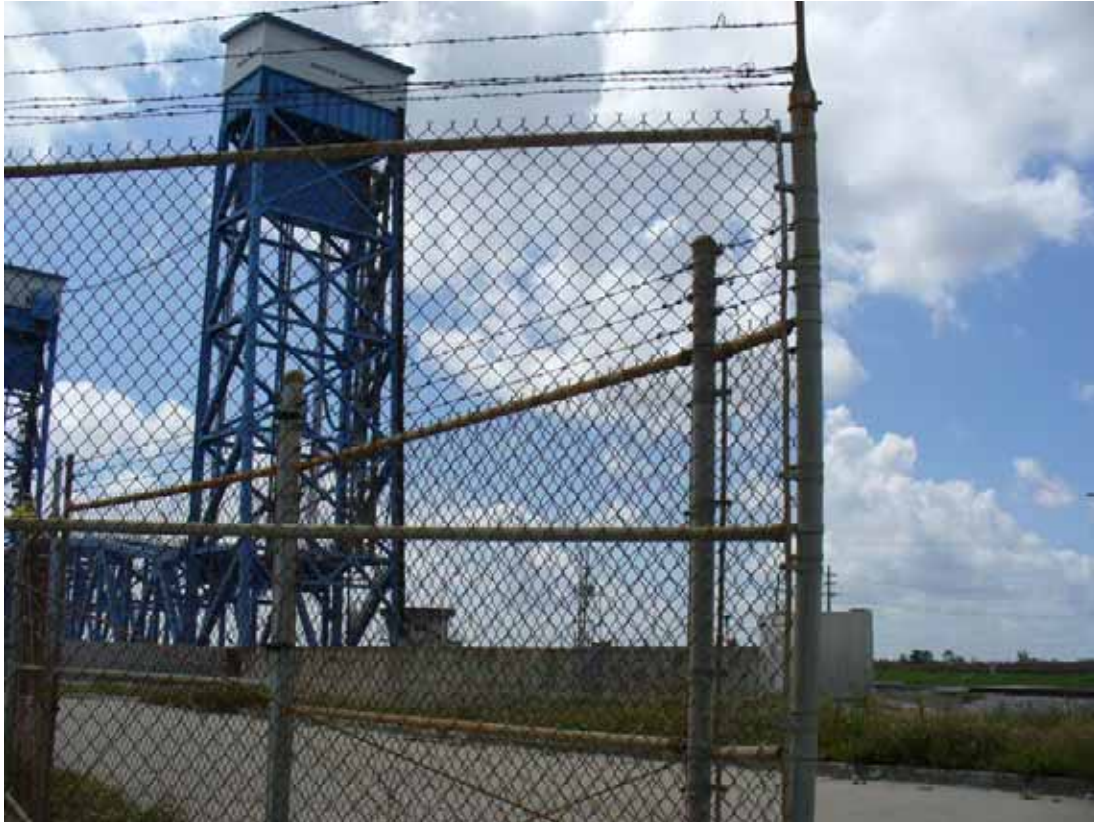
9. View of south area adjacent to the site in southeast area.

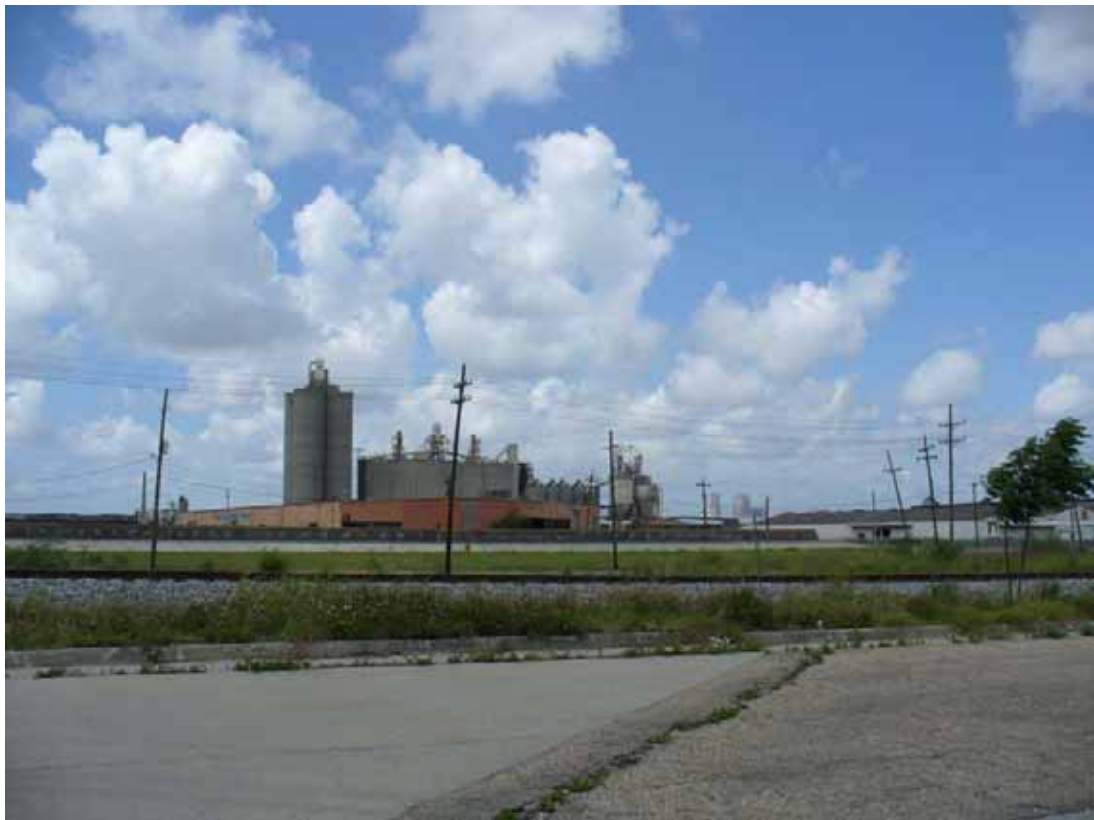
10. View of south area adjacent to the site.

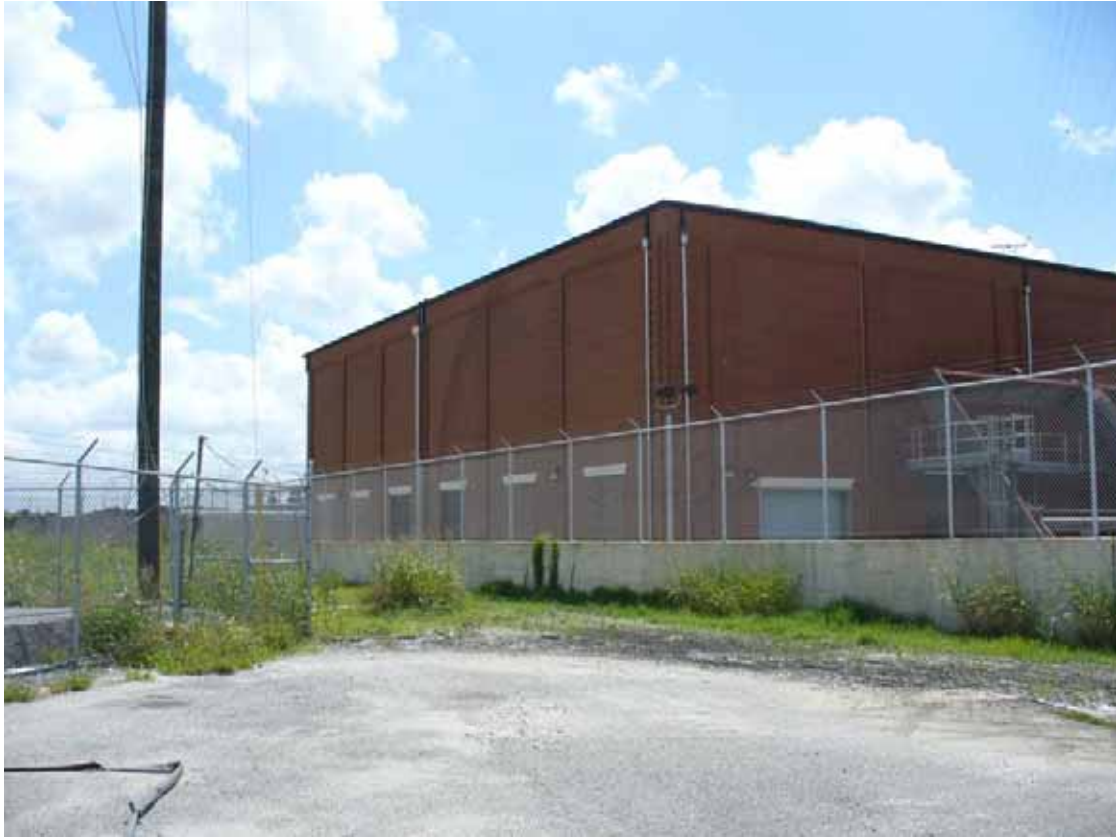
11. View of site as seen from the west direction.

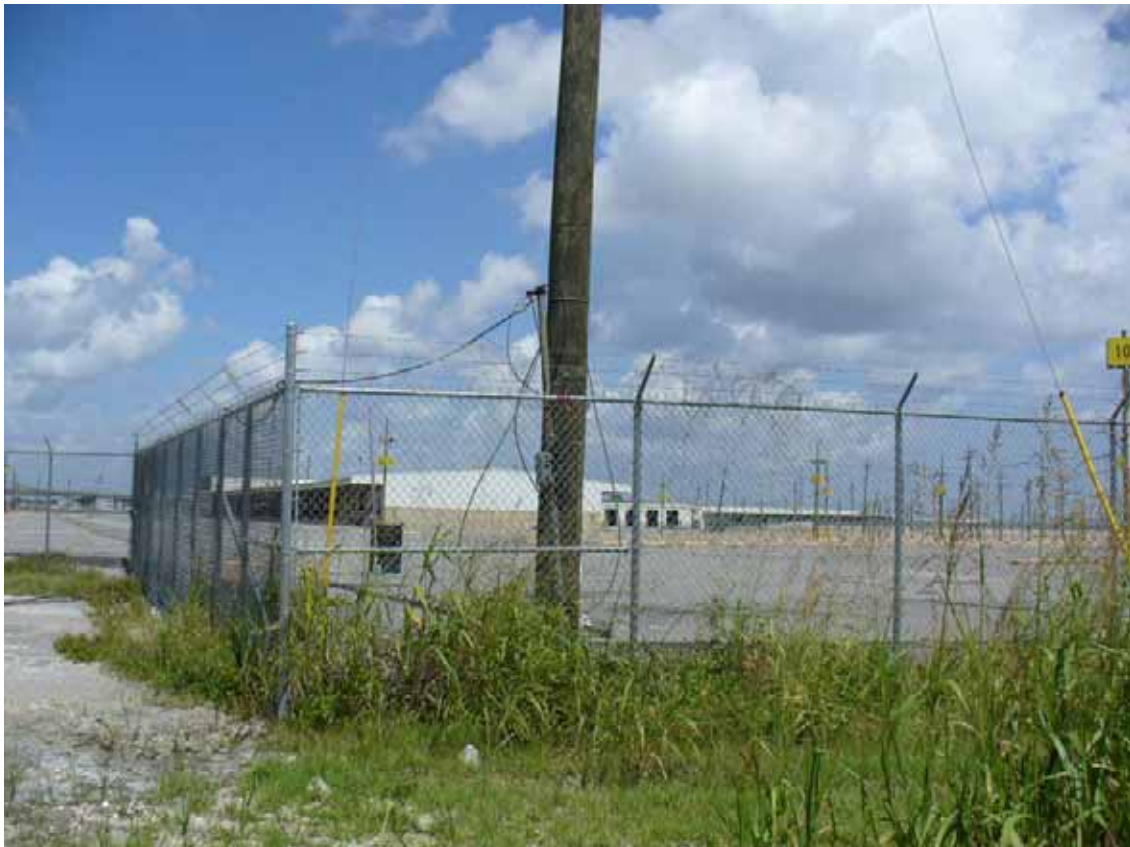
12. View of west area adjacent to the site in northwest direction

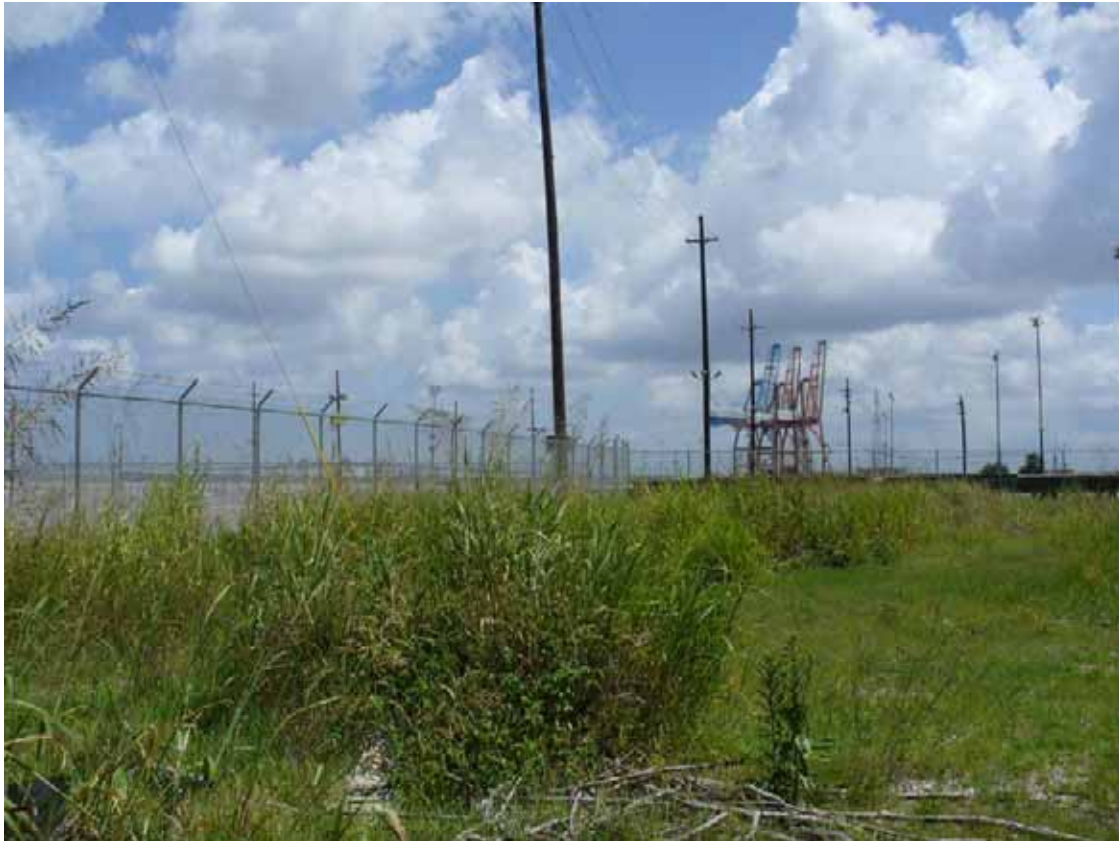
13. View of west area adjacent to the site in northwest corner.

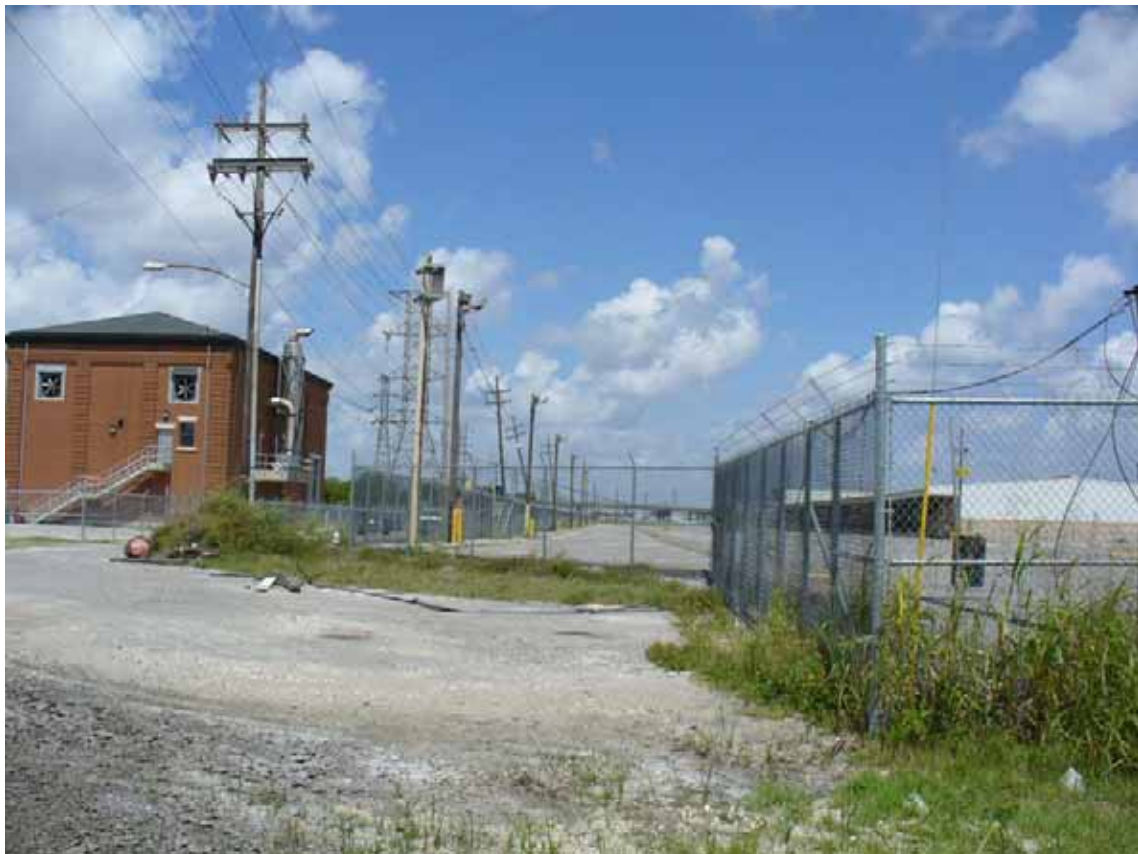
14. View of west area adjacent to the site, including generator building.

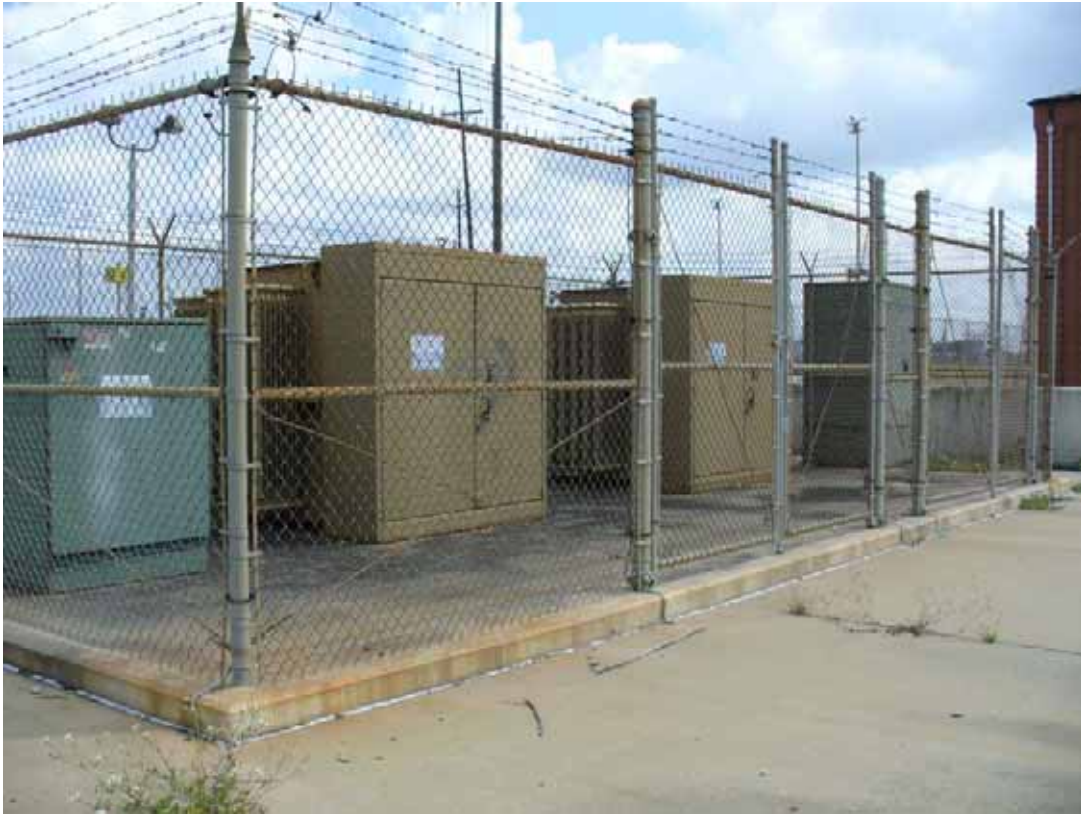
15. View of transformers, located on south side.

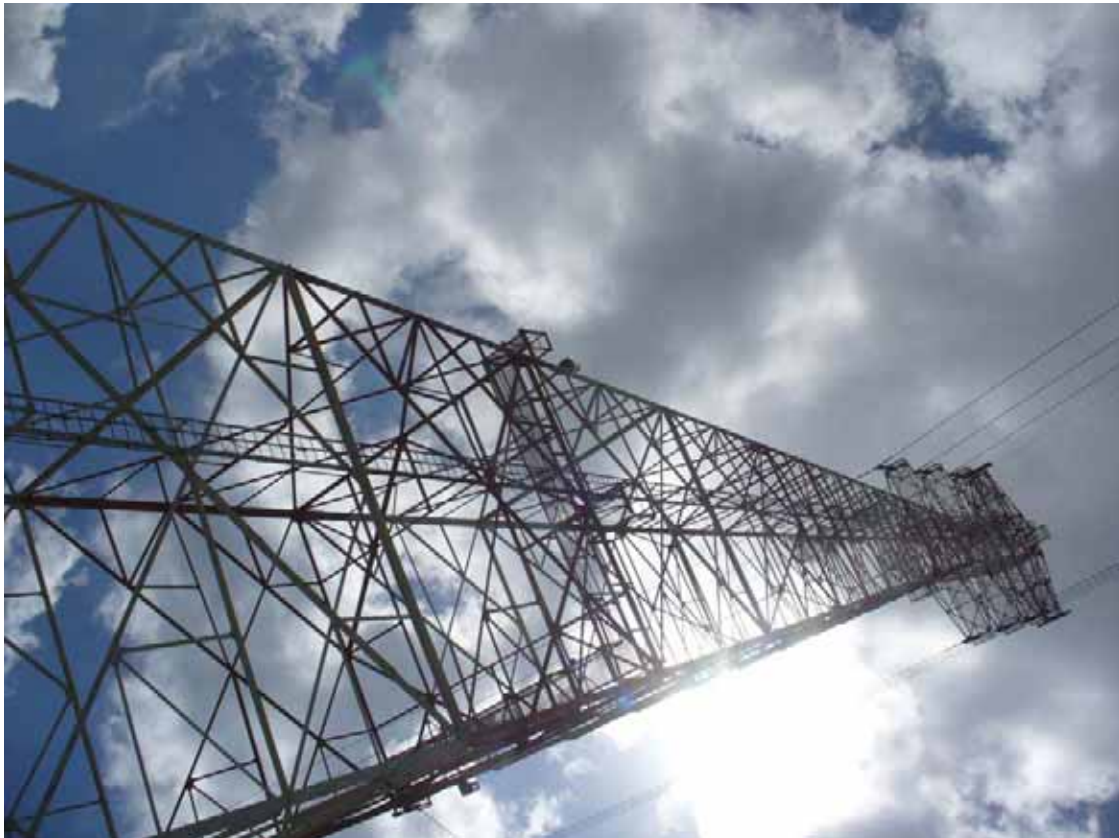
16. Tower south east of building.

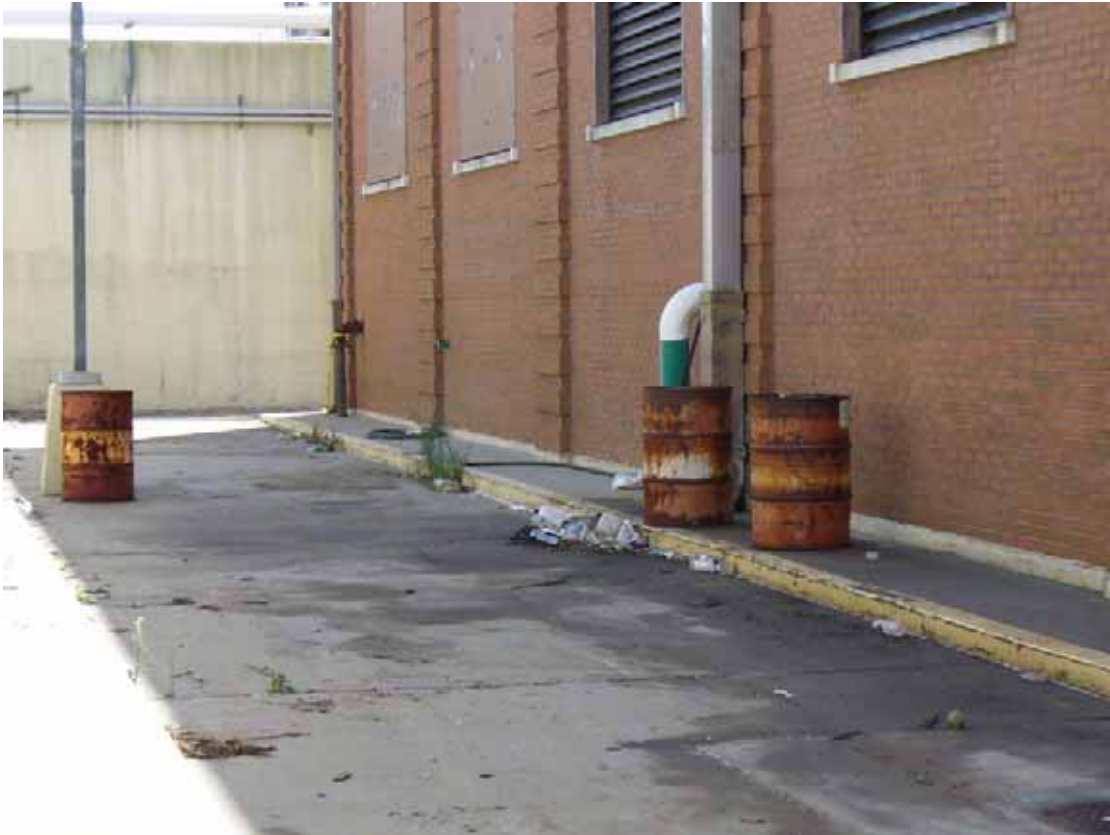
17. Drums located outside OP-19 building in west area.

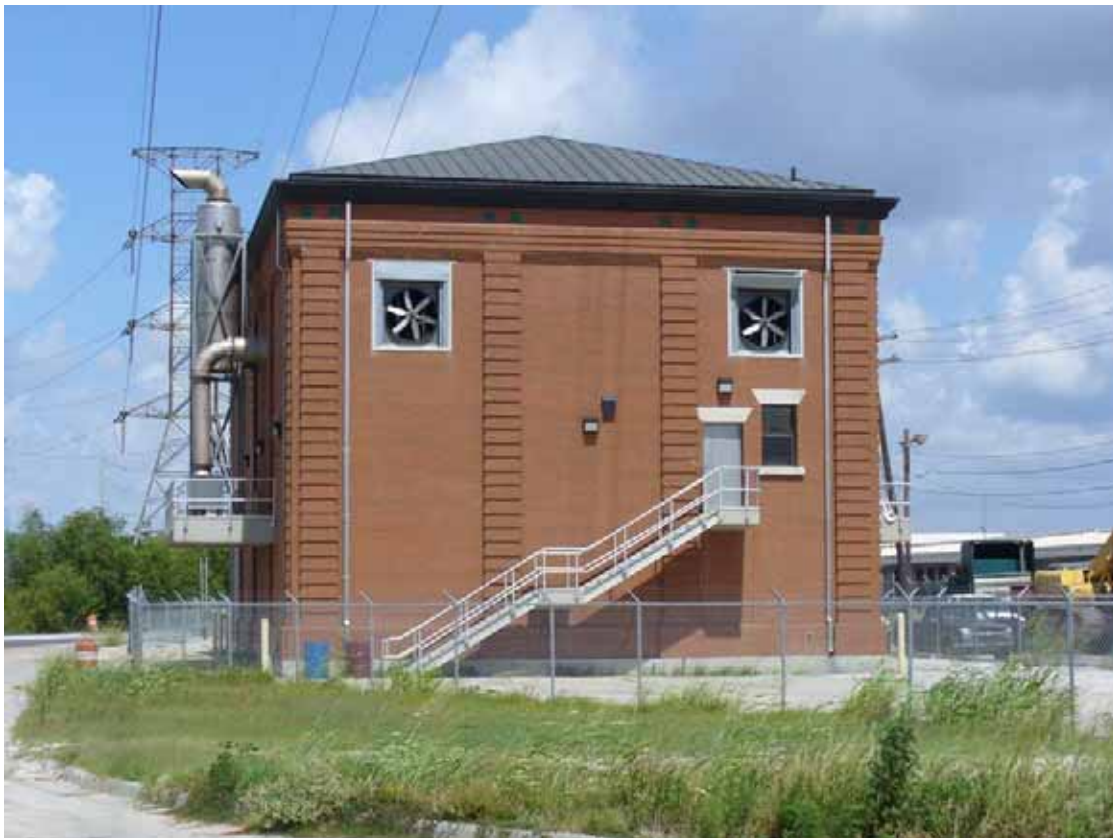
18. Generator building, east side.

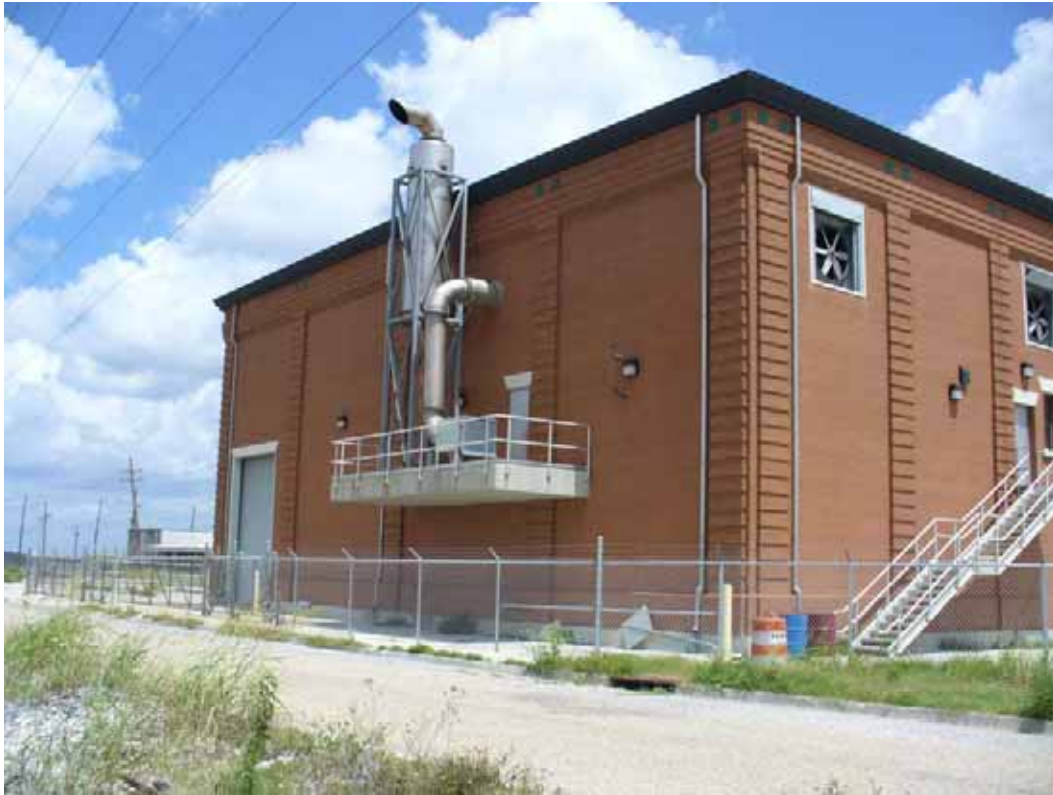
19. Generator building, south side.

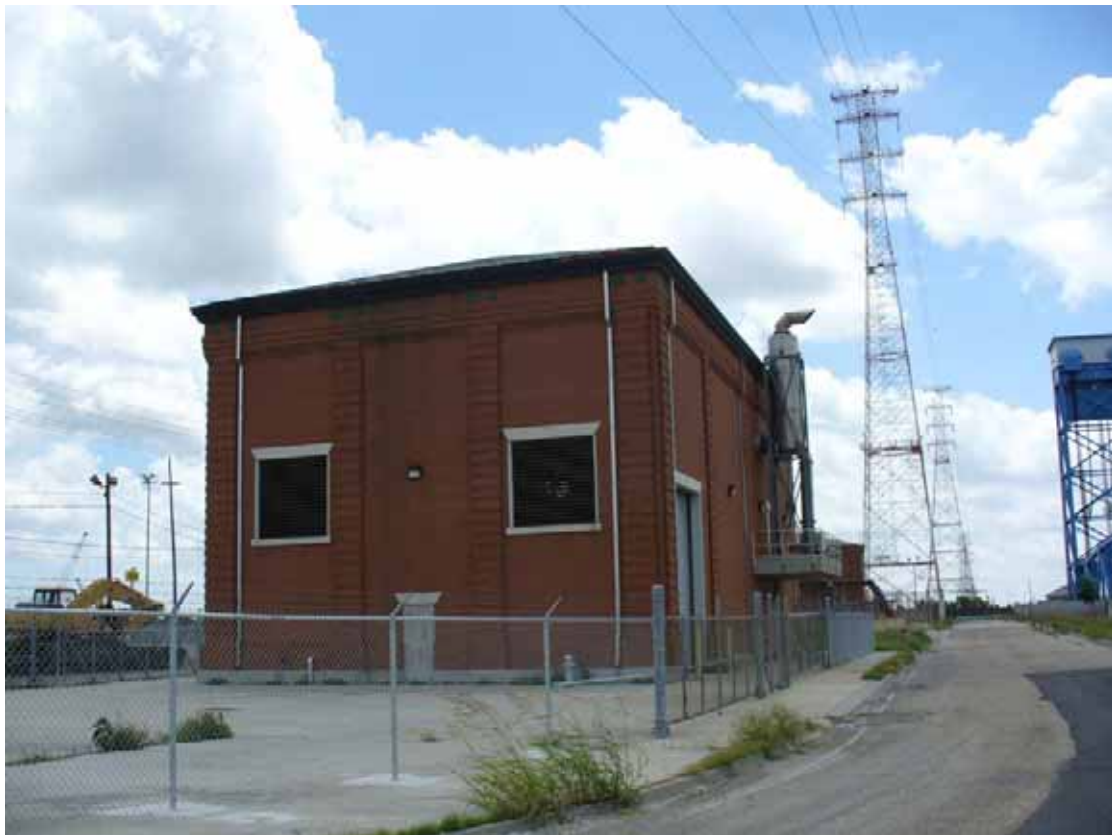
20. Generator building, west side.

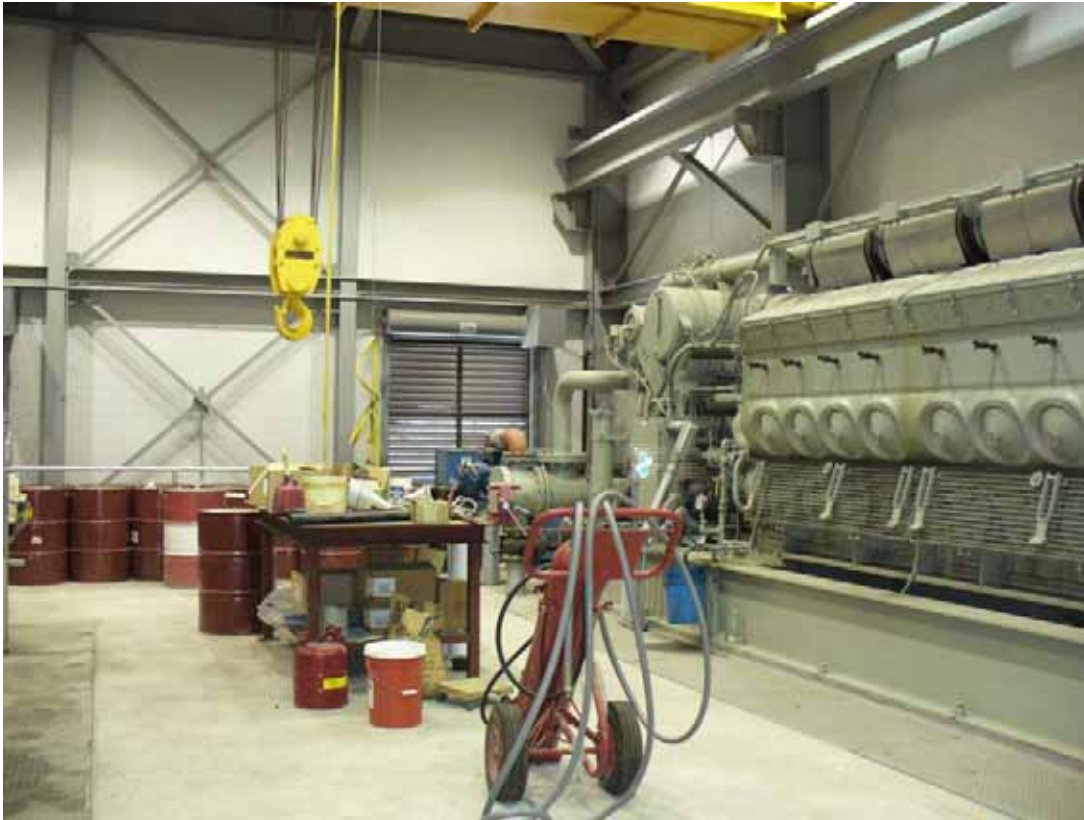
21. Engines and drums inside generator building.

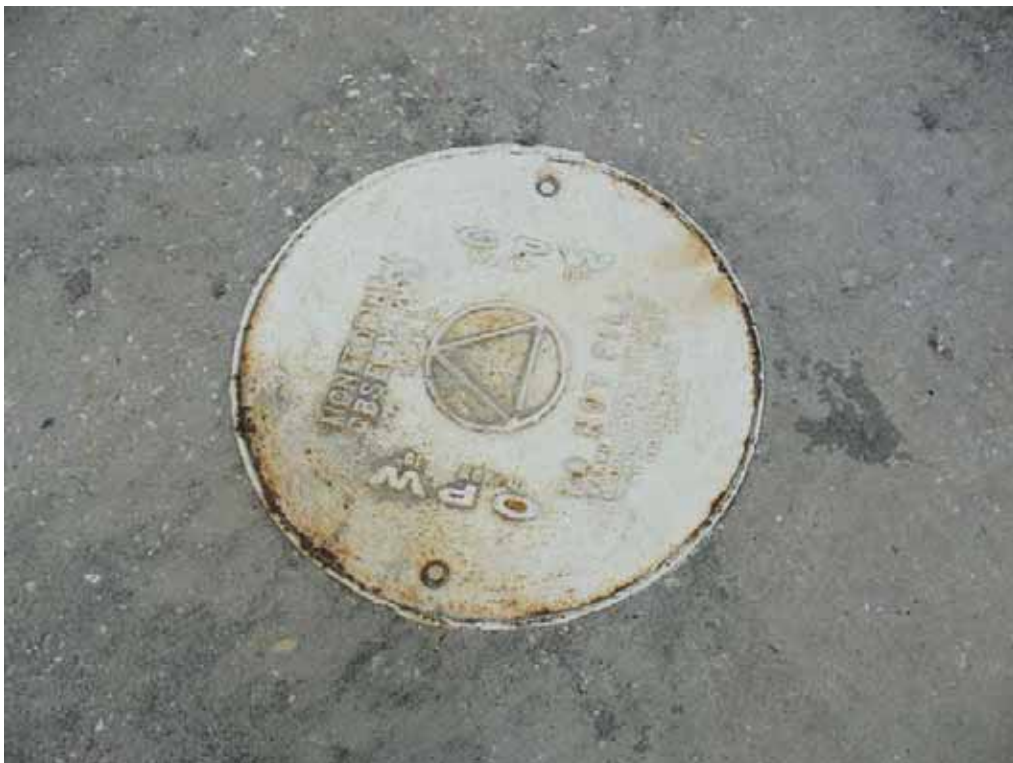
22. Underground storage tanks, for generator building located outside in west area.

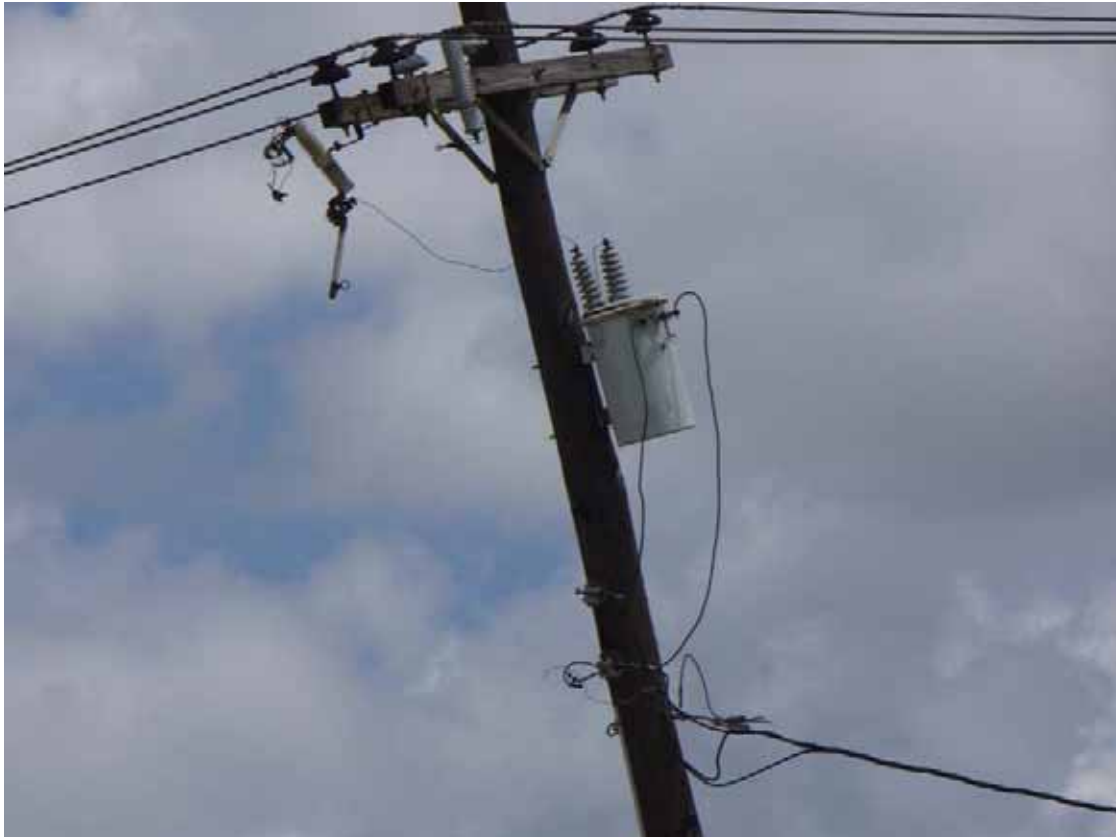
23. Transformer observed on south of property.

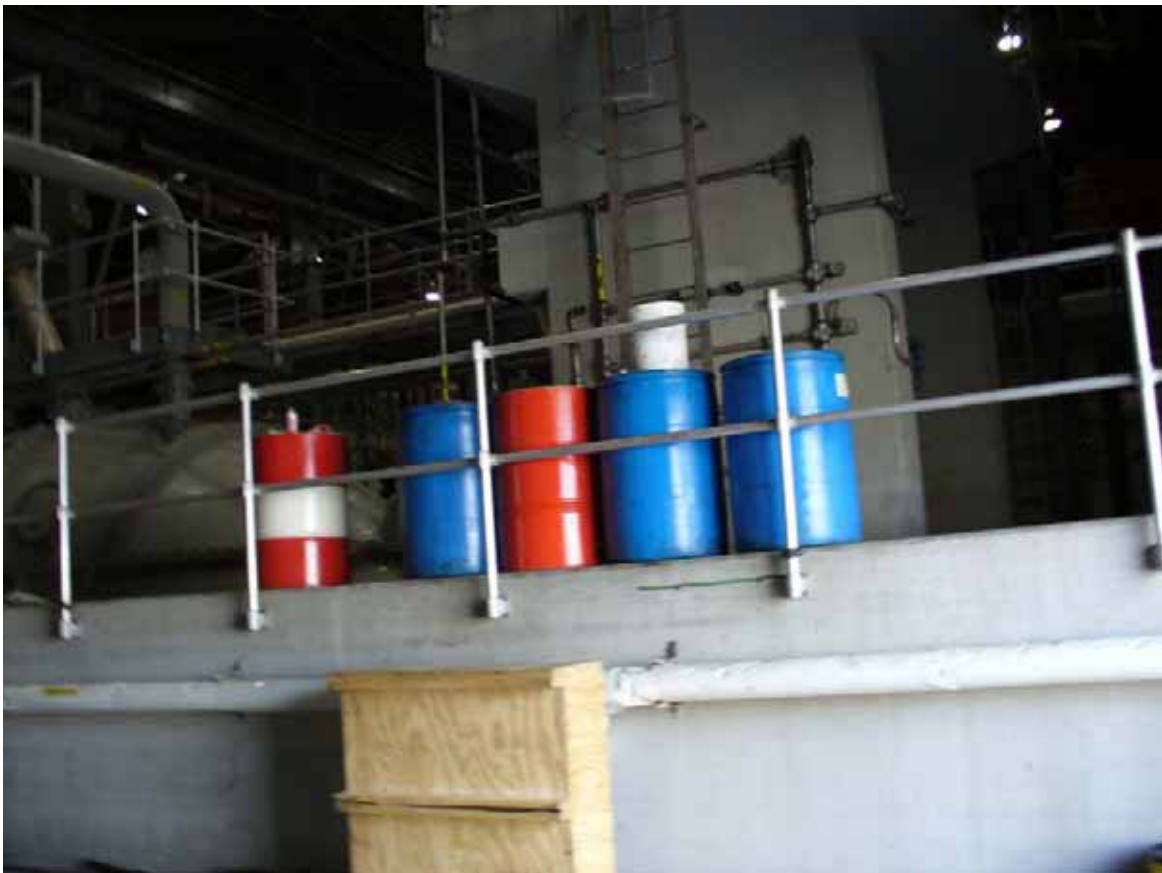
24. Drums observed inside OP-19 building.
