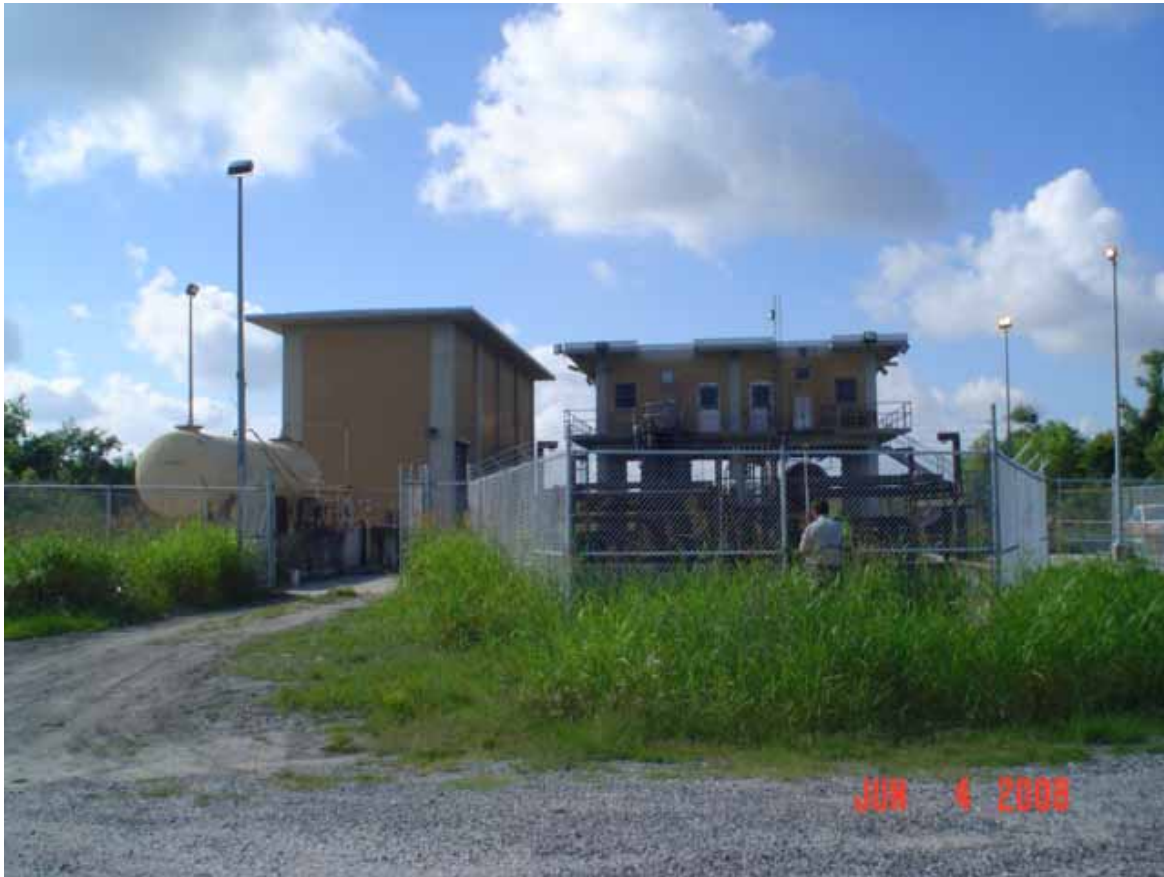
1. View of site as seen from the north direction.

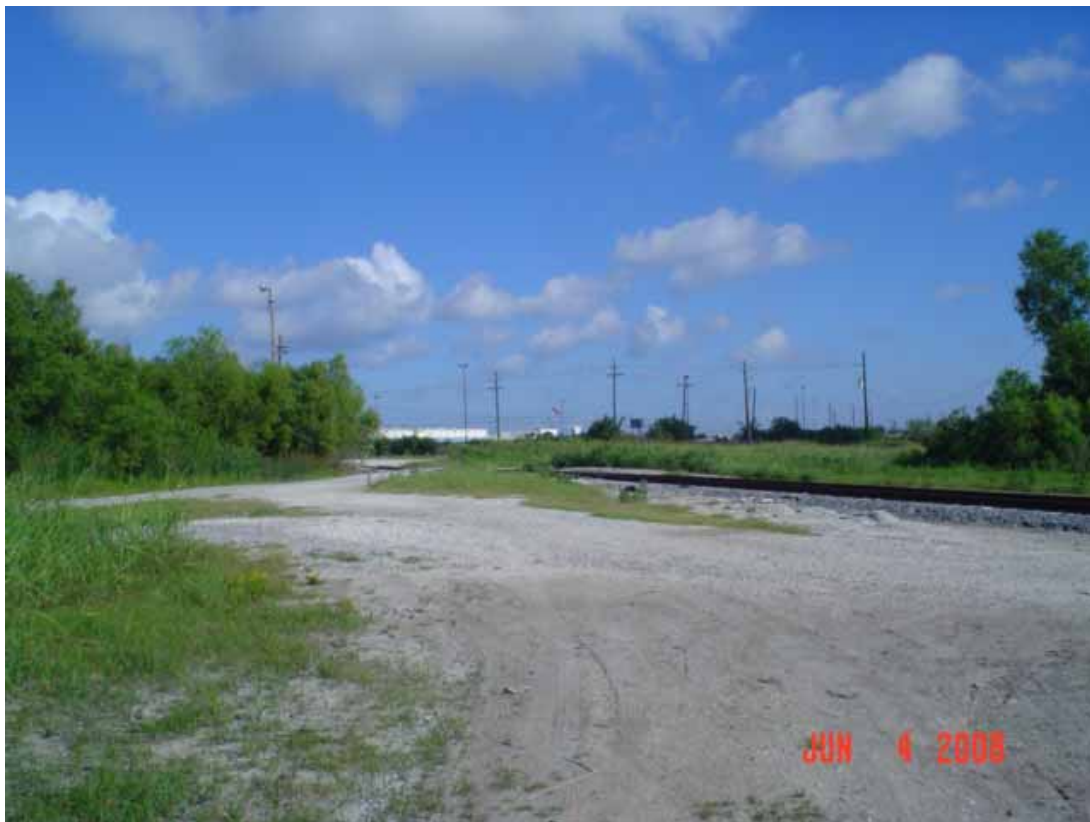
2. View of north area adjacent to the site, showing railroad tracks.

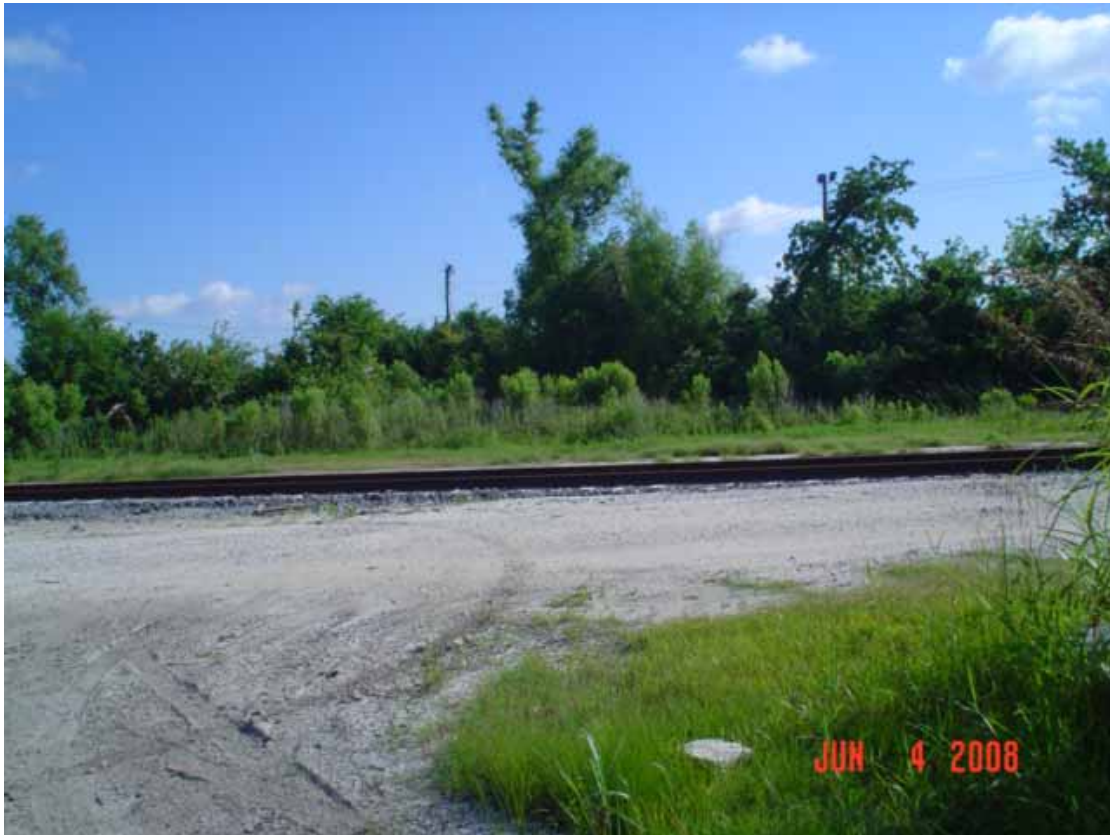
3. View of north area adjacent to the site, showing railroad tracks, northeast corner.

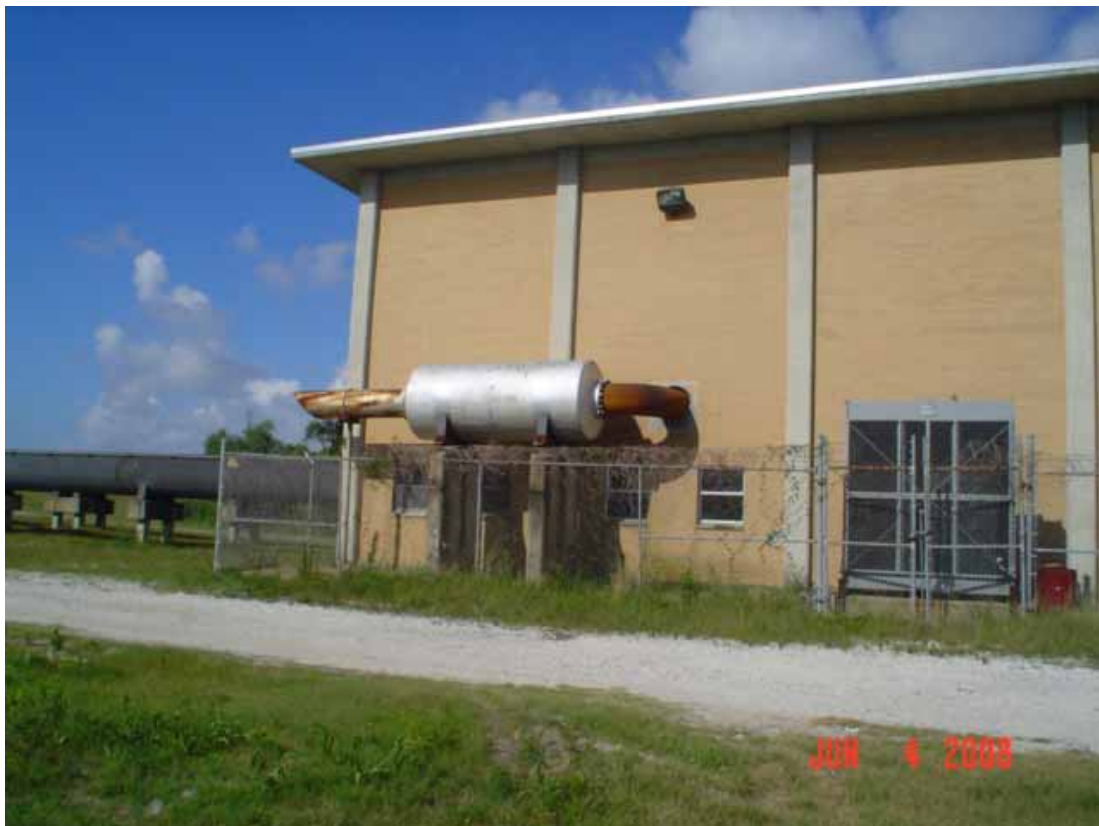
4. View of site as seen from the east direction, southeast corner.

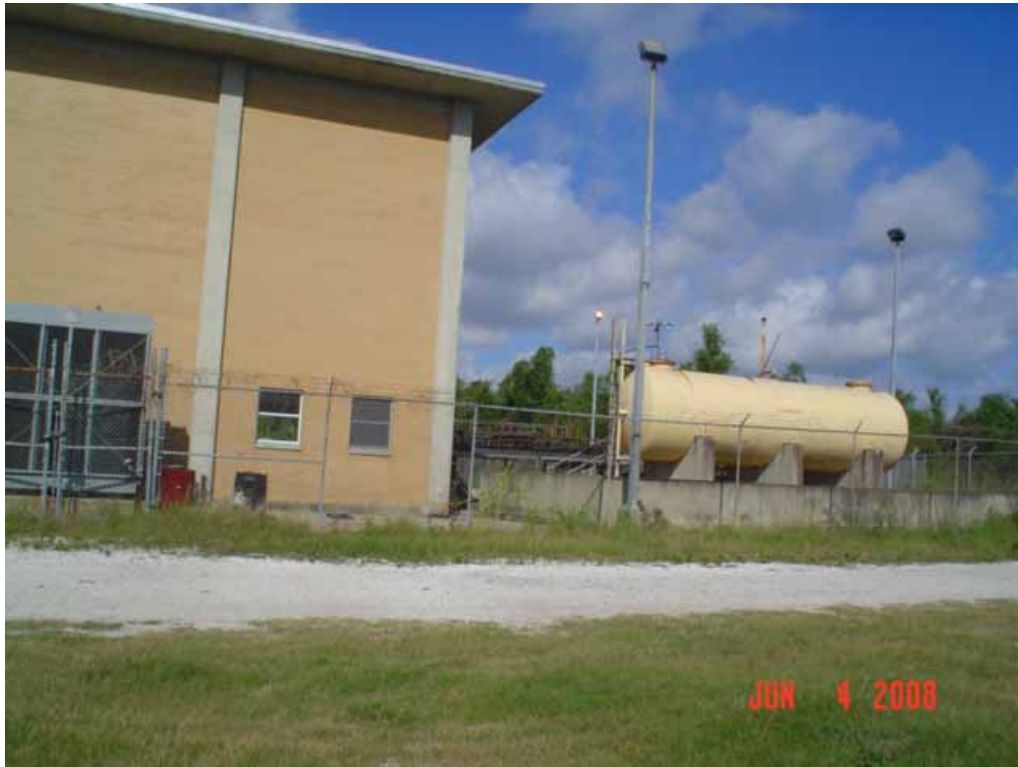
5. View of site as seen from the east direction, northeast corner.

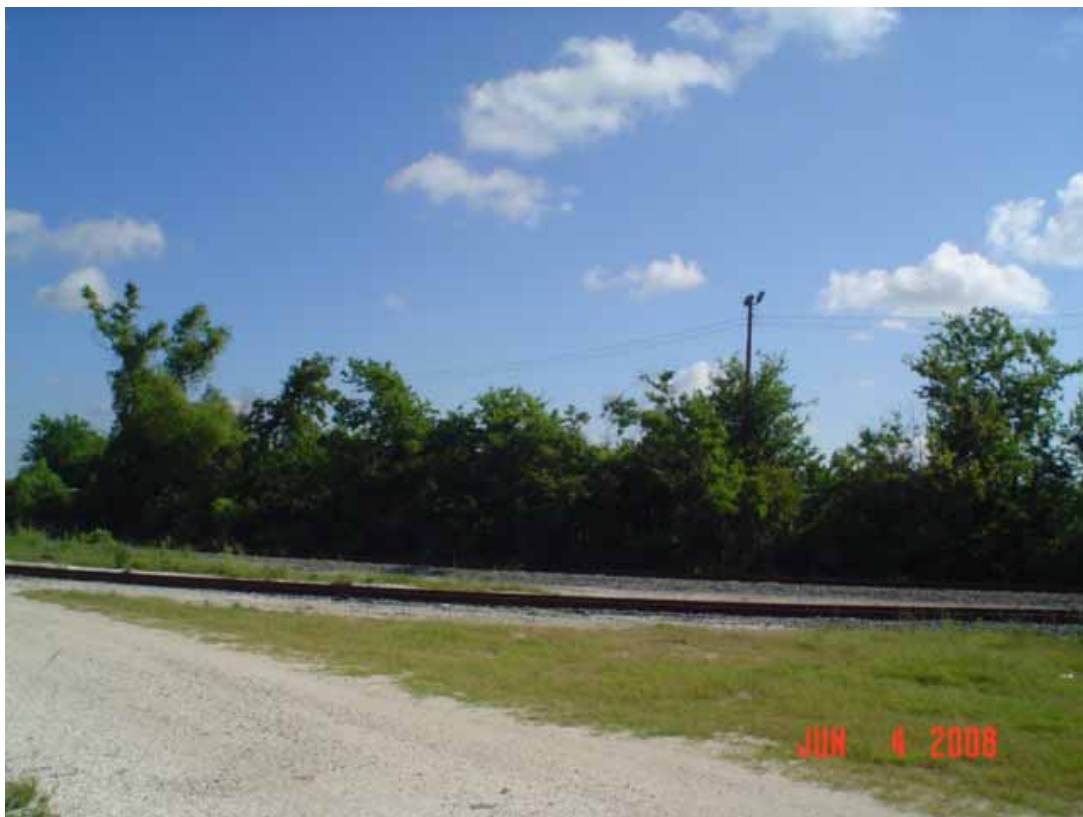
6. View of east area adjacent to the site, railroad tracks.

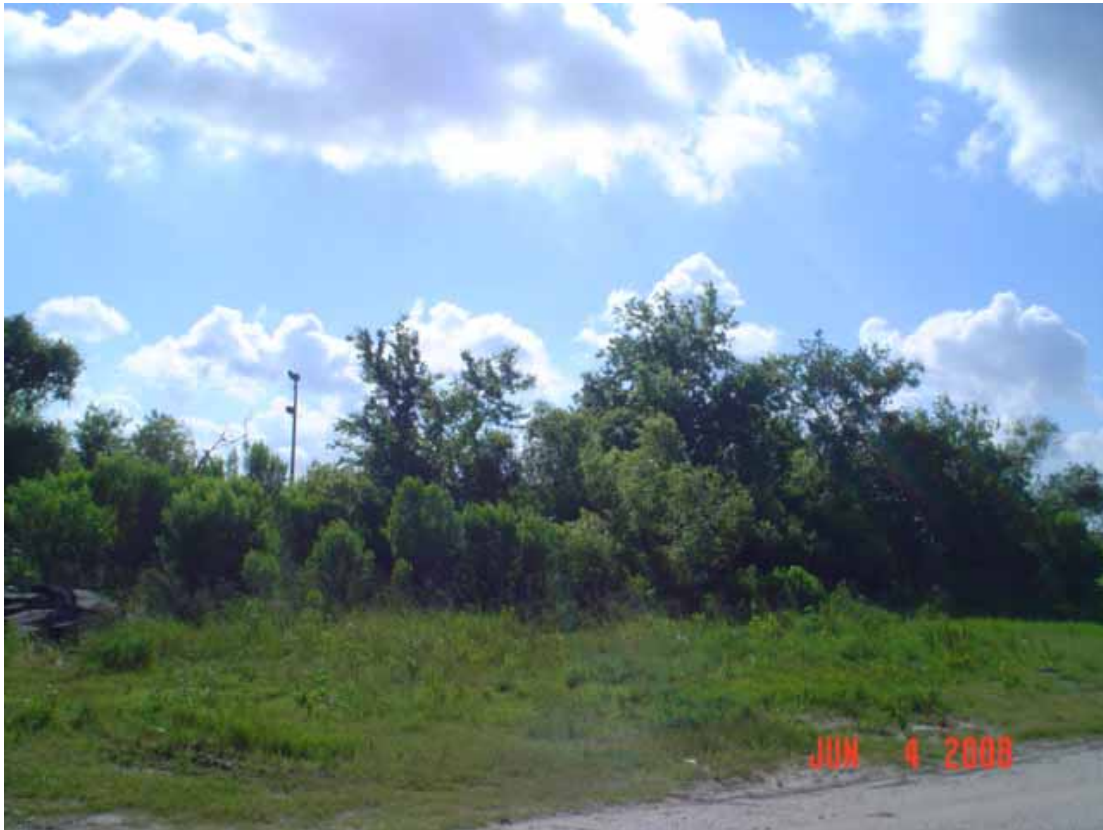
7. View of east area adjacent to the site, southeast corner.

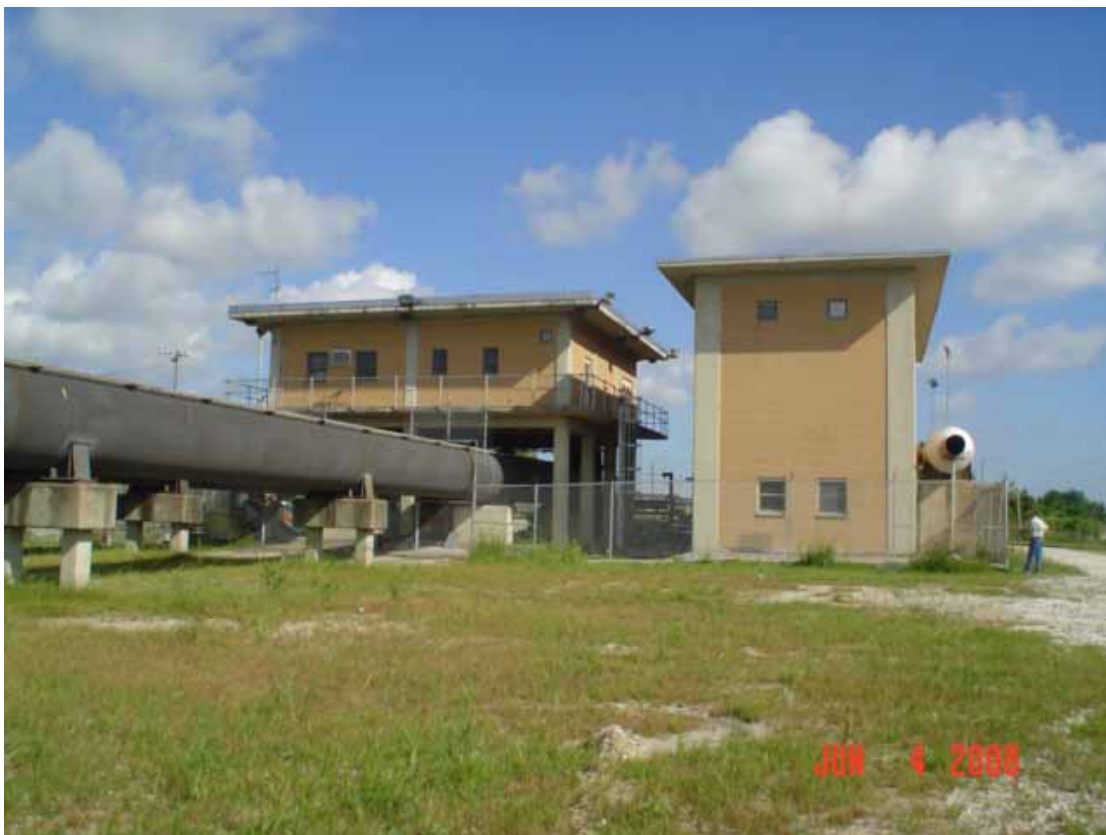
8. View of site as seen from the south direction.

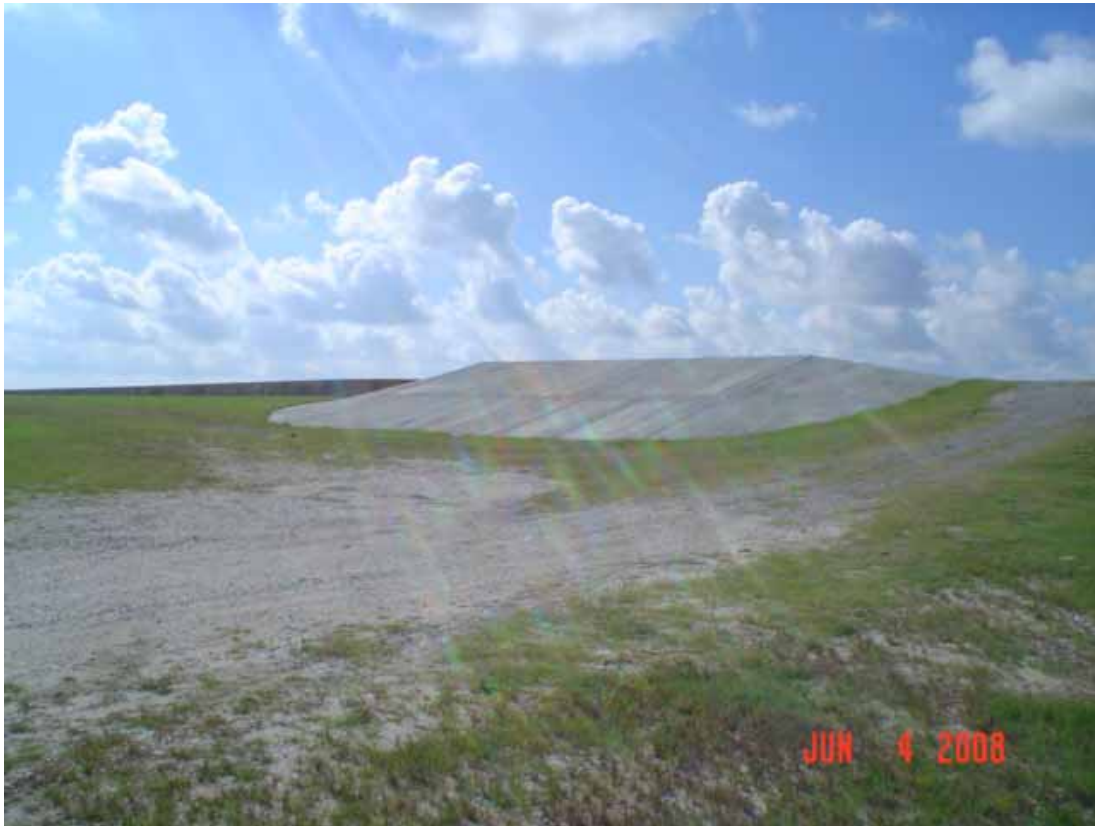
9. View of south area adjacent to the site, new levee section.

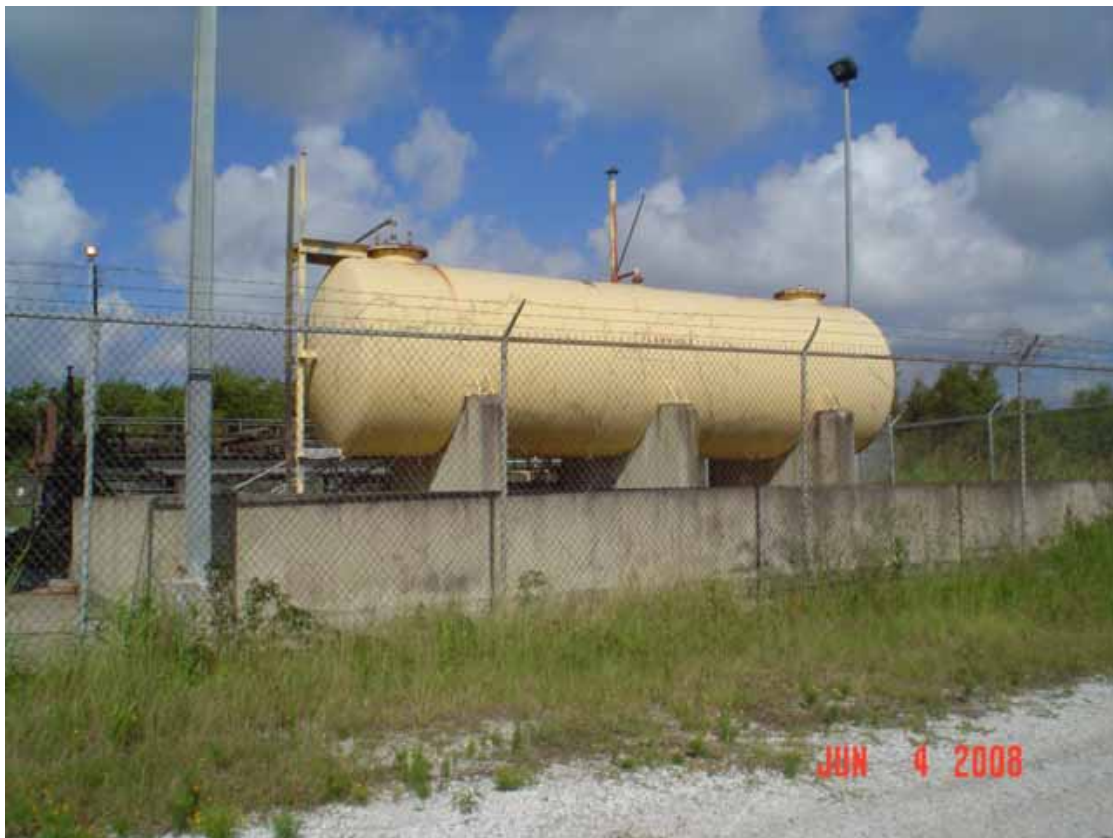
14. Fuel tank, northeast corner.

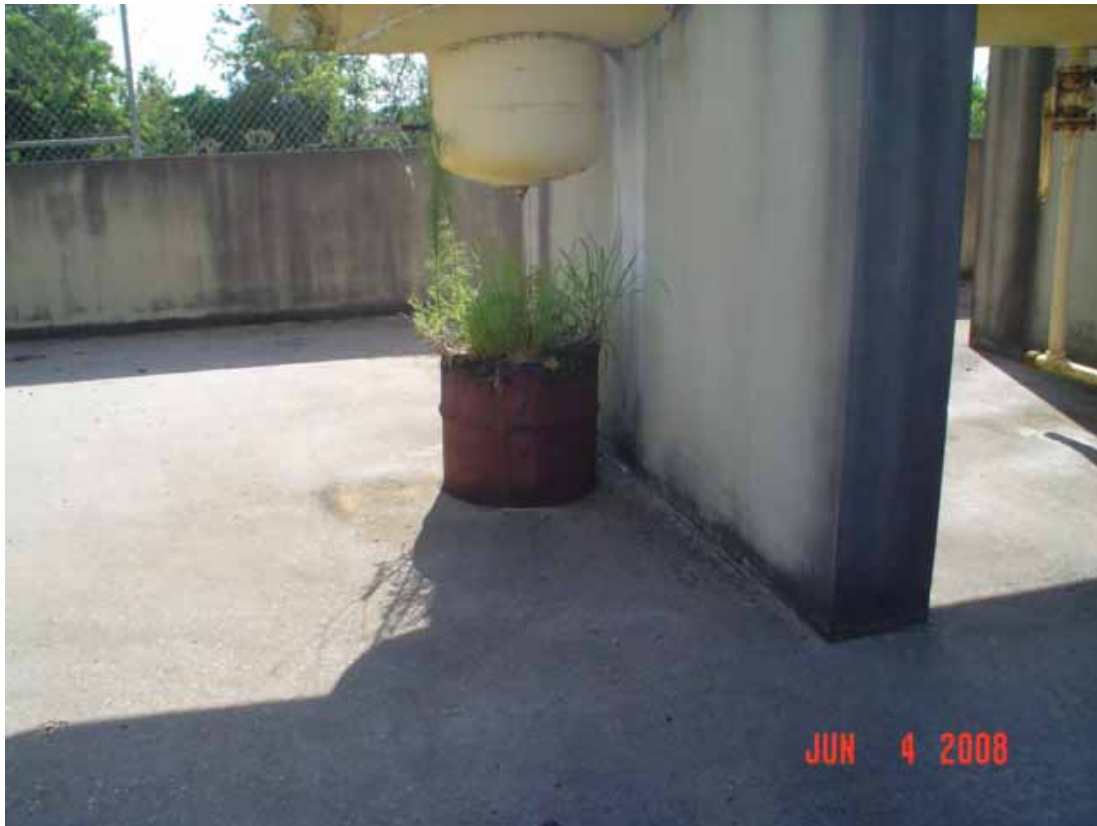
15. Plants growing under fuel tank.

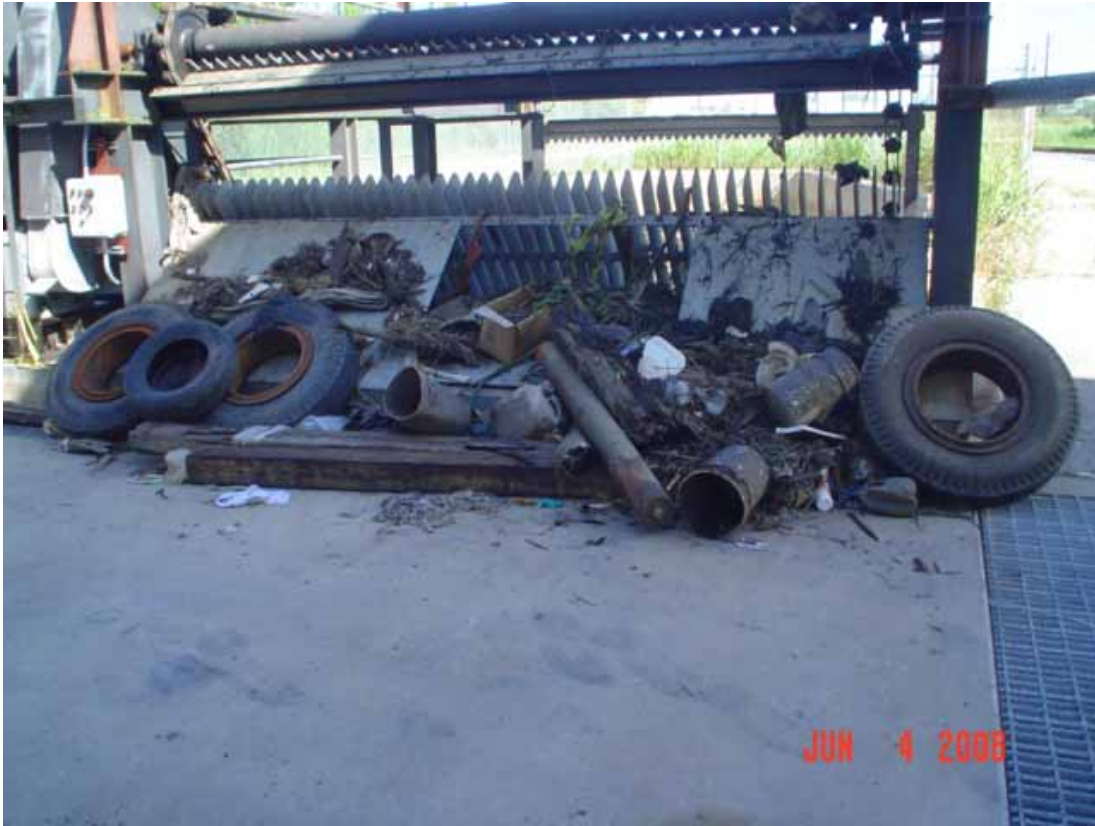
17. Refuse from canal.

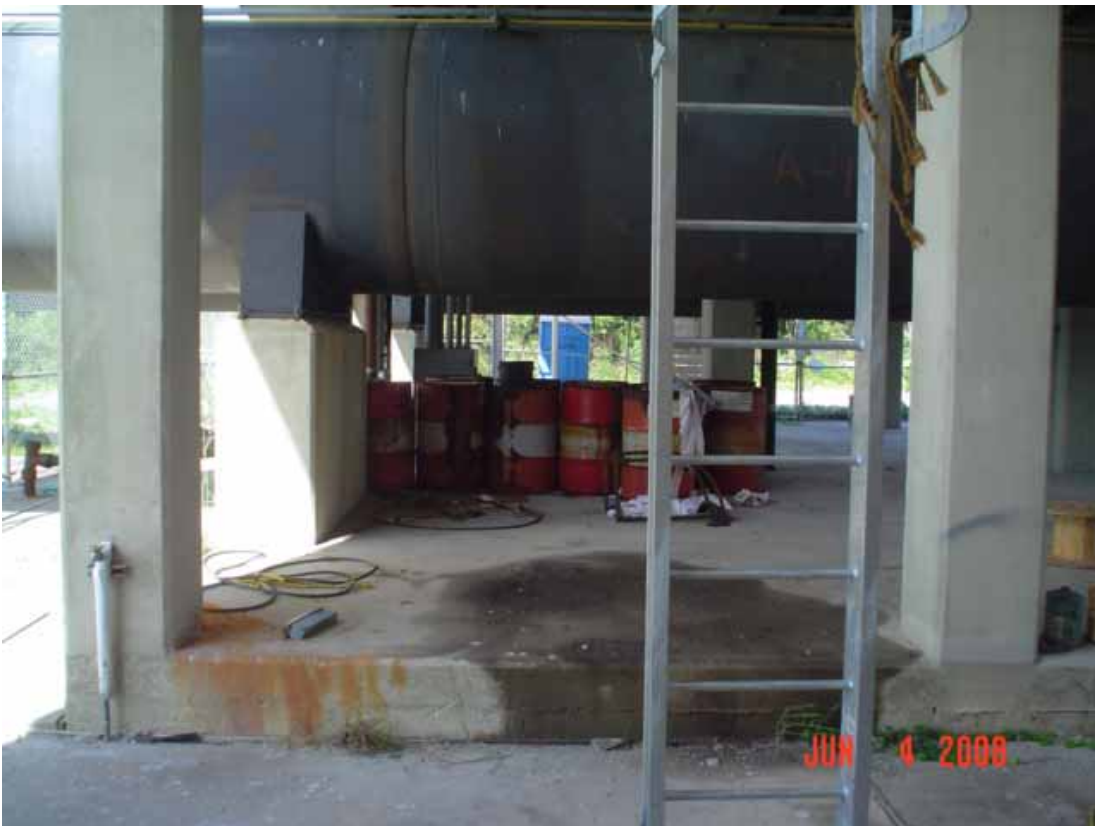
18. 55 gallon drums under pipeline.

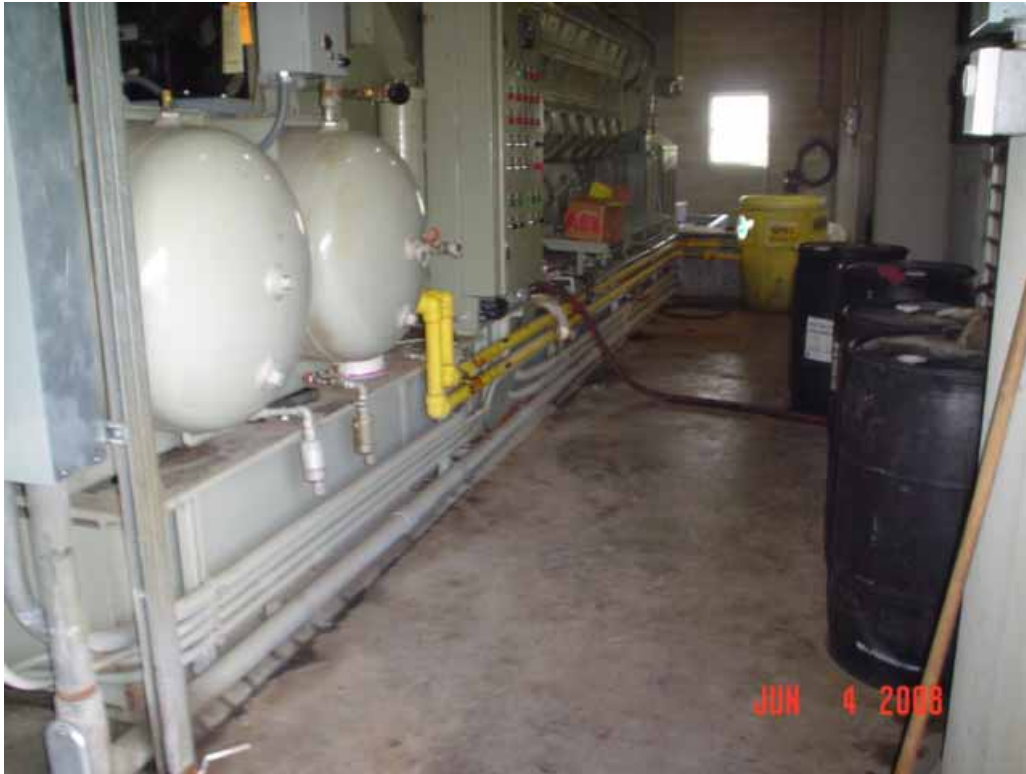
19. Tanks, drums, and switches inside building.

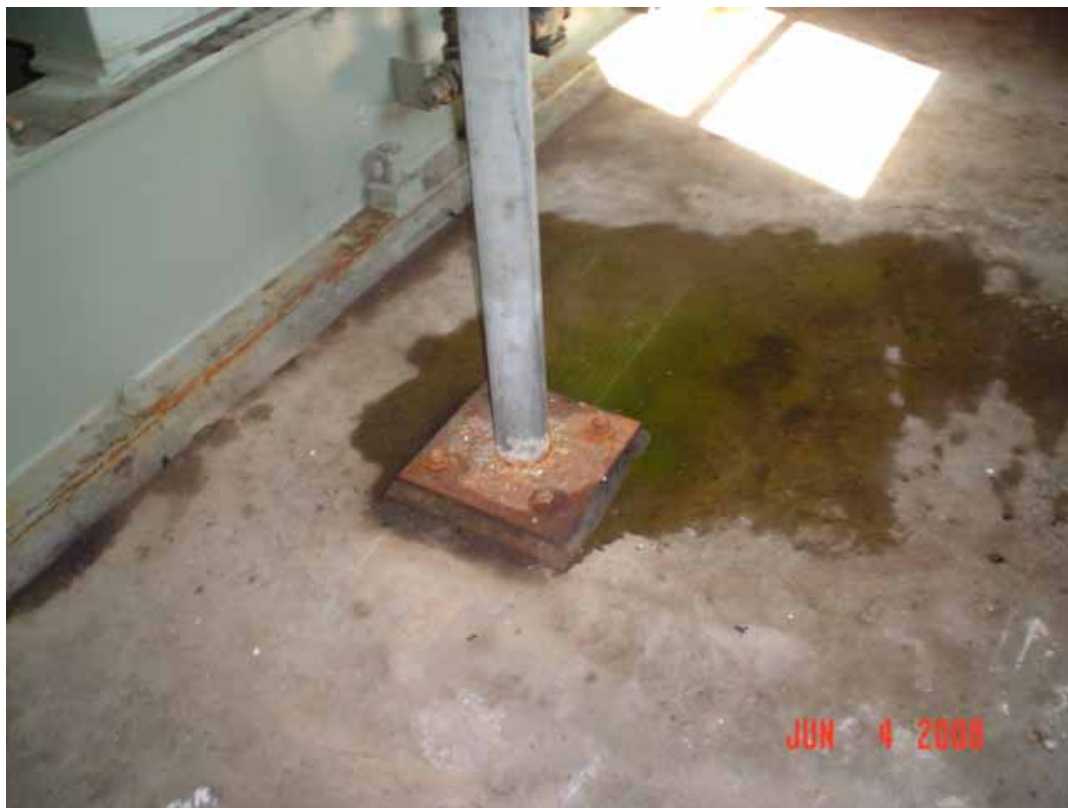
20. Antifreeze puddle near engine.

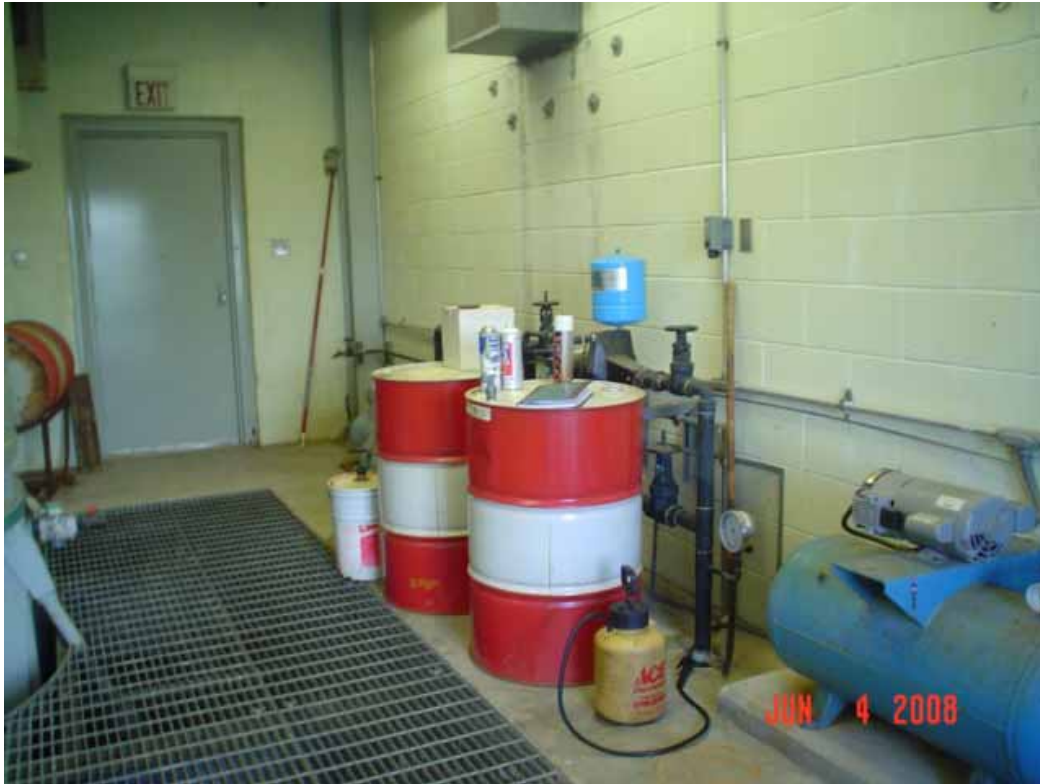
15. Drums inside levee

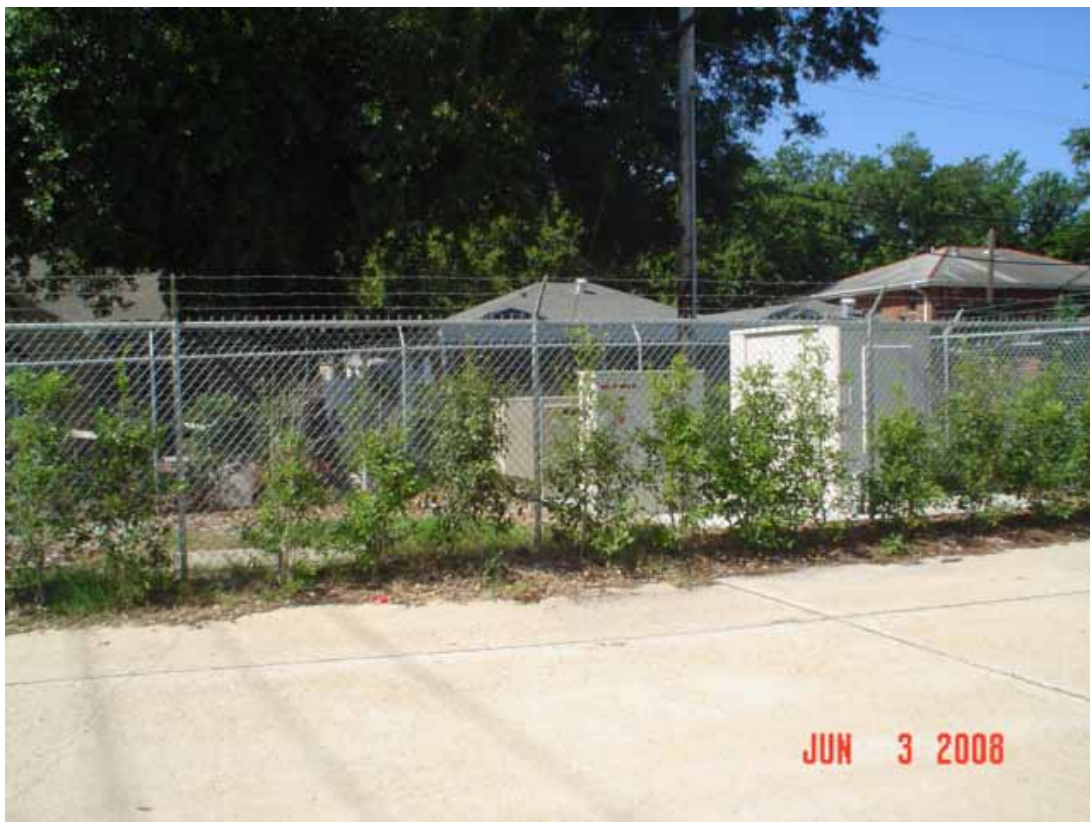
12. Transformers, southwest corner across road.

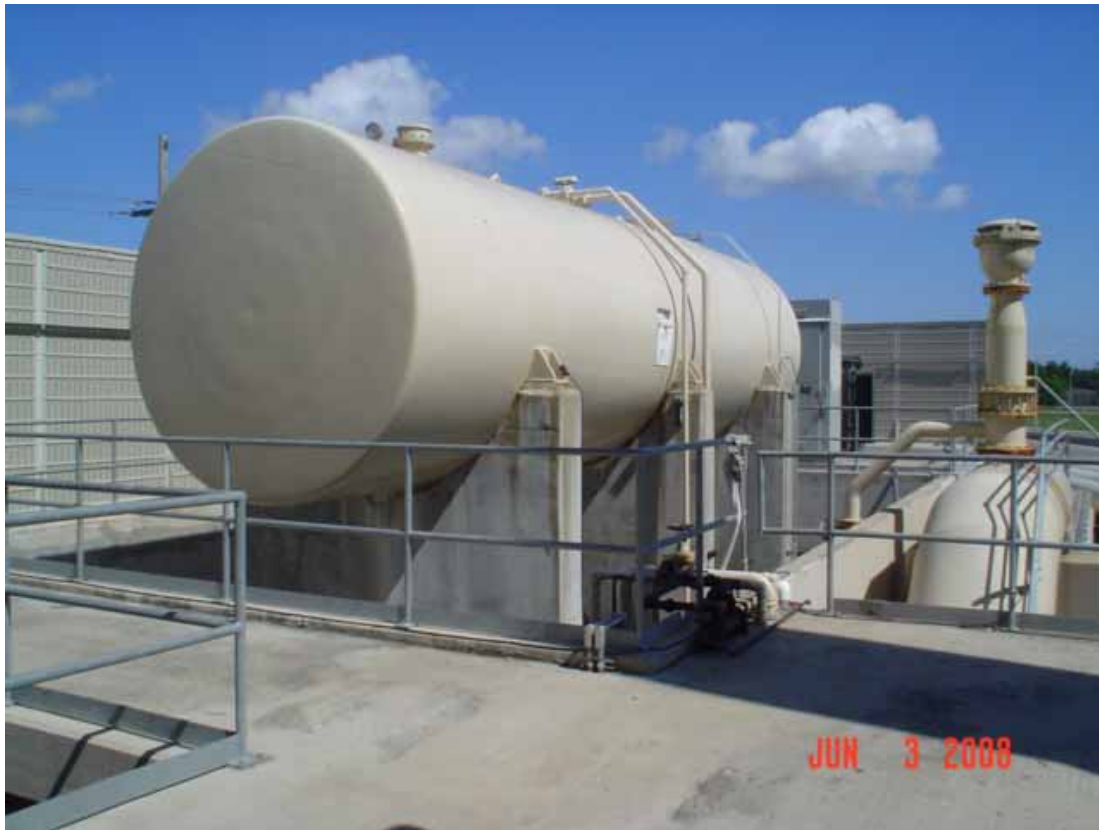
13. Fuel storage tank, northwest corner inside property.

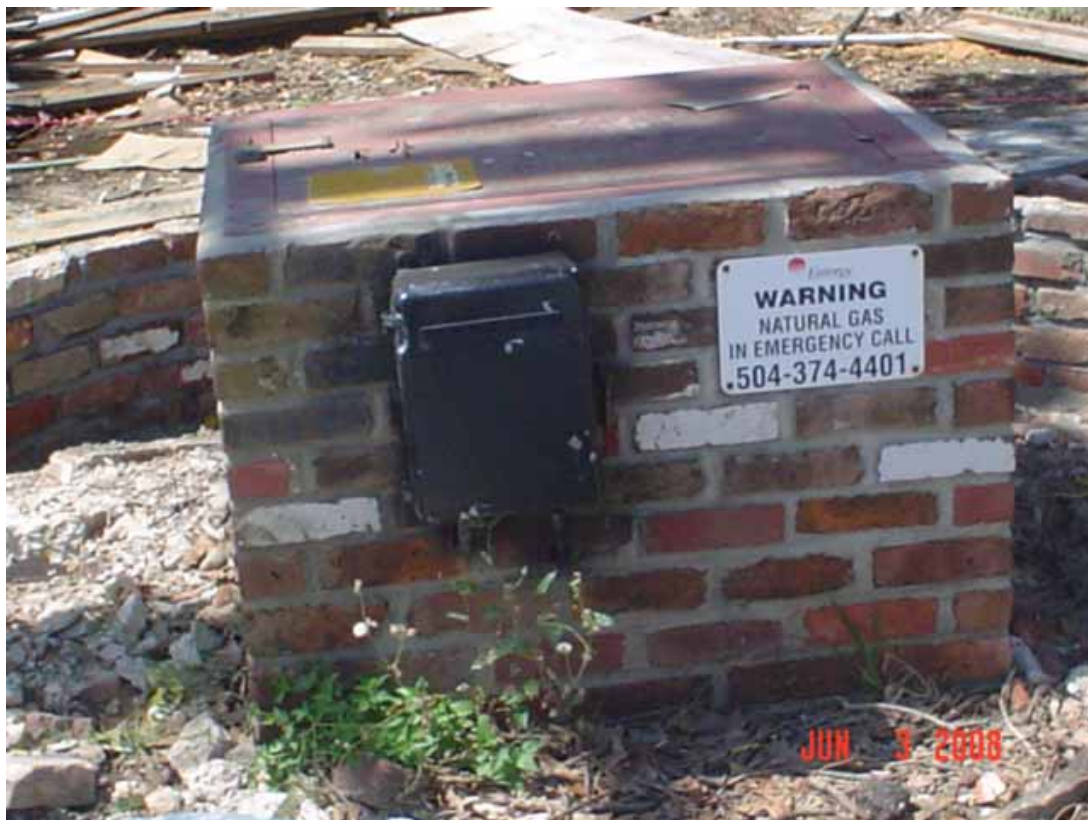
14. Gas line, residential area, southwest corner.

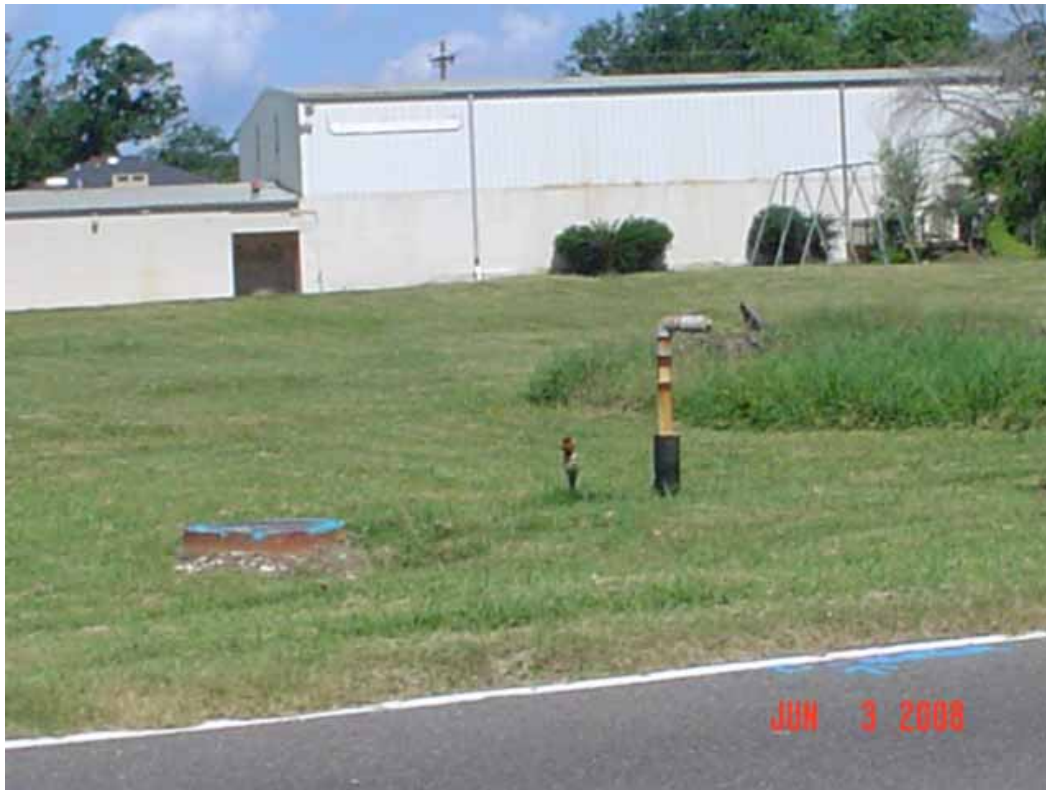
15. Unknown pipeline and man hole, west side, across road.

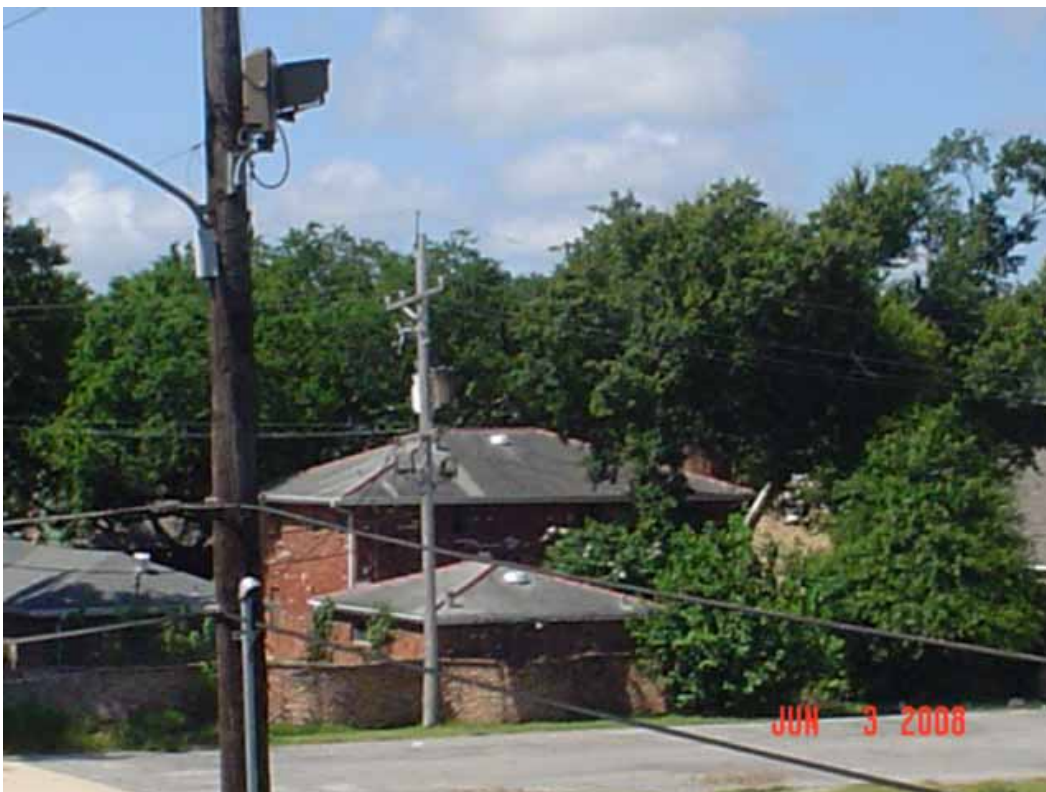
16. Transformers on poles, southwest corner.

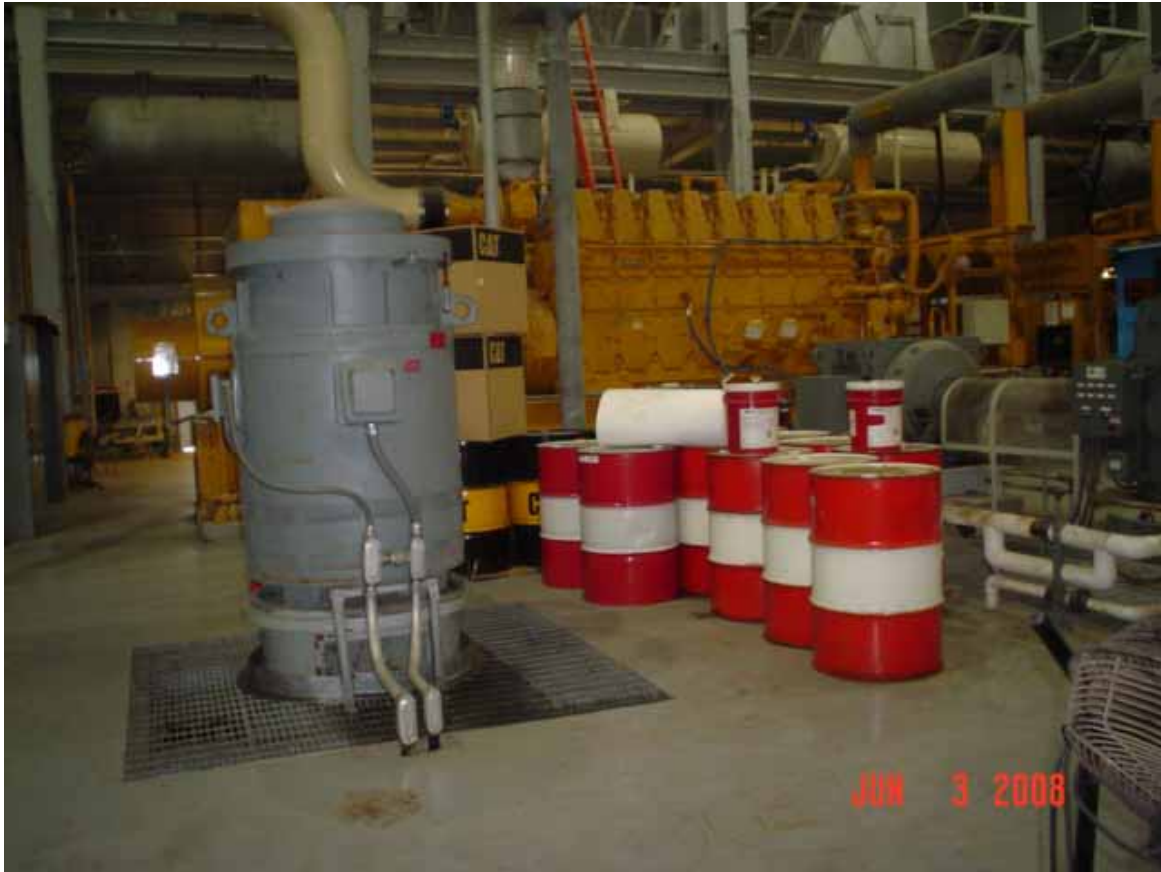
17. Diesel engine, pump motor and various drums inside building.

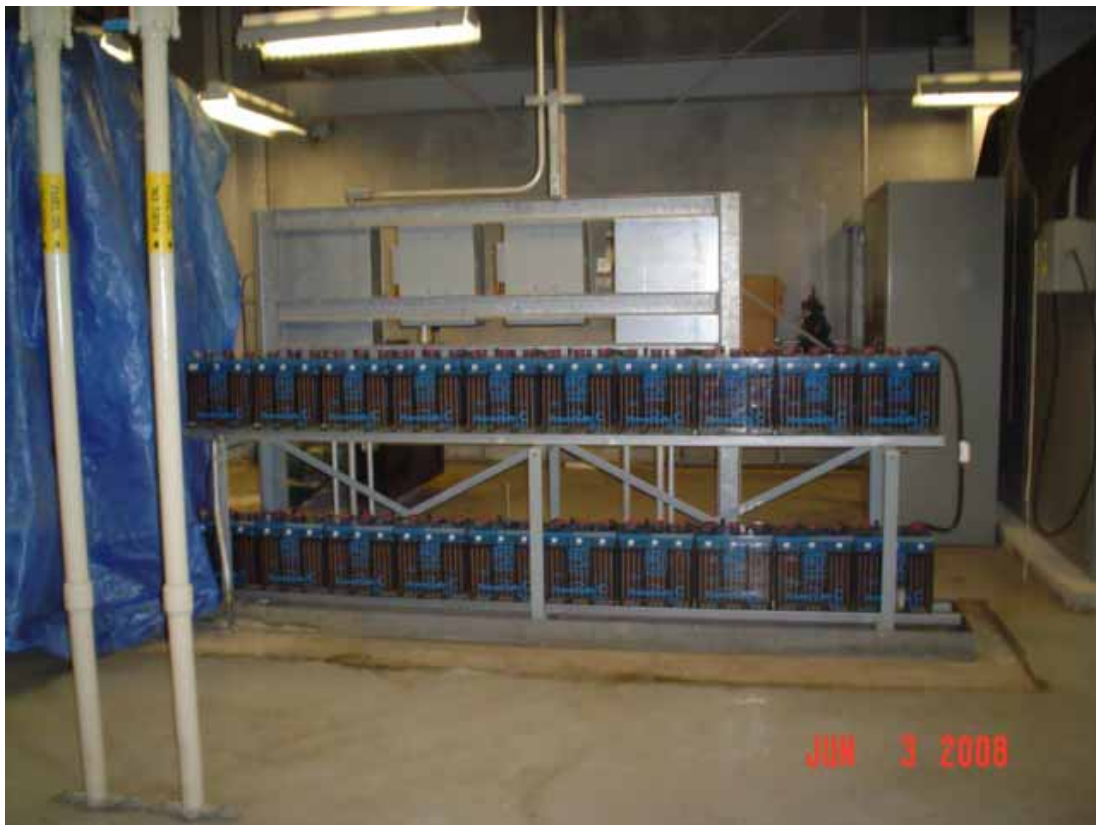
18. Battery bank and switch boxes inside building.

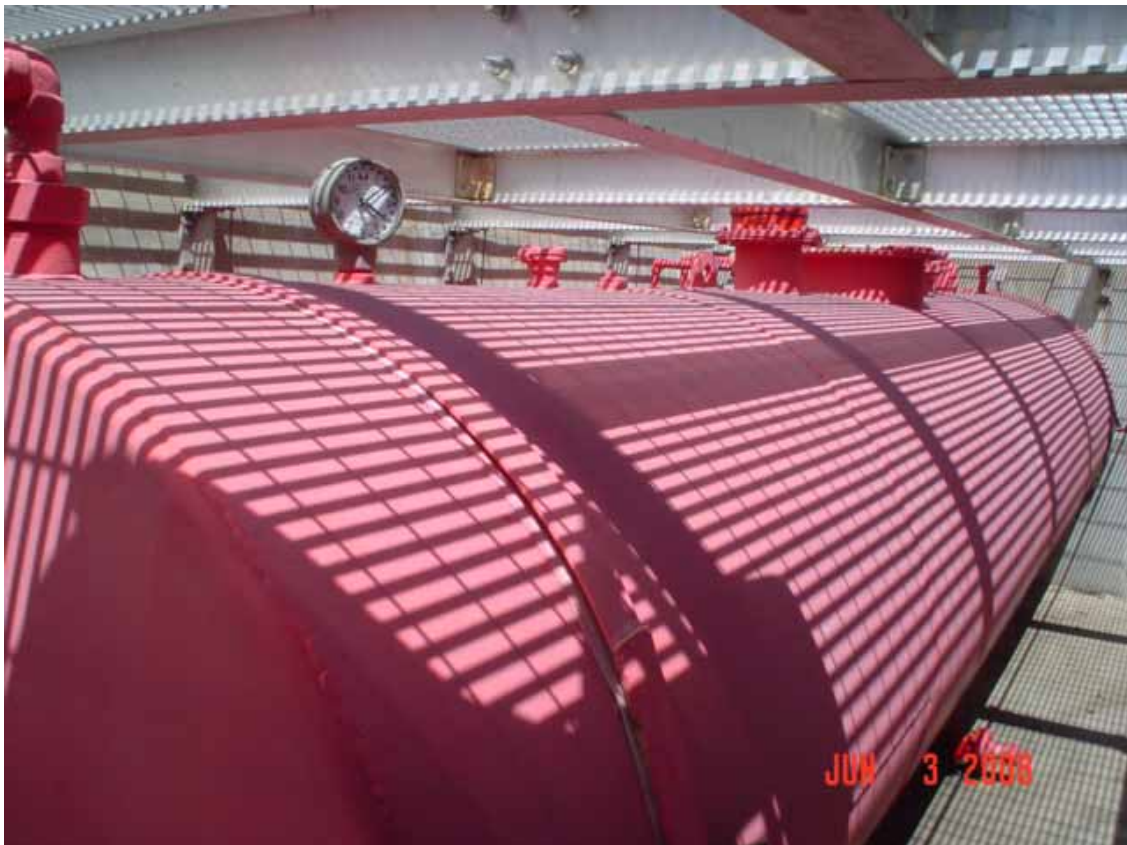
10. Fuel storage tank under grating on north side of building.

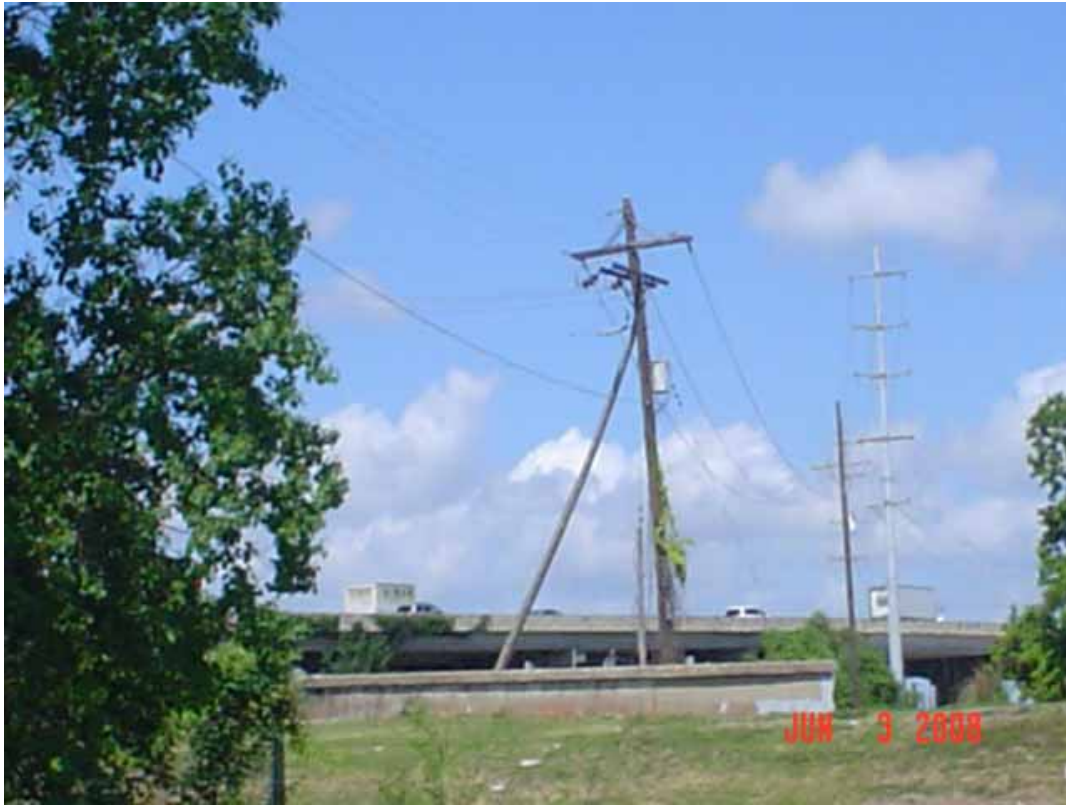
11. Example of transformers in the area, North side.
