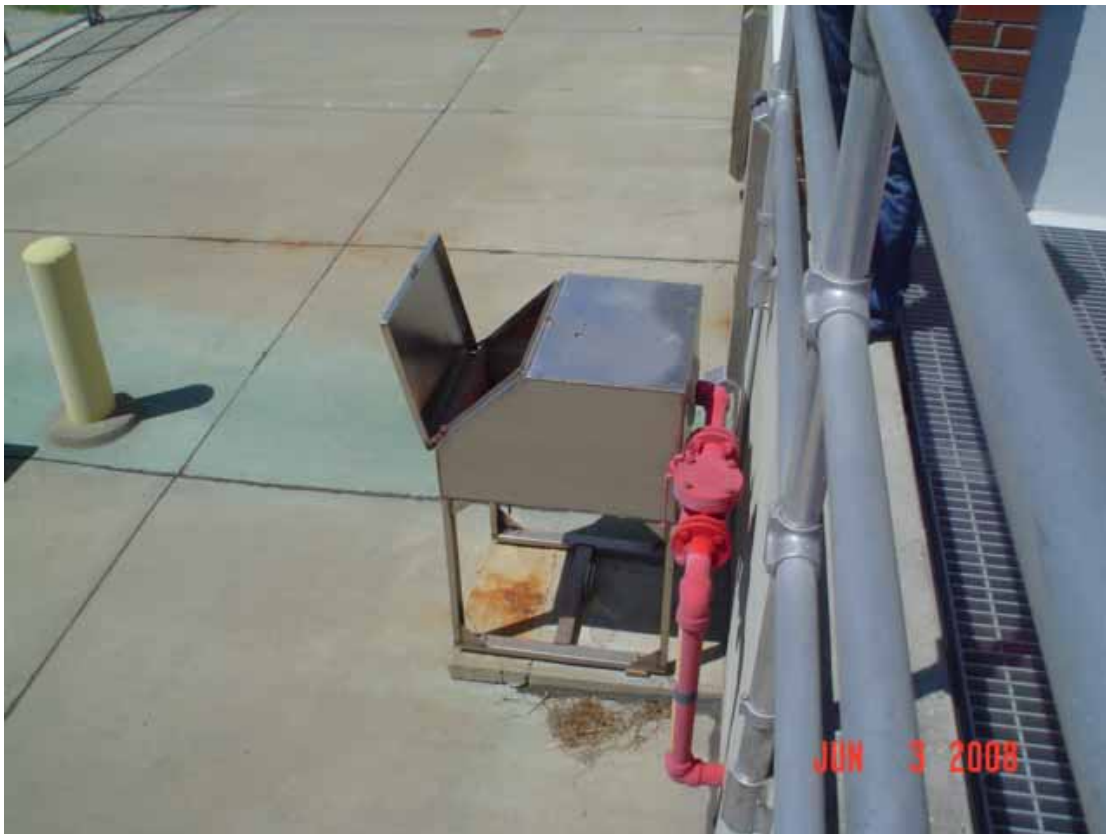
12. Fuel transfer box, southwest corner.

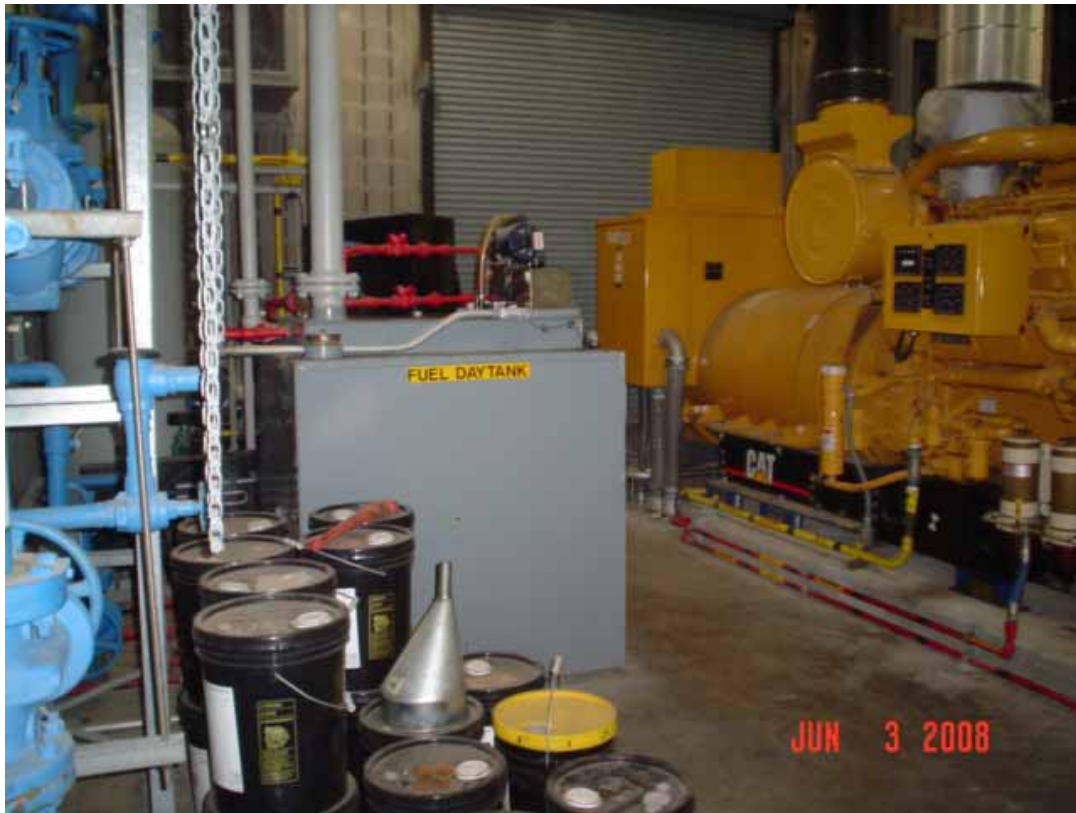
13. Diesel engine, lubricants and fuel tank inside building.

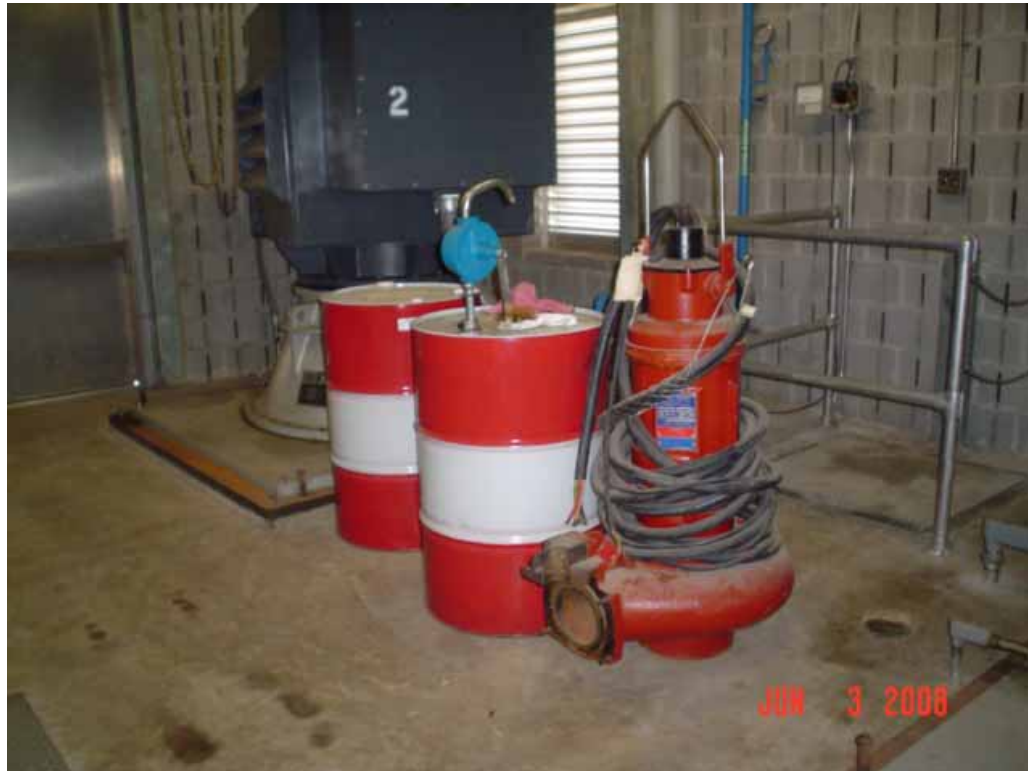
14. 55 gallon drums and pump motor inside building.

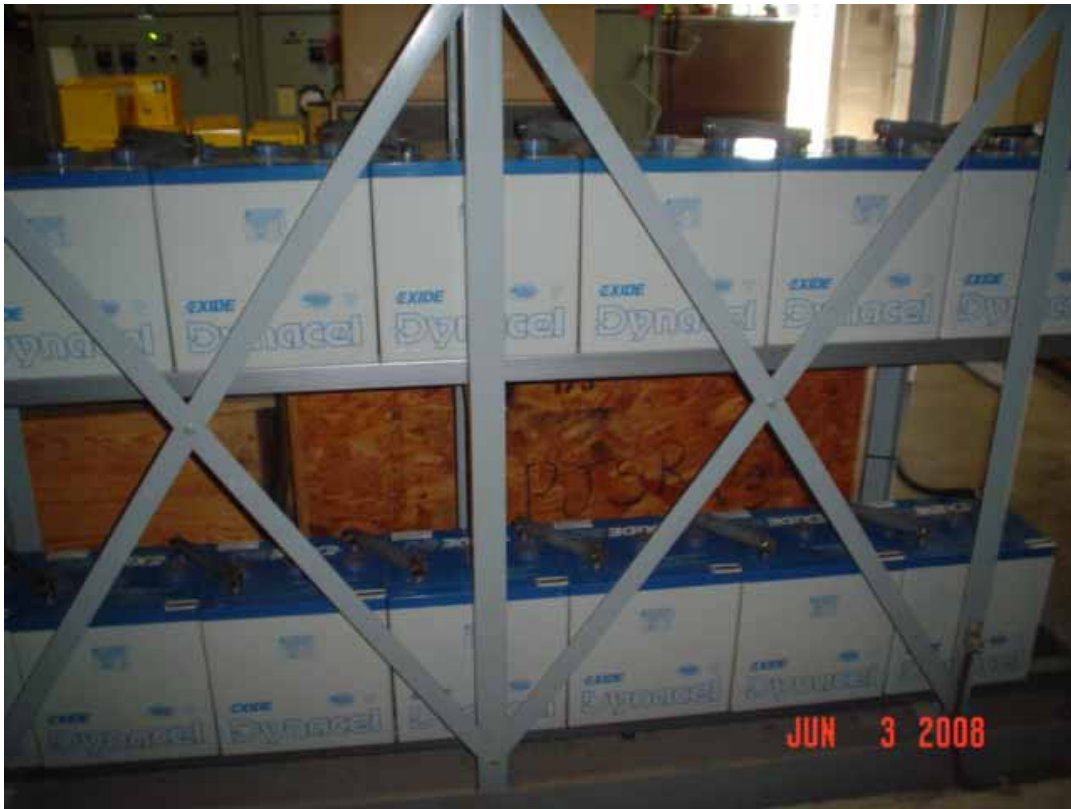
15. Battery bank.

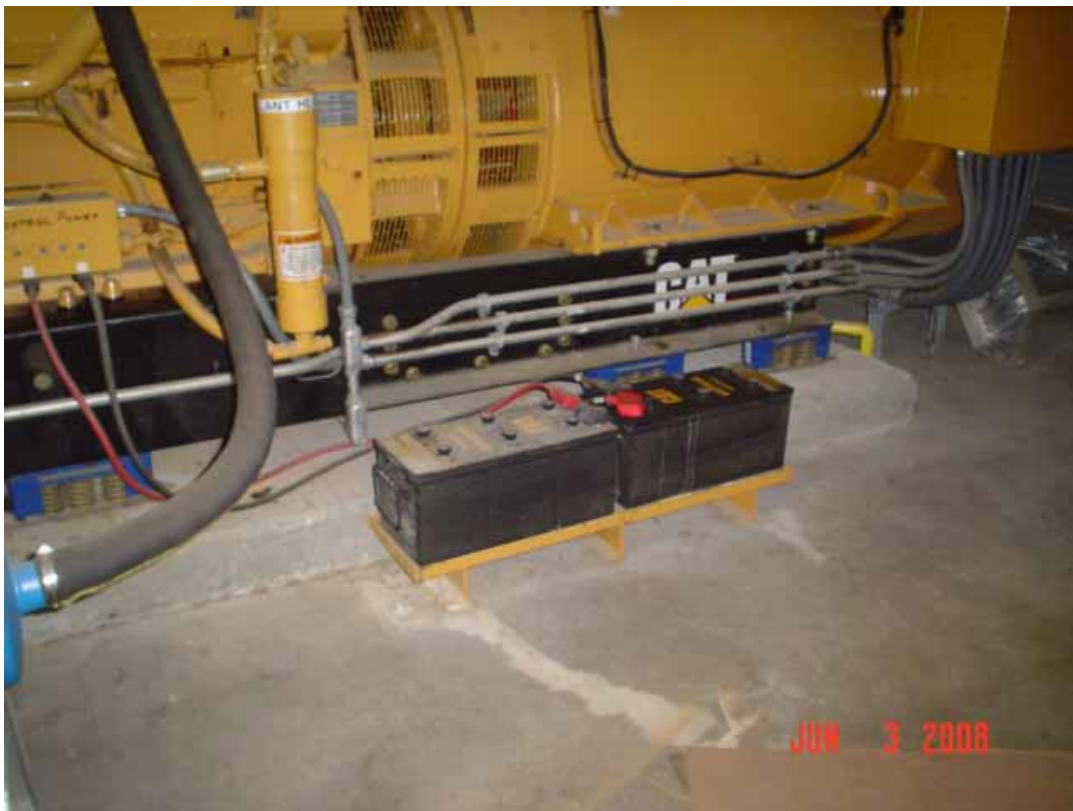
16. Batteries for diesel engine.

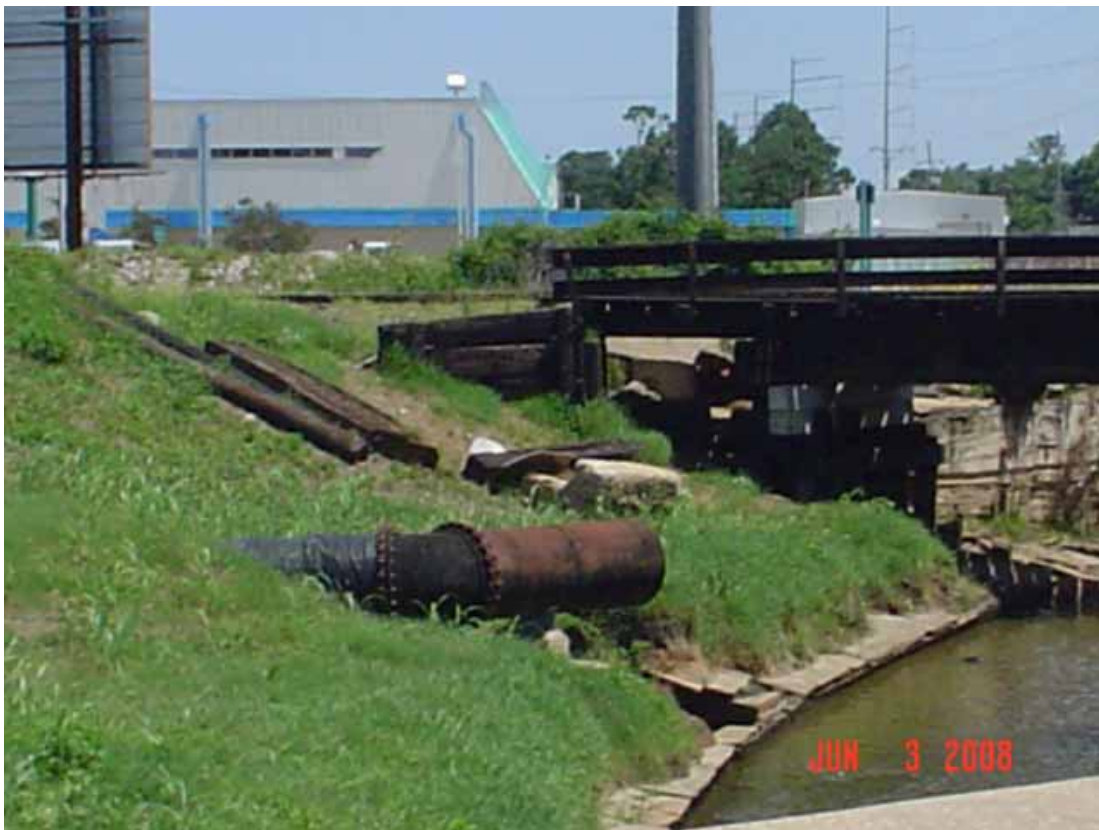
14. Pipes and railroad tracks across canal, northwest corner.

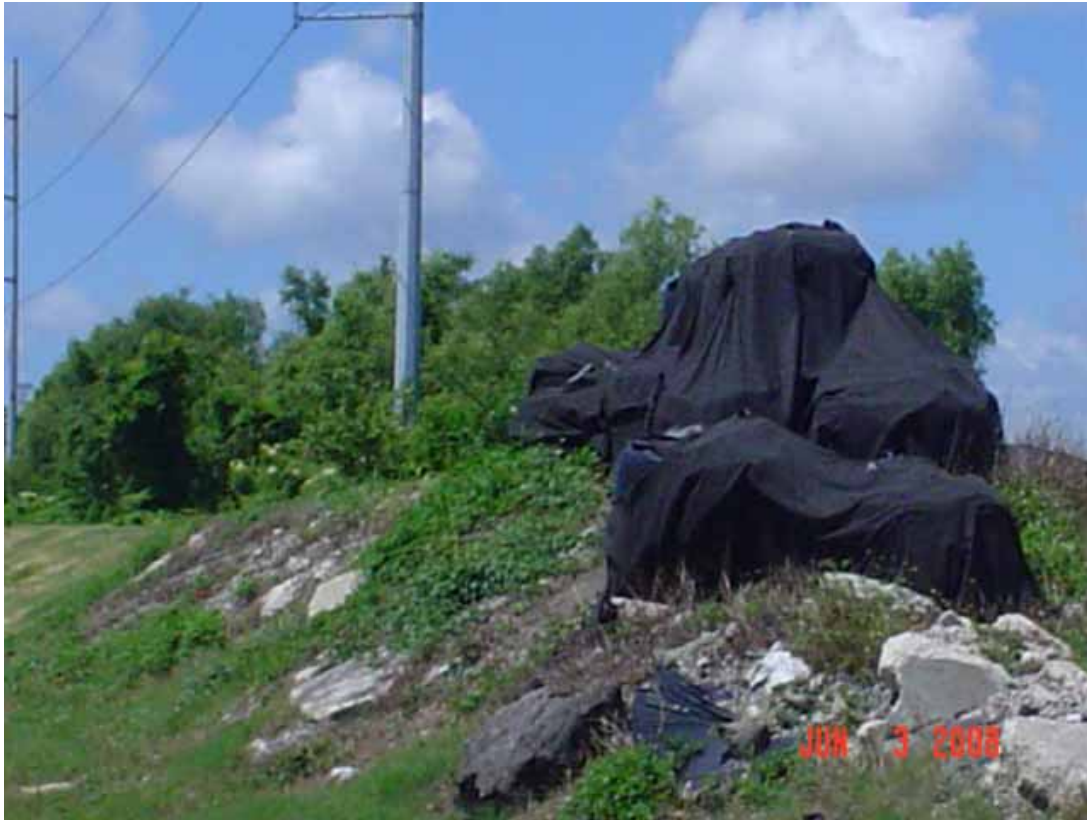
15. Unknown refuse along railroad tracks.

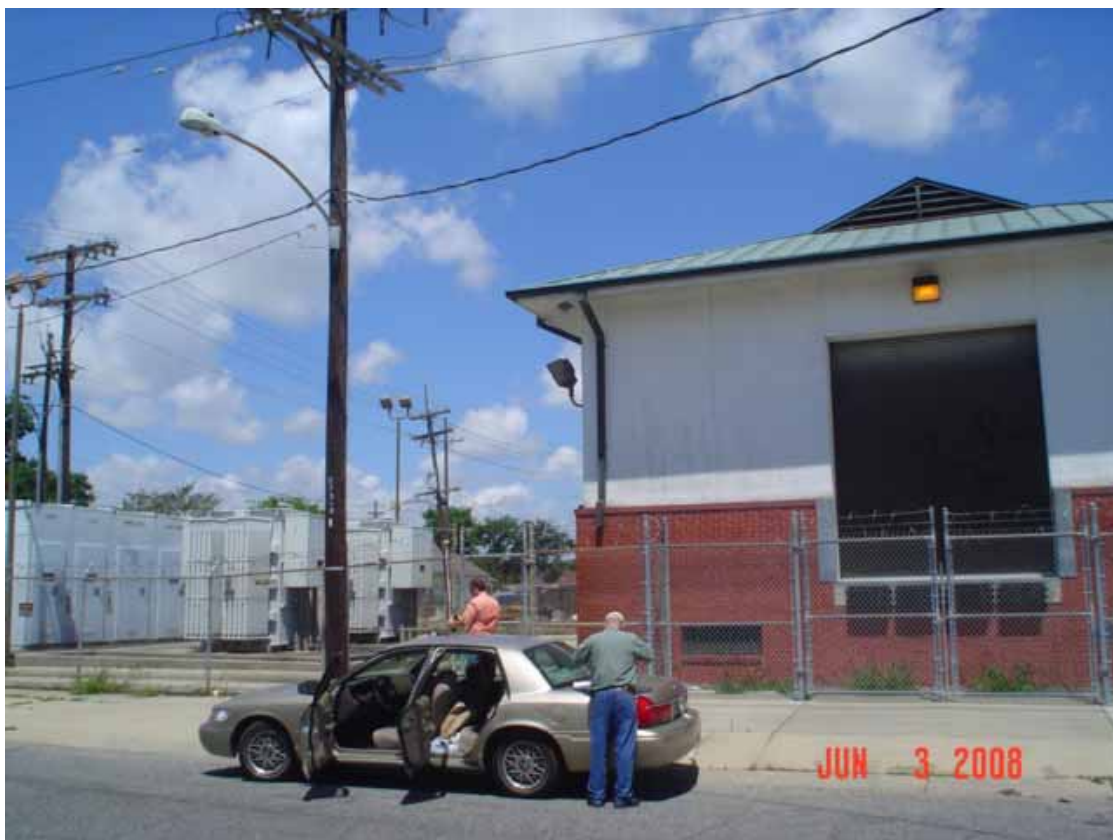
5. View of site as seen from the east direction, right side.

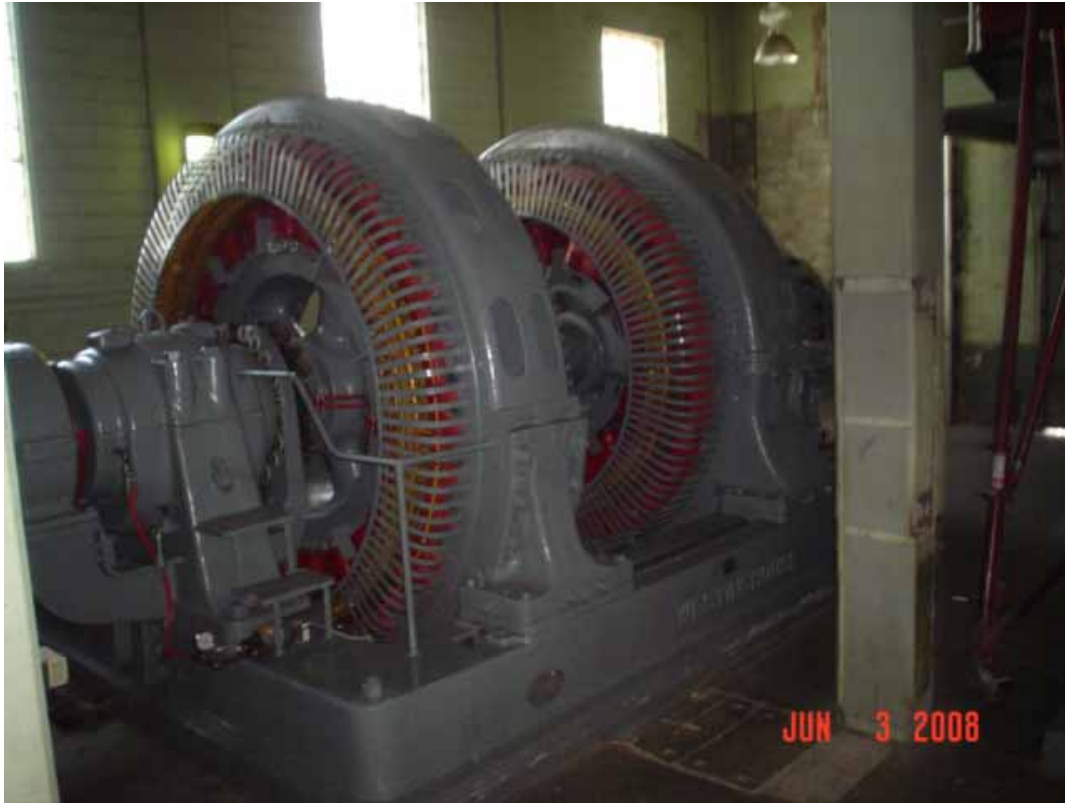
16. Drums and equipment inside building.

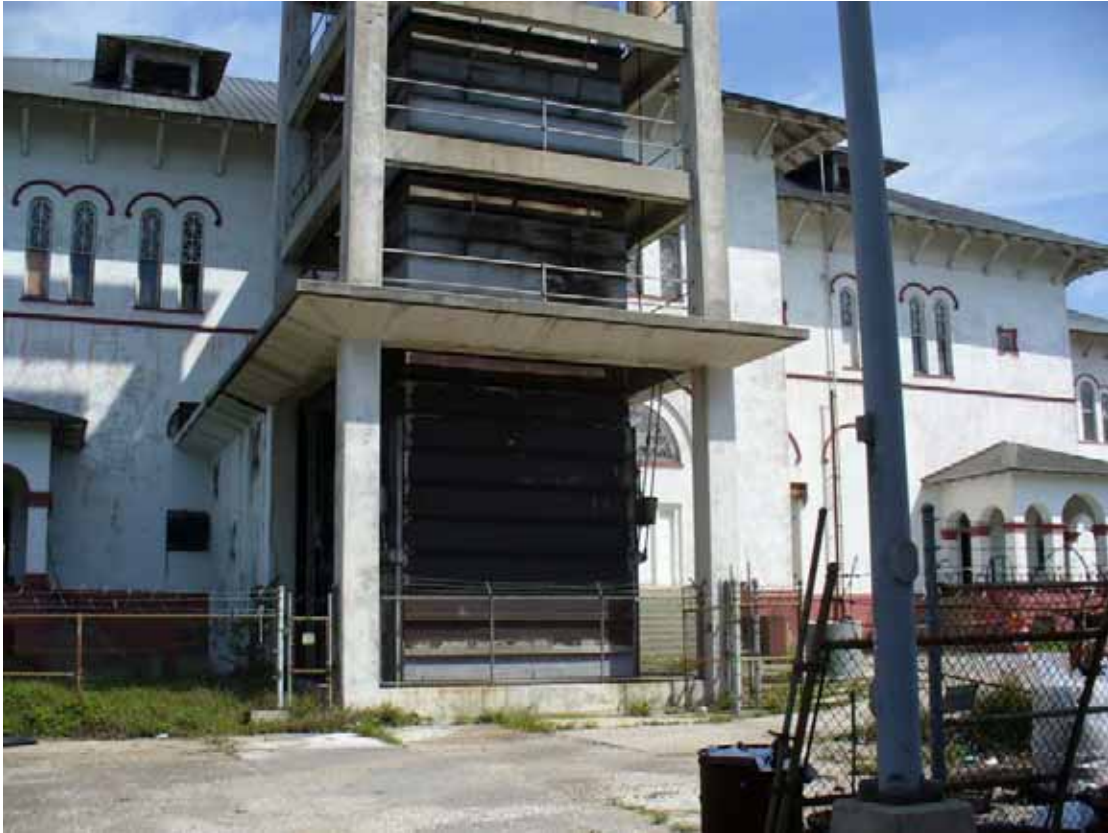
52. East side of high-lift building.

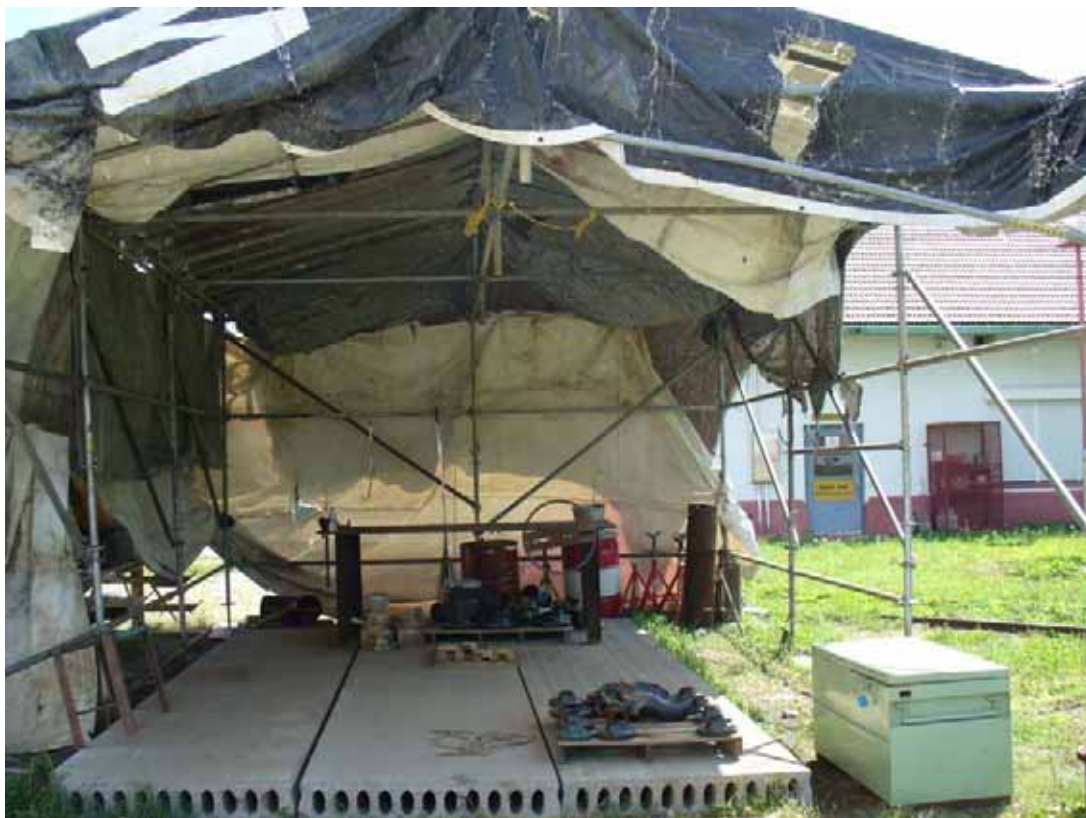
53. Welding station in southeast area of site.

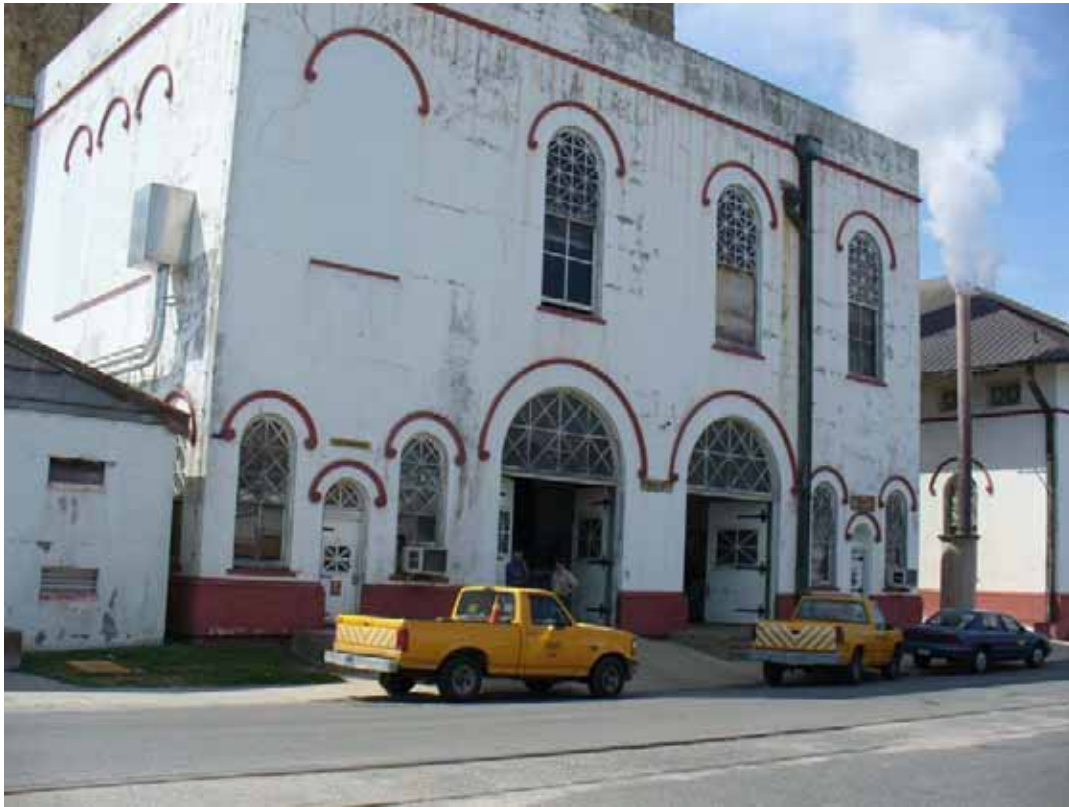
54. West side of Boiler room.

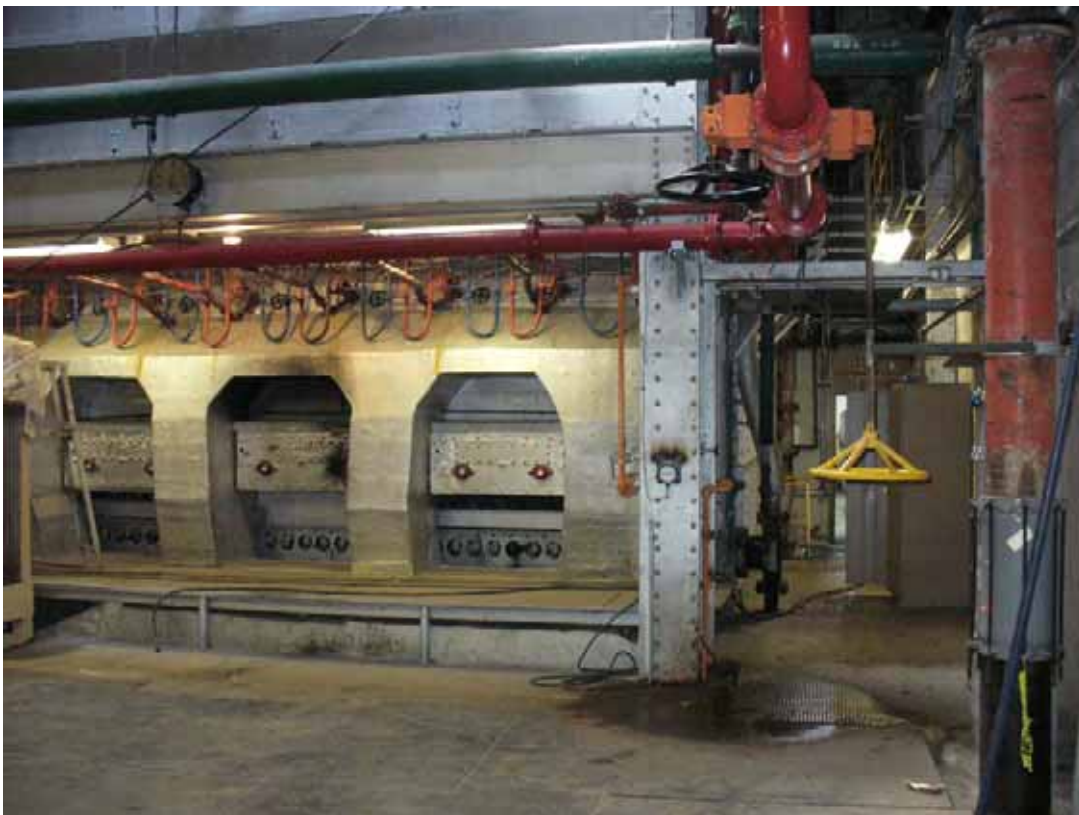
55. Boiler in boiler building.

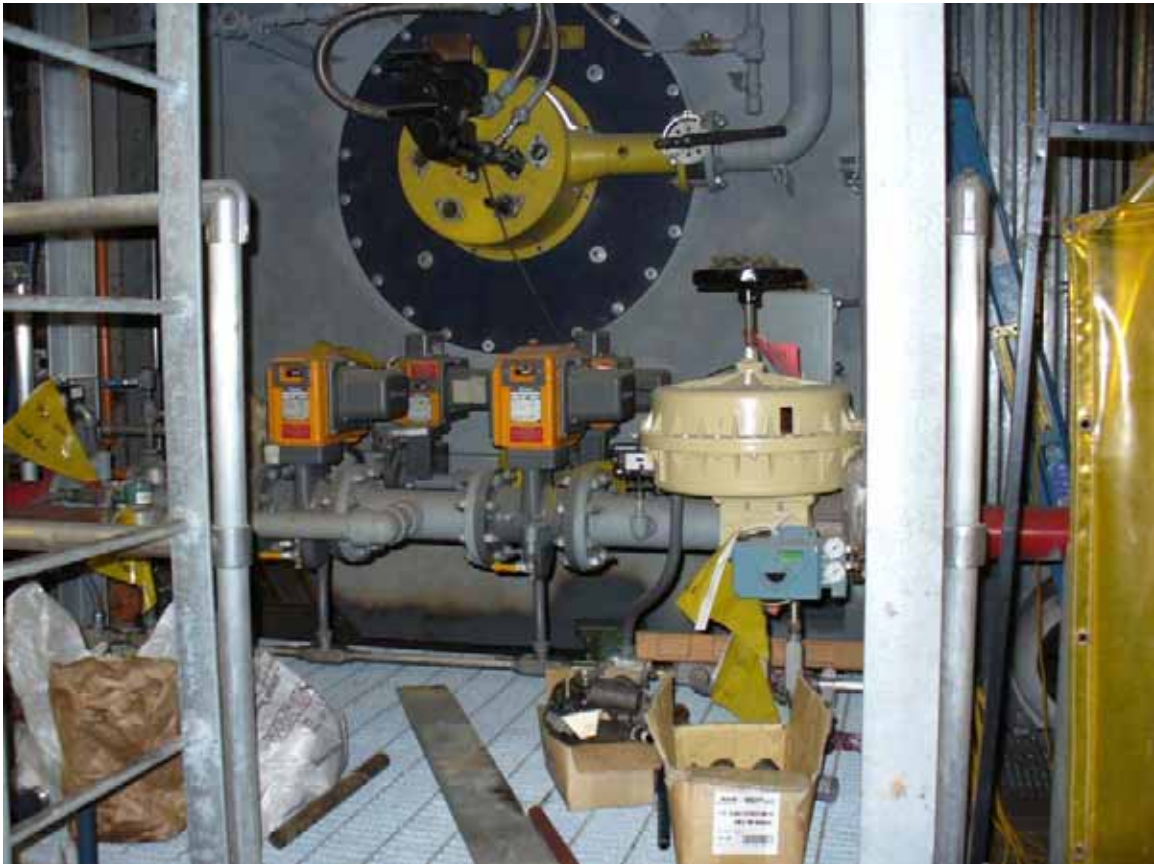
56. New pump in boiler building.

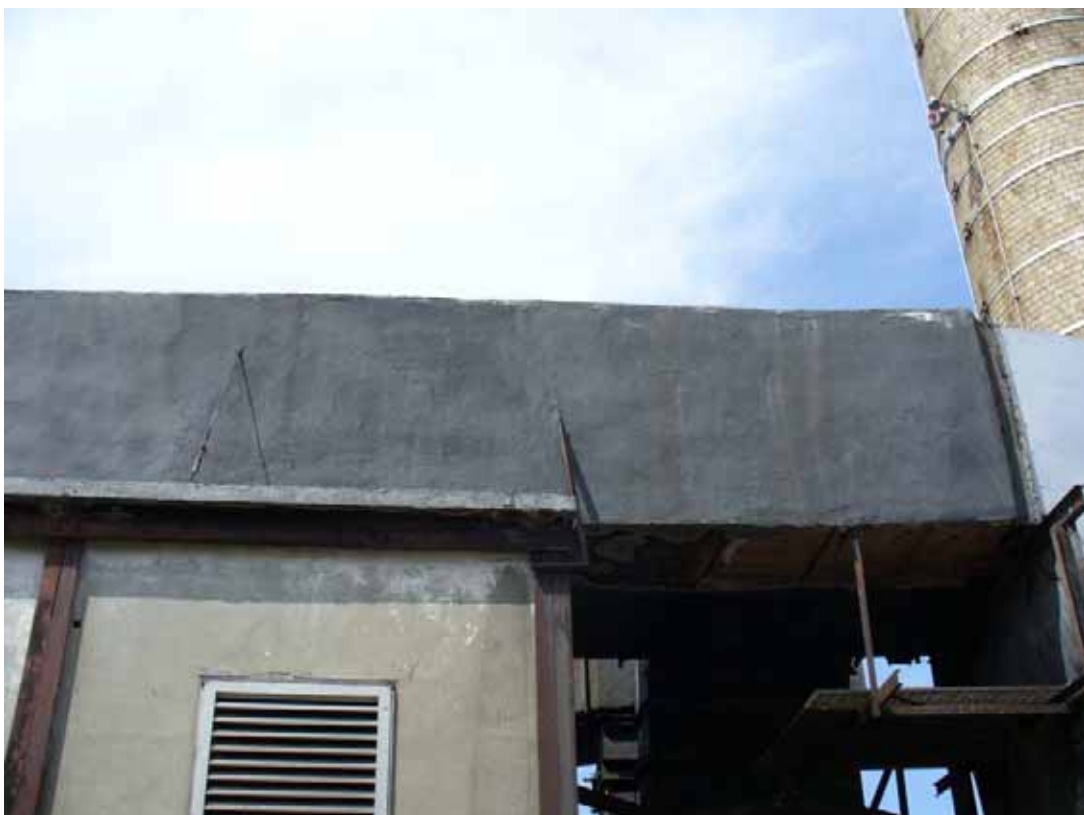
57. Asbestos wrapped duct insulation located on roof.

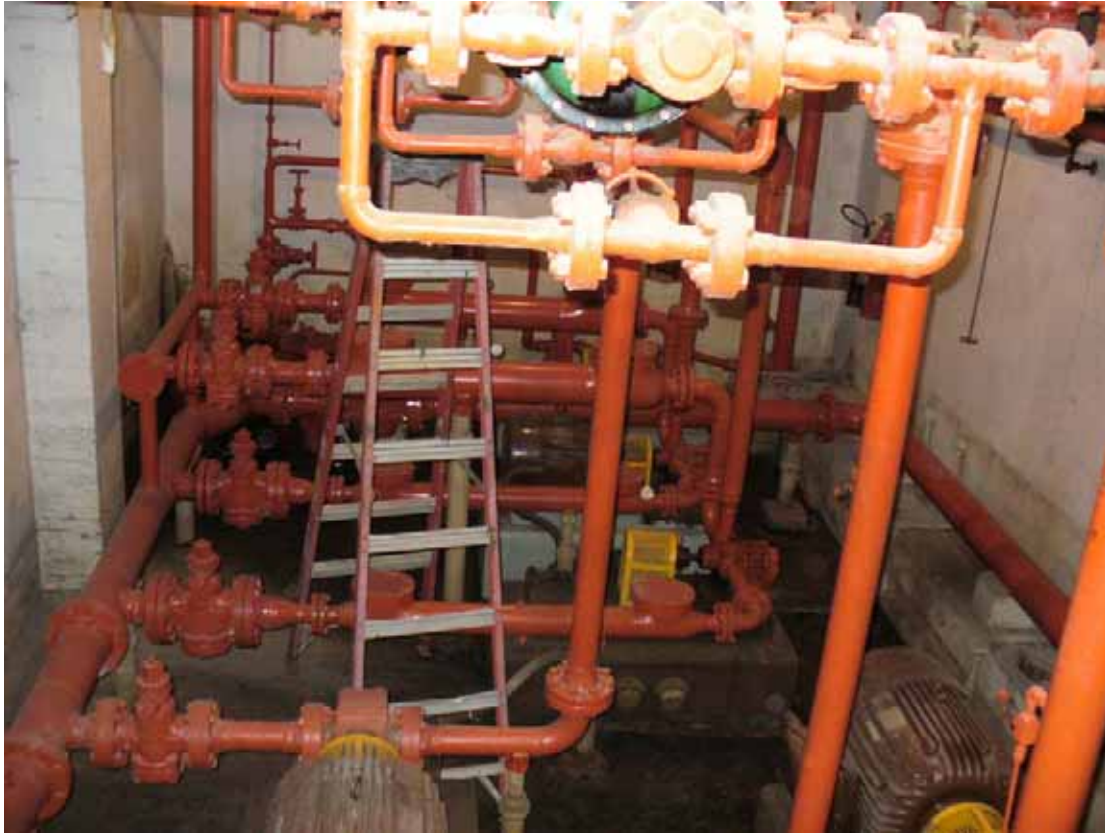
58. Diesel pump room in boiler house.

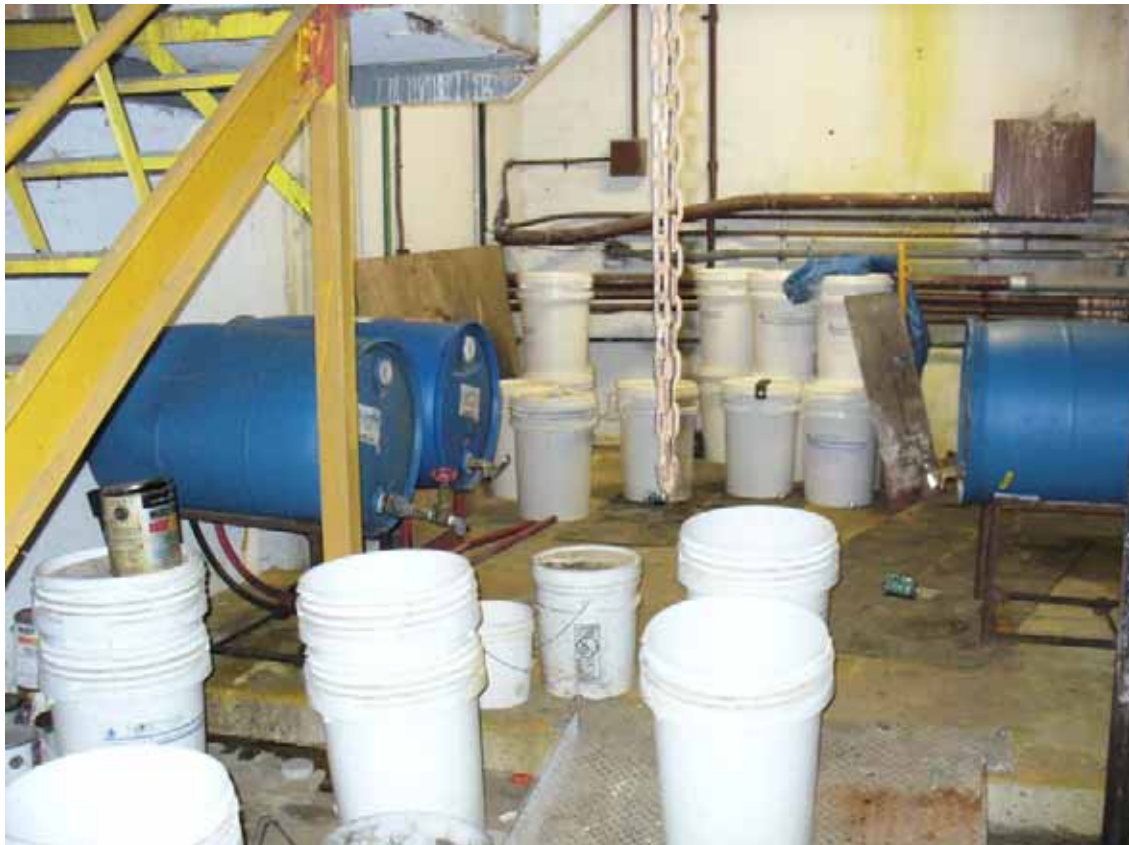
59. Chemicals stored in barrels used for water treatment.

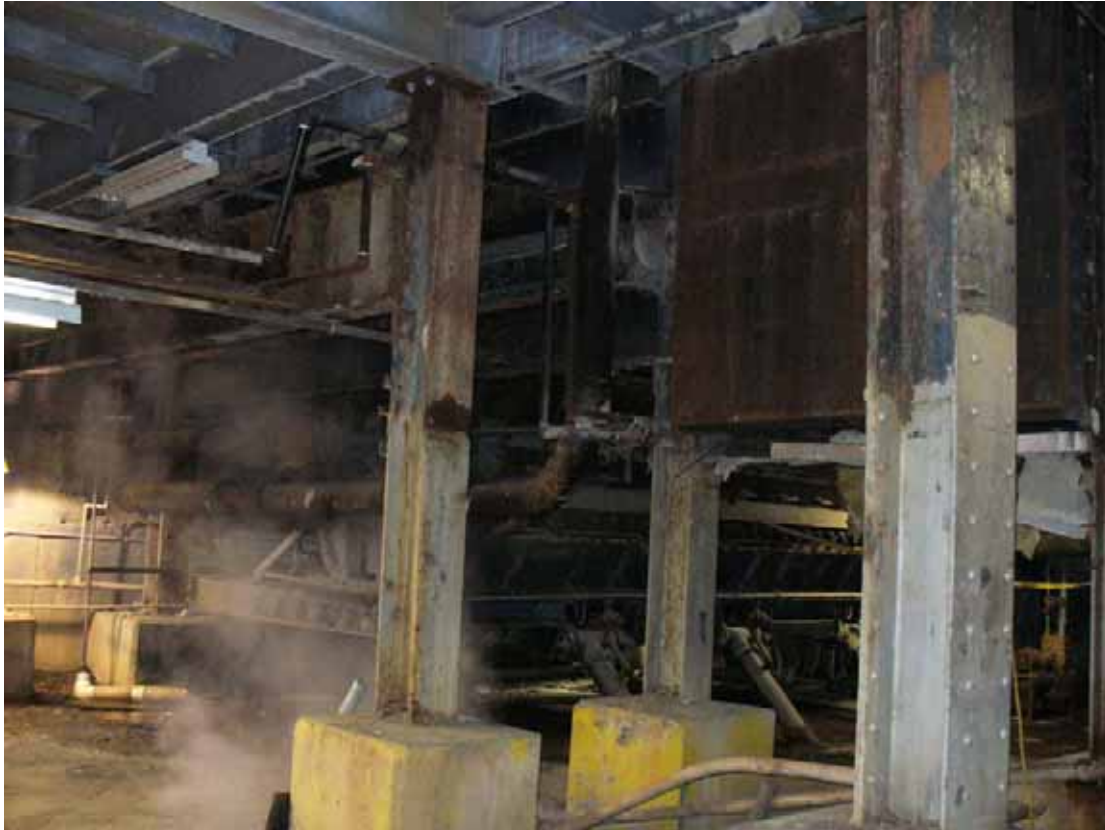
60. Basement of boiler house.

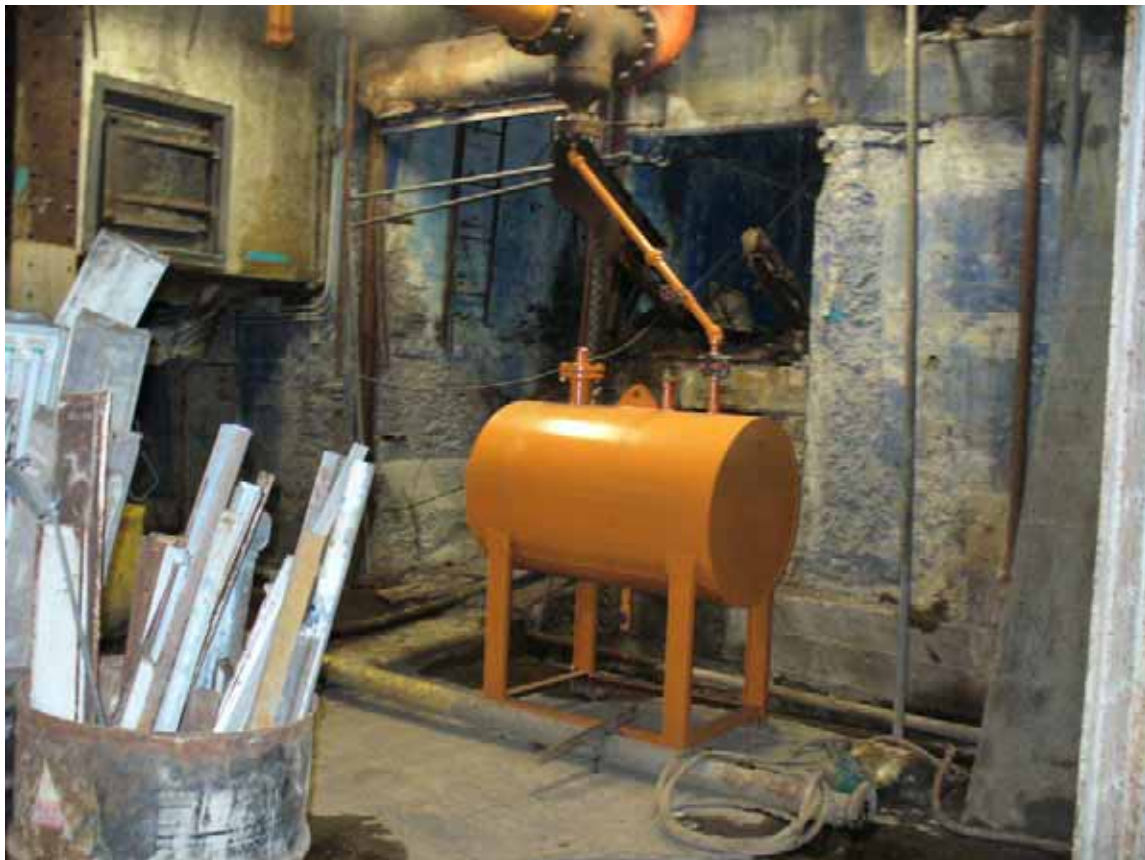
61. Diesel storage tank in basement.

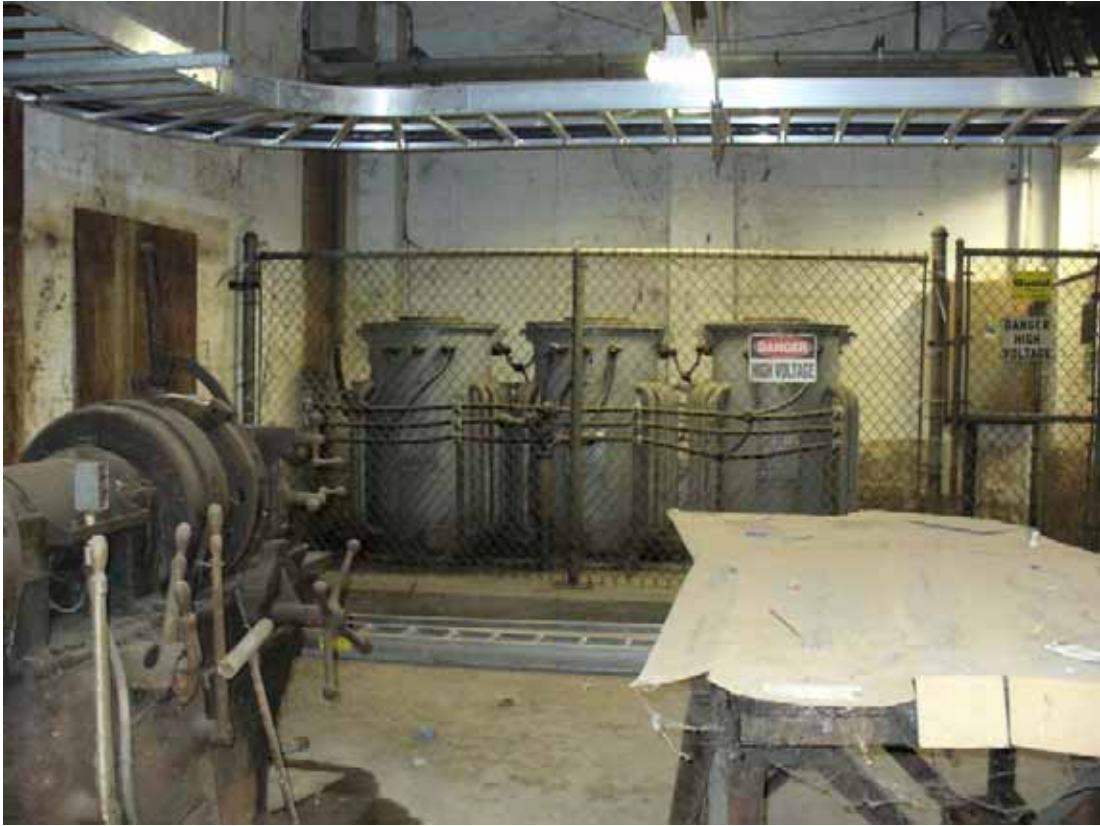
62. Transformers in basement of boiler room.

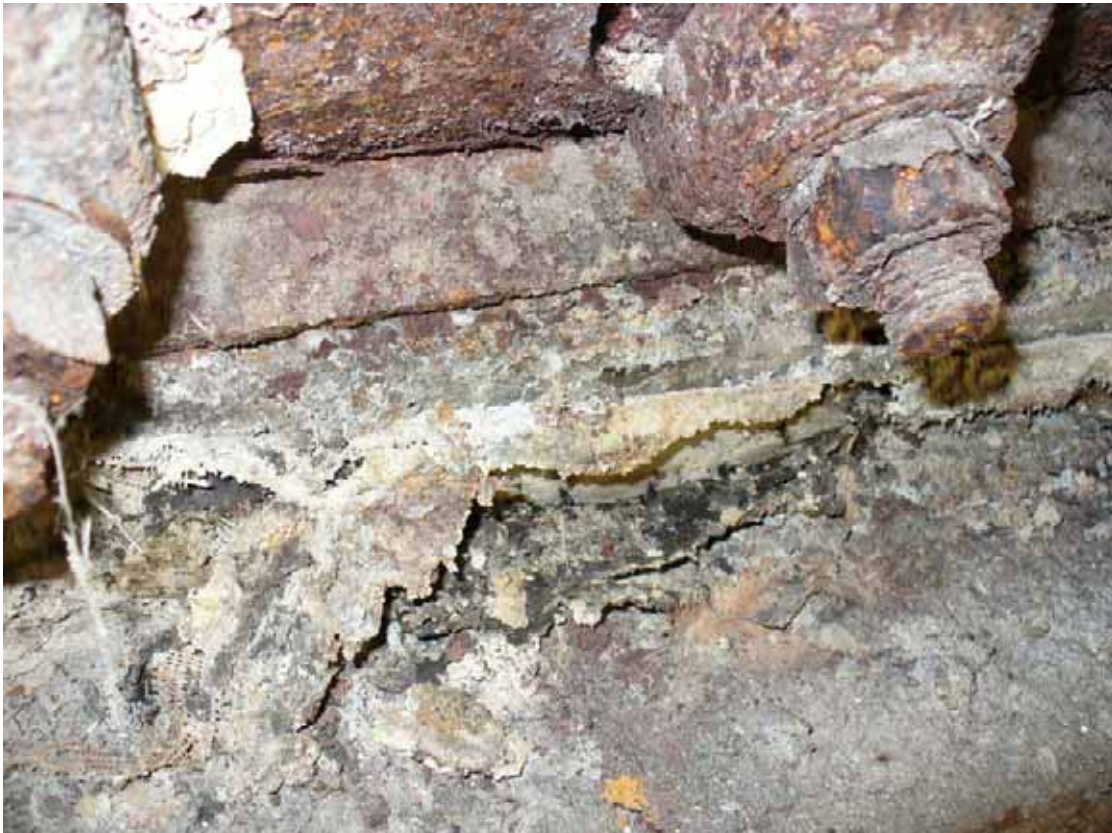
63. Boiler insulation that may contain asbestos.

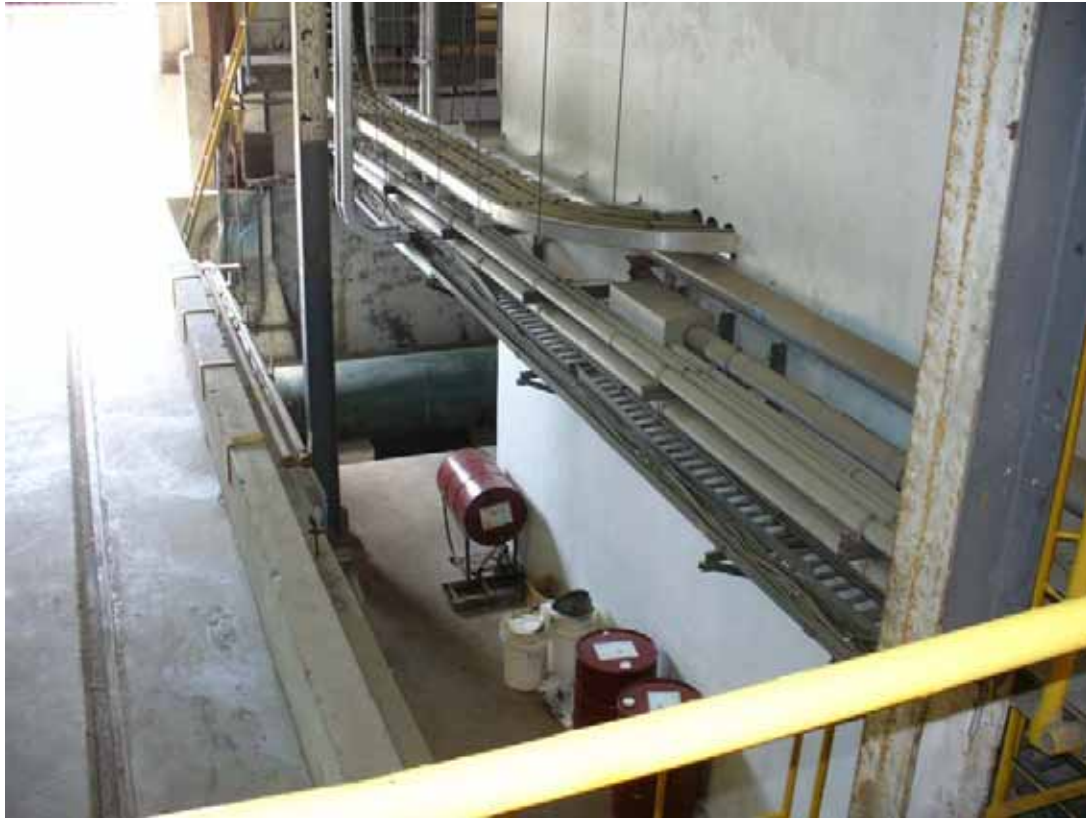
64. 55 gallon drums stored in basement of high-lift building.

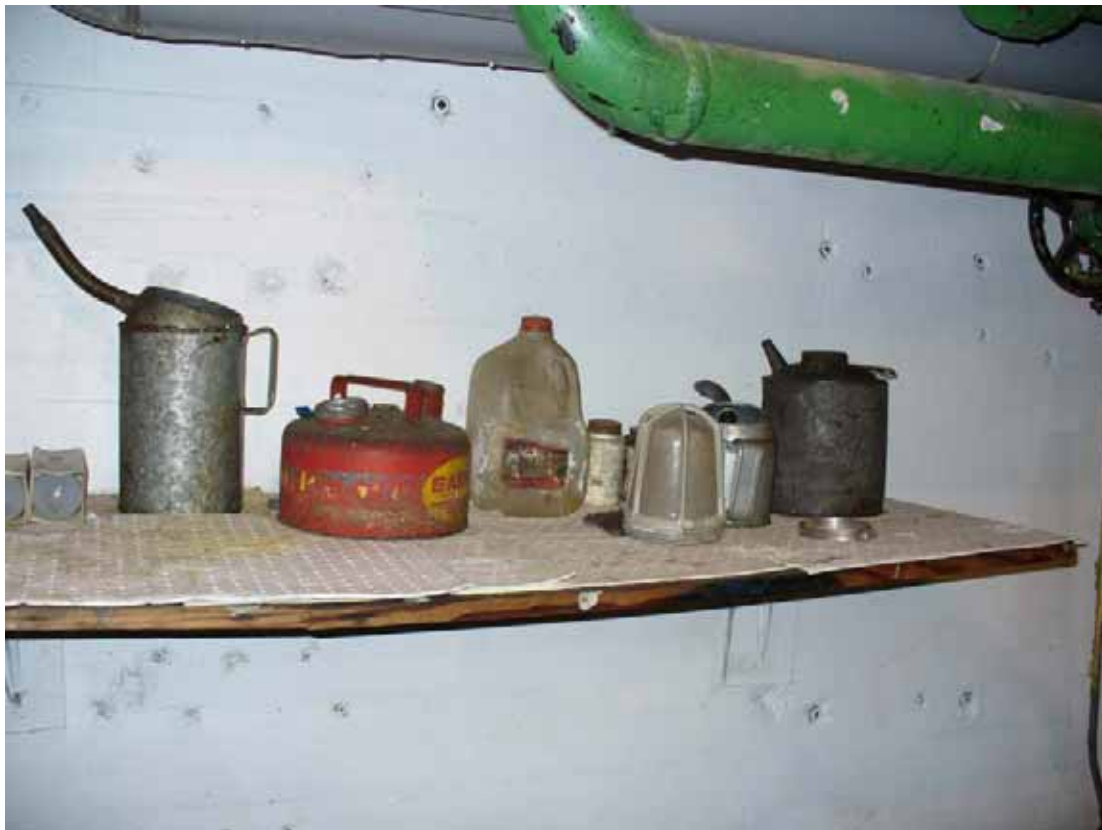
65. Miscellaneous containers storing petroleum products.

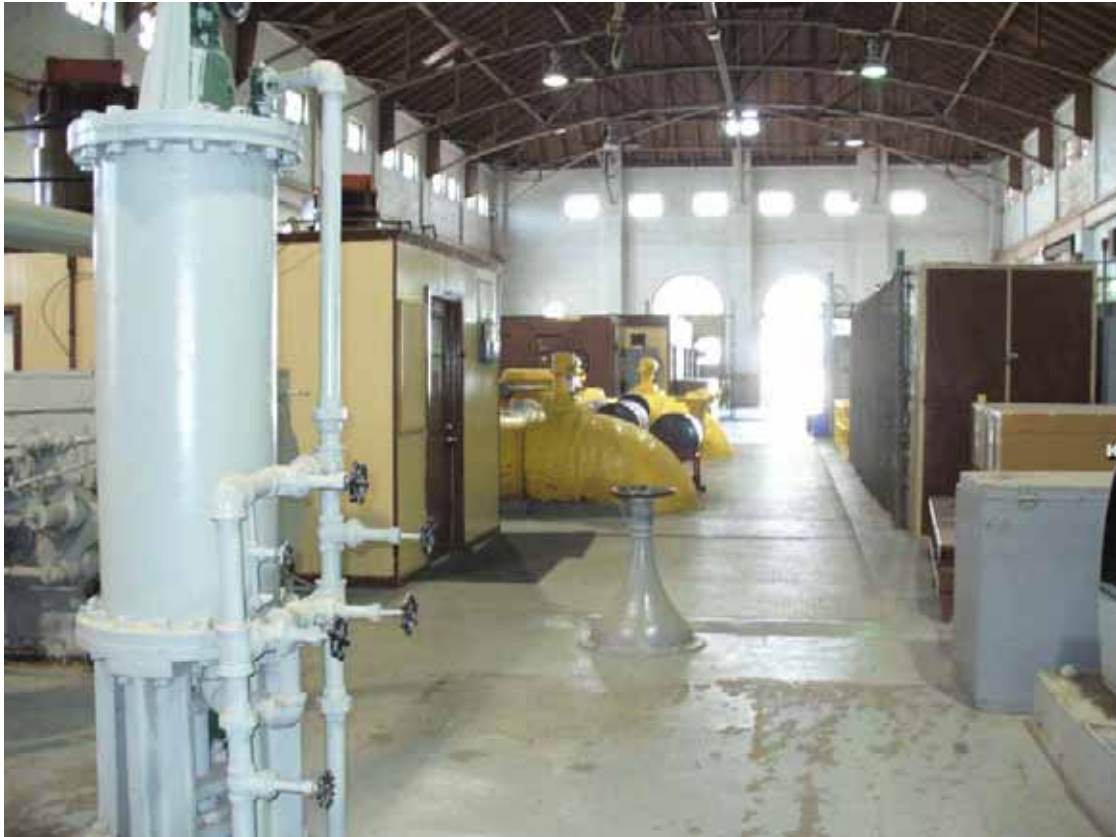
66. Pumps in the low-lift building.

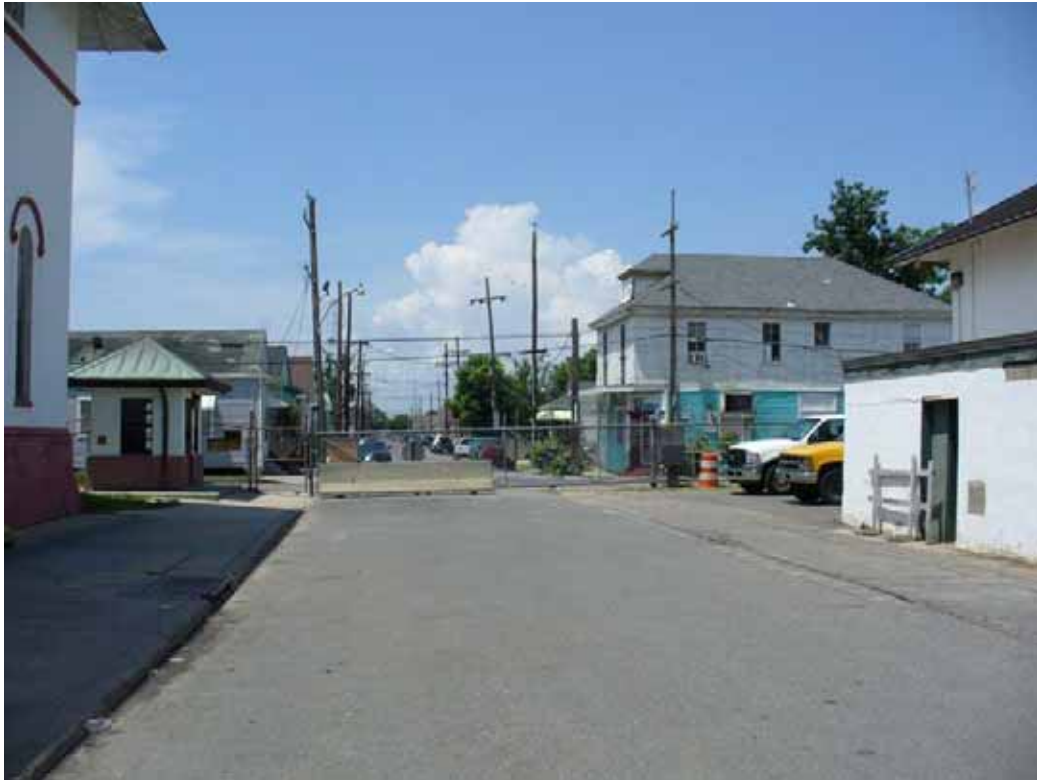
68. View south on Eagle Street.
