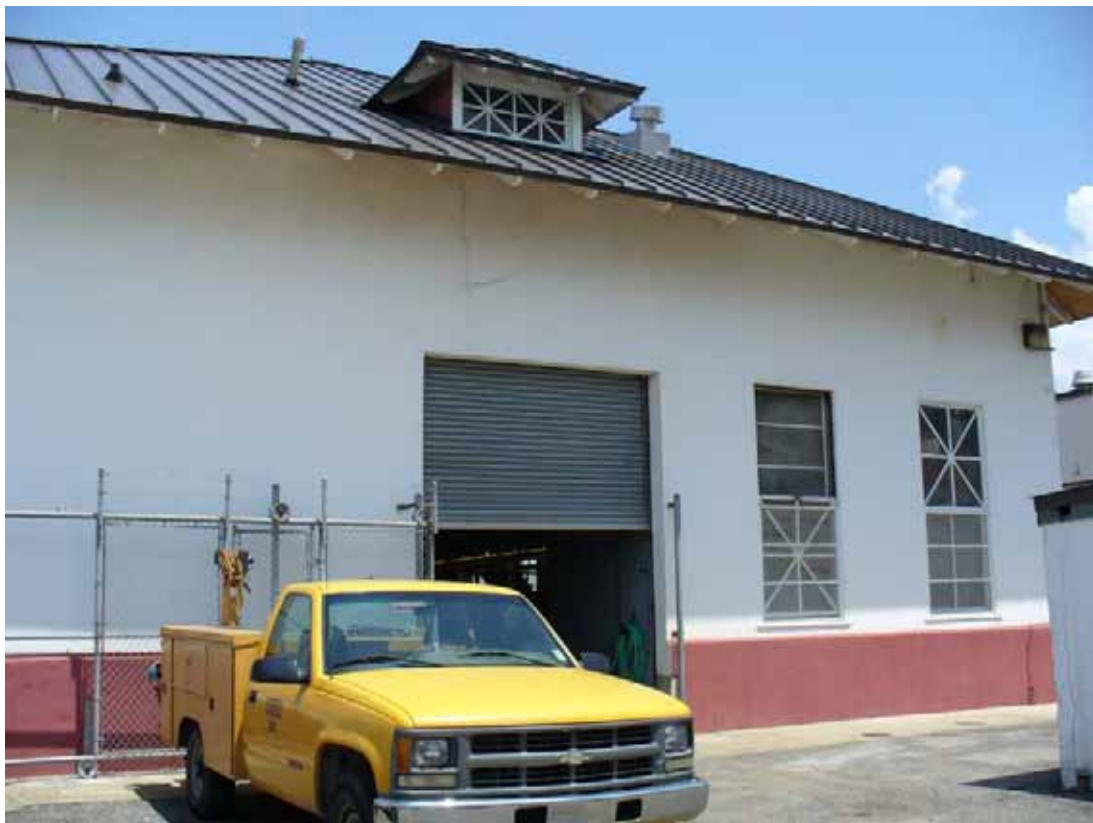
69. East side of meter building.

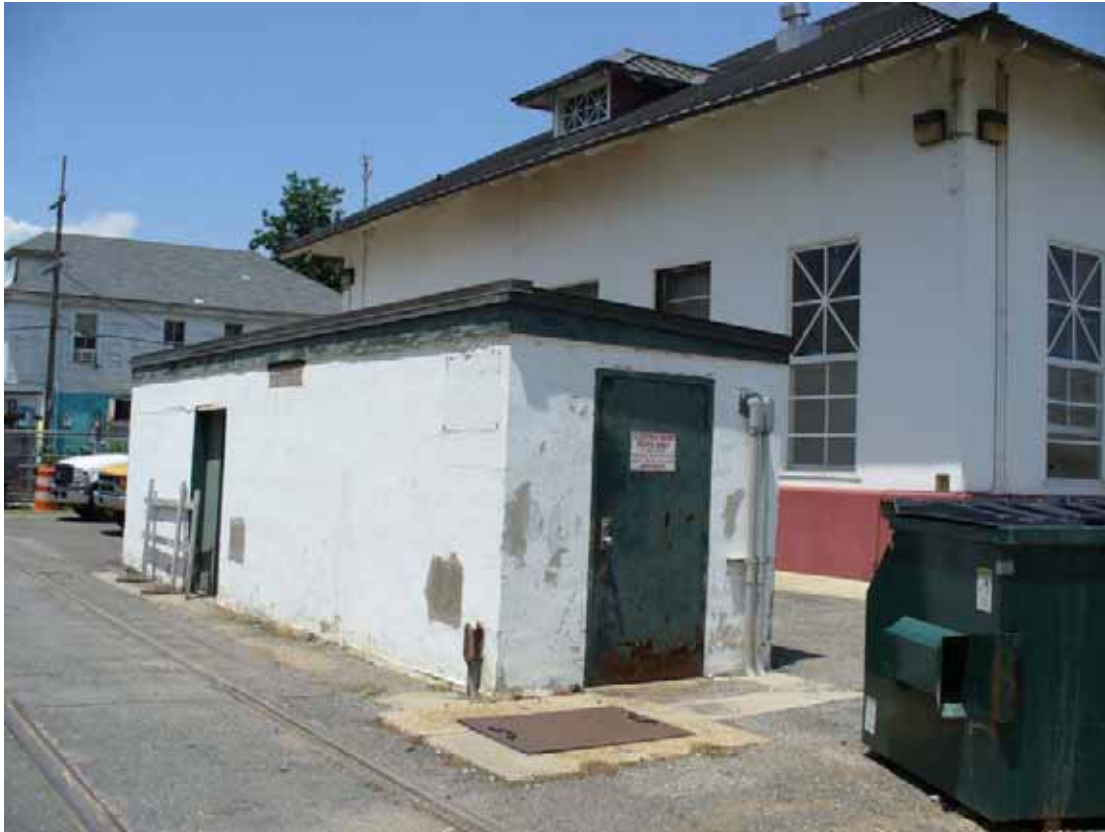
70. Electric parts storage house.

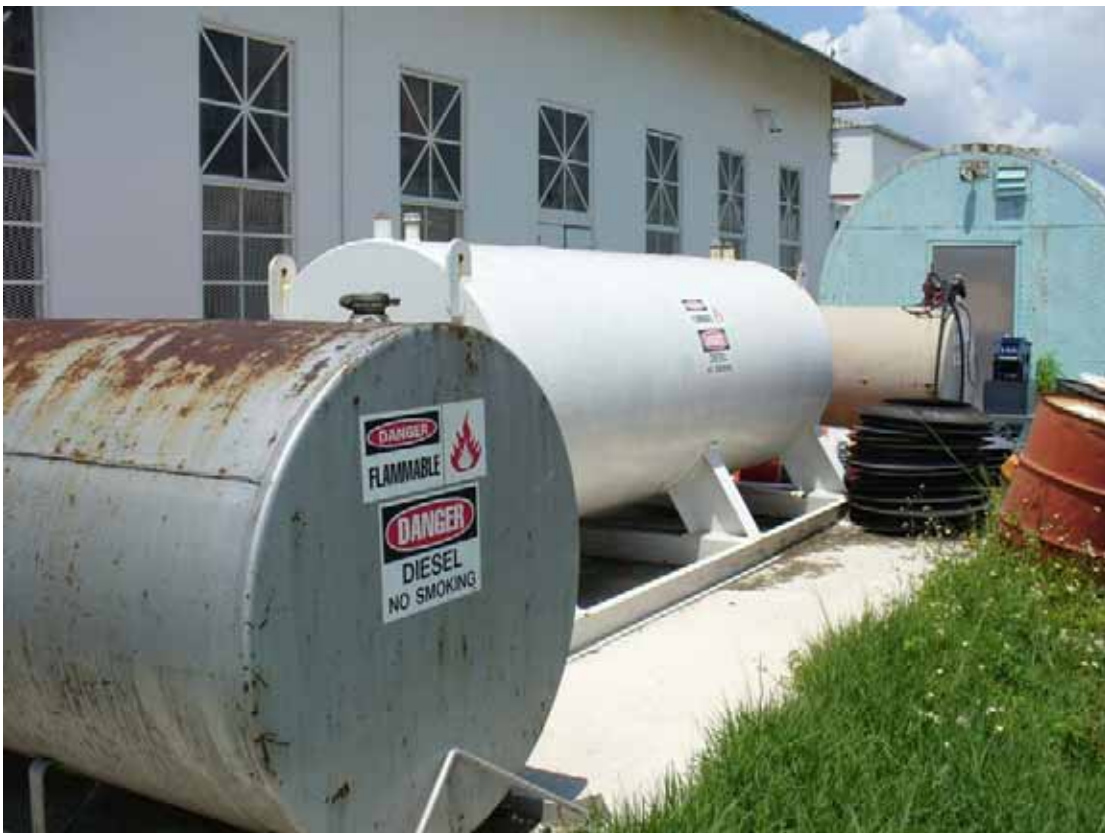
71. Above ground storage tanks located north of meter building.

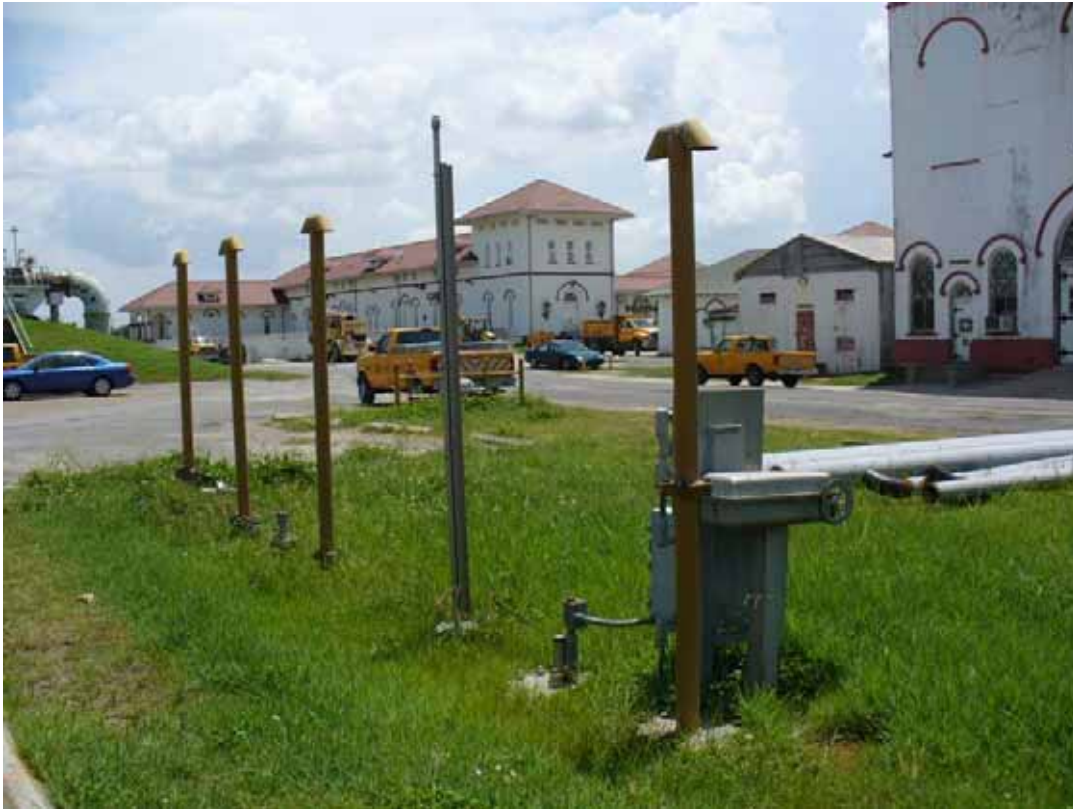
72. Location of underground storage tank with four vents.

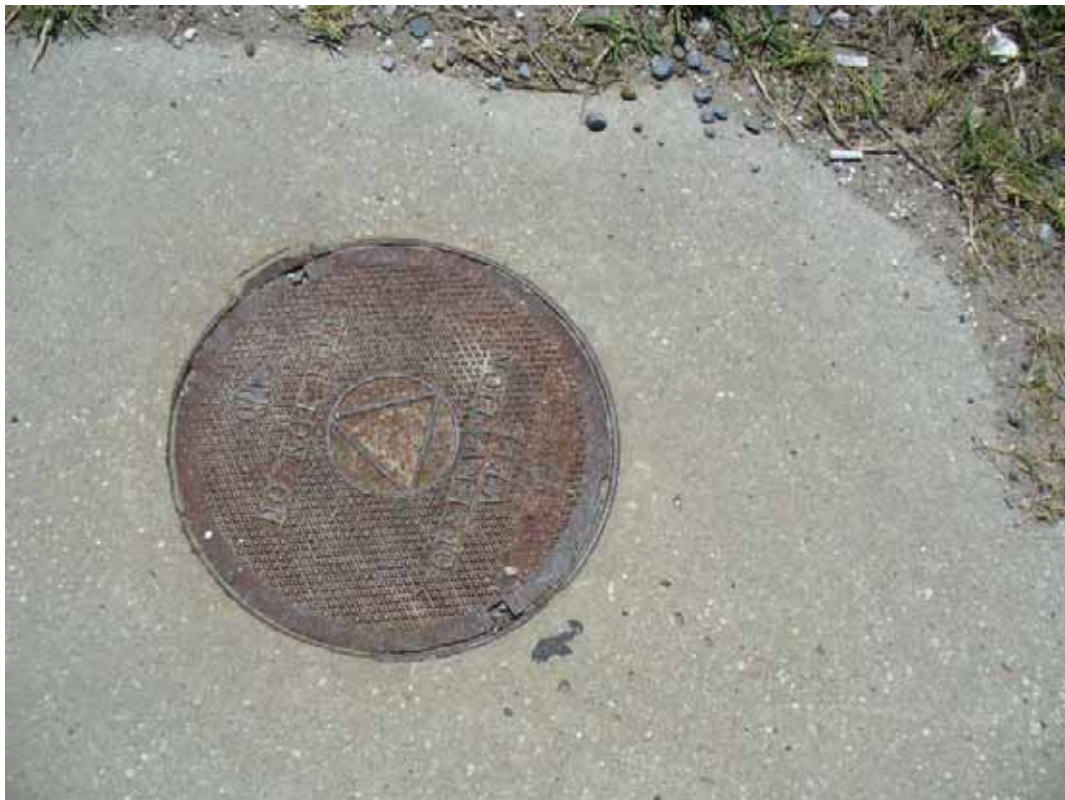
73. Monitoring well for underground storage tank.

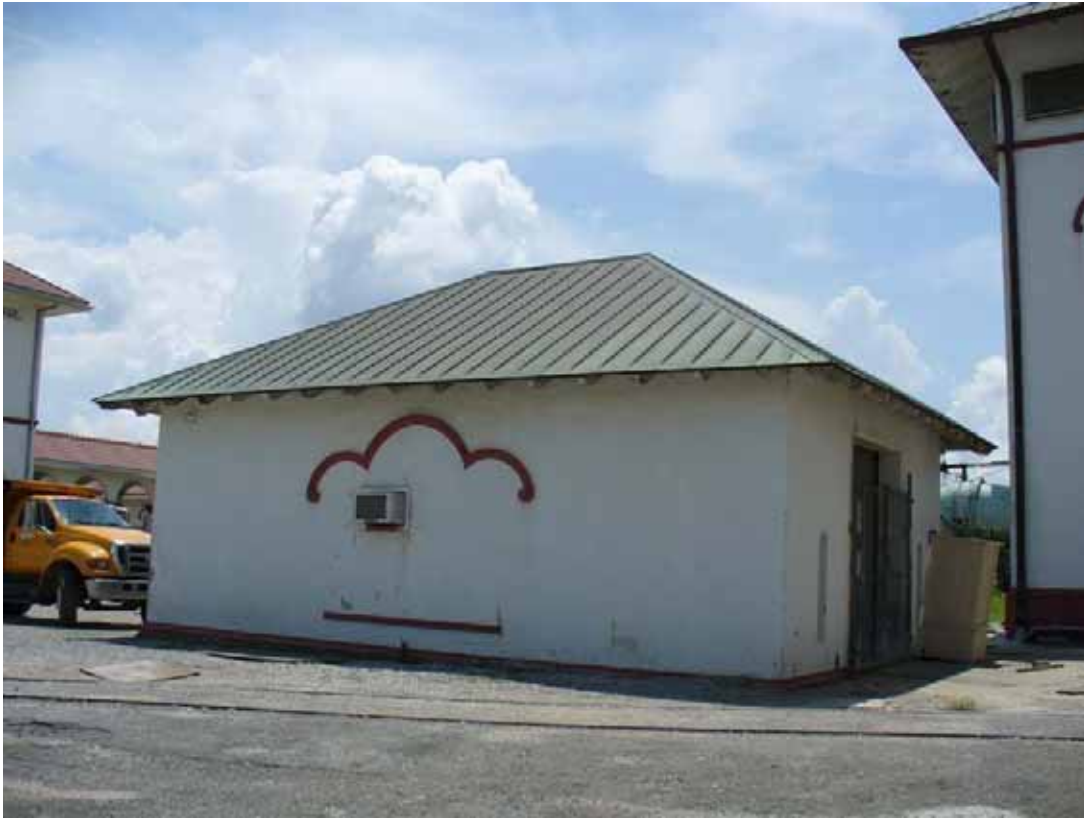
74. Old chlorine building, now used for pipe storage.

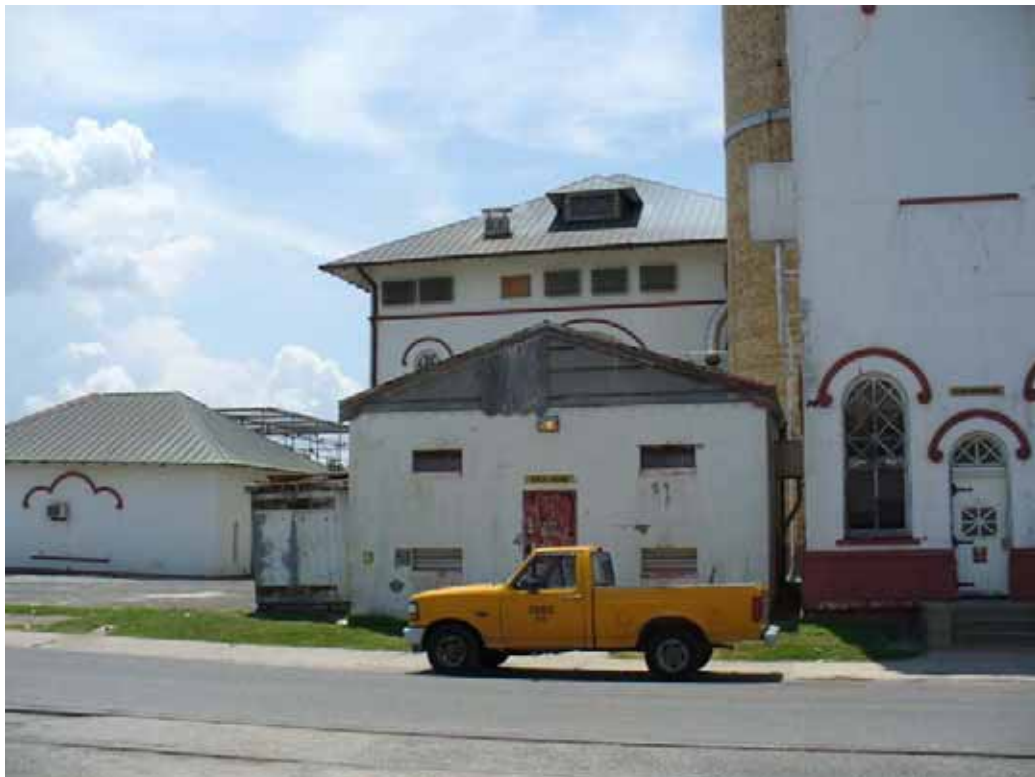
75. West side of 5 K. V. Building with breakers and switches located inside.

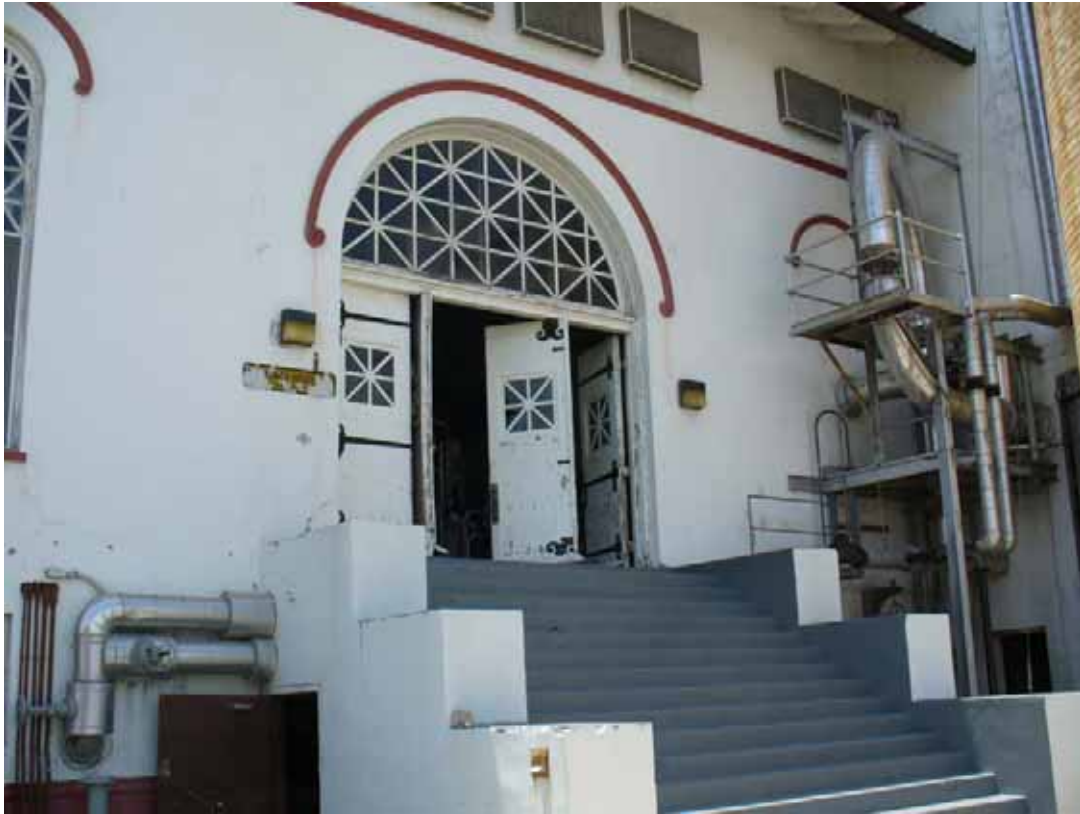
76. West entrance to power house.

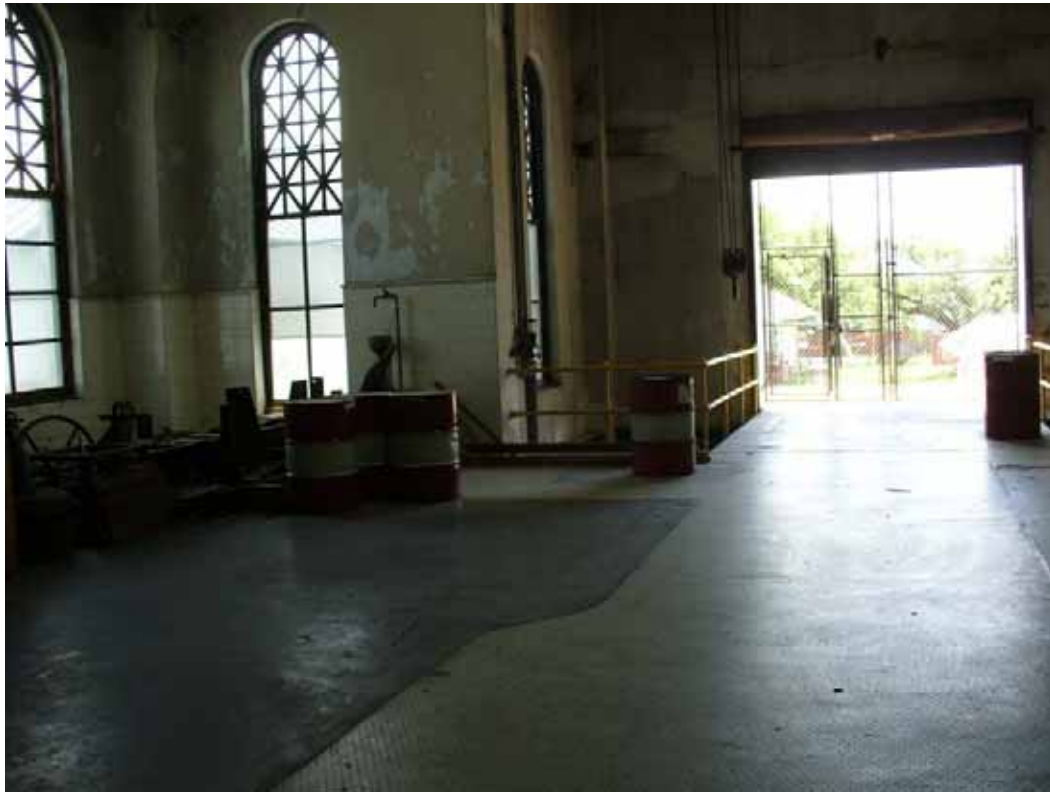
77. Stored 55 gallon drums in building.

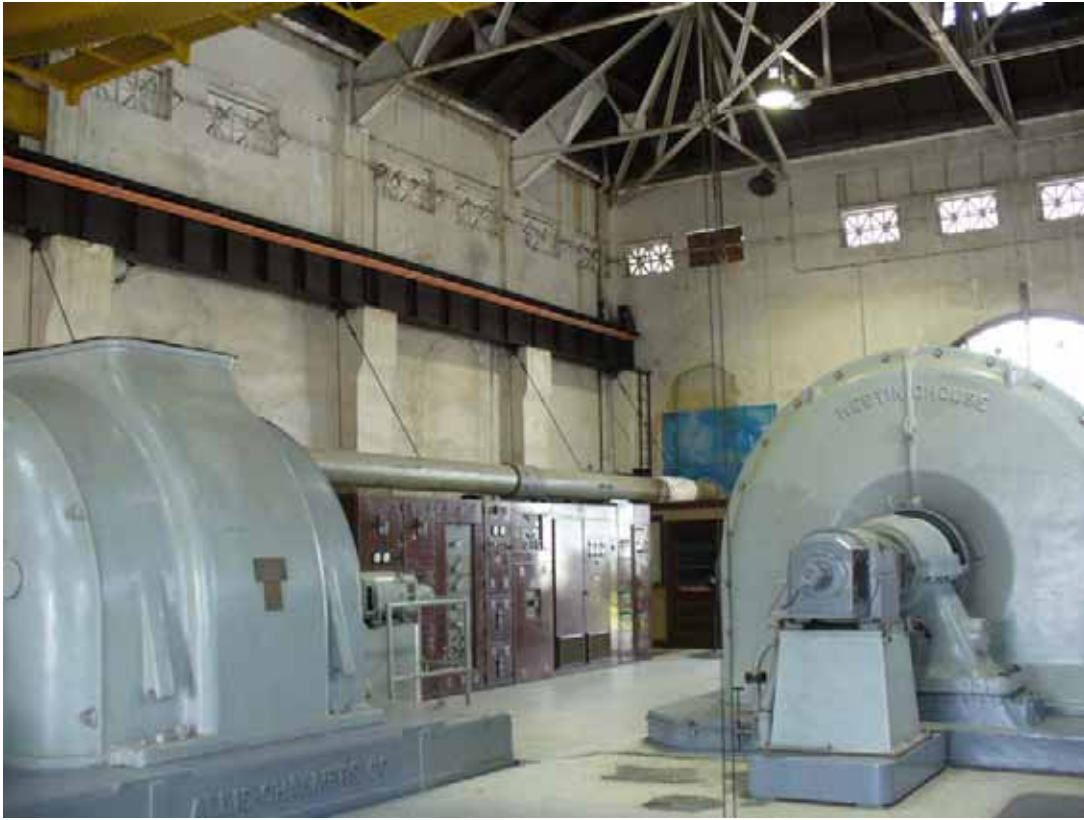
78. Pumps in power house.

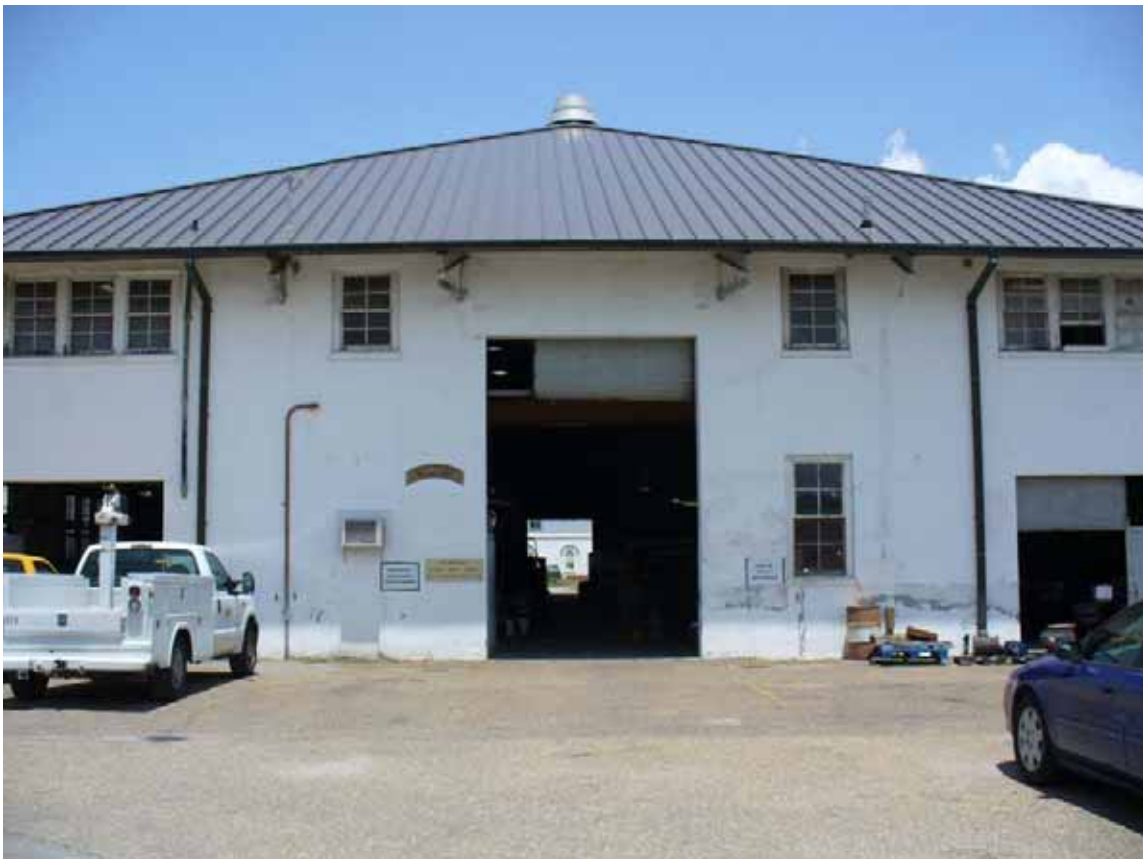
79. East side of machine shop building.

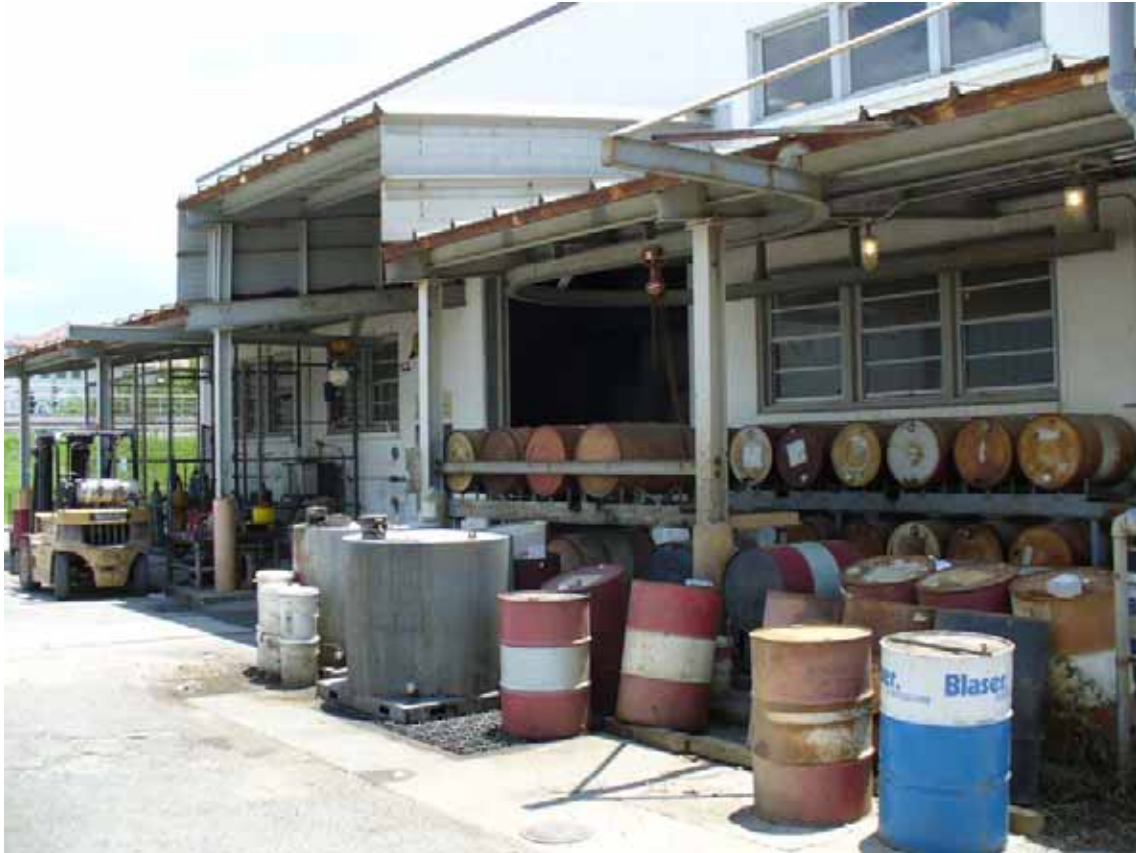
80. View of 55 gallon drums, waste oil tanks, 5 gallon, acetylene tanks and oxygen tanks stored on west side of machine shop.

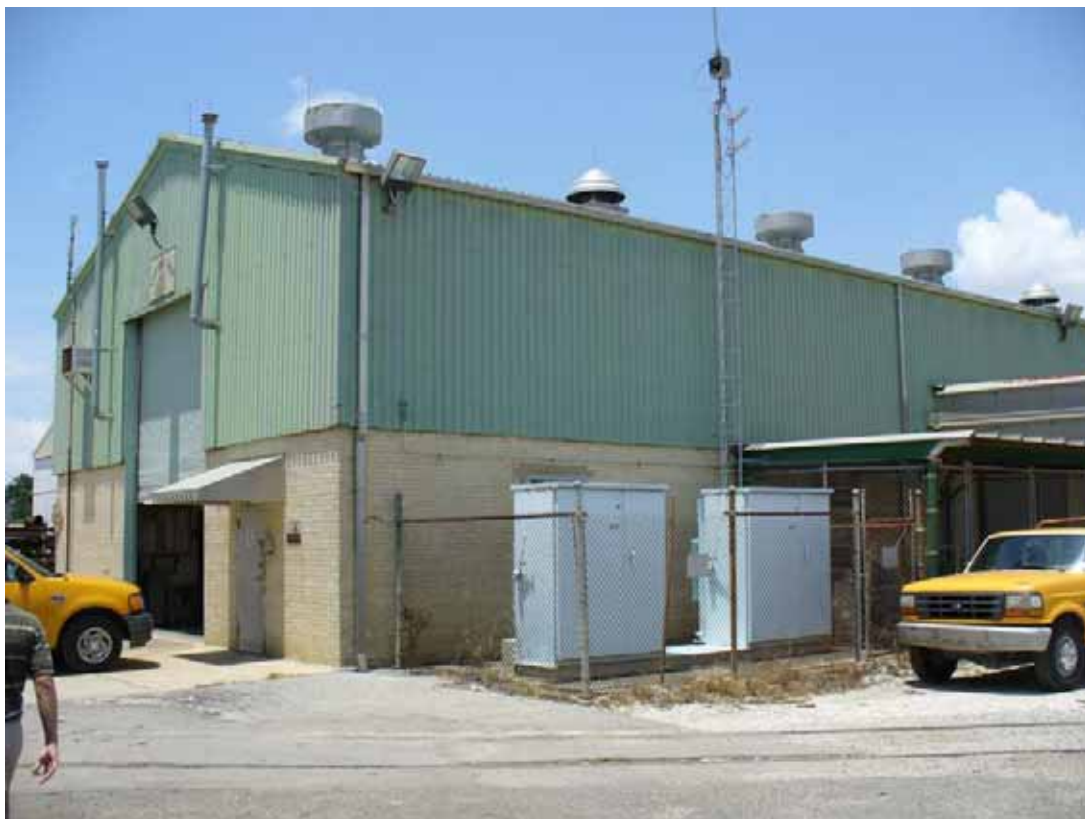
81. North and east side of electrical shop building.

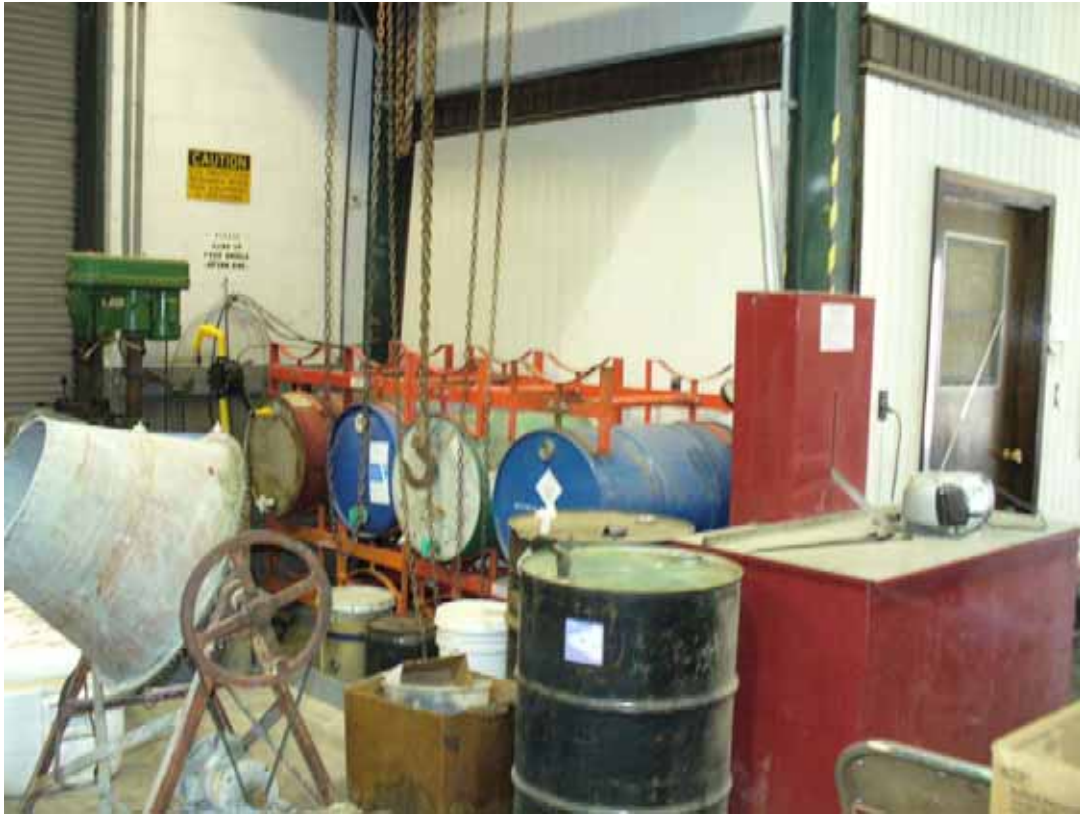
82. 55 gallon drums inside electrical shop.

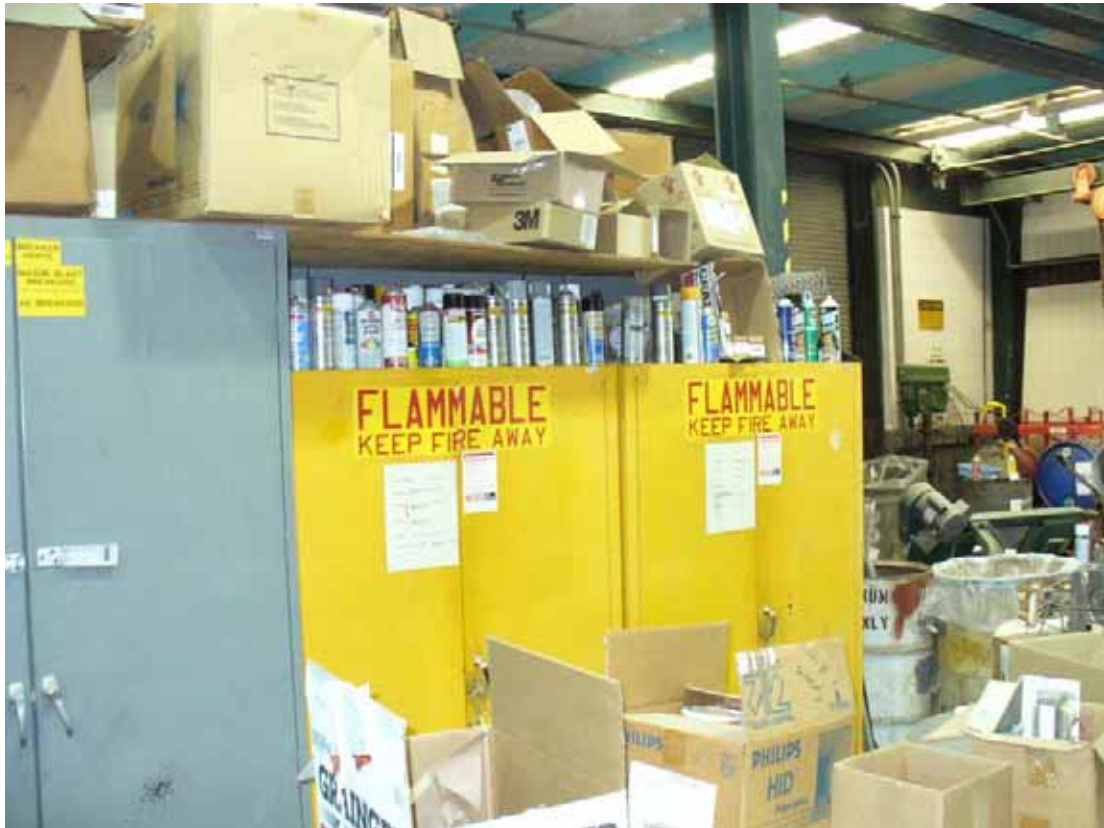
83. Flammable cabinet inside machine shop with flammables on top.

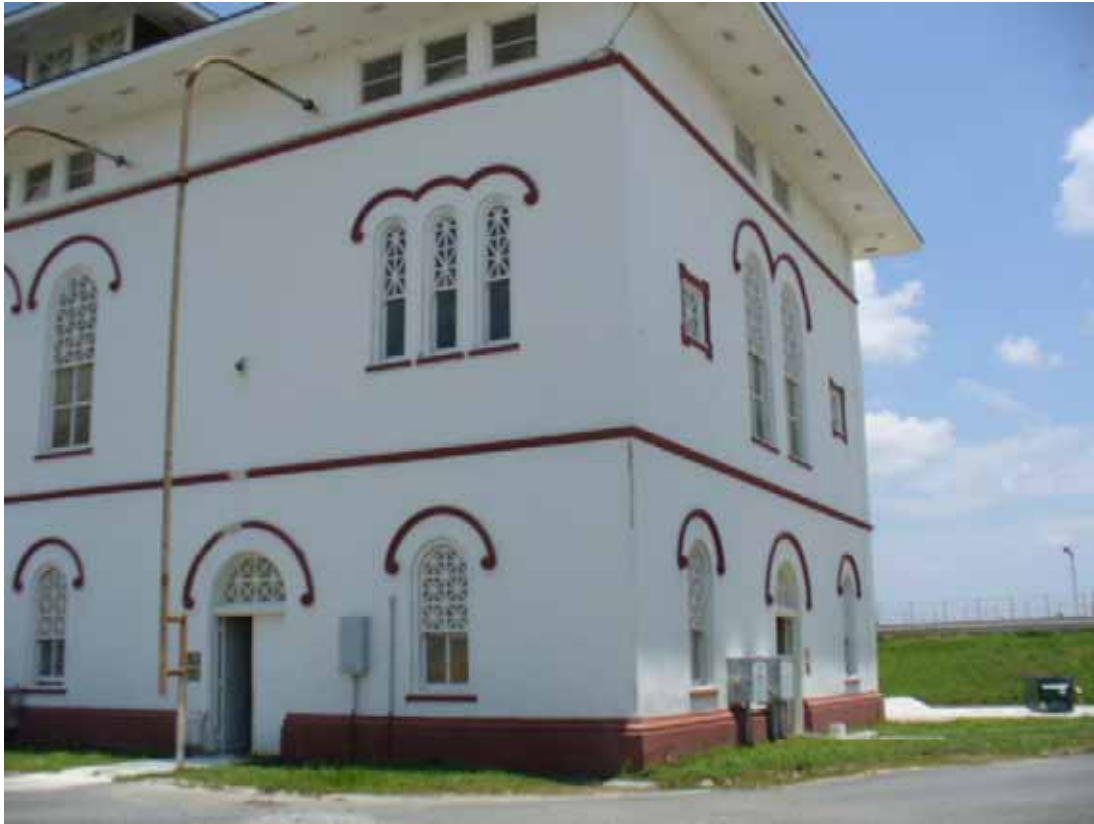
84. Southeast corner of chemical house.

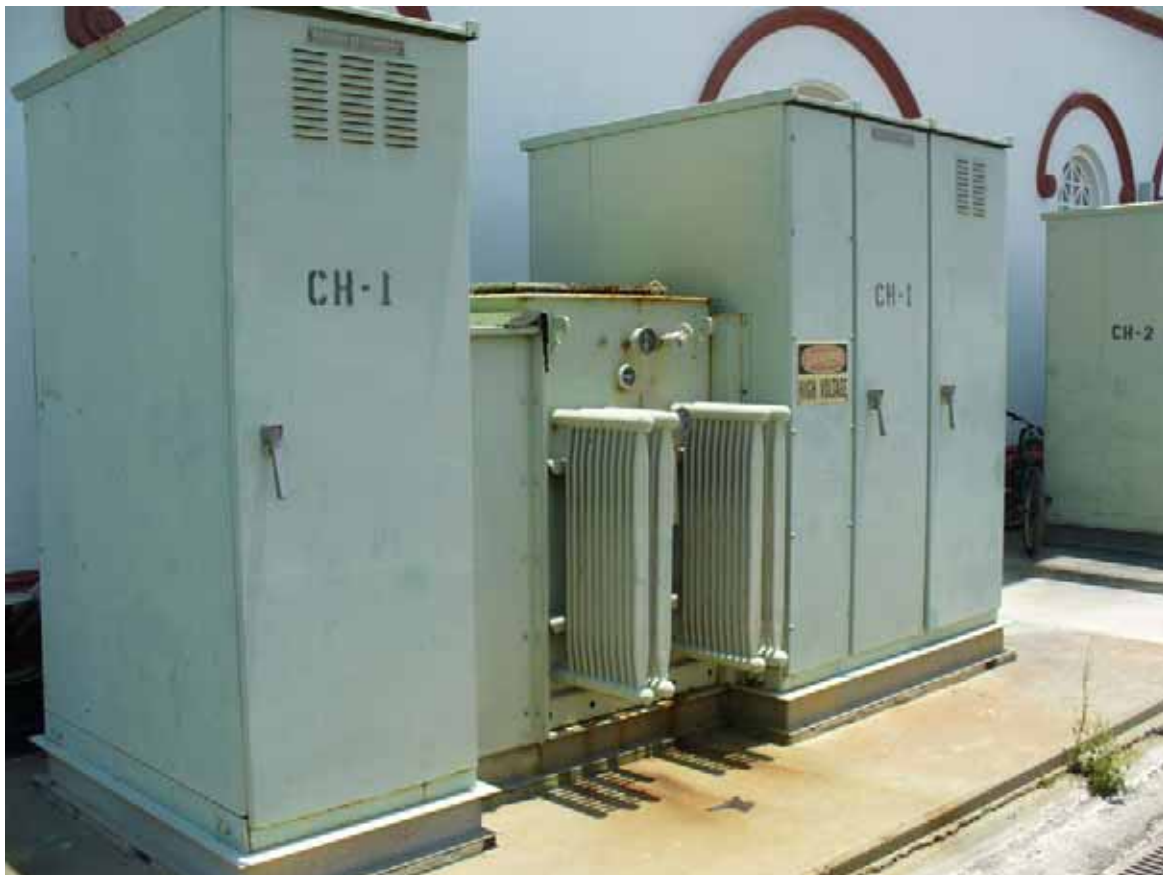
85. Transformers on south side of chemical house.

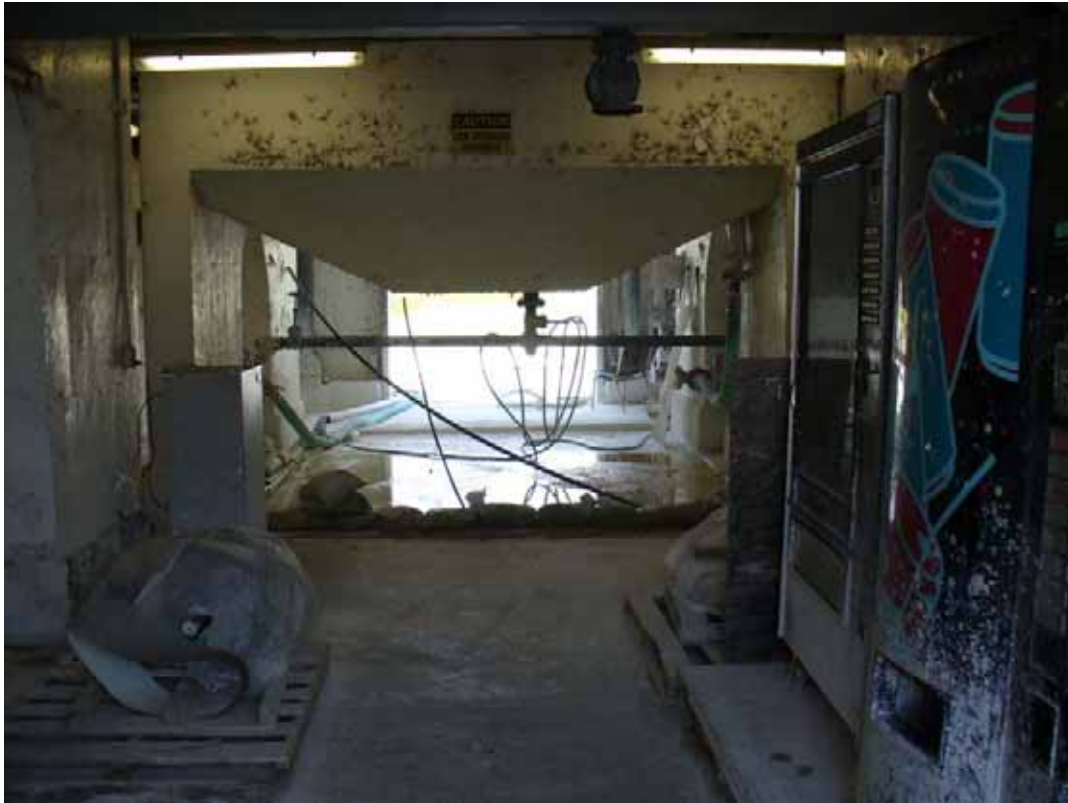
86. Lime storage dumpster in the chemical house.

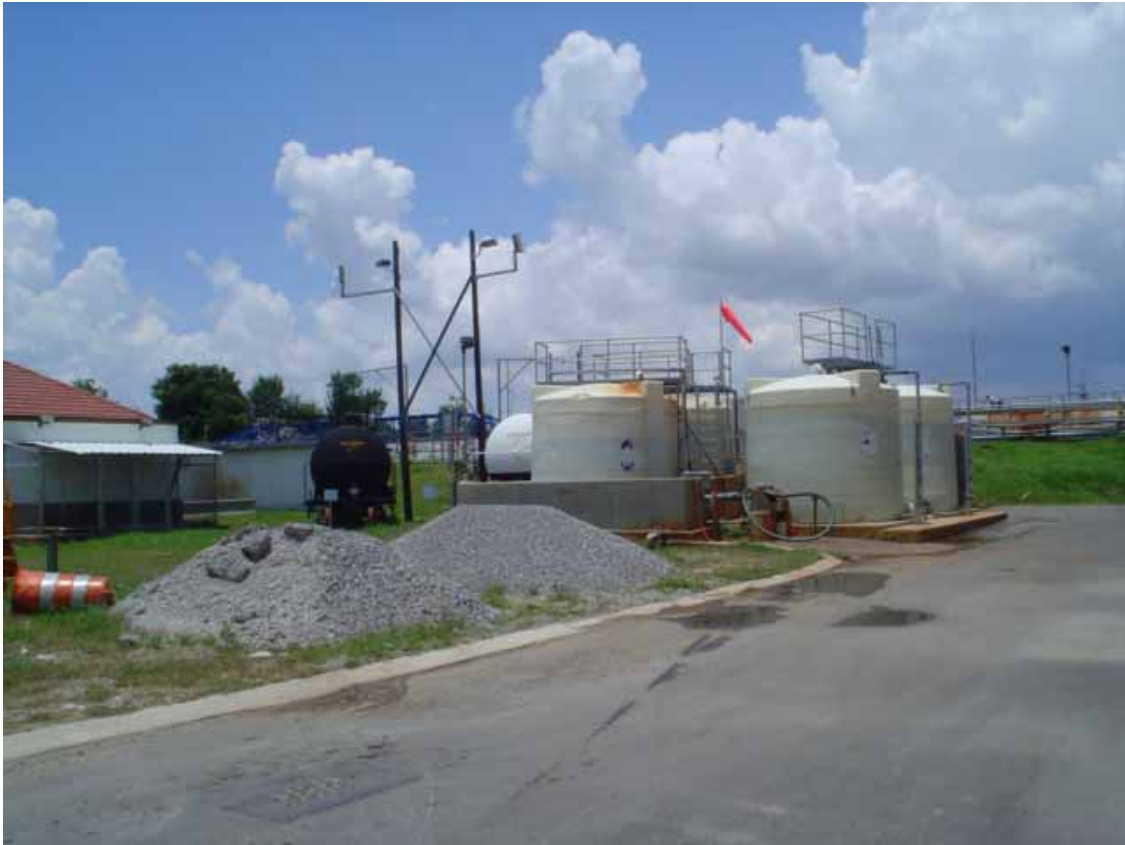
88. Two chlorine rail tanks, two ferric sulfate tanks and two clarifloc tanks southwest of chemical house.

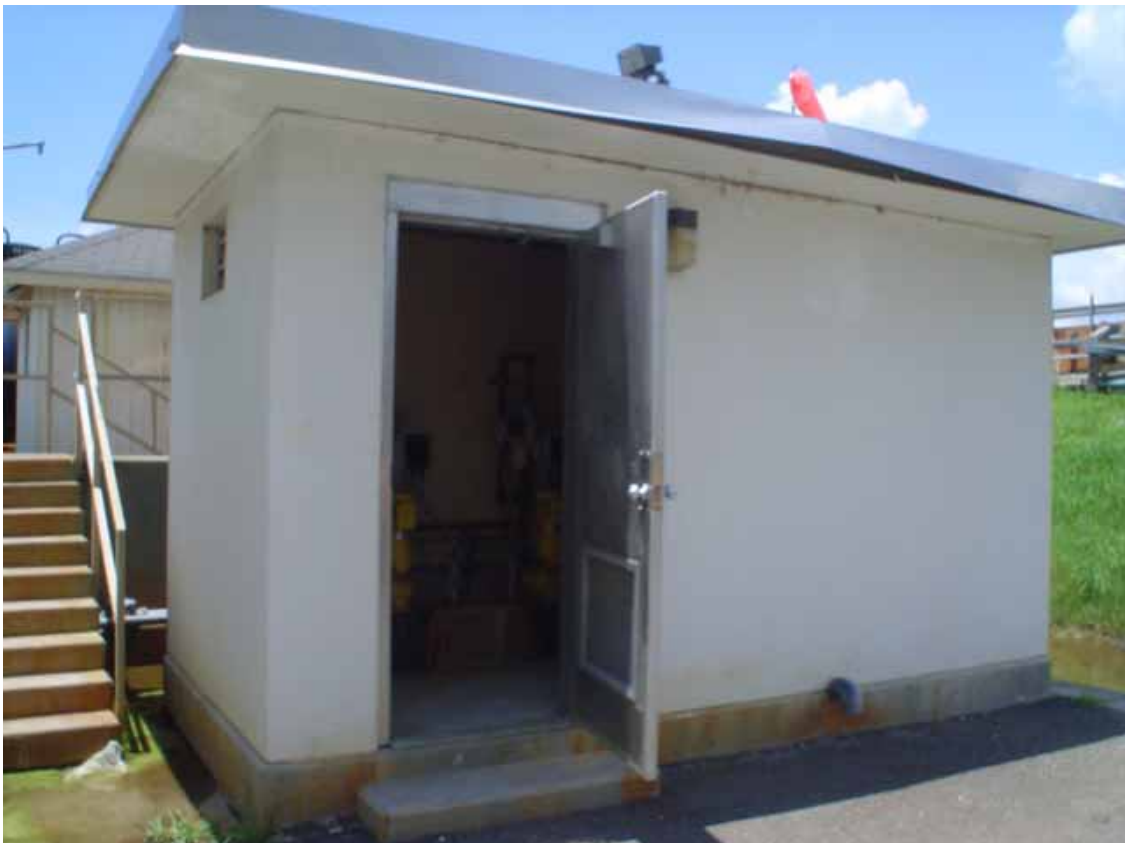
89. Example of polymer and ferric pump room buildings.

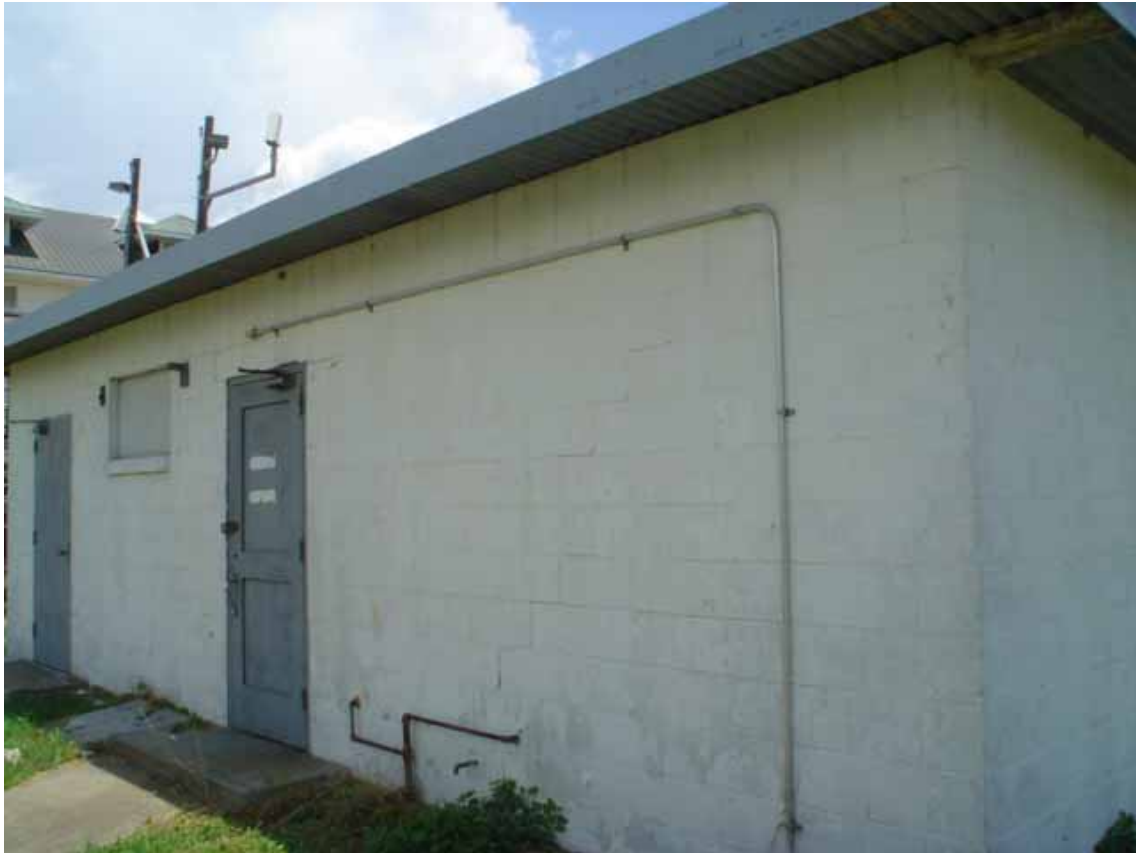
90. Laborers' shack southwest of chemical house.

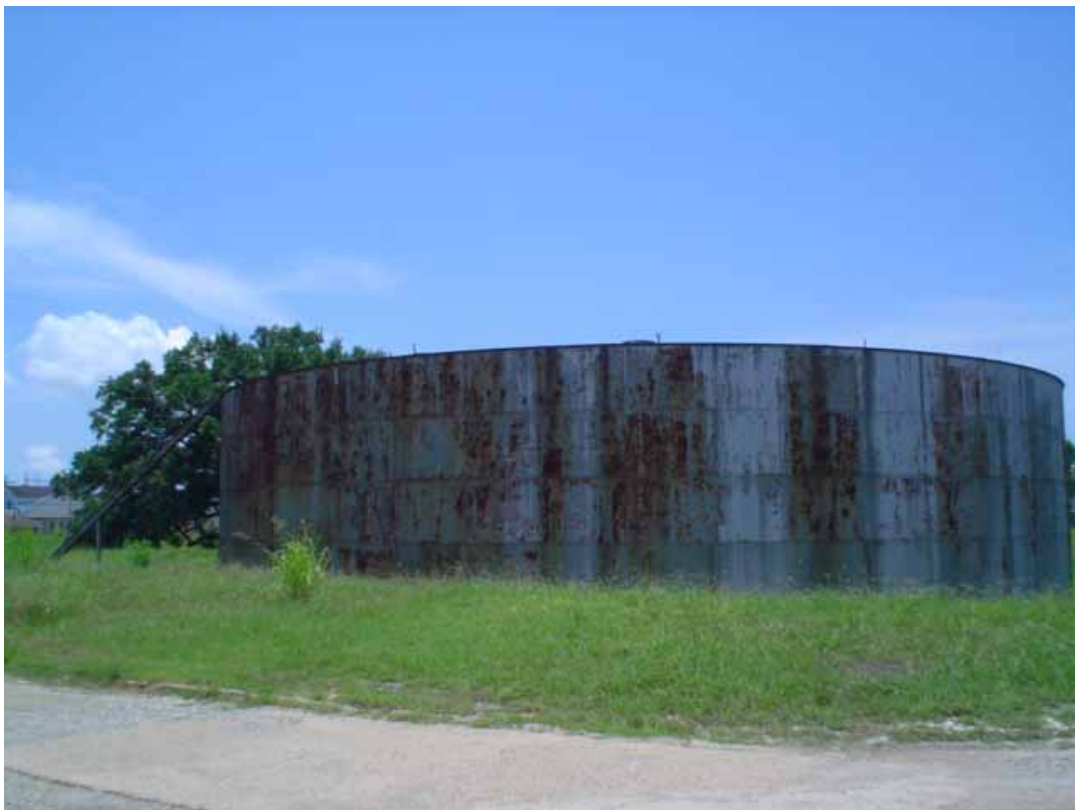
91. One and a half-million gallon diesel tanks on site in southwest area, one empty.

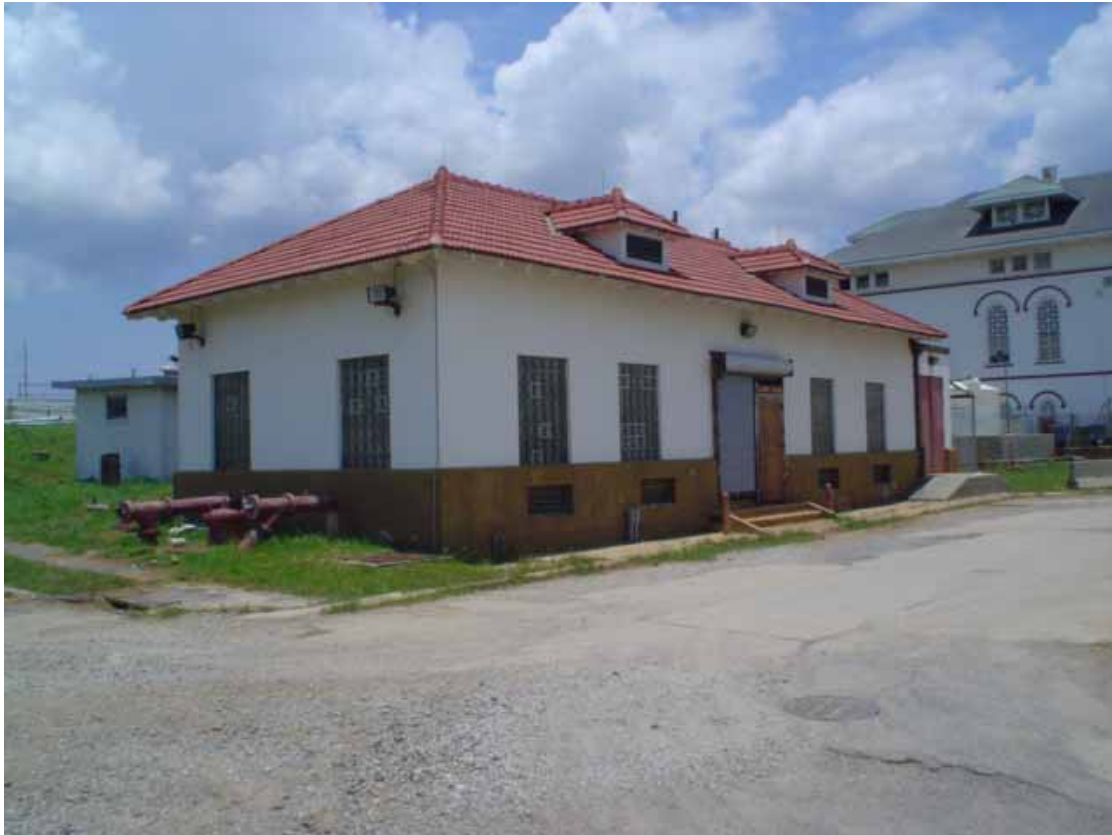
92. Sludge pump house southwest of chemical house visible in background.

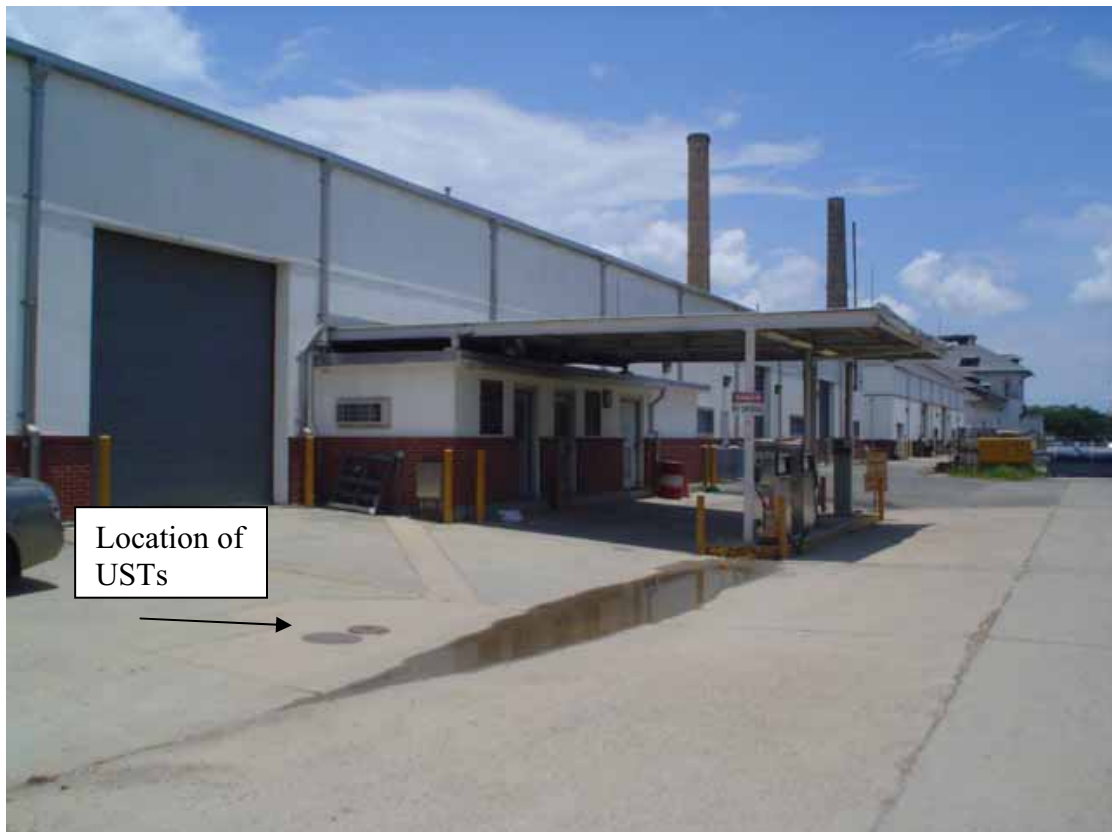
93. Gas station on south side of Spruce Street Warehouse, includes gas dispensers.

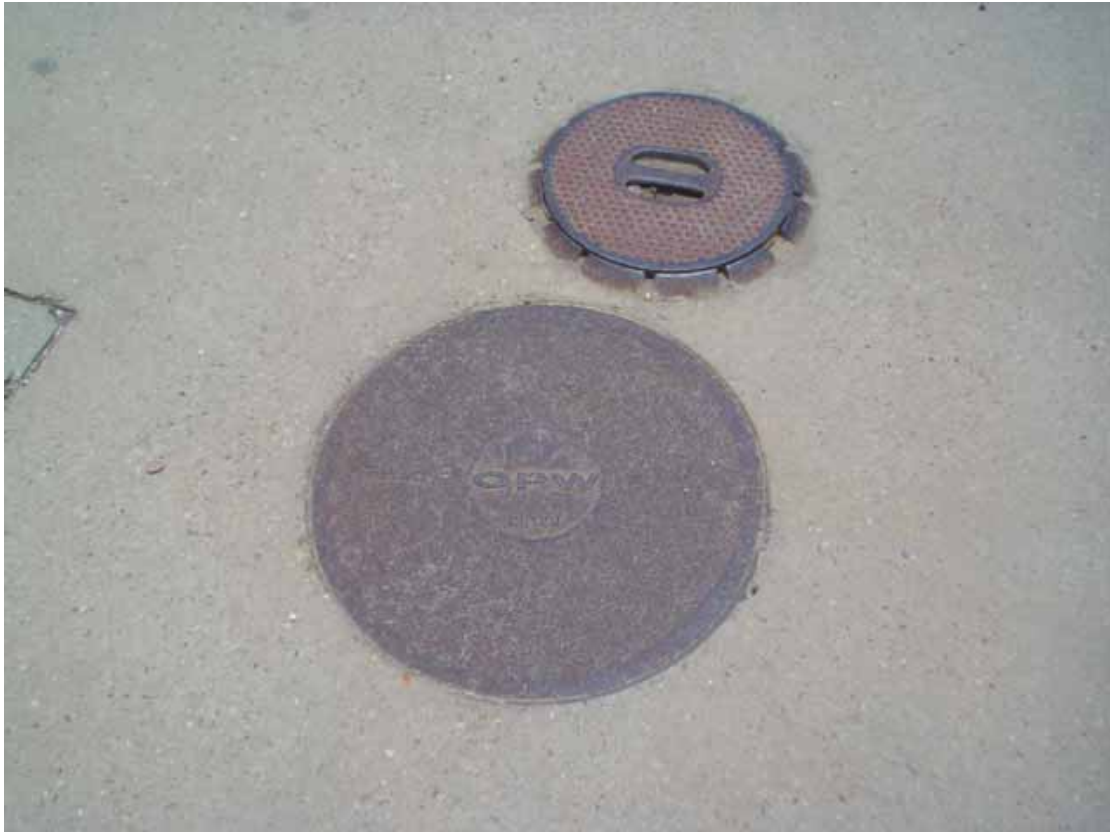
94. Close up of UST cover plates.
