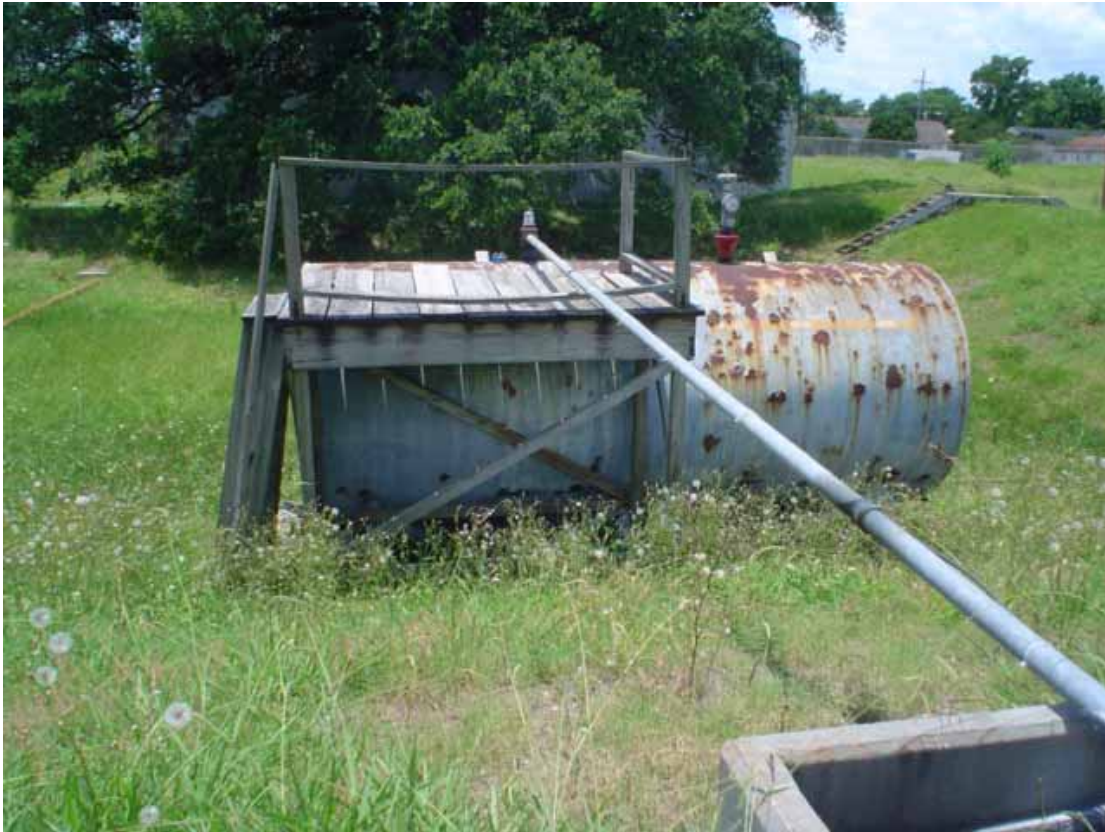
96. Diesel AST behind diesel pump that is stored in berm enclosure for one and a half million gallon tanks.

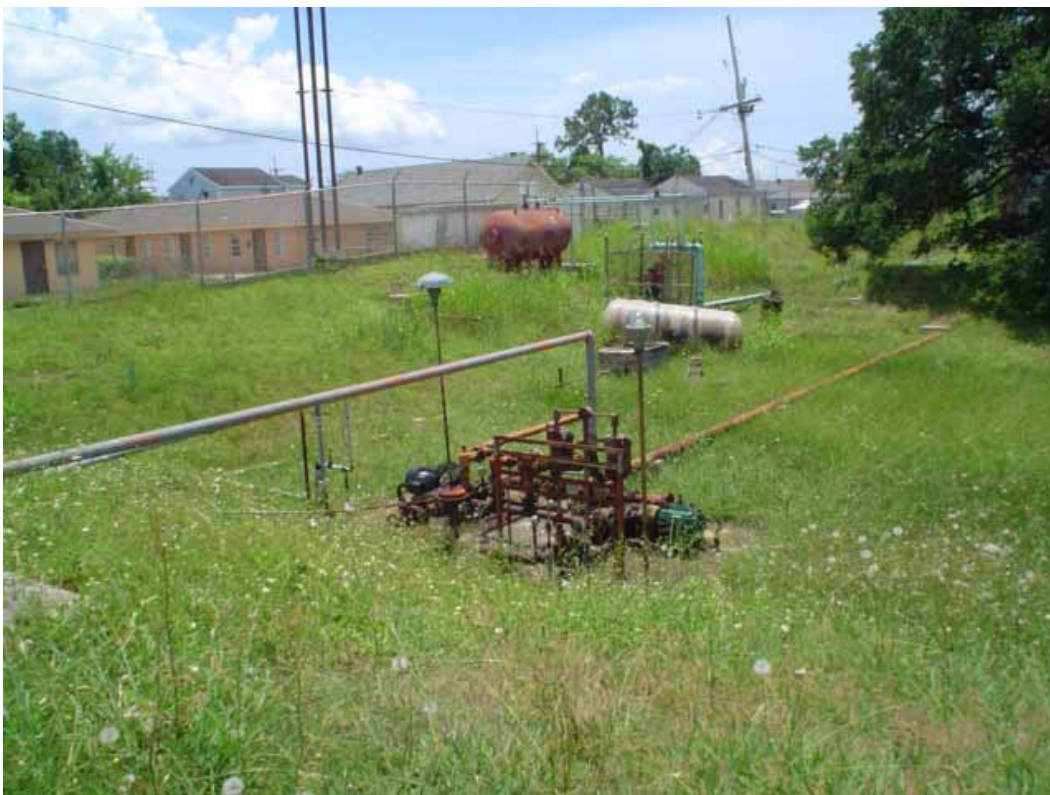
97. Pumps in foreground for UST located north of meter shop, orange tank in background for fire suppression system and abandoned fiberglass tank.

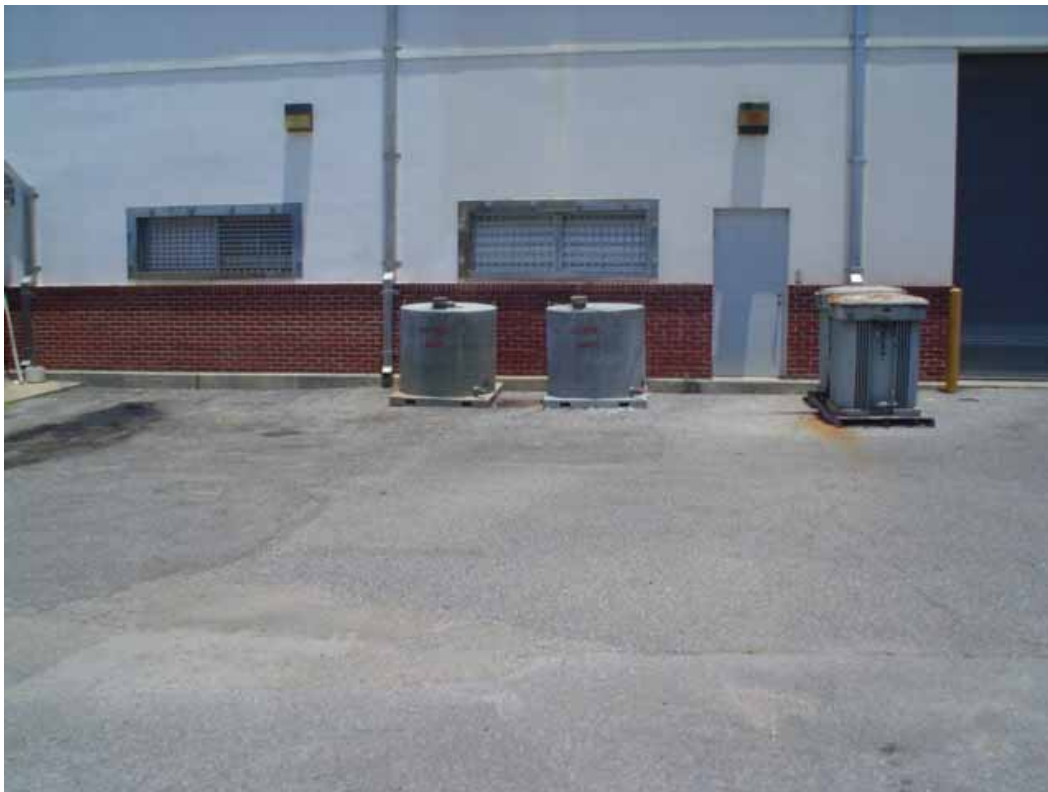
99. Waste storage tanks and transformer south of Spruce Street warehouse.

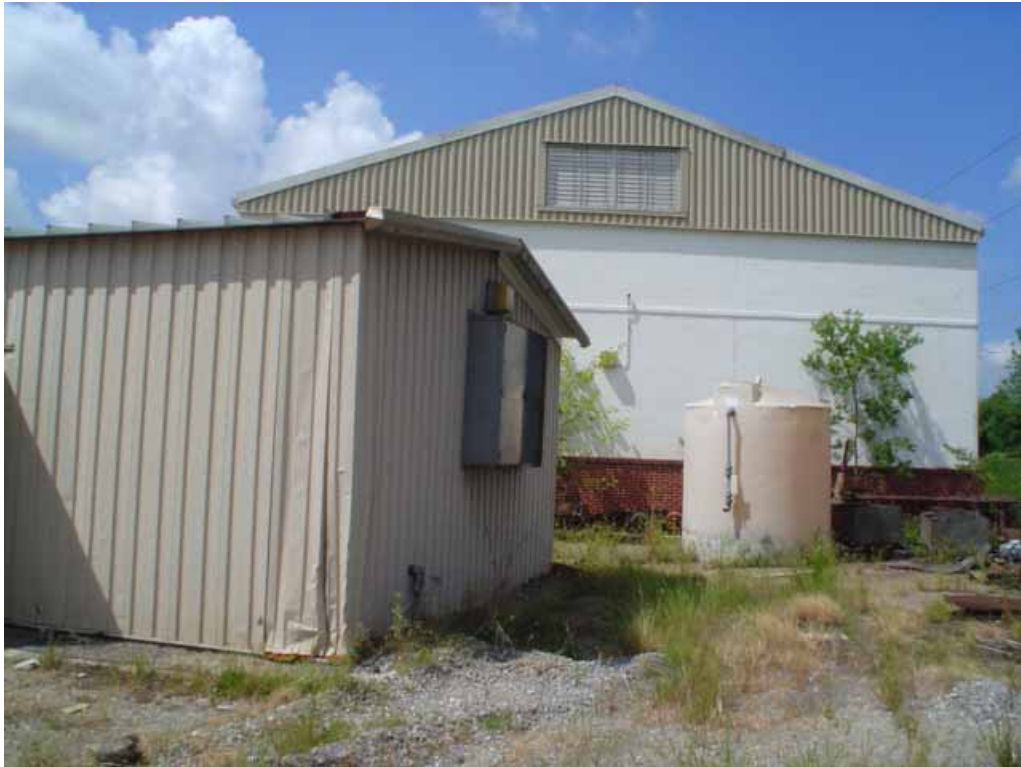
108. Empty tank southwest of carpenter building.

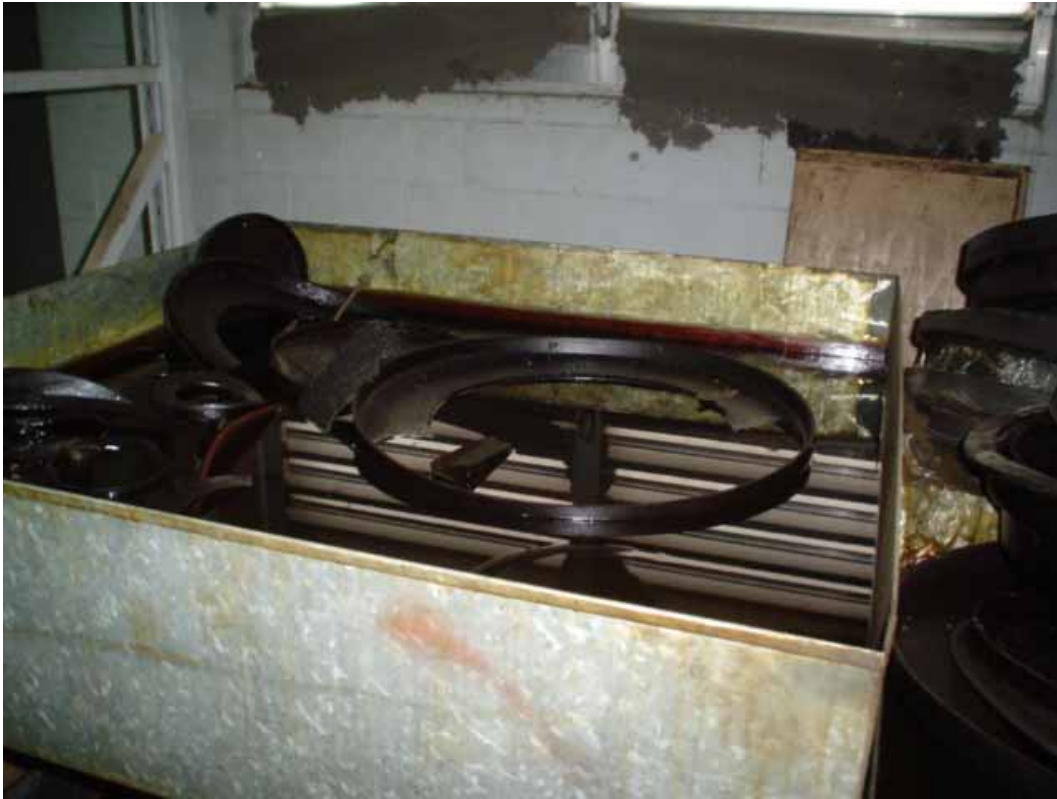
114. Open metal container with gaskets soaking in oil.

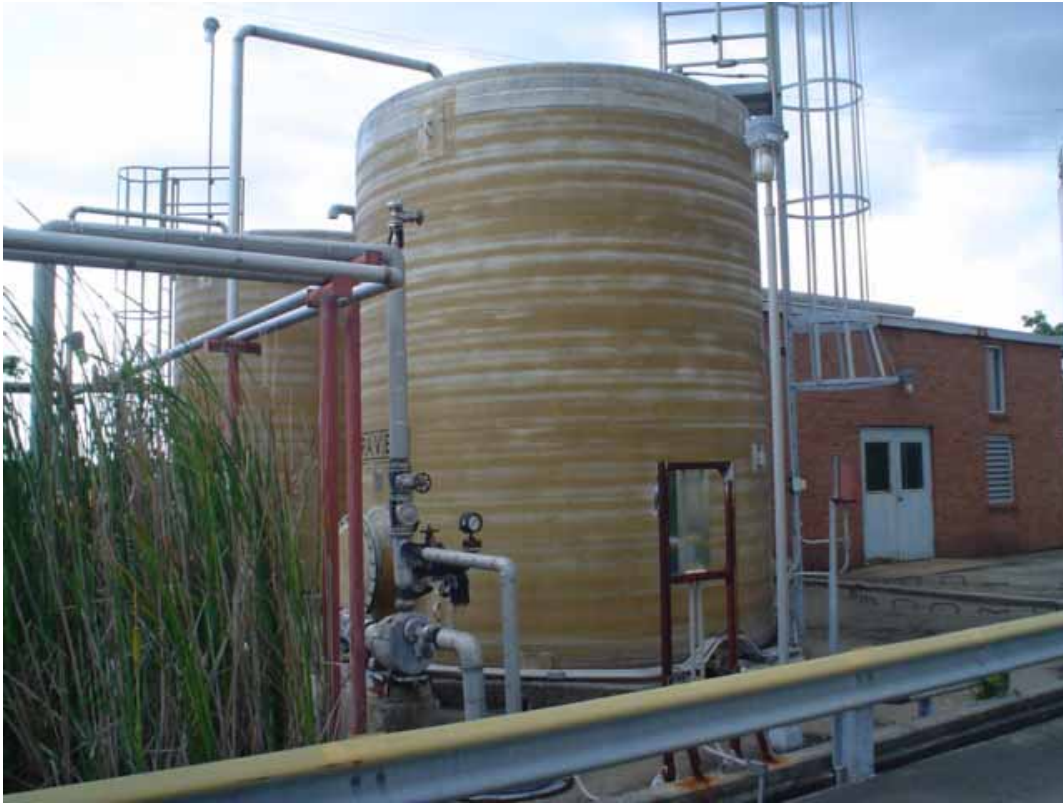
11. Additional building on access road, showing tanks formerly containing poly-electrolytes.

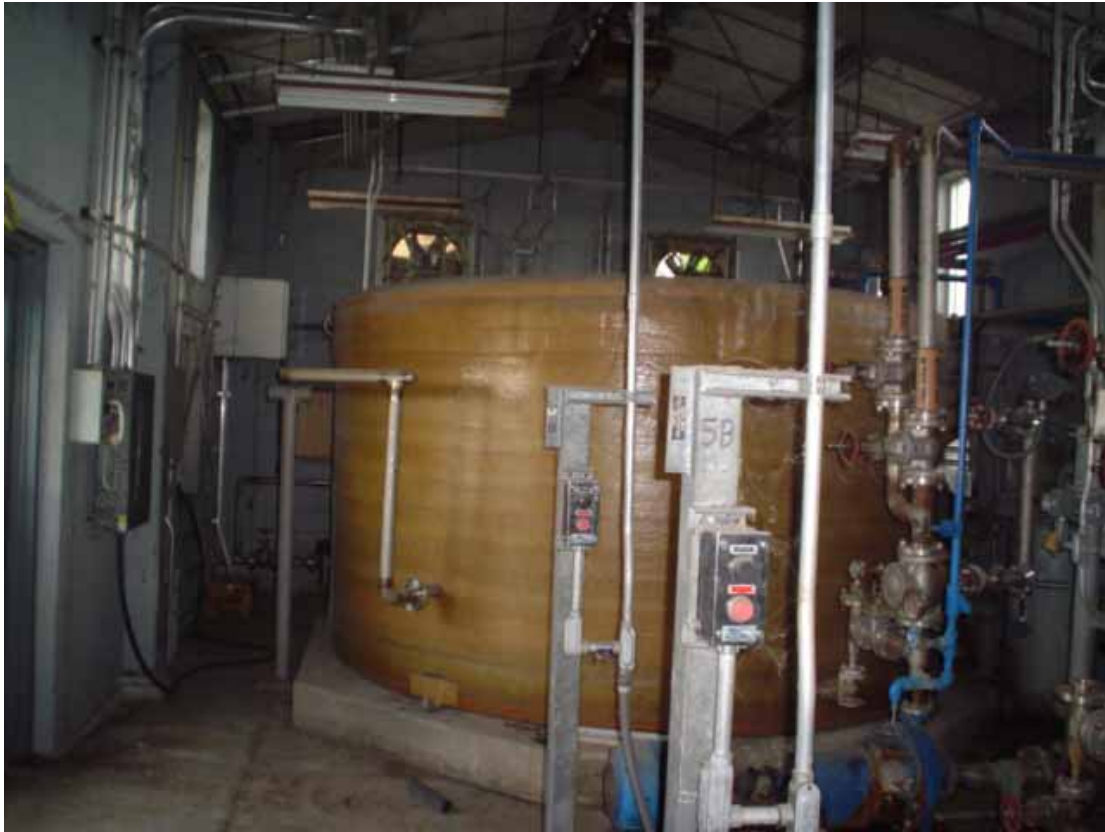
15. Purification treatment equipment, mixing tank for poly-electrolytes, no longer in use.
