JOHN SEVIER FOSSIL PLANT - ANNUAL INSPECTION OF WASTE DISPOSAL  
AREAS

**JOHN SEVIER FOSSIL PLANT (JSF)  
NPDES PERMIT NO. TN0005436  
ANNUAL ASH POND DIKE INSPECTION  
2000**

# JOHN SEVIER FOSSIL PLANT ANNUAL ASH POND DIKE STABILITY INSPECTION 2008

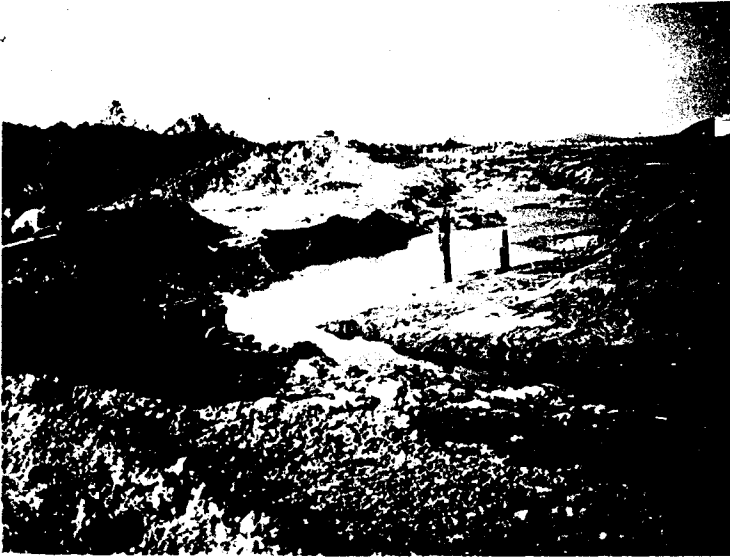
4 - Pump being installed behind the break after it was plugged

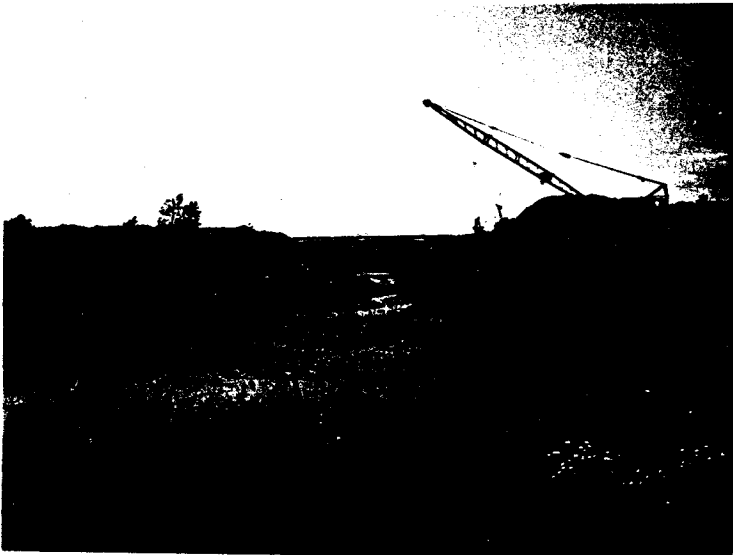
5 - The divider dike between E and F ponds being breached

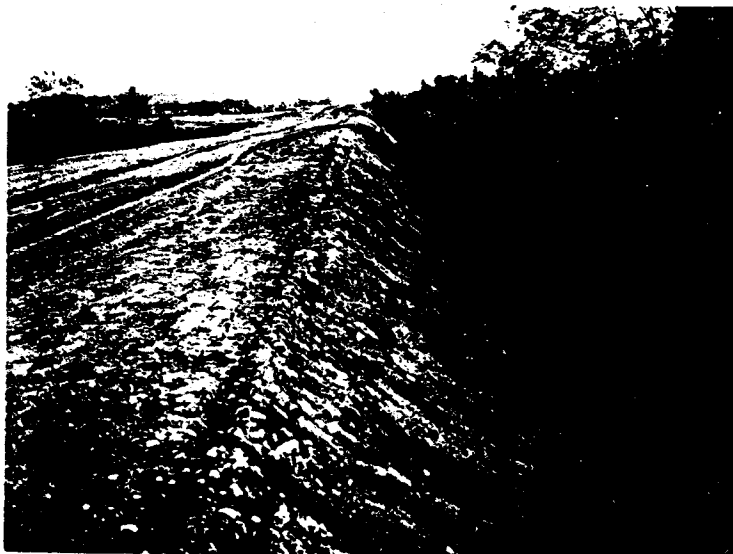
1. The outside slopes of the dikes are too steep as has been reported numerous times in the annual ash disposal pond inspection reports (1967-1972). The outside slope is 1.5:1, and the design drawings show slopes of 3:1 and 2:1 with berms. Recommendations had been made to establish a theoretical 3:1 slope point, leave a ten-foot berm, and all future raising was to be on a 3:1 slope (1967-1971). Dikes continued to be raised with a 1.5:1 slope, however.

6 - Outside of slope being raised on a 1.5:1± and bladed down the slope
