**WIDOWS CREEK FOSSIL PLANT
ANNUAL ASH POND DIKE STABILITY INSPECTION
FY 2009**

The waste disposal areas at Widows Creek Fossil Plant (WCF) were inspected for dike structural stability on October 15 and 16, 2008 by Kelly Evans of TVA Fossil Engineering Design Services (EDS) and Jamie Dotson of TVA Fuel By-products. The previous annual inspection was performed on December 5 and 6, 2007. The results of the inspection of the Coal Yard Drainage Basin, Coal Yard Perimeter Ditch, Limestone Pile Drainage Basin, Wet Gypsum Stacking Area, Stilling Pond for the Wet Gypsum Stacking Area, Active Ash Pond, Stilling Pond for Active Ash Pond, Dredge Cell, Perimeter Dikes, Red Water Pond, Chemical Treatment Pond, and the Abandoned Ash Disposal Area are listed below. A summary of recommendations is also provided. Estimated costs are based on the 2009 RSMEANS Building Construction Cost Data (quotes are advised for more accurate estimate).

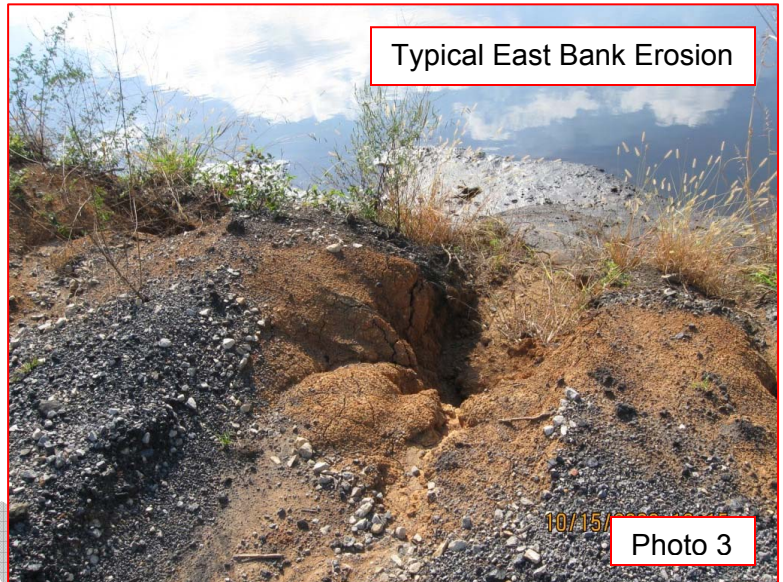
- Pump
 - ◆ Platform needs painting and repair to handrail. This is a future potential safety issue (Photo 6).
 - ◆ Operation of pump system was not part of the inspection.
 - ◆ Vegetation encroaching in access walkway (Photo 7).

- Cut vegetation on the east, south and north interior slopes.
- Clean-out sediment basin in front of inlet pipes ~ 60' by 30' by 3' deep. \$1000.00.
- Reset inlet pipes, cover (w/gravel or clay) - \$2,500.00.
- Construct weir to prevent sediment from clogging inlet pipes or install prefabricated weir boxes (3 Agri Drains) - \$5,000.00. Place riprap filter ring in front of inlet weirs.
- Repair erosion and re-grade roadway along east slope. Stabilize surface with 3 inches of crushed stone - 1500 sq. ft. - \$14,000.00.
- Repair erosion on east slopes and place geo-textile fabric and rip-rap - \$78,000.00. As a minimum repair erosion re-grade road and repair erosion to prevent sediment from filling pond.
- Repair pump platform handrail - \$300.00. Paint platform within next two to three years.

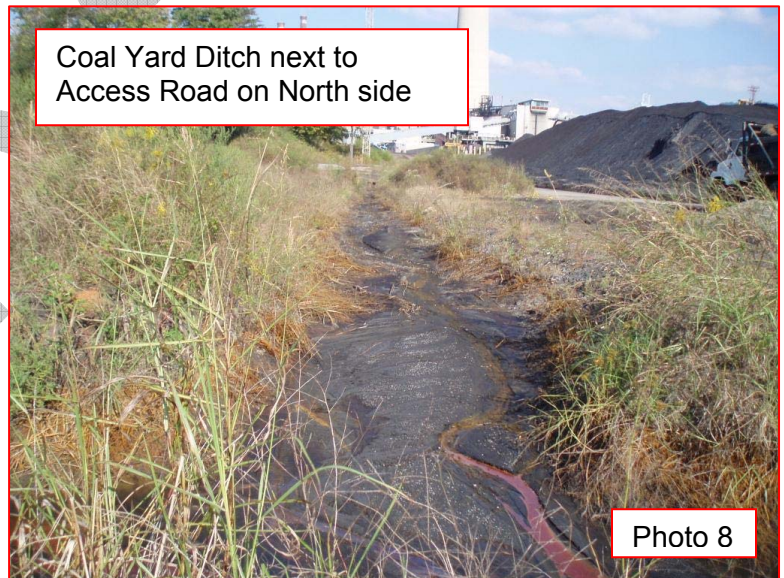
- **Location** - Perimeter of Coal Yard West of the Powerhouse.
- **Effluent** - Drains to the coal yard drainage basin.
- **Observations (see sketch API08-1 for photo locations)**
 - Sediment and coal fines fill the majority of the ditches. Clogging of the ditches has forced water over the access road into the coal yard drainage basin causing erosion in the east basin slopes. (Photos 8-14).

- **Recommendation**
 - Clean the perimeter ditches to allow run-off to be channeled into the coal yard drainage basin.

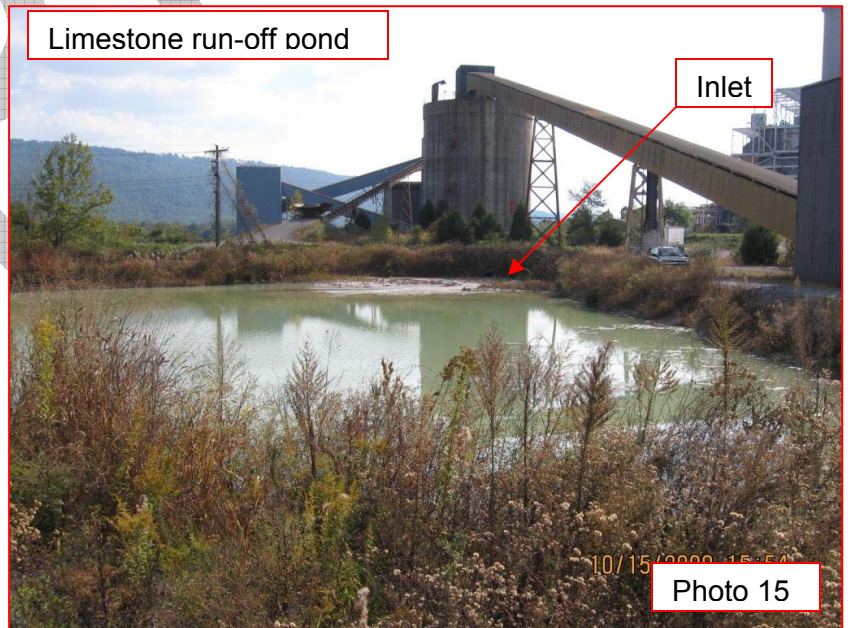
- **Location** - East of Powerhouse.
- **Effluent**
 - Discharges to a series of stilling ponds.
 - Final stilling pool discharges to Outfall 005 into Gunter'sville Reservoir.
- **Observations (see sketch API08-1 for photo locations)**
 - Interior Slopes - Satisfactory condition some erosion on interior slopes (Photo 17).
 - Sediment Level - Pond appears to be filling up again (Photos 15-16). Pond cleaned in November of 2006.
 - Discharge - submerged

- Continue good management practices utilized in maintaining the Limestone Pile Drainage Basin.
- Clean sediment around inlet. Monitor and clean-out pond as required.
- Perform isolated repairs at erosion locations along interior slopes. Pull slopes back to 3:1 smooth, seed and place seed mat ~250' of bank. Estimated ~2,500 sq. ft. - \$1200.00
- Remove vegetation around the surge basin. Pull trees up and fill holes with compacted material - \$3,000.00.
- Remove debris from surge basin. Repair Seep. Procedure to be developed by Engineering.
- Perform a dye test to see if observed seepage is coming from limestone surge basin.

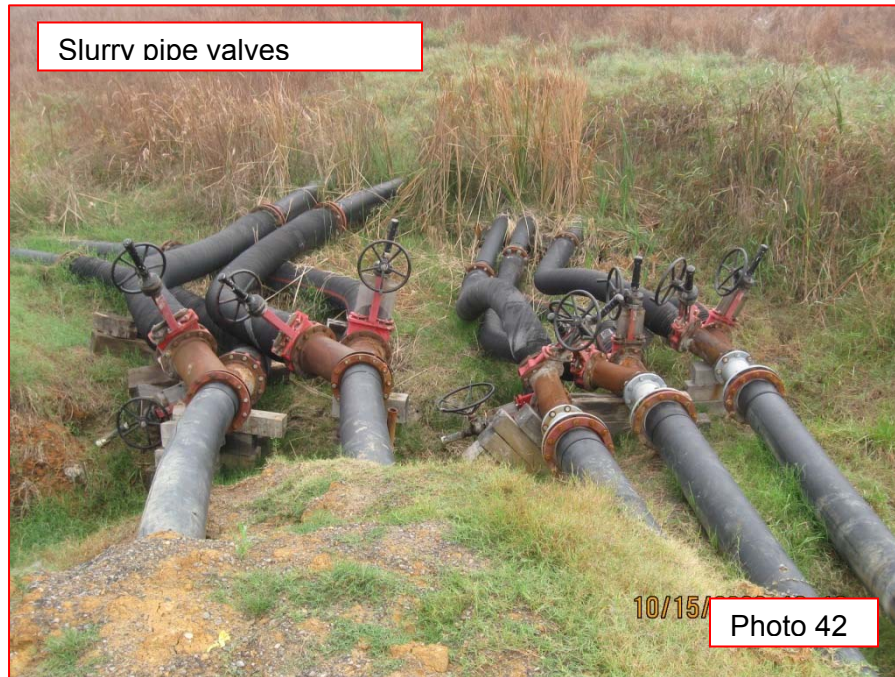
Photo 42

- ◆ Slurry line block supports have shifted making it difficult to operate transfer valves (Photo 42).

Slurry pipe valves

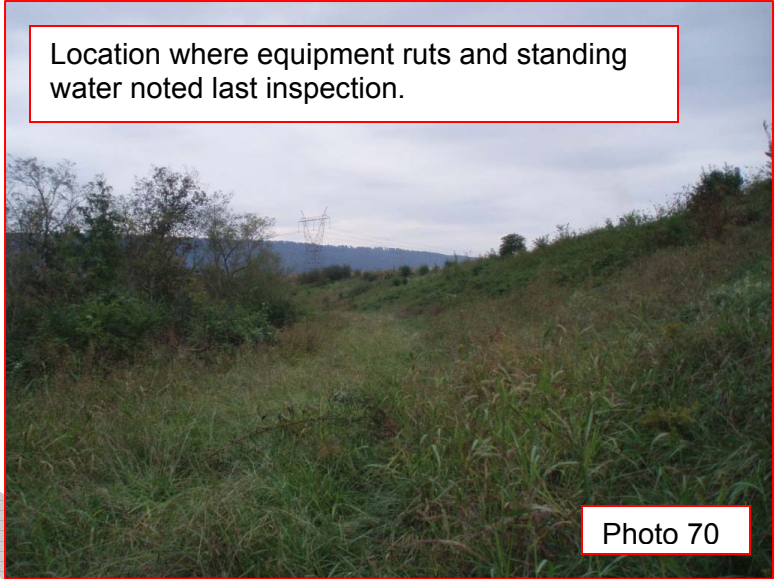
Photo 70

- ◆ The wet areas and (equipment) rutting at the Northeast perimeter dike base just south of the bridge accessing the Gypsum disposal area were not visible due to heavy vegetation. The area was damp but no seepage was visible (Photo 70).

Location where equipment ruts and standing water noted last inspection.

- ruts re-grade if required to prevent accumulation of water and then seed and mulch. Estimated area to be covered is 30,000 square feet (3,333 square yards) (Photo 70).
- Place labels identifying pump level operations on the red water pump electrical cabinet.
- Monitor erosion at the Red Water Pond interior slope. Notify EDS if erosion worsens. Placement of riprap is the recommended repair but not warranted at this time.

- Address area along base of northeast dike where equipment ruts and water was observed during the last inspection. This will start at the bridge accessing the gypsum area and extend to where the gypsum stilling pond gravity drain line discharges to the 008 outfall ditch. Expose the area, fill ruts re-grade if required to prevent accumulation of water and then seed and mulch. Estimated area to be covered is 30,000 square feet (3,333 square yards) (Photo 70).

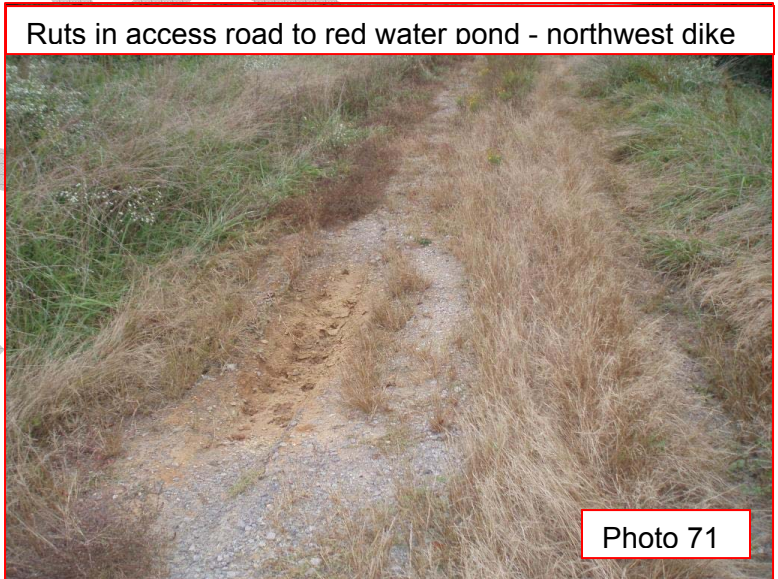
Photo 71

- ◆ Ruts forming on bench access road on the northwest dike. This serves as the access road to the red water pumping station. Standing water was observed (Photo 71).

Ruts in access road to red water pond - northwest dike

- Remove woody growth along the northwest perimeter dike next to the red water pond.
- Ruts forming on bench access road on the northwest dike. This serves as the access road to the red water pumping station. Gravel and re-grade to prevent standing water. This is needed on approximately 2000 feet of the access road (Photo 71).

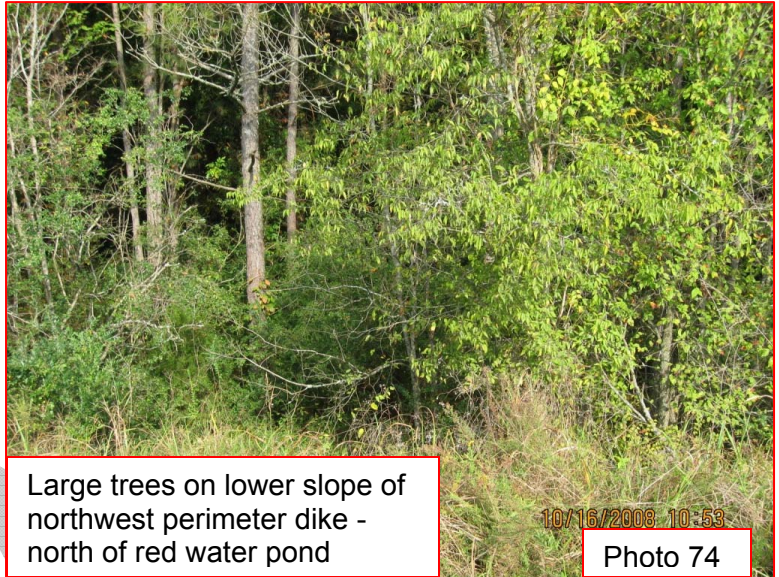
Photo 74

- ◆ Mature trees observed on the northwest lower dike to the north and south of the red water pond (Photo 72 and 74).
- ◆ Drainage ditch cut through to the red water pond for the new Scrubber Road storm water discharge (Photo 75).

Large trees on lower slope of northwest perimeter dike - north of red water pond

- Cutback vegetation on all slopes. Maintenance of the dike slopes by mowing annually will inhibit woody growth.
- Remove trees along slopes. See tree removal procedure. Note: trees on the bottom slopes on the west side of the ash ponds have many mature trees. Tree removal here may cause damage to the dike if removed. At this time the recommendation is to leave these trees in-place.

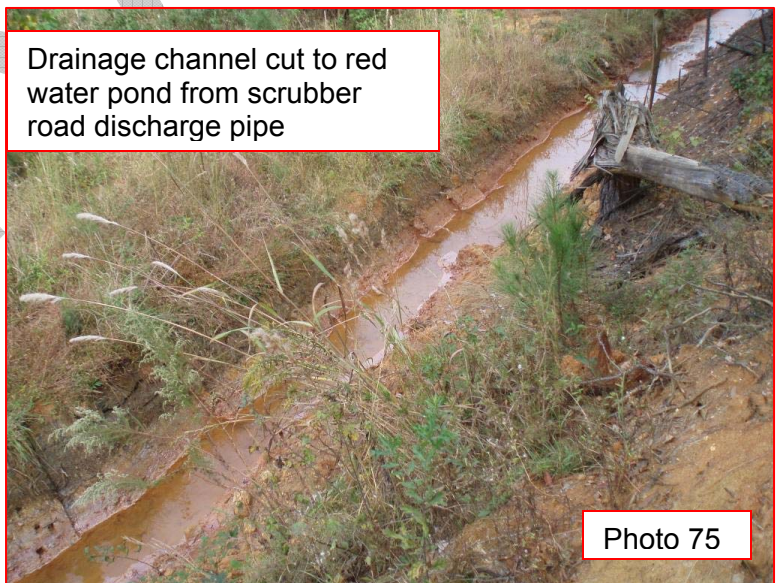
Photo 75

Drainage channel cut to red water pond from scrubber road discharge pipe

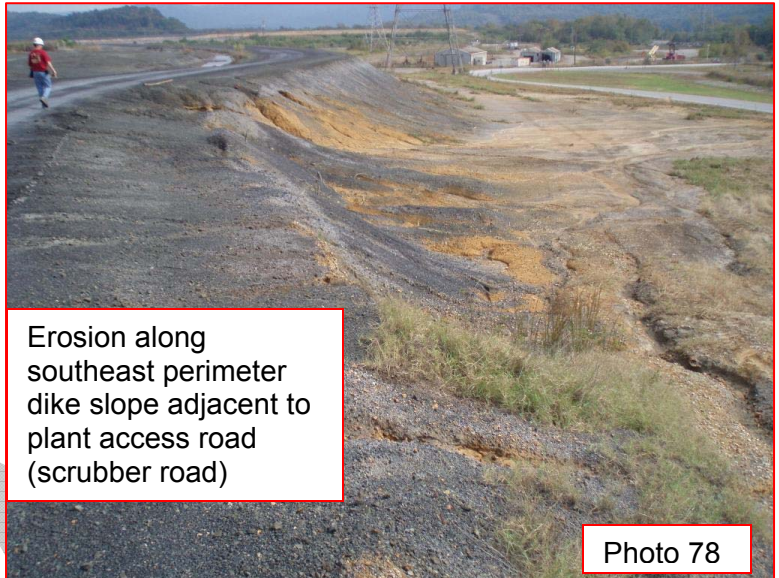
Photo 78

- Perimeter Dikes continued
 - ◆ Erosion noted starting at access road from the Stilling Pond and extending approximately 1400 feet west. Starts at the top of the dike and extends down the slope. The paved plant perimeter access road runs parallel to this area (Photos 78 and 79).

Erosion along southeast perimeter dike slope adjacent to plant access road (scrubber road)

- Place suitable earth material atop of the existing earth material that is not supporting vegetative cover on the South perimeter dike. This material shall then be seeded and mulched so that vegetative cover can be established (Photos 78 and 79). Some type of grass matting is recommended for this area. Estimated area to be covered, graded, and seeded - 6500 yd². If dirt access road is used in this area surface and gravel. Estimated area is 800 yd².

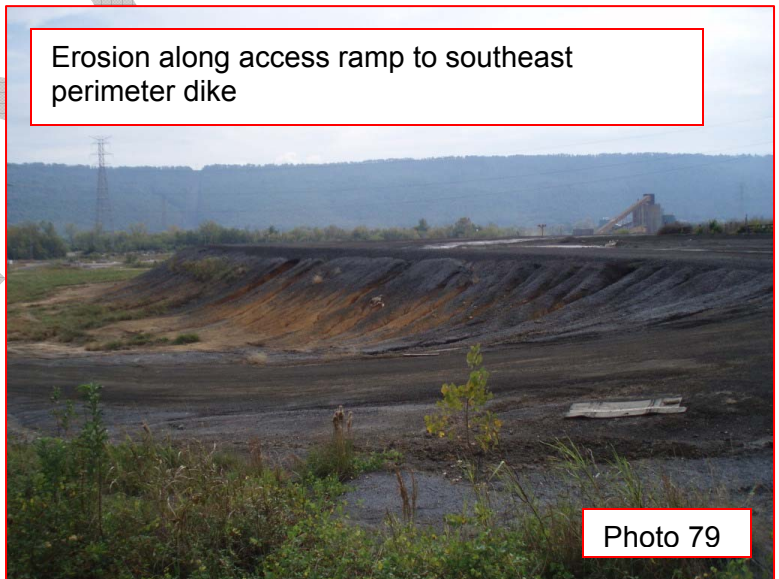
Photo 79

Erosion along access ramp to southeast perimeter dike

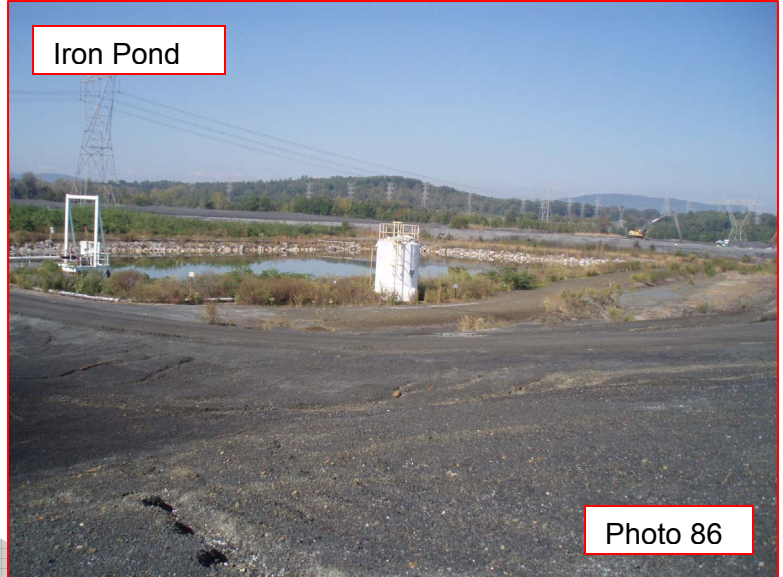
- **Location** - Inside the Ash Pond Perimeter Dikes Northwest of Powerhouse
- **Effluent** - Discharged into Active Ash Pond
- **Observations**
 - Interior slopes - Satisfactory - heavy vegetation with small trees and brush present along the edges of the Copper Pond (Photo 87).
 - ◆ Riprap cover in good condition in Iron Pond (Photo 86).
 - Platforms
 - ◆ Copper Pond - poor - appears structurally sound but needs paint. Access blocked by vegetation (Photo 88).
 - ◆ Iron Pond - satisfactory (Photo 89)
 - Ponds are enclosed by perimeter dikes forming a basin
 - ◆ Runoff from this area flows through two drainage pipes which penetrate the outside perimeter dike and runs down the slope to the perimeter ditch.
 - ◆ Inlet to these two pipes is partially clogged. (Photos 84 and 85).

- **Recommendations**
 - Unclog drainage pipes and place filter fabric and riprap check dam at entrance point to catch sediment (2 yd³).
 - Close ponds if they are not used and fill in basin area with bottom ash.
 - Remove brush and vegetation along the interior slope of the copper pond.

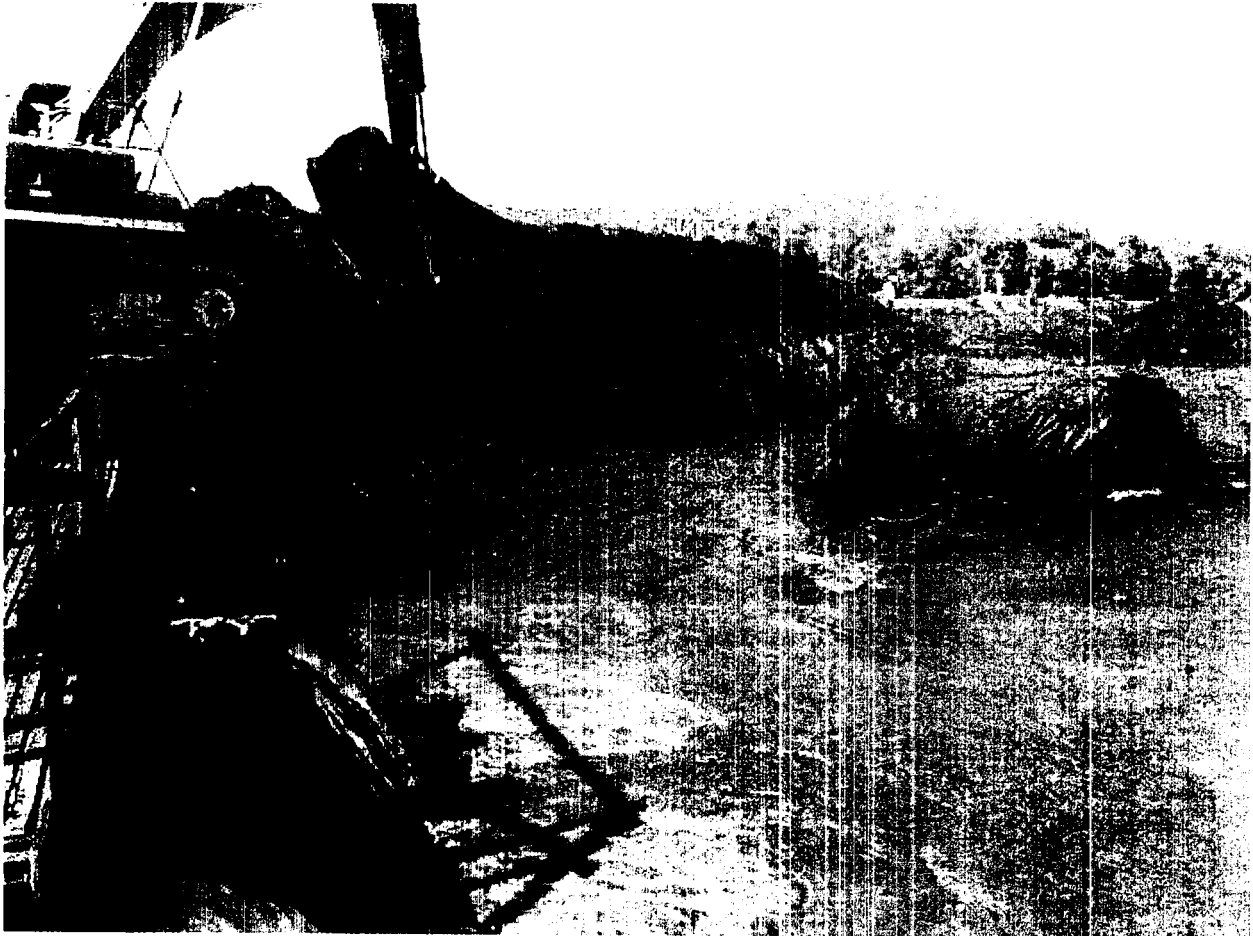
Photo 1. Newly constructed channel from Units 1 thru 6 ash sluice line discharge pipes to ash pond.

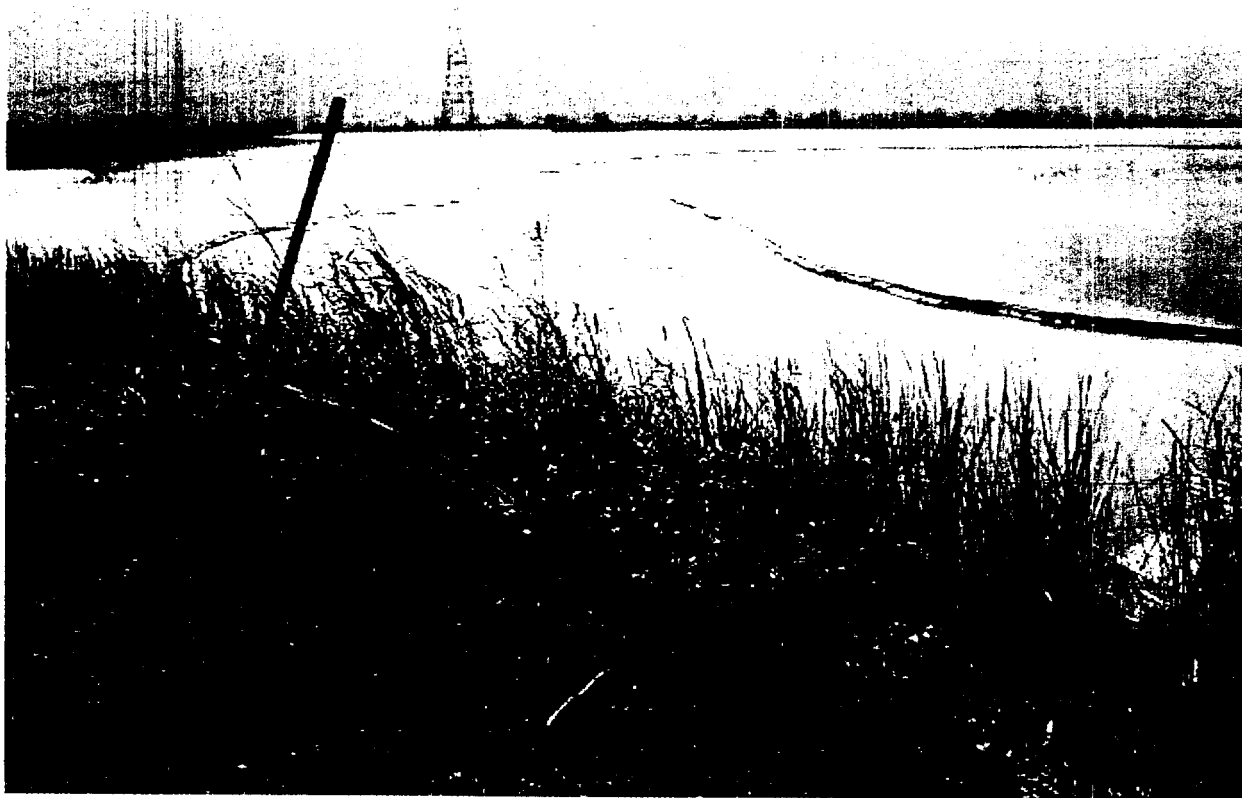
Photo 3. Active Ash Disposal Area.

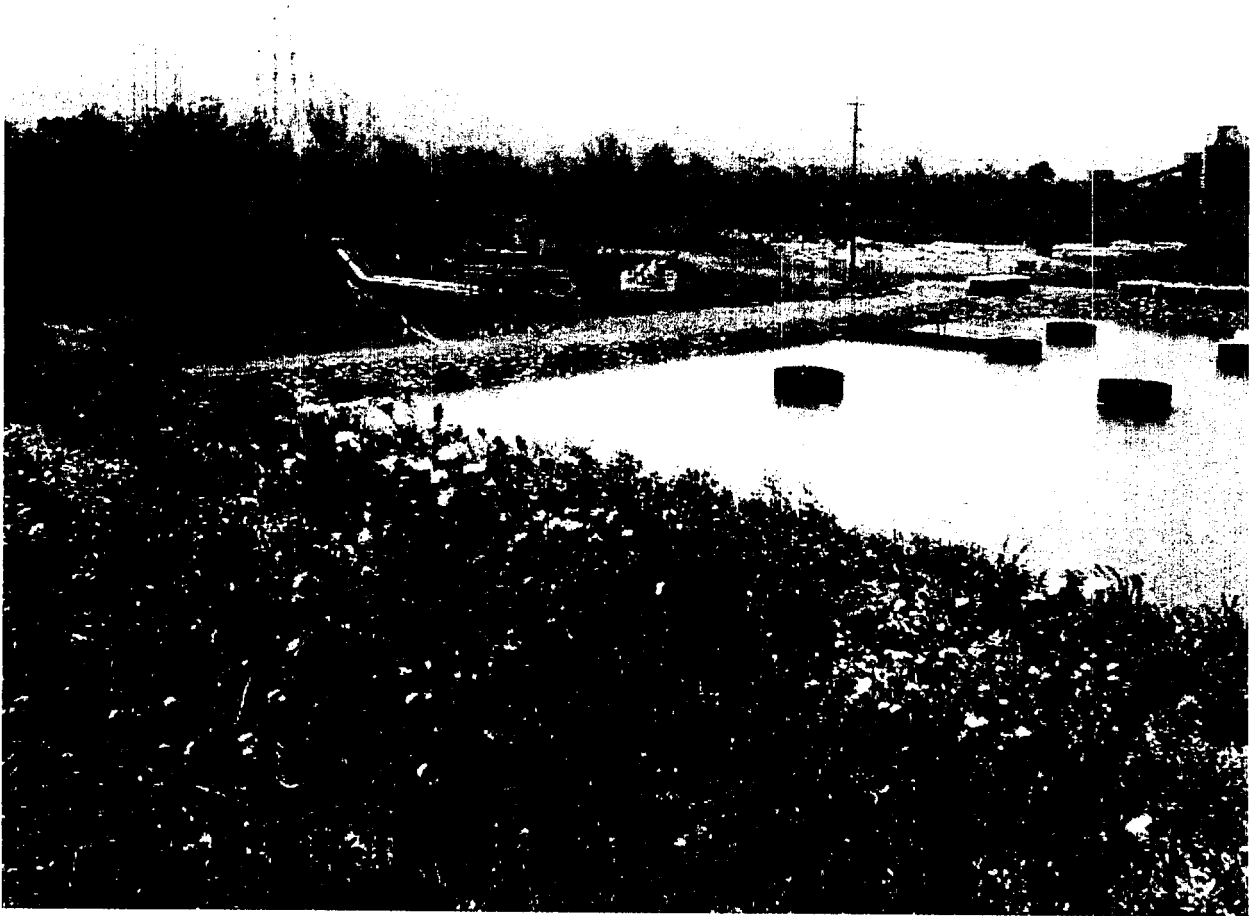
Photo 5. Active Ash Disposal Area – Stilling Pond discharge to Pumping Station Pond with new skimmers.

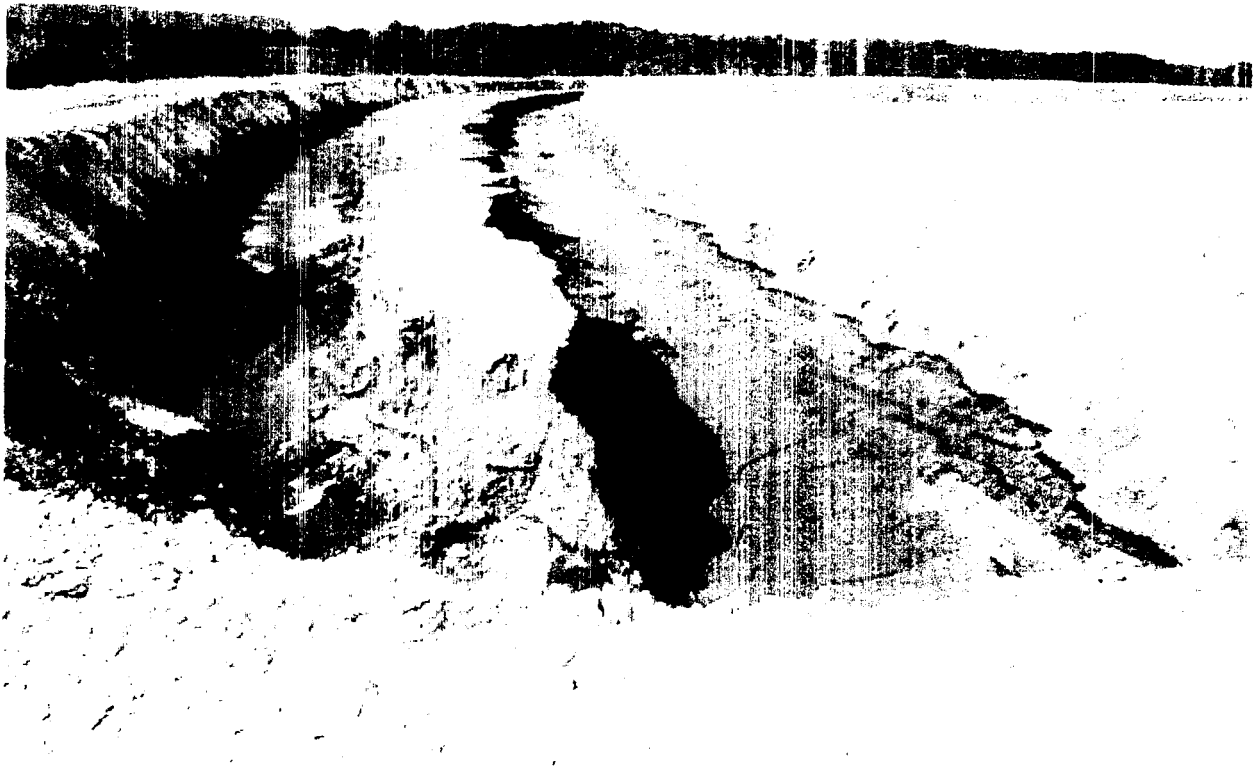
Photo 6. Active Gypsum Stacking Area – Gypsum sluice pipe discharge into Area 3 showing ditch being cleaned.

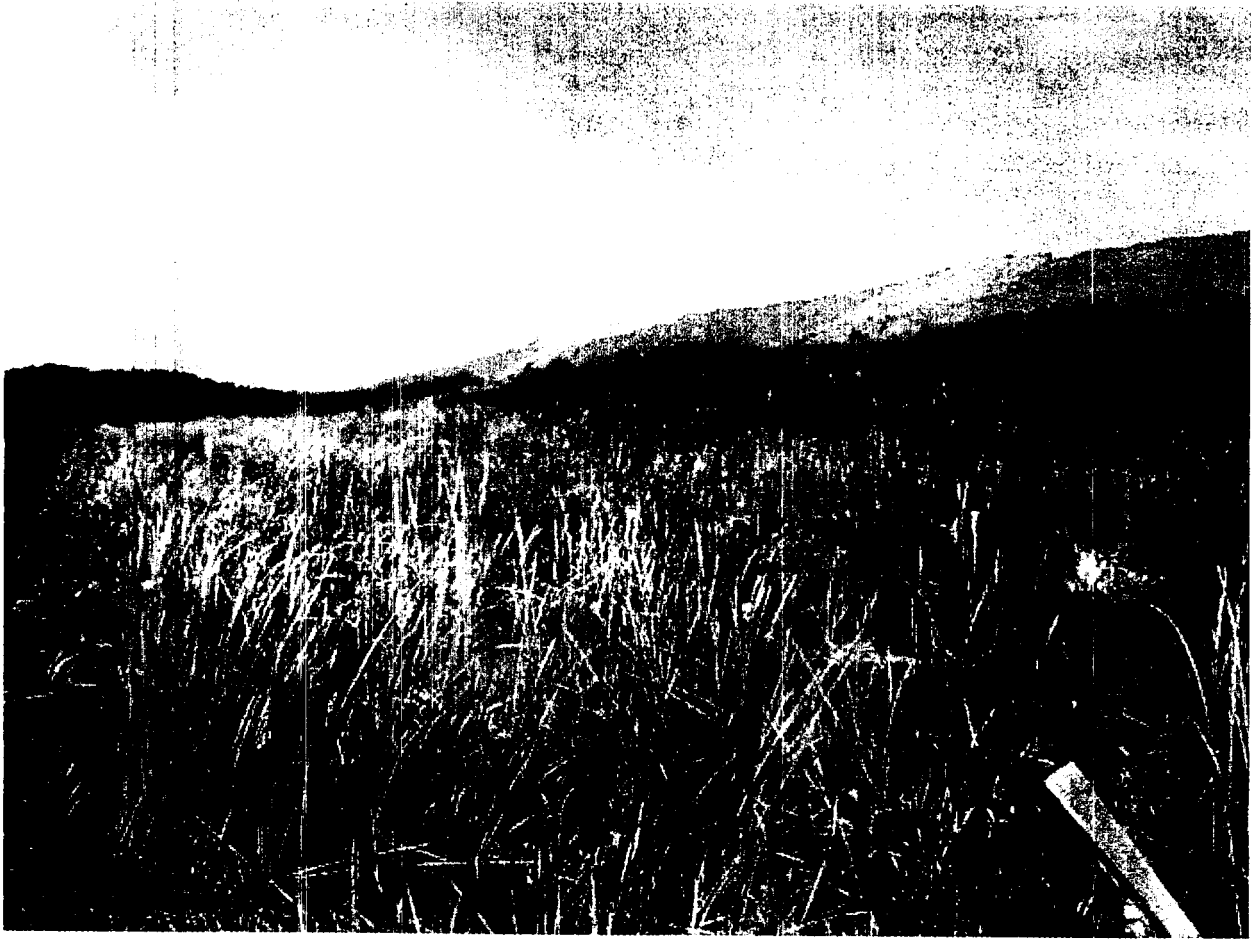
The perimeter dikes surrounding the gypsum stacking area appear to be in good condition with no signs of instability. However, the newly stacked slopes of gypsum at the top of the stacking area are too steep (photo 8). They should be flattened and final cover placed on them as soon as possible. The exterior slopes of these dikes generally have an excellent vegetative cover. The interior slopes of the Stilling Pool dikes are in good condition and have a good vegetative cover. Sediment build up has developed in the Stilling Pool Area to the point that it needs to be cleaned out. Also, an oil sheen was observed to be covering a large portion of the surface area and should be removed.

Photo 8. Active Gypsum Stacking Area (dike area of Pond 3)— new gypsum being stacked too steep.

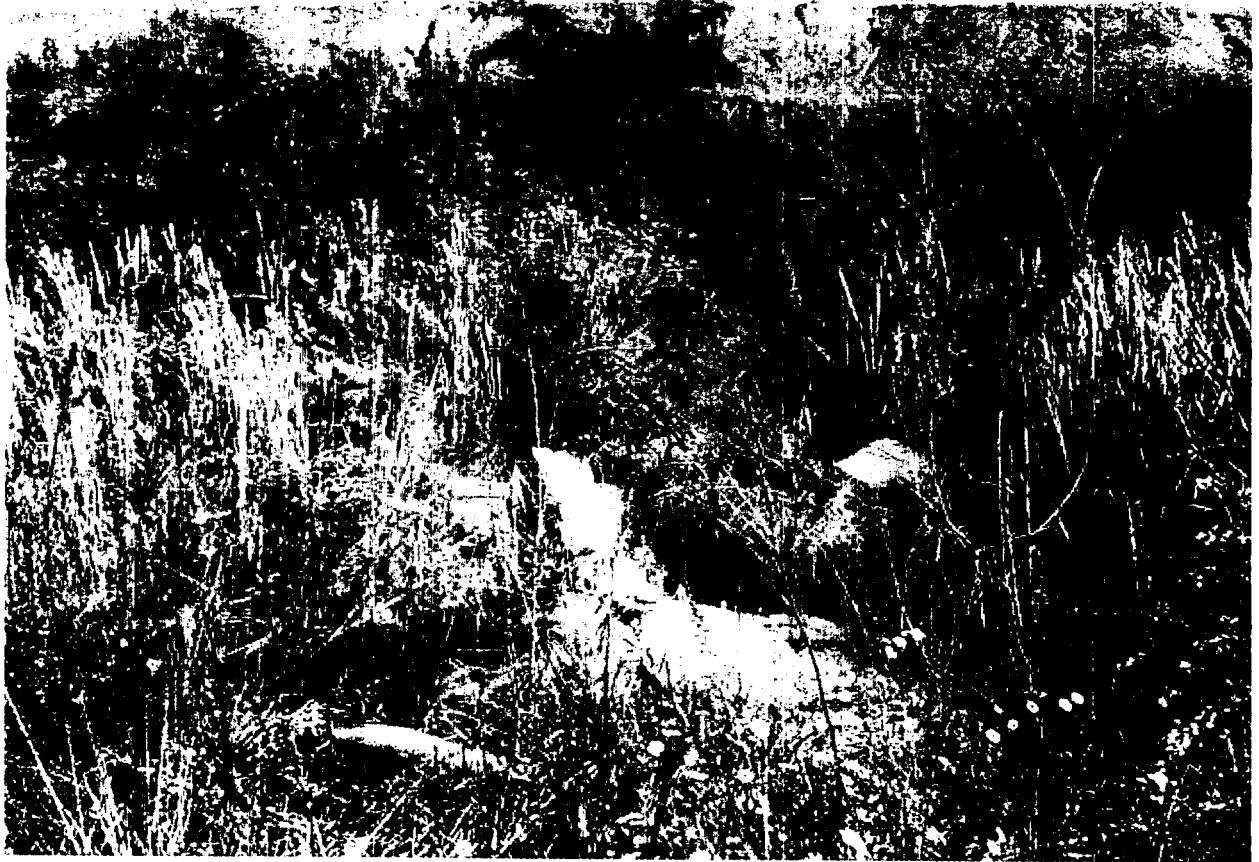
Photo 9. Active Gypsum Stacking Area – pipe discharging from pond 2b to perimeter ditch prior to discharge to stilling pond.

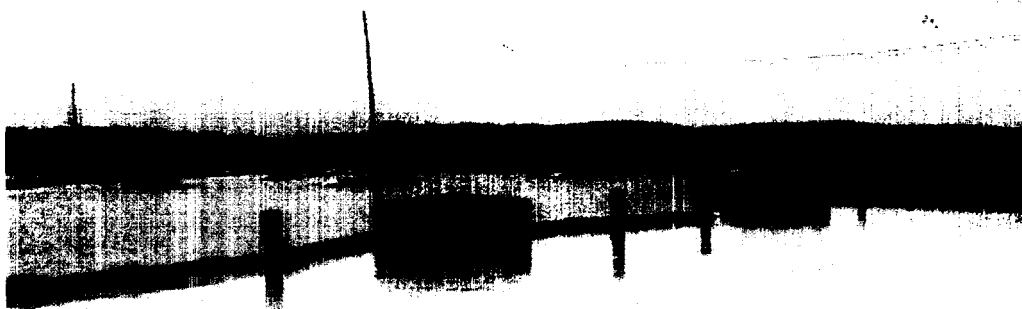
Photo 2—Looking north at active ash pond spillway skimmers. Note absence of access walkway

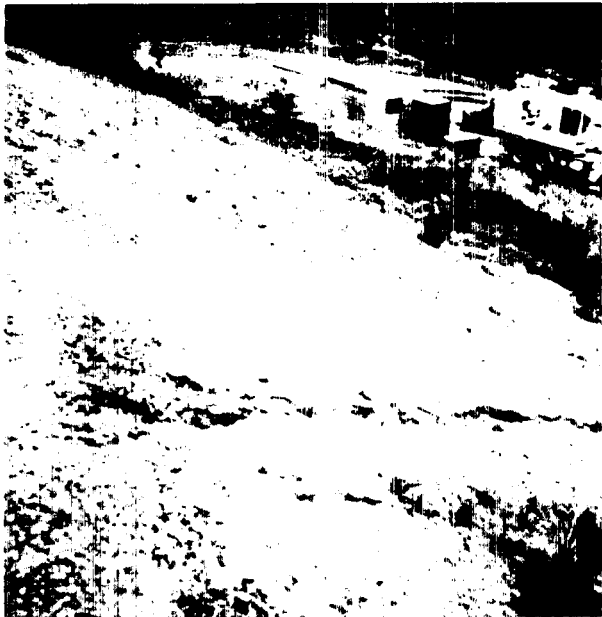
- 2 NOTE: SPARSE GRASS COVER
AND WASHED OUT ERRSION
GULLIES IN SLOPE.

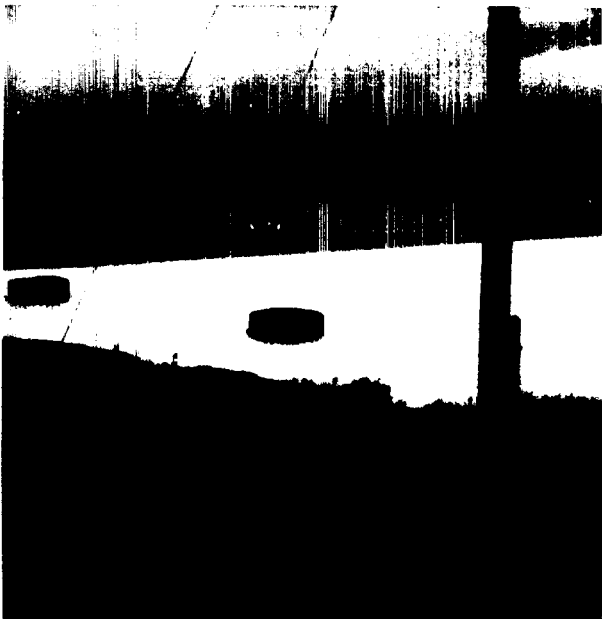
- 3 NOTE: FLOATING ASH
AROUND SKIMMER STURC-
TURES.

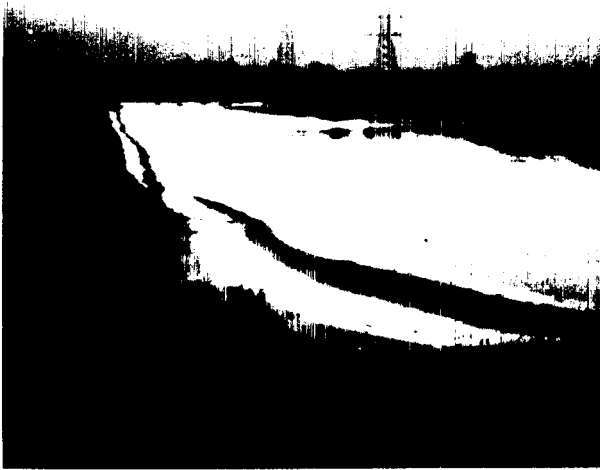
- 4 STILLING POOL WITH SMALL
PATCHES OF BRUSH AND
SMALL TREES.

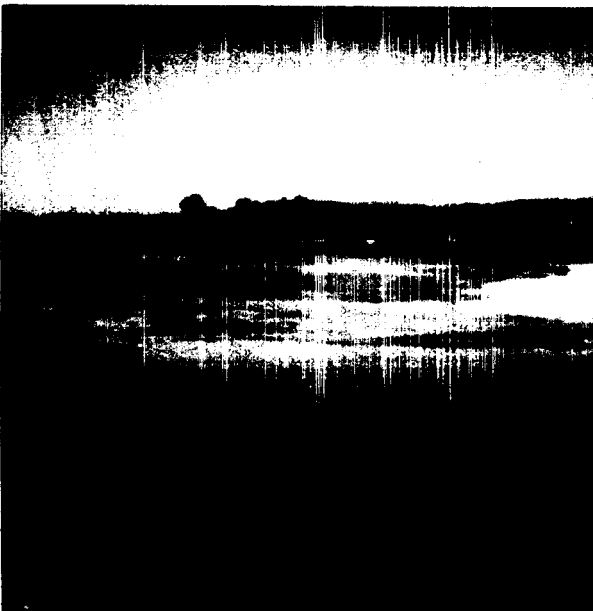
- 9) SOUTHWEST CORNER OF
POND 1 PHASE I GYPSUM
STACKING AREA.

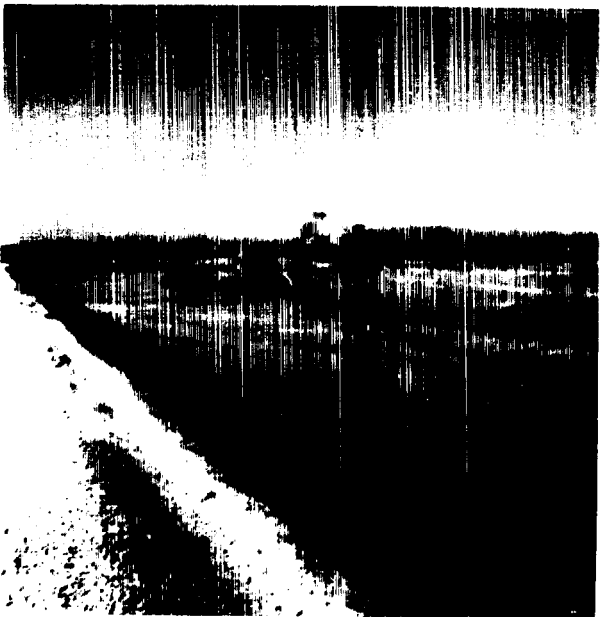
- 5.3 The perimeter dikes were found to be in stable condition, the roadways are surfaced and the dike slopes have a lush ground cover of grass. (Picture 7 and 8).

- 8 F.O.G. PHASE I STACK -
WET STACKING AREA -
PLANT IS EXTENDING
STARTER DIKE TO THE
EAST.

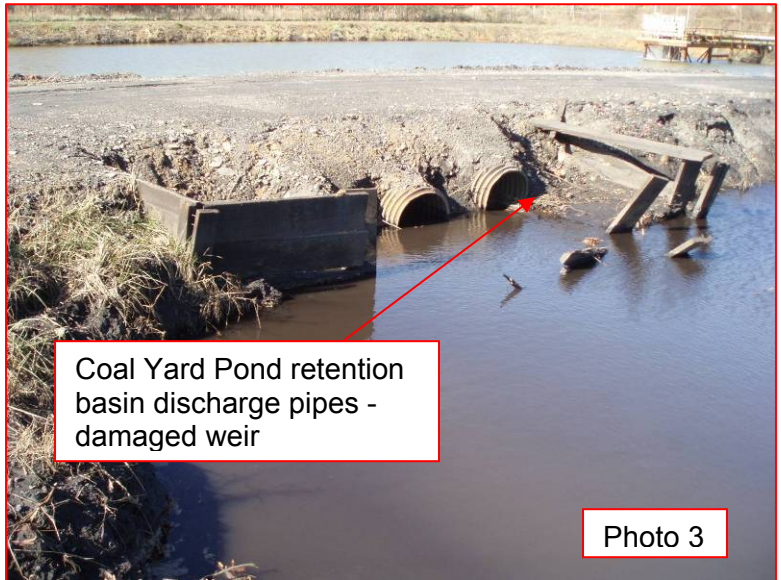
Photo 3

Coal Yard Pond retention basin discharge pipes - damaged weir

- **Recommendations**
 - Monitor the East interior slope. If erosions starts, place suitable earth material on slope prior to seeding and mulching.
 - ◆ Notify EDS of any changes.
 - Repair pump float switch so that pump can run in automatic mode. If this has been corrected disregard.
 - Repair pump platform handrail. Paint platform within next two to three years.
 - Clean sediment in retention basin and repair weir.

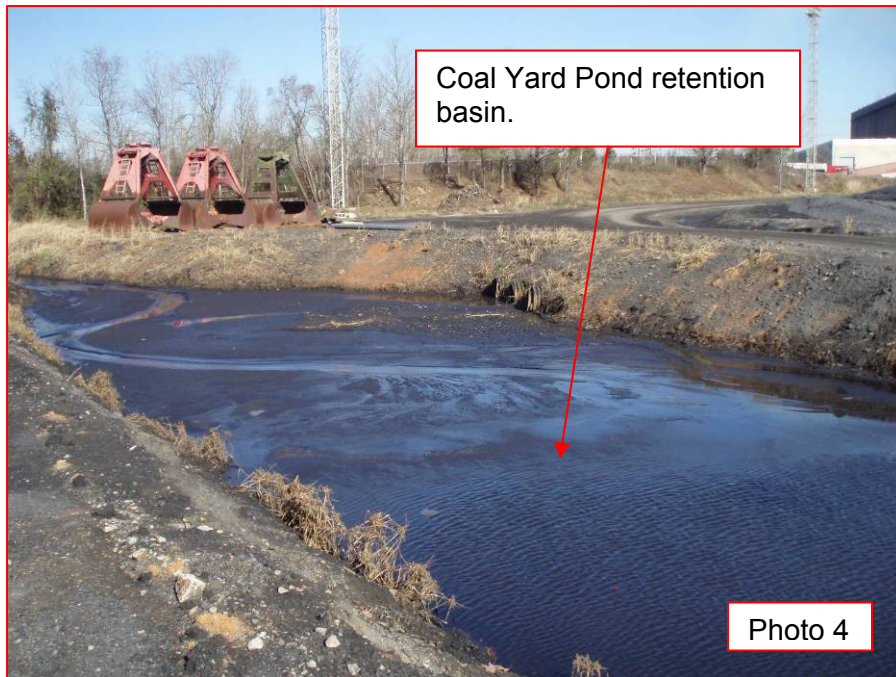
Photo 4

Coal Yard Pond retention basin.

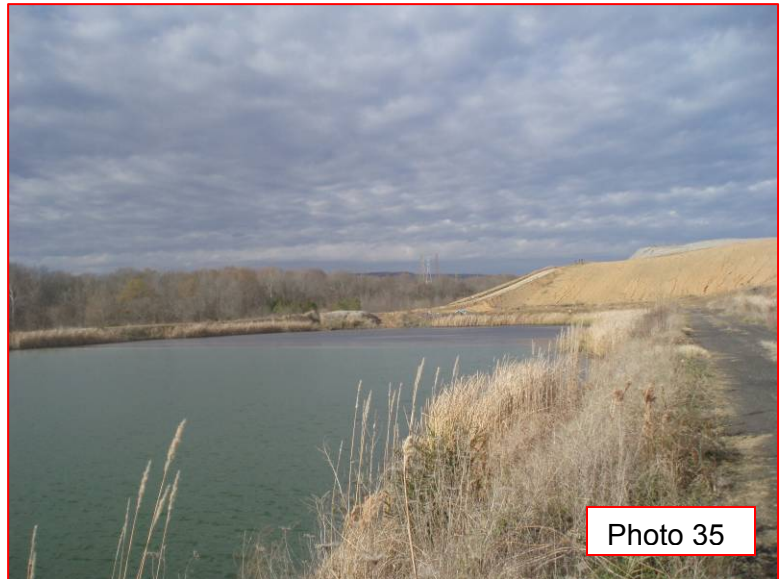
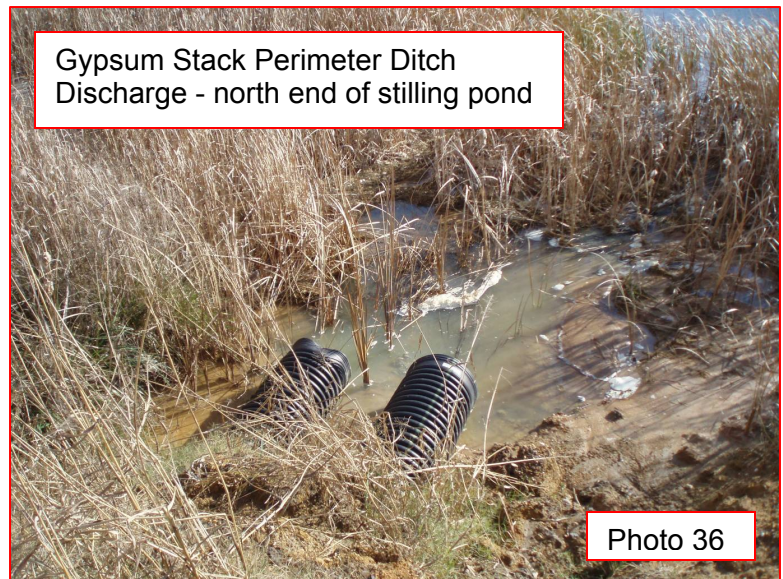
- Pond Surface - good no floating debris (Photo 35)
- Discharge pipes into Pond from Gypsum Wet Stack are in good condition (Photos 29, 36 and 37)
 - ◆ Southern Discharge is the existing concrete pipe for old gypsum discharge weir. Hole has been knocked through top of pipe wall so water from perimeter ditch can enter.
- Wooden Discharge Structure - could not be adequately inspected.
 - ◆ Access walkway unstable.
- Interior Slopes - established vegetation.
- Exterior Slopes - established vegetation.

- Floating ash removed.
- HDPE pipes at North end of pond installed per DCN WCF-04-1016 when construction sequence allowed.
- Vegetation on slopes cut back.
- New discharge pipe installed for weir installed on west side of gypsum sluicing operations (Photo 37).

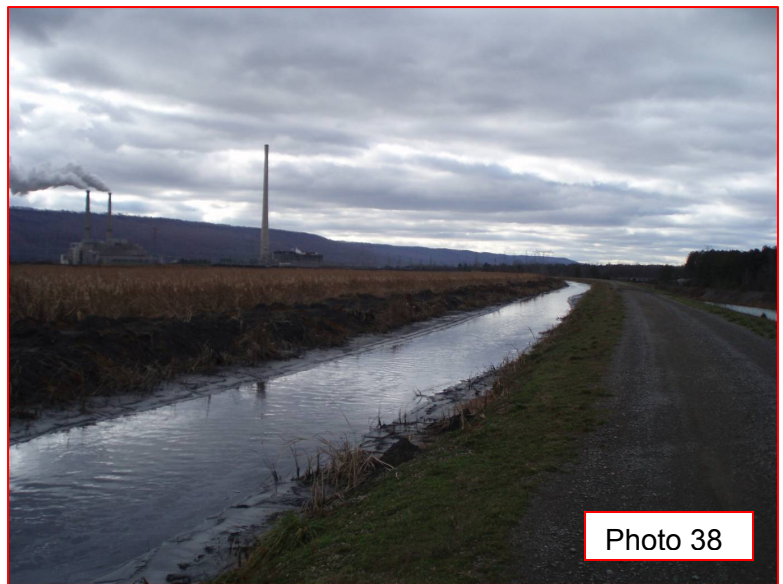
- **Location** - Northeast of Powerhouse
- **Effluent** - Discharges to Active Ash Pond Stilling Pond
- **Observations (photos taken on 2/1/08)**
 - Interior Slopes - Satisfactory (Photo 38).
 - Pond Surface - small amount of floating ash observed
 - Discharge Structures - Good condition (Photos 39 & 40)
 - ◆ Only one of five structures could be inspected.

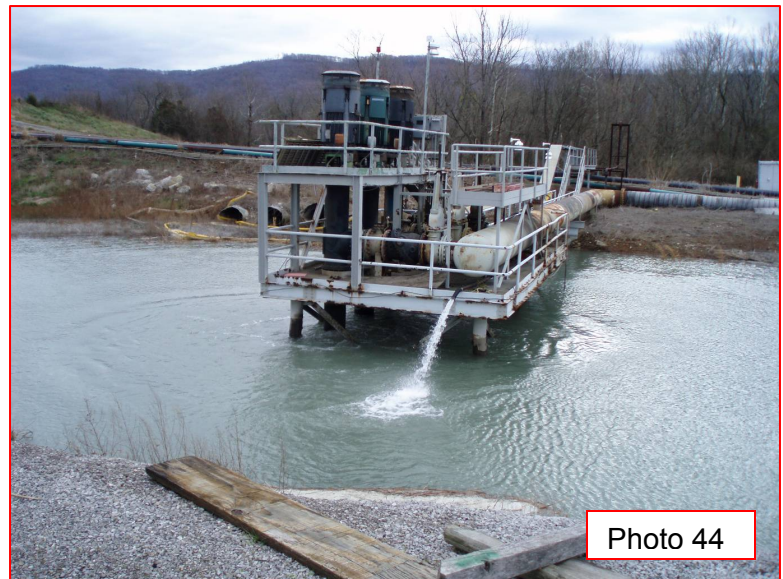
- **Observations (Photos taken on 2/1/08)**
 - Stilling Pond surface had very little ash accumulation (Photo 43).
 - Interior Slopes - Good condition with vegetation.

- ◆ Pumping Station Pump just has Riprap.
 - ◆ Seepage observed last inspection at the Pumping Station Pond interior slope was not observed. This primarily due to the higher water level in the pumping station pond (Photo 44).

- Stilling pond discharge Structures - Good condition (Photos 45 and 46)
 - ◆ Only one structure was accessible.
 - Pump Station Pond
 - ◆ Water level higher than last inspection.

- **Recommendations**
 - Continue good maintenance and BMP's for Active Ash Stilling Pond operations.
 - Monitor seep in dike between Stilling Pond and Pumping Station Pond. This can only be done when the water level in the Pumping Station Pond is lower.

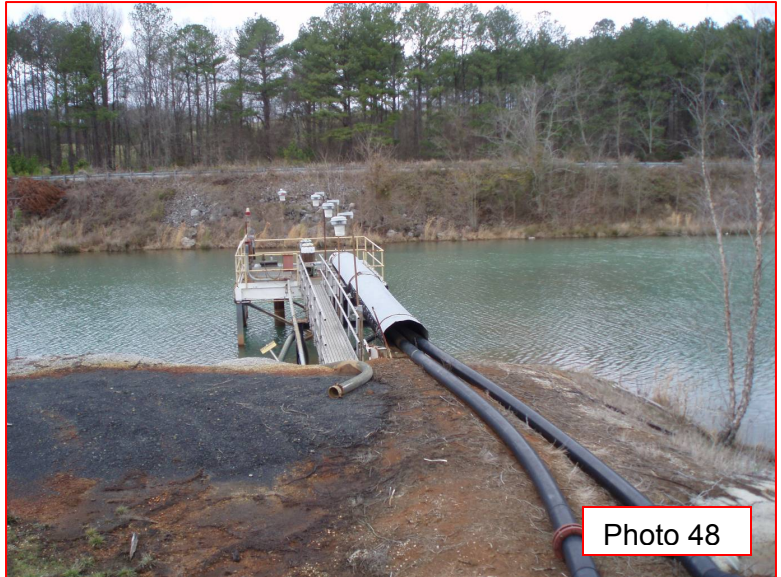
- ◆ Erosion noted last inspection on the northeast dike near southeast corner has been repair but vegetation is sparse. (Photo 50).
- ◆ Animal burrow holes were observed at the northeast corner and North Slope as noted on sketch API2008-1.
- ◆ Damaged manhole for the gypsum stilling pond drain line observed base of the northeast dike (Photo 51).

- Repair erosion observed on Northeast Dike between the bridge over Widows Creek and the southeast corner. Place suitable earth material atop of the existing earth material that is not supporting vegetative cover. This material shall then be seeded and mulched so that vegetative cover can be established. Some type of grass matting is recommended for this area. Estimated area to be covered, graded, and seeded - 300 yd².

- Repair damaged manhole for the gypsum stilling pond gravity drain. This is located at the base of the northeast perimeter dike and shown on drawing API08-1.

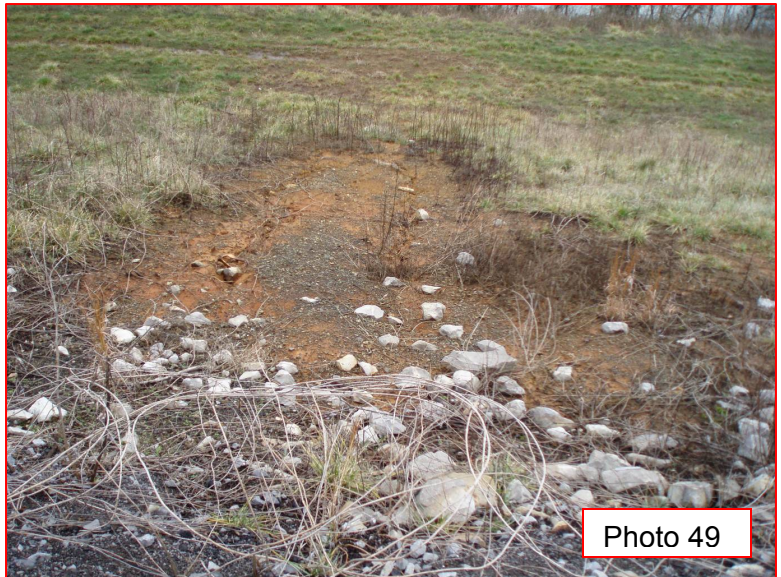
- ◆ Several wet areas and some rutting was observed on the Northeast perimeter dike slope just south of the bridge accessing the Gypsum disposal area. There is a bench formed in the slope here which the Gypsum Stilling Pond discharge line is buried. The bench flows the slope of the drain line to its discharge point at outfall 008 (Photo 52 & 53). The ruts are most likely due to equipment traffic used for mowing
- ◆ Ruts forming on bench access road on the northwest dike. This serves as the access road to the red water pumping station. Standing water was observed (Photos 54).
- ◆ Mature trees observed on the northwest lower dike to the north and south of the red water pond.
- ◆ Erosion observed at the southwest corner next to the units 1-6 ash pipes. It appears that this was where previous ash pipes were located (Photo 55).

- Repair Erosion observed at the southwest corner next to the units 1-6 ash pipes (Photo 55). Re-grade, seed, and mulch approximately 3,000 square feet (333 square yards).

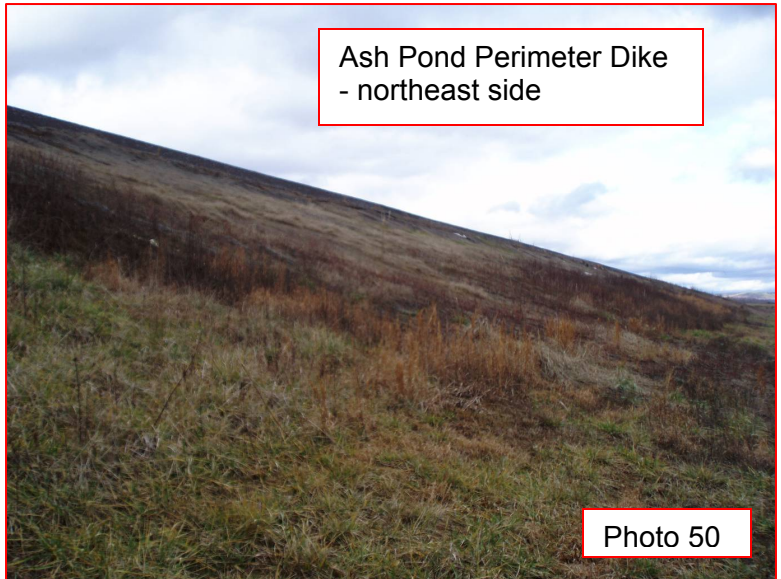
- Perimeter Dikes continued
 - ◆ Erosion noted starting at access road from the Stilling Pond and extending approximately 1400 feet west. Starts at the top of the dike and extends down the slope. The paved plant perimeter access road runs parallel to this area (Photos 56 and 57).
 - ◆ Some erosion was noted at the top of the perimeter dike next to the Stilling Pond (Photo 58).
 - ◆ Woody growth observed on perimeter dike slopes bordering the stilling pond (Photo 58).
- The red water seepage along the southern dike parallel to the paved plant perimeter access road is still present. In comparison with the last inspection report it hasn't worsened.

- Place suitable earth material atop of the existing earth material that is not supporting vegetative cover on the South perimeter dike. This material shall then be seeded and mulched so that vegetative cover can be established (Photo 56 and 57). Some type of grass matting is recommended for this area. Estimated area to be covered, graded, and seeded - 6500 yd². If dirt access road is used in this area surface and gravel. Estimated area is 800 yd².
