**WIDOWS CREEK FOSSIL PLANT
ANNUAL ASH POND DIKE STABILITY INSPECTION
FY 2009**

The waste disposal areas at Widows Creek Fossil Plant (WCF) were inspected for dike structural stability on October 15 and 16, 2008 by Kelly Evans of TVA Fossil Engineering Design Services (EDS) and Jamie Dotson of TVA Fuel By-products. The previous annual inspection was performed on December 5 and 6, 2007. The results of the inspection of the Coal Yard Drainage Basin, Coal Yard Perimeter Ditch, Limestone Pile Drainage Basin, Wet Gypsum Stacking Area, Stilling Pond for the Wet Gypsum Stacking Area, Active Ash Pond, Stilling Pond for Active Ash Pond, Dredge Cell, Perimeter Dikes, Red Water Pond, Chemical Treatment Pond, and the Abandoned Ash Disposal Area are listed below. A summary of recommendations is also provided. Estimated costs are based on the 2009 RSMEANS Building Construction Cost Data (quotes are advised for more accurate estimate).

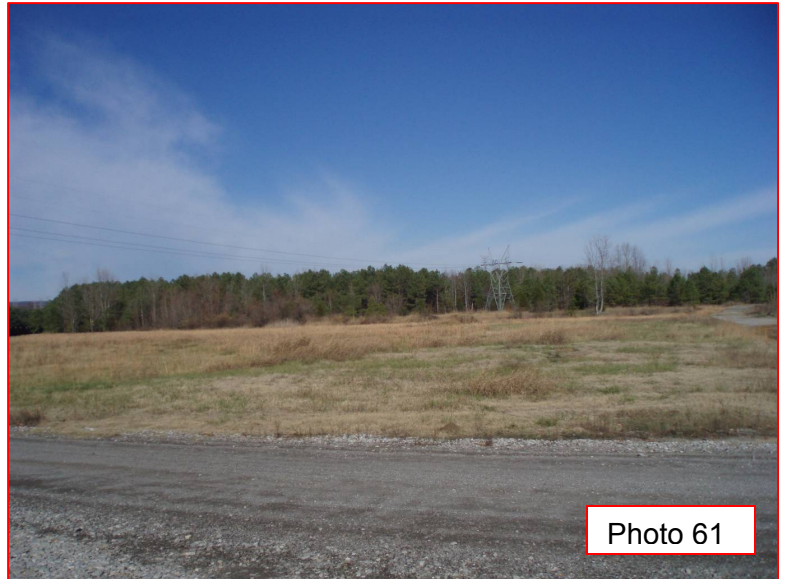
- **Location** - Inside the Railroad Loop Northwest of Powerhouse
- **Effluent** - Majority of runoff goes to the Red Water Pond
- **Observations**
 - Heavily wooded in areas with thriving vegetation throughout area (Photo 89).
 - Old discharge structures still present (Photos 90)
- **Actions Since Previous Inspection**
 - None that inspector is aware of.
- **Recommendations**
 - None
