NCHRP Report 350 Test Report Compilation

Full-Scale Crash Evaluations of the ET Plus[®] End Terminal with 4-inch Wide Guide Channel Installed with a Rail Height of 31 Inches

Test Level 3, Test 3-33, 3-31, 3-32, and 3-30

SwRI[®] Project No. 18.20887

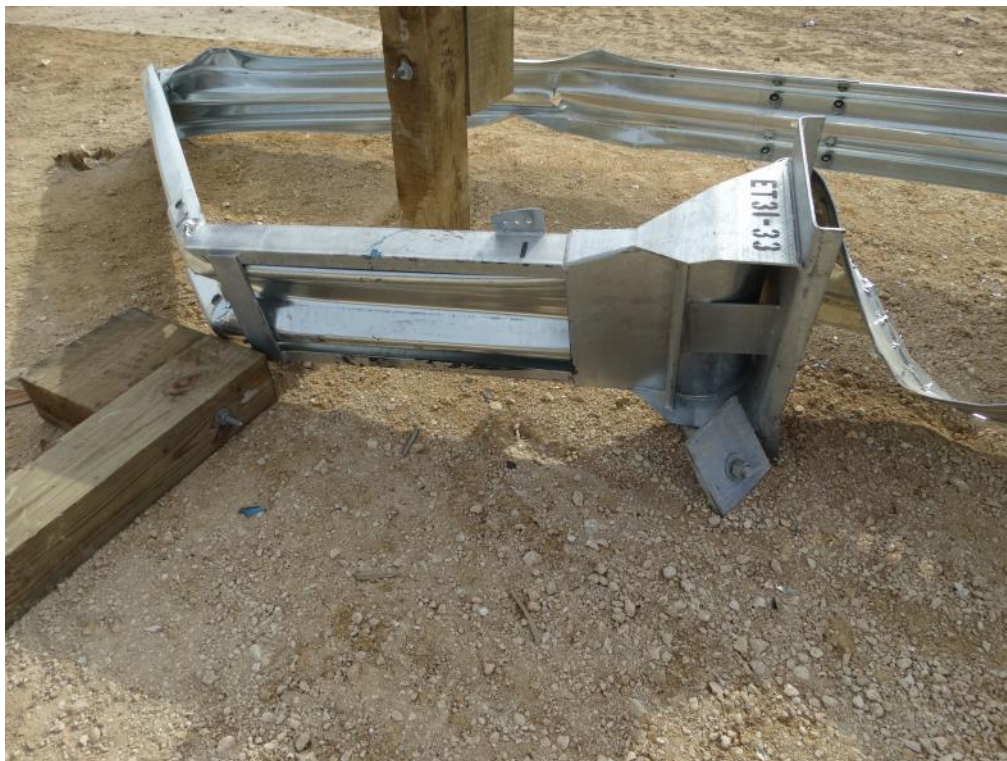
Figure 3.8: Post Test – Traffic Side of Extruder Head

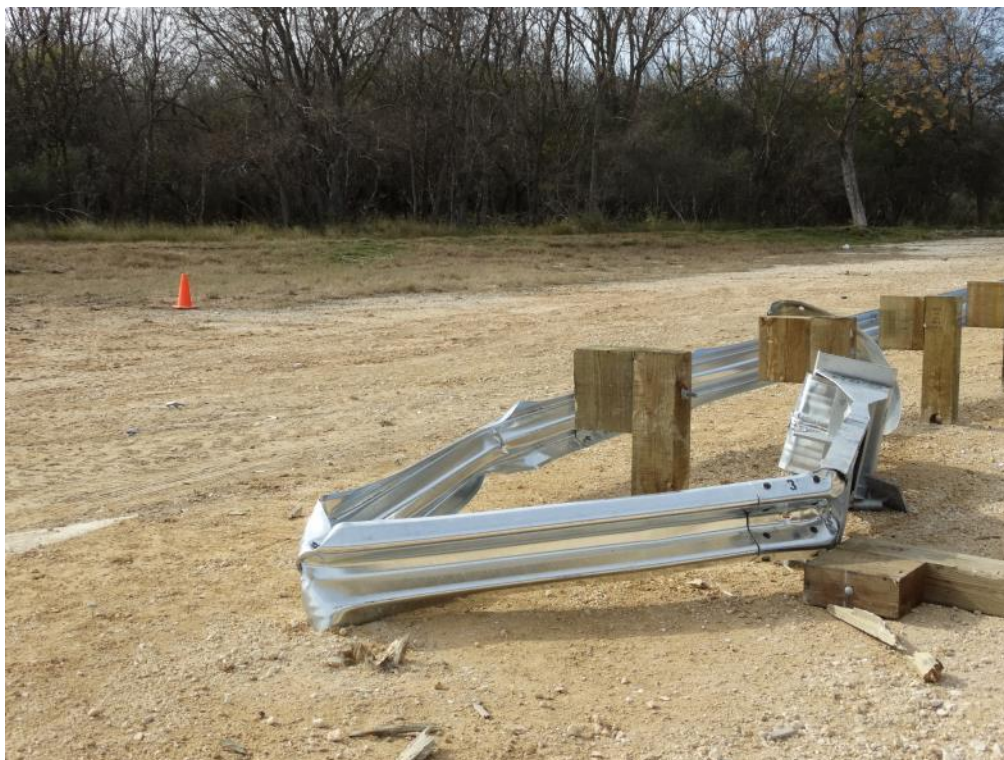
Figure 3.10: Post Test – Side View of Gated Terminal

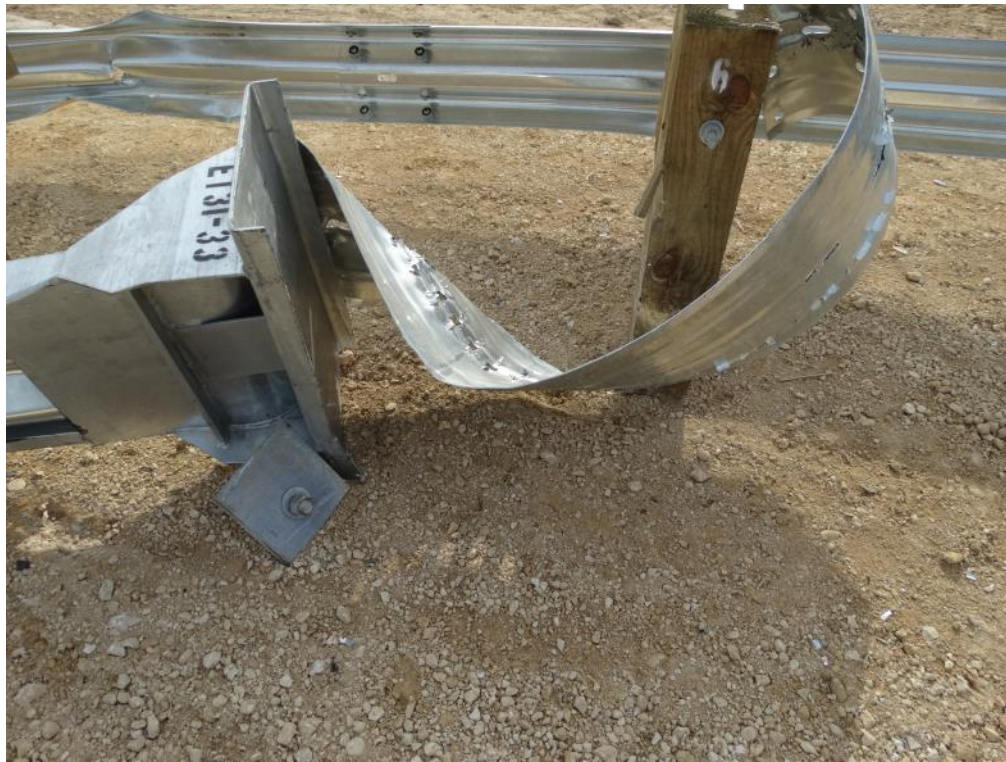
Figure 3.11: Post Test – Extruded Guardrail

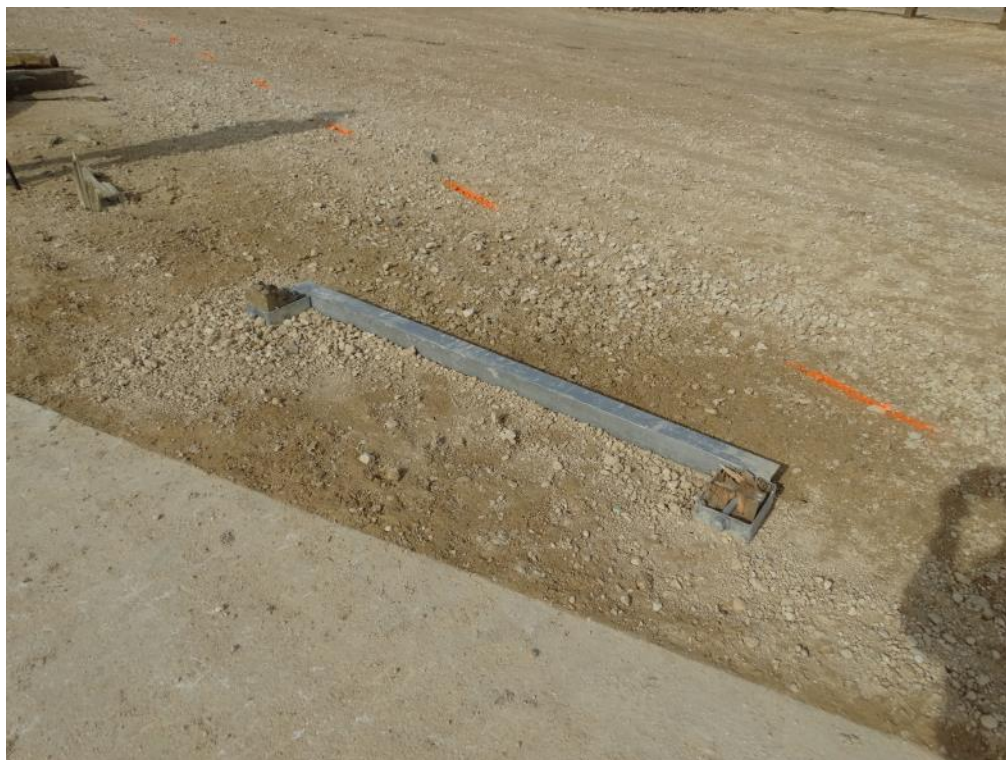
Figure 3.12: Post Test – Posts 1, 2 and 3

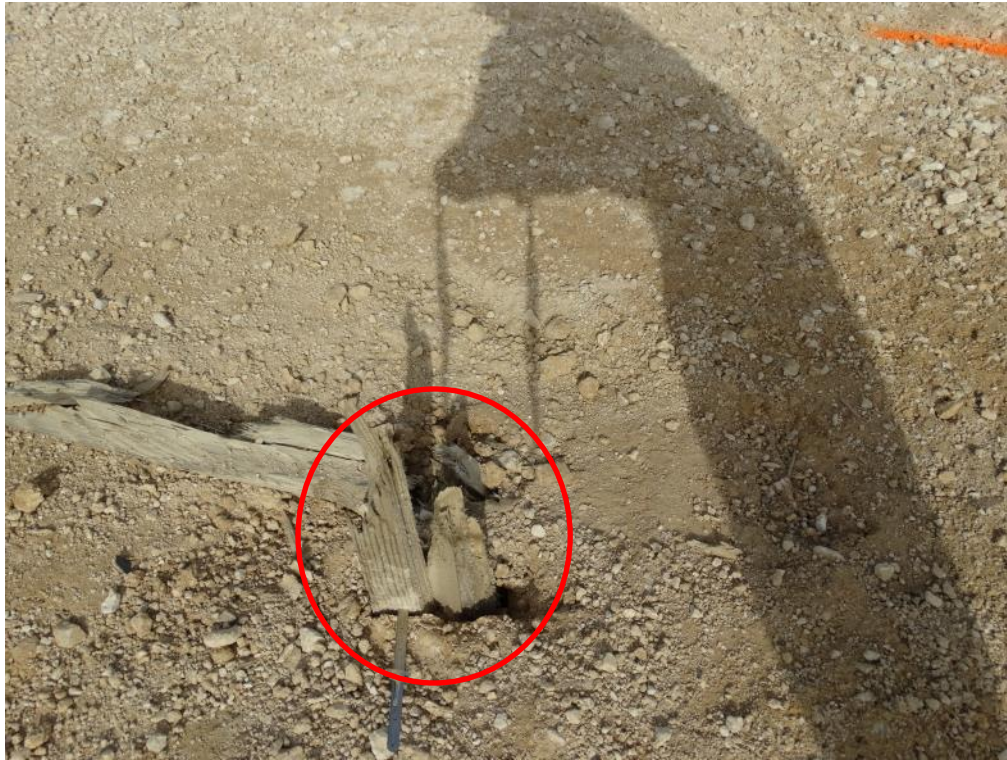
Figure 3.15: Post Test – Post 3

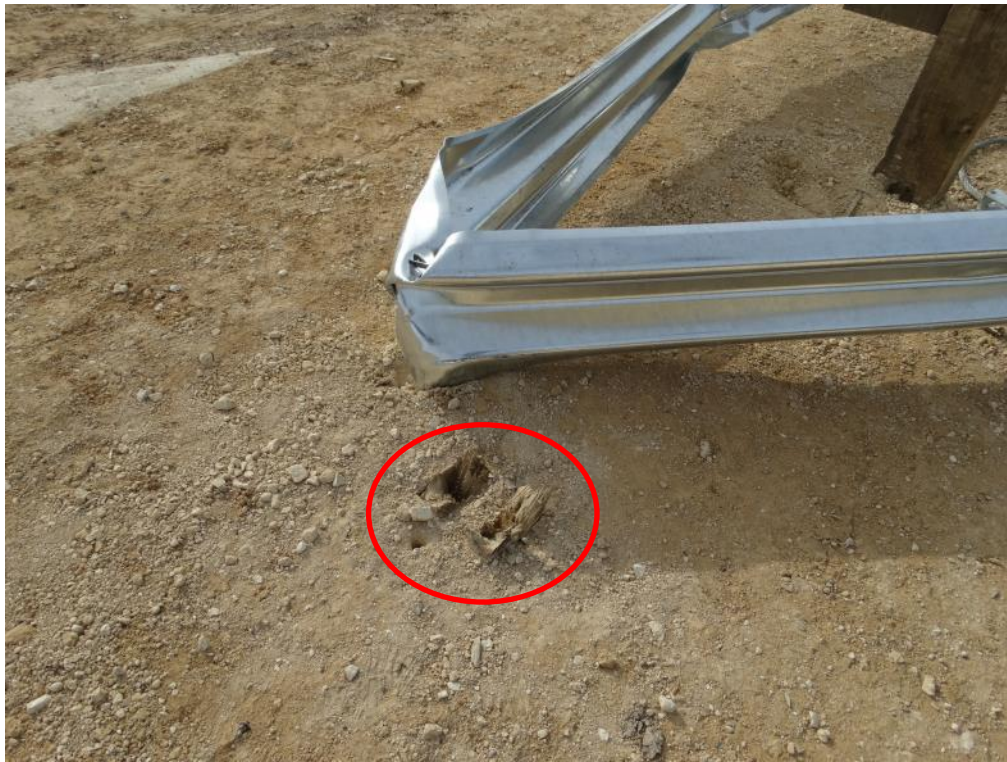
Figure 3.17: Post Test – W Beam Fold and Post 4

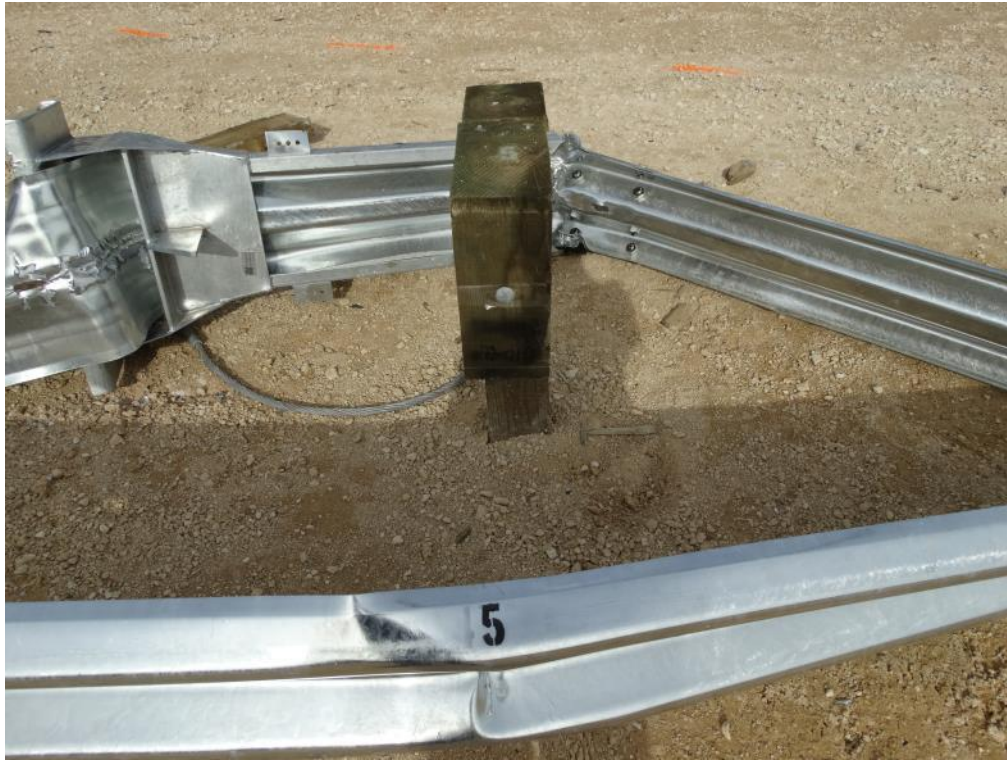
Figure 3.19: Post Test – Traffic Side View of Post 5

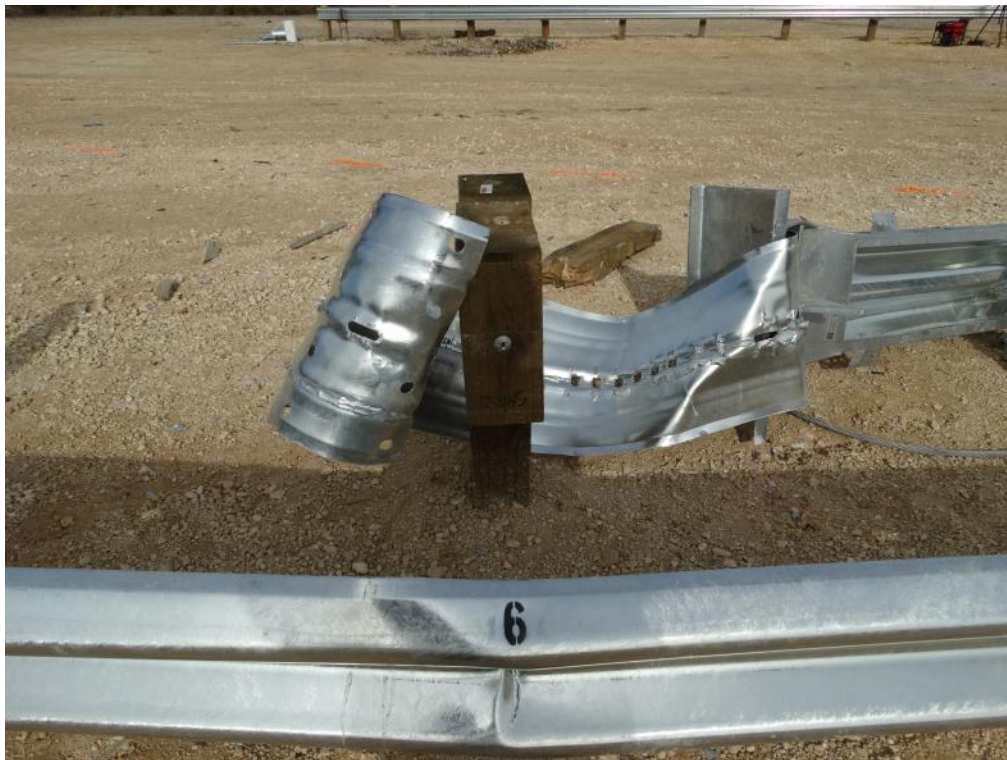
Figure 3.22: Post Test – Traffic Side View of Post 6

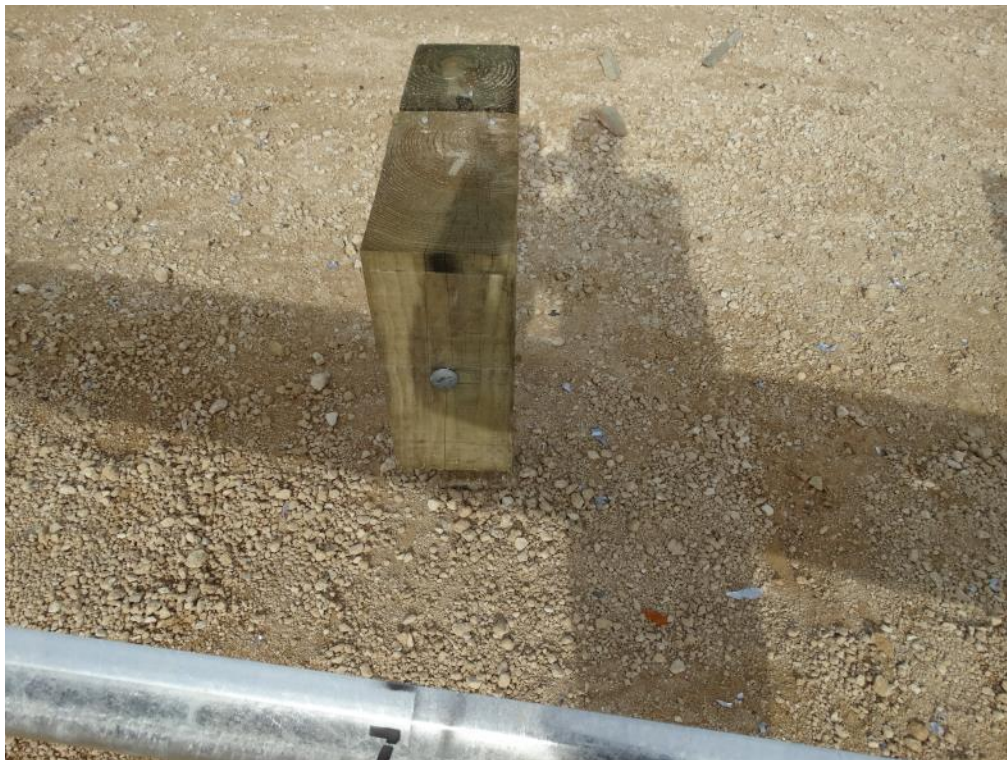
Figure 3.24: Post Test – Traffic Side View of Post 7

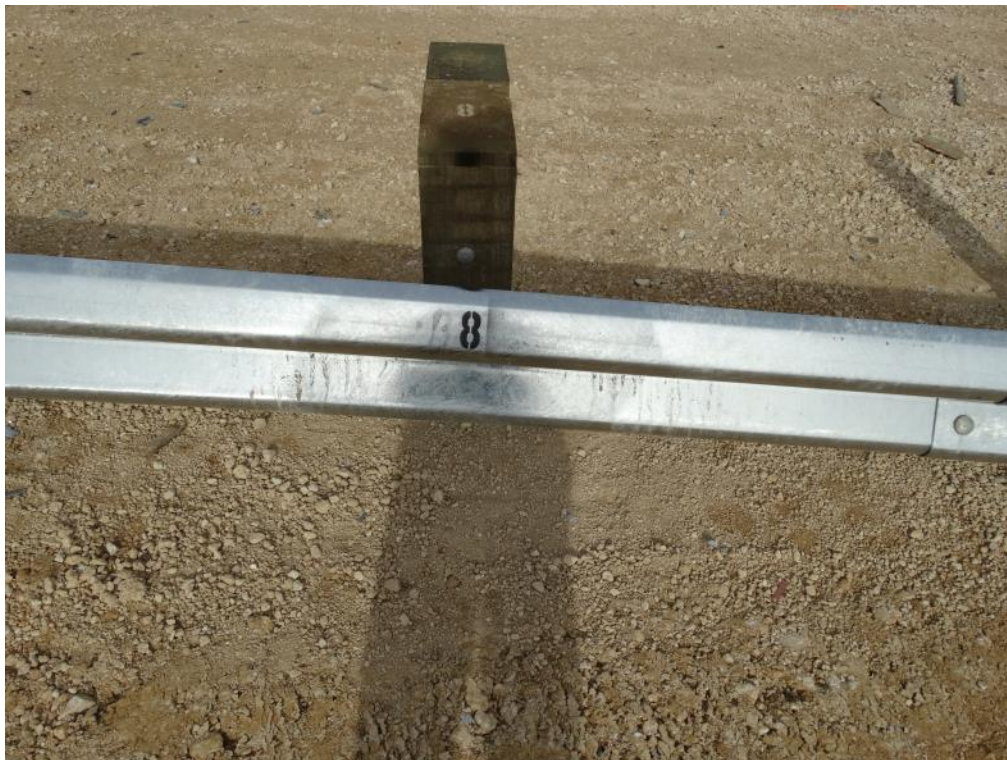
Figure 3.26: Post Test – Traffic Side View of Post 8

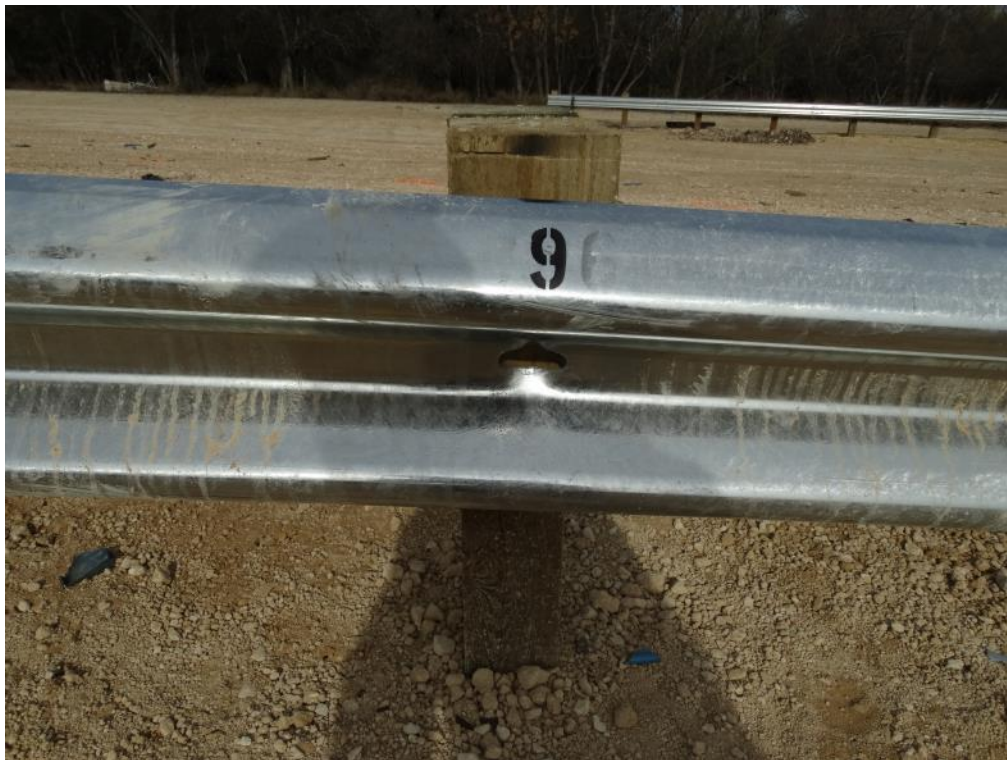
Figure 3.28: Post Test – Traffic Side View of Post 9

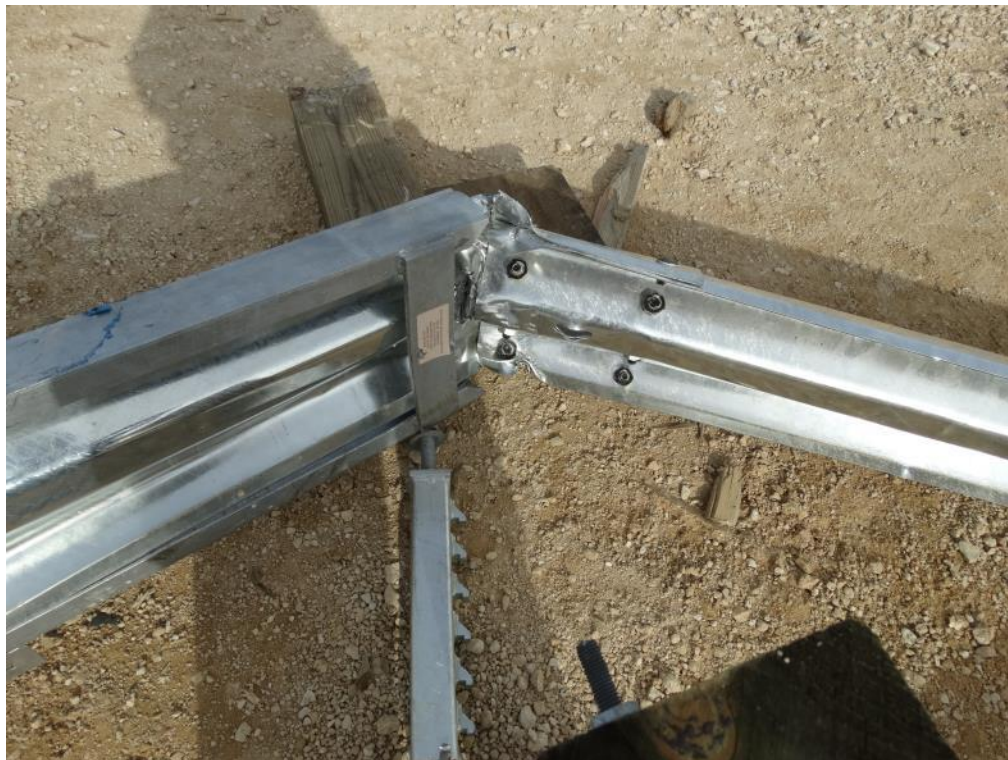
Figure 3.34: Post Test – ET Plus Head Guide Channel Entrance, Non-Traffic Side

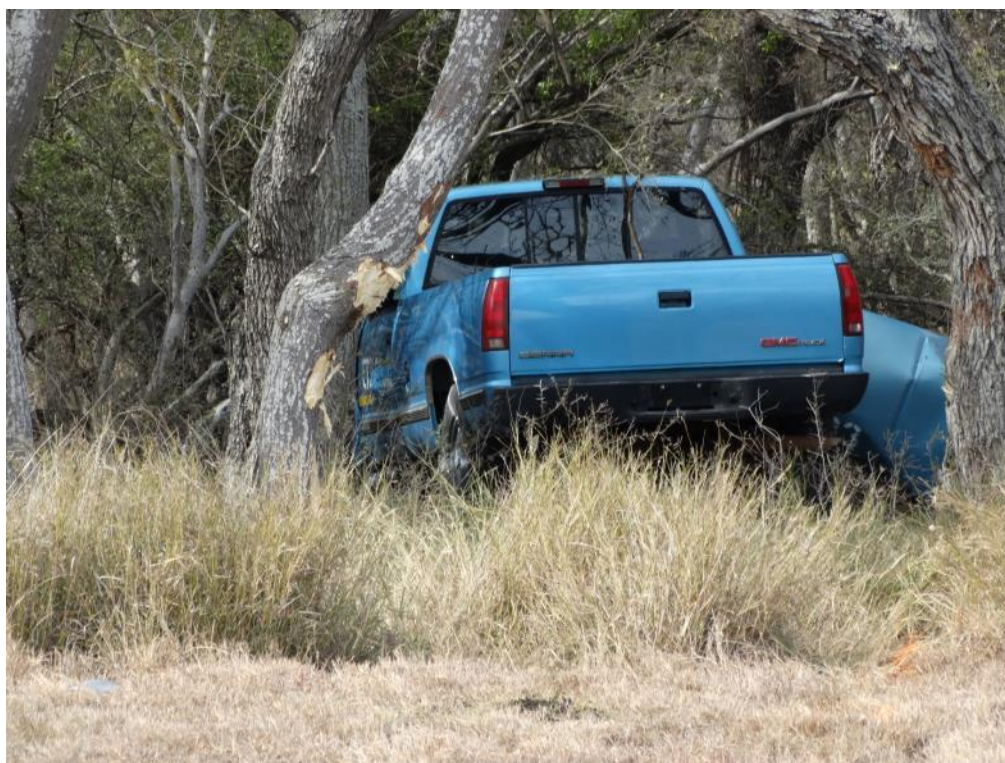
Figure 3.46: Test Vehicle Impacted Tree

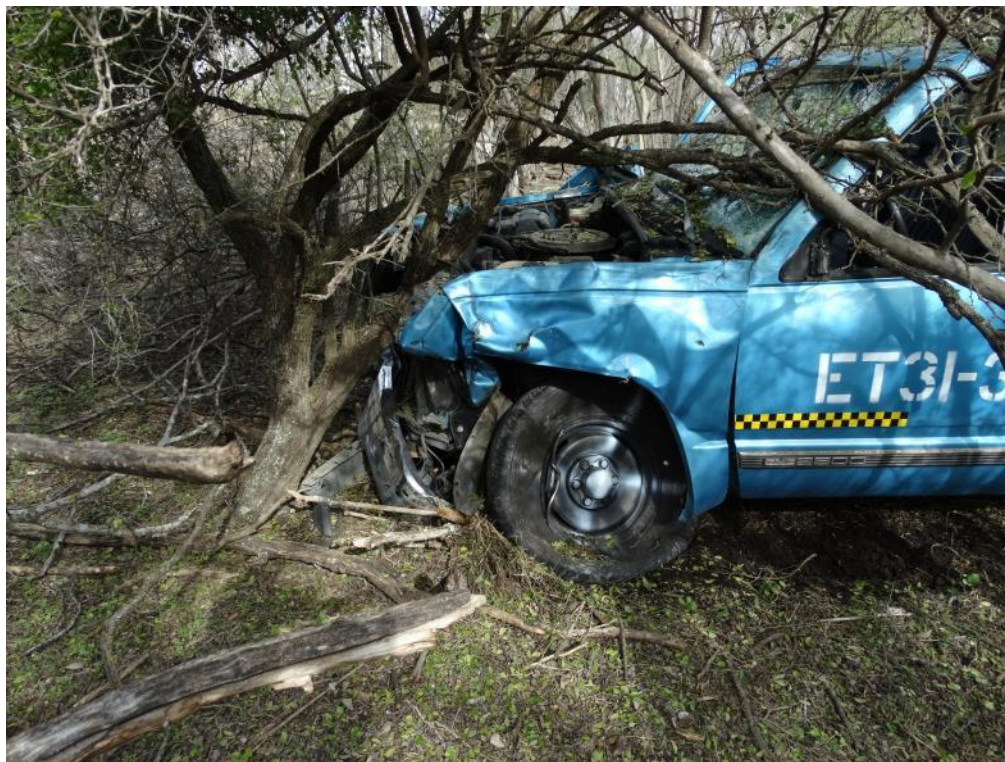
Figure 3.47: Test Vehicle Impacted Tree

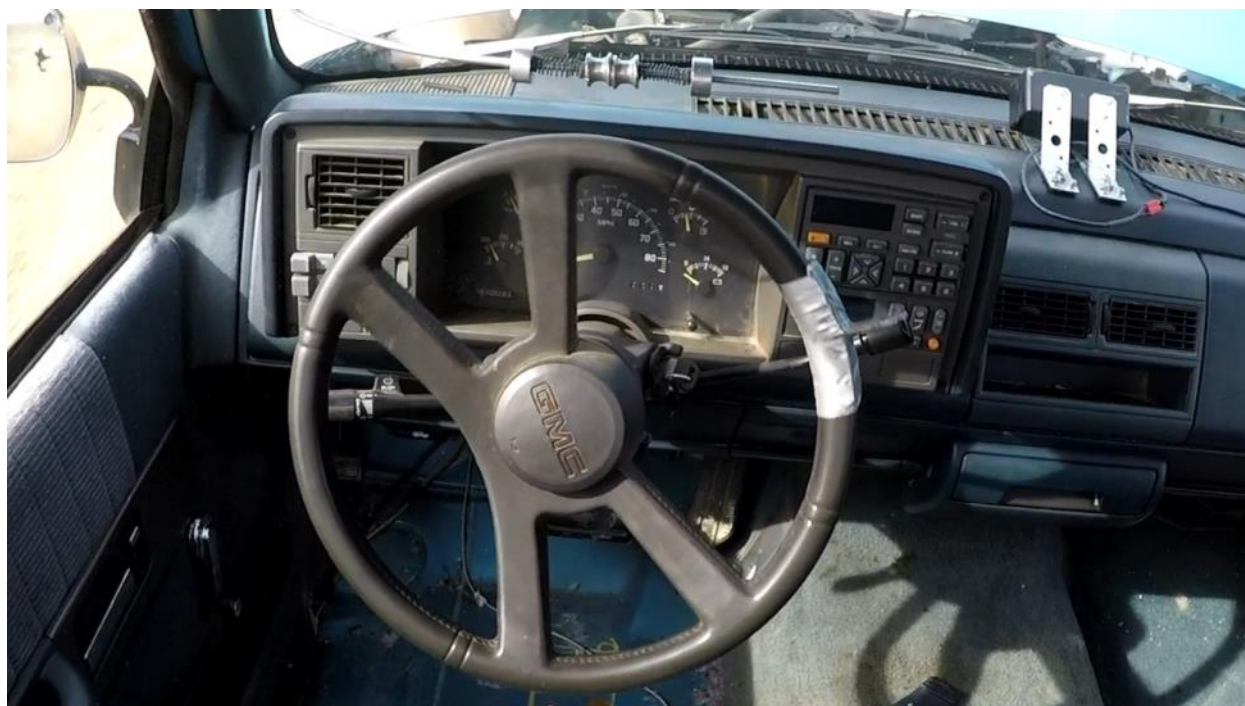
Figure 3.56: Occupant Compartment Following ET Plus Impact (Onboard Camera, Left)

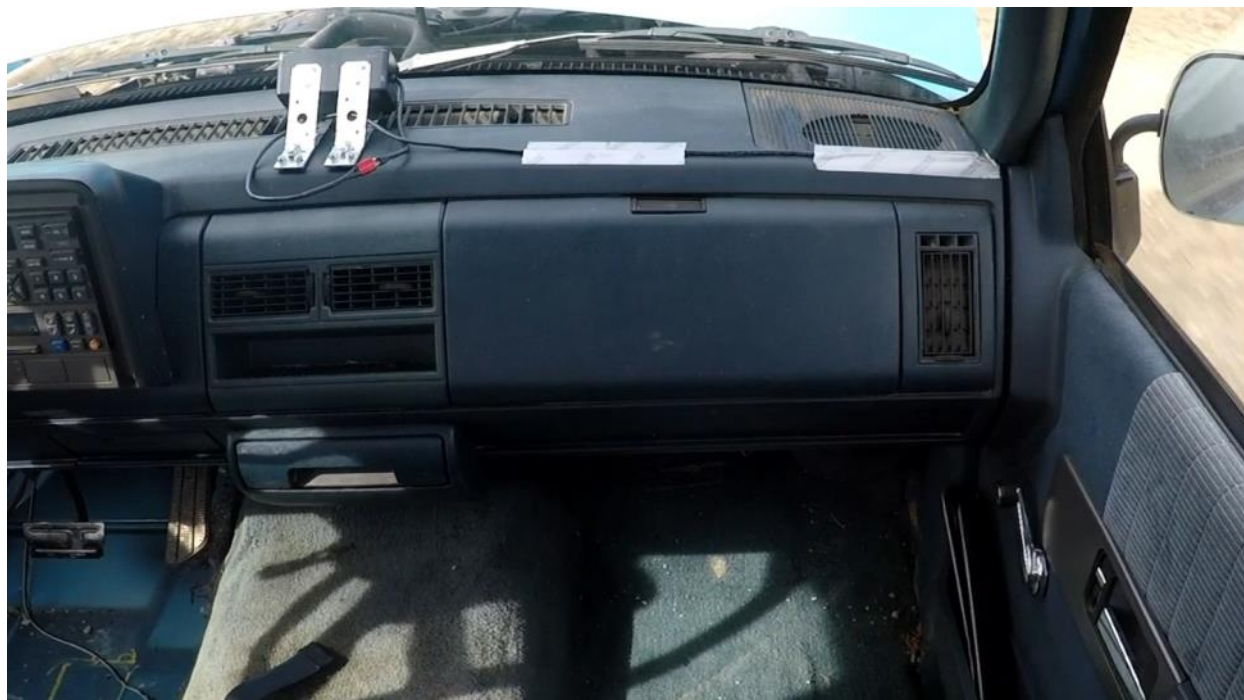
Figure 3.57: Occupant Compartment Following ET Plus Impact (Onboard Camera, Right)

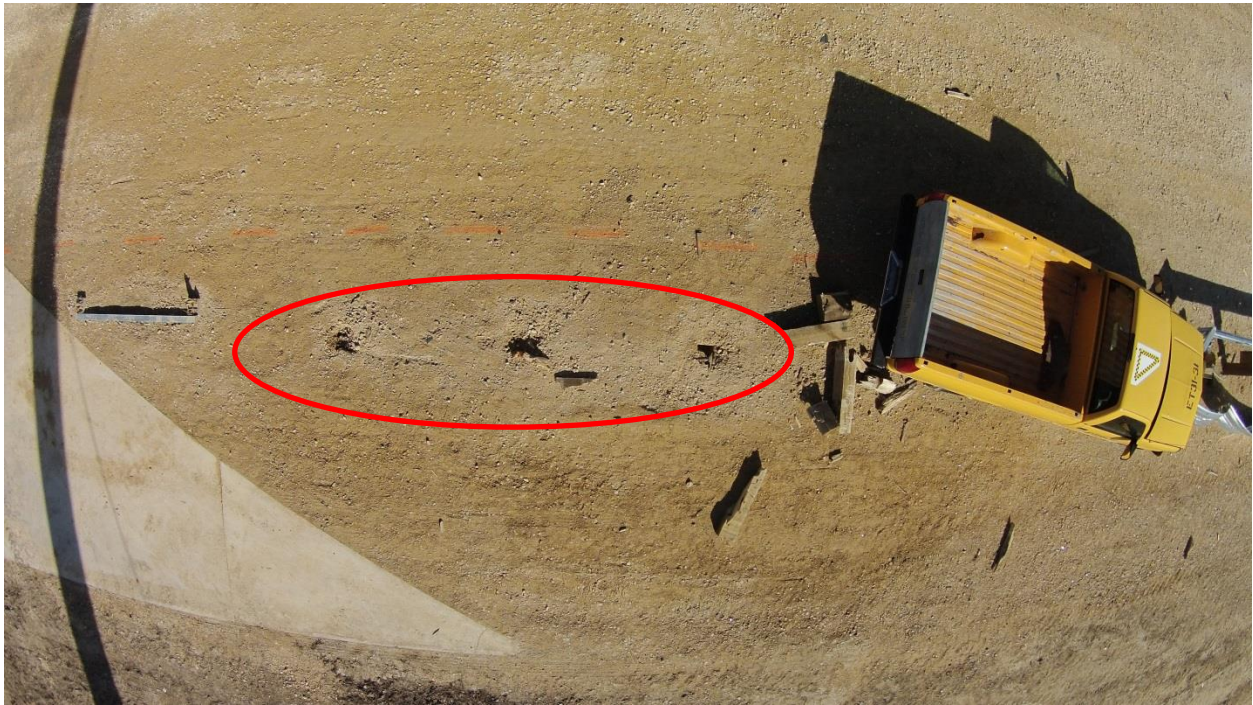
Figure 3.10: Post Test – Posts 3, 4, and 5

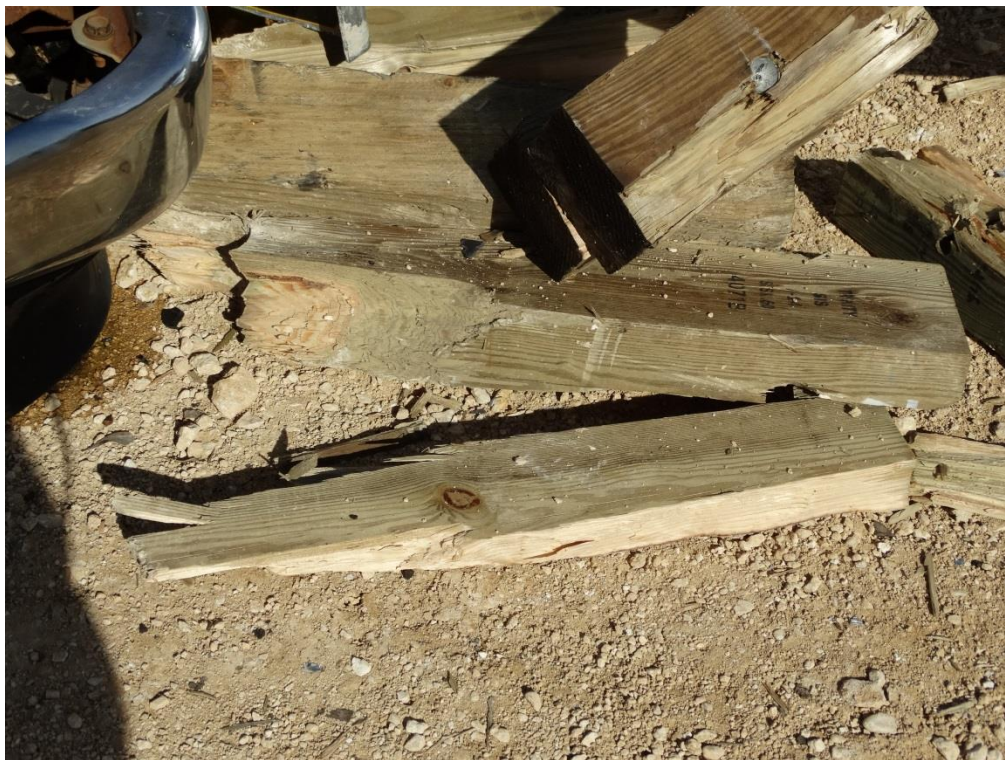
Figure 3.13: Post Test – Post Debris at Front of Truck

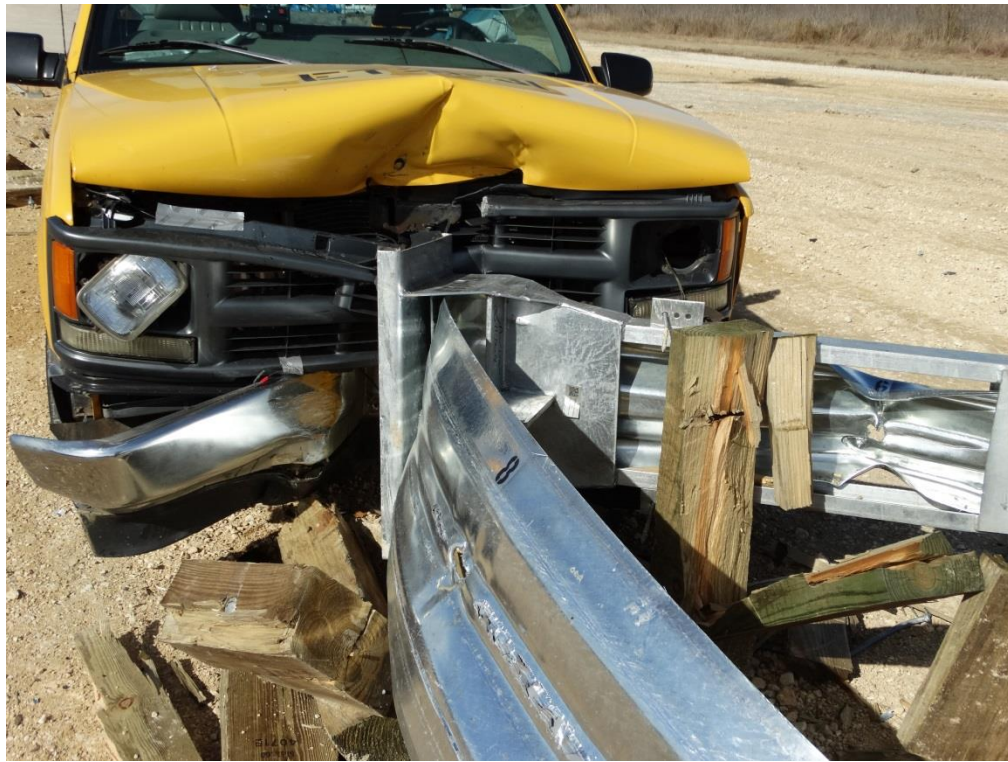
Figure 3.16: Post Test – Non-Traffic Side of Extruder Head

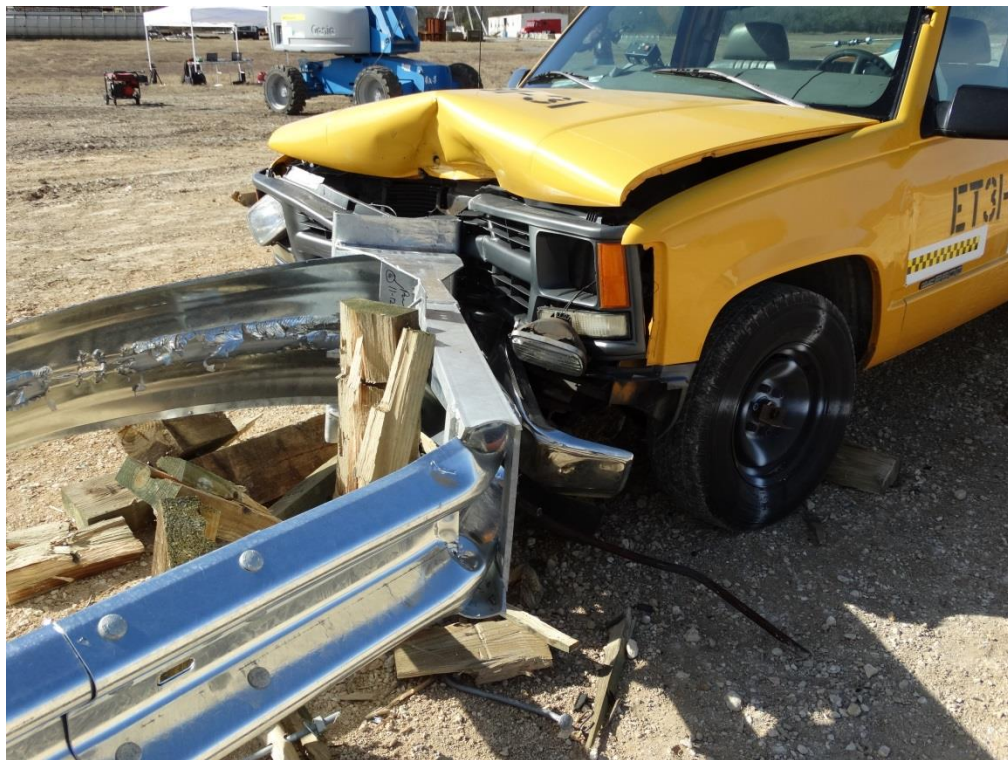
Figure 3.17: Post Test – Guide Channel Entrance, Traffic Side

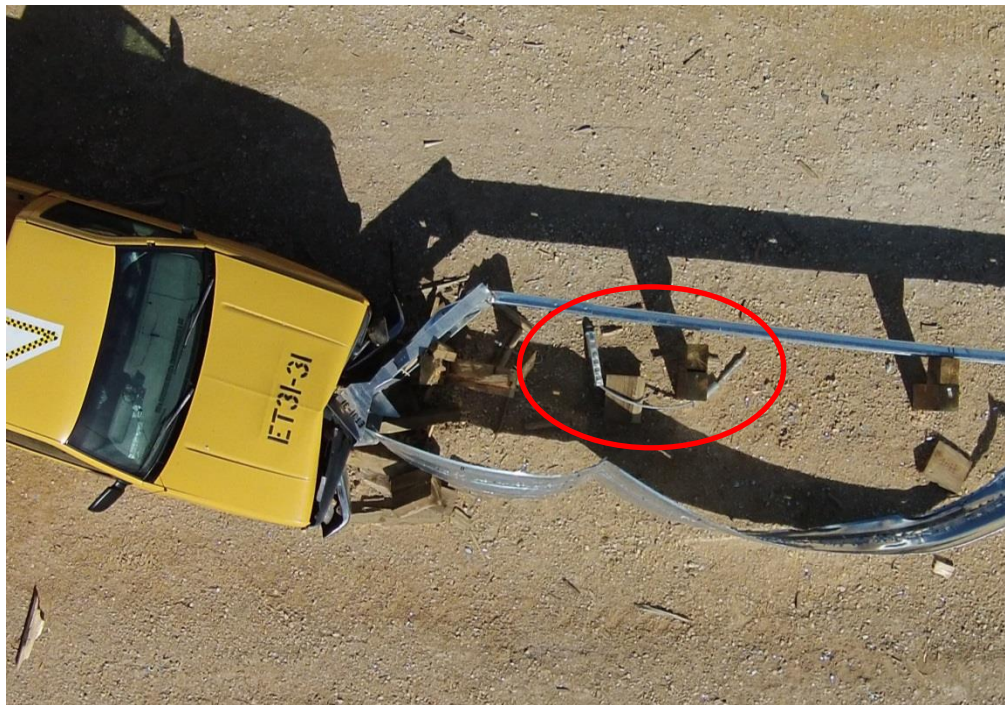
Figure 3.18: Post Test Location of Anchor Cable

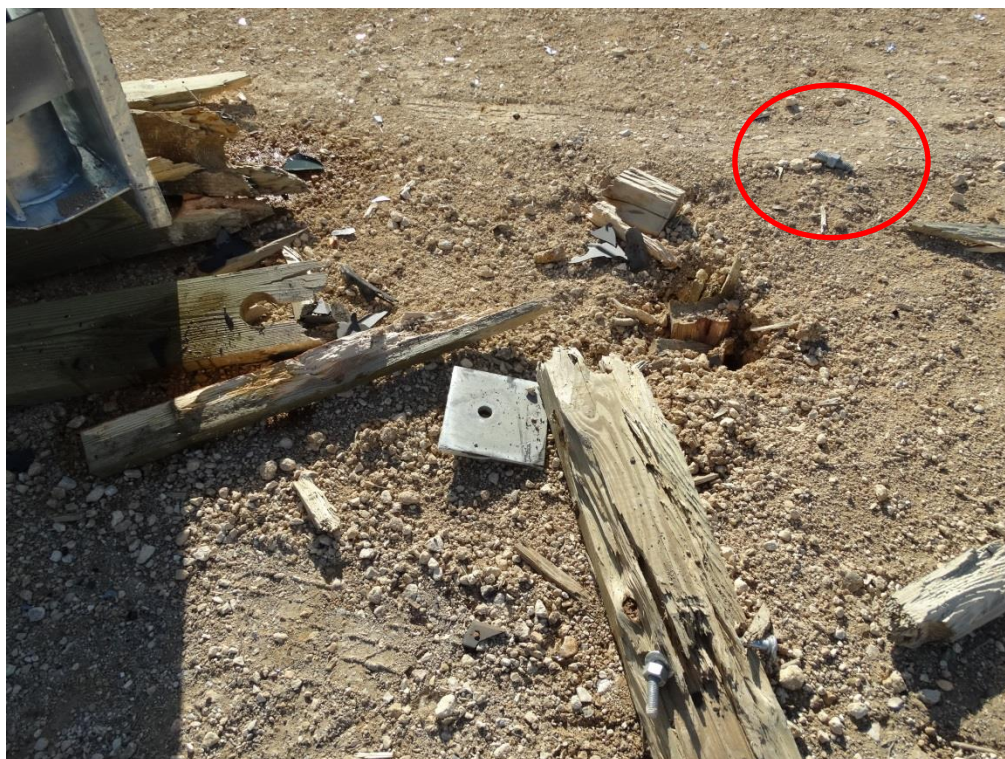
Figure 3.19: Post Test Location of Anchor Cable Bolt

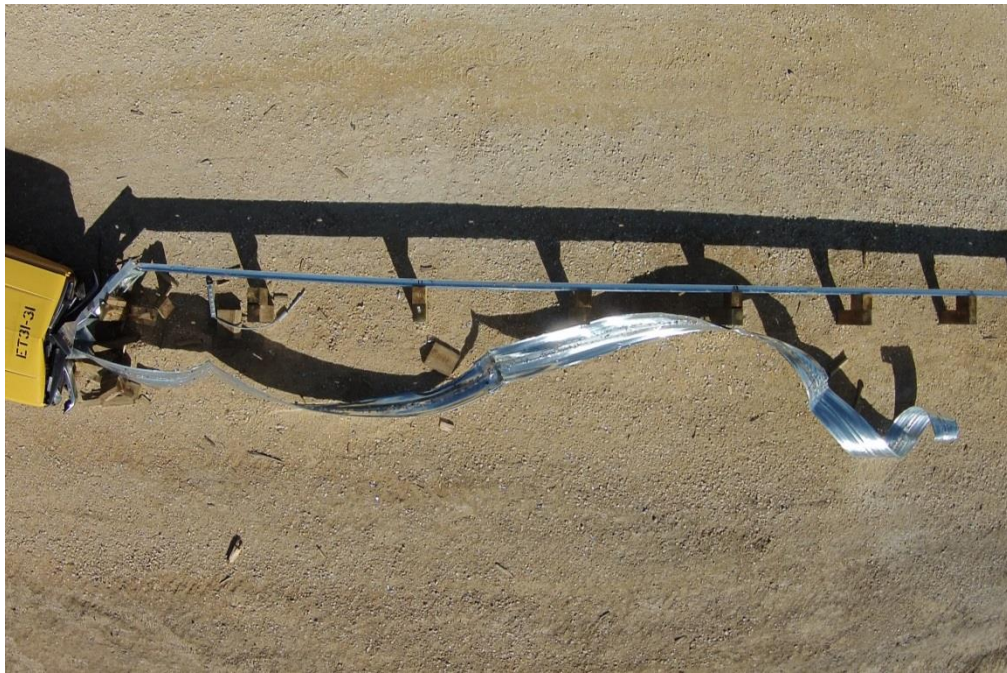
Figure 3.20: Post Test – Extruded Guardrail

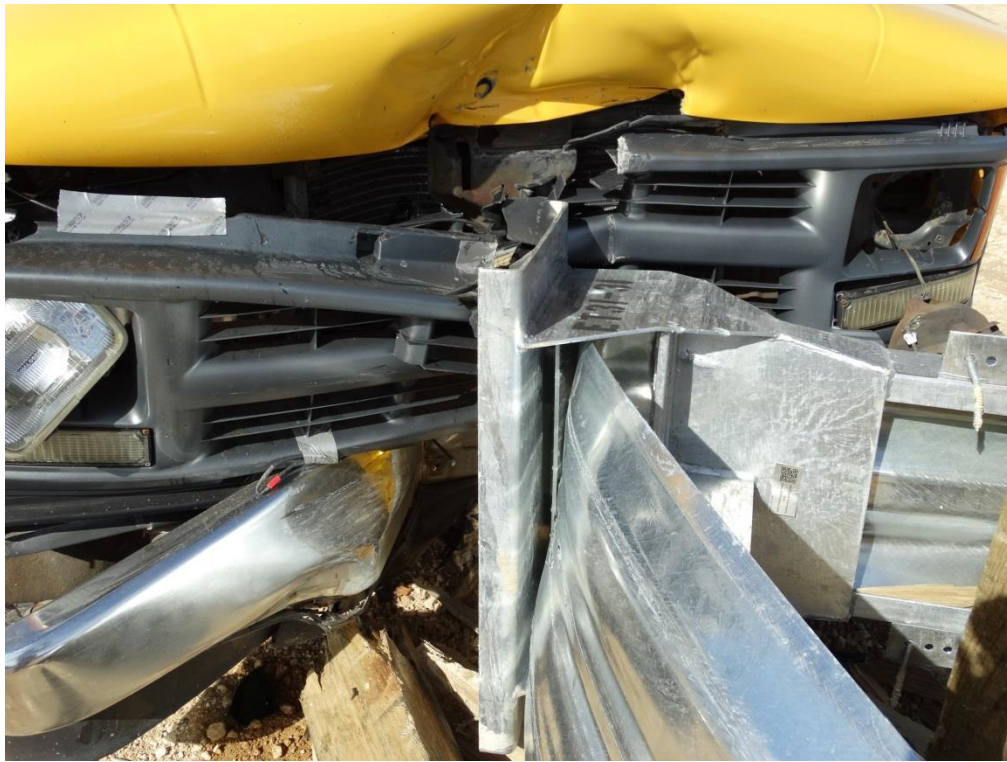
Figure 3.28: Post-Test – Extruder Exit

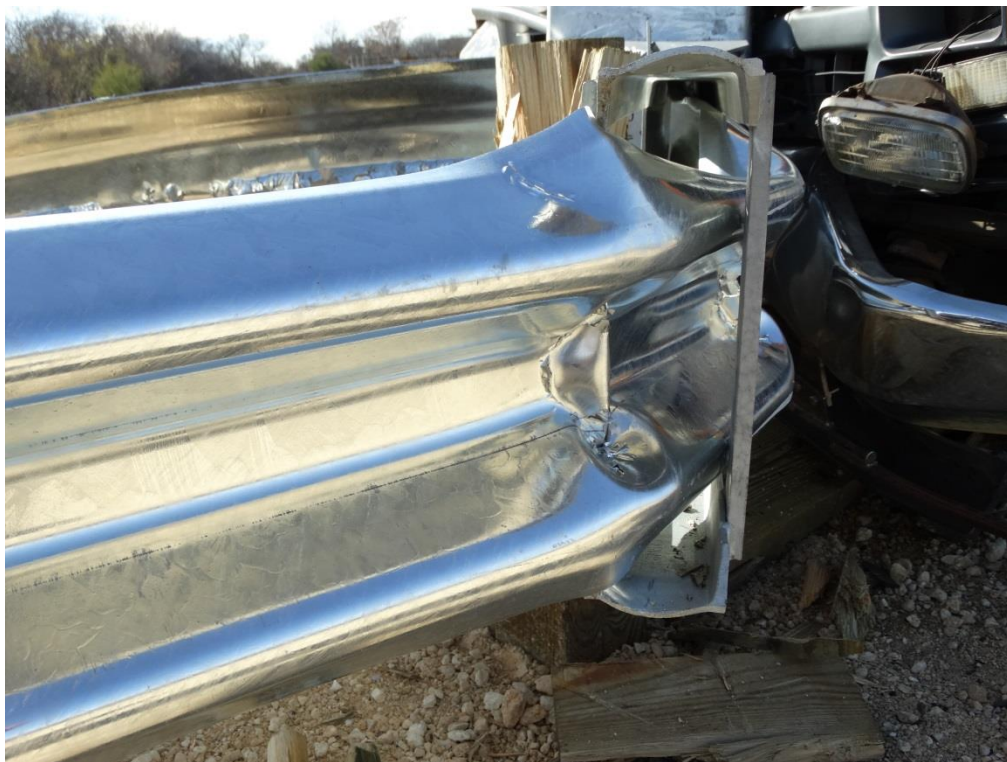
Figure 3.29: Post-Test –Guide Channel Entrance, Traffic Side

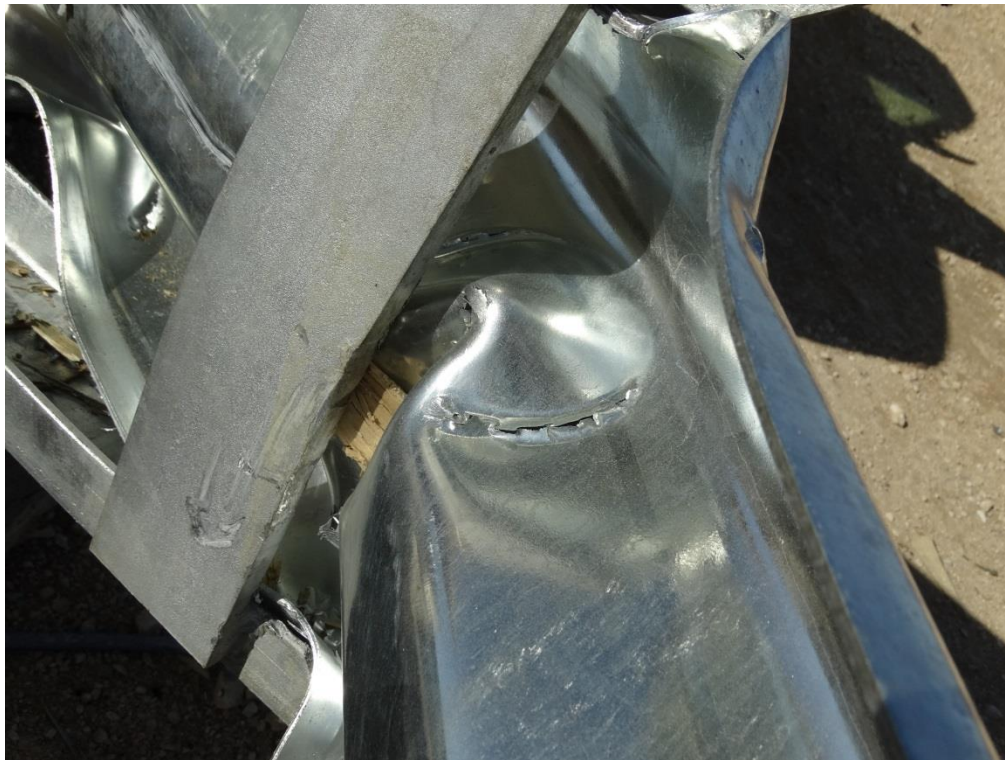
Figure 3.30: Post-Test –Guide Channel Entrance, Non-Traffic Side

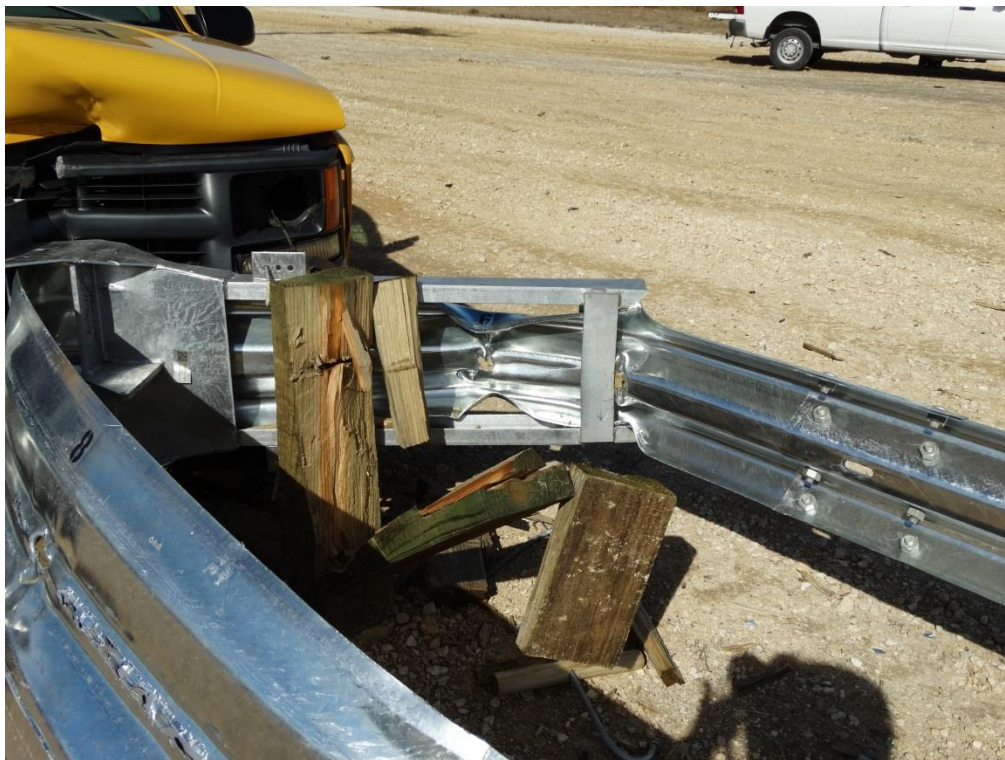
Figure 3.31: Post-Test – ET Plus Head, Non-Traffic Side

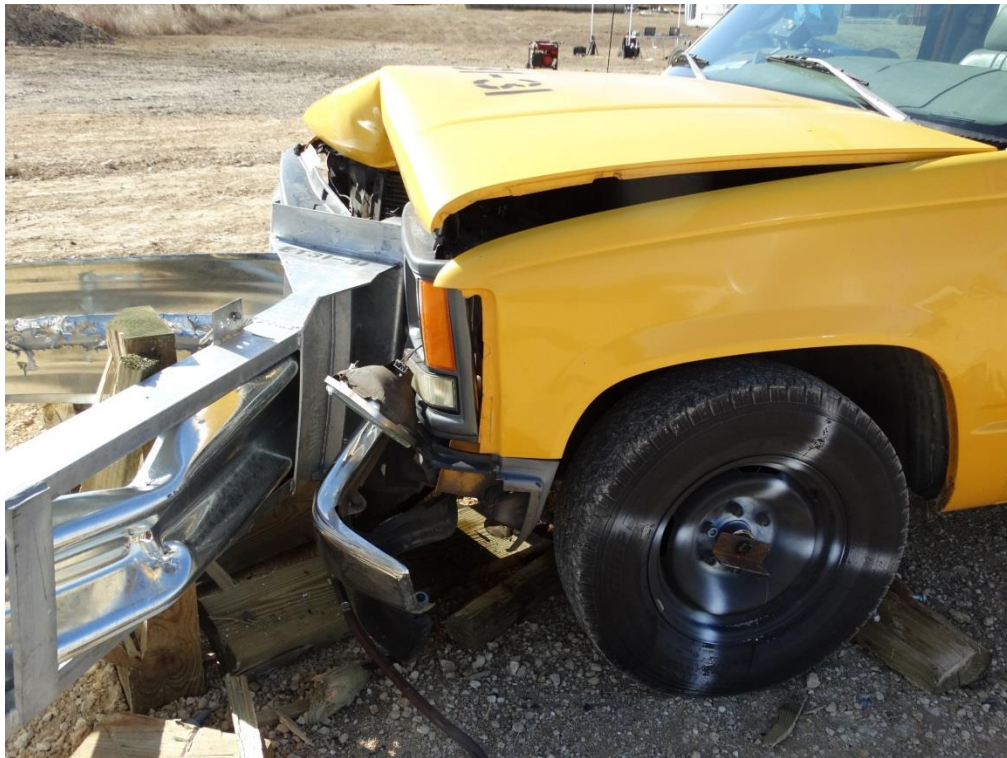
Figure 3.33: Post-Test – ET Plus Head, Traffic Side

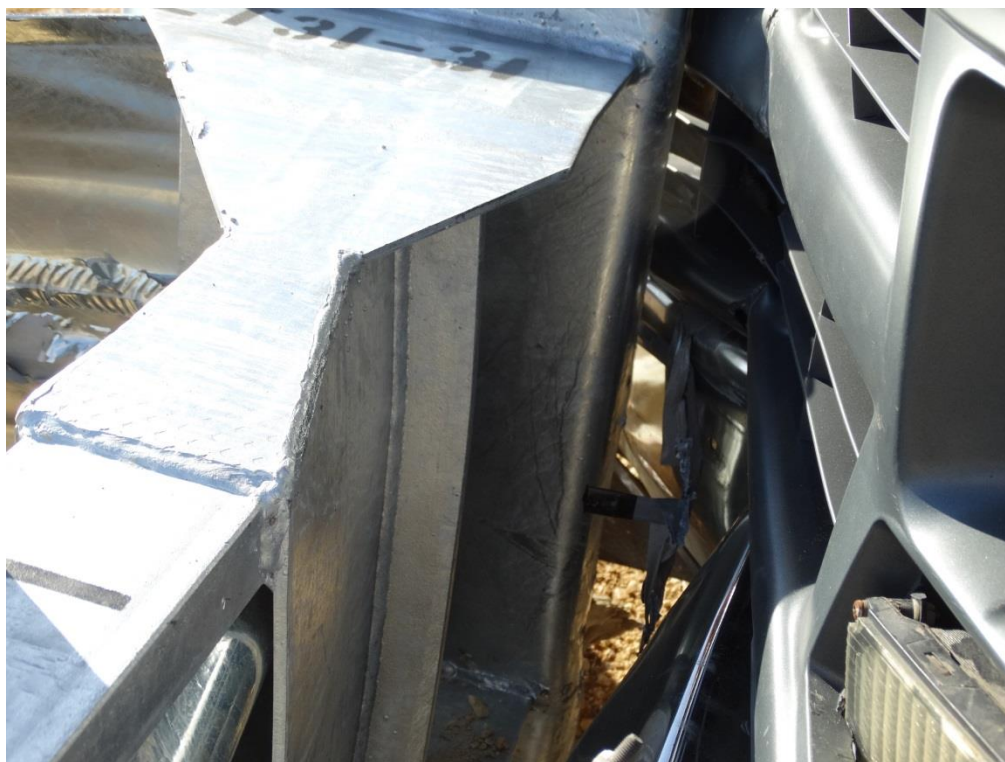
Figure 3.34: Post-Test – ET Plus Head, Traffic Side, Close-up
