NCHRP Report 350 Test Report Compilation

Full-Scale Crash Evaluations of the ET Plus[®] End Terminal with 4-inch Wide Guide Channel Installed with a Rail Height of 31 Inches

Test Level 3, Test 3-33, 3-31, 3-32, and 3-30

SwRI[®] Project No. 18.20887

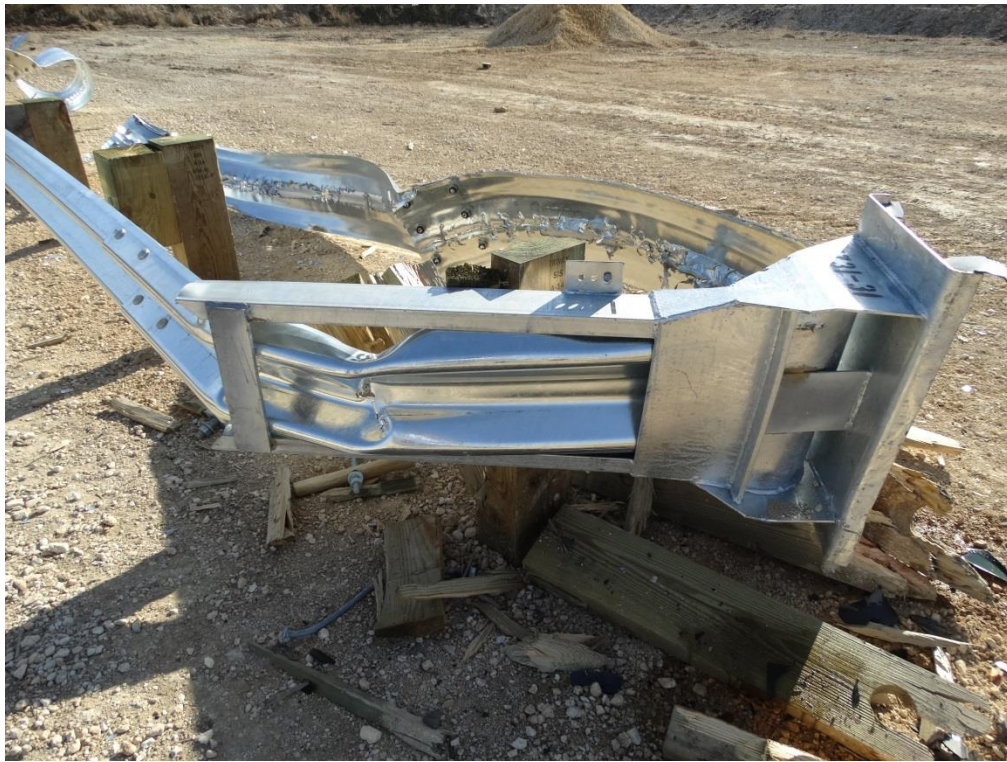
Figure 3.38: Post-Impact Test Article after Vehicle Removed – Traffic Side View

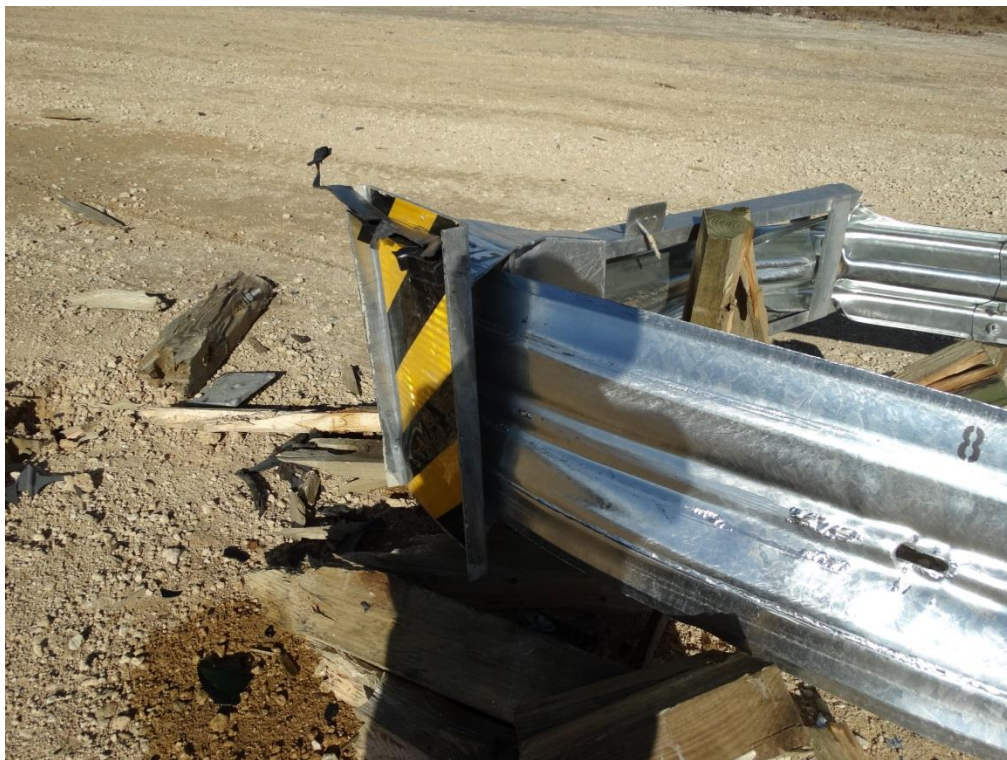
Figure 3.39: Post-Impact Test Article after Vehicle Removed – Non-Traffic Side View

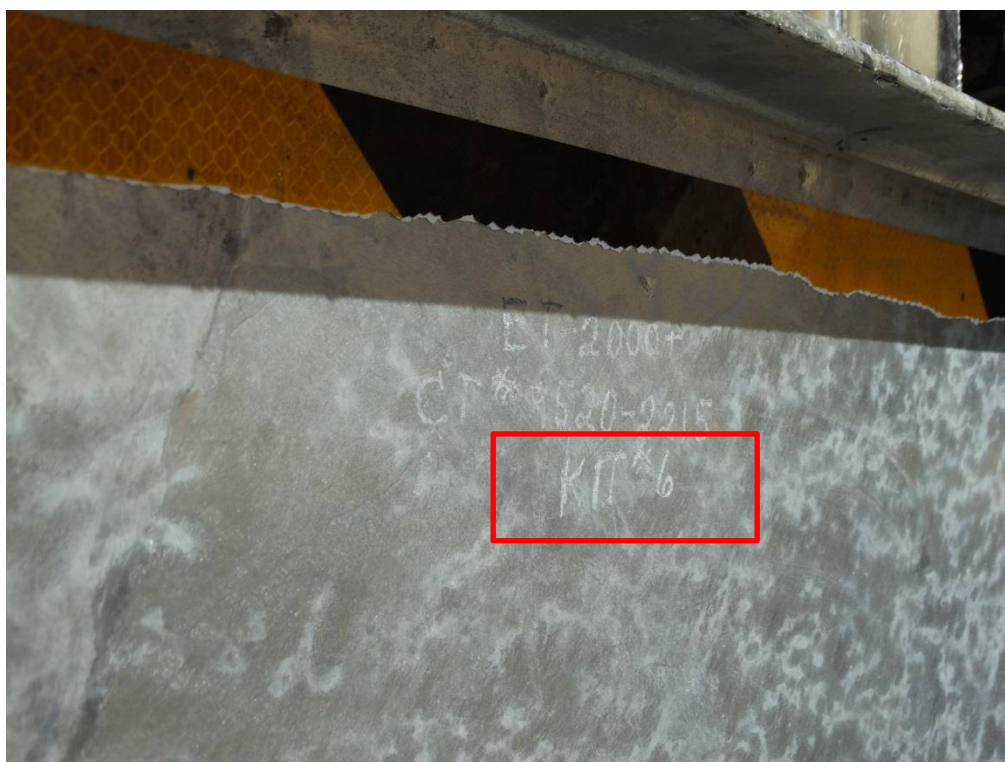
Figure 3.41: Post Test Verification of Extruder Head 6

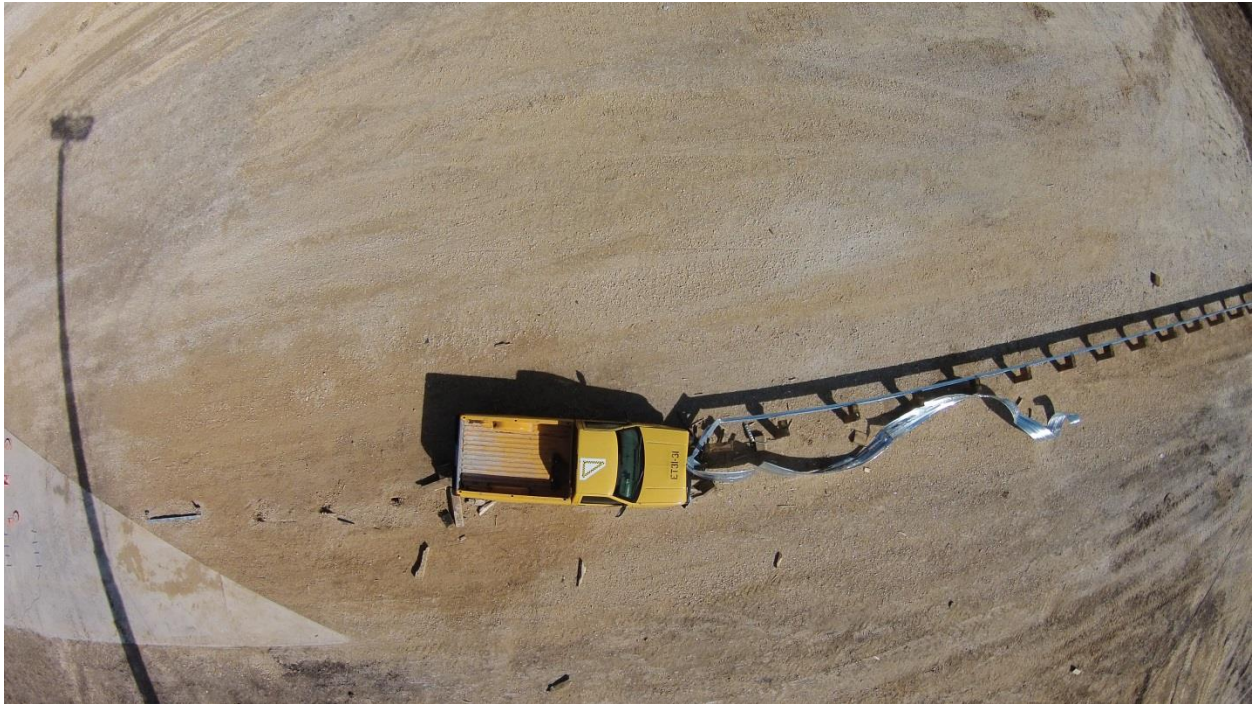
Figure 3.42: Test Vehicle Post-Test Location

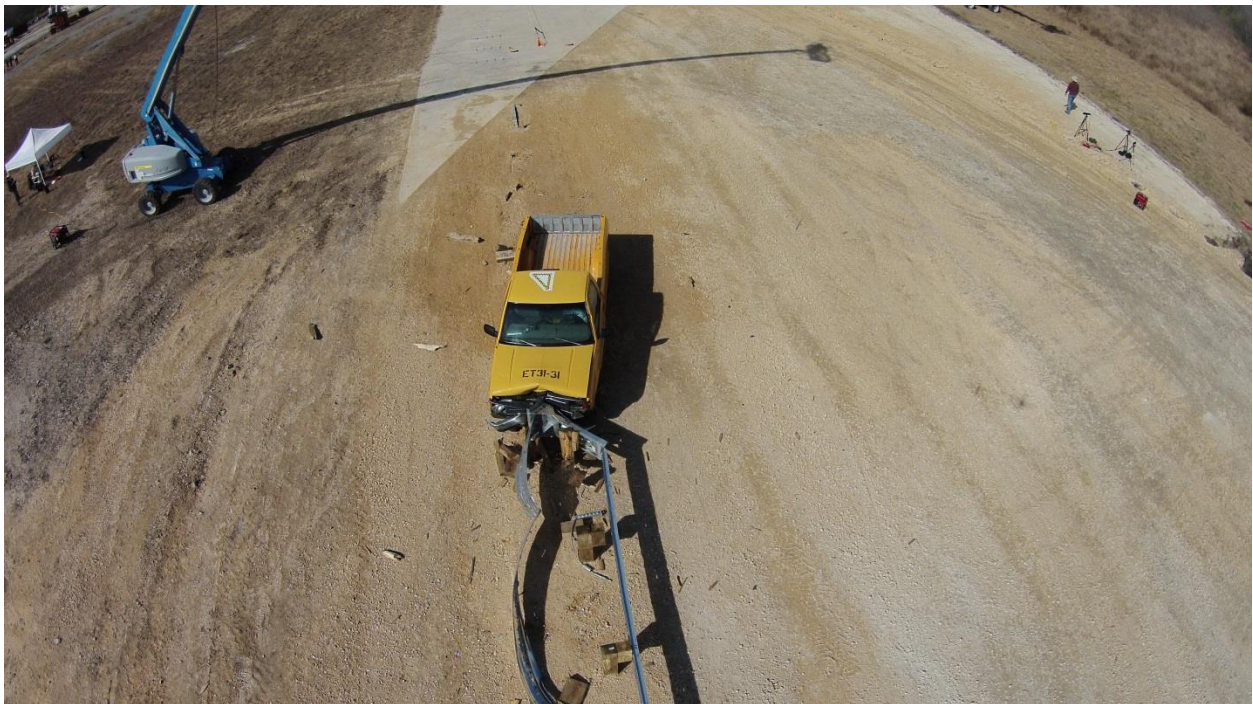
Figure 3.43: Post Test Vehicle – Overhead View

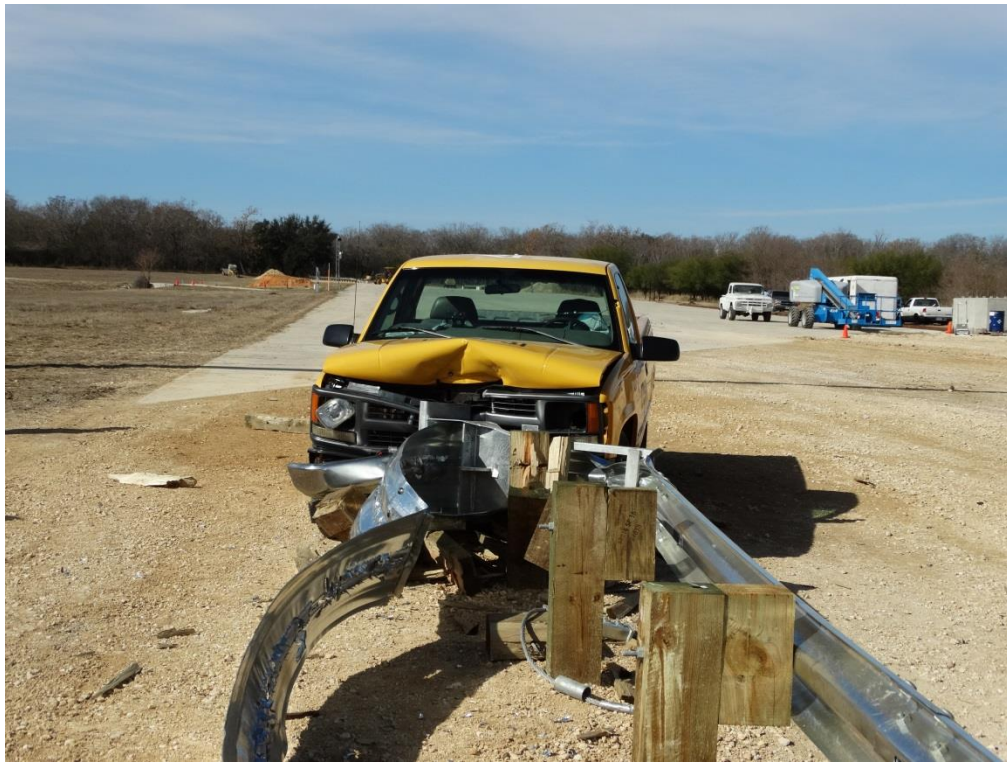
Figure 3.44: Post Test Vehicle – Front View

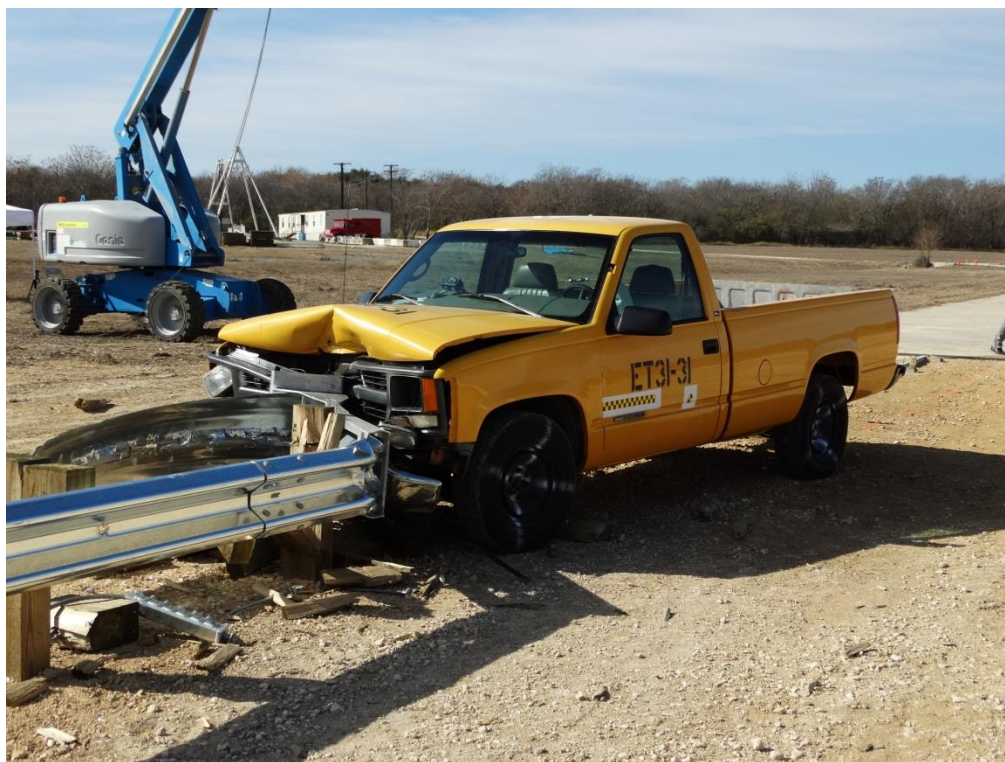
Figure 3.46: Post Test Vehicle – Left Side

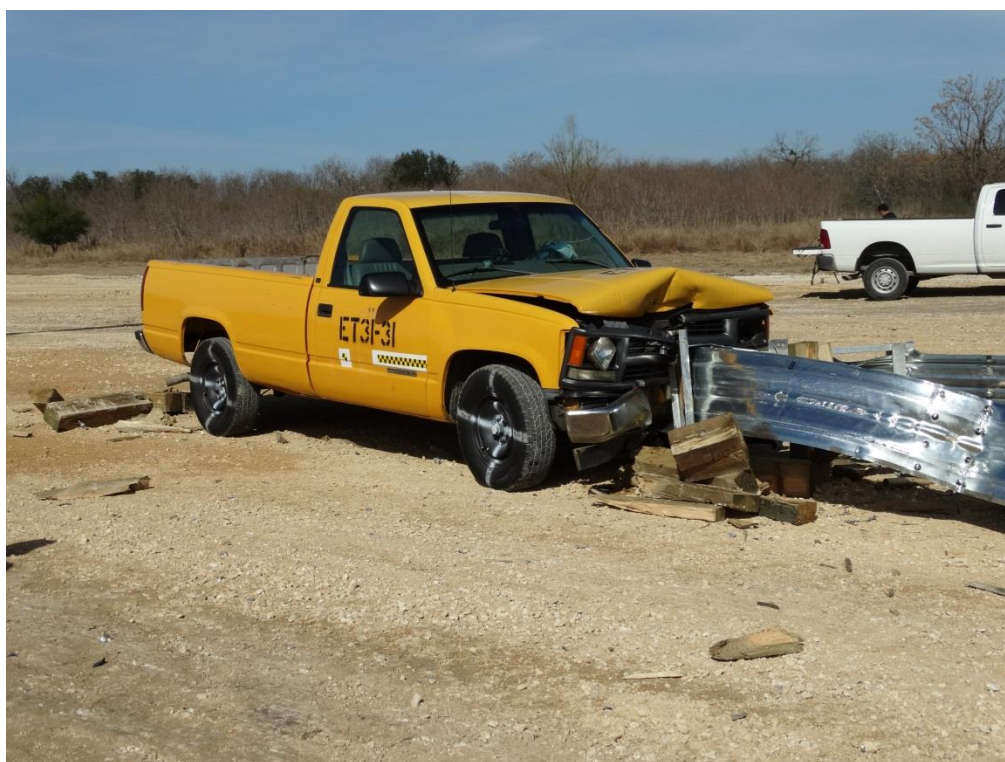
Figure 3.47: Post Test Vehicle – Right Side

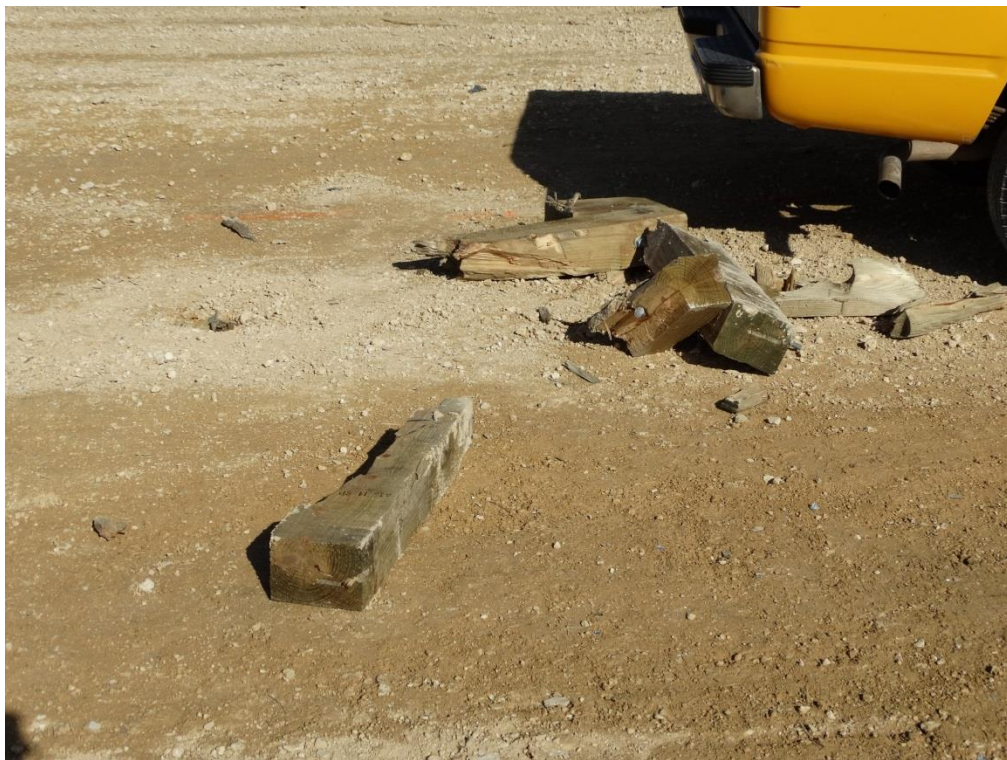
Figure 3.49: Post Test Vehicle – Accumulated Posts at Rear of Vehicle

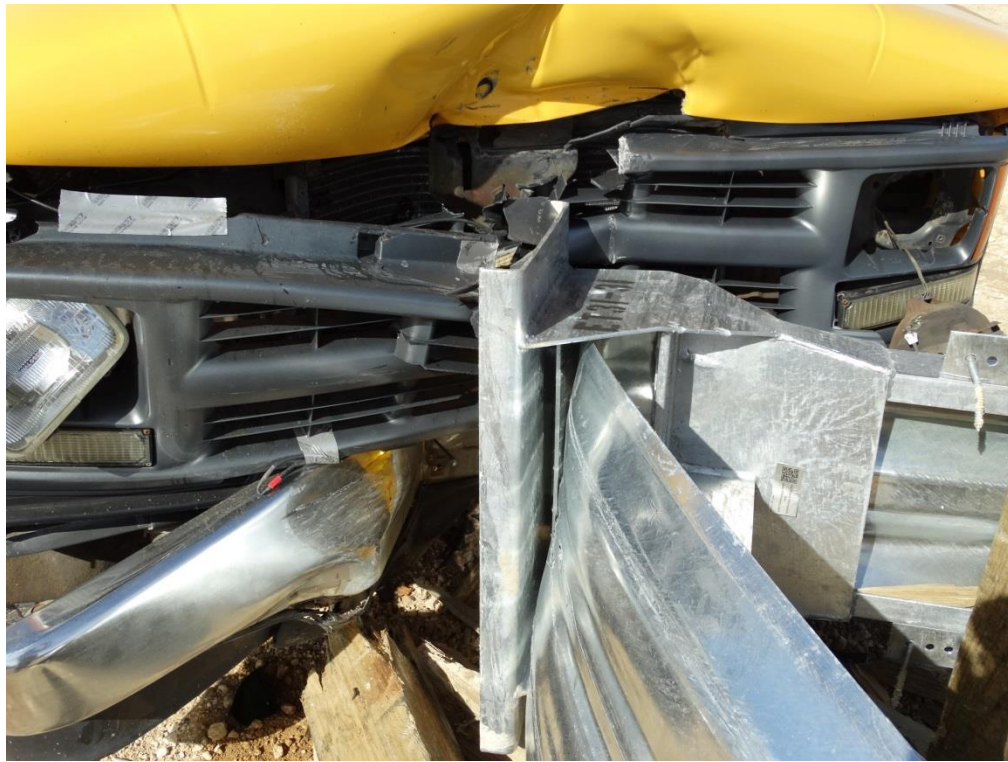
Figure 3.50: Post Test Vehicle – ET Plus Head at Front of Vehicle

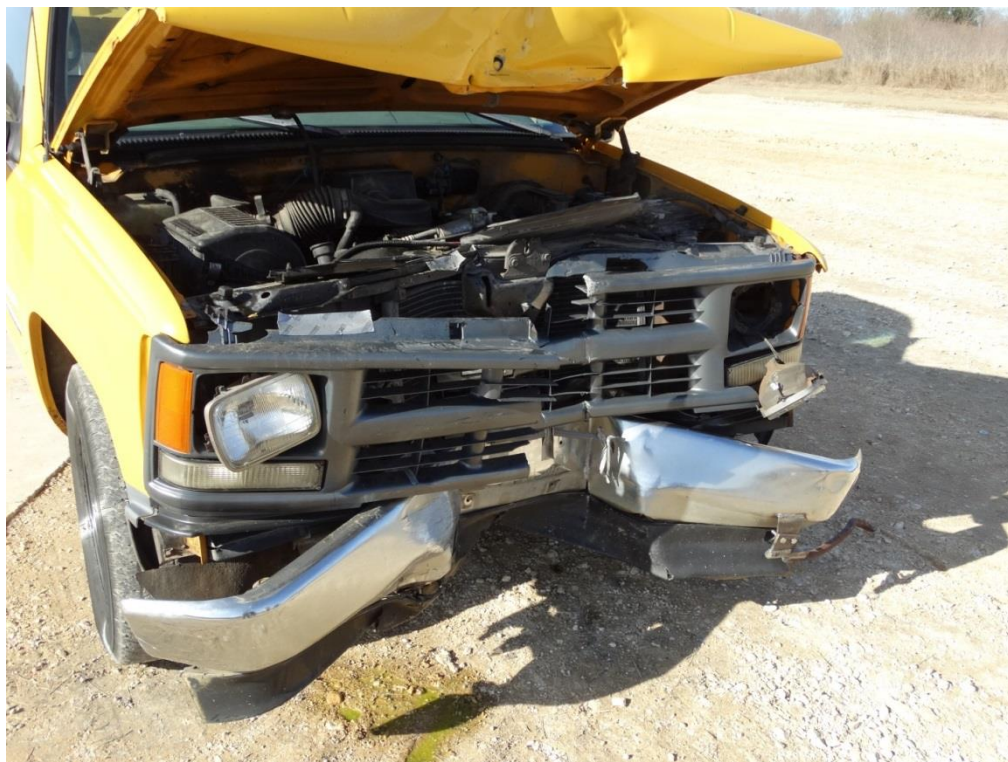
Figure 3.51: Post Test Vehicle – Front View after Removal from Guardrail

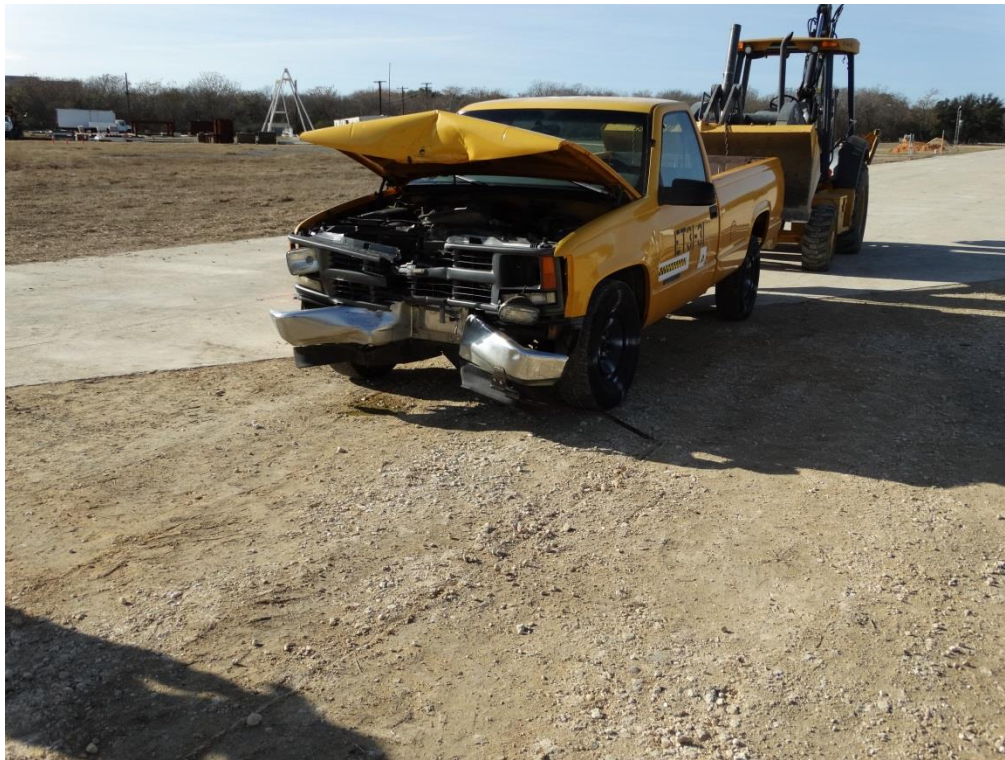
Figure 3.52: Post Test Vehicle – Left Side after Removal from Guardrail

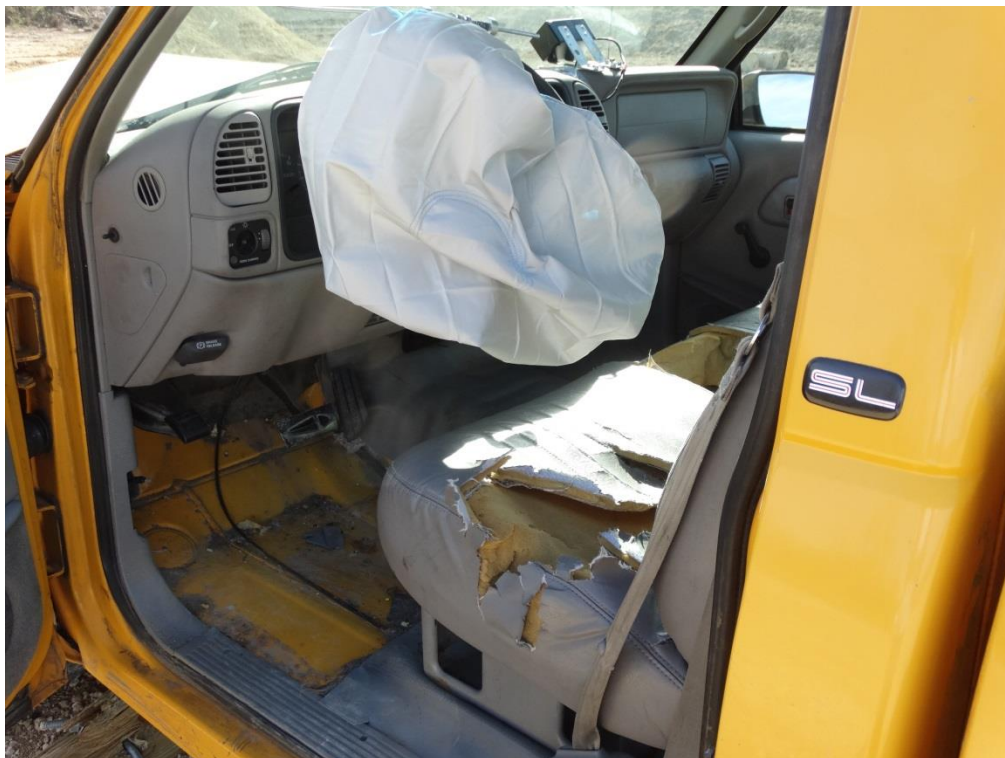
Figure 3.53: Post Test Vehicle – Occupant Compartment, Airbag Deployment

- There was no penetration of the vehicle by the test article, and no deformation of the occupant compartment resulting from the test.
- There was no undue hazard presented by test article debris outside of the immediate impact zone; the only debris thrown from the installation included pieces of posts and blockouts, the majority of which fell to the non-traffic side of the guardrail.
- The vehicle remained upright during and following the impact.
- The test article provided for controlled deceleration with impact velocity and ridedown acceleration values within allowable limits.

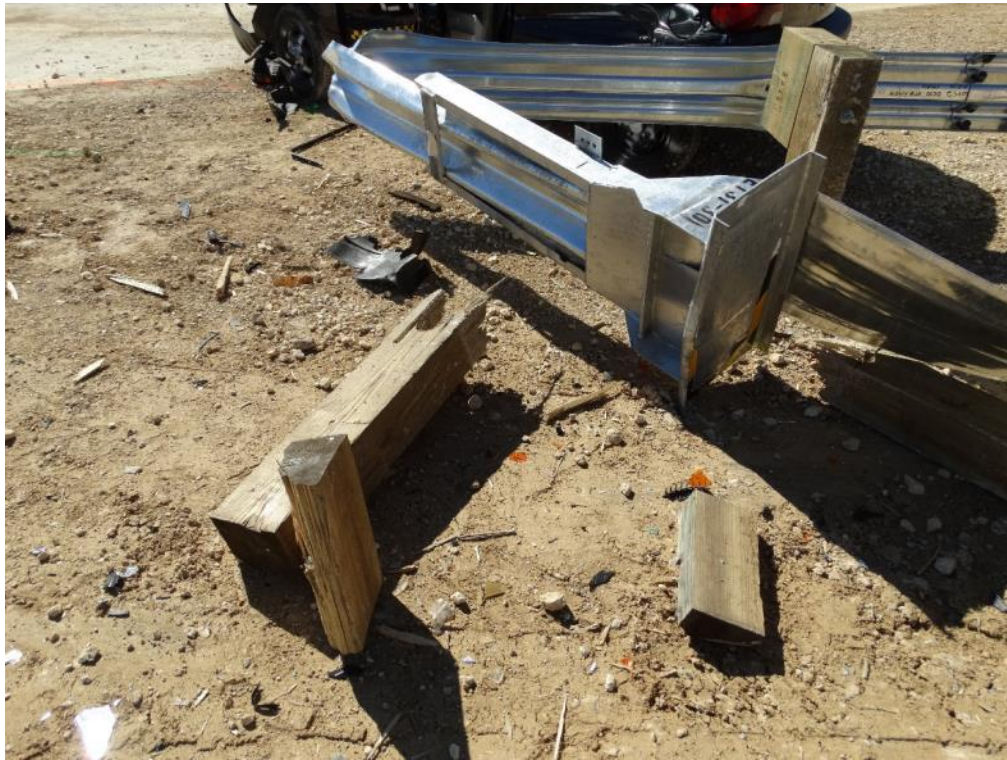
Figure 3.11: Post Test – Traffic Side View of Extruder Head

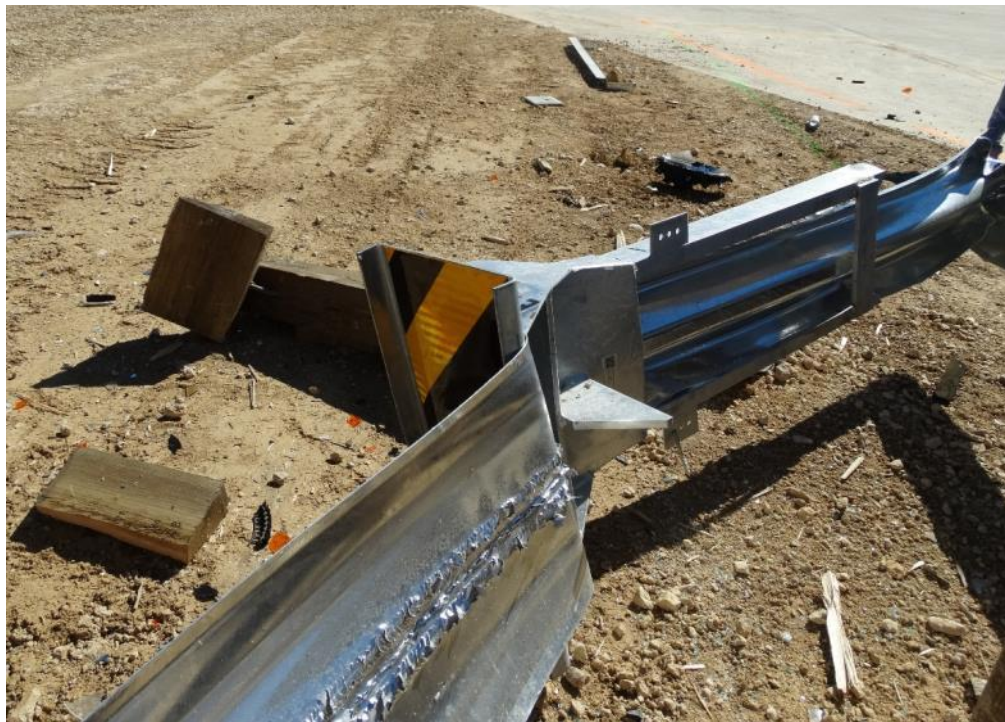
Figure 3.13: Post Test – Non-Traffic Side View of Extruder Head

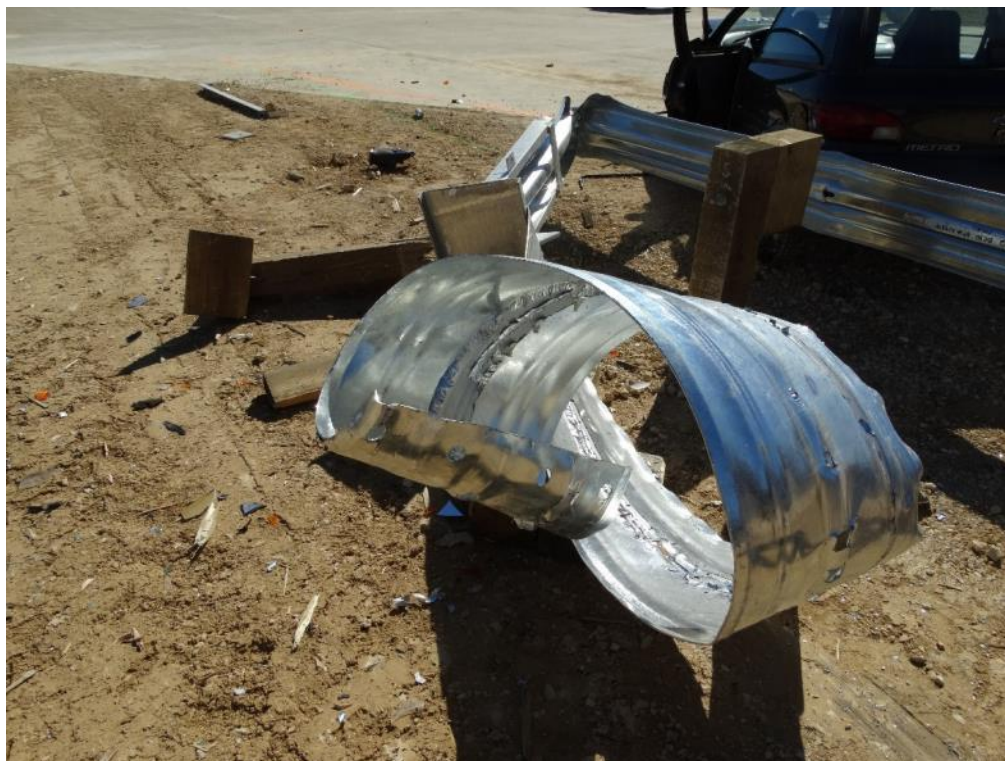
Figure 3.14: Post Test – Extruded Guardrail

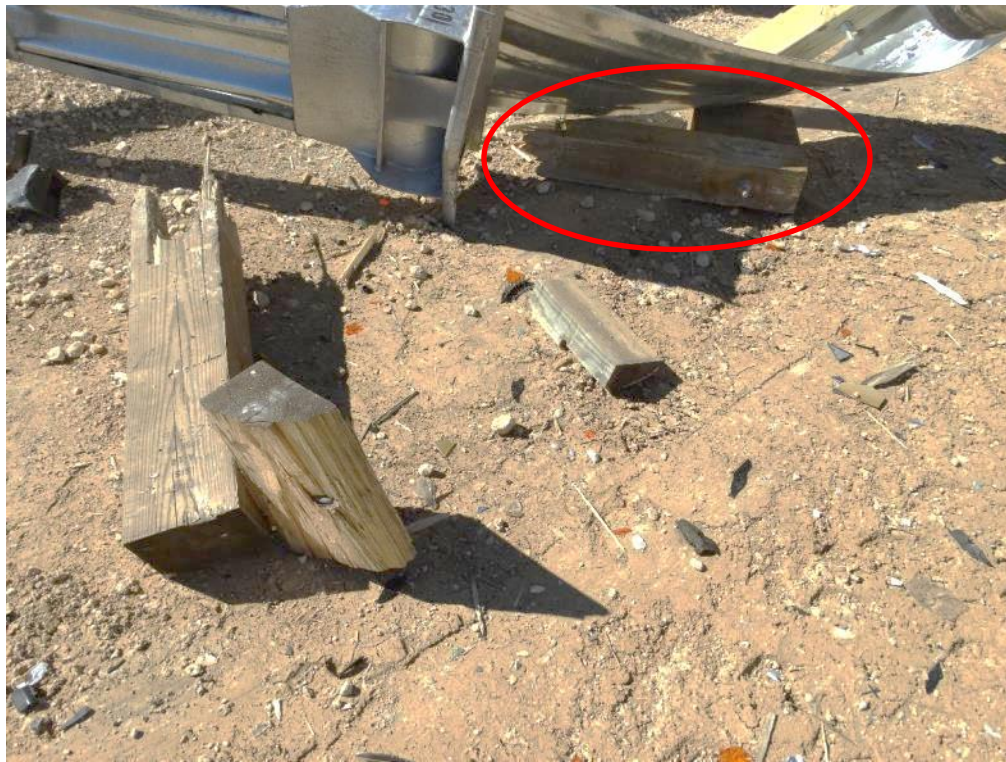
Figure 3.19: Post Test – Final Location of Post 3 (Left) and Post 4 (Right)

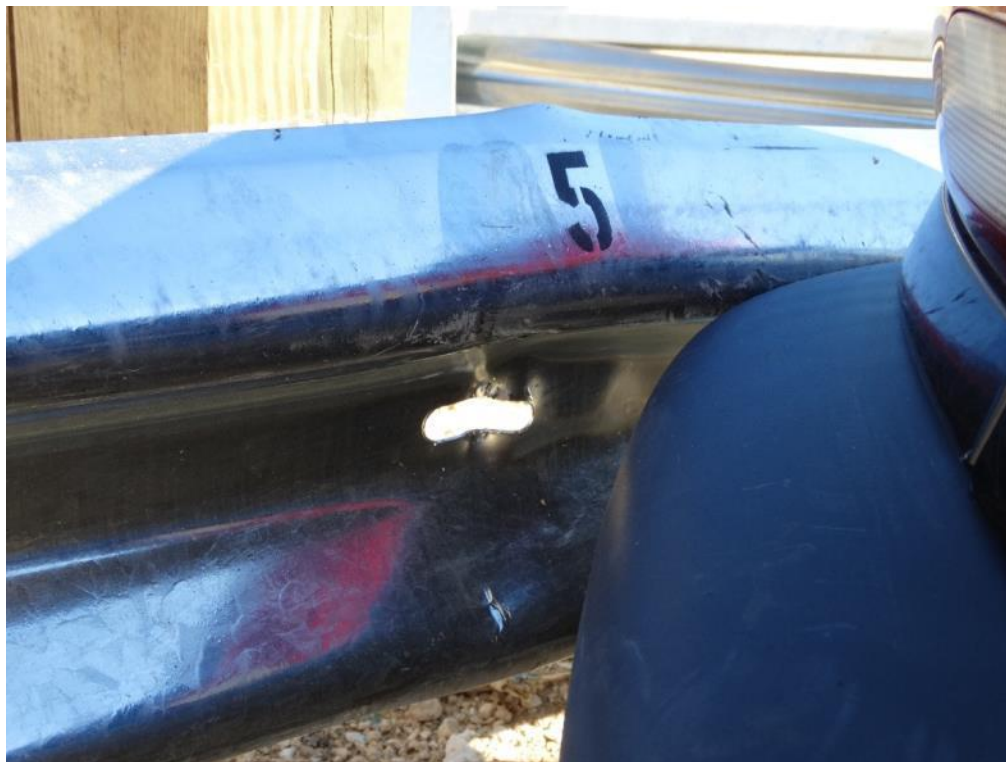
Figure 3.20: Post Test – Traffic View of Post 5

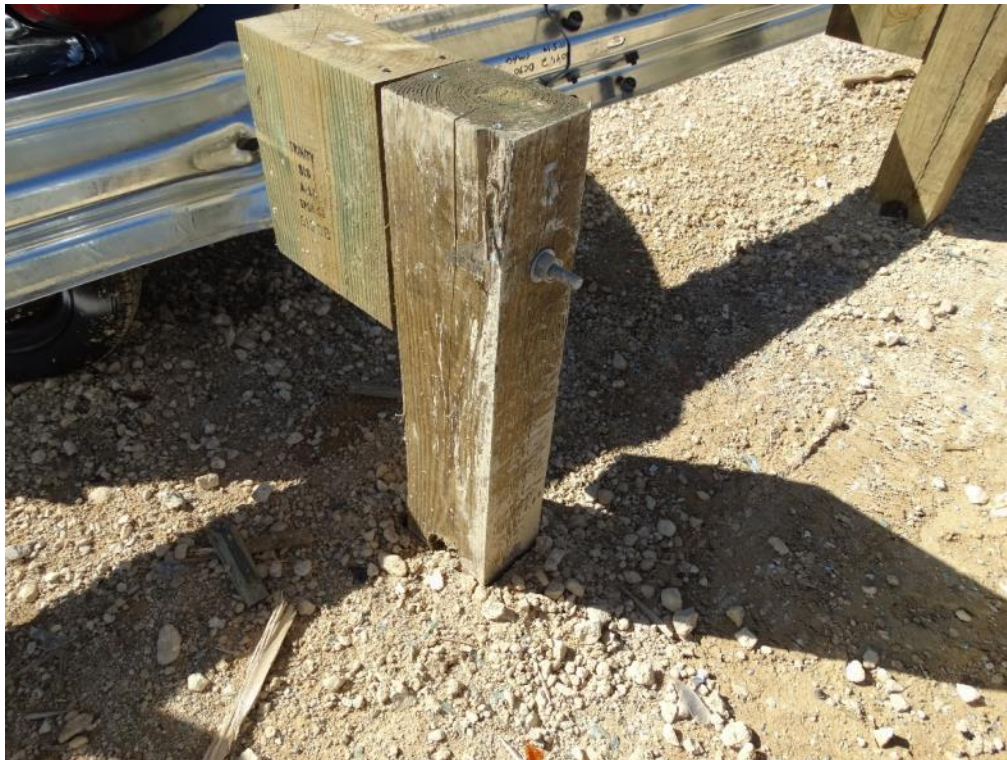
Figure 3.22: Post Test – Non-Traffic View of Post 5

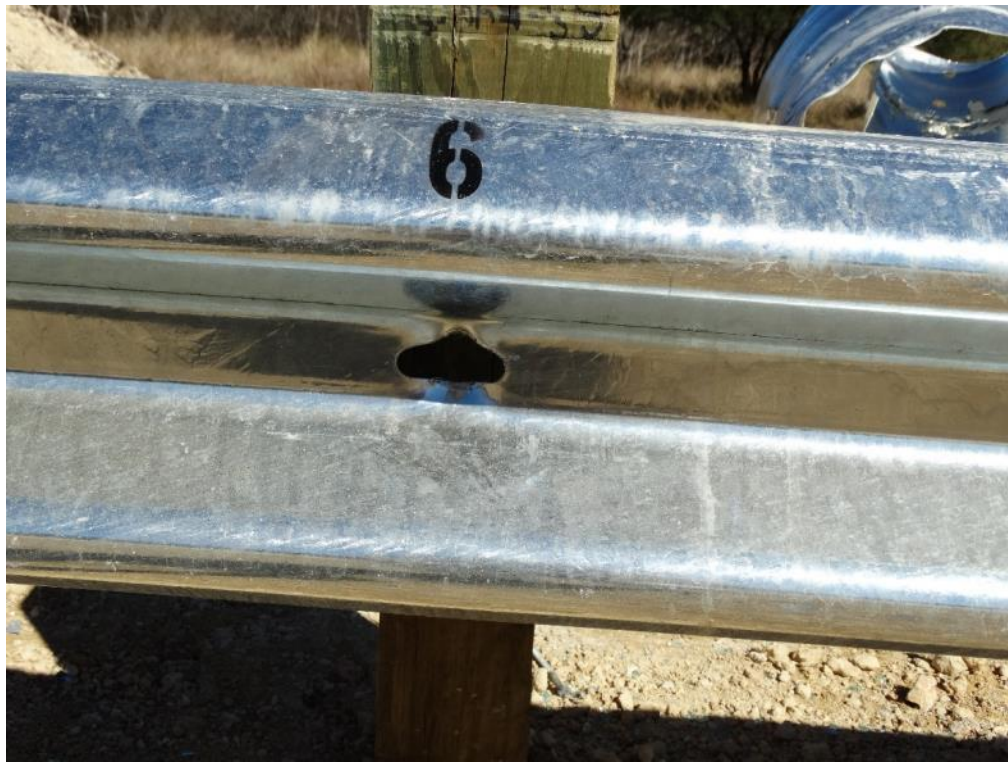
Figure 3.23: Post Test – Traffic View of Post 6

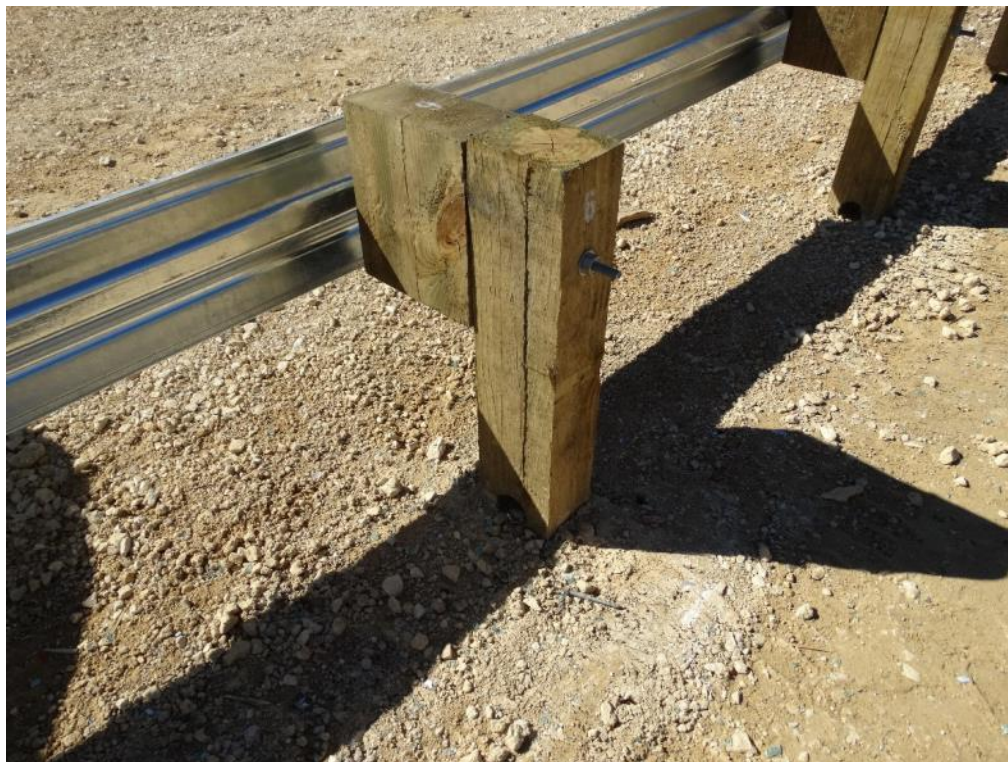
Figure 3.24: Post Test – Non-Traffic View of Post 6

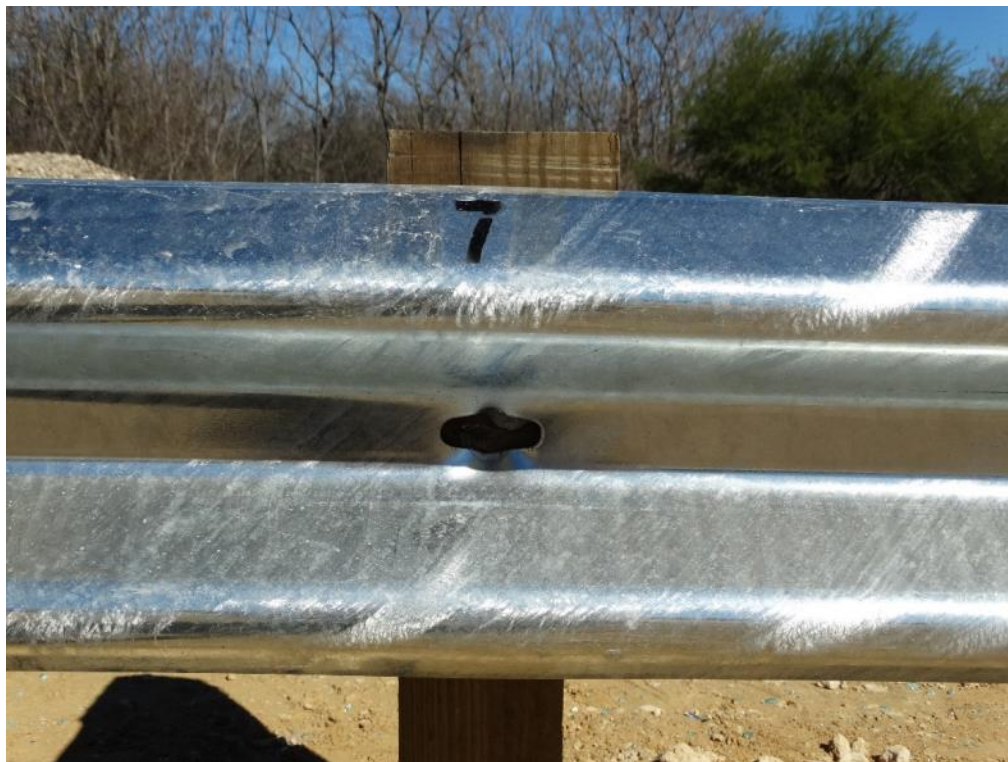
Figure 3.26: Post Test – Traffic View of Post 7

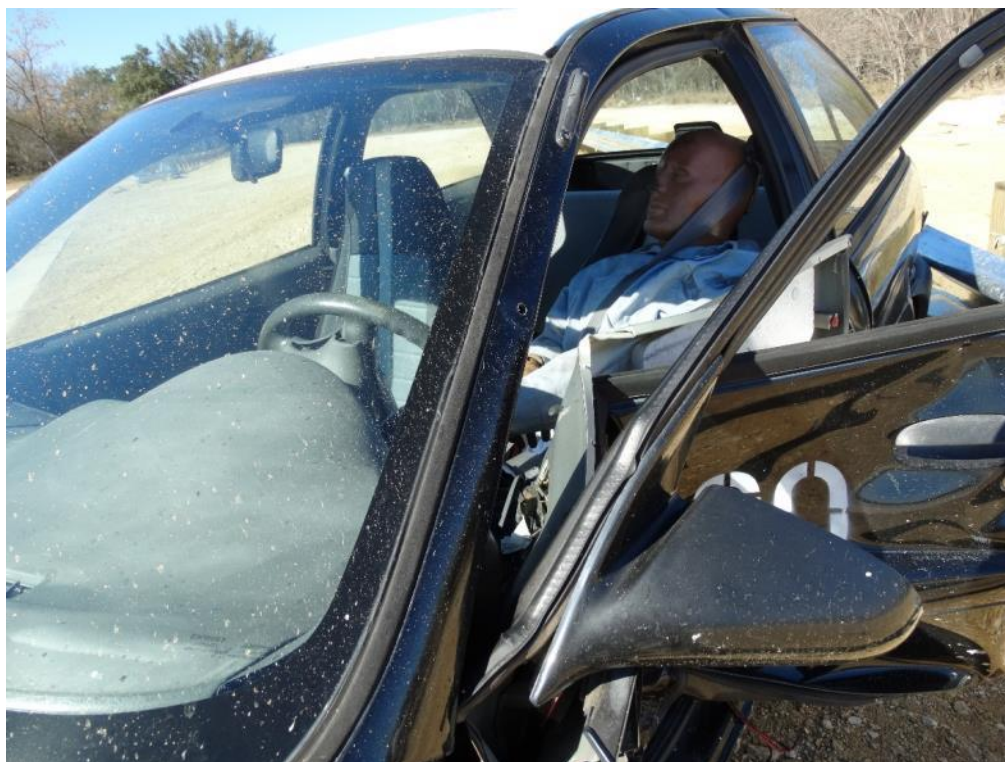
Figure 3.68: Post Test Vehicle – Left Side Door

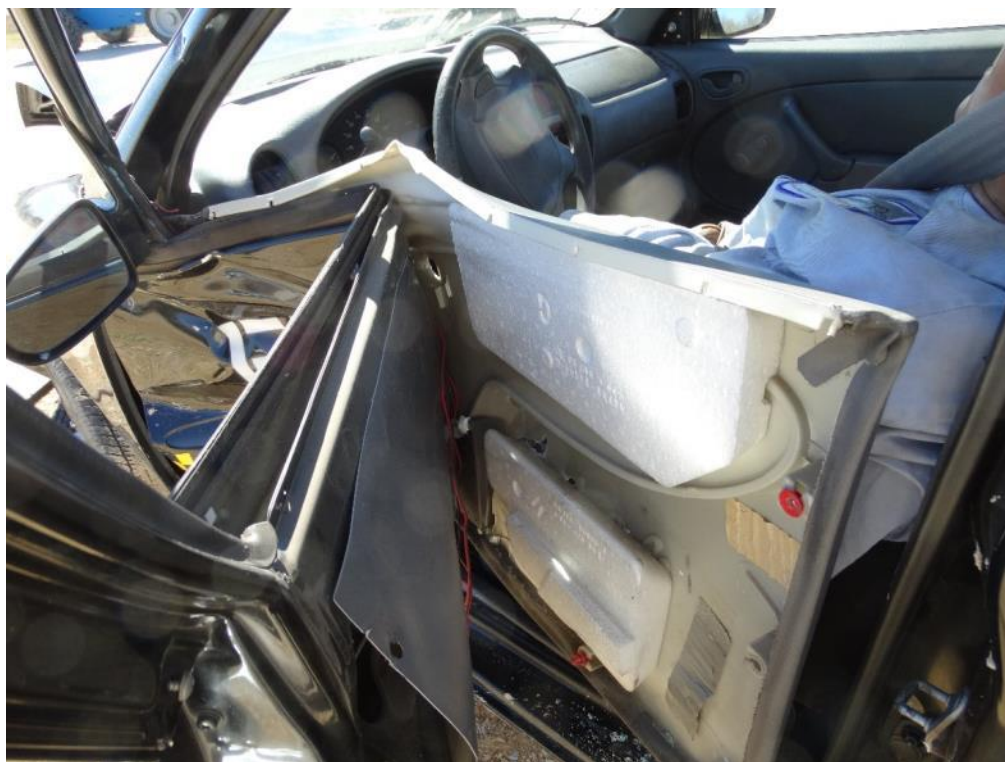
Figure 3.70: Post Test Vehicle – Left Side Door Panel

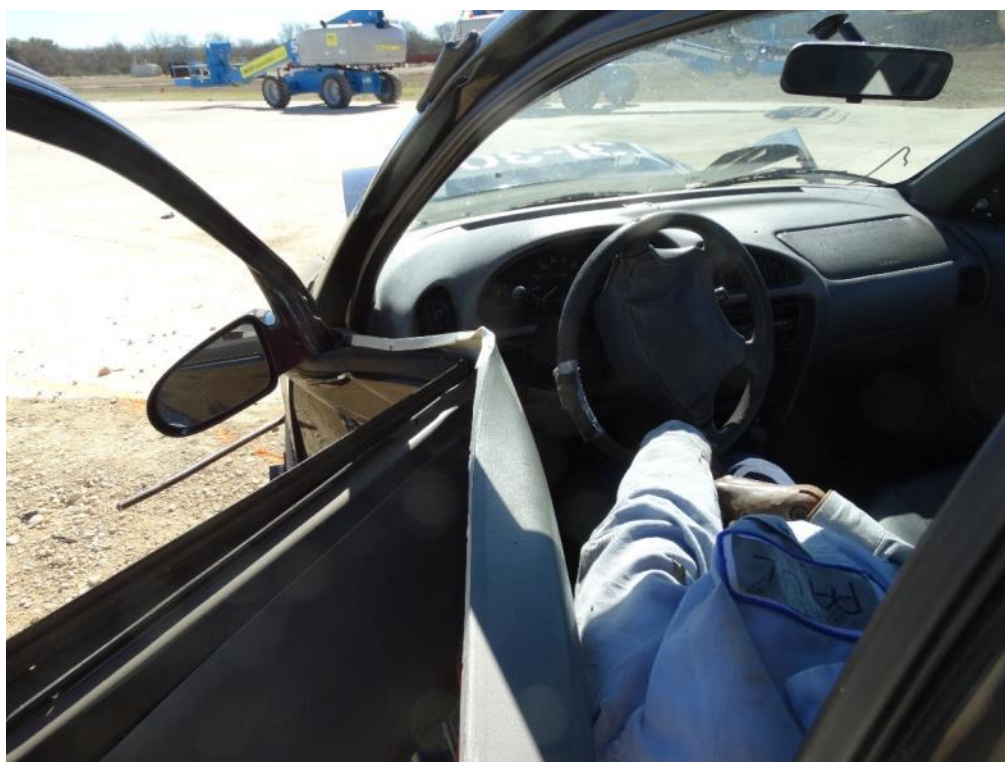
Figure 3.71: Post Test Vehicle – Left Side Door Panel, Interior

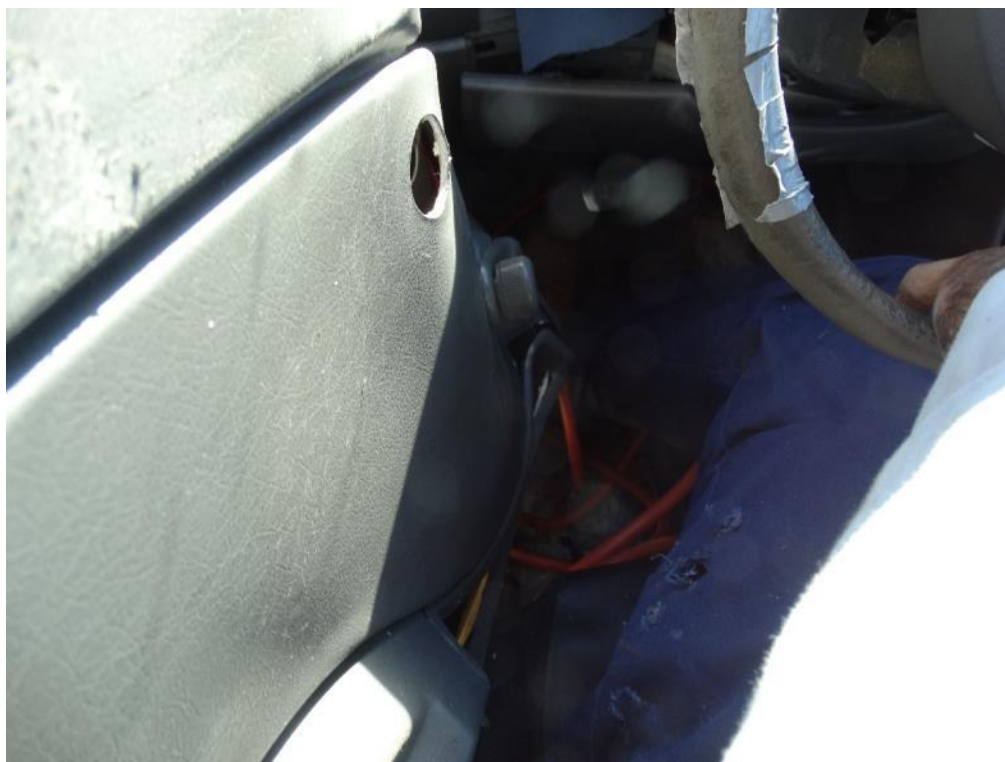
Figure 3.72: Post Test Vehicle – Left Side Door Panel , Interior

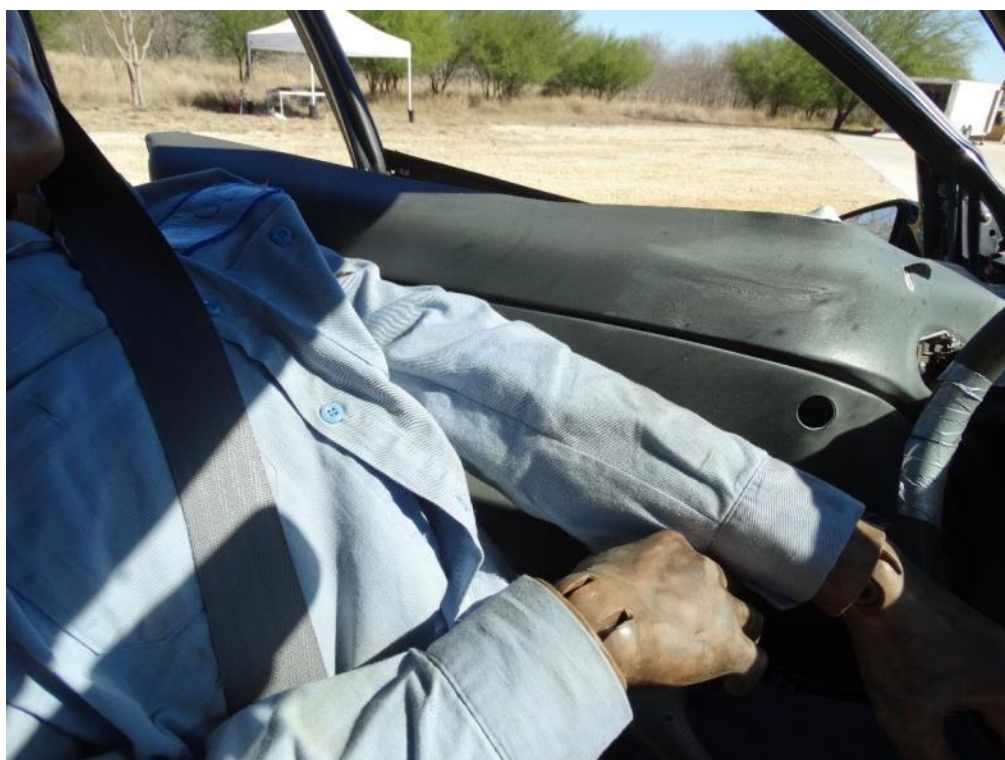
Figure 3.73: Post Test Vehicle – Left Side Door Panel, Interior

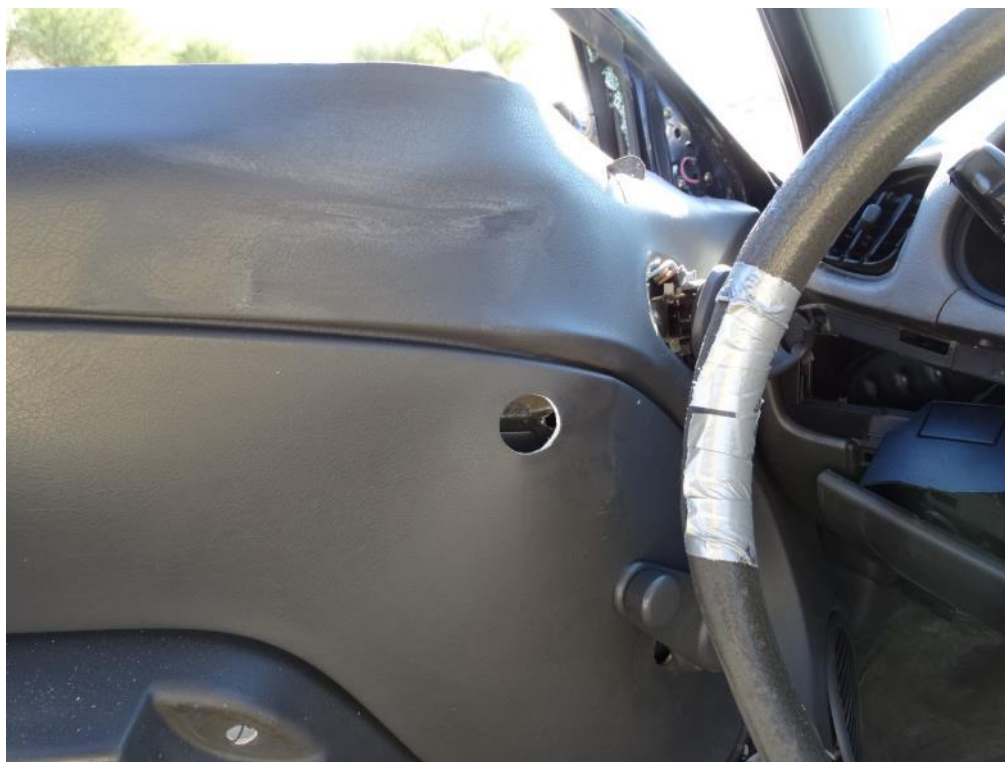
Figure 3.74: Post Test Vehicle – Left Side Door Panel, Interior

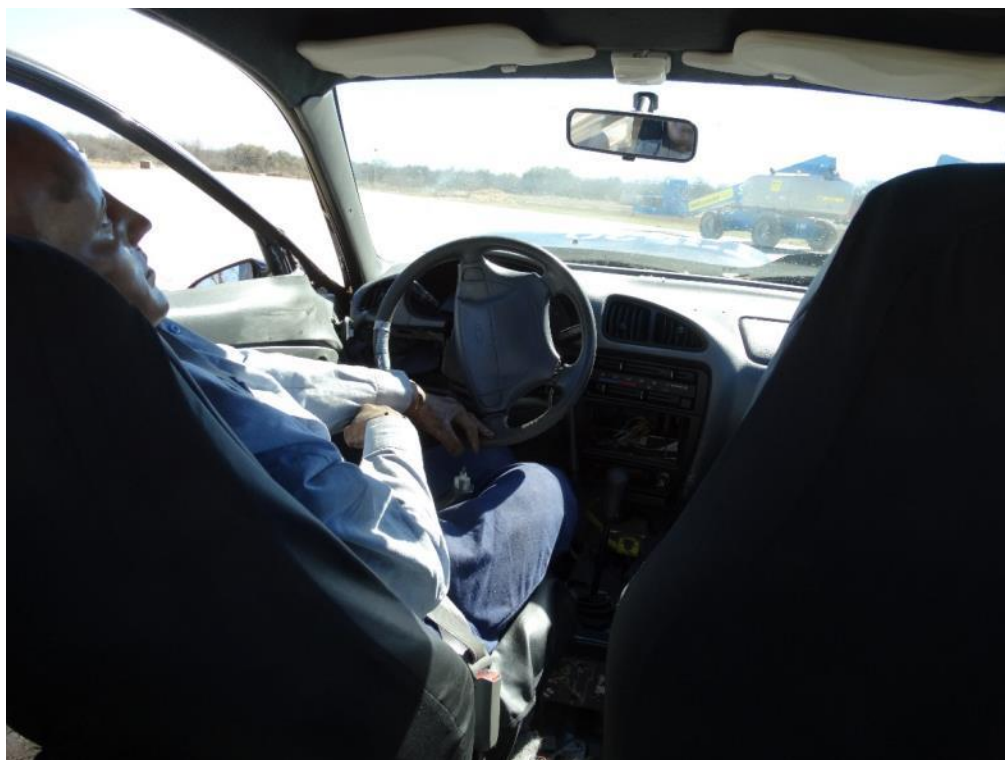
Figure 3.75: Post Test Vehicle – Occupant Compartment
