NCHRP Report 350 Test Report Compilation

Full-Scale Crash Evaluations of the ET Plus[®] End Terminal with 4-inch Wide Guide Channel Installed with a Rail Height of 31 Inches

Test Level 3, Test 3-33, 3-31, 3-32, and 3-30

SwRI[®] Project No. 18.20887

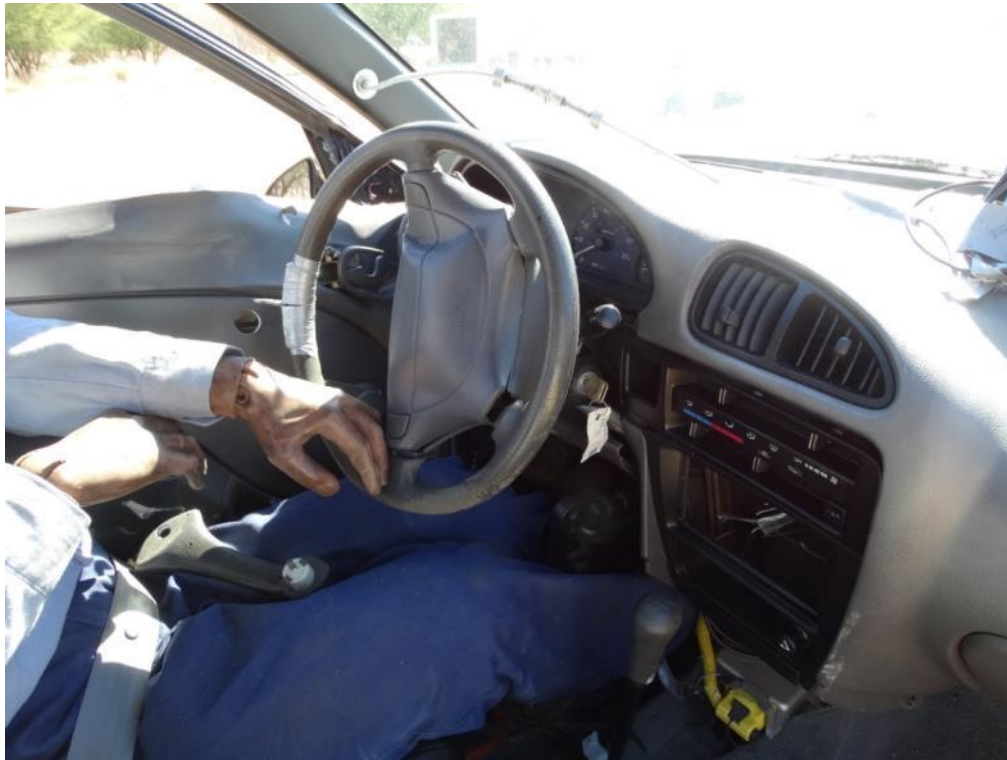
Figure 3.76: Post Test Vehicle – Occupant Compartment

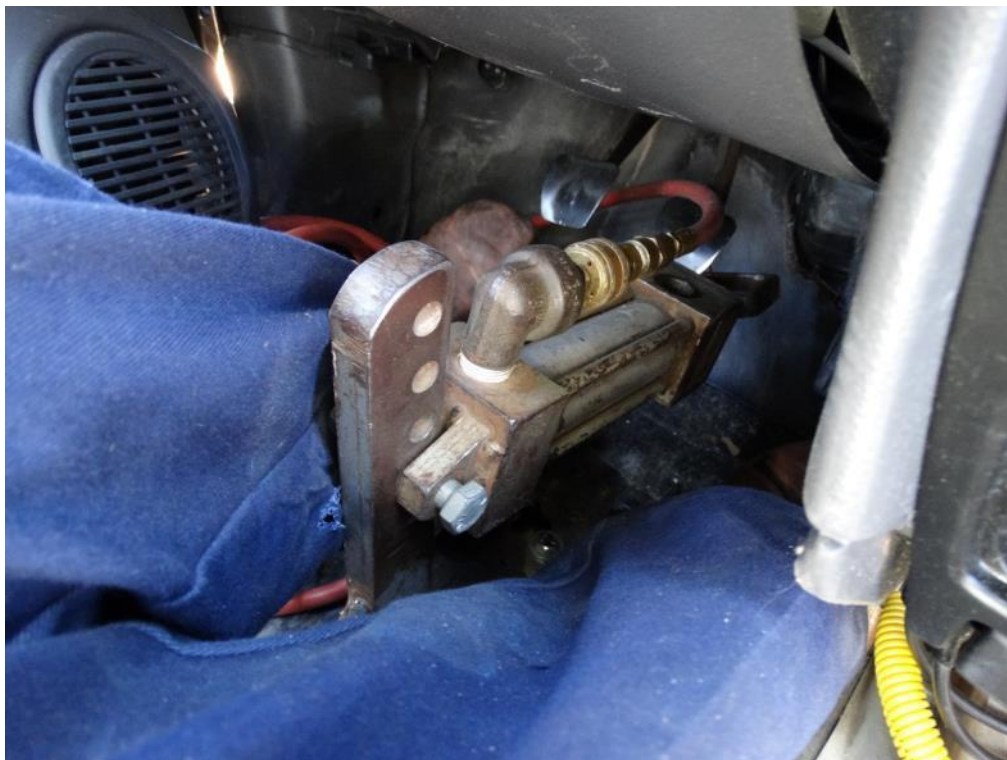
Figure 3.77: Post-Test – Driver Side Floorboard

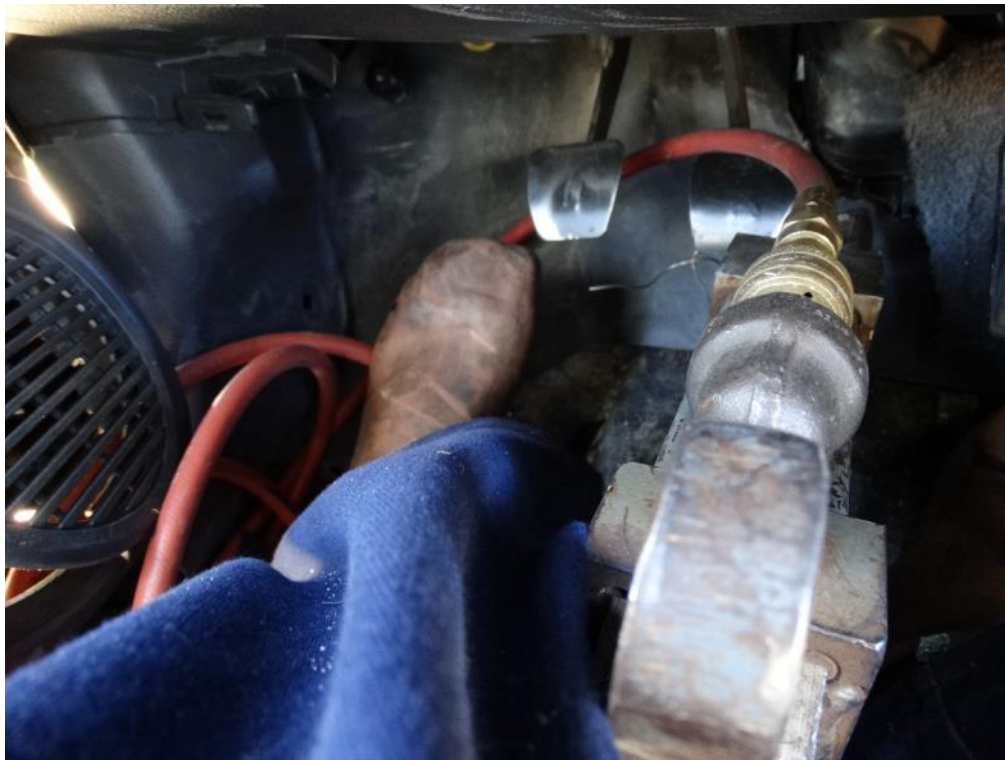
Figure 3.78: Post-Test – Driver Side Floorboard, Close-up

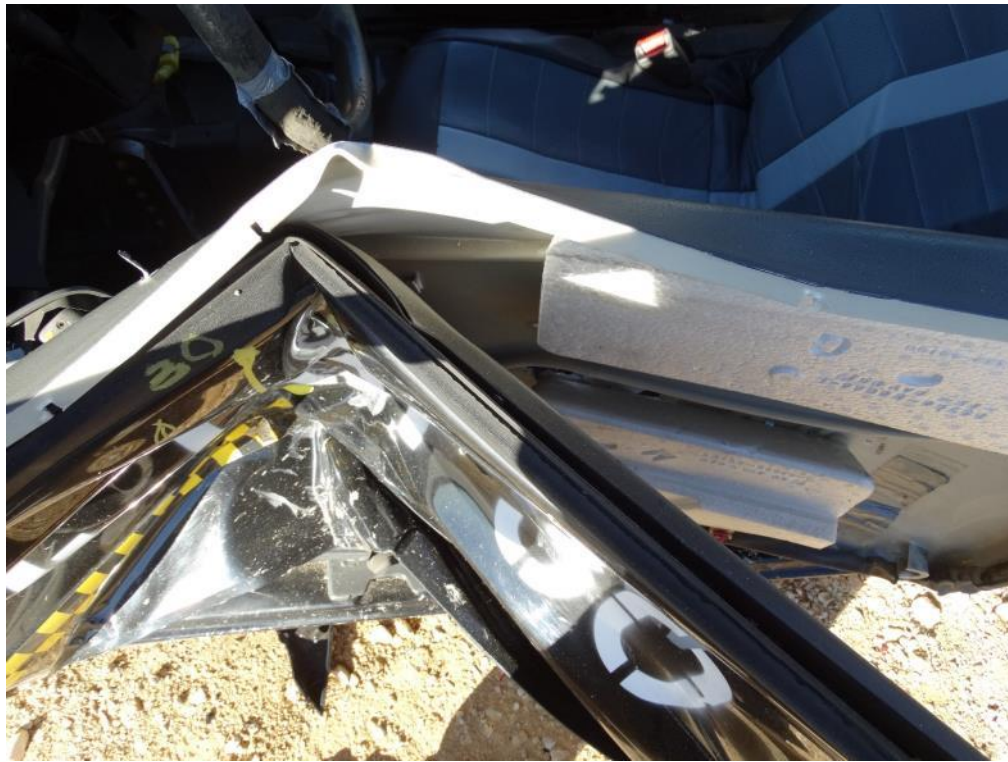
Figure 3.80: Dummy Removed – Left Side Door, Top View

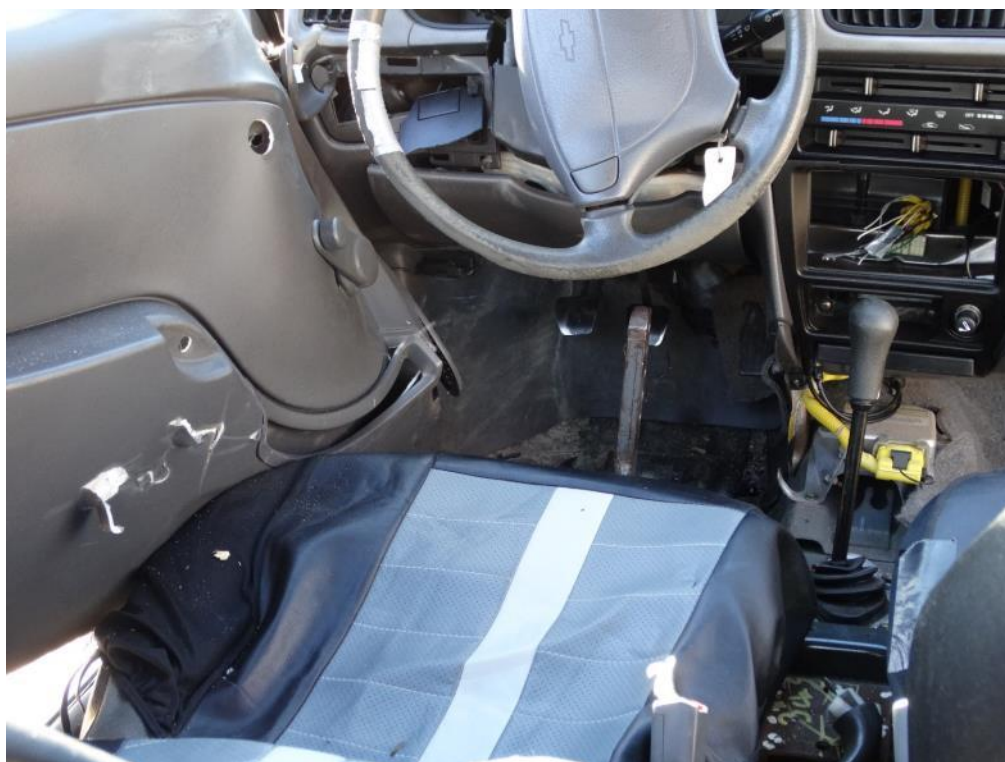
Figure 3.83: Dummy Removed – Driver Side Occupant Compartment

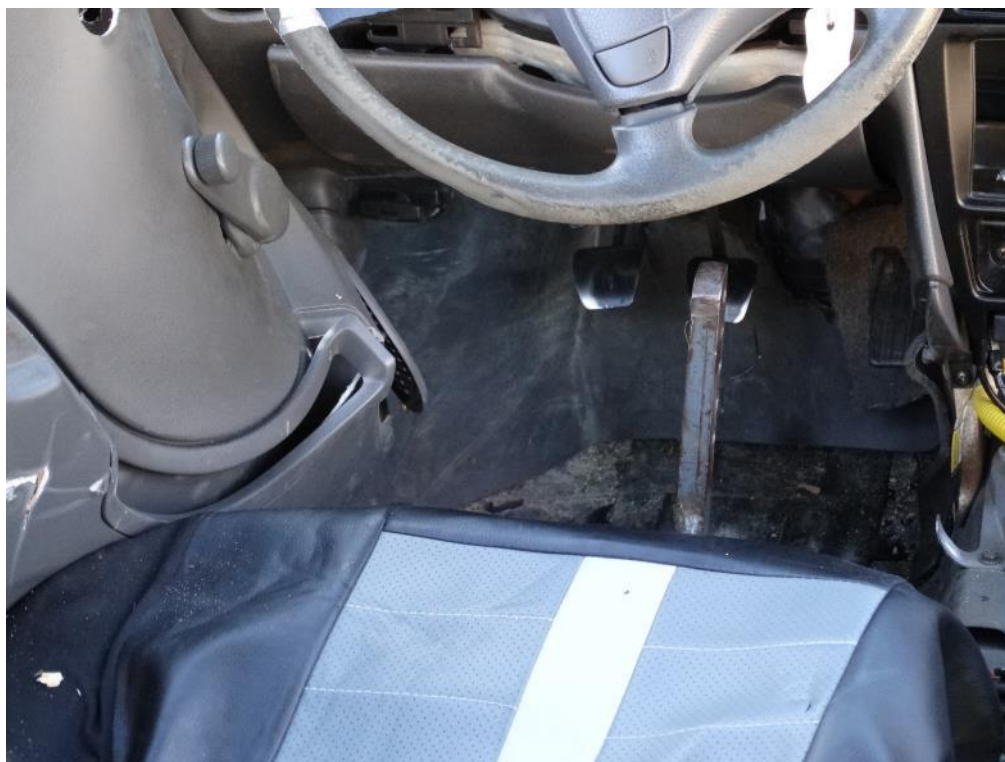
Figure 3.84: Dummy Removed – Driver Side Floorboard

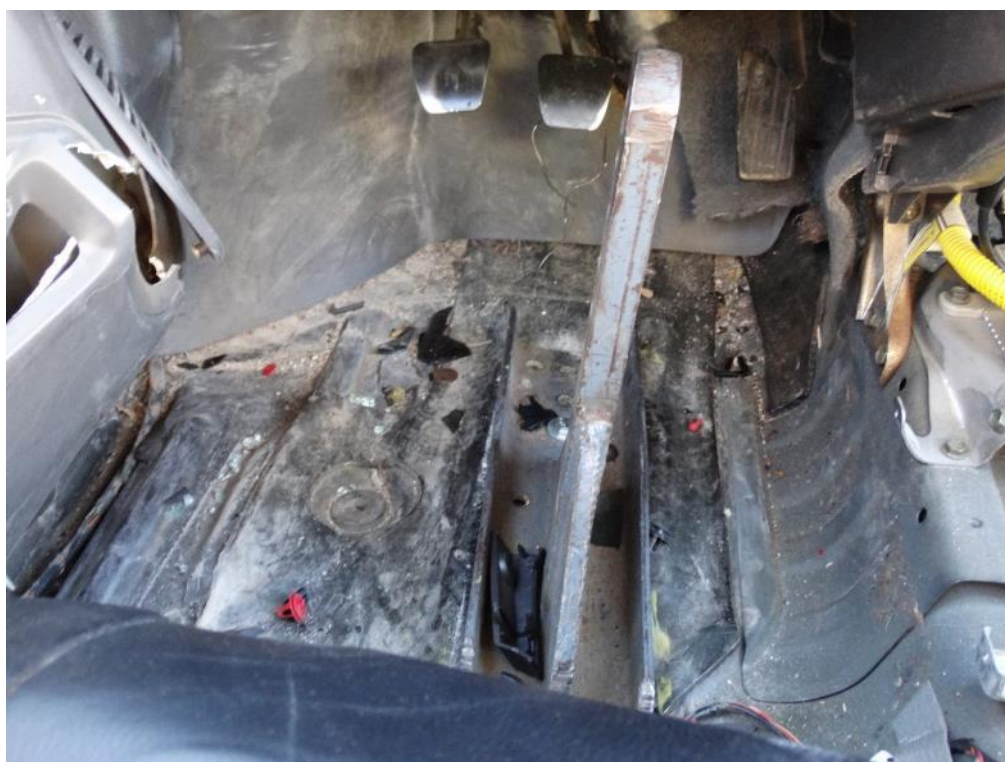
Figure 3.85: Dummy Removed – Driver Side Floorboard, Close-up
