### Post Inspection Memorandum (PIM)

**Synopsis:** On Monday, March 1, 2010 crude oil was released in the Enbridge pipelines, Clearbrook Terminal. At approximately 9:16 AM CST, an accidental valve closure occurred as a result of controller error at their Edmonton, Canada control center, causing line 81 to build up enough back pressure to force the thermal reliefs and rupture pin to relieve to the station sump. The station sump overflowed and approximately 3 barrels were released. The spill was contained in the facility and cleaned within 27 hours.

**Rupture of Enbridge Pipeline and Release of Crude Oil  
near Cohasset, Minnesota  
July 4, 2002**

**NTSB/PAR-04/01**

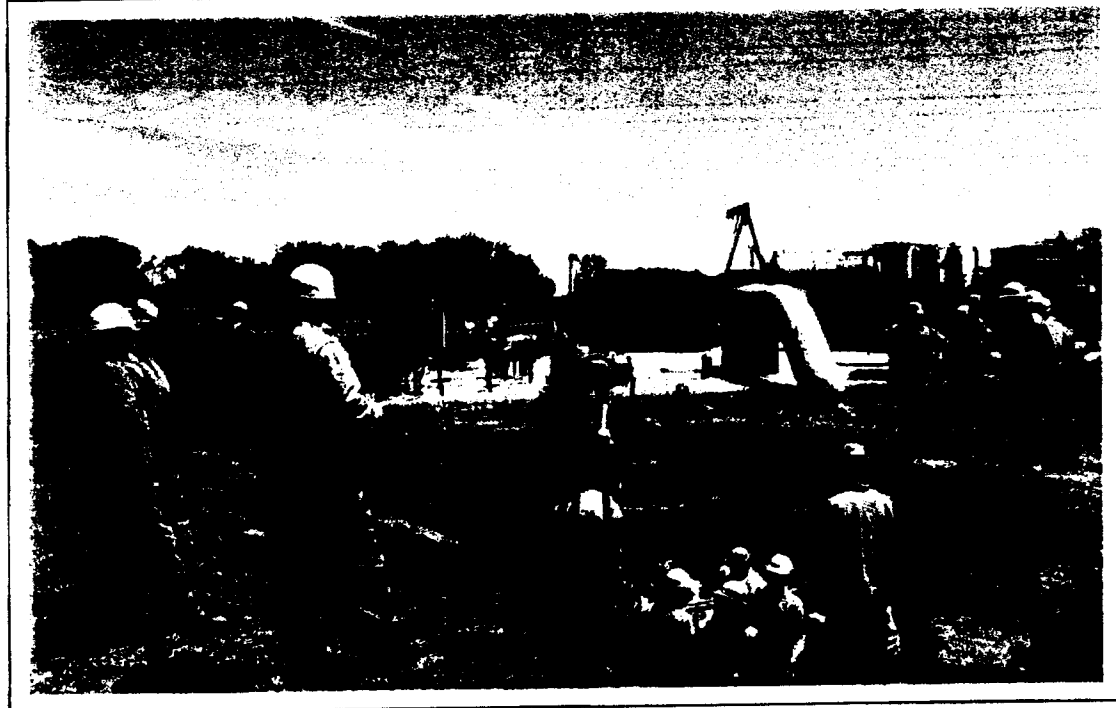
**Photo  
#2**

Photo#2: Looking E at crossover block valve between mainline 6B and loop line C1. The mainline block valve is in the background just to the left of the crossover block valve stem indicator.

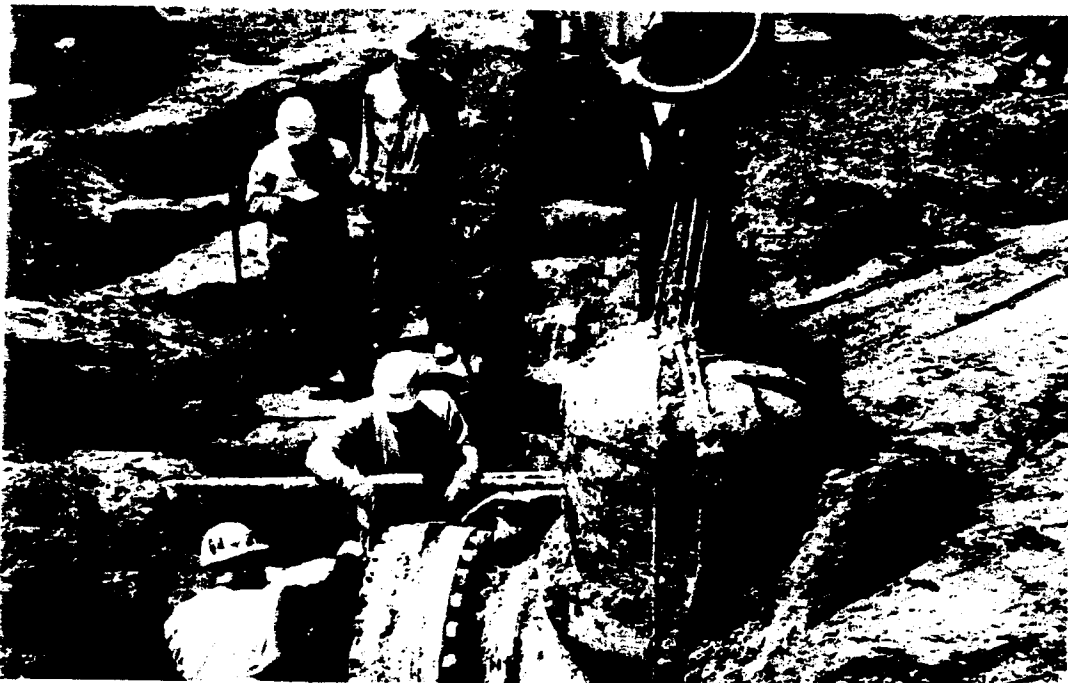
**Photo  
#4**

Photo#4: Looking W at leaking flange gasket on crossover block valve on loop line C1 side

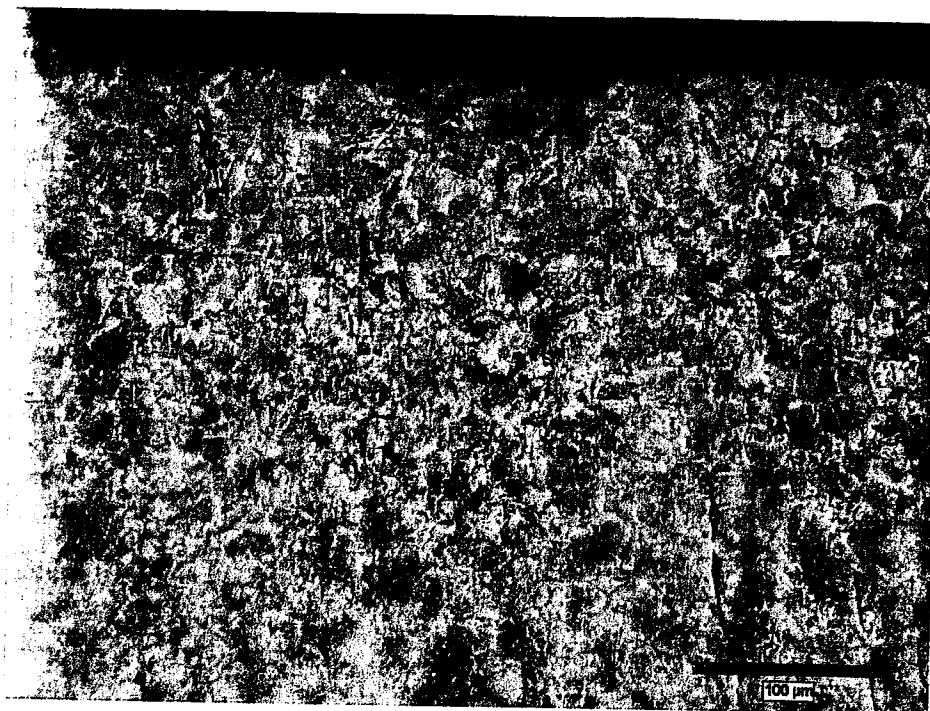
Figure 27. Carburized microstructure near flame-cut end in Sample MET 0.

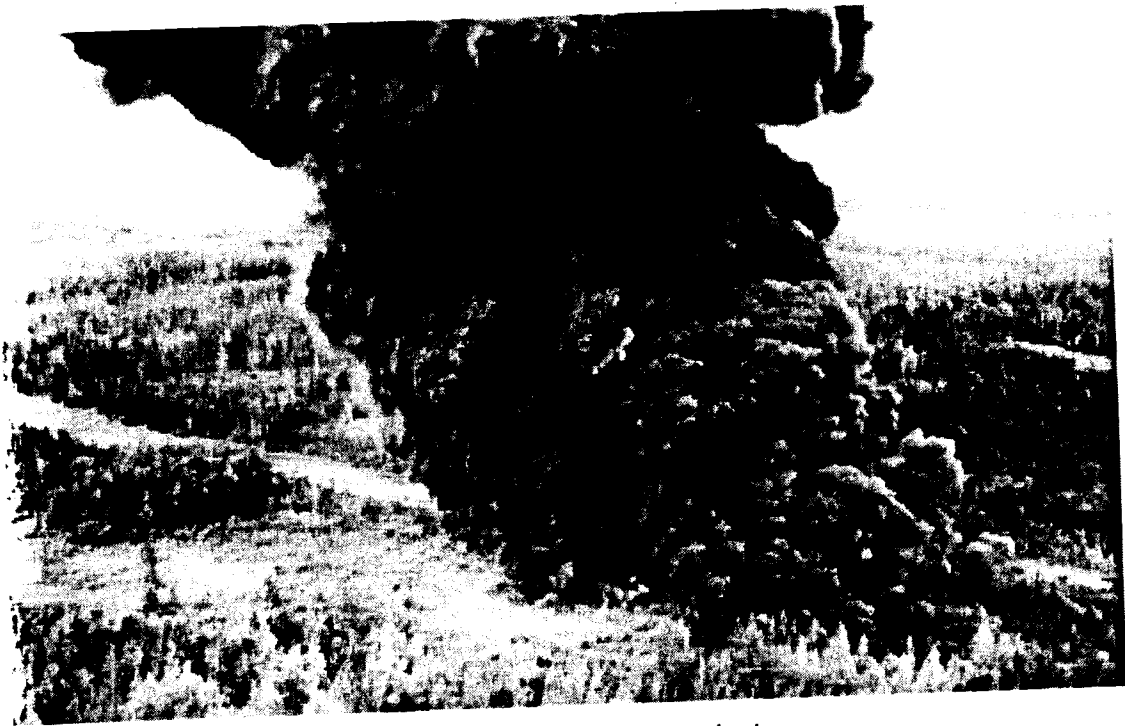
The controlled burn was ignited about 4:45 p.m. (See figure 3.) The burn created a smoke plume about 1 mile high and 5 miles long. (See figure 4.) The controlled burn lasted until about 5:00 p.m. the next day, July 5. While they monitored the fire, Enbridge personnel, firefighters, and environment authorities also monitored the spill perimeter to ensure that no crude was getting into area waterways. Reportedly, no free-flowing product reached any of the boomed areas.

Figure 3. Controlled burn surrounded by white fire retardant.

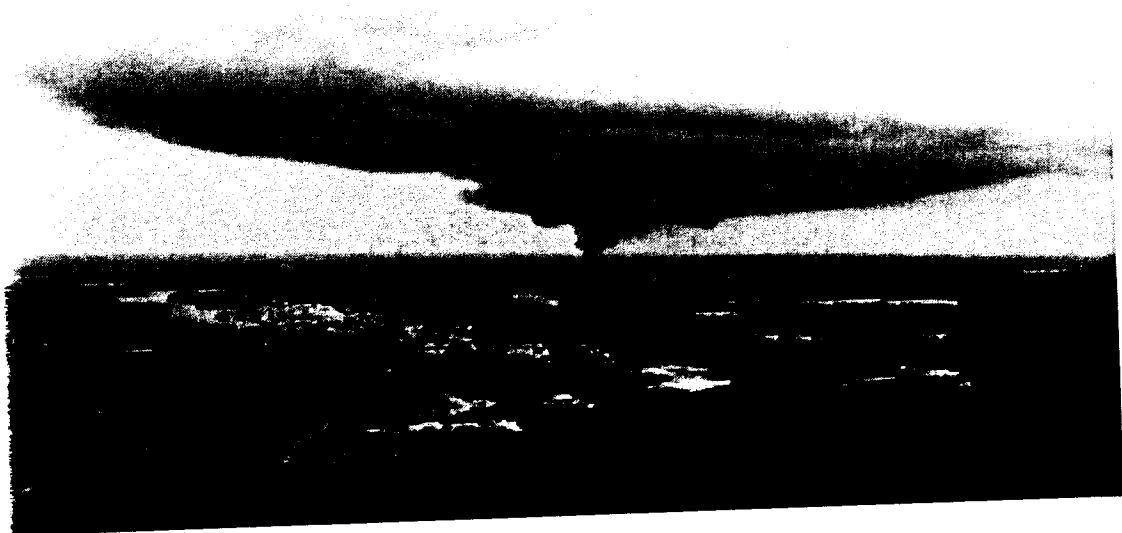
Figure 4. Smoke plume 1 mile high and 5 miles long.
