U.S. Department  
of Transportation

Central Region,  
Pipeline Safety

**NOTICE OF AMENDMENT**

CPF No. 3-2002-5005M

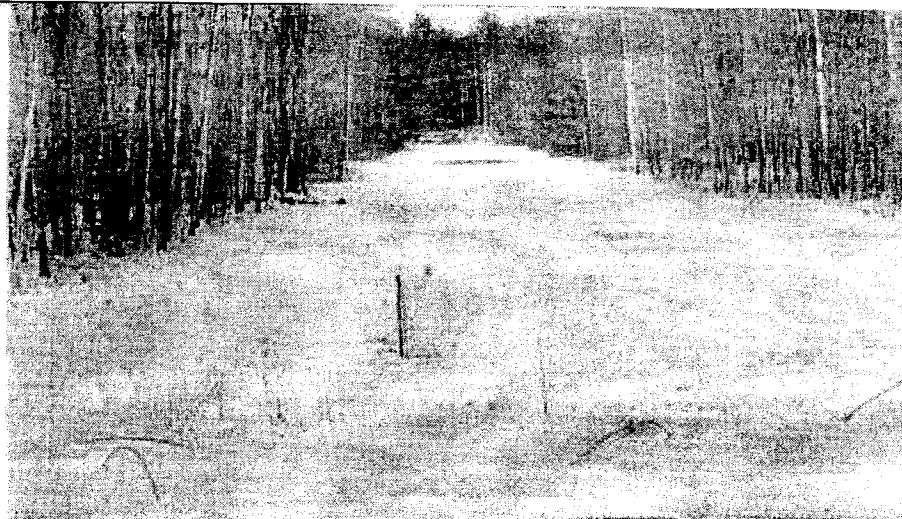
**MP 1149.44**

View upstream from the recreational corridor across the blacktop road.

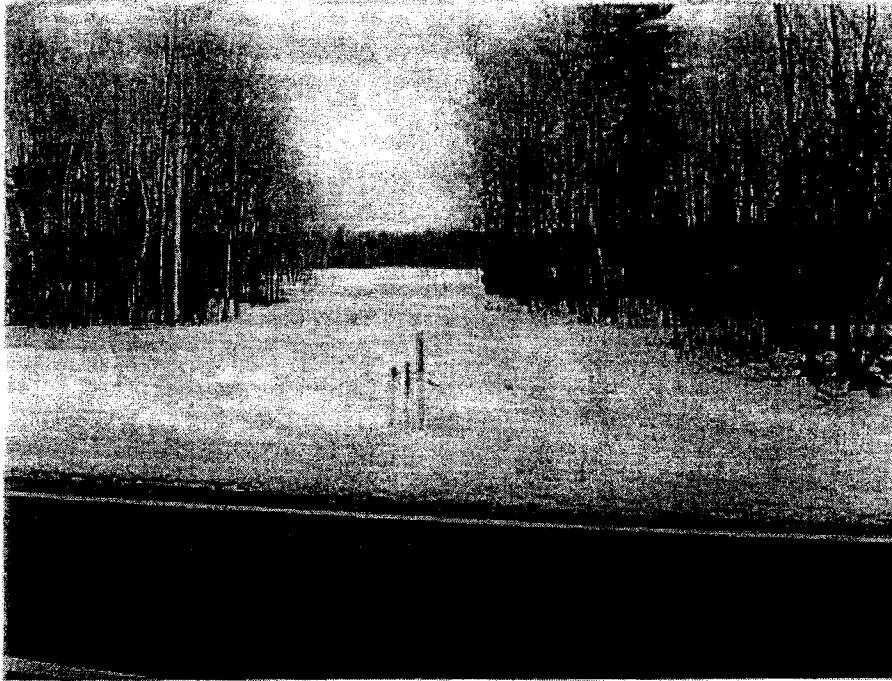
View downstream from blacktop road across recreational corridor into field.

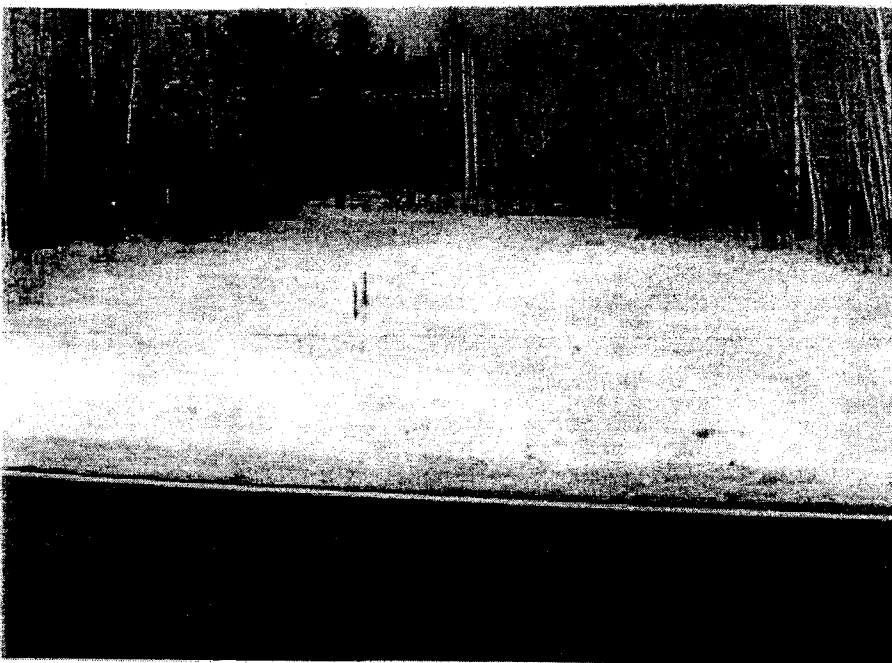
View upstream from blacktop road. R-O-W turns left at power lines.

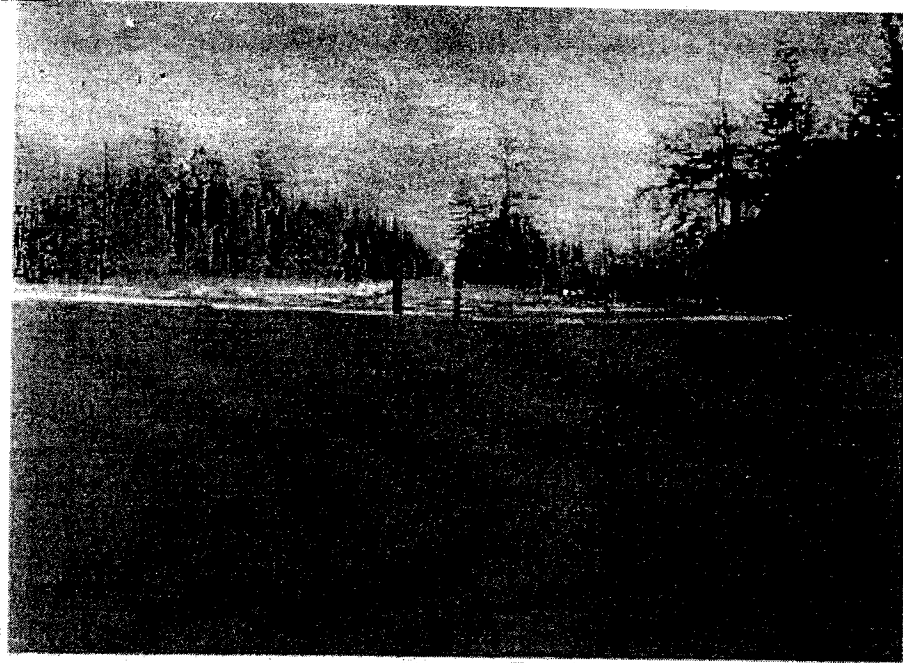
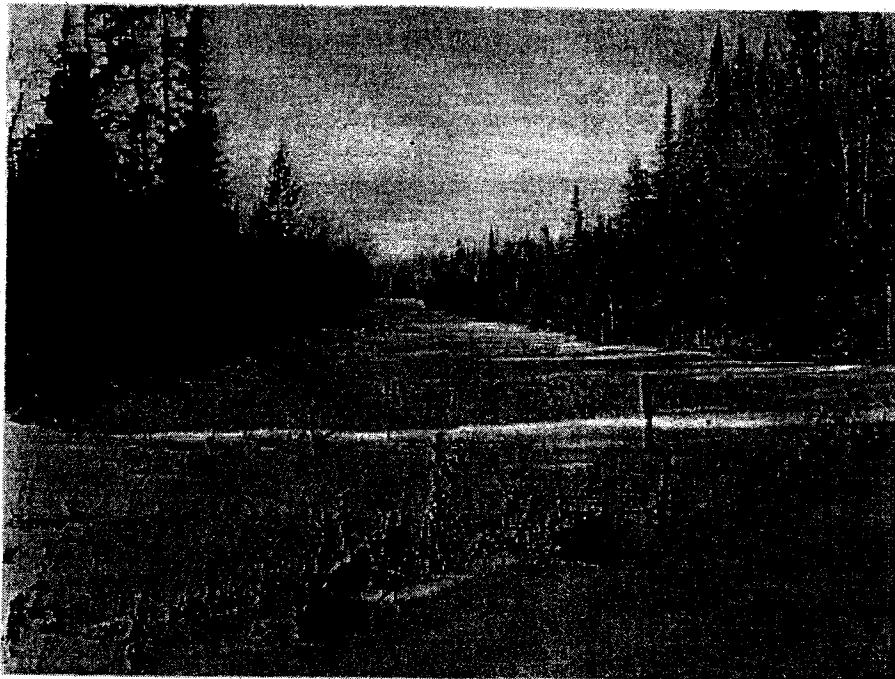
View upstream of road crossing.
